Lone Star Stucco, LLC

Moisture Assessment Report

1931 Indiana Street

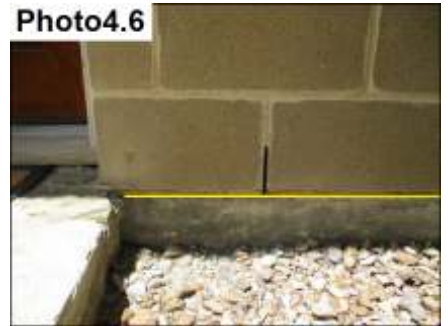
Photo4.6

Proper Grade Termination With Weep Holes / Positive Detail

Grid Location	Item Description	Moisture Readings	Substrate Condition	Observations
Yellow Lines	Grade Termination			CMU appears to be typically detailed at grade for the time of this construction. No visible evidence of moisture intrusion was observed at the time of this inspection at this location. The inspector suggests that this is a positive detail and recommends no modification at this time but to always keep soil away from the structure. Please refer to photos #4.2, #4.3, #4.4, #4.5 and #4.6 for more detail.

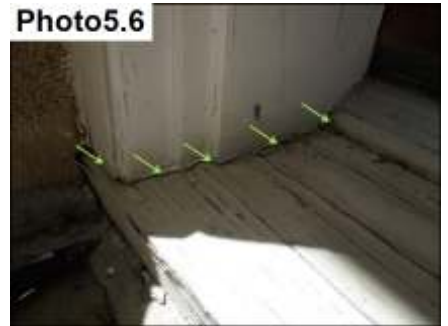
Photo5.6

Door Sealant Separation / Seal

Grid Location	Item Description	Moisture Readings	Substrate Condition	Observations
Green Arrows	Doors			The door trim sealants are missing, aged or separated. The inspector suggests to have a qualified waterproofing contractor seal this area with a low modulus sealant in an effort to prevent moisture intrusion. These types of sealants are of high quality and compatible with stucco and other termination points. Please refer to photos #5.2, #5.3, #5.4, #5.5 and #5.6 for more detail.

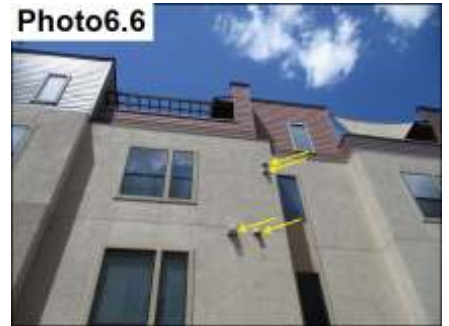
Photo6.6

Penetration Sealants / Seal

Grid Location	Item Description	Moisture Readings	Substrate Condition	Observations
Yellow Arrows	Penetrations			The penetration sealants are aged and separated. The inspector suggests to have a qualified waterproofing contractor seal this area with a low modulus sealant in an effort to prevent moisture intrusion. These types of sealants are of high quality and compatible with stucco and other termination points. Please refer to photos #6.2, #6.3, #6.4, #6.5, #6.6, #7.1, #7.2, #7.3 and #7.4 for more detail.

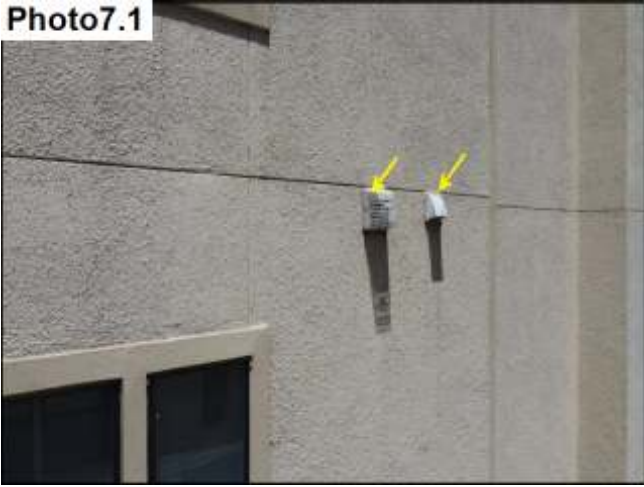
Photo7.1

Penetration Sealants / Seal

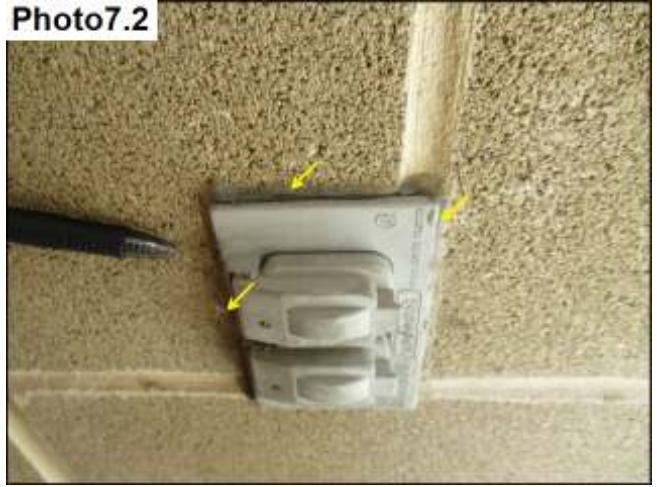
Photo7.2

Penetration Sealants / Seal

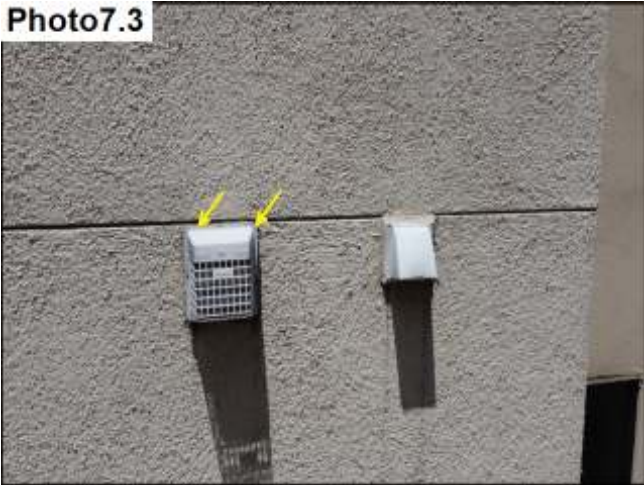
Photo7.3

Penetration Sealants / Seal

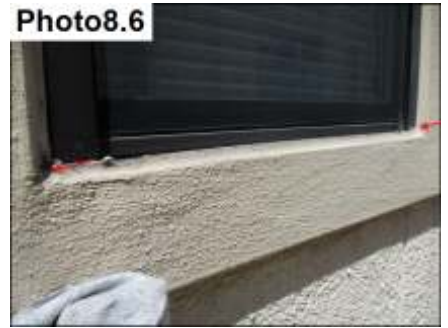
Photo8.6

Window Sealants / Seal

Grid Location	Item Description	Moisture Readings	Substrate Condition	Observations
Red Arrows	Windows			The window sealants are separated. The inspector suggests to have a qualified waterproofing contractor further assess and seal this area with a low modulus sealant in an effort to prevent moisture intrusion. These types of sealants are of high quality and compatible with stucco and other termination points. Please refer to photos #8.2, #8.3, #8.4, #8.5 and #8.6 for more detail.

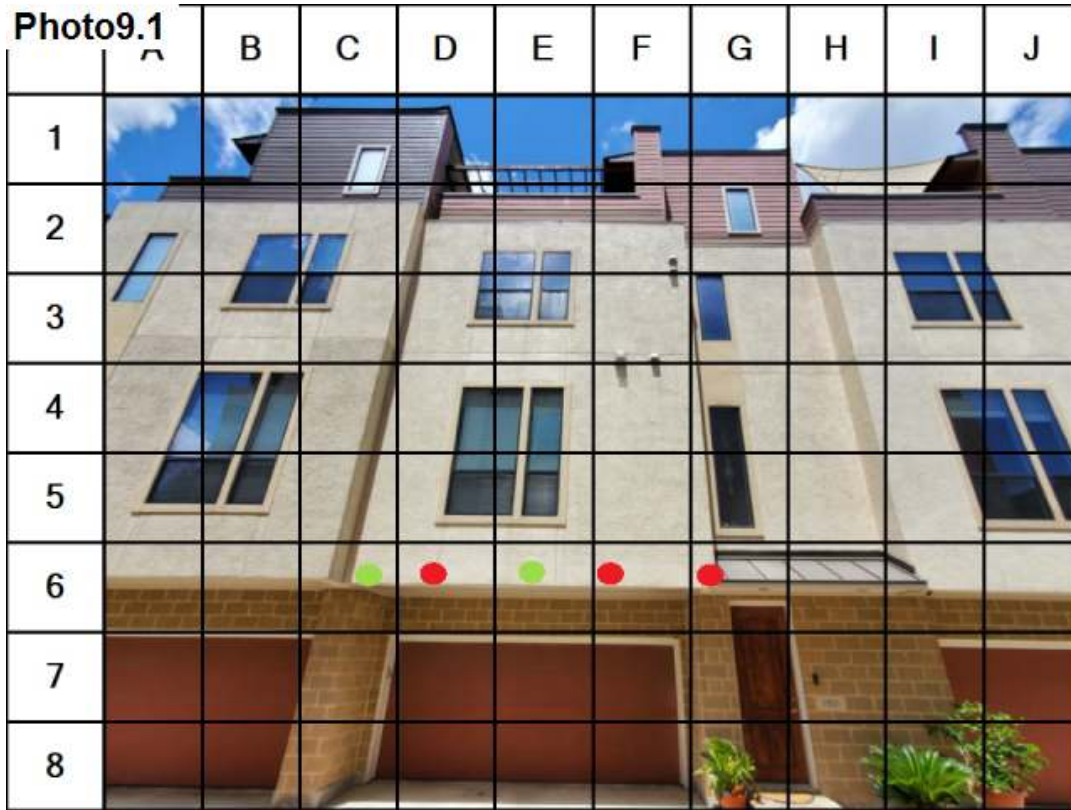
Grid Location	Item Description	Moisture Readings	Substrate Condition	Observations
C6	Bottom Wall	18%	Firm	A moisture probe was made at bottom wall. The substrate was firm with no damage noted at this time.
D6	Bottom Wall	20%	Firm	A moisture probe was made at bottom wall. An elevated moisture reading was noted with a firm substrate.
E6	Bottom Wall	18%	Firm	A moisture probe was made at bottom wall. The substrate was firm with no damage noted at this time.
F6	Bottom Wall	22%	Firm	A moisture probe was made at bottom wall. An elevated moisture reading was noted with a firm substrate.
G6	Bottom Wall	23%	Firm	A moisture probe was made at bottom wall. An elevated moisture reading was noted with a firm substrate.

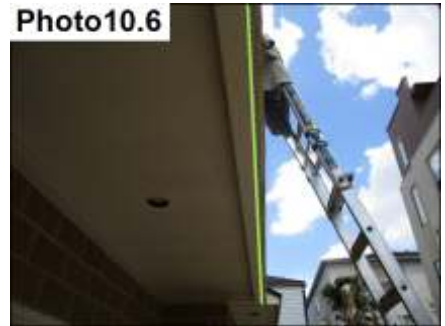
Photo10.6

Reglet Vent Installed / No Modification

Grid Location	Item Description	Moisture Readings	Substrate Condition	Observations
Green Lines	Reglet Vent			The bottom of the bump out wall does have a reglet vent. For the time of construction, this was an acceptable detail but it has been realized that it still has the potential to obstruct proper moisture evacuation. At the time of inspection, the substrate was firm and the inspector recommends no modification at this time as the system is properly functioning. It is suggested to maintain all window sealants above. Please refer to photos #10.2,#10.3, #10.4, #10.5 and #10.6 for more detail.

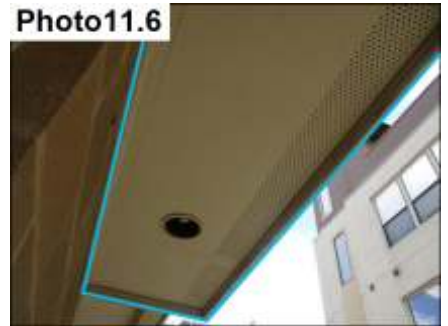
Photo11.6

Pull Back Trim To Create A Relief

Grid Location	Item Description	Moisture Readings	Substrate Condition	Observations
Blue Boxes	Siding			The bottom of the wall trim is preventing the potential moisture to properly evacuate the system. The inspector suggests to pull back the trim at this location and provide a 1/4 inch void to create a relief to allow for proper evacuation of moisture from the system. Please refer to photo #11.2, #11.3, #11.4, #11.5 and #11.6 for more detail.

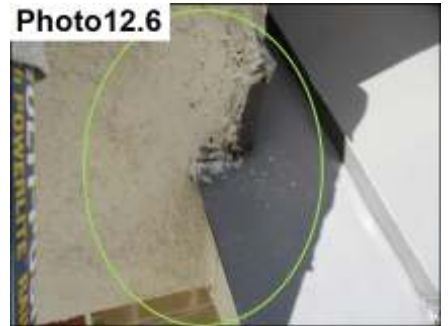
Photo12.6

Roof Diverter Flashing / Seal

Grid Location	Item Description	Moisture Readings	Substrate Condition	Observations
Green Circles	Flashing			Roof diverter flashing sealants are separated. The inspector suggests to have a qualified waterproofing contractor further assess and seal this area with a low modulus sealant in an effort to prevent moisture intrusion. These types of sealants are of high quality and compatible with stucco and other termination points. Please refer to photos #12.2, #12.3, #12.4, #12.5 and #12.6 for more detail.

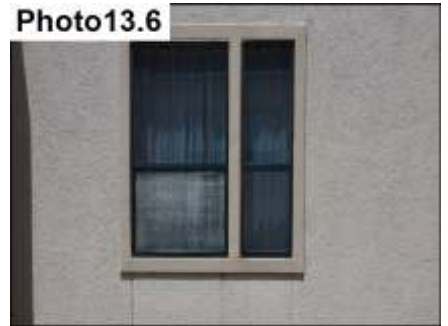
Photo13.6

Window Accent/Stucco Termination / Seal

Grid Location	Item Description	Moisture Readings	Substrate Condition	Observations
Green Boxes	Stucco Termination			The window accents/stucco termination sealants are aged. The inspector suggests to have a qualified waterproofing contractor further assess and seal this area with a low modulus sealant in an effort to prevent moisture intrusion. These types of sealants are of high quality and compatible with stucco and other termination points. Please refer to photos #13.2, #13.3, #13.4, #13.5 and #13.6 for more detail.

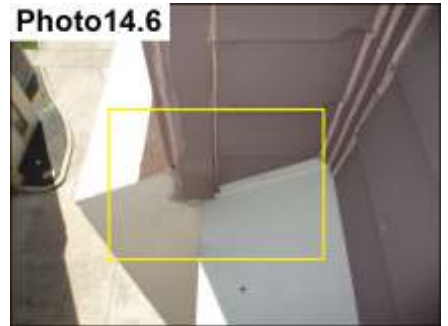
Photo14.6

Metal Cap/Siding Termination / Maintain

Grid Location	Item Description	Moisture Readings	Substrate Condition	Observations
Orange Lines	Metal Cap			The metal cap sealants are present at these locations. The inspector suggests to maintain these sealants in an effort to prevent moisture intrusion. Please refer to photos #14.2, #14.3, #14.4, #14.5 and #14.6 for more detail.

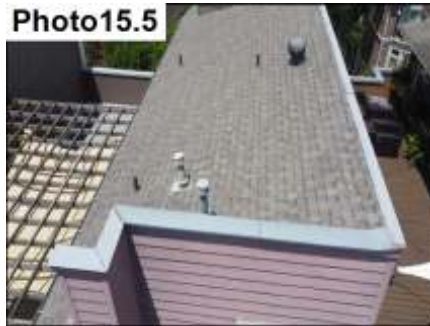
Photo15.5

Roof Flashing / Seal

Grid Location	Item Description	Moisture Readings	Substrate Condition	Observations
Blue Circles	Flashing			The metal cap flashing sealants are beginning to age at these locations. The inspector suggests to have a qualified waterproofing contractor further assess and seal this area with a low modulus sealant in an effort to prevent moisture intrusion. These types of sealants are of high quality and compatible with stucco and other termination points. Please refer to photos #15.2, #15.3, #15.4 and #15.5 for more detail.

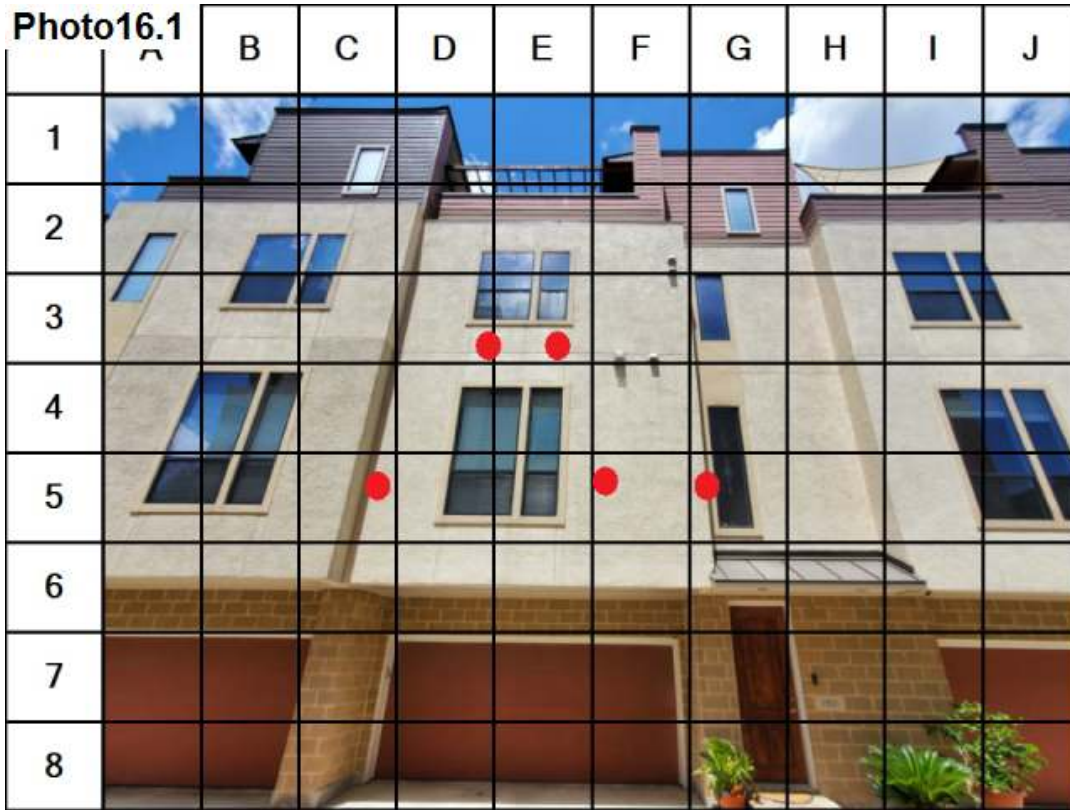
Grid Location	Item Description	Moisture Readings	Substrate Condition	Observations
C5	Corner Wall	20%	Firm	A moisture probe was made at corner wall. An elevated moisture reading was noted with a firm substrate.
F5	Mid Wall	22%	Firm	A moisture probe was made at mid wall. An elevated moisture reading was noted with a firm substrate.
G5	Window Header	23%	Firm	A moisture probe was made at window header. An elevated moisture reading was noted with a firm substrate.
D3	Window Header	22%	Firm	A moisture probe was made at window header. An elevated moisture reading was noted with a firm substrate.
E3	Window Header	21%	Firm	A moisture probe was made at window header. An elevated moisture reading was noted with a firm substrate.

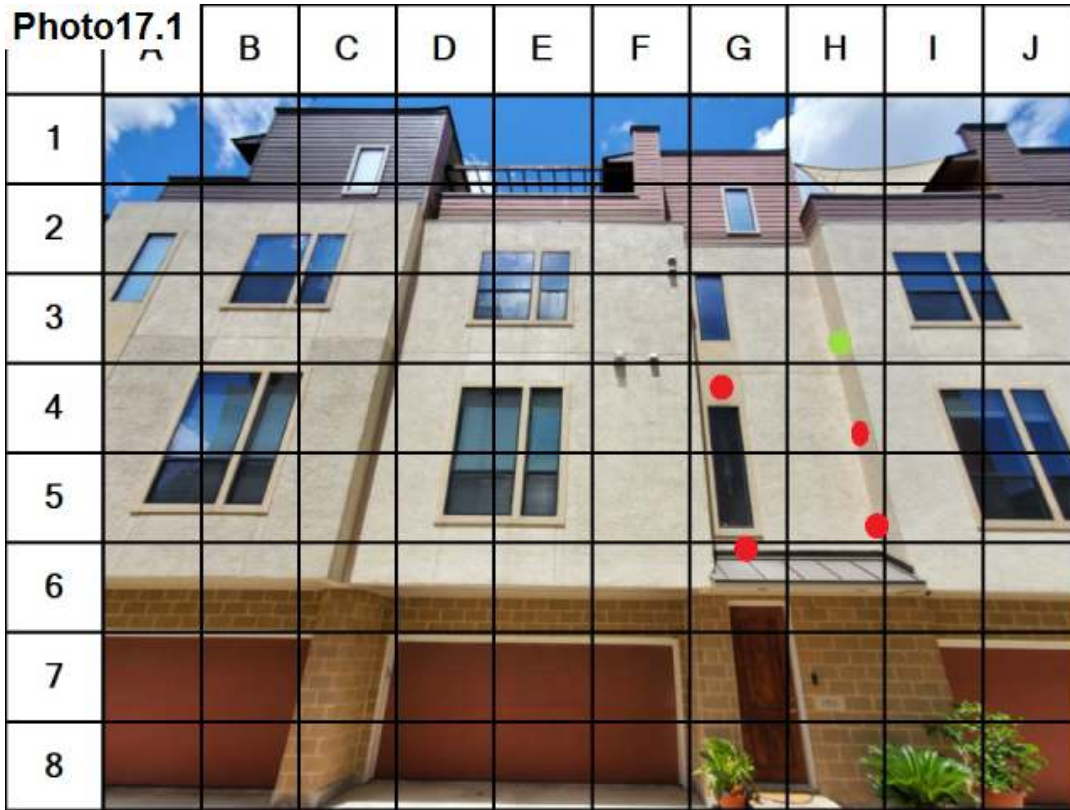
Grid Location	Item Description	Moisture Readings	Substrate Condition	Observations
G6	Wall Below Siding	20%	Firm	A moisture probe was made at wall below siding. An elevated moisture reading was noted with a firm substrate.
G4	Wall Below Siding	23%	Firm	A moisture probe was made at wall below siding. An elevated moisture reading was noted with a firm substrate.
H5	Wall Below Siding	22%	Firm	A moisture probe was made at wall below siding. An elevated moisture reading was noted with a firm substrate.
H4	Wall Below Siding	22%	Firm	A moisture probe was taken at wall below siding. An elevated moisture reading was noted with a firm substrate.
H3	Wall Below Siding	18%	Firm	A moisture probe was taken at wall below siding. The substrate was firm with no damage noted at this time.

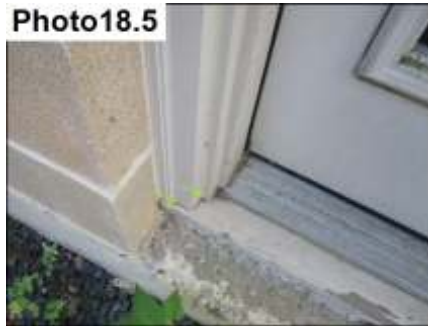
Photo18.5

Door Sealant Separation / Seal

Grid Location	Item Description	Moisture Readings	Substrate Condition	Observations
Green Arrows	Doors			The door trim and miter sealants are aged and separated. The inspector suggests to have a qualified waterproofing contractor seal this area with a low modulus sealant in an effort to prevent moisture intrusion. These types of sealants are of high quality and compatible with stucco and other termination points. Please refer to photos #18.2, #18.3, #18.4 and #18.5 for more detail.

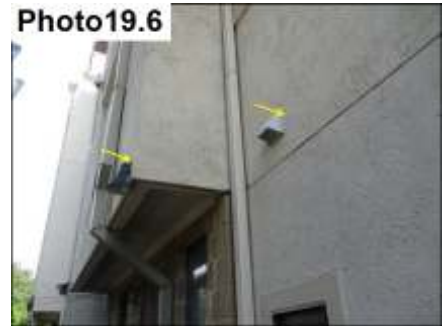
Photo19.6

Penetration Sealants / Seal

Grid Location	Item Description	Moisture Readings	Substrate Condition	Observations
Yellow Arrows	Penetrations			The penetration sealants are aged. The inspector suggests to have a qualified waterproofing contractor remove aged sealants then seal this area with a low modulus sealant in an effort to prevent moisture intrusion. These types of sealants are of high quality and compatible with stucco and other termination points. Please refer to photos #19.2, #19.3, #19.4, #19.5, #19.6, #20.1, #20.2, #20.3 and #20.4 for more detail.

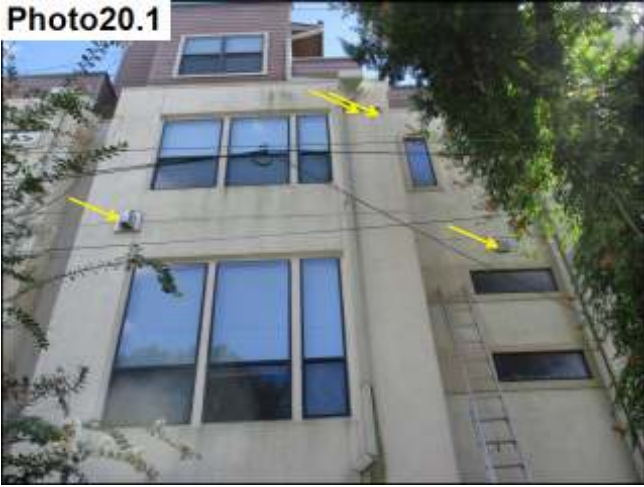
Photo20.1

Penetration Sealants / Seal

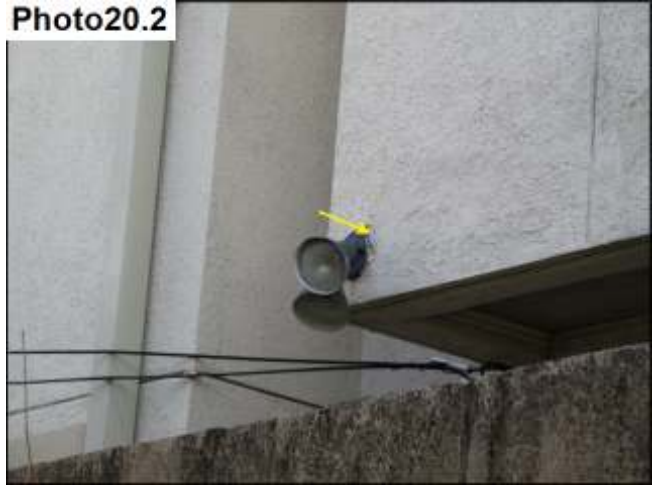
Photo20.2

Penetration Sealants / Seal

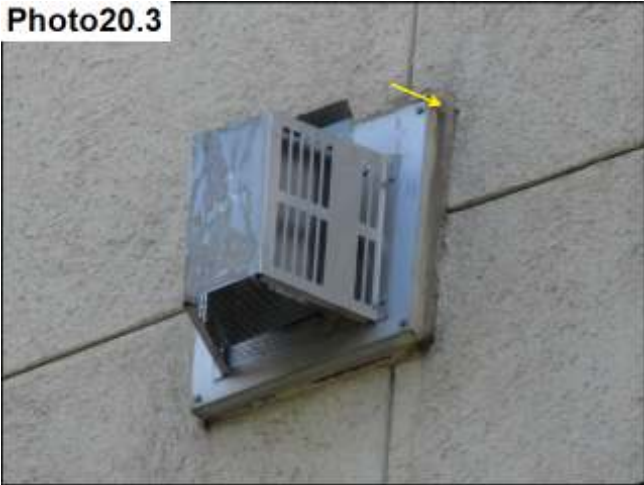
Photo20.3

Penetration Sealants / Seal

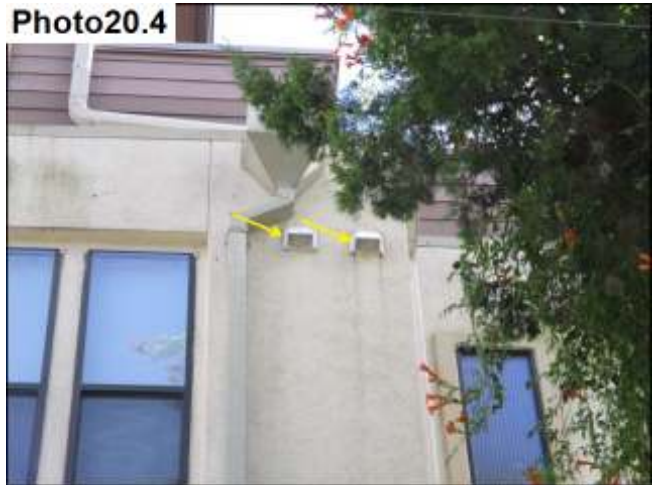
Photo20.4

Penetration Sealants / Seal

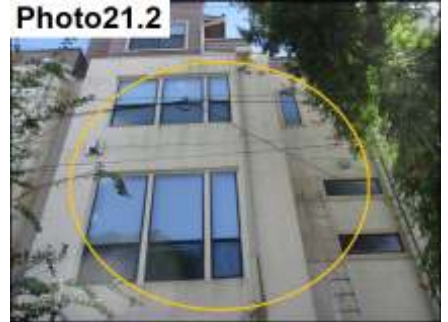
Photo21.2

Mildew Noted & Runoff Stains /
Clean Aesthetic Concern

Grid Location	Item Description	Moisture Readings	Substrate Condition	Observations
Orange Circles	Stains			Mildew and run off stains have been noted in these areas. The inspector suggests to clean and paint the area as needed from an aesthetic concern only. Please refer to photos #21.2, #21.3, #21.4, #21.5 and #21.6 for more detail.

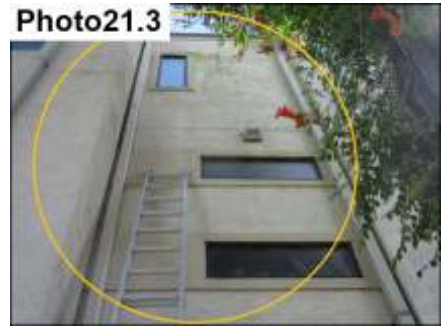
Photo21.3

Mildew Noted & Runoff Stains /
Clean Aesthetic Concern

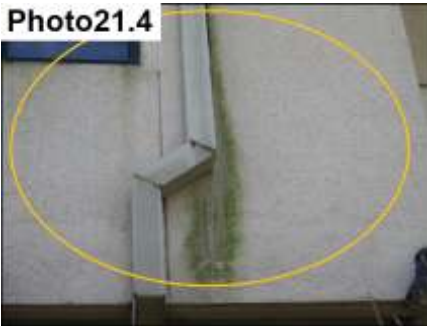
Photo21.4

Mildew Noted & Runoff Stains /
Clean Aesthetic Concern

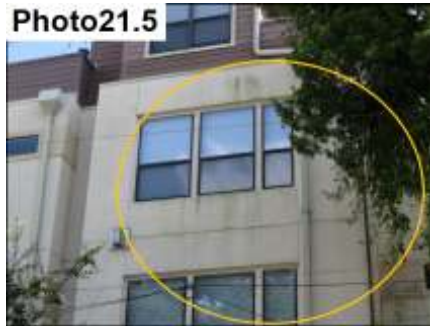
Photo21.5

Mildew Noted & Runoff Stains /
Clean Aesthetic Concern

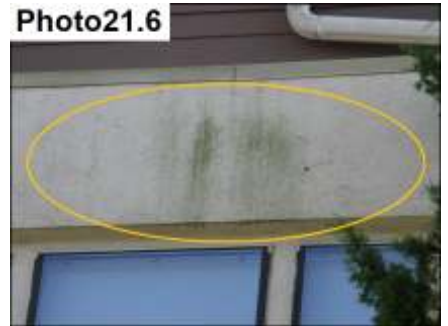
Photo21.6

Mildew Noted & Runoff Stains /
Clean Aesthetic Concern

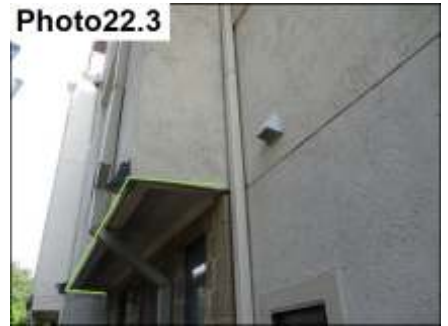
Photo22.3

Reglet Vent Installed / No Modification

Grid Location	Item Description	Moisture Readings	Substrate Condition	Observations
Green Lines	Reglet Vent			The bottom of the bumpout does have a reglet vent with elevated moisture and firm substrate noted. For the time of construction, this was an acceptable detail but it has been realized that it still has the potential to obstruct proper moisture evacuation. The inspector suggests not to modify this area at this point in time but to maintain window sealants above. Please refer to photos #22.2 and #22.3 for more detail.

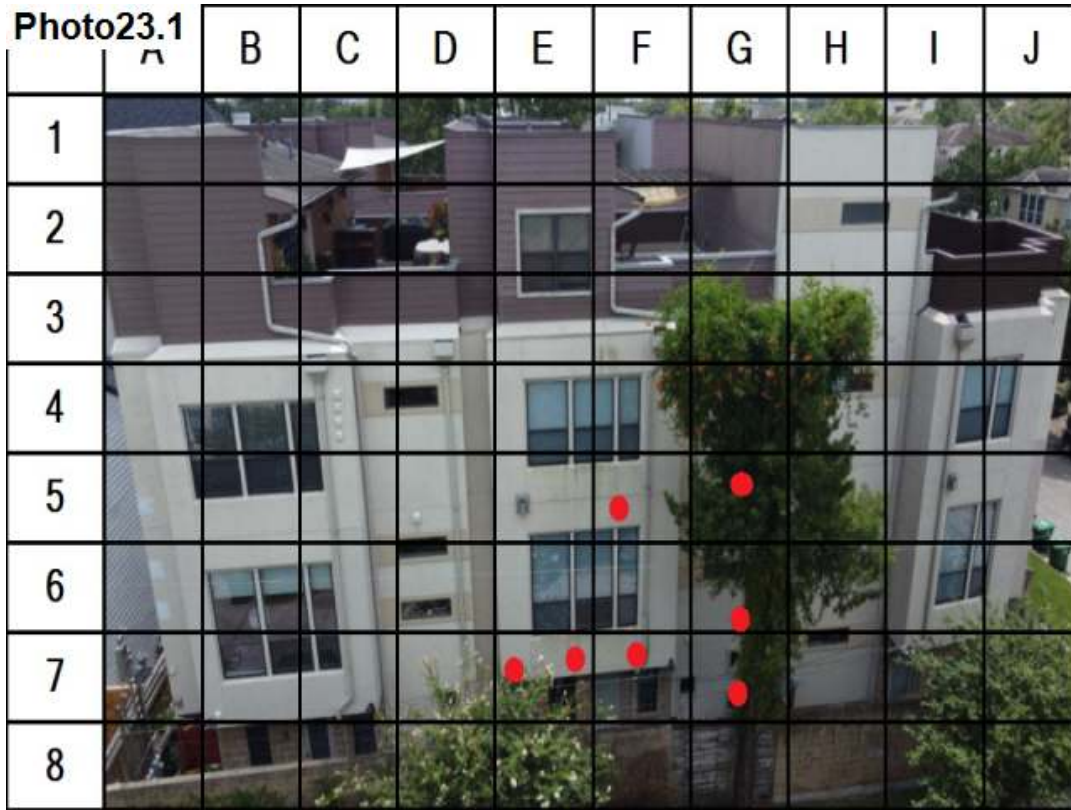
Grid Location	Item Description	Moisture Readings	Substrate Condition	Observations
E7 (right)	Bottom Wall	24%	Firm	A moisture probe was made at bottom wall. An elevated moisture reading was noted with a firm substrate.
E7 (left)	Bottom Wall	23%	Firm	A moisture probe was made at bottom wall. An elevated moisture reading was noted with a firm substrate.
F7	Bottom Wall	22%	Firm	A moisture probe was made at bottom wall. An elevated moisture reading was noted with a firm substrate.
G7	Window Lower Right	24%	Firm	A moisture probe was made below the window bottom right. An elevated moisture reading was noted with a firm substrate.
G6	Window Header	26%	Semi-Firm	A moisture probe was made at window header. An elevated moisture reading was noted with a semi-firm substrate.
F5	Window Header	27%	Semi-Firm	A moisture probe was made at window header. An elevated moisture reading was noted with a semi-firm substrate.

G5	Window Header	28%	Semi-Firm	A moisture probe was made at window header. An elevated moisture reading was noted with a semi-firm substrate.

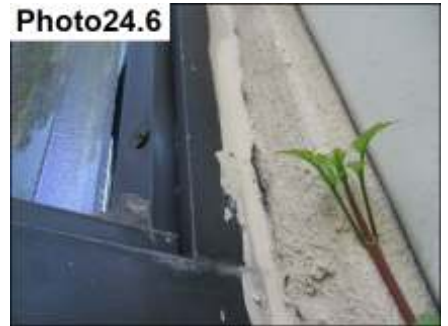
Photo24.6

Window Sealants / Seal

Grid Location	Item Description	Moisture Readings	Substrate Condition	Observations
Red Arrows	Windows			The window sealants are separated. The inspector suggests to have a qualified waterproofing contractor further assess and seal this area with a low modulus sealant in an effort to prevent moisture intrusion. These types of sealants are of high quality and compatible with stucco and other termination points. Please refer to photos #24.2, #24.3, #24.4, #24.5, #24.6, #25.1, #25.2, #25.3 and #25.4 for more detail.

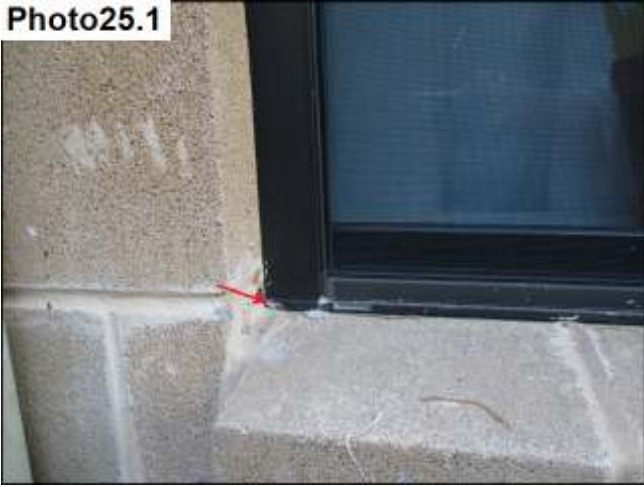
Photo25.1

Window Sealants / Seal

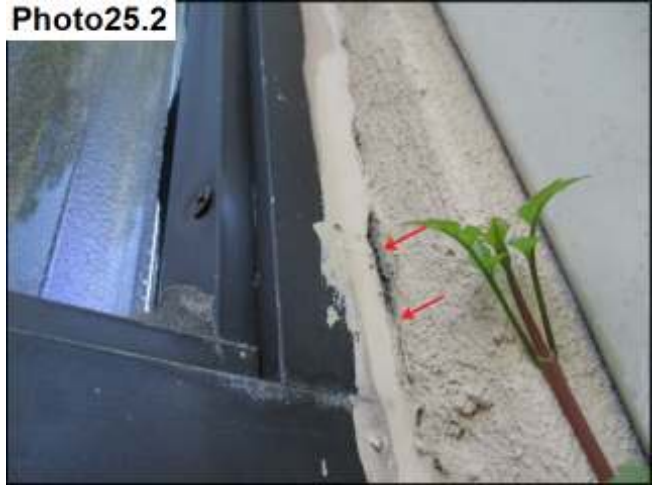
Photo25.2

Window Sealants / Seal

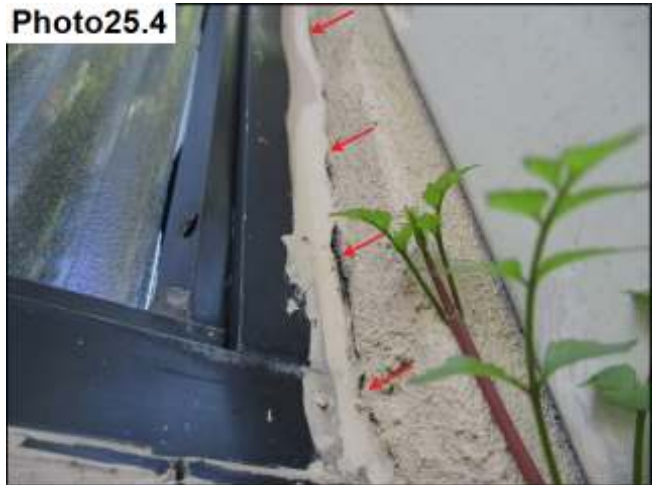
Photo25.4

Window Sealants / Seal

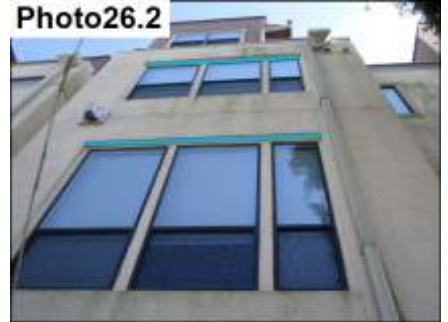
Photo26.2

Relief Missing / Install

Grid Location	Item Description	Moisture Readings	Substrate Condition	Observations
Blue Lines	Relief			The bottom of the wall at the window header is missing a proper relief and elevated moisture noted. The inspector suggests having a qualified waterproofing contractor further assess and modify this location, creating a relief to allow for proper evacuation of moisture from the system. Please refer to photos #26.2, #26.3, #26.4, #26.5 and #26.6 for more detail.

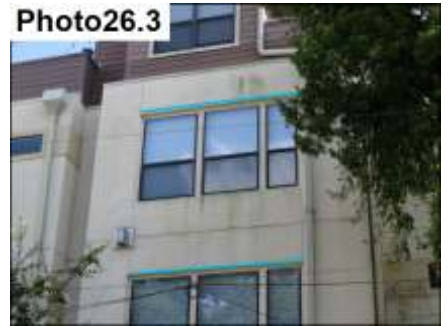
Photo26.3

Relief Missing / Install

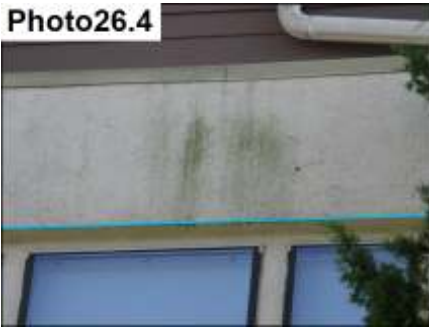
Photo26.4

Relief Missing / Install

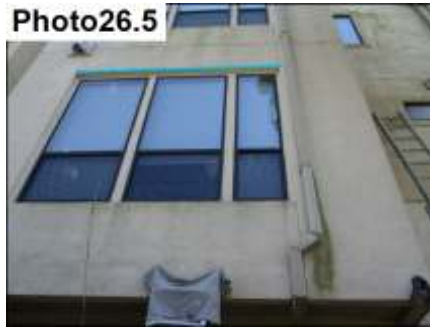
Photo26.5

Relief Missing / Install

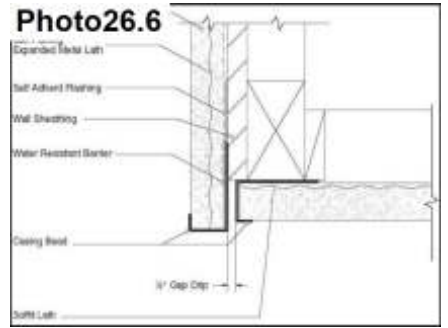
Photo26.6

Proper Detail

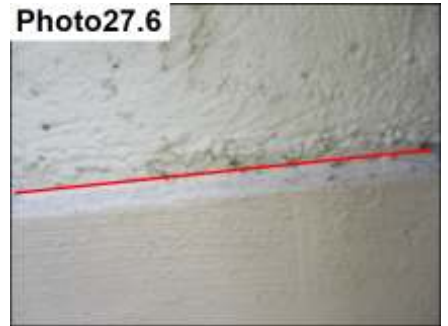
Photo27.6

Window Accent Band/Stucco Termination / Seal

Grid Location	Item Description	Moisture Readings	Substrate Condition	Observations
Green Boxes	Stucco Termination			The window accent band/stucco termination sealants are aged or separated. The inspector suggests to have a qualified waterproofing contractor further assess and repair all cracks then seal the termination with a low modulus sealant in an effort to prevent moisture intrusion. These types of sealants are of high quality and compatible with stucco and other termination points. Please refer to photos #27.2, #27.3, #27.4, #27.5 and #27.6 for more detail.

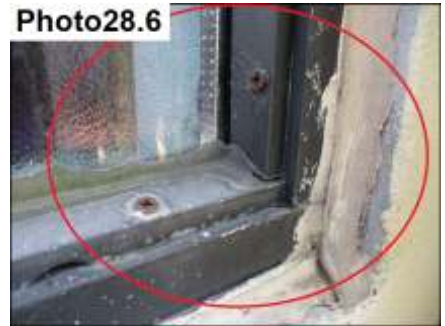
Photo28.6

Refasten & Seal All Screws Then Wet Glaze

Grid Location	Item Description	Moisture Readings	Substrate Condition	Observations
Red Circle	Windows			Fixed windows are noted in these areas with missing and unsealed screws allowing moisture to penetrate the system. The inspector suggests refastening and seal all screws then wet glaze these windows to help decrease the amount of moisture intrusion that can occur at windowpane itself. Glazing the window is using a silicone sealant to seal the glass windowpane to the metal frame. Please refer to photos #28.2, #28.3, #28.4, #28.5 and #28.6 for more detail.

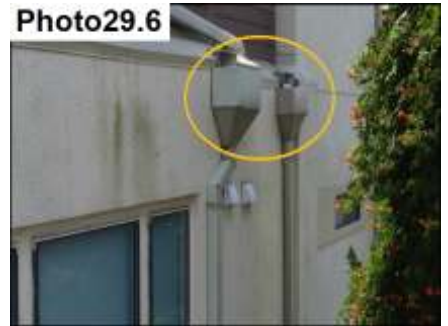
Photo29.6

Scupper Sealants / Seal

Grid Location	Item Description	Moisture Readings	Substrate Condition	Observations
Orange Circle	Scupper			The scupper sealants are aged. The inspector suggests to have a qualified stucco waterproofing contractor seal this area with a low modulus sealant in an effort to prevent moisture intrusion. These types of sealants are of high quality and compatible with stucco and other termination points. Please refer to photos#29.2, #29.3, #29.4, #29.5 and #29.6 for more detail.

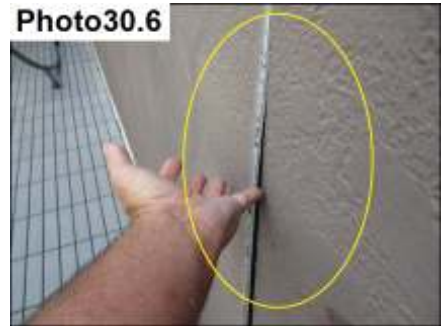
Photo30.6

Cement Fiber Panels Separated /
Re-Fasten and Seal

Grid Location	Item Description	Moisture Readings	Substrate Condition	Observations
Yellow Circles	Siding			The cement fiber panels are separated. The inspector suggests having a qualified waterproofing contractor further assess this area and re-fasten and seal joints to prevent moisture intrusion. Please refer to photos #30.2, #30.3, #30.4, #30.5 and #30.6 for more detail.

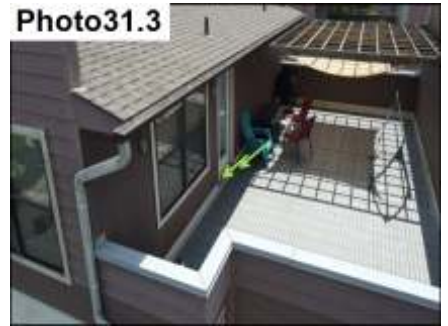
Photo31.3

Door Sealant Separation / Seal

Grid Location	Item Description	Moisture Readings	Substrate Condition	Observations
Green Arrows	Doors			The door trim sealants are aged. The inspector suggests to have a qualified waterproofing contractor seal this area in an effort to prevent moisture intrusion. Please refer to photos #31.2 and #31.3 for more detail.

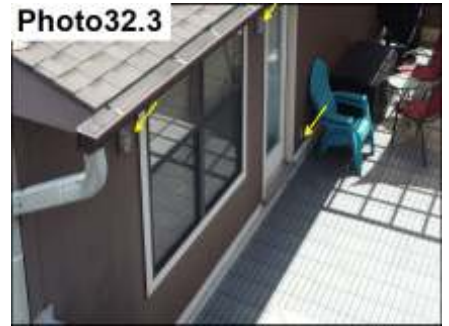
Photo32.3

Penetration Sealants / Seal

Grid Location	Item Description	Moisture Readings	Substrate Condition	Observations
Yellow Arrows	Penetrations			The penetration sealants are aged and separated. The inspector suggests to have a qualified waterproofing contractor seal this area in an effort to prevent moisture intrusion. Please refer to photos #32.2 and #32.3 for more detail.

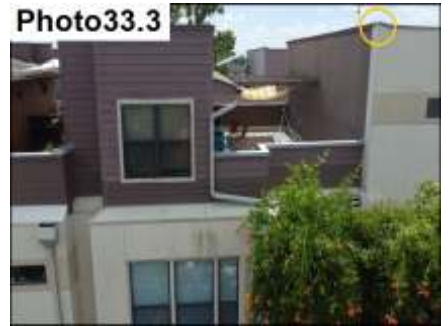
Photo33.3

Metal Cap/Siding Termination / Seal

Grid Location	Item Description	Moisture Readings	Substrate Condition	Observations
Orange Lines	Metal Cap			The metal cap sealants are aged at these locations. The inspector suggests to have a qualified waterproofing contractor further assess and seal in an effort to prevent moisture intrusion. Please refer to photos #33.2 and #33.3 for more detail.
