Inspection Report

Property Address:
8014 Green Devon Dr
Houston TX 77095

PROPERTY INSPECTION REPORT

By: S. Brad Williams TREC# 23549 / Sunbelt Inspections 4/25/2020

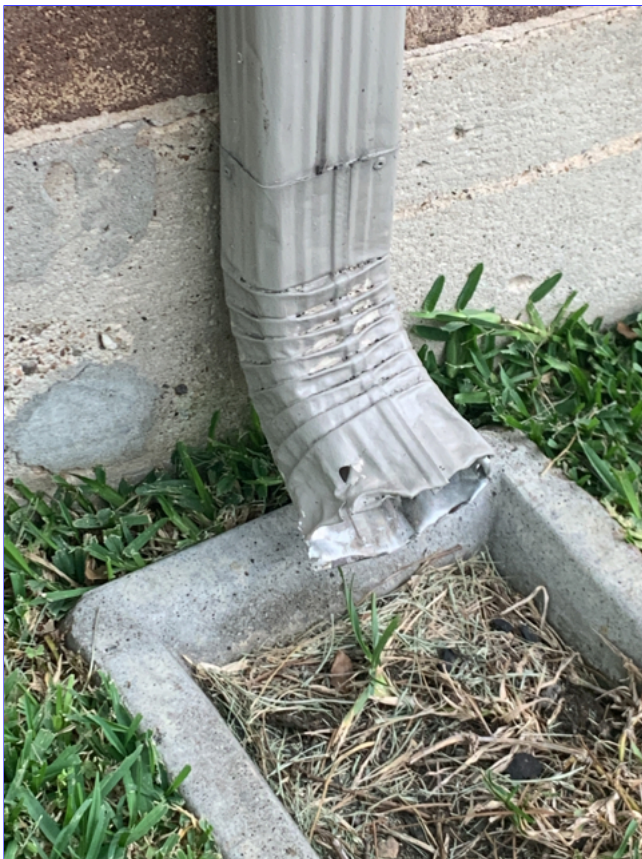
(1) Several damaged downspout turn outs were observed.

B. Photo 1(Picture) Several damaged downspout turn outs were observed.

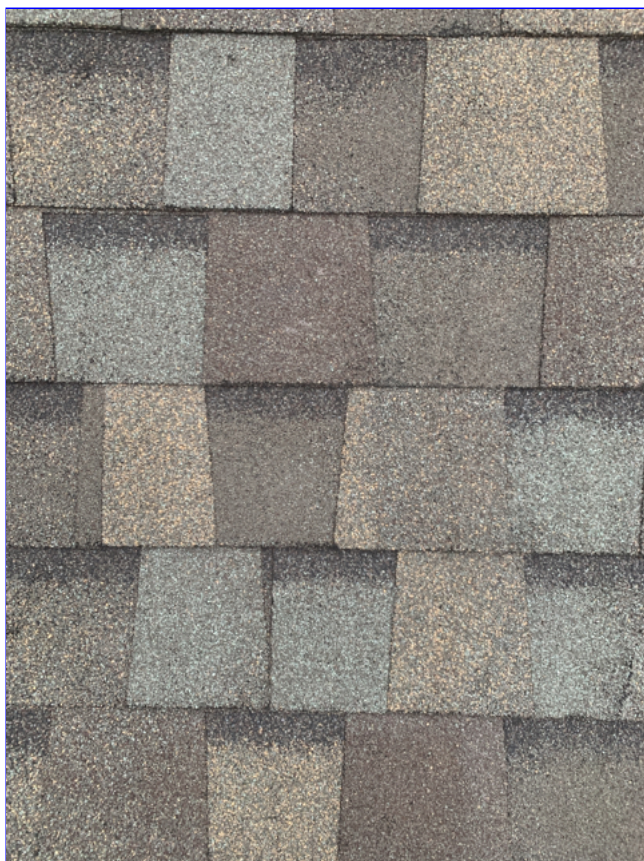
(1) The roof covering is relatively new. The overall condition of the roof covering appears to be acceptable and no indications of moisture penetration into the structure were observed. This roof is an Architectural style shingle that will typically last 20 years in this climate.

C. Photo 1(Picture) This roof is an Architectural style shingle that will typically last 20 years in this climate.

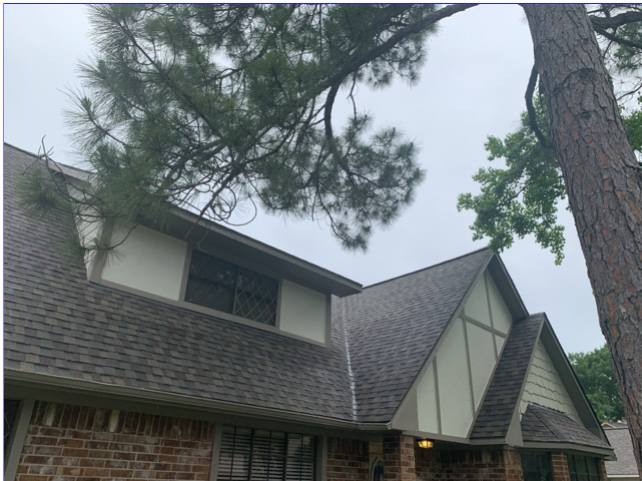
(2) **Note:** Tree limbs that are in contact with roof or hanging near roof should be trimmed. Tree limbs in contact with the shingles can cause damage.

C. Photo 2(Picture) Note: Tree limbs that are in contact with roof or hanging near roof should be trimmed. Tree limbs in contact with the shingles can cause damage.

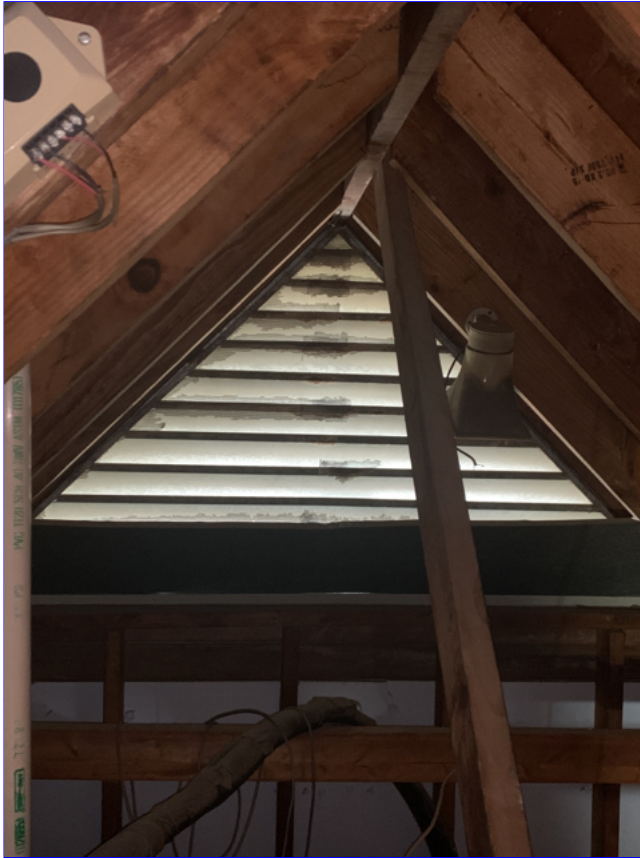
The gable vent screens have deteriorated. Recommend replacement.

D. Photo 1(Picture) The gable vent screens have deteriorated. Recommend replacement.

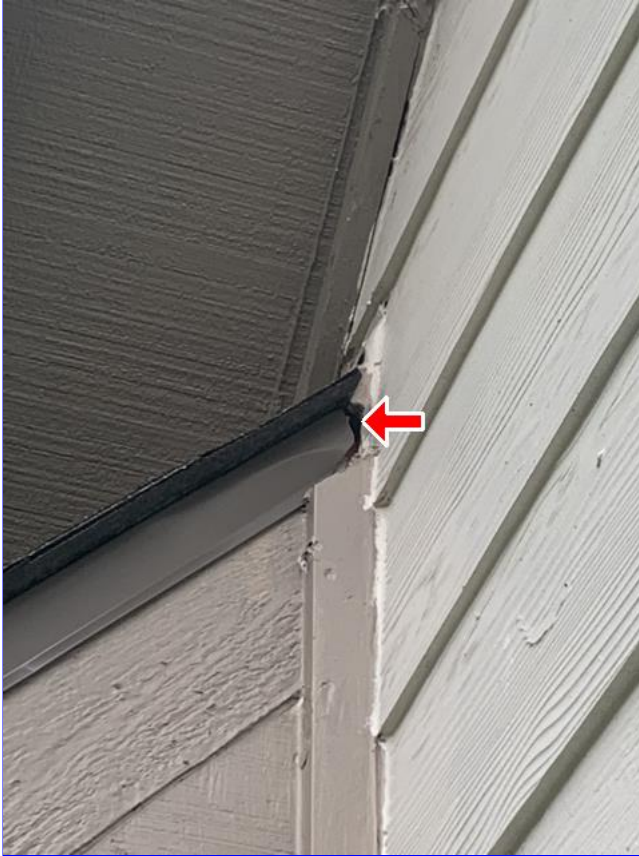
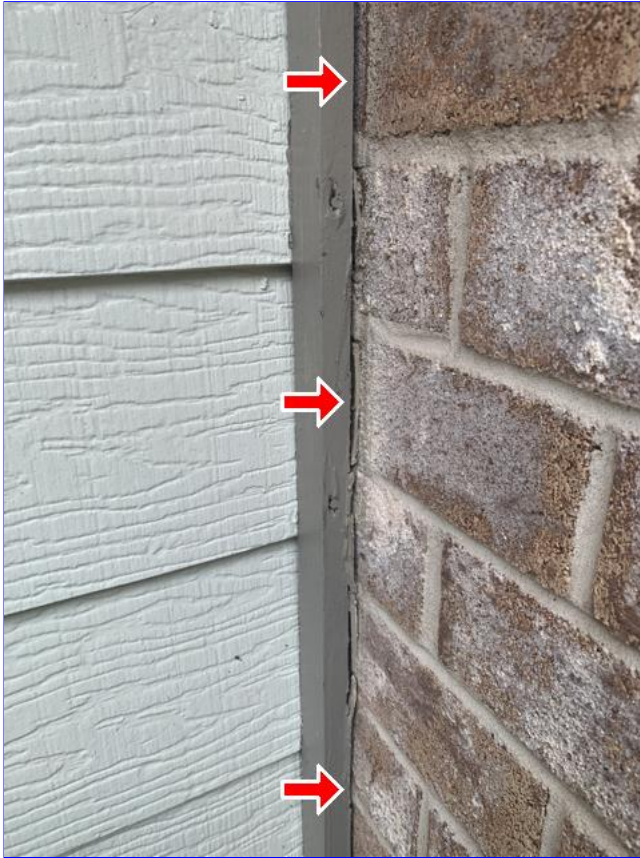
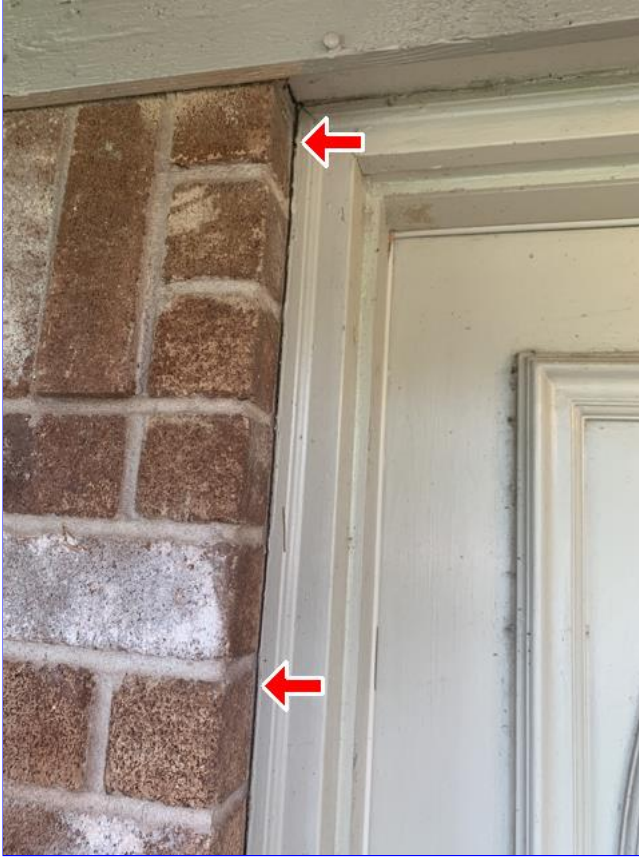
(1) Areas were observed, where the brick, siding and/or trim needs to be resealed.

E. Photo 1(Picture) Areas were observed, where the brick, siding and/or trim needs to be resealed.

E. Photo 2(Picture) Areas were observed, where the brick, siding and/or trim needs to be resealed.

E. Photo 3(Picture) Areas were observed, where the brick, siding and/or trim needs to be resealed.

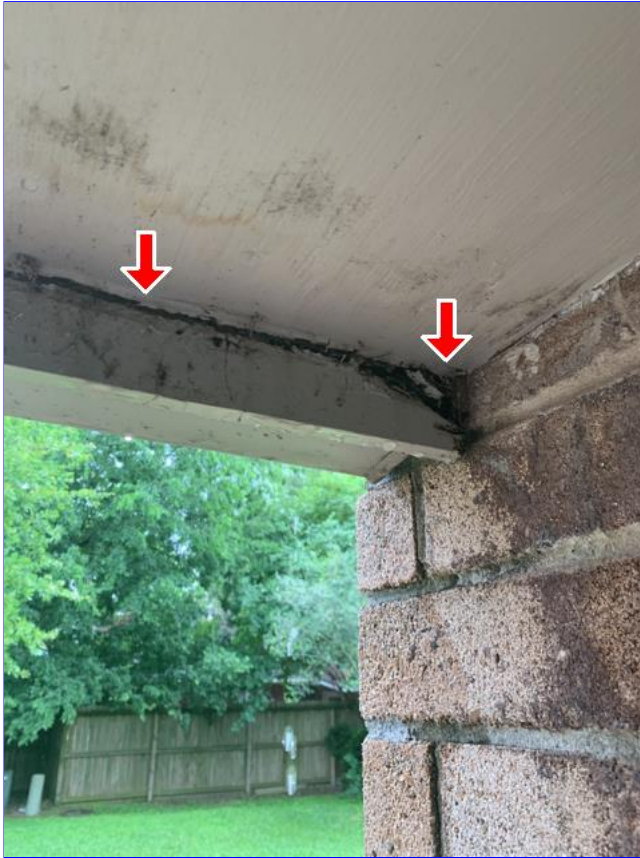
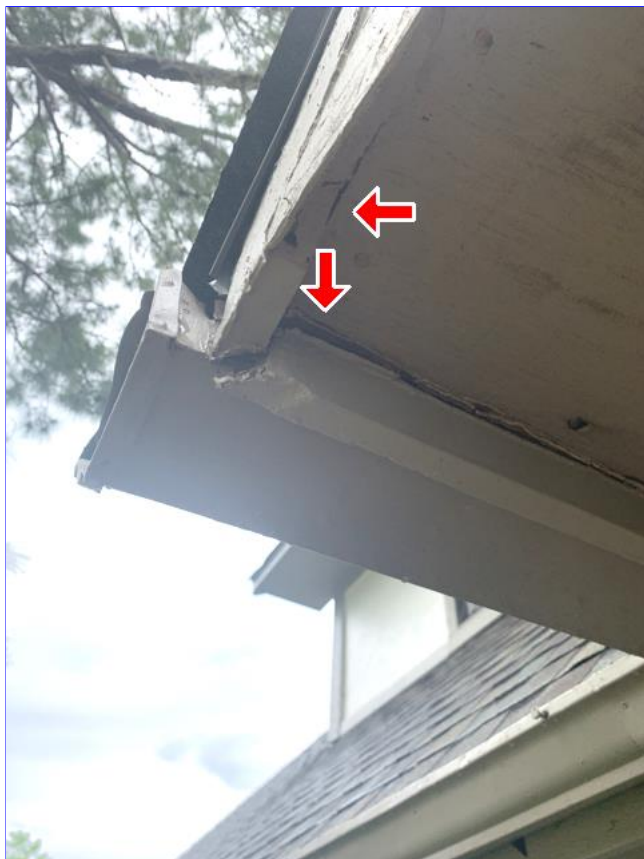
(2) Areas of wood rot were observed on the soffit fascia boards.

E. Photo 4(Picture) Areas of wood rot were observed on the soffit fascia boards.

E. Photo 5(Picture) Areas of wood rot were observed on the soffit fascia boards.

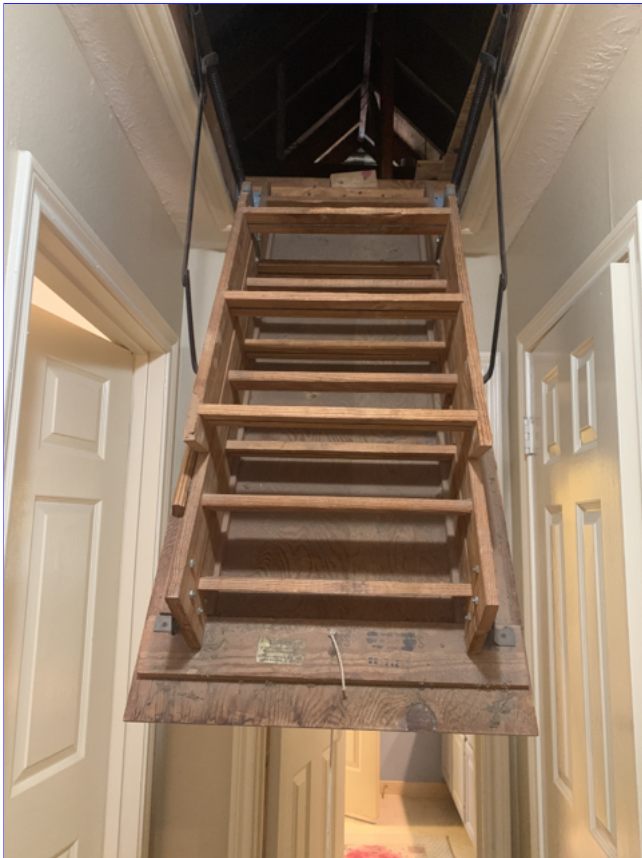
Note: The attic access door (pull down stairs), is not insulated or weather stripped. This door separates a non-conditioned space (attic) from the interior conditioned space and should be insulated and weather stripped for energy efficiency reasons.

G. Photo 1(Picture) Note: The attic access door (pull down stairs), is not insulated or weather stripped. This door separates a non-conditioned space (attic) from the interior conditioned space and should be insulated and weather stripped for energy efficiency reasons.

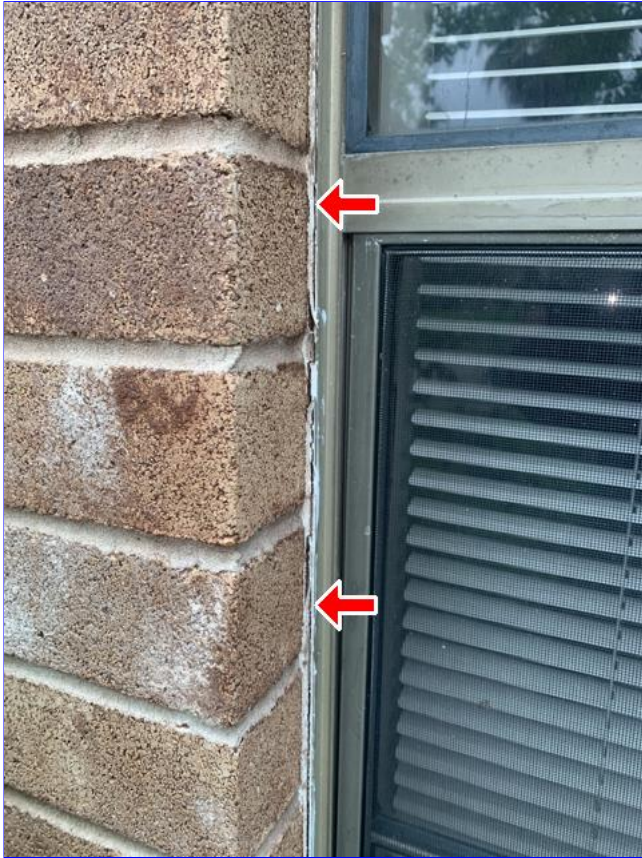
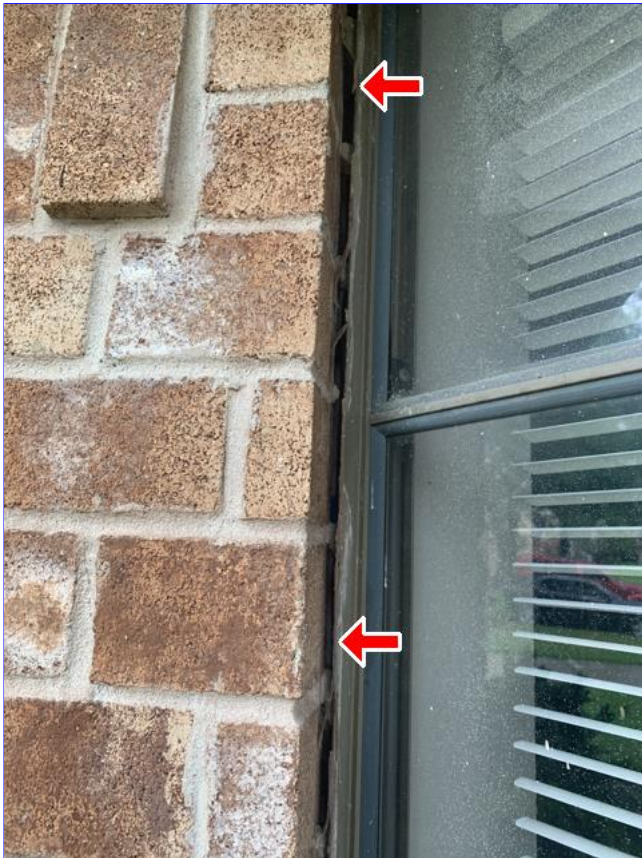
(1) The perimeter sealant, has failed on some windows.

H. Photo 1(Picture) The perimeter sealant, has failed on some windows.

H. Photo 2(Picture) The perimeter sealant, has failed on some windows.

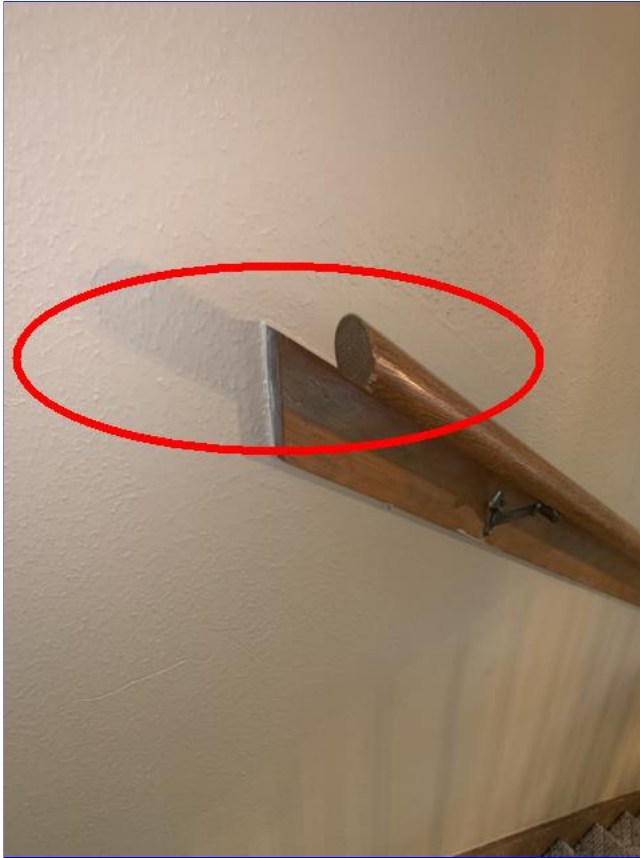
The handrail ends do not return to the walls. Open handrail ends can catch on clothes causing safety concerns on stairs.

I. Photo 1(Picture) The handrail ends do not return to the walls. Open handrail ends can catch on clothes causing safety concerns on stairs.

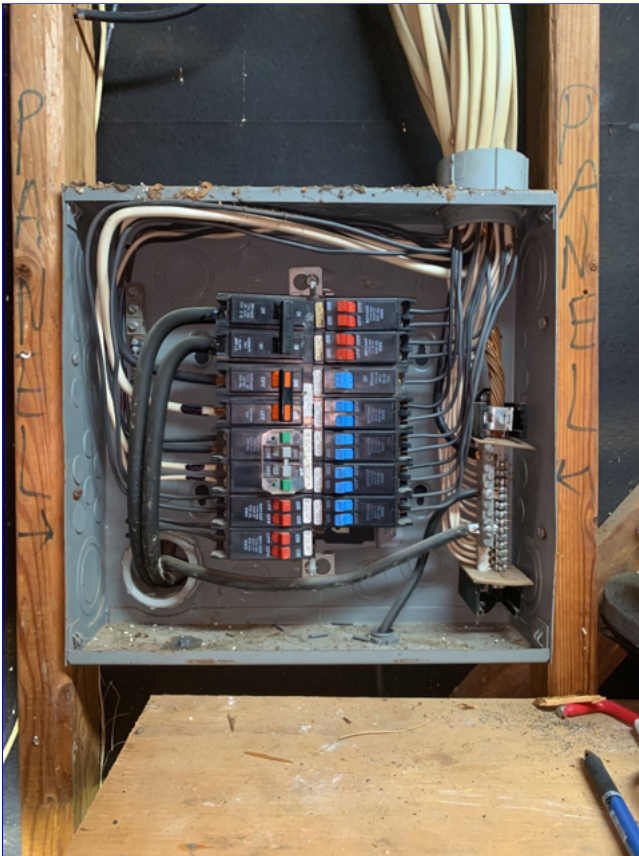
The main electrical service panel, shown with dead front cover removed for inspection purposes. The panel inspected okay.

A. Photo 1(Picture) The main electrical service panel, shown with dead front cover removed for inspection purposes. The panel inspected okay.

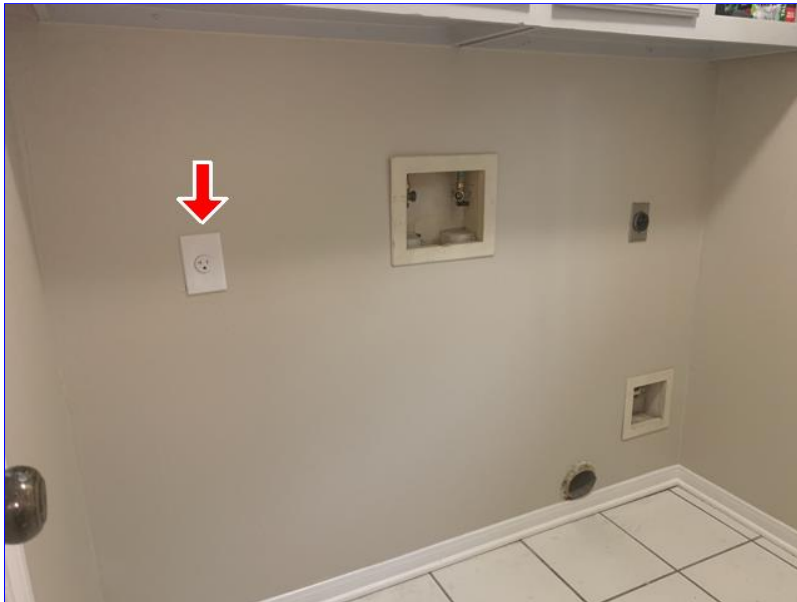
(3) In the laundry room, there's only one receptacle for both the washer and gas dryer.

B. Photo 1(Picture) In the laundry room, there's only one receptacle for both the washer and gas dryer.

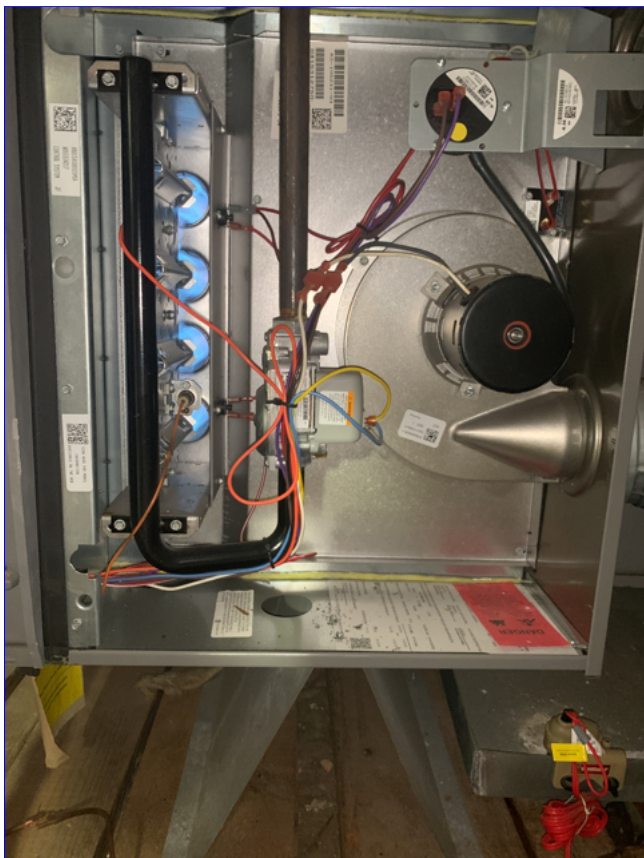
(1) The unit appeared to operate normally using the standard controls. I could not determine if the heat exchanger is cracked or not without dismantling the furnace. Dismantling of components is outside of the scope of a standard home inspection.

A. Photo 1(Picture) The unit appeared to operate normally using the standard controls.

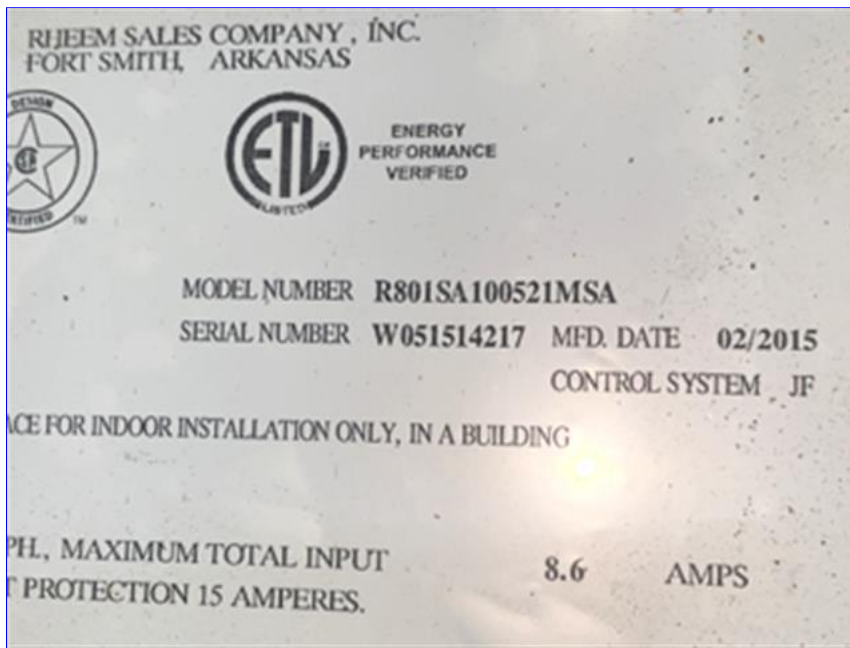
Manufacture date 2015.

A. Photo 2(Picture) Furnace service tag.

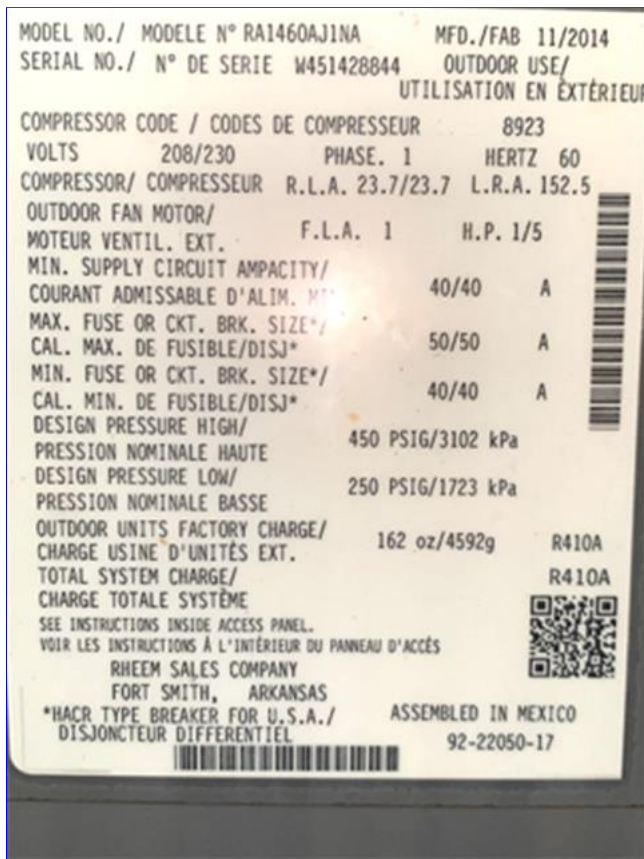
Manufacture date 2014.

B. Photo 1(Picture) Air conditioner service tag.

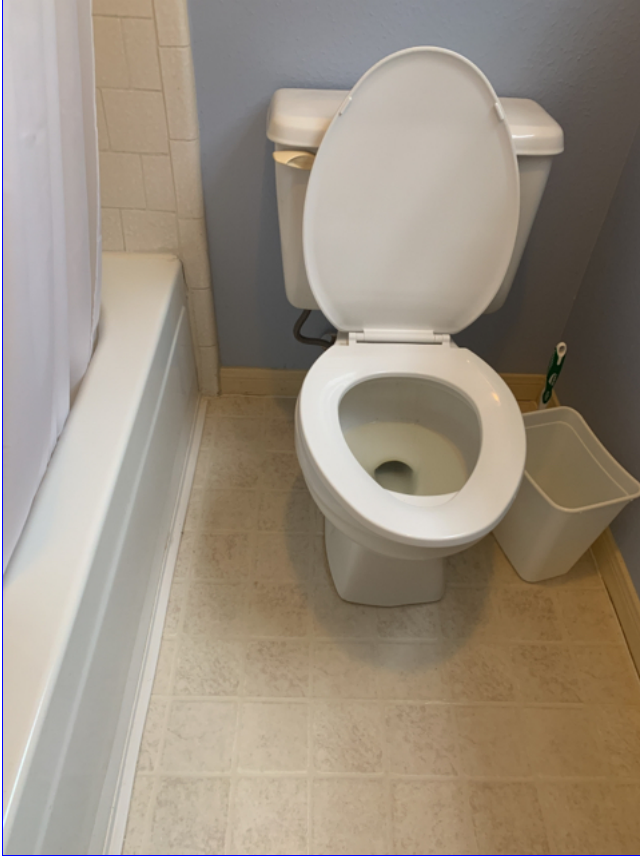
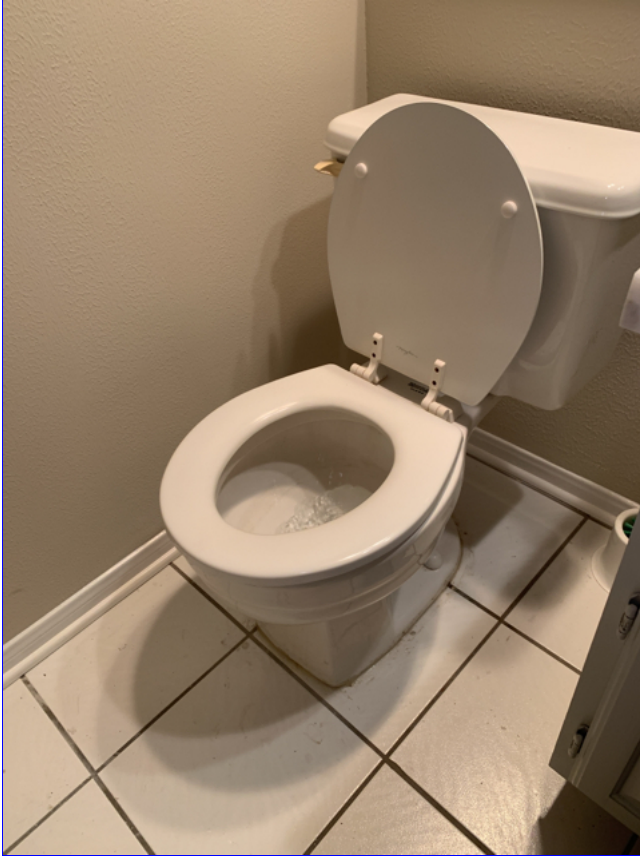
(1) The toilet is loose at floor at the bath. Repairs may involve re-setting the toilet on a new wax seal. I recommend a qualified licensed plumber repair or correct as needed.

A. Photo 1(Picture) The toilet is loose at floor at the bath. Repairs may involve re-setting the toilet on a new wax seal. I recommend a qualified licensed plumber repair or correct as needed.

A. Photo 2(Picture) The toilet is loose at floor at the bath. Repairs may involve re-setting the toilet on a new wax seal. I recommend a qualified licensed plumber repair or correct as needed.

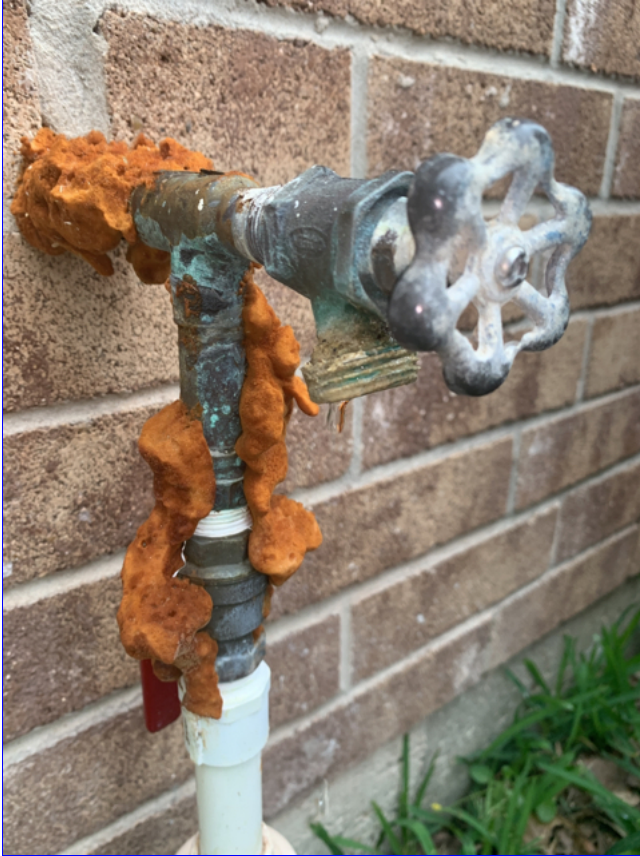
(2) On the right side of the home, the hose bib has a constant leak.

A. Photo 3(Picture) On the right side of the home, the hose bib has a constant leak.

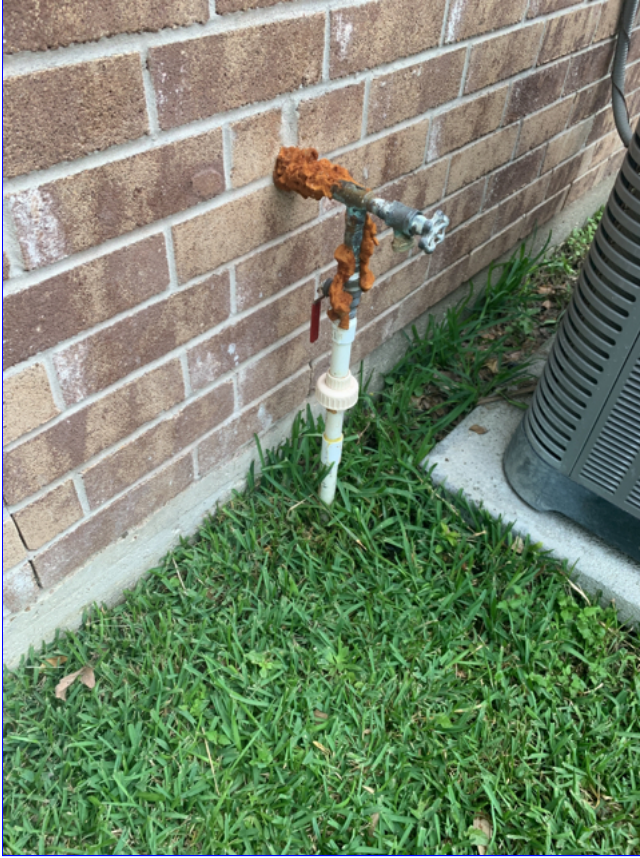
(3) The main water supply line at the exterior, is not properly protected from freezing.

A. Photo 4(Picture) The main water supply line at the exterior, is not properly protected from freezing.

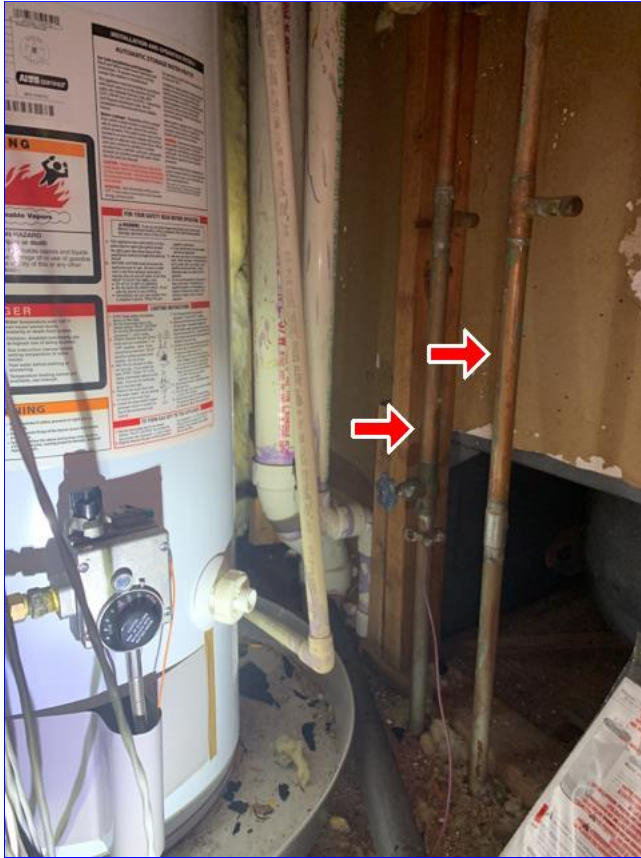
(4) Exposed water pipes observed in the attic space are not properly protected from freezing. Water pipes should be buried under the insulation or properly wrapped to prevent breakage from freezing.

A. Photo 5(Picture) Exposed water pipes observed in the attic space are not properly protected from freezing. Water pipes should be buried under the insulation or properly wrapped to prevent breakage from freezing.

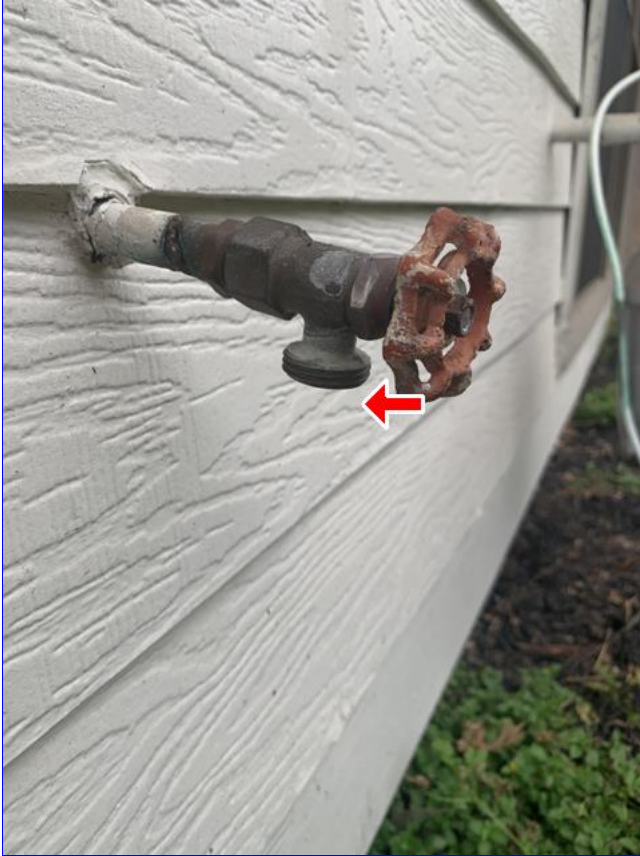
(5) No anti-siphon devices, were observed at exterior hose bibbs. These are low cost devices that screw on to the exterior hose bibbs to prevent back-flow into the water supply. They are required by most municipalities.

A. Photo 6(Picture) No anti-siphon devices, were observed at exterior hose bibbs. These are low cost devices that screw on to the exterior hose bibbs to prevent back-flow into the water supply. They are required by most municipalities.

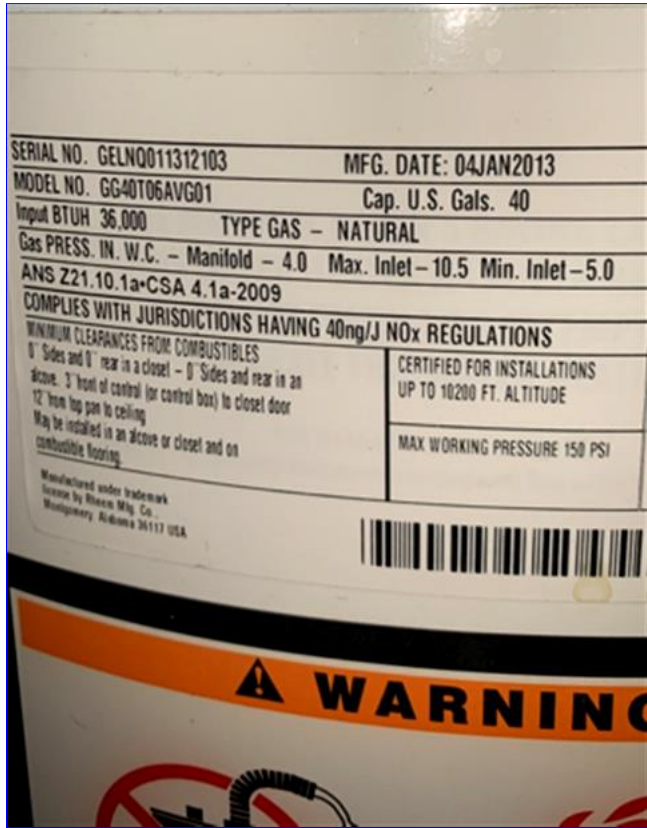
C. Photo 1(Picture) Water heater service tag.
