Your Inspection Report

6852 Dogwood Cliff Ln
Dickinson, TX 77539

INSPECTION DATE:
Tuesday, February 23, 2016

PREPARED BY:
Adam Wells License 21140

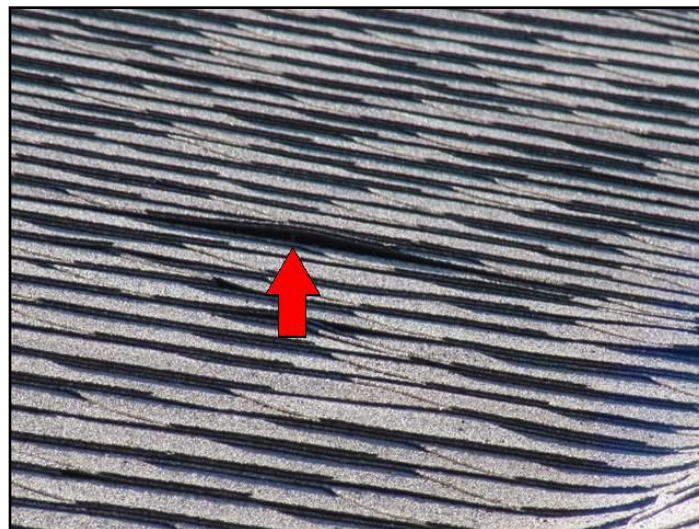
Condition: • Popped up nail heads observed. Remedy as needed to prevent possible damage to roof covering.

1. Condition: • Popped up nail heads observed. Remedy as needed to prevent possible damage to roof covering.

Location: Front roof section above the garage ridge.

1. Popped up nail heads observed. Remedy as...

Composition shingles: **Popped up nail heads observed. Remedy as needed to prevent possible damage to roof covering.**

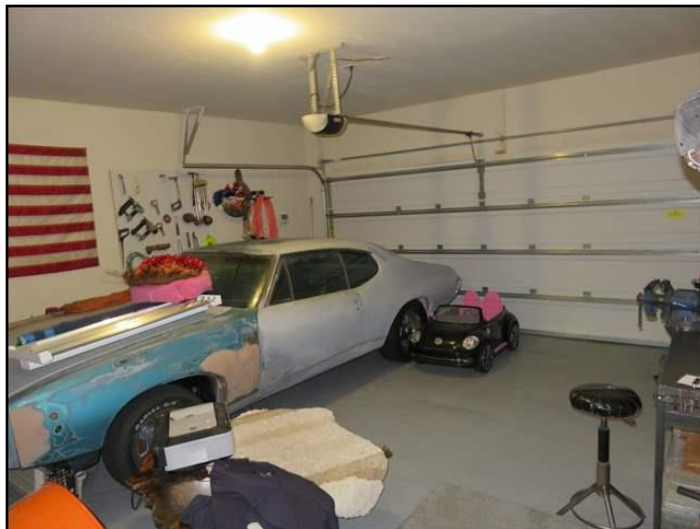
5. Shelving and personal storage prevented...

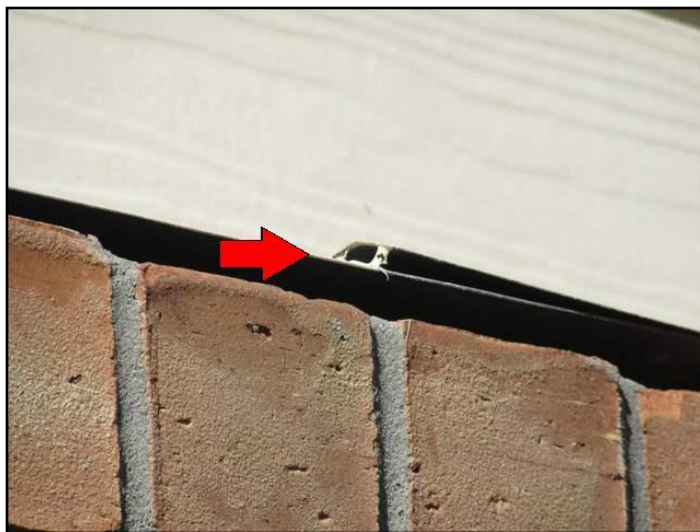
6.

Condition: • Flashings at the top of the brick was are not properly sealed in some areas. Evaluate and remedy as needed.

3. Condition: • Flashings at the top of the brick was are not properly sealed in some areas. Evaluate and remedy as needed.

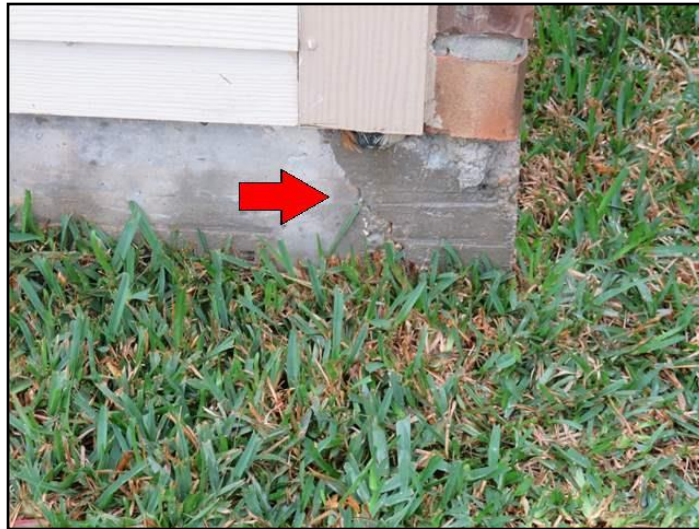
Condition: • Corner(s) of the concrete foundation have cracked and/or "sheared" off. While this will not negatively affect the foundation performance, re-sealing of these cracked foundation corners is recommended.

5. Condition: • Corner(s) of the concrete foundation have cracked and/or "sheared" off. While this will not negatively affect the foundation performance, re-sealing of these cracked foundation corners is recommended.

8. Corner(s) of the concrete foundation have...

Performance opinion: **Corner(s) of the concrete foundation have cracked and/or "sheared" off. While this will not negatively affect the foundation performance, re-sealing of these cracked foundation corners is recommended.**

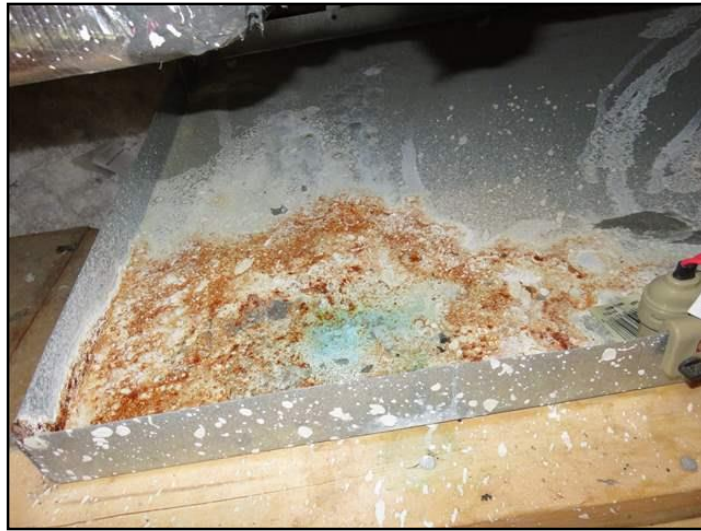
Condition: • Rusting in the evaporator condensate overflow pan indicates possible blockage of the condensate drain line(s) and a dirty evaporating system: service of the system is recommended.

9. Condition: • Rusting in the evaporator condensate overflow pan indicates possible blockage of the condensate drain line(s) and a dirty evaporating system: service of the system is recommended.

12. Rusting in the evaporator condensate...

Condensate system: **Rusting in the evaporator condensate overflow pan indicates possible blockage of the condensate drain line(s) and a dirty evaporating system: service of the system is recommended.**

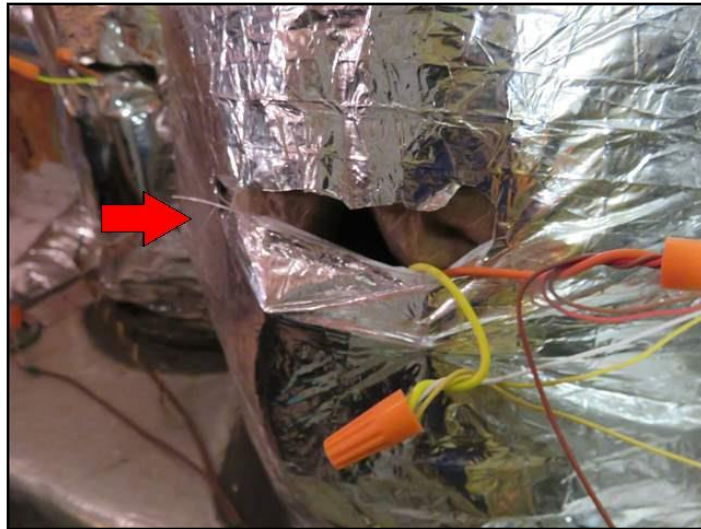
13.

Condition: • Insulation wrap on duct work in the attic at the unit is cut and wires are installed. These areas should be sealed to prevent conditioned air loss. Remedy as needed.

10. **Condition:** • Insulation wrap on duct work in the attic at the unit is cut and wires are installed. These areas should be sealed to prevent conditioned air loss. Remedy as needed.

Duct system: **Insulation wrap on duct work in the attic at the unit is cut and wires are installed. These areas should be sealed to prevent conditioned air loss.**

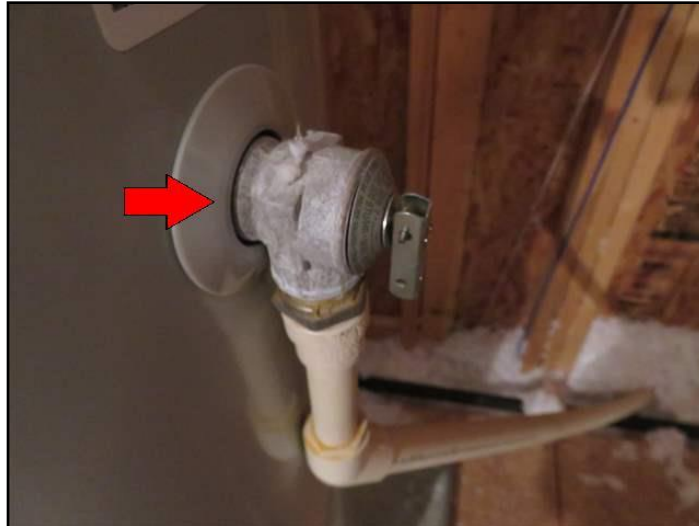
13. Condition: • Note: The manufacturer recommends replacement

of the pressure relief valve every three years to ensure proper emergency function. Inspection company does not test TPR valves due to safety hazard or possible damage to unit.

17. Note: The manufacturer recommends...

Temperature/pressure relief valve: **Note: The manufacturer recommends replacement of the pressure relief valve every three years to ensure proper emergency function. Inspection company does not test TPR valves due to safety hazard or possible damage to unit.**

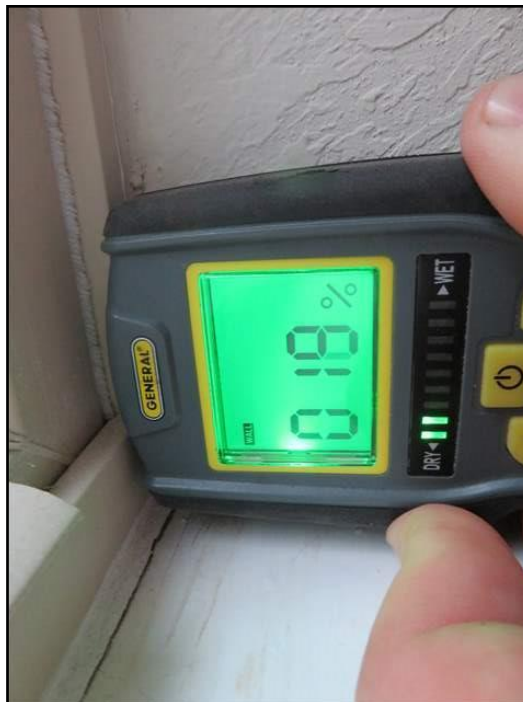
25.

Condition: • Moisture staining was observed on the rear window in the master bedroom at the window sill. Moisture was detected at the time of inspection. The cause could not be determined. Evaluation by a qualified contractor is recommended to determine the best method of remedy.

15. Condition: • Moisture staining was observed on the rear window in the master bedroom at the window sill. Moisture was detected at the time of inspection. The cause could not be determined. Evaluation by a qualified contractor is recommended to determine the best method of remedy.

General: Moisture staining was observed on the rear window in the master bedroom at the window sill. Moisture was detected at the time of inspection. The cause could not be determined. Evaluation by a qualified contractor is recommended to determine the best method of remedy.

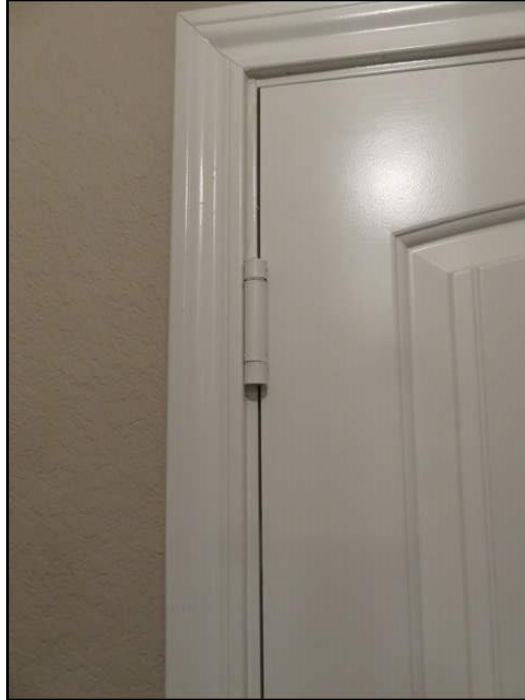
26.

Condition: • The self-closing hinges installed on the garage entry door do not properly close the door. Adjustment to the hinges is recommended to ensure proper closure of the door.

18. Condition: • The self-closing hinges installed on the garage entry door do not properly close the door. Adjustment to the hinges is recommended to ensure proper closure of the door.

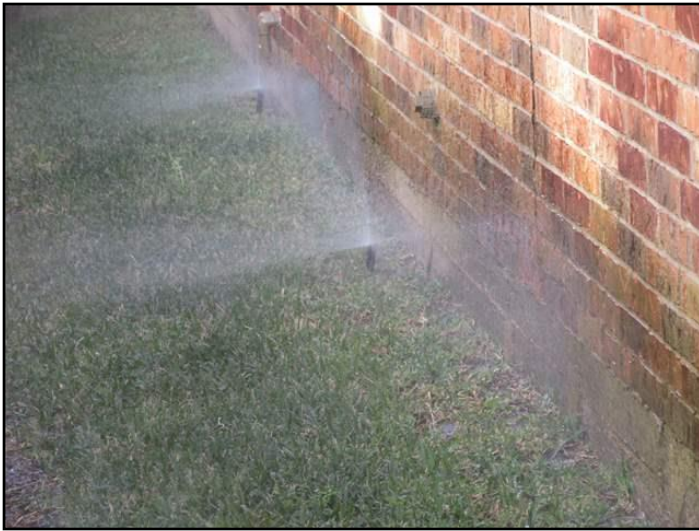
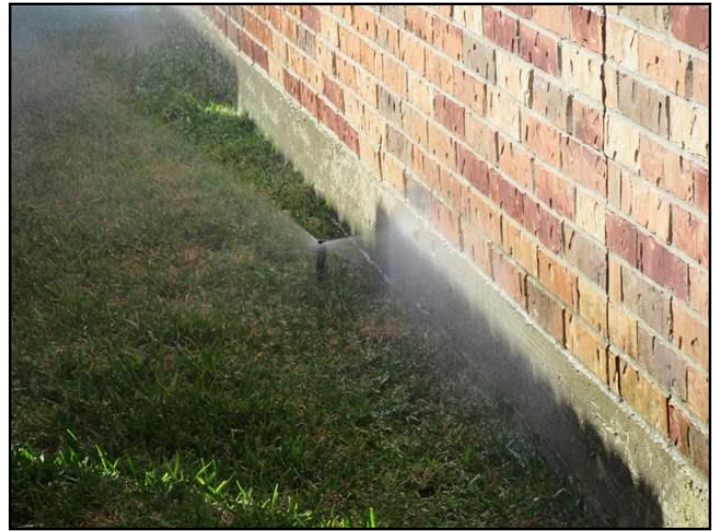
Condition: • Sprinkler heads should be adjusted to spray away from the house/garage.

Location: Zones 1, 3, 4, and 6.

20. Condition: • Sprinkler heads should be adjusted to spray away from the house/garage.

30. Sprinkler heads should be adjusted to spray...

31. Sprinkler heads should be adjusted to spray...

Task: Remedy as needed.
