PROPERTY INSPECTION REPORT

Concerning: 16342 Many Trees Ln., Conroe, TX 77305
(Address or Other Identification of Inspected Property)

By: Rudolph Depena & Martha Kaplan Lic. 5191/5863 04-21-2018
(Name and License Number of Inspectors) (Date of Inspection)

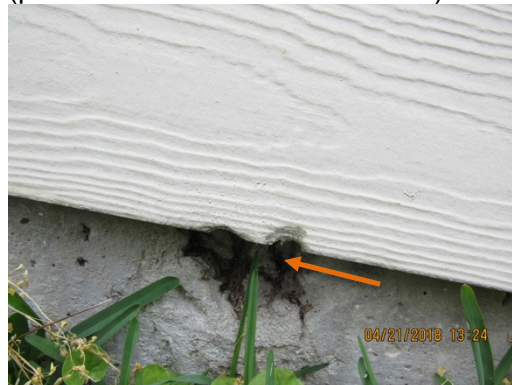
Cleaning and covering with an approved material. exposed tendon end (post tension steel reinforcement) at the West perimeter.

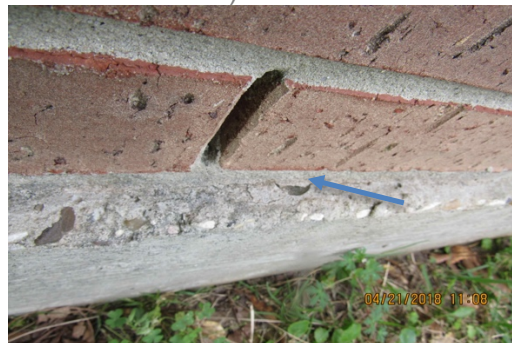
General Information: Visible brick seat (foundation perimeter) at the North side is approx. 3/4" to 1" is protruding outward. This is considered a latent construction defect. (Typically, alignment of the board-form lost at time of construction due to concrete pressure and lack of bracer of the retention boards.)

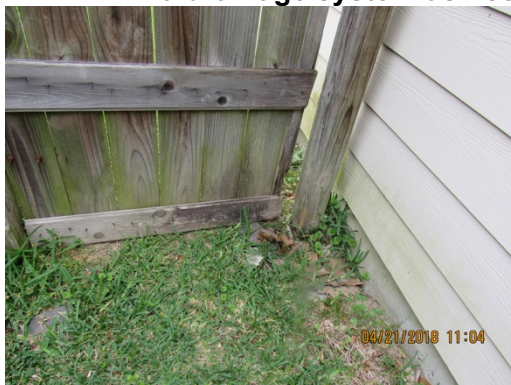
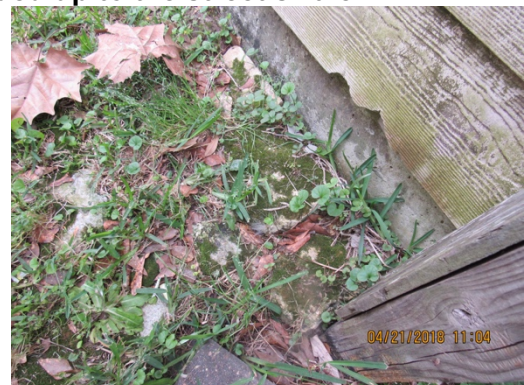
D - Builders developed Swale from the south to the east and west side is no longer present. Visible retention of water is noted at the West side, with obstruction at the east side at front fence level.

Re-grade above mention areas with positive slope at top soil (avoid ponding of water), for storm waters to run away from the foundation. (Foundation maintenance). This may be aided by recreating the Builder's swale from the south to the east and west side and/or with a drainage system as needed up to the street swale.

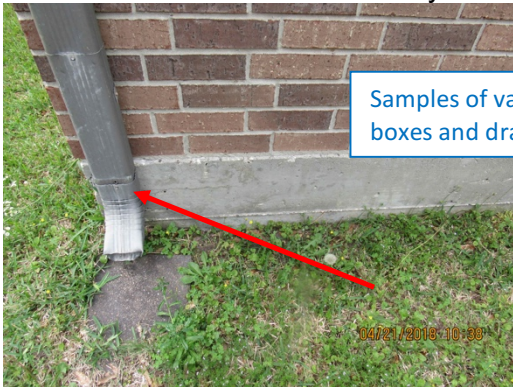
D - The N.E. downspout is in need of a splash box and/or extension vinyl drain pipe. Currently it has a stone under it, considered not a proper splash box element to discharge and conduct water away from the foundation perimeters. These may also be connected to a drain system if one is chosen.

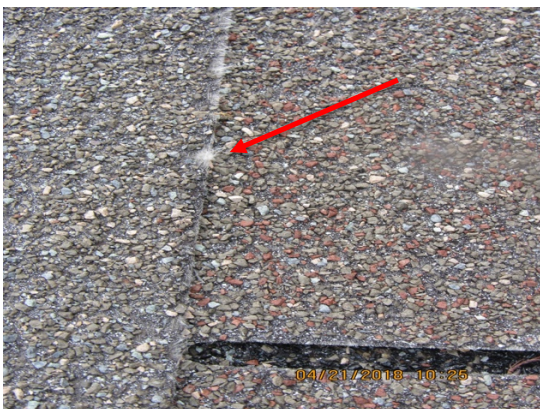
OBSERVATION:* Asphalt shingle lost granules is showing over the structure layer at the edges of the shingles elements of the roof inspected, condition was observed at different areas of the roof planes of the main structure and garage. Manufacturer adhesive is no longer functional. This inspector did not observe any possible indication of water penetration (stain or rot) within the limited visible roof decking area of the attic. Further evaluation of a Professional in the field is recommended. **Roof covering should be budgeted for the near future.*

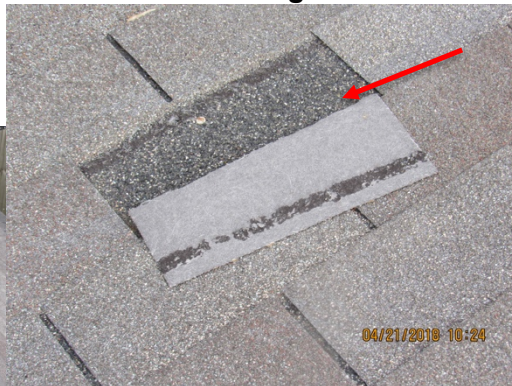
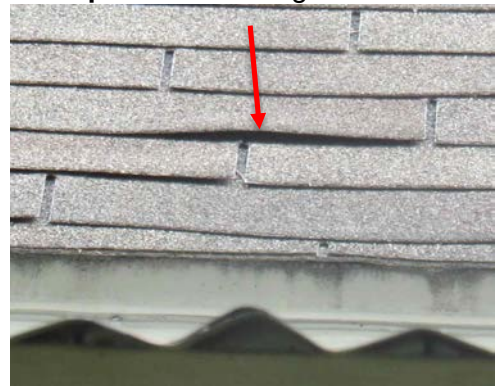
- Lifted shingles at the rear roof slope. Reseal shingle.

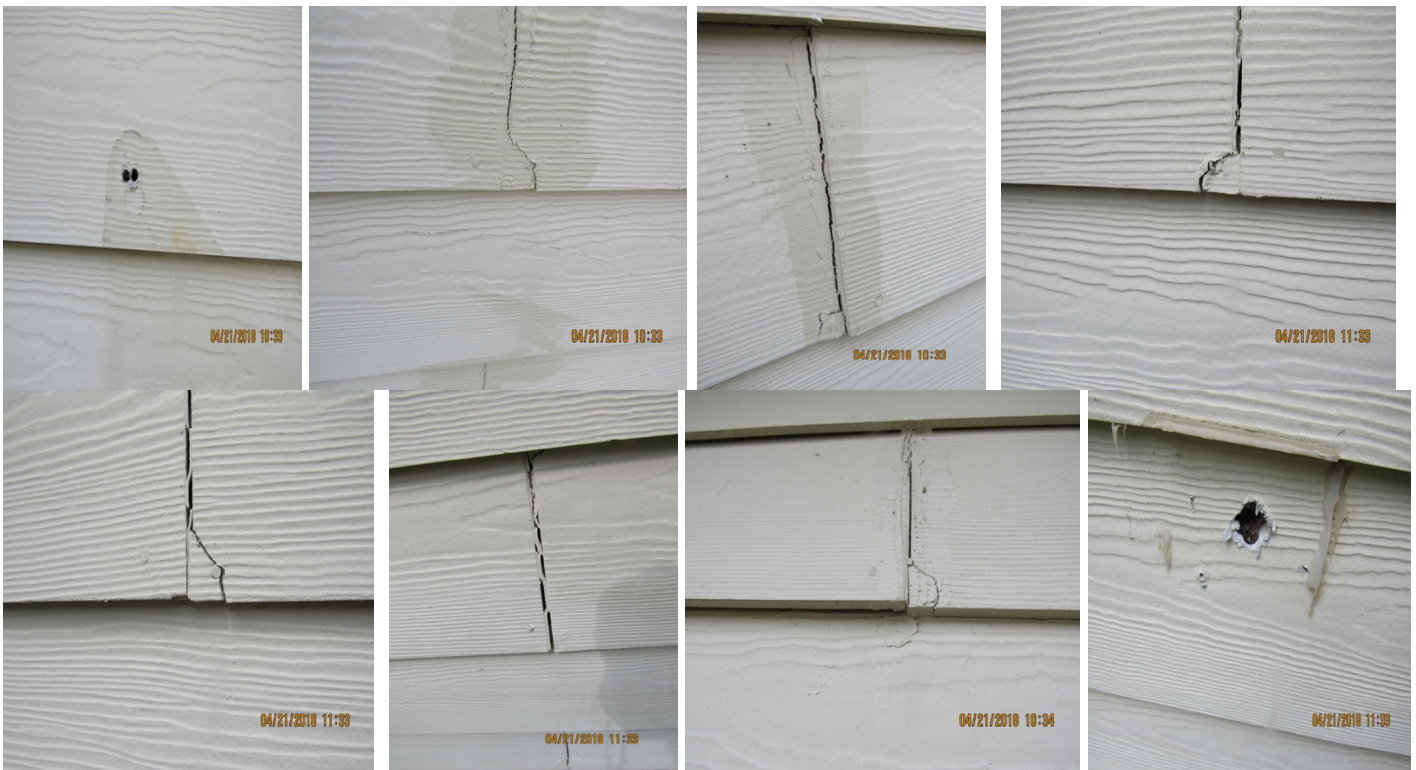
D - Restore corners with chip and siding planks unsealed at all sides, attributed to expansion and contraction of the wall framing structure, as reaction of the natural wood. Seal all areas with perforations. Suggested setting of fiber cement cladding planks per MFG is to be installed over structural backing-OSB or any other acceptable sheathing element. Cladding/veneer should be kept watertight at all times.

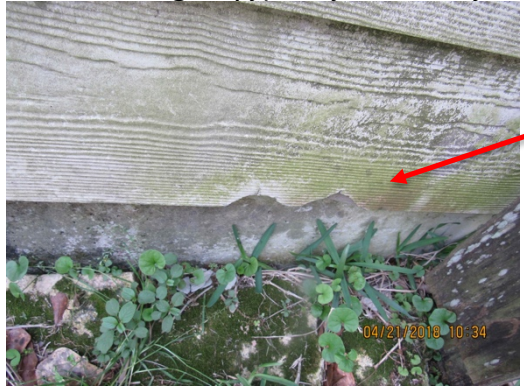
D - Siding at the west side has excess of mildew. This is indicative of needed wash. If after washing the siding mildew returns in a short time it is recommended to prime and paint. Bottom plank at this side is damaged (typically caused by lawn equipment).

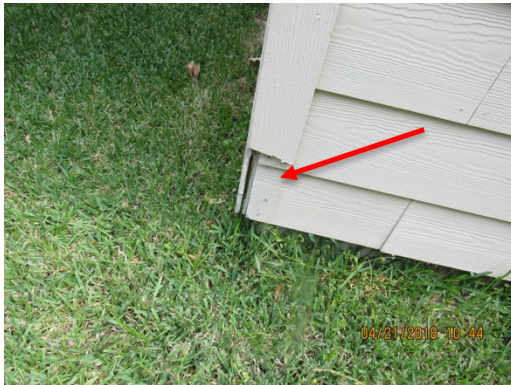
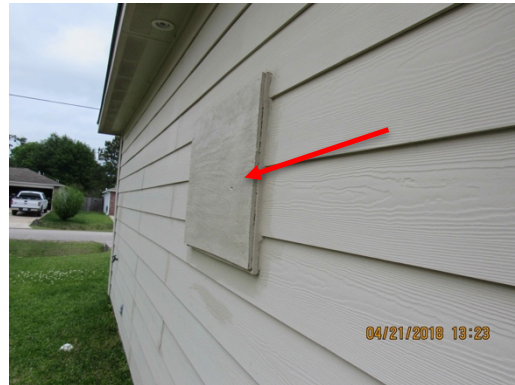
- Broken vertical trim at the S.W. corner. Restore trim and seal all corner trims.
- Siding needs repair at the west side where a piece of plywood was installed.

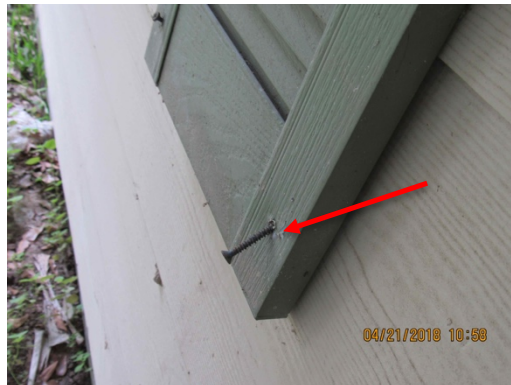
- **Rear west window shutter is loose.** Properly secure shutter to prevent further deflection and/or deterioration.

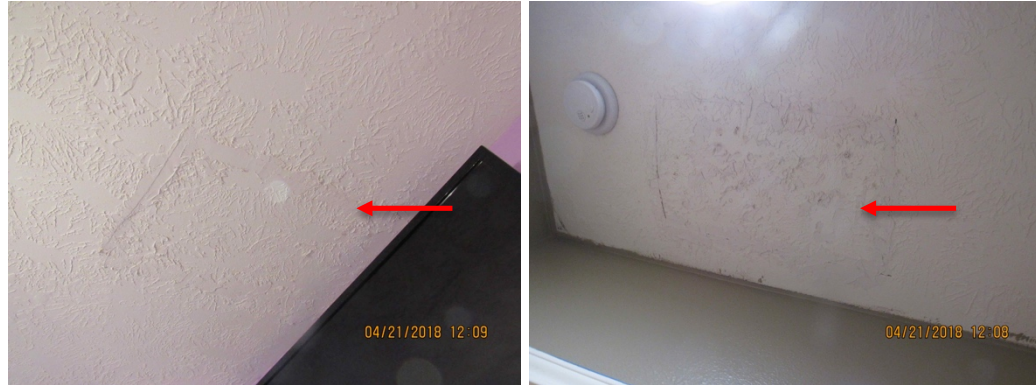
Improper patching to cut-outs are visible in one of the bedrooms and living room. These appear to be from electrical alterations. Recommend to restore areas as needed. See electrical system for other comments.

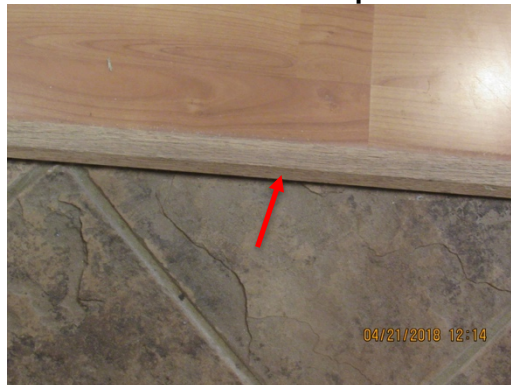
- Secure the transition strips at the entry to the living room area.

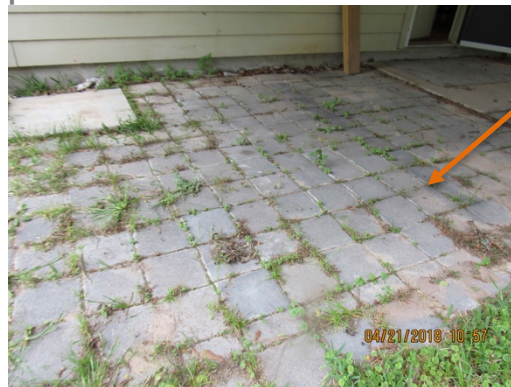
Uneven pavers layout over soil is noted under the rear canopy. This may be a trip hazard to pedestrian. **Recommend** restore level to the pavers over soil.

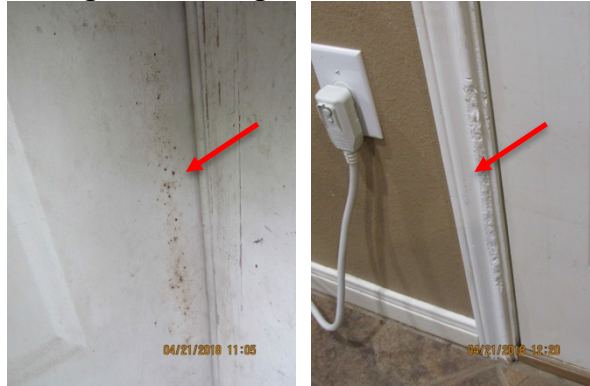
D - Rear exterior door metal veneer is viewed with corrosion. Recommend refinishing the door slab and restoring the interior door casing with damage.

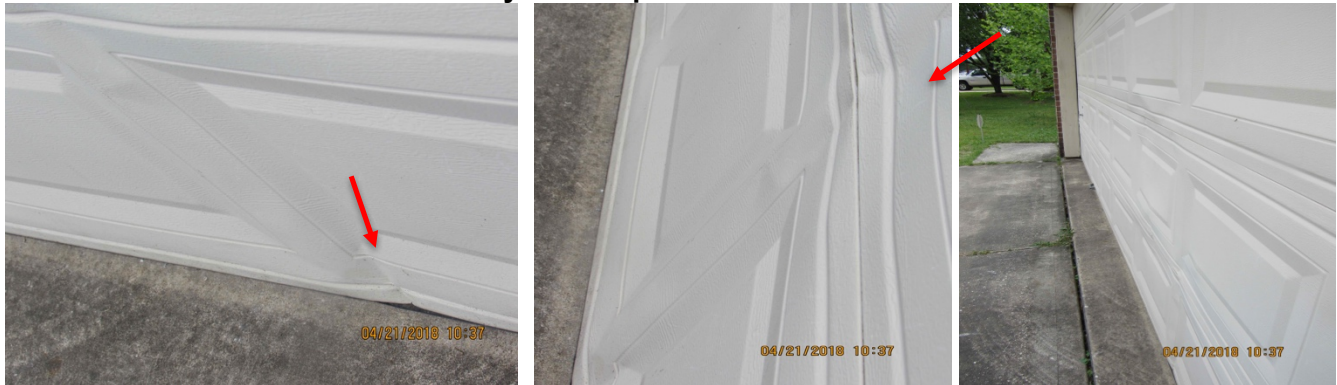
- Garage door with buckled/dented/damaged panels. Door panels (3) may need replacement.

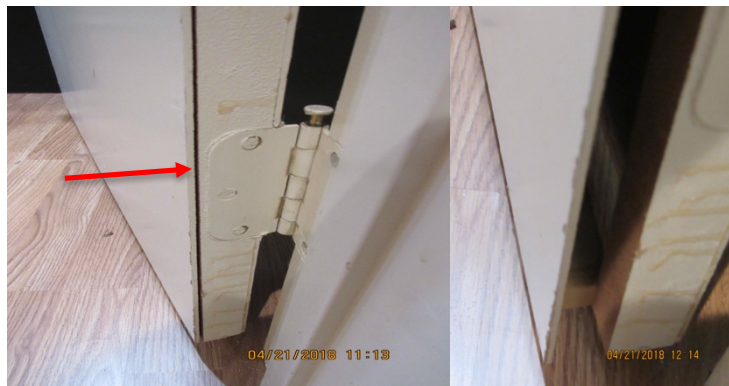
- The S.E. bedroom door slab veneer is detaching. Recommend restoring the door-slab with proper adhesive, preventing further damage.

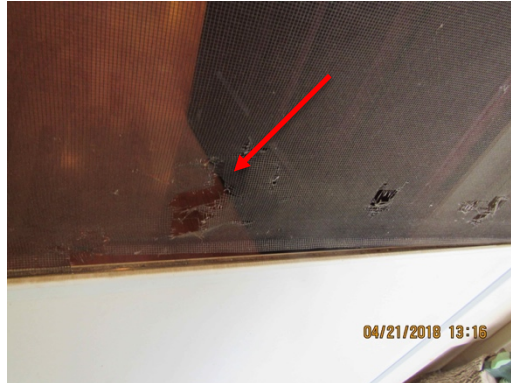
D - Front Iron door has screen damage.

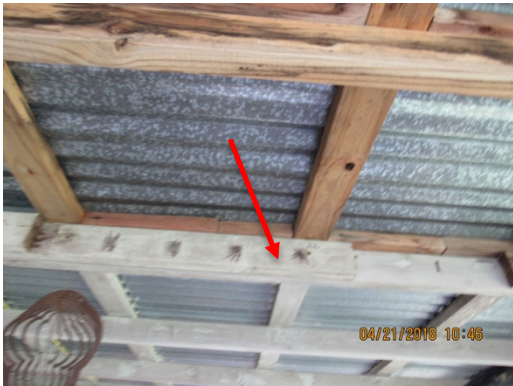
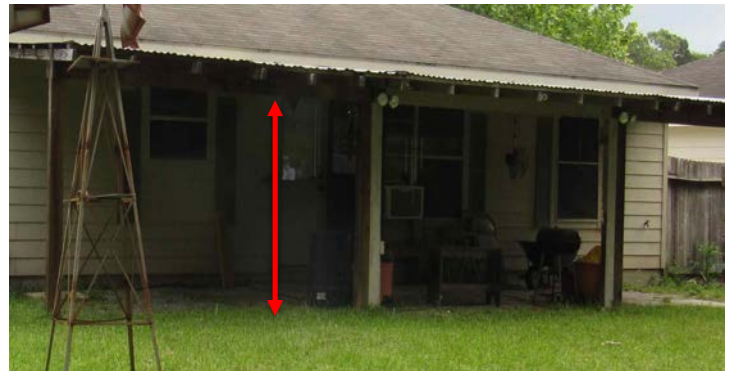
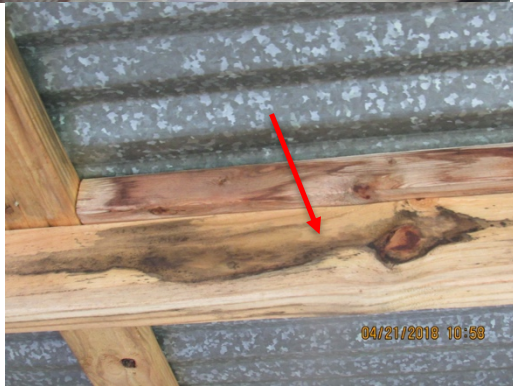
Roof corrugated metal panels, within several areas permit water penetration visible to several rafter elements of the canopy. It appears that in some areas of the corrugated metal roof another type of adhesive cover has been placed over the panels, this maybe to control water leaks.

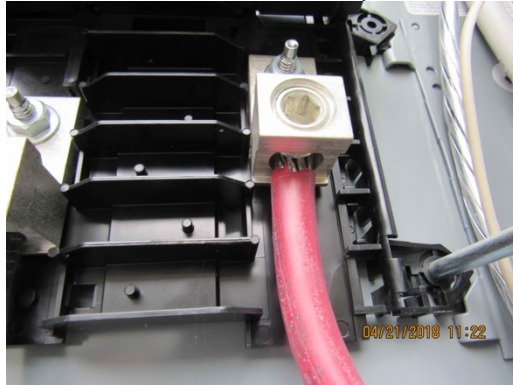
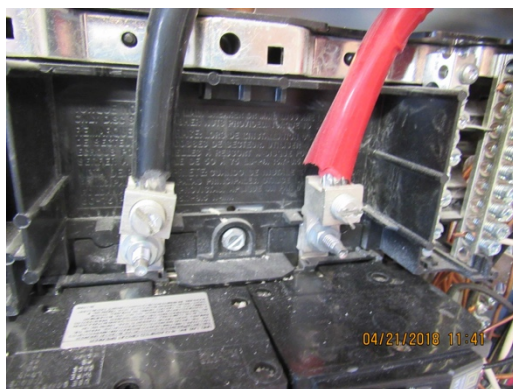
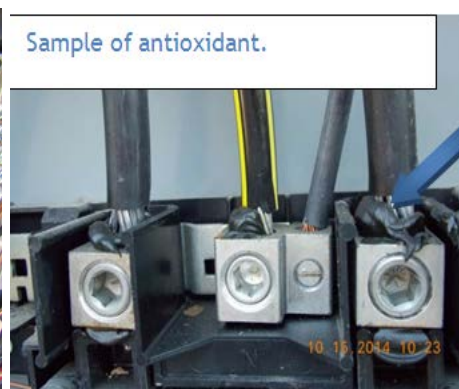
D - Antioxidant is needed at the AL (aluminum) conductors at the service entrance wires with entrance lugs. This is to prevent overheating or corrosion. Place antioxidant to the exterior main panel box and interior panel boxes aluminum wiring.

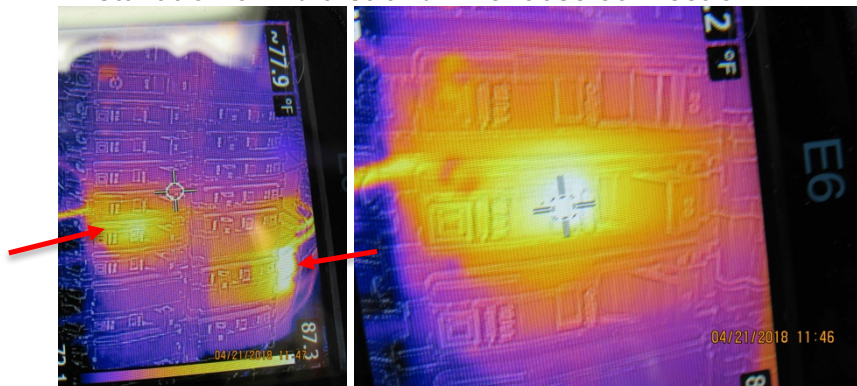
- Sub Panel "B" was tested for hot spots. Increase of temperature due to high resistance, noted with the infrared camera, to the bottom leg connection of wiring to a 30 amp and 20 amp breakers. License electrician to check for loose wiring terminal, loose wire splices or installation of multi strand wire loose connection.

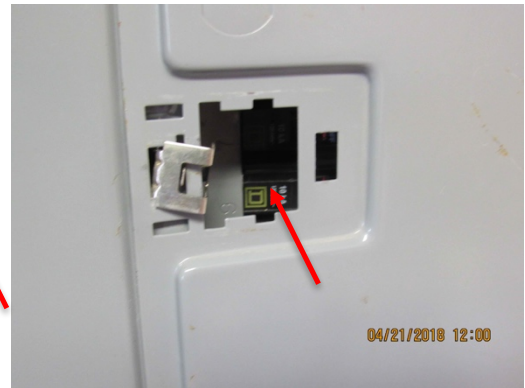
- Several blunt screws are missing at exterior panels and interior sub-panels dead front cover or present screws appear to be too short and not securing the panel cover.
- Locking clip to the interior "B" panel door cover is damaged/not present.
- Dead front cover (interior panel cover) of the electrical panels are in need of proper labels to show what circuits breakers control. Some have partial labels others do not have label.

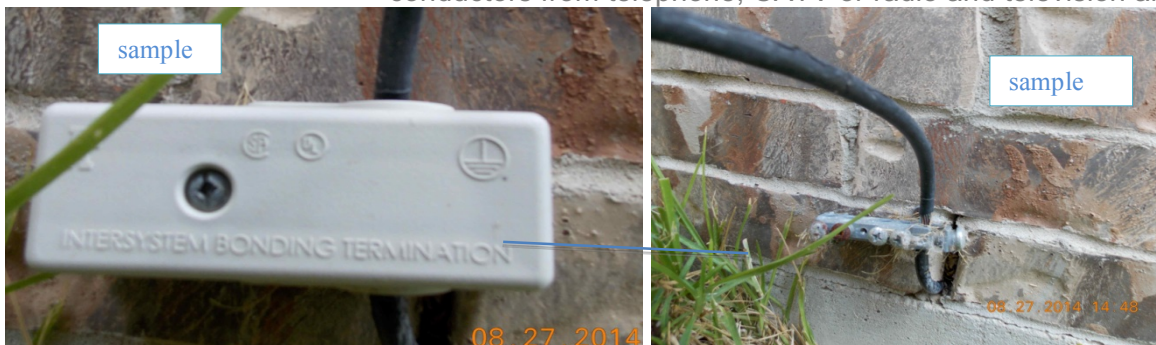
- Installation Inter-system bonding termination at the wall connected to ground rod is **recommended** at the exterior wall.
General Information from manufacture: The Intersystem Bonding Termination (IBTB), part of the ERITECH® line of Facility Electrical Protection products, is designed to meet the requirements of the 2008 NEC® Article 250.94 “Bonding for Other Systems.” The IBTB is mounted adjacent to the meter base or service entrance equipment and is a convenient way to interconnect and terminate grounding conductors from telephone, CATV or radio and television antennas.

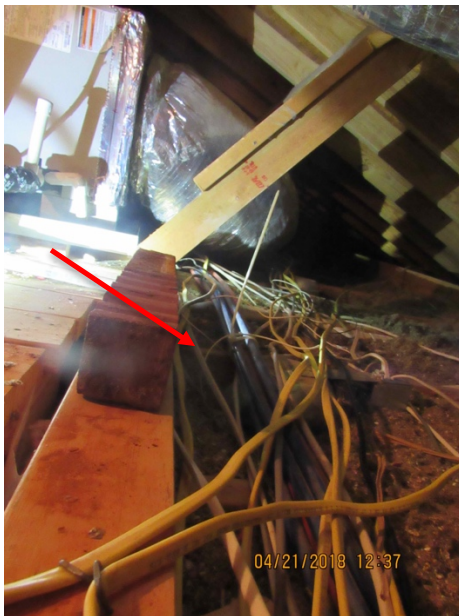
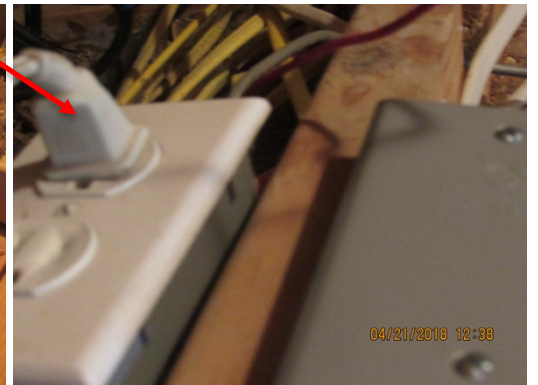
- Loose wiring at the attic and around the Scuttle areas need to be strapped to the structure every 4' and 12 inches from junction boxes. Wires need to be a minimum 6' from any scuttle opening to attic. **Safety hazard.**
 - Electrical extension cords are viewed plug to outlets in the attic. For permanent use of fixtures, permanent acceptable wiring is required per code.
 - Wiring splices need a junction box, secure to the structure.
 - Some junction boxes viewed are not secured to the structure.
 - Wiring staples in some areas are viewed opened, in danger of puncturing the wire if moved. **Safety hazard.**
- See additional related photos on the next page.

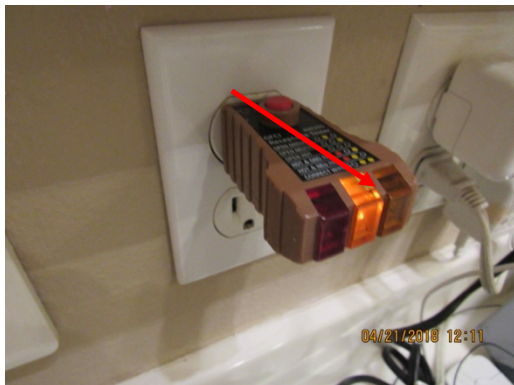
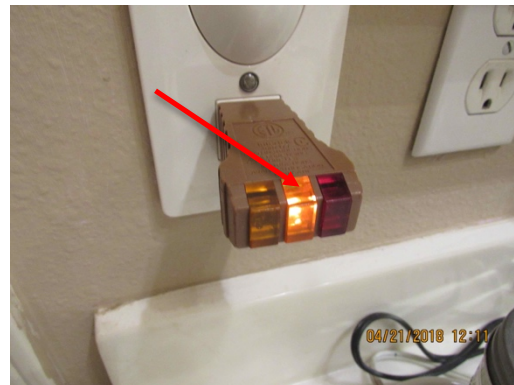
D - Open ground is noted to outlets at the hall bathroom. These outlets need to be GFCI. This is an alteration of additional two outlets at this location.

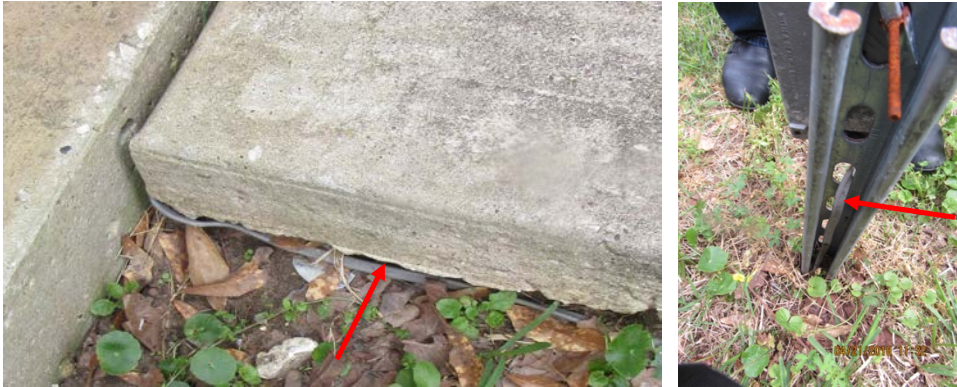
B. Branch Circuits, Connected Devices and Fixtures- Comments: CONTINUE
D - Exposed wires traveling over the ground to a standing bracket/outlet at the front yard need to be in a conduit. (This is an alteration to the electrical system). Safety hazard.

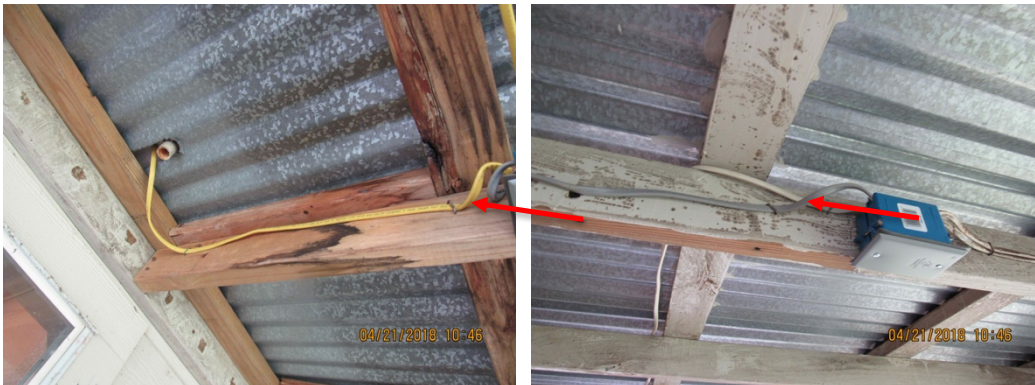
- All exposed wires traveling over the rafters and or crossing metal laminate at the rear attached canopy need to be in a conduit protection. Safety hazard.

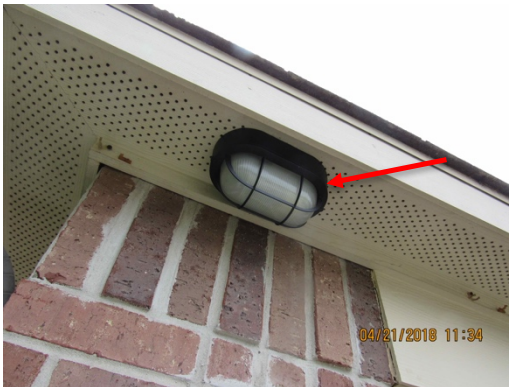
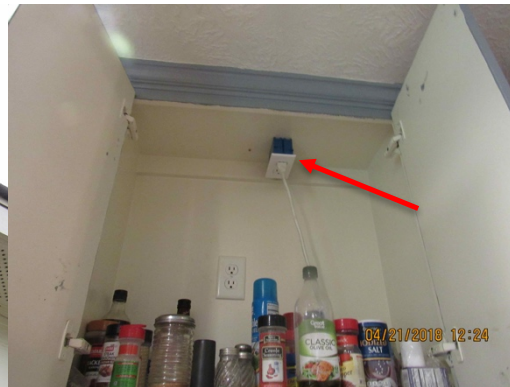
Additional alterations viewed: Light fixture within the soffit of the garage (cancelation of the original light fixture at the wall), additional outlets within the wall cabinet above the microwave (the original outlet has electrical current); outlets at S.E. bedroom above the beds, not with the standard height within the wall from the floor at this bedroom and at the living room area.

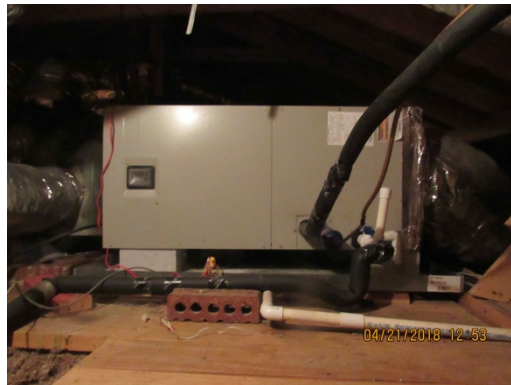
D - Highly recommended to install an independent HVAC switch disconnect to the power line at the attic within reach of the system. Currently it only has the manufacture breakers within the HVAC cabinet.

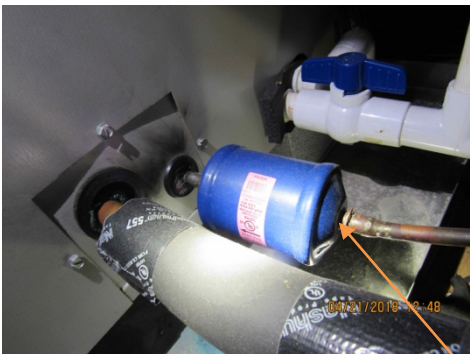
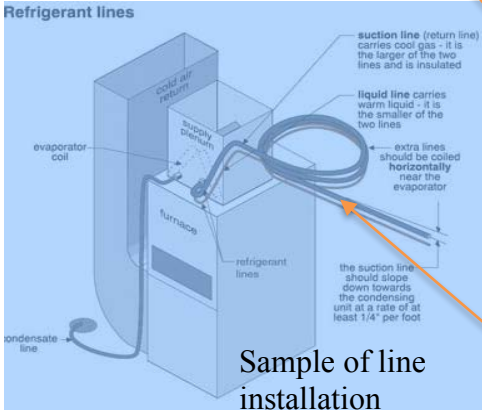
The temperature differential tested falling out of the acceptable range may be cause by restriction in the liquid line or unbalance refrigerant level in the system.

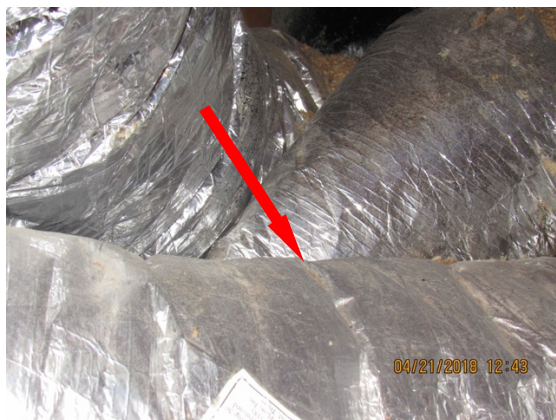
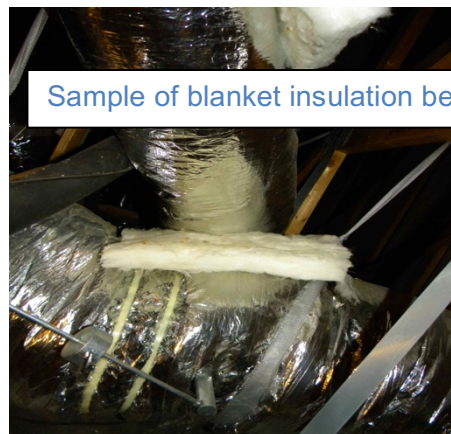
D - At the intersection of the condition air ducts in contact it is recommended to place a piece of blanket insulation. Aluminum flex ducts in contact with each other in the hot humid environment of the attic transmit electrostatic heat flow (heat transfer) throughout the aluminum surface of the duct promoting the cold ducts in contact causing moist air to drop below dew point dropping condensation in a water form from the duct surface. IRC (International Residential Code) M1601.2

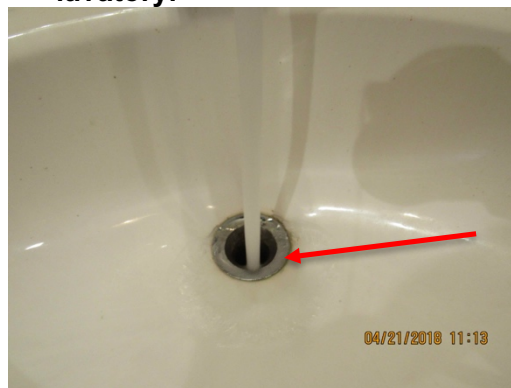
- No drain pop-up stopper at the right master lavatory and hall bath lavatory.

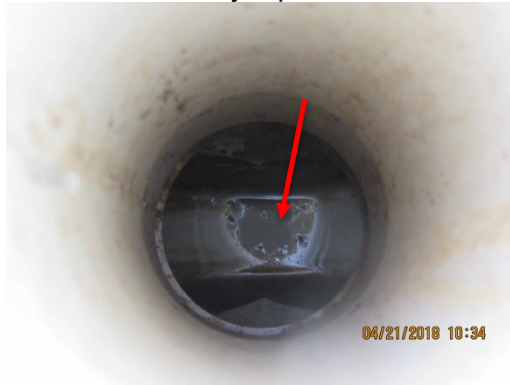
D - The horizontal drain pipe was viewed from the cleanout with water retention. No standing water should be seen within this main drain pipe. This may indicate a stoppage in the line or improper sloping within the pipe. Typically, this drain pipe is install with 2% slope/grading the community tap sewer line.

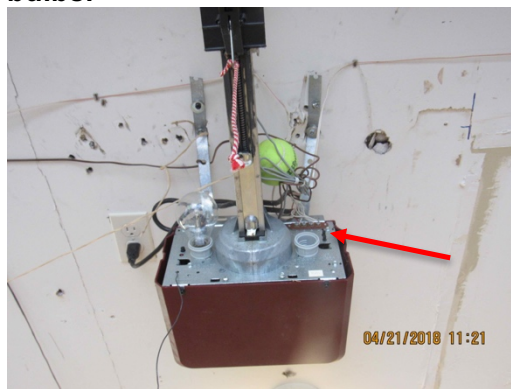
- Garage operator is missing the light diffuser and one of the light bulbs.
