PROPERTY INSPECTION REPORT

Concerning: 7 Craven Park Court, The Woodlands, TX 77354

By: Todd Goodwin : TREC# 21218

10/16/2019

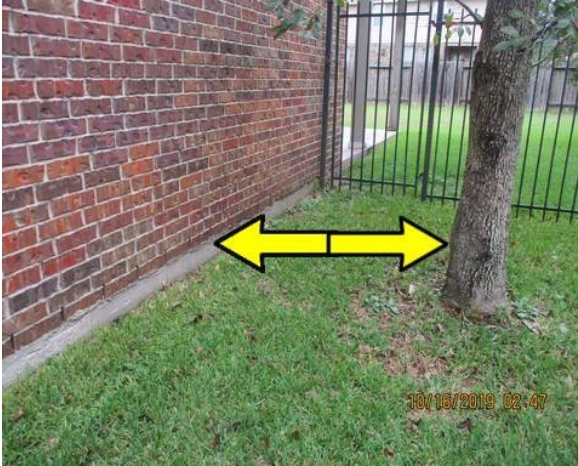
Tree in close proximity. Tree roots may cause damage to the foundation - Recommend to consult a tree contractor to install a root barrier.

Tree in close proximity

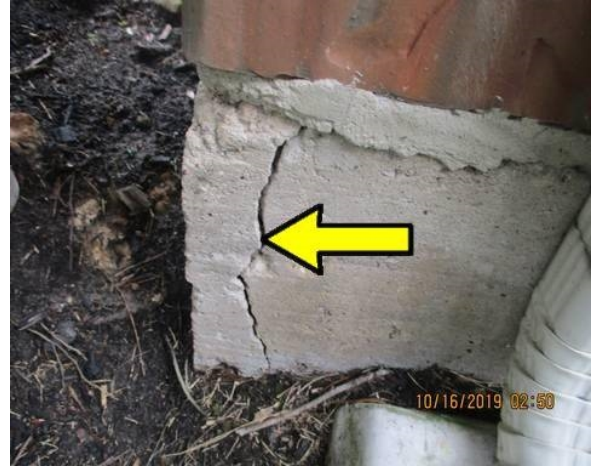
The concrete slab foundation corners were spalled at the front right and back left. This is caused by thermal expansion of the walls and the tight connection between the veneer and concrete surface. The expanding veneer in the hot sun exerts a force sufficient to shear the corner from the foundation. This is common and is not considered a significant structural defect. Should the crack open beyond one-sixteenth of an inch, the corners should be repaired, to avert deterioration of the veneer at the corner and to prevent access by wood destroying insects. Concrete repair specialists and some masons in your area are equipped for these repairs.

Spalled at front right

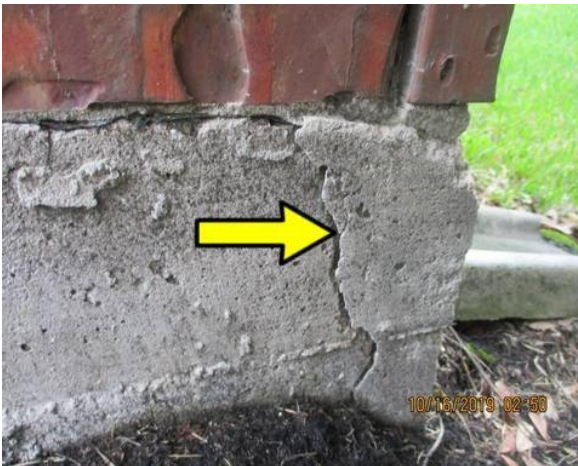
Spalled at back left

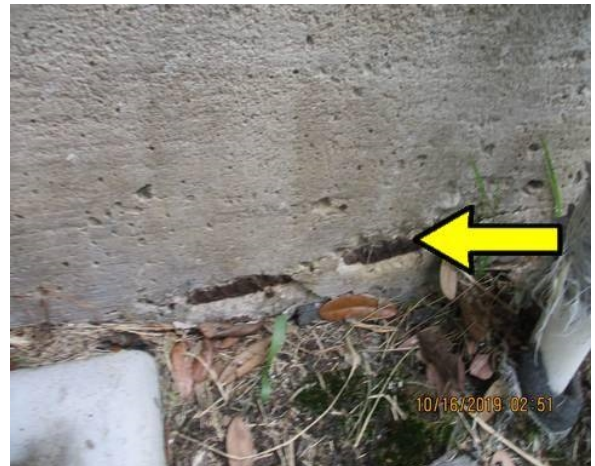
Steel reinforcing is exposed on the right side of the home. Exposed reinforcing is not considered a significant structural defect. Recommend scraping the steel with a wire brush, applying a rust inhibitor and sealing with a fine sand mortar.

Exposed reinforcing at right side

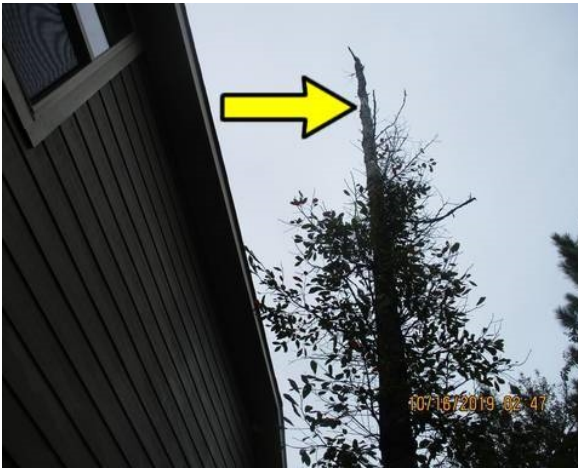
Top of tree at the right side of the home appears dead. Recommend having the tree evaluated by a qualified tree company.

Dead tree at right side

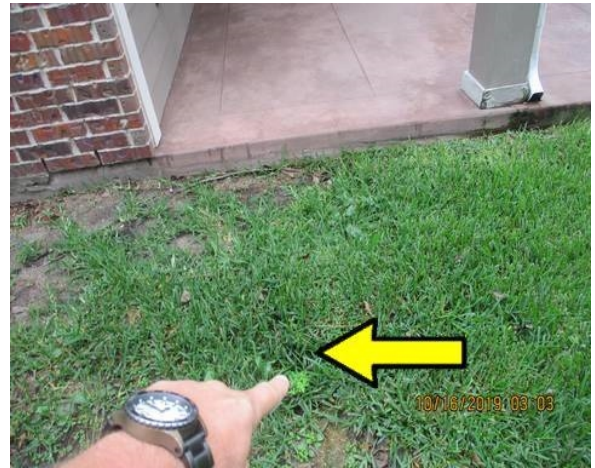
Fill hole at right of back porch

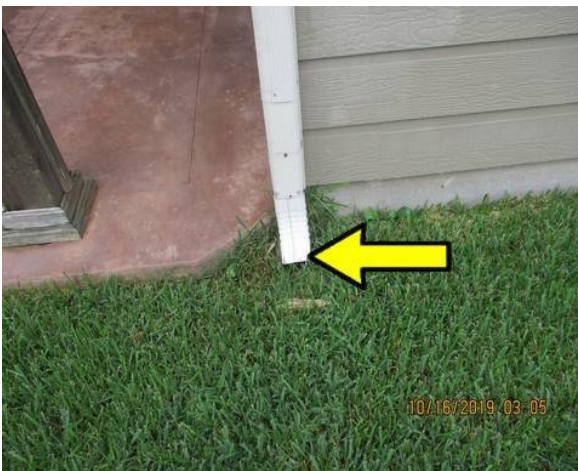
Extend leaders on downspouts and add splash blocks so water run off from roof is directed to drain away from the foundation. We mention this because poor drainage is a frequent contributor to differential movement.

Extend leaders

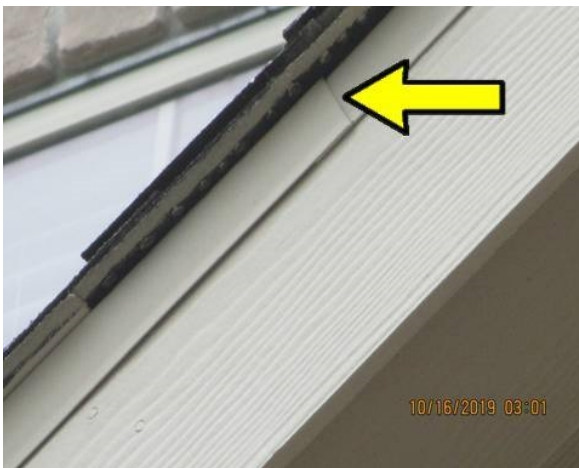
The drip edge has been installed improperly. The drip edge should be installed in a shingle like fashion. Recommend qualified roofing company evaluate and correct as needed.

Drip edge is not properly installed

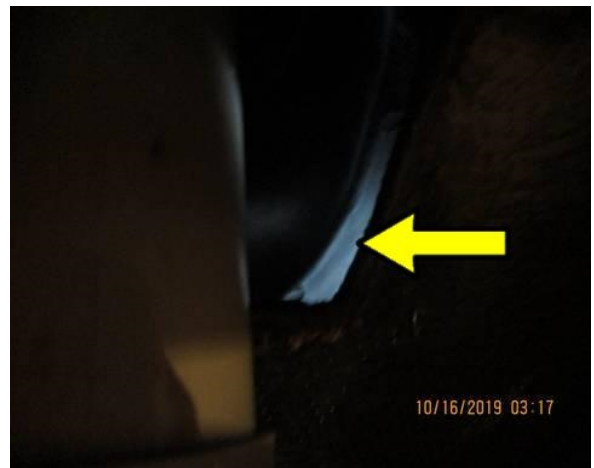
Outside light was noted around the furnace flue vent. Recommend securing the vent to prevent water intrusion and related damage.

Outside light is visible around furnace flue vent

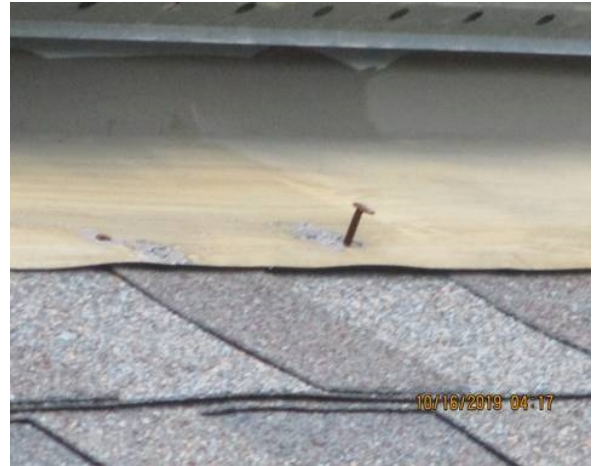
Secure and seal the nail that has backed out at the flashing above the front porch to prevent water intrusion and related damage.

Secure and seal flashing nail above front porch

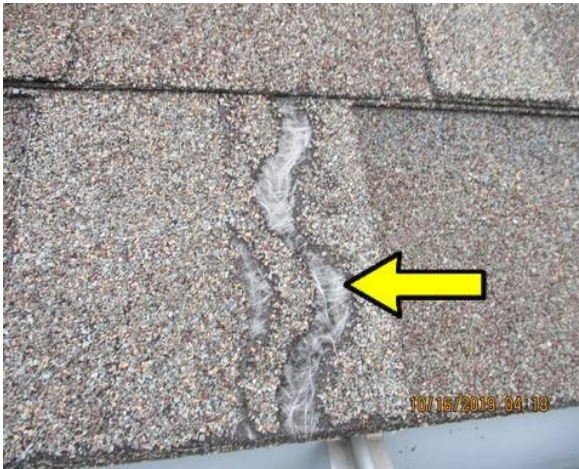
Damaged shingles noted above the front porch. Recommend qualified roofing company evaluate and correct as needed.

Damaged shingle above front porch

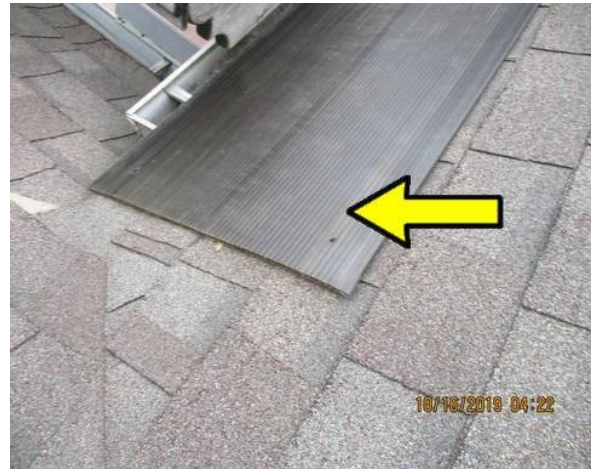
Improper flashing on the back slope above the back patio cover. Recommend qualified roofing company evaluate and correct as needed.

Improper flashing at back slope above patio cover

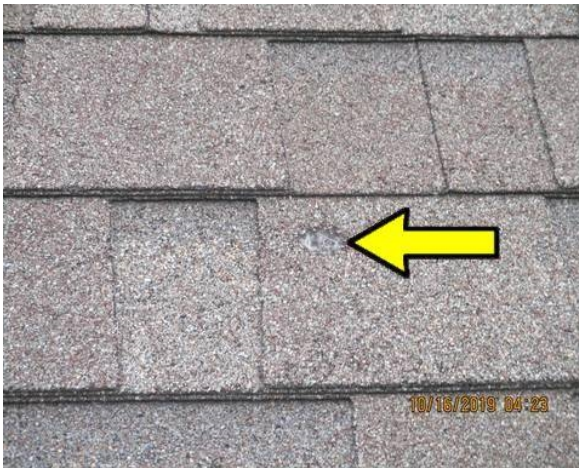
Several areas on the back slope of the home show evidence of possible hail damage. Recommend qualified roofing company evaluate.

Possible hail damage at back slope

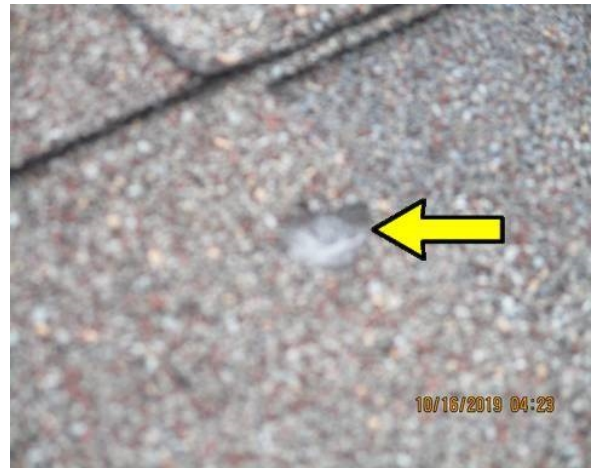
Possible hail damage in back

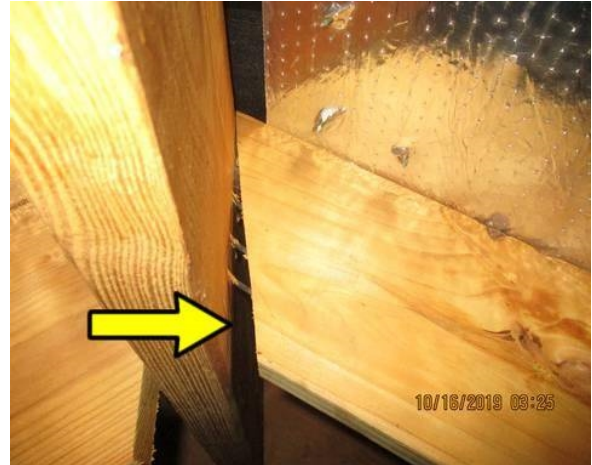
Rafter has pulled away from the ridge board in the pull down attic. Recommend consulting with a qualified carpenter to evaluate and correct as needed.

Rafter has pulled away from ridge board

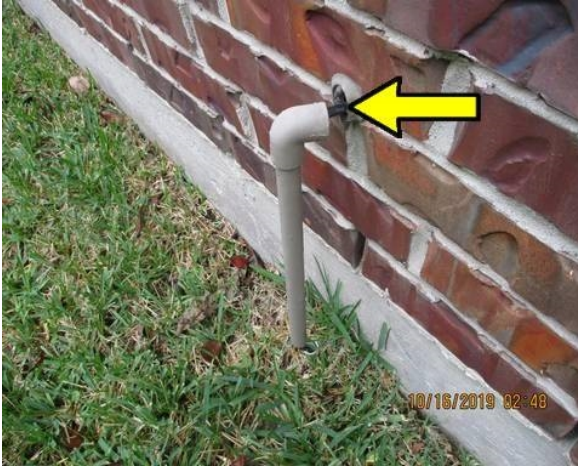
Seal around penetrations (Irrigation wire)

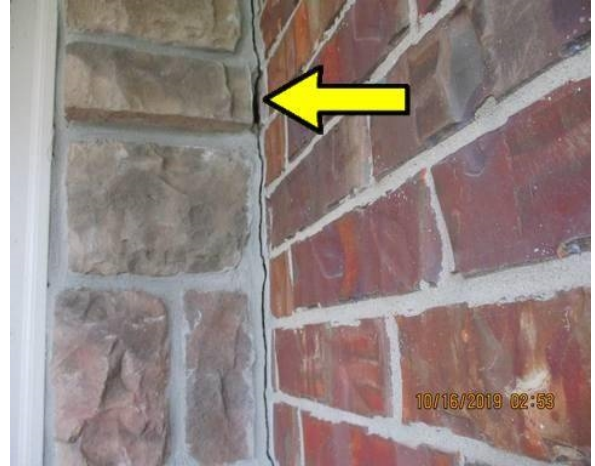
Seal mortar at right of front door

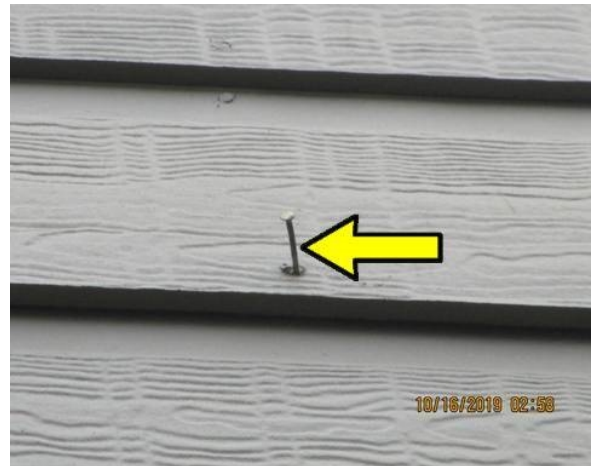
Nail has backed out of siding at left side

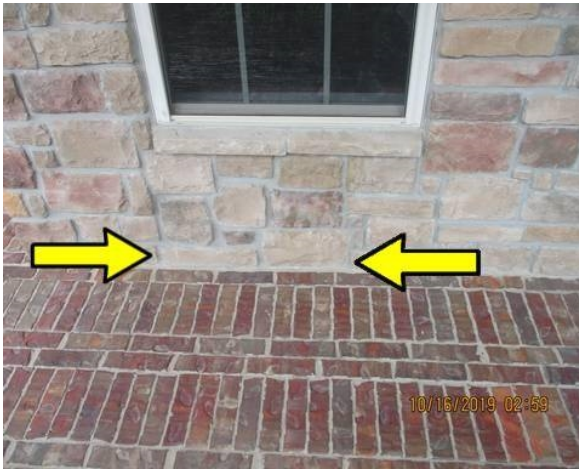
Missing weep holes / weep screed above windows and doors, and at the bottom of exterior walls at the front porch. Recommend adding weep holes / weep screed to allow moisture an avenue to escape the wall cavity.

Missing weep screed / weep holes at entry

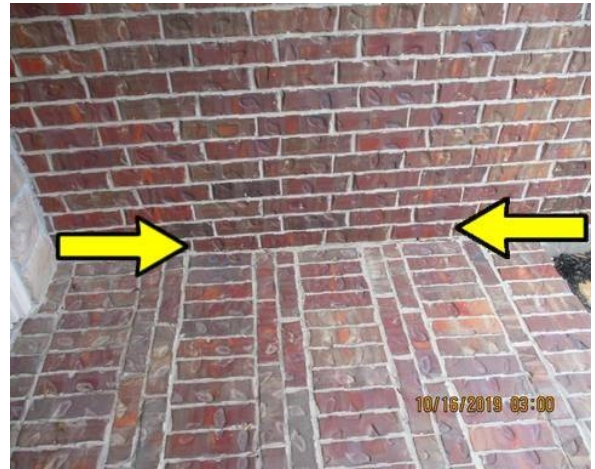
Missing weep holes at entry

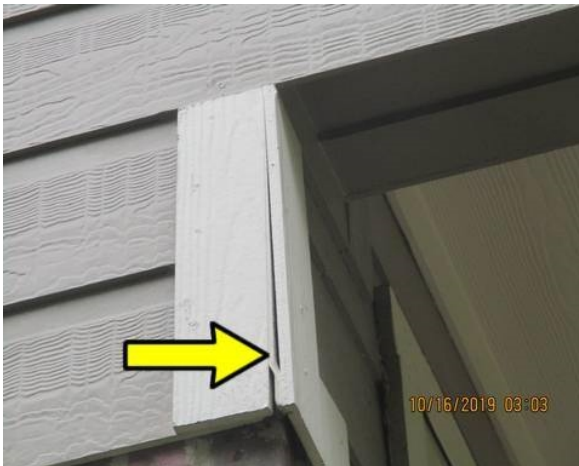
Secure and seal trim piece at back patio

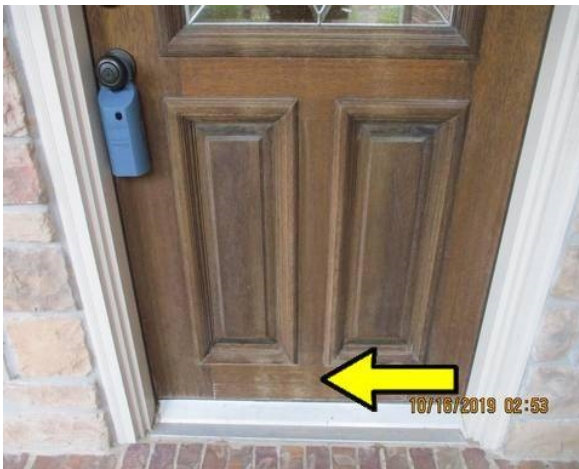
Finish is deteriorating at the front door. Recommend refinishing the door to prevent further deterioration.

Finish on front door is deteriorating

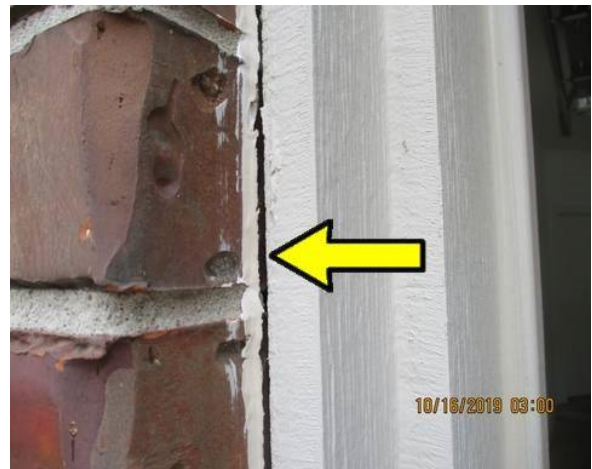
Repair caulk around overhead garage door to prevent water intrusion and related damage.

Repair caulk around overhead garage door frame

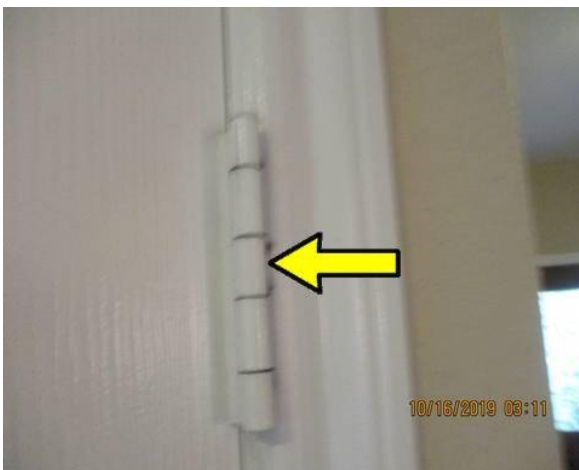
Door leading to the garage should have self closing hinges installed for safety reasons.

Door leading to the garage should have self closing hinges

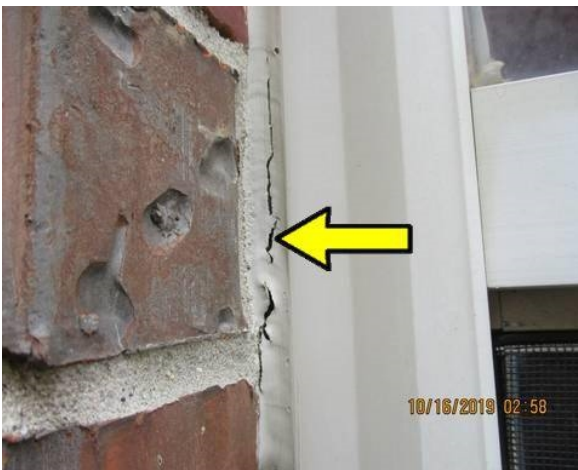
The caulking compound around the window frames is generally serviceable. However, some touch-up work is needed in places, not limited to the left side of the home.

Repair caulk around windows

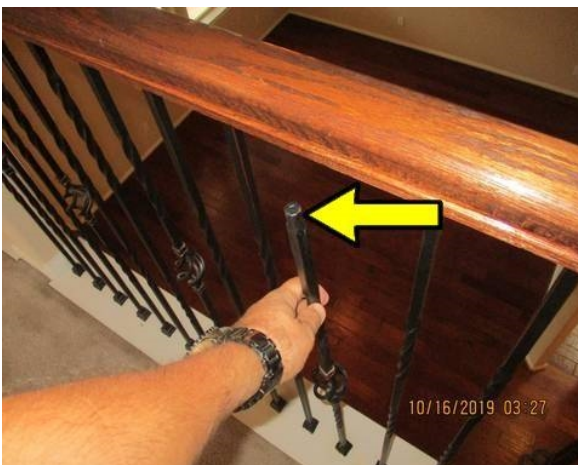
Baluster is loose at the railing over looking the living room. Recommend securing for safety reasons.

Baluster not attached

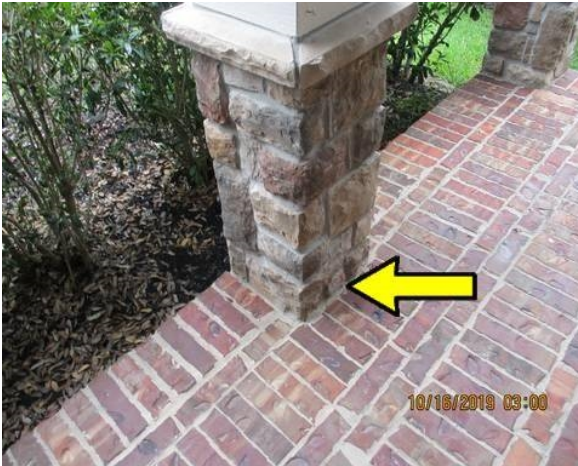
Weep hole / weep screed missing at front porch column. Recommend adding to allow moisture an avenue to escape the wall cavity.

Missing weep holes at front porch column

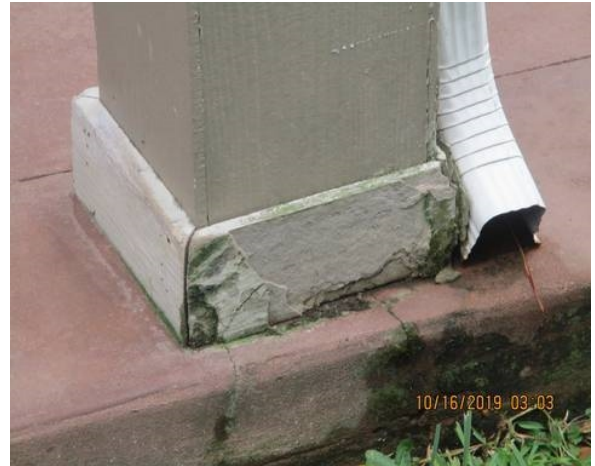
Deteriorated trim around back patio column. Recommend replacing the trim.

Deteriorated trim around back porch post

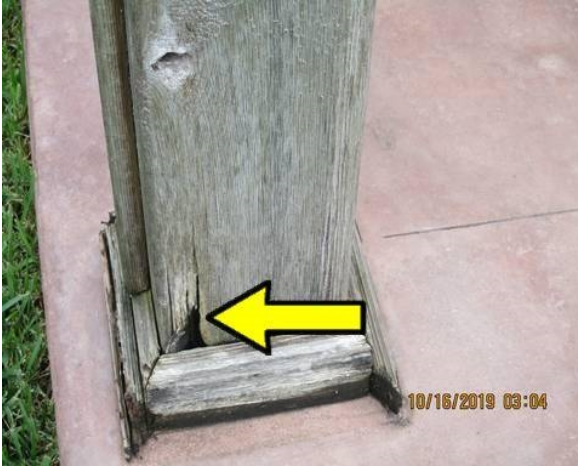
Deterioration noted to the back patio cover post. Recommend repairing / replacing all deteriorated wood.

Deteriorated wood at back patio cover post

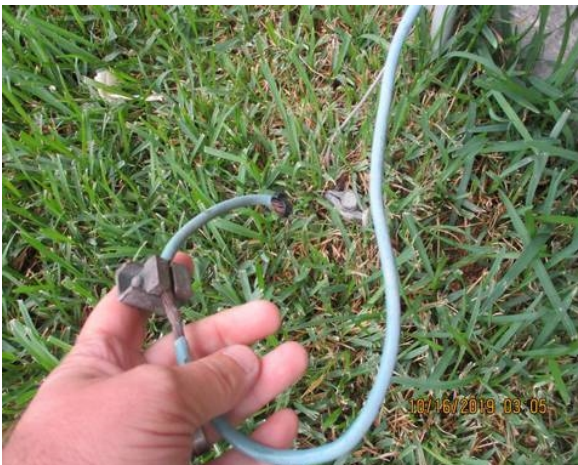
Ground wire is not attached to the ground rod. Recommend correcting.

Ground wire is not attached

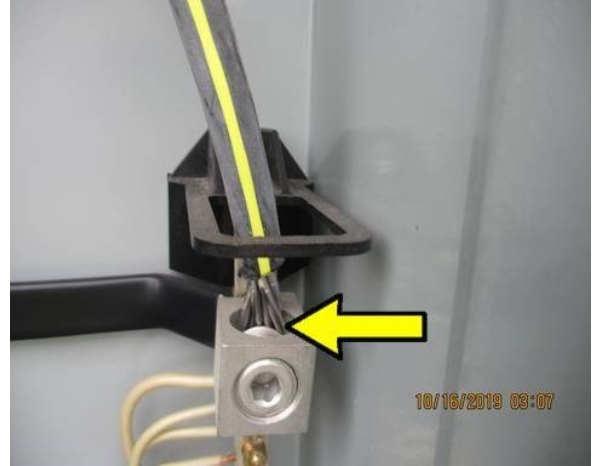
No antioxidant on service wires

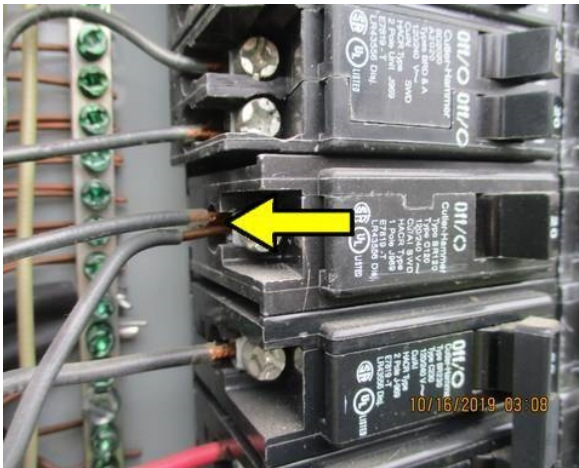
Double tapping noted. This is when two or more wires are connected to one breaker in the panel and is considered unsafe. Recommend having electrician evaluate system.

Double tapped breaker

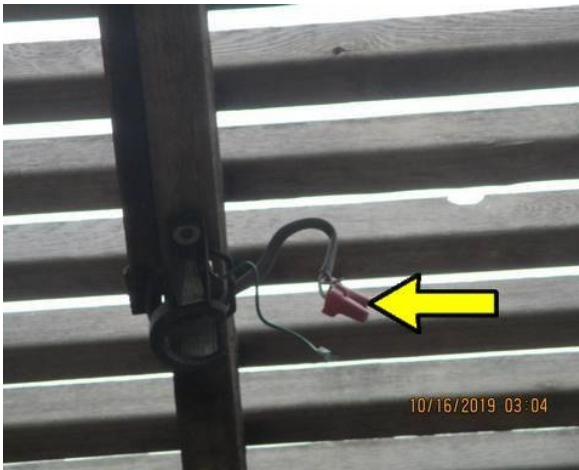
Secure exposed wire at back patio cover

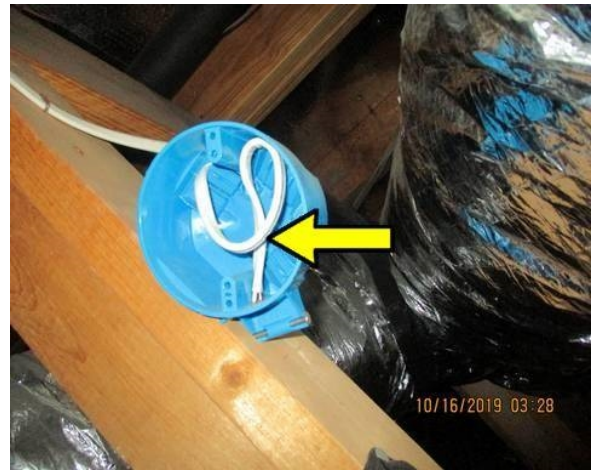
Add cover plate to junction box in attic access at top of stairs

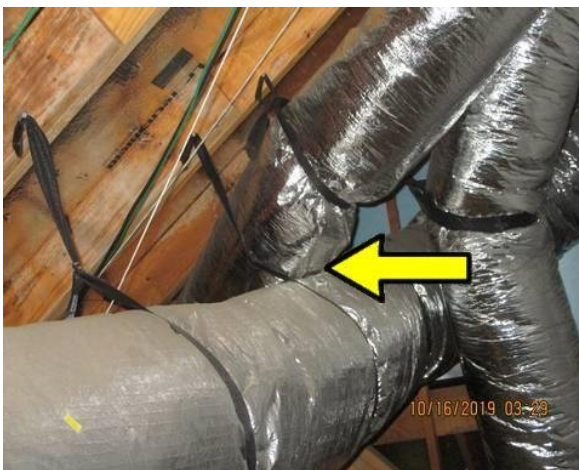
Install batt insulation between ducts that touch each other to prevent condensation build up and premature wear of the ducts.

Add batt insulation between ducts that touch

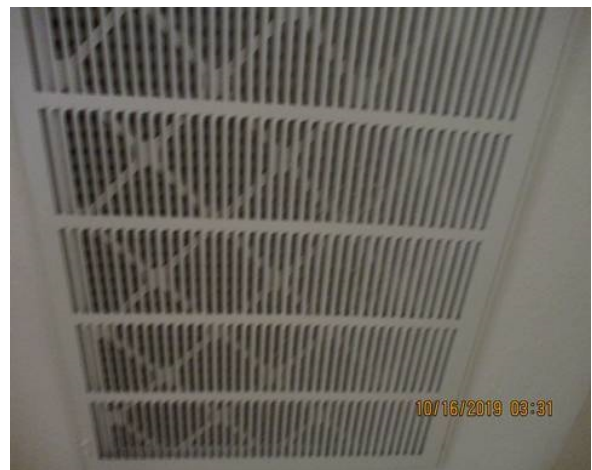
This unit utilizes a media filter that is at the unit in the attic. Filters should not be installed at the return air grilles. Recommend removing these filters.

Remove filters out of return air grilles

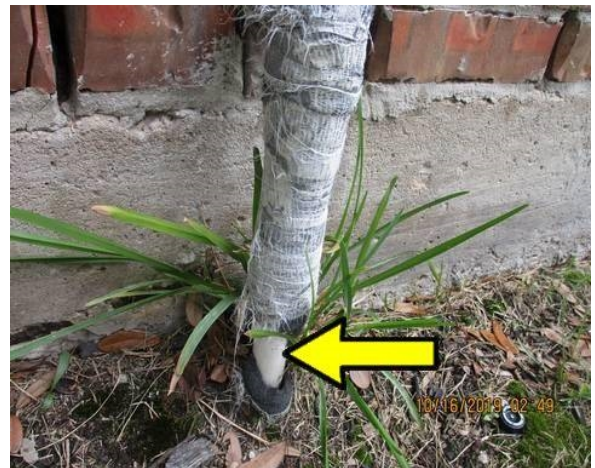
Repair insulation on water main shut off

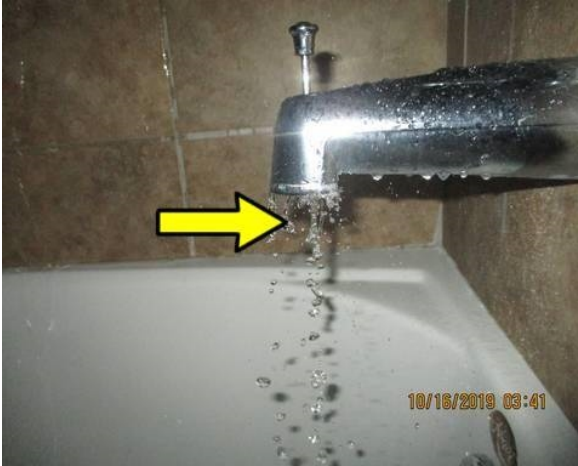
Diverter leaks at upstairs bath

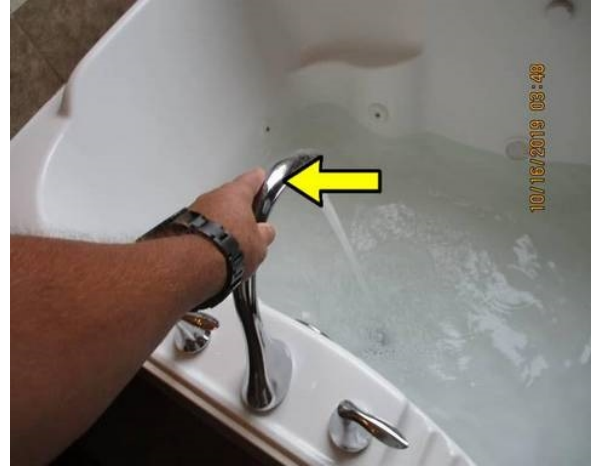
Faucet is loose at master tub

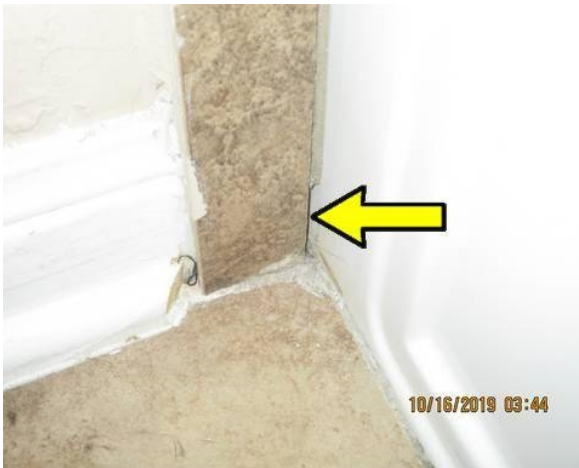
Seal grout around tub at upstairs bath

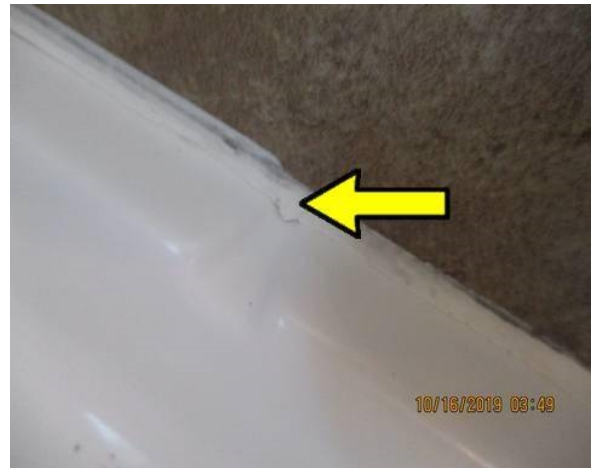
Remove caulk around weep holes at master shower pan

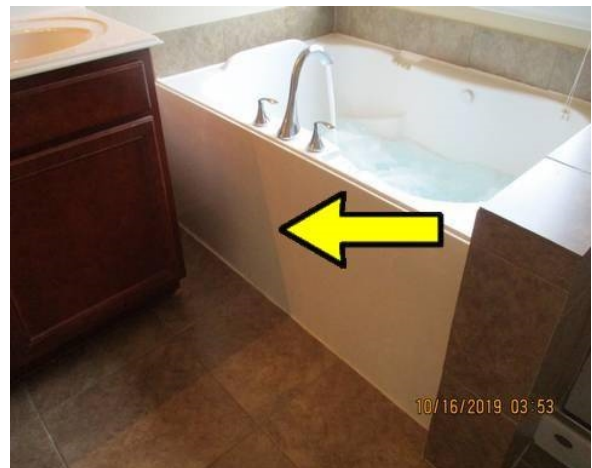
There is no access to the motor. Recommend providing access.

No access to the motor

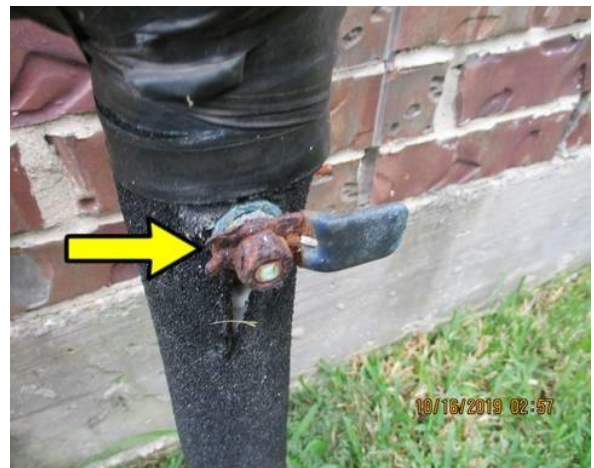
Handle is damaged at the backflow preventer valve. Recommend replacing this valve handle.

Handle is broke on backflow preventer valve

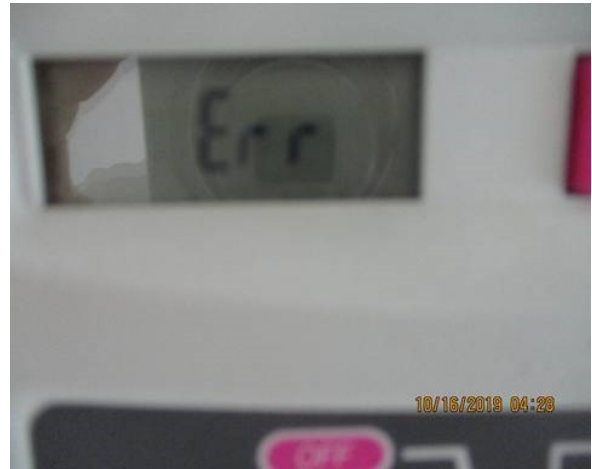
Error code flashing (System did not work)
