24507 Rossmore Hill Court
Spring, TX 77389

PROPERTY INSPECTION REPORT FORM

Jetmir Aga <i>Name of Client</i>	02/24/2022 <i>Date of Inspection</i>
24507 Rossmore Hill Court, Spring, TX 77389 <i>Address of Inspected Property</i>	
Mike L Weible <i>Name of Inspector</i>	4596 <i>TREC License #</i>
<i>Name of Sponsor (if applicable)</i>	<i>TREC License #</i>

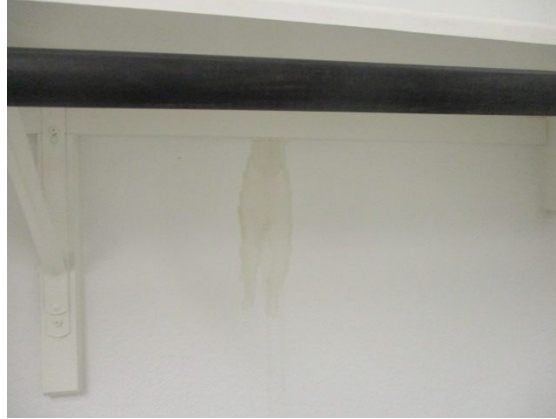
There is what appears to be a water stain in the wall by the shelves in the master bathroom. No moisture was detected at the time of the inspection. This stain appears to have been caused by a spill.

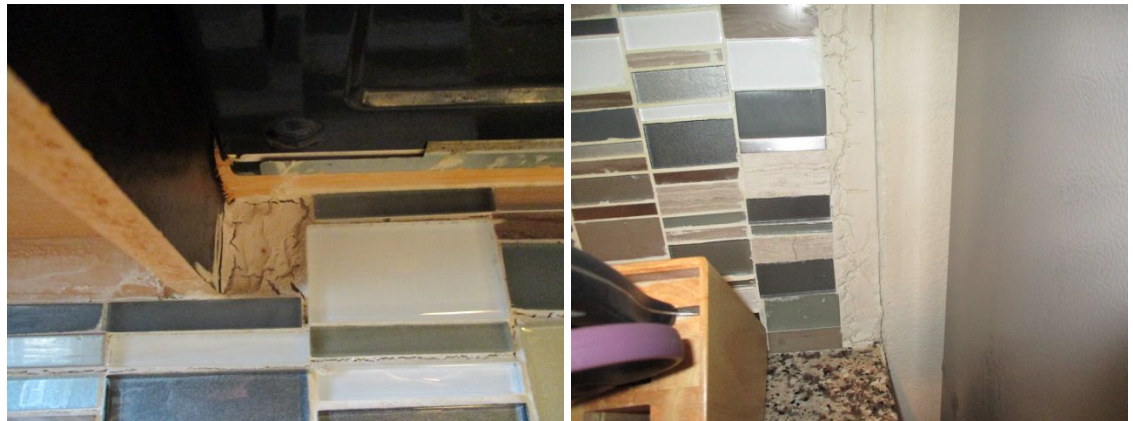
There are gaps / missing tile around the backsplash on the north wall of the kitchen.

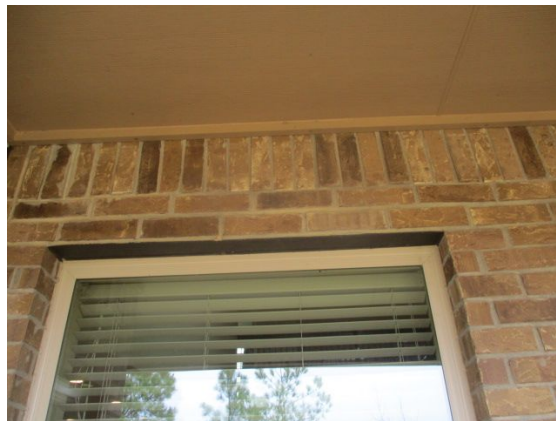
There are no weep holes in the brick mortar joints above the exterior window at the back patio.

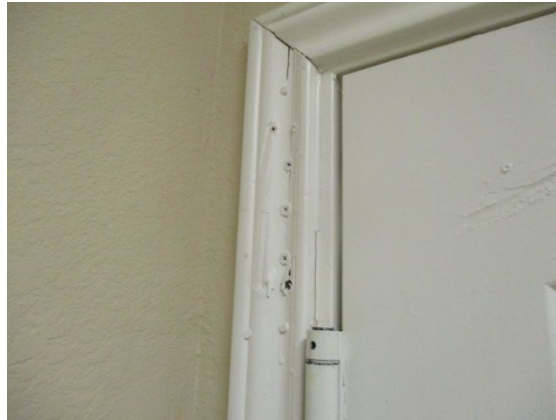
The trim on the door between the house and garage is damaged.

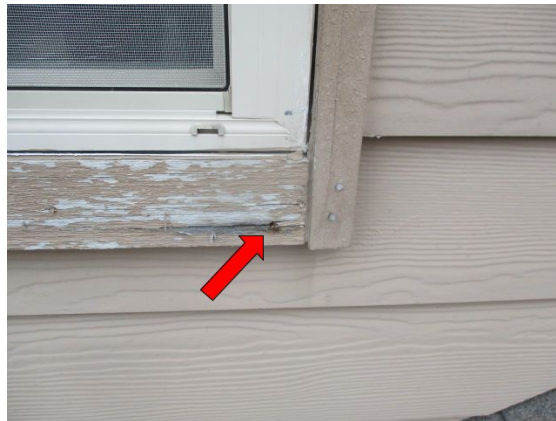
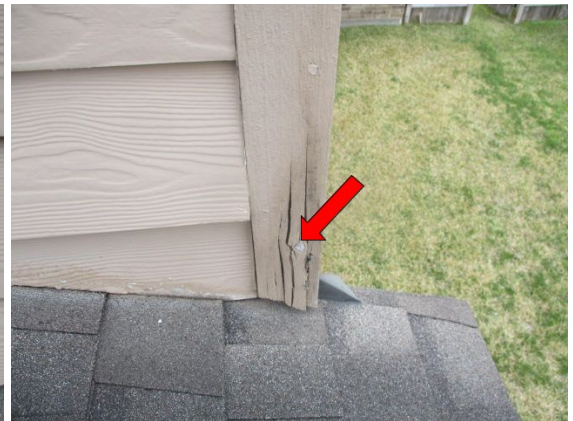
There is a small amount of rotten wood at the exterior trim at the bottom of the upper level window at the south side of the house and to the upper level trim above the roof at the southwest corner of the house.

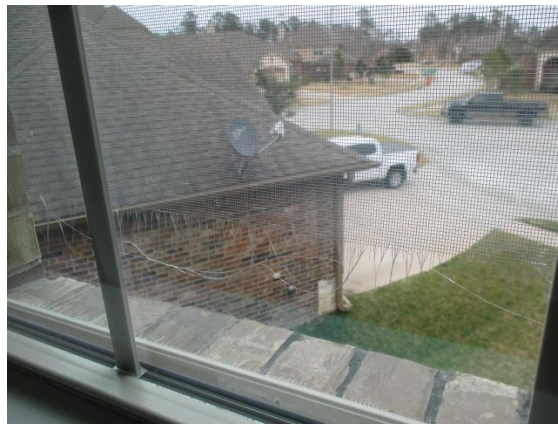
There are many damaged window screens throughout the house.

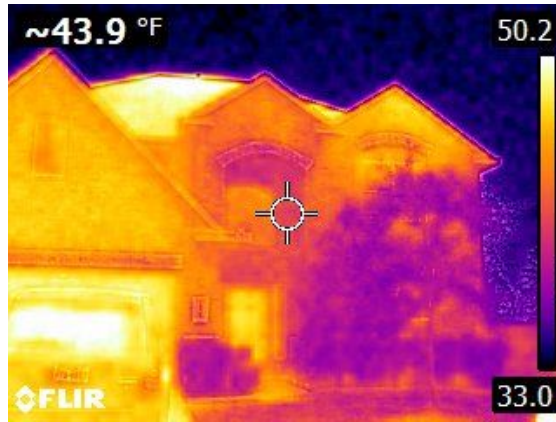
A thermographic scan of the interior of the house was performed with an infrared camera to detect problems such as water penetration, electrical overheating, and insulation issues. No defects were found with the infrared camera at the time of the inspection.

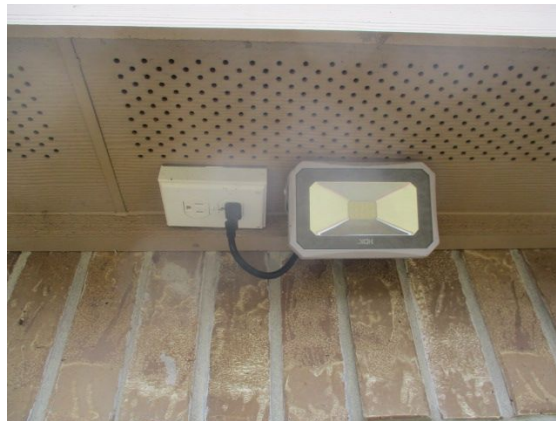
There are two exterior receptacles in the eaves at the back of the house that are not grounded, not GFCI protected, and neither have a weather proof cover.

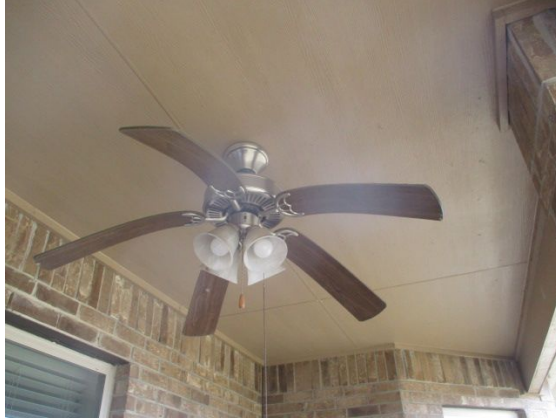
The blades for the ceiling fan at the back patio are drooping. This is an indication that the fixture is not rated for use in an exterior location.

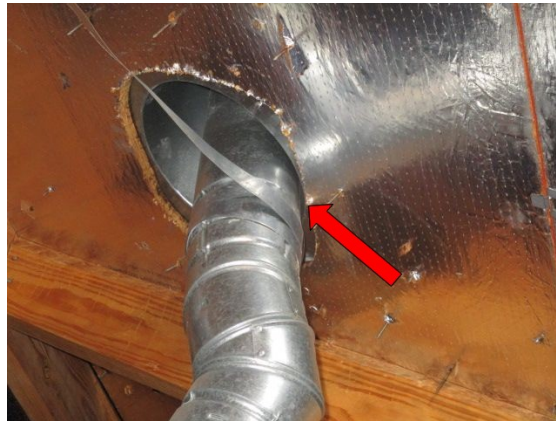
The vent for the heating system is too close to the roofing materials in the roof deck. Recommend a minimum 1 inch clearance to combustible materials.

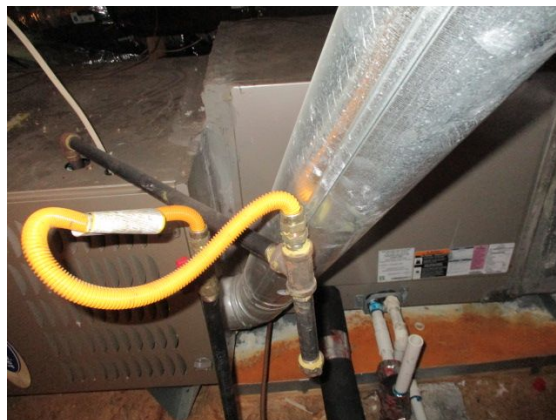
The gas line for the heating system is in contact with the heating vent. There should be a minimum of 1 inch clearance to all combustible materials.

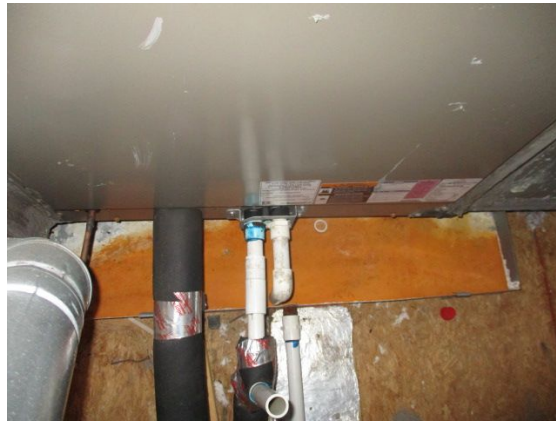
There is heavy corrosion in the secondary condensate drain pan under the evaporator coils in the attic. Recommend replacement of the pan by a licensed HVAC contractor.

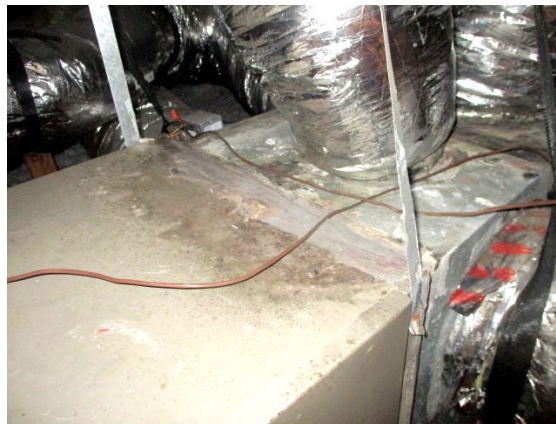
There is what appears to be a fungal growth on the evaporator coils and plenum in the attic. Recommend further evaluation and repairs by a licensed HVAC contractor.

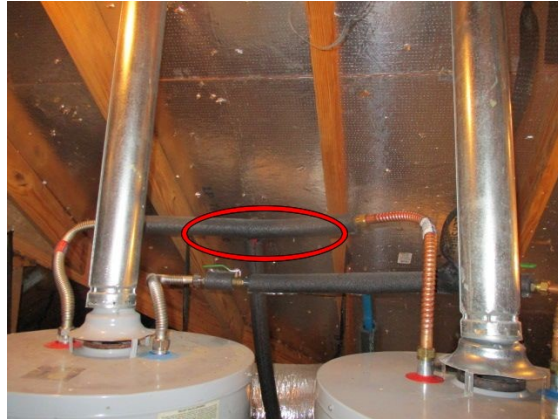
The water heaters are connected in series. This may cause the first tank to age more quickly. This is typical for the age of the house and is not considered a deficiency. The current standard is to connect the tanks in parallel.

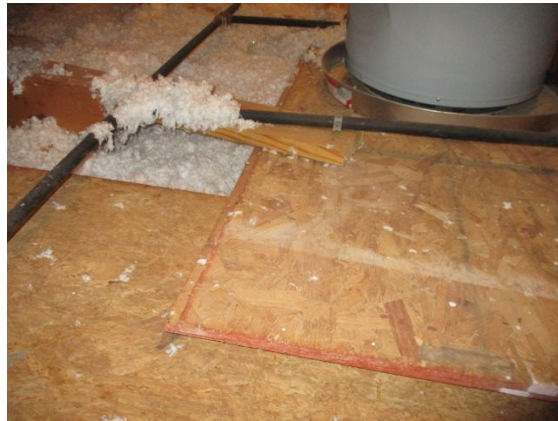
The floor under the water heaters in the attic appears to be bowed. Recommend further evaluation and repairs to ensure the water heaters are properly supported.

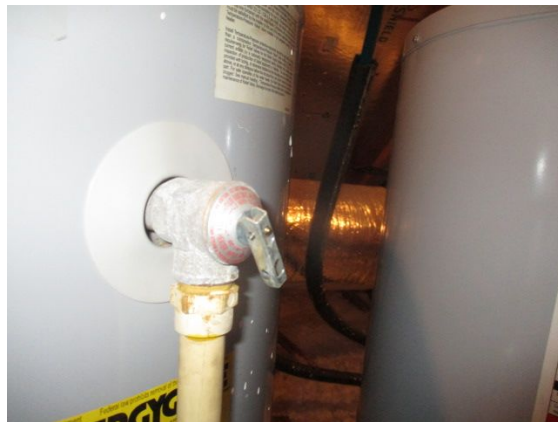
The temperature / pressure relief valve for the 2014 water heater is stuck. Recommend replacement of the valve by a licensed plumber.

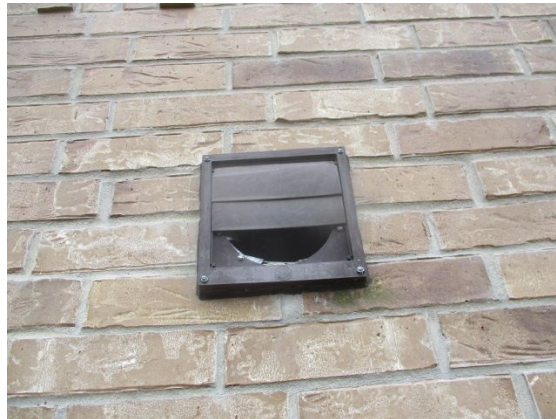
One of the louvers on the termination of the range hood duct is missing.

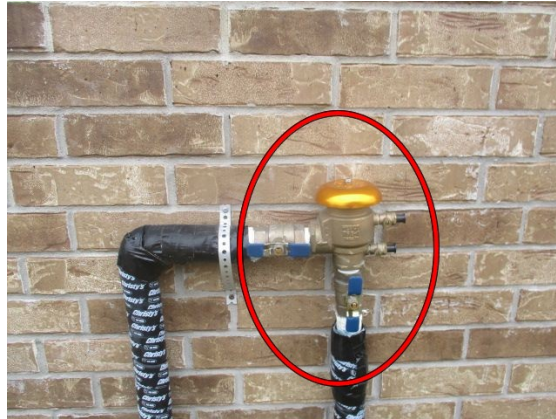
The anti-siphon for the sprinkler system is located on the south side of the house.

Recommend insulating the anti-siphon valve to reduce the possibility of freezing.
