# Inspection Report

**Property Address:**  
330 S Walnut St  
Kountze TX 77625

# PROPERTY INSPECTION REPORT

**By:** Joe Askew TREC # 10495 / Ethos Home Services dba Housemaster 9/17/2021

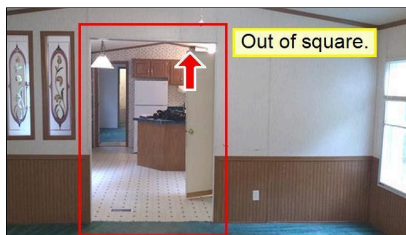
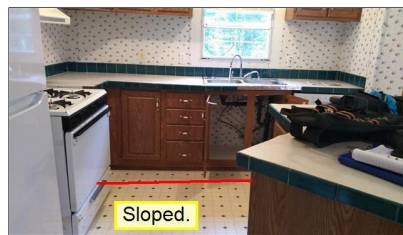
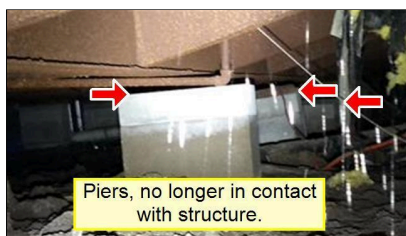
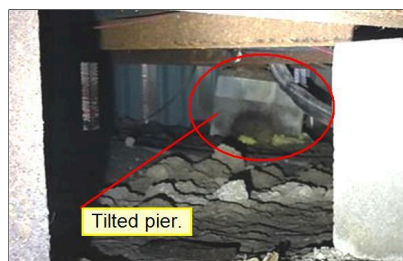
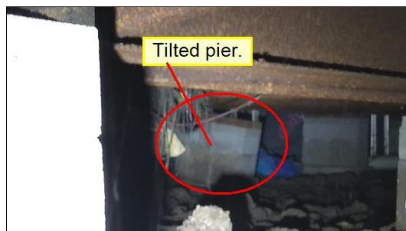
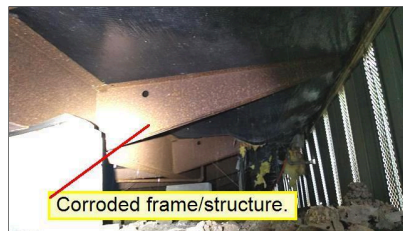
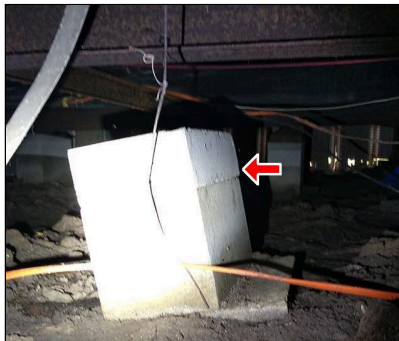
(1) Evidence of settlement and/or deflection was noted.

-Sloped floors were noted.

While viewing the underside of the home, inspector found multiple piers that were no longer in contact with/supporting the home. Some of the piers were also tilted/off-center. This is likely related to the settlement/deflection.

-The frame exhibited some corrosion.

Recommend having checked and corrected/repared as necessary by a qualified contractor.

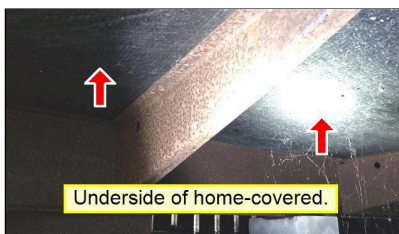
A. (Picture 8)

(2) Inspector had limited access to crawlspace/underside of home. The underside of the home is covered/concealed by a factory installed house wrap. This wrap holds the floor insulation/duct work in place and is not removable without damaging it. The framing/subfloor under the home and the majority of the plumbing under the home is concealed by this wrap. No determination/evaluation could be made of structural components, conditions, or building materials in inaccessible areas.

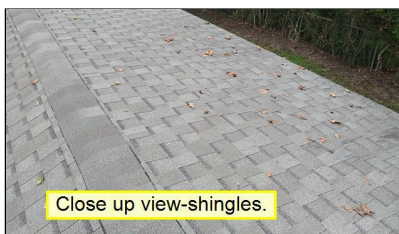
C. (Picture 1)

(1) Architectural shingles present. No shingles were forcefully lifted due to possible damage. Fasteners were not visible (no attic access).

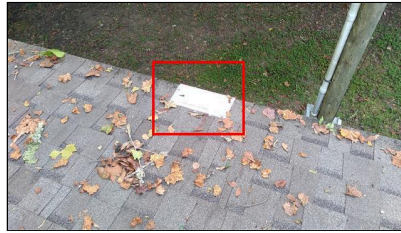
C. (Picture 2)

(2) One area at the left side of the rear slope was repaired with a metal flashing (somewhat unusual).

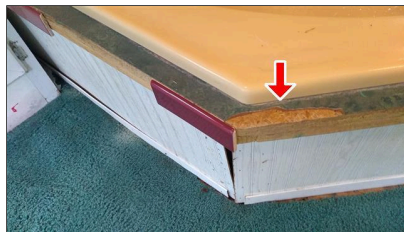
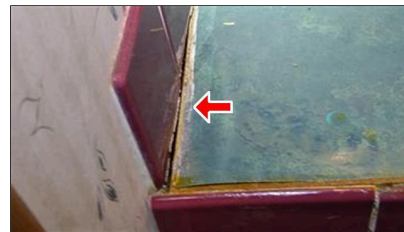
(1) The tub surround and sink countertop at the left side bath could benefit from repair.

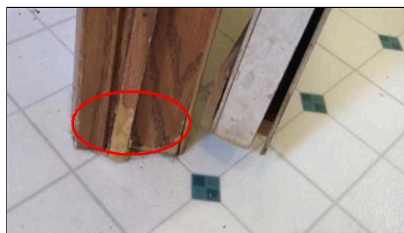
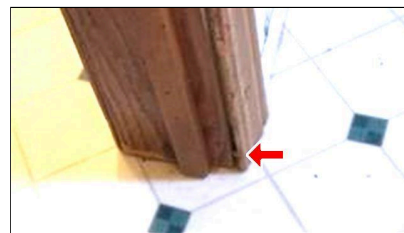
(2) The interior of the home exhibited various wear and rear (cosmetic damage noted).

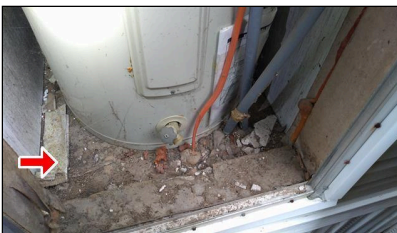
E. (Picture 5)

(3) Some deterioration was noted under the water heater.

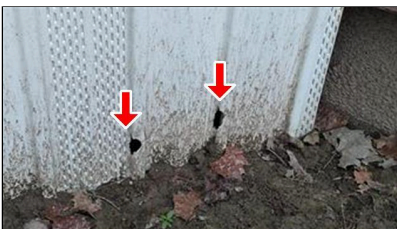
E. (Picture 6)

(4) Some damaged skirting/siding was observed.

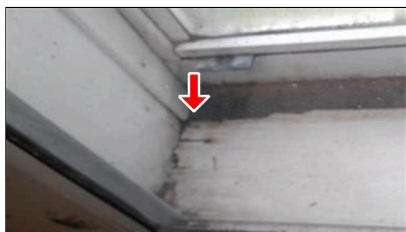
E. (Picture 7)

(5) Deterioration was noted under some of the windows.

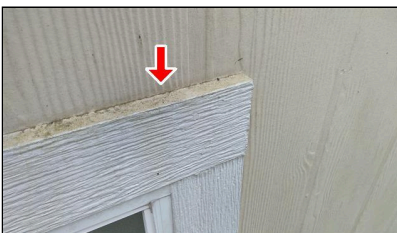
E. (Picture 9)

(6) The installer did not use a flashing above the windows and at horizontal transitions in the siding.

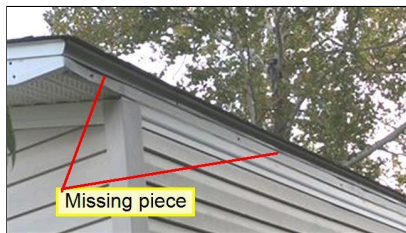
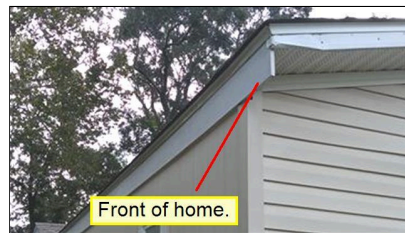
(7) A piece of trim was missing at the rear of the home (see front of home for example).

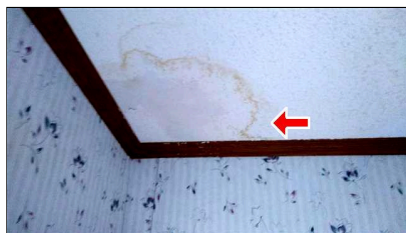
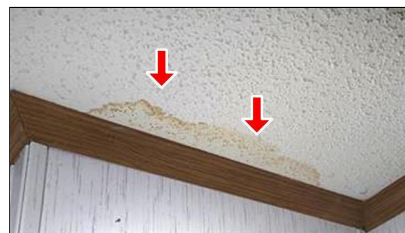
(1) Stains were noted at the ceiling in the far left bath and and the far left bedroom. This is indicative of a leak at some point. No evidence of a current leak was present at the time of inspection. Inspector recommends repairing these areas and monitoring occasionally. If the staining re-appears, further investigation may be needed.

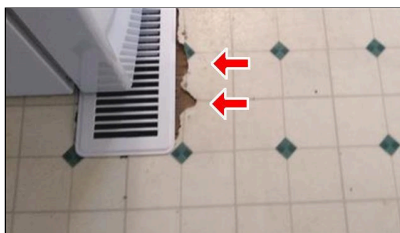
F. (Picture 3)

(2) The floor covering was damaged in some areas.

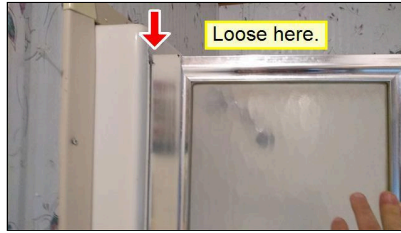
G. (Picture 1)

(1) The shower door assembly was loose at the left side bath.

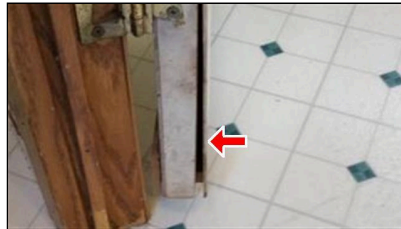
G. (Picture 2)

(2) The entry door to the washroom exhibited damage.

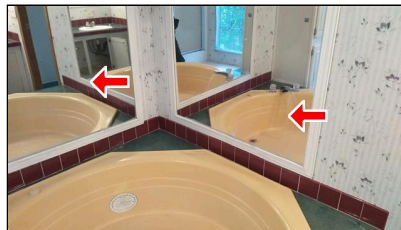
H. (Picture 1)

(1) Mirrors were installed over the tub at the primary bath. Inspector did not observe a sticker or label to indicate these mirrors were constructed with safety glass.

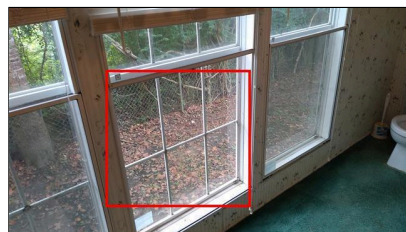
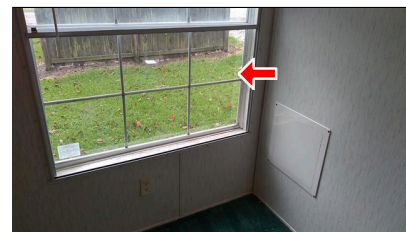
(2) The bottom sash of one of the storm windows at the left side bath was missing. Another was missing at the far right bedroom.

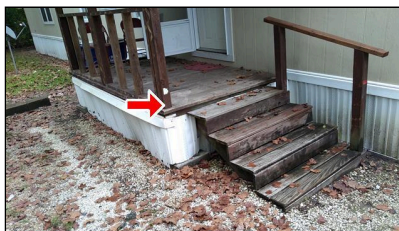
I. (Picture 1)

The exterior steps exhibited some deterioration.

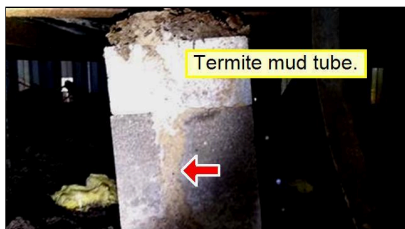
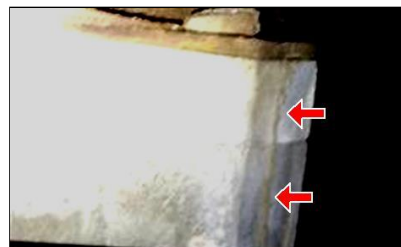
(1) Inspector found evidence of subterranean termite activity under the home (termite mud tubes observed on sides of piers). Some of the wooden blocks on top of the piers were damaged/deteriorated.

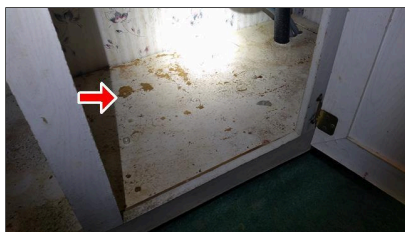
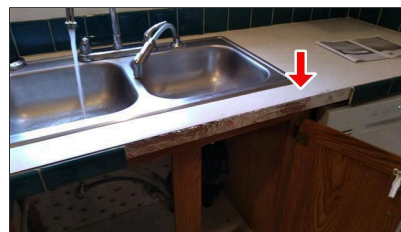
(2) Deterioration was noted at some of the cabinetry.

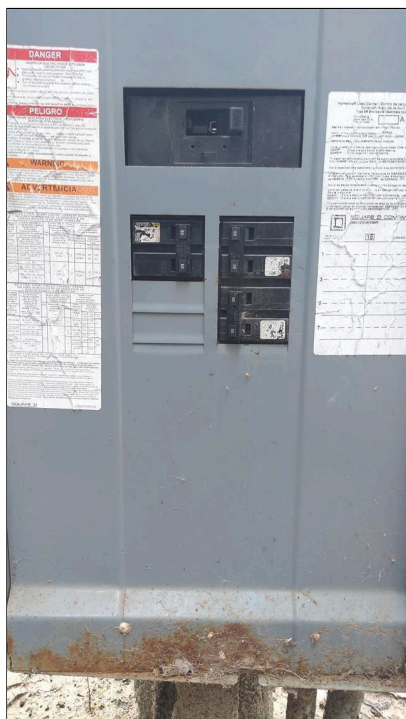
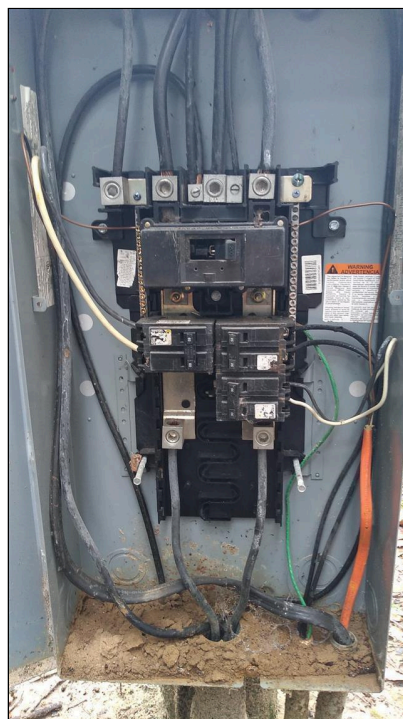
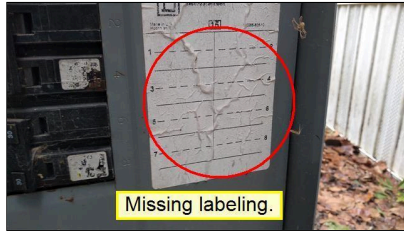
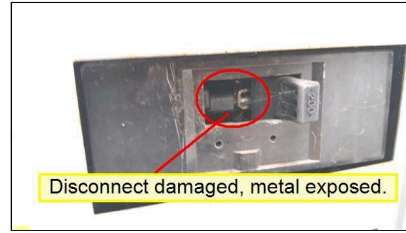
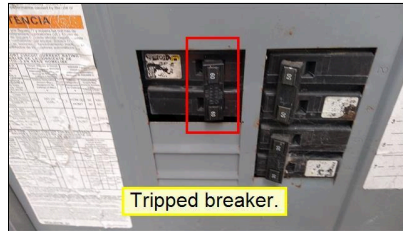
(1) A 200 amp panel box was noted at the rear of the home.

-Most of the labeling was missing.

-One cover screw was missing.

-Corrosion was noted.

-The disconnect breaker was damaged (leaving metal components of breaker exposed).

-A tripped breaker was noted (appeared to be related to malfunction of HVAC equipment).

-The conductors ran to the sub panel inside the home were not appropriately sized.

Recommend having serviced and repaired/corrected as necessary by a qualified electrical contractor.

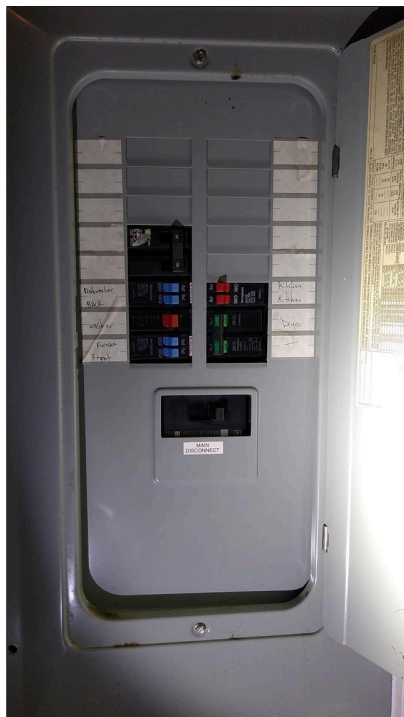
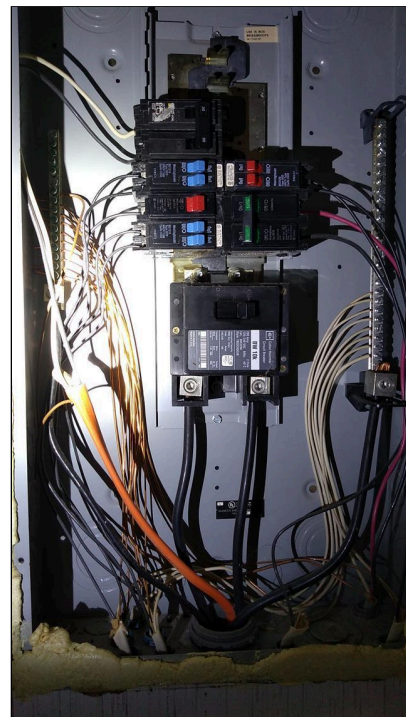
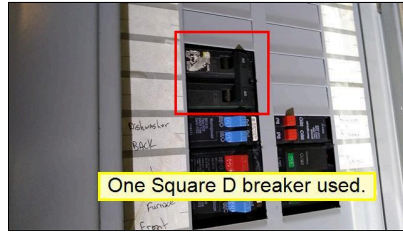
(2) A Cutler Hammer brand Panel box was noted at the far left bedroom.

-One dead front cover screw was missing.

-One Square D brand breaker was installed. The panel box manufacturer (Cutler Hammer) generally recommends that only their brand breakers be used.

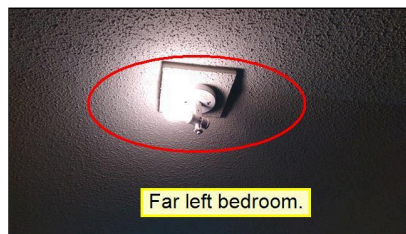
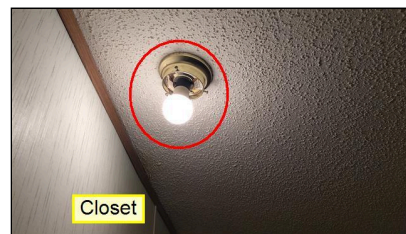
(2) Multiple light fixtures were missing covers/globes.

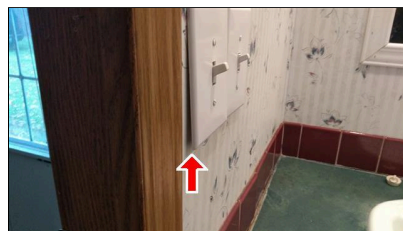
B. (Picture 3)

(3) One light switch did not fit flush with the wall at the left side bath

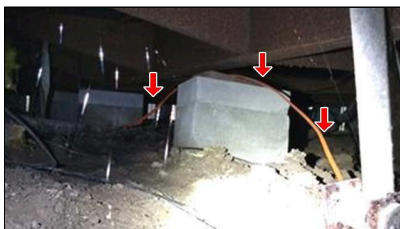
B. (Picture 4)

(4) Exposed romex was observed under the home. Romex is designed for use inside stud walls and should generally be protected from damage, moisture, and sunlight exposure.

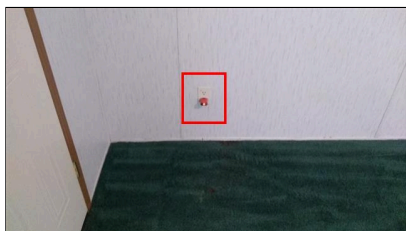
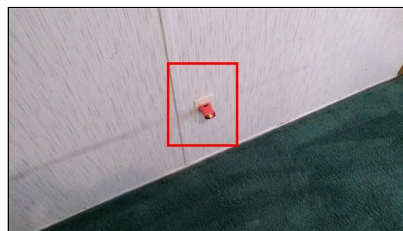
(5) Two receptacles at the far left bedroom tested as "open ground". Recommend correction as necessary by an electrical contractor.

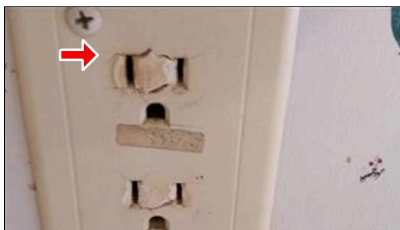
B. (Picture 7)

(6) The receptacle to the left of the kitchen sink exhibited discoloration/damage. Recommend replacing as a precaution.

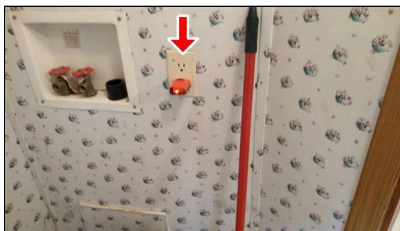
B. (Picture 8)

(7) One receptacle in the washroom tested as "open ground". Recommend correction as necessary by an electrical contractor.

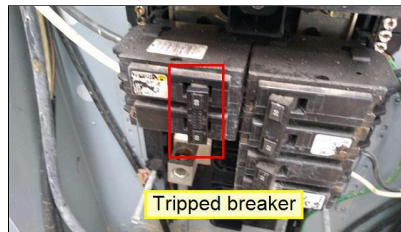
A. (Picture 1)

The HVAC equipment did not provide heated or cooled air to industry standards at the time of inspection. It appeared that the air handler/furnace did not have power. This may be related to the tripped 60 amp breaker in the exterior panel box (see comments in electrical section).

Recommend having serviced and corrected/repared as necessary by a qualified contractor.

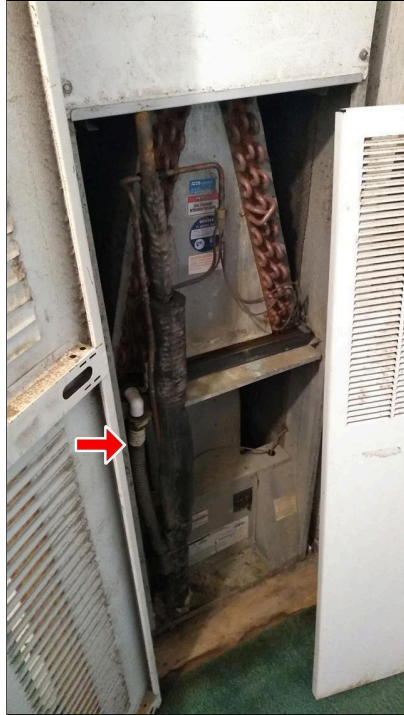
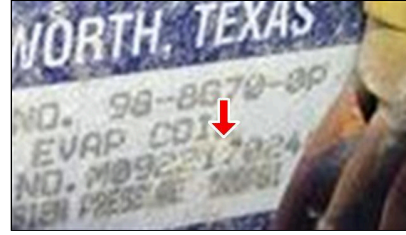
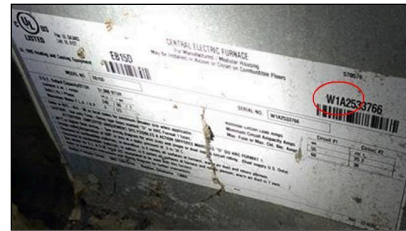
(1) A coleman brand furnace/air handler was noted at the right side hallway. According to accessible serial numbers, this equipment was manufactured in 2012.

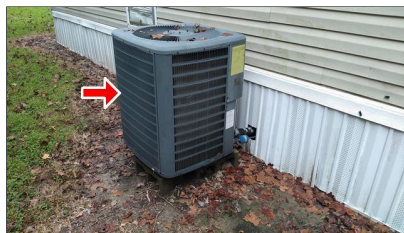
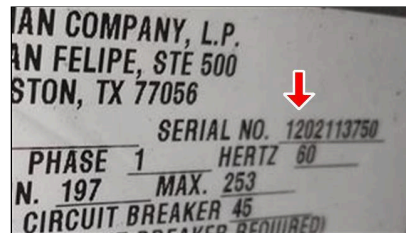
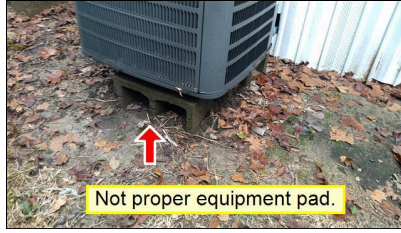
(2) A Goodman brand condenser unit was noted at the rear of the home. According to the serial number, it was manufactured in 2012.

-This unit was not secured to a proper equipment pad.

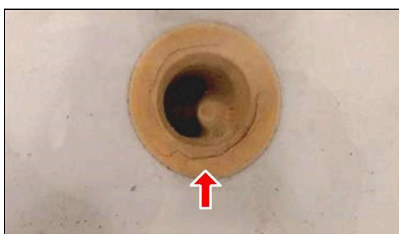
A. (Picture 1)

(2) One of the sinks in the left side bath exhibited cracking/damage.

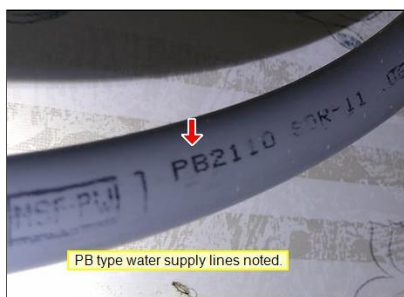
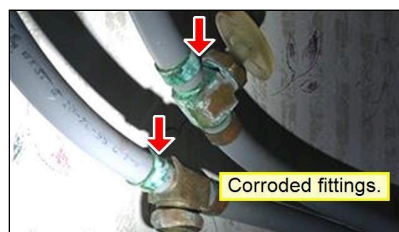
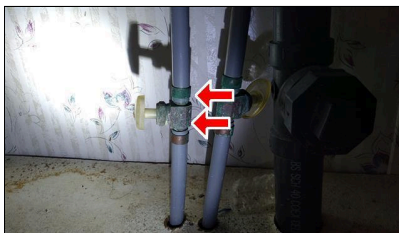
(3) The home has PB type water supply lines. Polybutylene has been used in this area for many years, but has had a higher than normal failure rate, and is no longer being widely used. Copper and Brass fittings used in later years have apparently reduced the failure rate (This house appears to have copper fittings). Inspector observed some corrosion at visible/accessible fittings (see pictures for example).

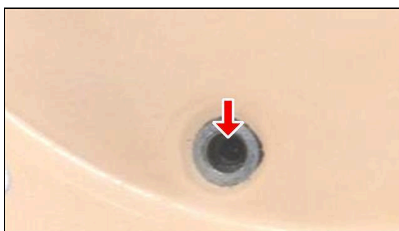
A. (Picture 5)

(6) The drain grate was removed from the tub at the left side bath.

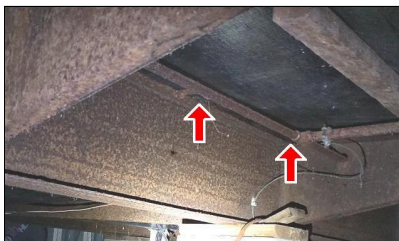
A. (Picture 6)

(8) A corroded gas line was noted under the home.

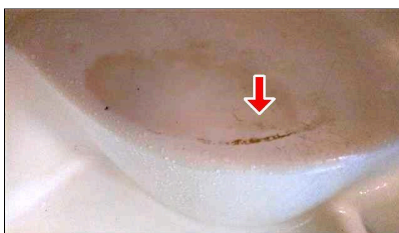
A. (Picture 7)

(9) The shower stall at the left side bath was weathered

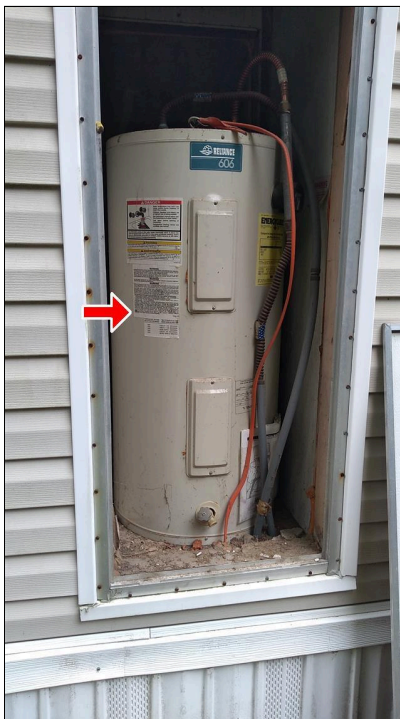
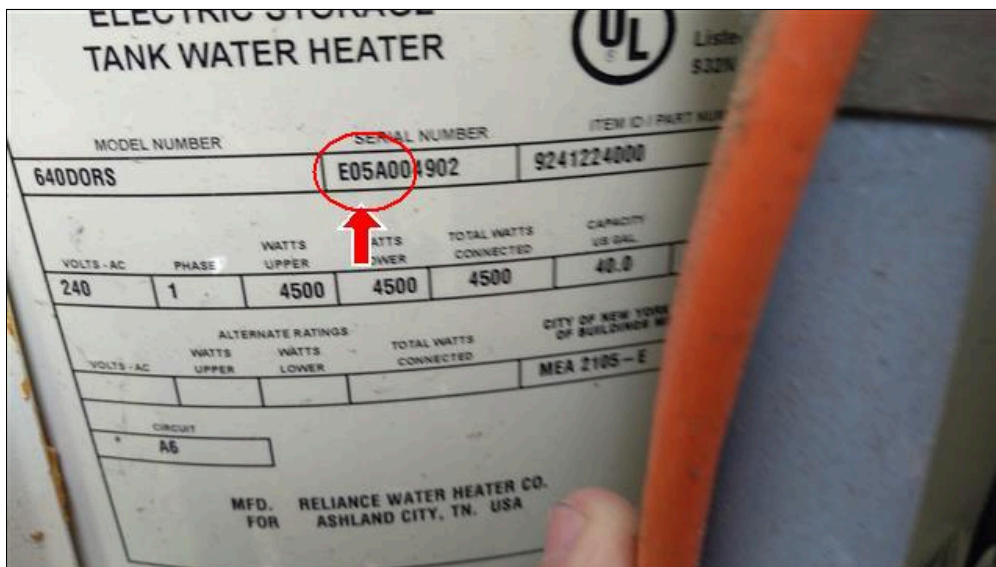
(1) A 40 gallon electric water heater was noted in a closet at the rear exterior of the home. It was manufactured in 2005.

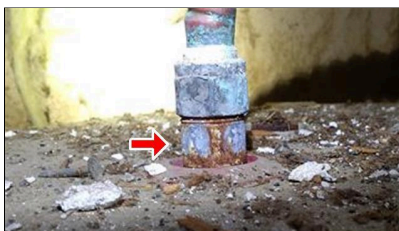
C. (Picture 3)

(2) Corrosion was noted at the top of the water heater.

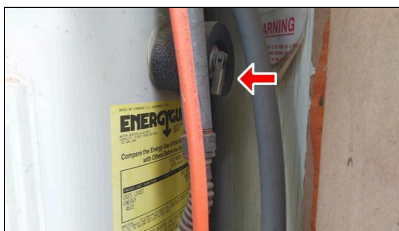
C. (Picture 4)

(3) The T&P valve on water heater needs a 3/4 threaded pipe to extend within 6 inches of floor for safety. Recommend correction as necessary by a plumbing contractor.

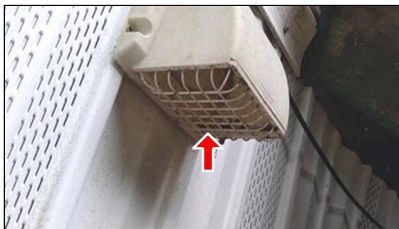
I. (Picture 1)

The exterior cover for the dryer vent has a screen. The Texas Real Estate Commission requires inspectors to note this as a deficiency (screen could clog with lint). Client may wish to remove the screen.
