## **Mechanical and Structural Inspection Report**

**November 16, 2019**

**20 Campeche Estates Drive, Galveston, Texas 77554**

## PROPERTY INSPECTION REPORT

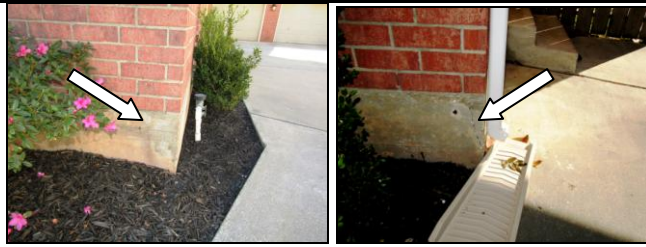
**Note #3:** *Diagonal cracks were present at all four corners of the houses foundation. Although not usually structurally significant, they can be the point of entry for WDI (Wood Destroying Insects).*

**Recommendations:** It is the inspector's opinion that the cement slab foundation was performing its intended function on the day of the inspection. I recommend that you obtain as much historical information as possible about the house and its foundation. Historical information includes but is not limited to: builder's reports, disclosures, previous inspection reports, engineering reports and reports generated by municipal departments, lenders, insurers and/or appraisers. (C-1) Monitor the diagonal cracks at the corners of the houses foundation and repair as needed. (C-2) It would be prudent to have the house inspected for WDI (Wood Destroying Insects) and other insects, prior to purchase and periodically thereafter.

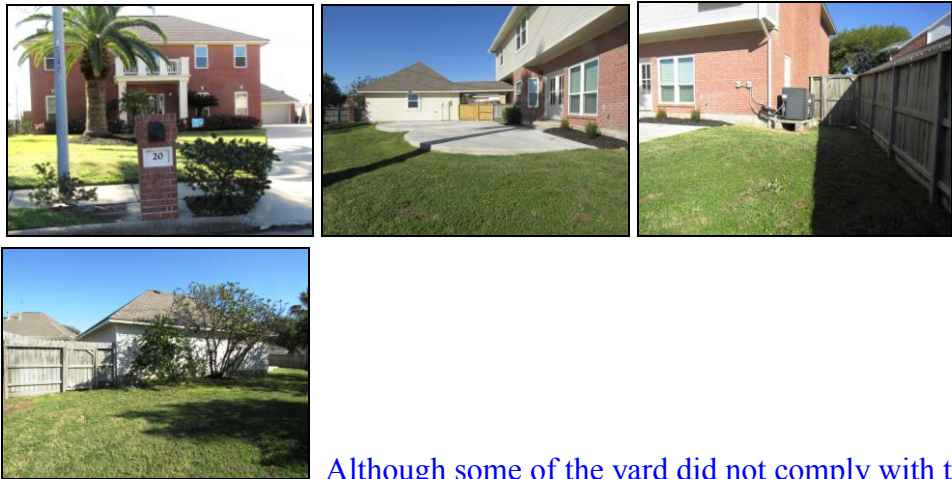
**Comments:** Guidelines for drainage state that the yard around the house should slope 5 to 6-inches in first 10-feet, away from the house/foundation.

Although some of the yard did not comply with the guidelines, the grade appeared to be appropriate for the location.

**Recommendation:** (C-1) It would be prudent to install gutters with downspouts and “splash-blocks” or black corrugated landscape piping (or other drainage systems) along the front edge of the house’s roof and at the garage’s roof. (D-1) Install a “splash-block” or black corrugated landscape piping (or other drainage system) at the downspout near the cooling system condensing units (to direct rainwater away from the house/foundation). (C-2) It would be prudent to ask the seller or neighbors about drainage, especially during periods of heavy rain.

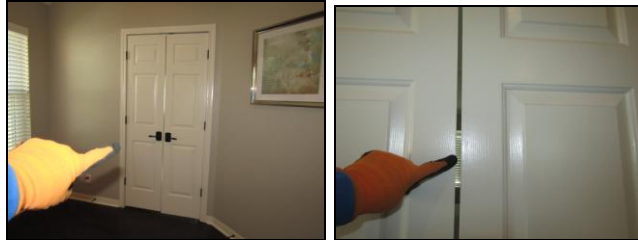
**Note #1:** *An inappropriately spaced gap was present at the double doors to the master bathroom (limits privacy).*

**Recommendations:** **Interior Doors:** (D-1) Repair/adjust/shim the double doors to the master bathroom, the gap was too wide and limits privacy. **Exterior doors:** (D-1) Repair/replace the missing hardware at the “pin” at the bottom of the double doors at the rear of the living room area. (C-1) It would be prudent to re-key all exterior door locks upon taking ownership of the house.

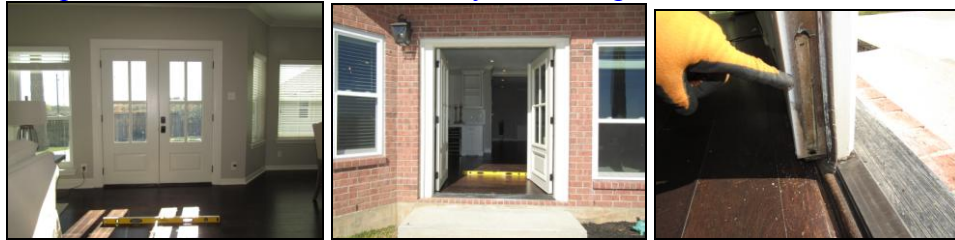
**#1:** *The bottom “pin” device for the double doors at the rear of the house was missing.*

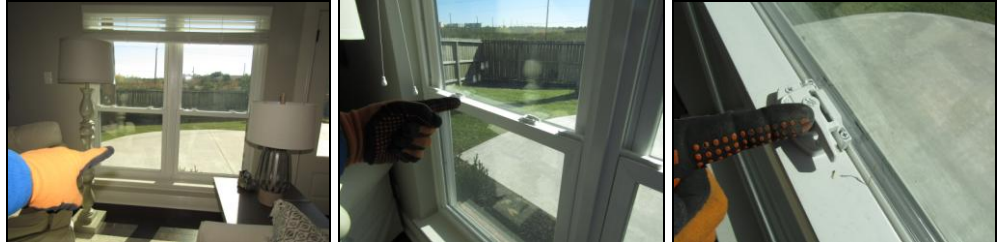
**Note #1:** One of the windows in the living room (nearest the fireplace) would not latch/lock when closed. The latches did not “line-up” properly. **Note #2:** Evaluation of damage inside walls [around windows] [like that caused by water, insects or structural abnormalities (like inappropriate sealing)] requires dismantling and is beyond the scope of this inspection. **Note #3:** This inspection does not include testing for fungi or other environmental contaminants that may be present due to conditions conducive to their growth (i.e. wood products [including paper] in the presence of moisture).

**Recommendations:** (D-1) Repair/adjust the window installed in the living room (nearest the fireplace) so that the latches “line-up” properly and can be locked. The windows in the house and garage were replaced 04/17/2018 and inspected/certified by an Appointed Qualified Inspector with the Texas Department of Insurance 03/21/2019. Unofficial copies of the Windstorm certificates (WPI-8 2119120 and WPI-8 2119123) are attached at the end of this report. More information can be viewed at <https://appscenter.tdi.texas.gov/windstorm/p/searchForAppl>

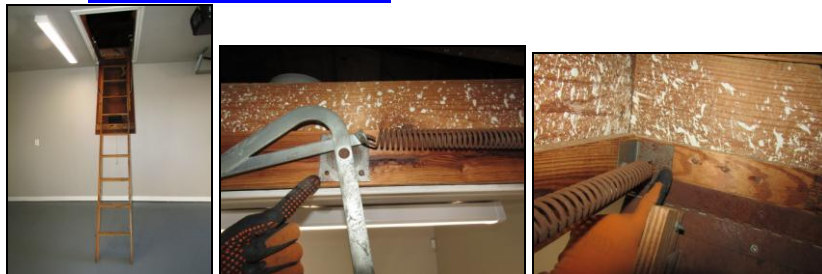
**Note #1:** The “pull-down” attic access stairway (installed in the garage) was missing

*fasteners at the spring hinge and corner brackets.*

*Recommendations: INTERIOR STAIRWAYS: (D-1) (As per the manufacturer’s installation instructions) install fasteners (typically 16-penny nails or ¼-inch lag screws) through the provided holes, into the adjacent attic framing at the spring hinge and corner brackets for the “pull-down” attic access stairway (installed in the garage). (D-2) (As per the manufacturer’s installation instructions) install fasteners (typically 16-penny nails or ¼-inch lag screws) through the provided holes, into the adjacent attic framing at the spring hinge and corner brackets for the “pull-down” attic access stairway (installed in the upstairs hallway). EXTERIOR STAIRWAYS: None.*

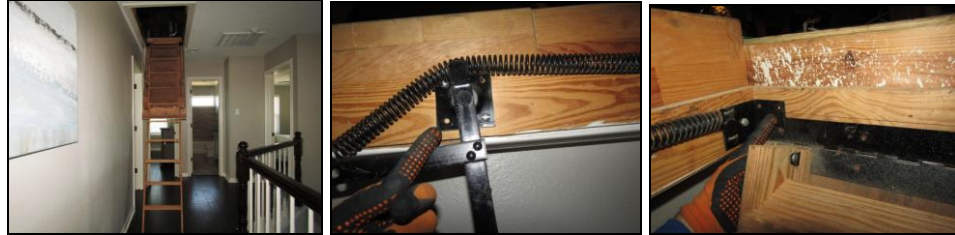
*#2: The “pull-down” attic access stairway (installed in the upstairs hallway) was missing fasteners at the spring hinge and corner brackets.*

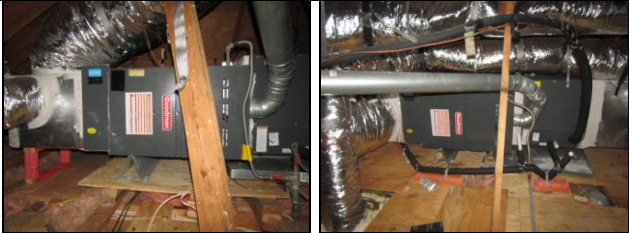
*Comments:*      The **“Goodman”** natural gas furnaces (installed the attic space) started and ran as intended on the day of the inspection when the controls (thermostats) were placed in the “heat” mode and the set points raised to 90-degrees.

***Note#1:*** A **“Type B”** flue cap was not installed for the **“Goodman”** natural gas furnace. ***Note#2:*** It is prudent to have the heating units serviced by a HVAC technician prior to use every fall. ***Note#3:*** The visual inspection of the heating equipment does not include internal parts that require disassembling of the unit. The condition of the heating equipment is based on the performance of the system when tested and those components that are visually accessible at the time of the inspection. Full evaluation of the integrity of components such as a heat exchanger requires dismantling of the furnace and is beyond the scope of a visual inspection.

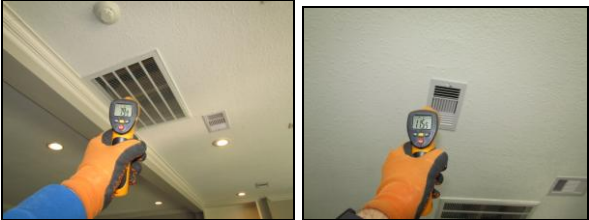
The temperature rise for the downstairs unit was about **36-degrees** after about 10-minutes of operation.

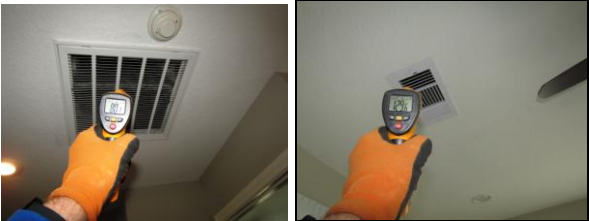
The temperature rise for the upstairs unit was about **49.5-degrees** after about 10-minutes of operation.

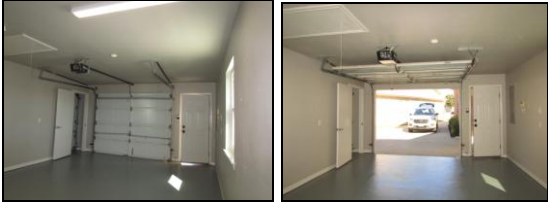
The smaller garage door operator performed as intended on the day of the inspection. It opened, closed and reversed the door when the blockage sensor beam was interrupted.

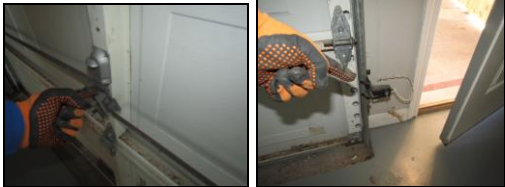
**Note #1:** *The smaller garage door's mechanical locking device was not disabled (typically required if an operator is installed) and the "blockage sensors" were installed greater than 6-inches above the garage floor.*

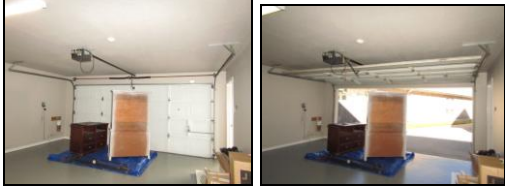
The larger garage door operator performed as intended on the day of the inspection. It opened, closed and reversed the door when the blockage sensor beam was interrupted.
