PROPERTY INSPECTION REPORT

Concerning: 16842 BONNYTON DRIVE, RICHMOND, TX 77407

By: Dan Romero : Trec # 5674

10/16/2019

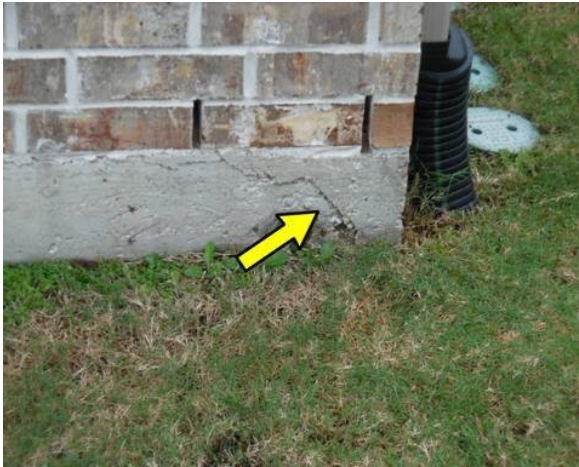
The Foundation appears to be functioning as intended at the time of the inspection, but there were some cracks observed in the garage flooring.

NOTE: These cracks appear to be typical and have a tendency of forming during the curing process of the foundation, and while no repairs may be needed now, it is still advised to consult with the builder so that they may further evaluate them.

Observed a corner pop in one of the back corners.

Monitoring the cracks should also be done periodically for signs of movement or spreading, and should consult with a licensed structural engineer and or qualified foundation company if any changes are observed.

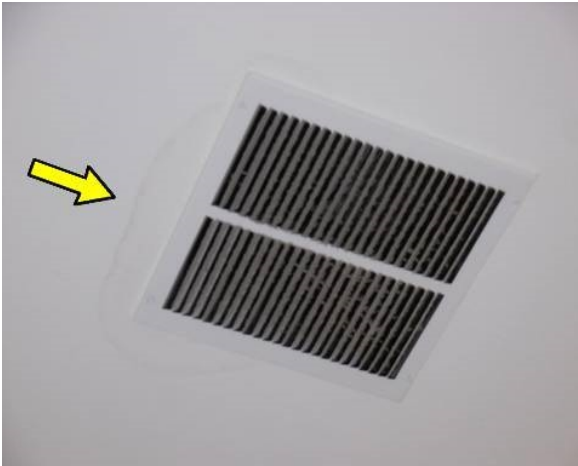
Observed water stain at the bedroom next to the vent.

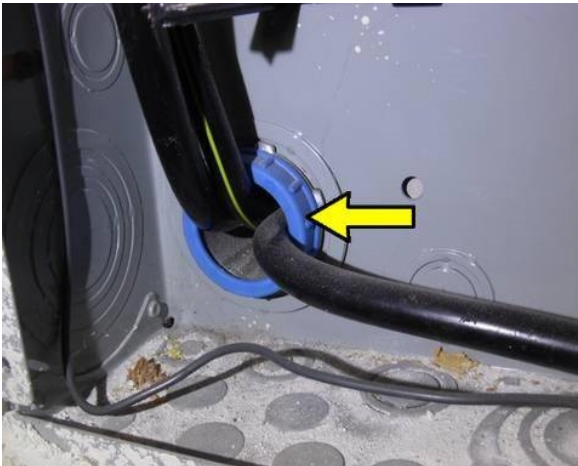
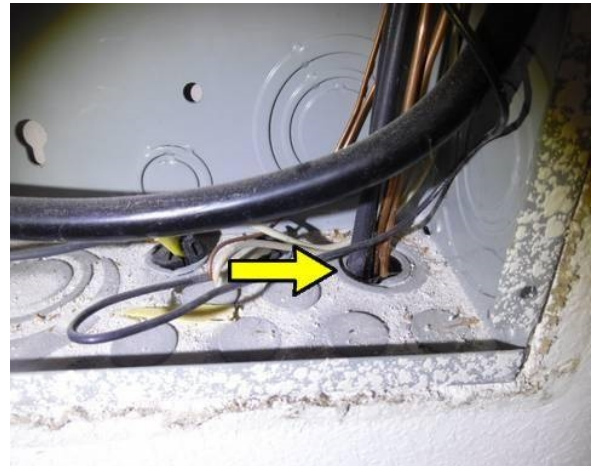
Observed broken and damaged form boards.

The bonding jumper clamp was not noted between the panel and the meter can at the connector bushing in panel.

Observed missing plastic connector bushing at the wire point of entry along the bottom of the panel.

It is advised that the electrical system be evaluated and repaired by a licensed Electrician for safety and updated recommendations.
