SUMMARY 7301 Palmira Way, Galveston, TX 77551

April 7, 2022

RESIDENTIAL INSPECTION

7301 Palmira Way Galveston, TX 77551

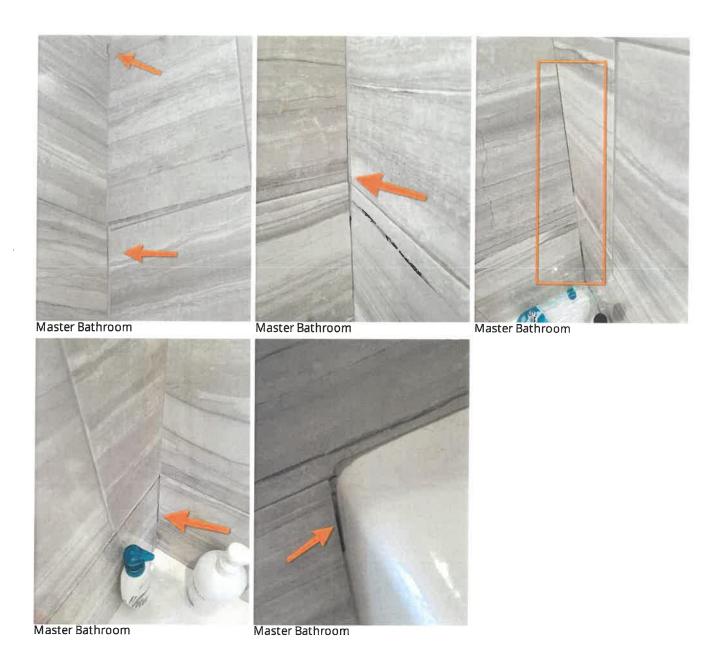
Cracked paint or caulking in a bathroom wall is usually due to the underlying substrate (plaster or drywall) deteriorating or flexing with temperature and humidity changes but also the settlement of the house. Bathrooms exhibit the same settlement cracks as the rest of the house, plus the environment can be hostile for paint and caulking because of the high moisture levels. I recommend a qualified technician to evaluate and repair.

Recommendation Contact a qualified professional.

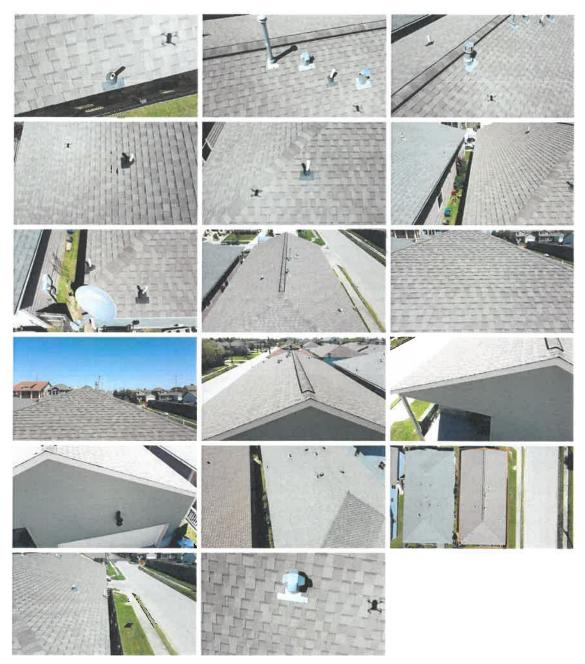
Roof Antennas:
Antennas bolted directly to the roof, could create leaks. I recommend installing antenna brackets for anchoring the antennas.

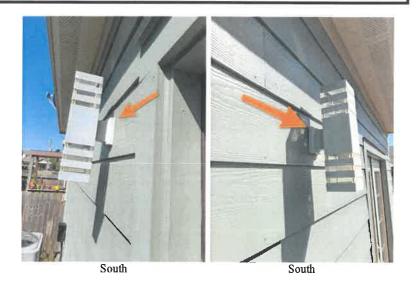
3: Previous repairs

Previous repairs were observed at the time of the inspection

Recommendation: Contact a qualified professional.

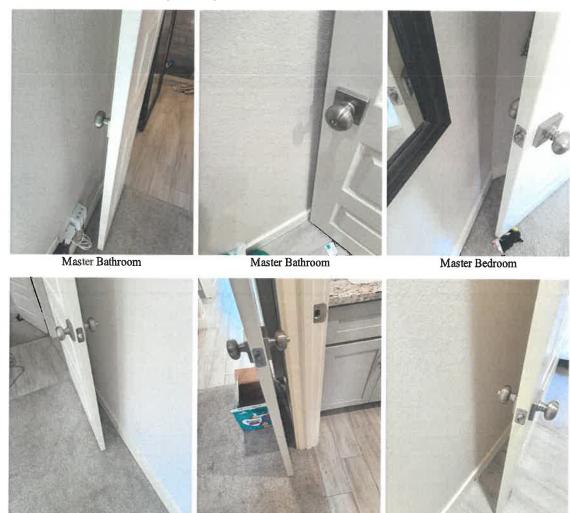
2: Missing door stops

The purpose of a door stopper is to eliminate any damage to the adjoining wall next to your door.

Recommendation: Contact a qualified professional.

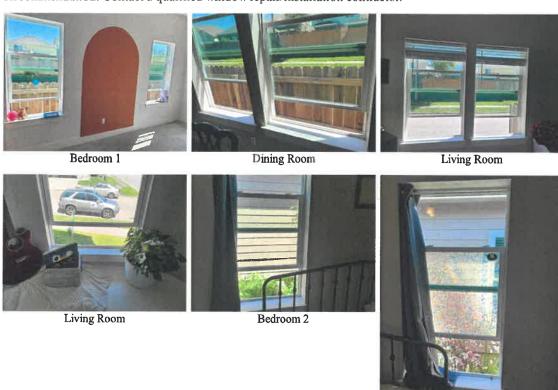
2: Missing Screen(s)

One or more windows are missing a screen. Recommend replacement. They are the barrier that keeps insects from coming into your house when you open your windows up to let the fresh air in. And they keep a whole range of potential pests from using your windows as a doorway into your home. Screens are important.

Recommendation: Contact a qualified window repair/installation contractor.

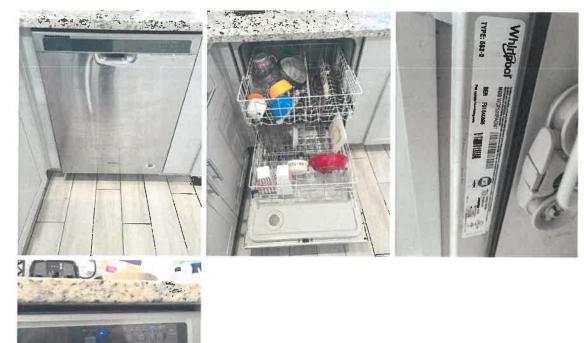
1: Missing Anti-syphon loop

The dishwasher drain is missing an anti-siphon loop. The purpose of a dishwasher air gap or anti-siphon is to prevent the siphoning and back flow of water. The water can flow back into the dishwasher which will leave water in the bottom of the dishwasher. The air gap or anti-siphon prevents siphoning if sinks are drained simultaneously.

Recommendation: Contact a qualified professional.

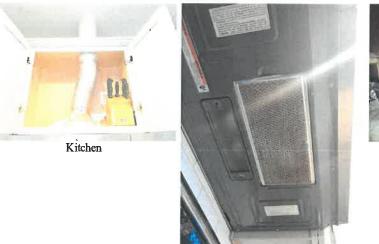
1: Inoperable light ©Recommendation

The light was not operating at the time of the inspection. I recommend a handyman evaluate and repair.

Recommendation: Contact a qualified professional.
