HOUSTON INSPECTIONS

May 9, 2019

PROPERTY INSPECTION REPORT

Concerning: 14911 Bramblewood Dr, Houston, TX 77079
(Address or Other Identification of Inspected Property)

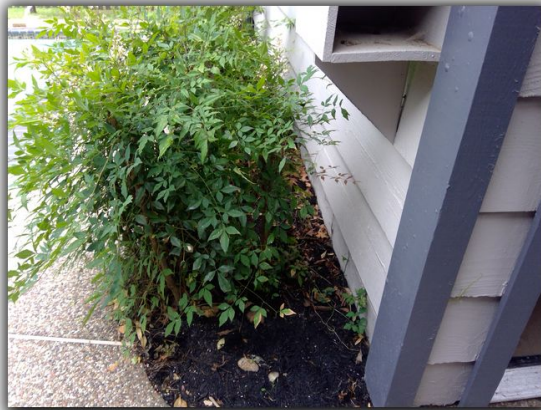
The top soil and / or mulch around the structure is too high in some areas. The soil should be lowered to provide 4-6" exposure of the foundation. Lowering the top soil will reduce the likelihood of damage at the exterior veneers, allow proper ventilation of the wall cavities, and assist in monitoring the foundation for movement.

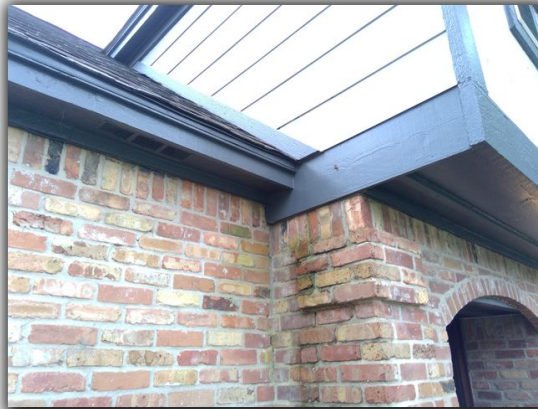
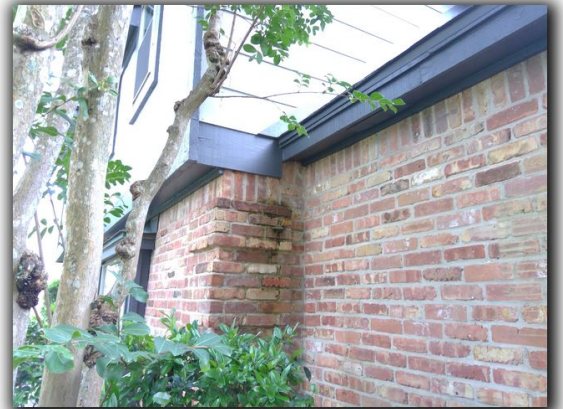
Kickout or diverter flashing is not installed at the required locations. This creates a possibility of water penetrations if not corrected.

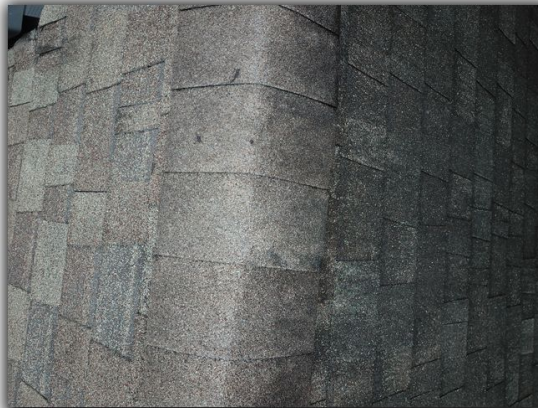
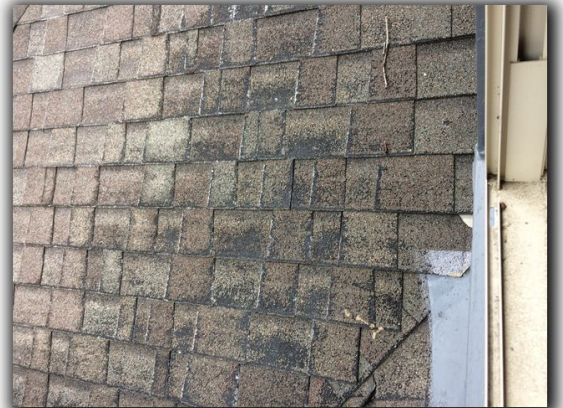
Loss of aggregate was noted during the inspection of the roof covering as evidence of aging.

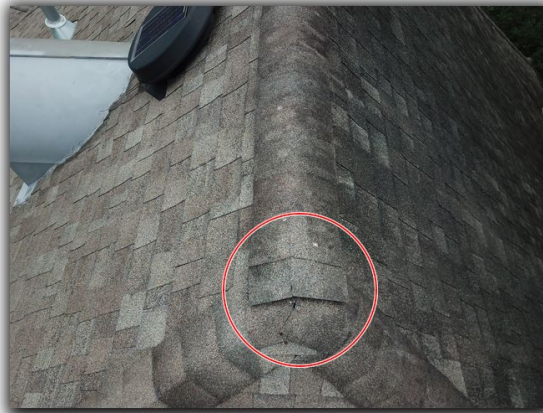
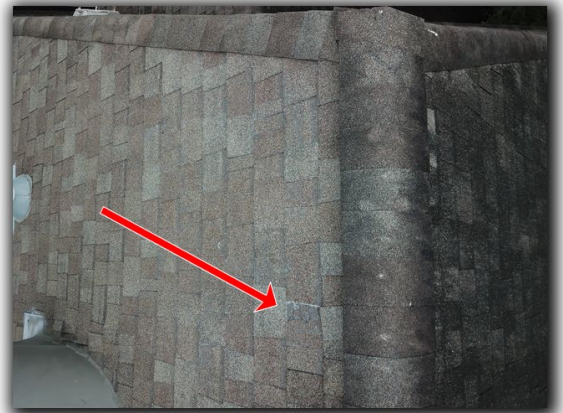
Damaged and / or missing shingles were found during the inspection of the roof covering. Recommend repairs by a qualified tradesman.

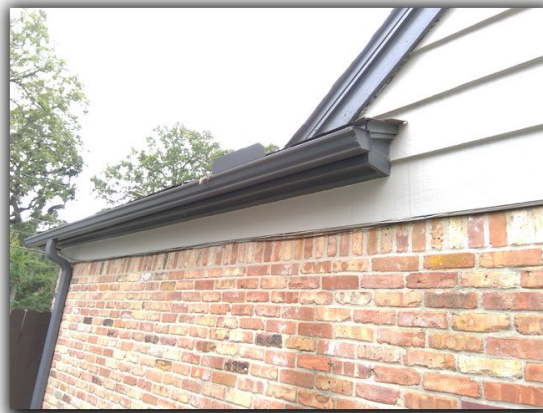
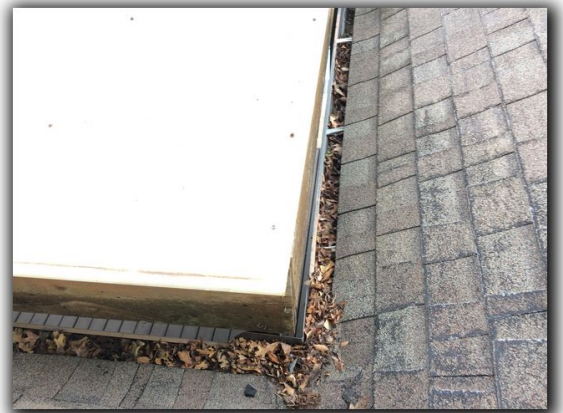
The debris should be cleaned from the gutters to allow proper drainage of rainwater from the roof covering.

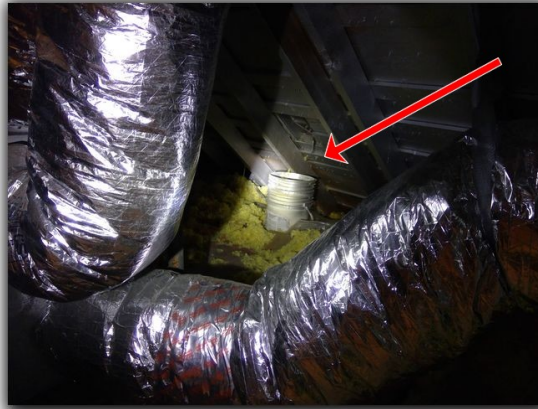
A plastic bucket was found beneath a roof vent at the rear left portion of the attic as indication of roof leaks. Repair by a qualified tradesman is recommended.

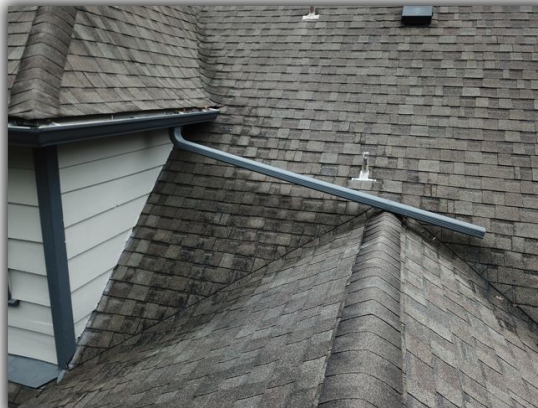
Gutter downspouts at the rear left and right roof are not installed in a typical manner. This installation may be more prone to displacement. These areas should be monitored and repaired/improved as needed.

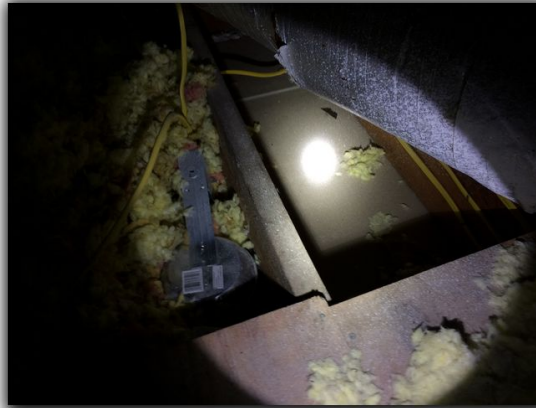
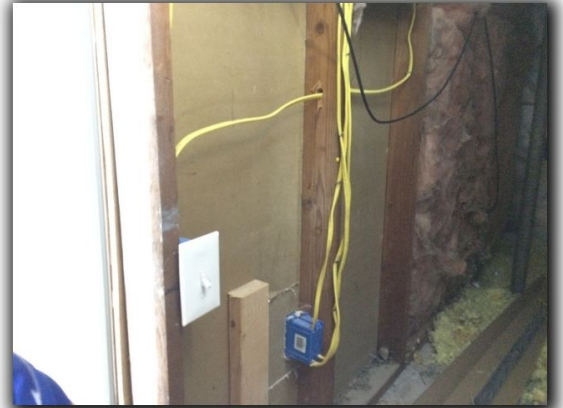
Missing insulation was noted in portions of the attic. Recommend installing insulation at the needed areas to improve the energy efficiency of the building.

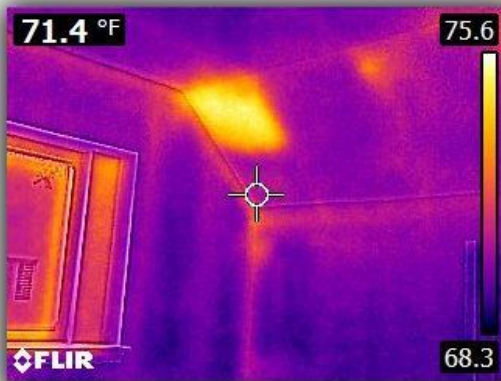
Missing insulation was found at sections of the ceiling / attic while using an infrared camera. Improvements in the insulation is recommended to increase the energy efficiency of the building.

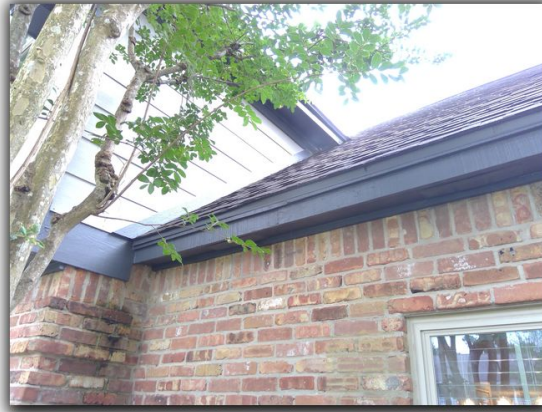
Evidence of rodent damage (chew marks, scratch, etc) were found on the exterior of the structure.

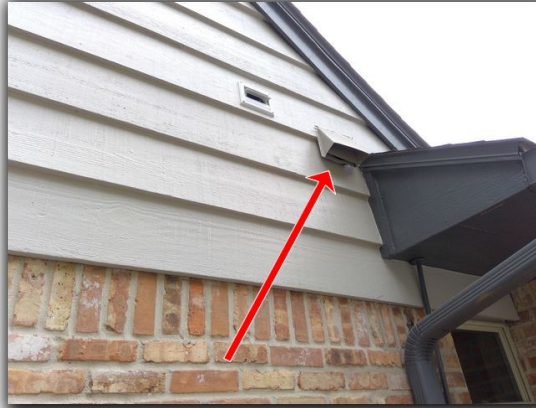
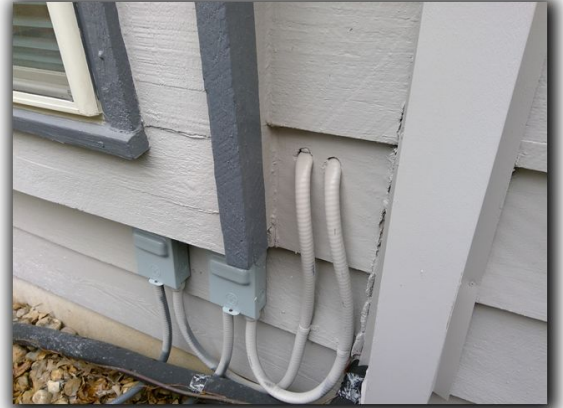
All exterior wall penetrations (electrical panels, electrical disconnects, light fixtures, etc.) and openings (expansion joints, windows, door thresholds, etc.) should be sealed with an approved material to prevent water penetrations into the wall cavities. Properly sealed exterior veneers help provide a barrier against the weather, insects, and enable environmental control of the interior spaces.

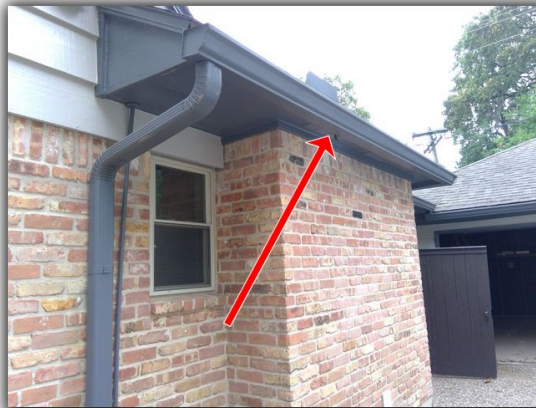
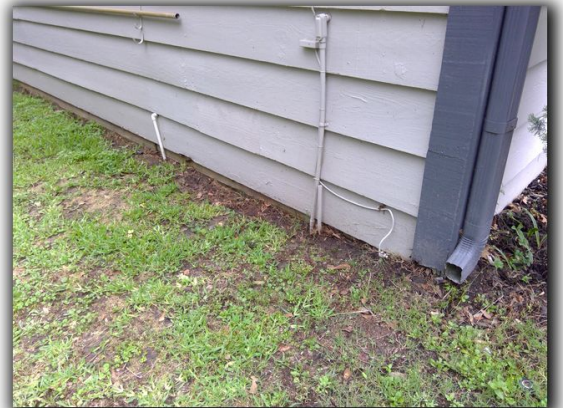
Damaged and / or missing items were found on the exterior of the property. The damage was found at the following locations:

1. Right rear fascia
2. Garage rear siding

Recommend repairs / replacement of the affected areas. In addition, areas where decay is present should be removed, exposing underlying materials for inspection prior to repair by a qualified tradesman.

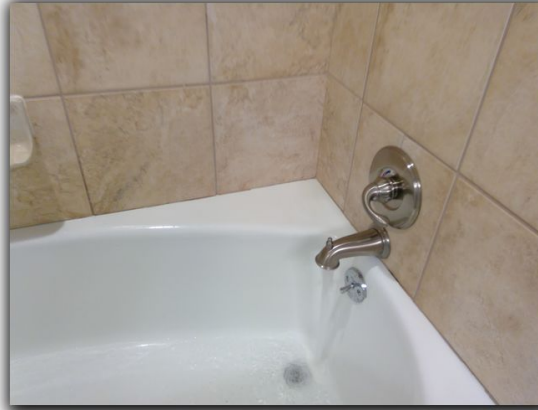
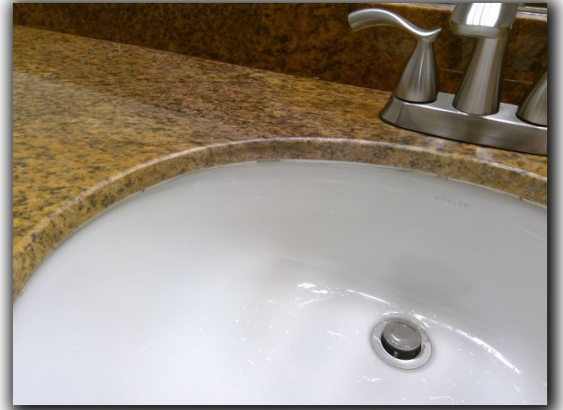
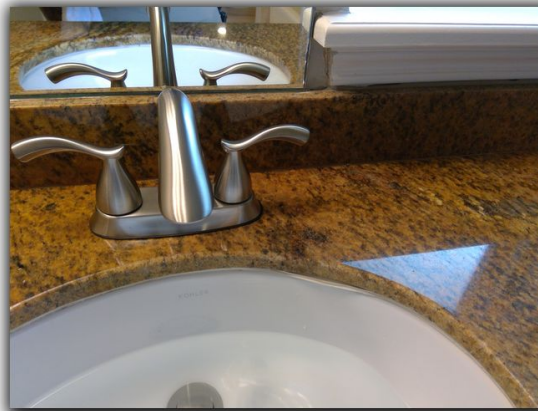
Damaged and missing grout/caulking was noted in the upstairs guest bathroom shower/bathtub enclosure and sinks. It is recommended that the damaged or missing items be repaired/replaced.

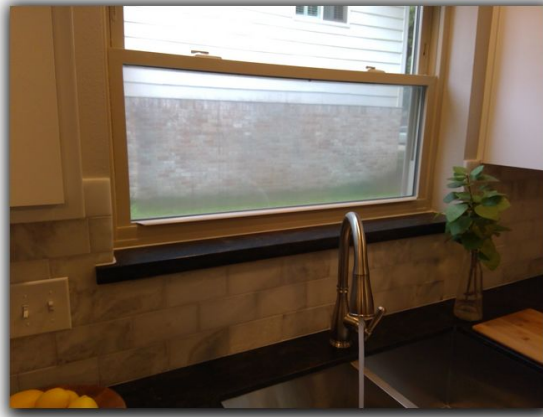
1. Kitchen

This was evident by the build up of condensation and / or discoloration between the two window panes. A qualified tradesman should be consulted to repair or replace the windows found deficient and evaluate the other windows in the property for additional lost seals.

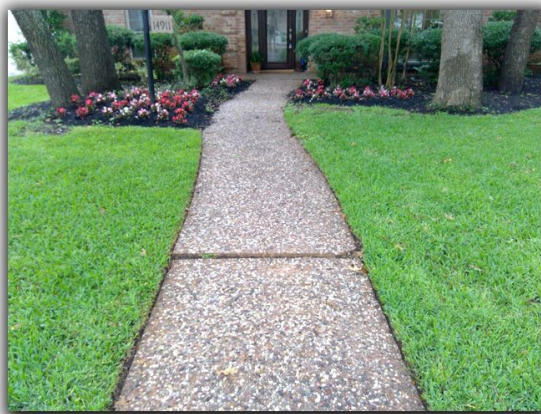
Uneven materials were observed at the flatwork. Flatwork should have a uniform surface (to prevent tripping) and slope away from the dwelling (i.e. patios, driveways, sidewalks, etc.).

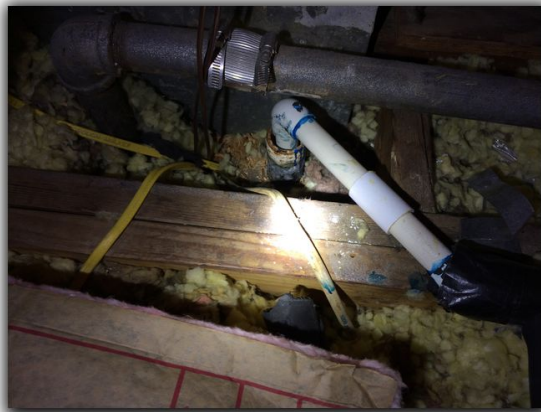
Damaged and missing insulation on the visible portions of the primary drain lines should be repaired/replaced.

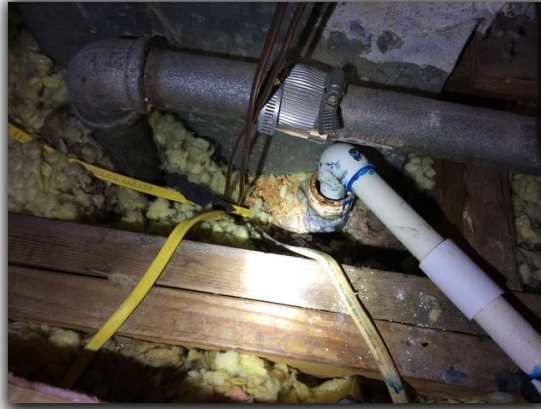
The primary drain line terminates in a plumbing vent in the attic, which could lead to water damage on the interior of the home if the line becomes obstructed. The primary drain lines are combined in the attic, which can increase the frequency/likelihood of obstruction. Recommend improvements.

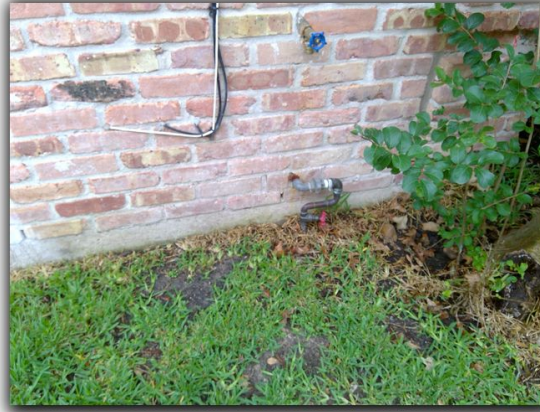
The supply piping should be insulated to protect from freezing.

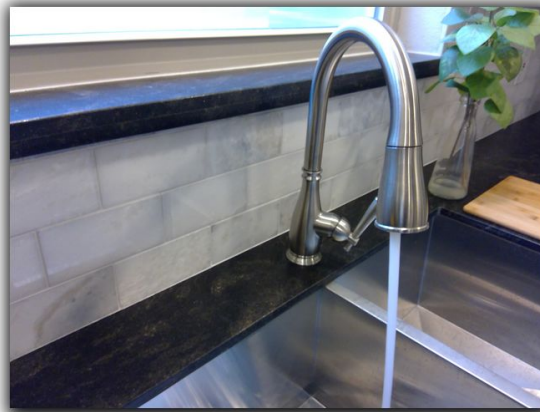
Kitchen

The sink faucet is loose at the counter top.

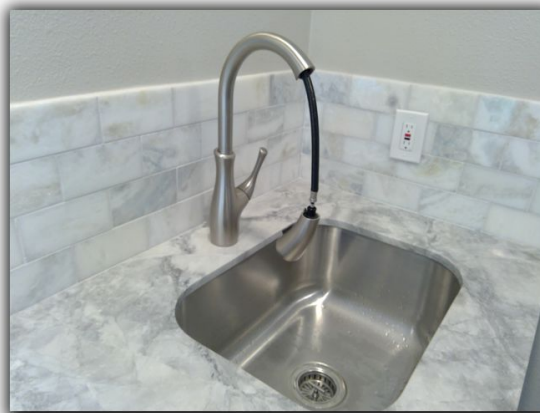
Bar

The sink sprayer attachment does not properly retract.

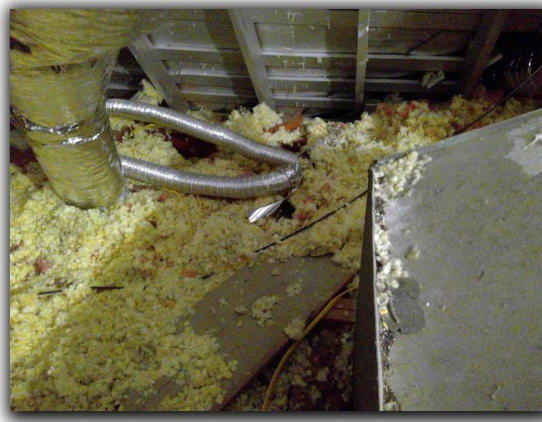
- Fans terminate in attic or soffits

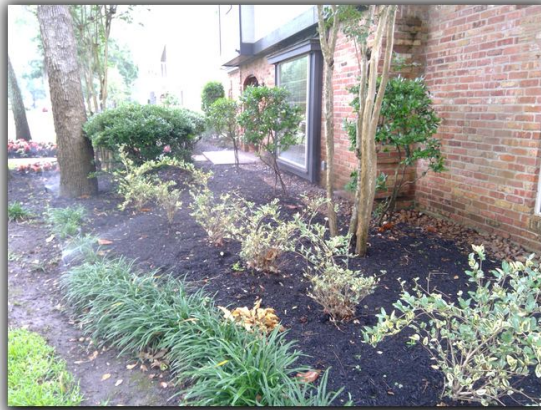
Several sprinkler heads are spraying against the exterior veneers. This can lead to future damage and other problems. Recommend adjusting the heads.

The water spray from the sprinkler system should be re-directed away from the structure and/or any fencing, decks, etc., to decrease the possibility of damage.
