REDSTAR PROFESSIONAL HOME INSPECTION, INC

REDSTAR RESIDENTIAL INSPECTION REI 7-6

14114 Mary Sue Ct
Sugar Land, TX 77498

PROPERTY INSPECTION REPORT FORM

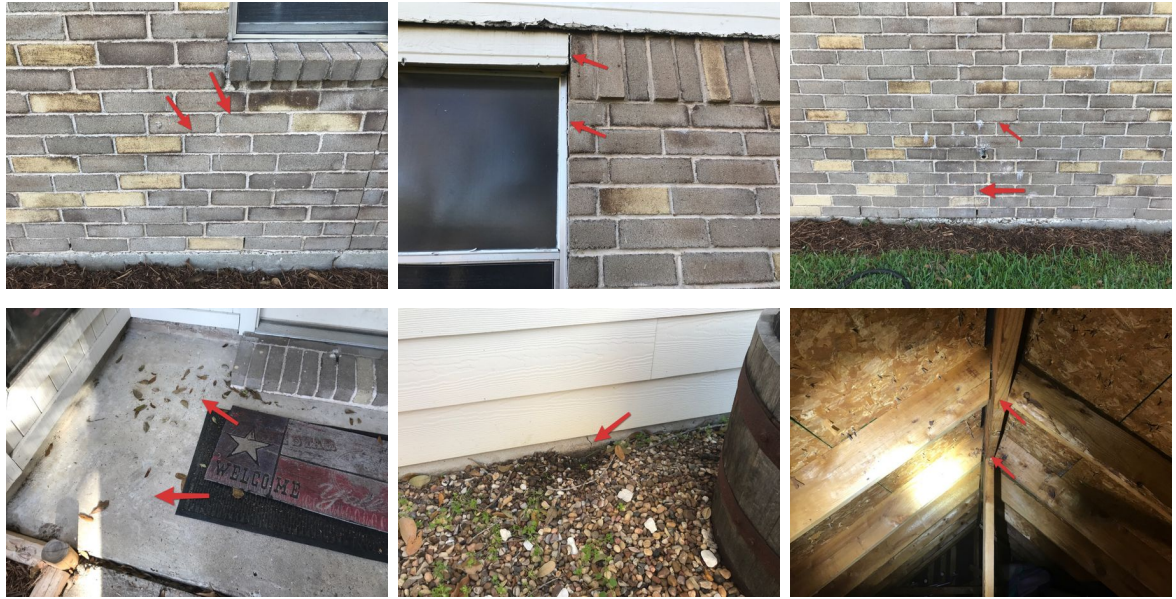
1: Slab Foundation: Recommend further evaluation

Multiple signs of differential movement of the foundation structure observed at the time of inspection. These signs include:

- Moderate cracks at the exterior masonry walls and repairs to cracks.
- Cracks visible in the foundation sidewall, including a moderate crack of over 1/8" in width at the back foundation sidewall.
- Separation at exterior of windows.
- Separation of the roof rafters from the ridge board connection at the garage attic space.

It is the inspectors opinion that these issues are indicative of movement of the foundation and I recommend further evaluation by a qualified professional to render a foundation performance evaluation and determine if any foundation repair is required, or if the foundation is performing with settlement and only maintenance is needed.

- Recommend consulting with a qualified foundation company.
- Recommend correction of all issues stated in the Grading and Drainage section of this report to promote health of the foundation.
- Recommend consulting with a qualified plumber to evaluate the condition of the underground plumbing drain lines, as these lines often become damaged from foundation movement.
- Recommend you budget for repair of above stated issues and any other related items with foundation movement/repair.

Recommendation: Contact a qualified structural engineer.

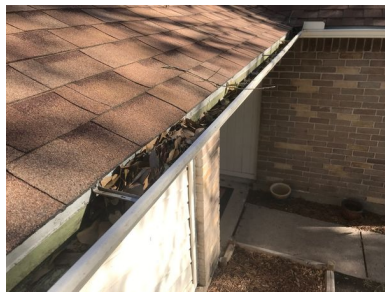
Recommend clearing gutters of debris to improve drainage. Debris in the gutters gutters can cause water to back up under the roof covering and cause damage to the home.

Recommendation: Contact a handyman or DIY project

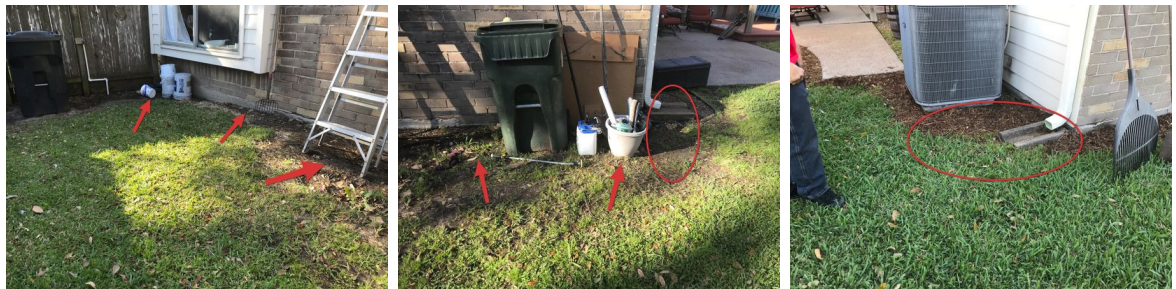
There appears to be improper grading and drainage of the property at multiple locations around the home. Issues observed include negative slope towards foundation, soil erosion around perimeter of the home, and inadequate slope of the grade around property to ensure proper drainage. Recommend consulting with a qualified contractor to determine the best method of repair.

Drainage Building Code: IRC R401.3 Drainage. Surface drainage shall be diverted to a storm sewer conveyance (typically the street) or other approved point of collection so as to not create a hazard. Lots shall be graded to drain surface water away from foundation walls. The grade shall fall a minimum of 6 inches within the first 10 feet. The final grade shall slope away from the foundation at a minimum slope of 5 percent and the water shall be directed to drains or swales shall be provided to ensure drainage away from the structure.

Recommendation: Contact a qualified landscaping contractor

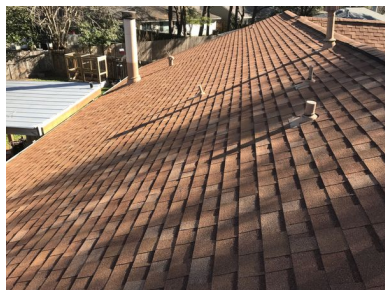
1: Rusted Flashings

Sections of the exposed flashing and/or other areas were observed to be displaying rust. This condition can result in failure of the covering/flashing and I recommend further evaluation and correction as needed to prevent further deterioration or potential moisture penetration.

Recommendation: Contact a qualified roofing professional.

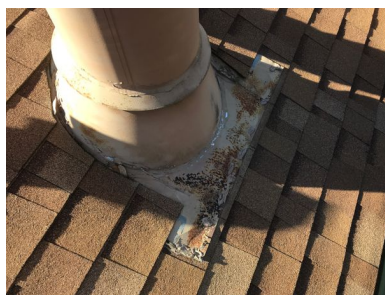
2: Vent height

One of the plumbing vents at the back right roof slope area was observed to protrude only slightly over the roof jack at this location. Building code does require a minimum penetration of 6 inches above the roofline of these plumbing vents. Recommend you consider adjustment to ensure performance.

Recommendation: Contact a qualified professional.

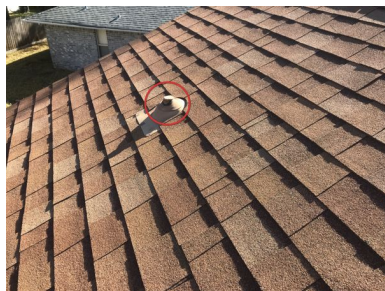
3: Fishmouth shingles

Some of the shingles at the front roof slope were observed to be lifted or “fishmouthed”. Recommend evaluation and sealing of these locations to avoid uplift from high winds.

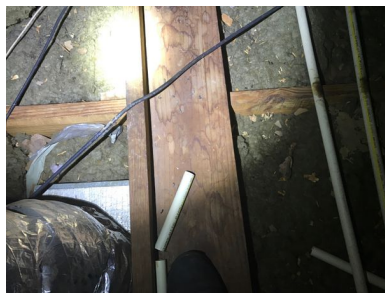
There was evidence of possible rodent activity in the attic. While this is not uncommon, a qualified pest control company should be contacted if remediation or exclusion is desired.

Recommendation: Contact a qualified pest control specialist.

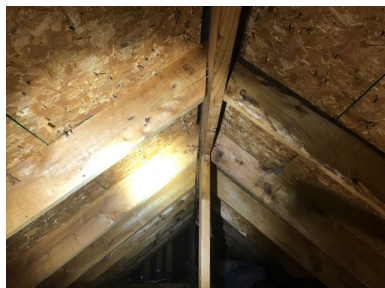
2: Rafter issues

Inspector observed minor cracking and separation of the rafter boards near the connection to the ridge board at the area above the garage. Recommend supplementing and repair at these locations to avoid further deterioration.

Recommendation: Contact a qualified professional.

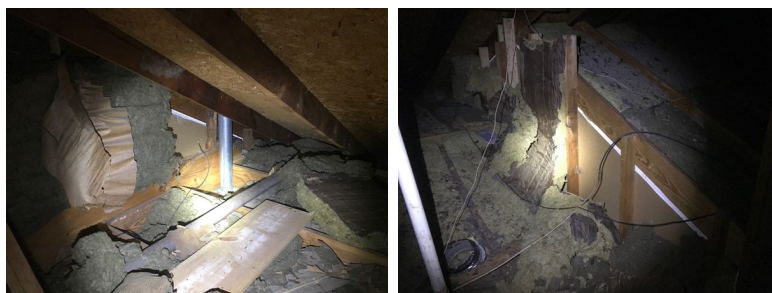
3: Insulation

Inspector observed several locations where the insulation has fallen from the vertical walls in the attic space. The overall insulation depth of the ceiling was also observed to be degraded and some energy savings may be achieved by supplementing the insulation. Recommend repair of the insulation at the vertical walls and considering supplementing of the overall insulation depth.

Recommendation: Contact a qualified insulation contractor.

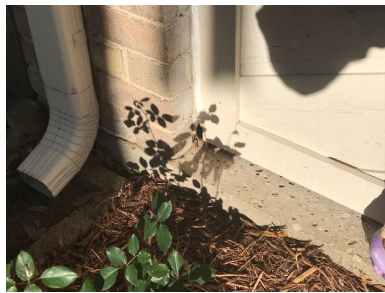
2: Caulking and Sealing Needed

The above stated locations were identified as areas in need of proper caulking and sealing, or maintenance to the existing sealant. Examples of locations needing sealing are pictured for your reference. Recommend further evaluation of these areas and all others to determine the extent of needed repairs.

Recommendation: Contact a qualified handyman.

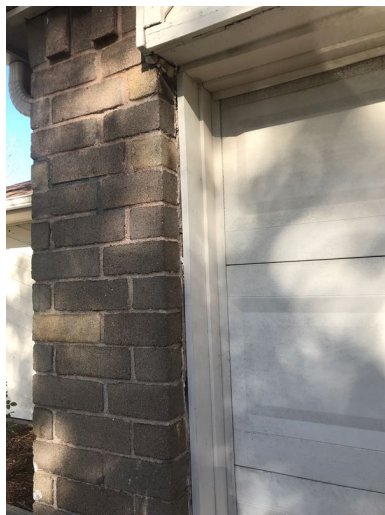
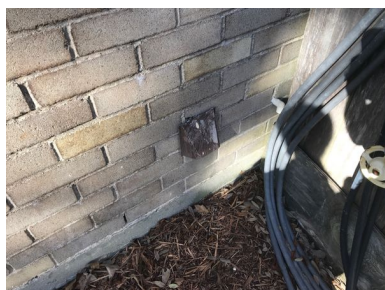
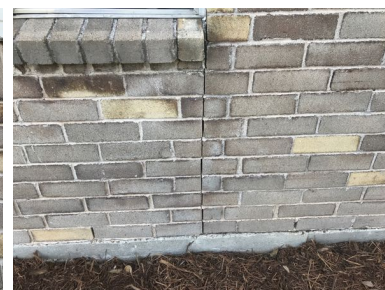
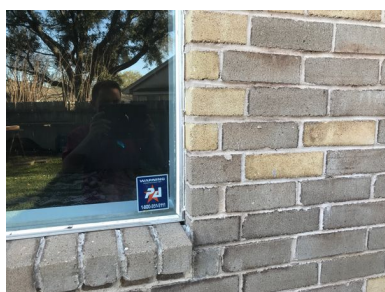
3: Masonry: Cracks/Maintenance Recommended

Cracks were observed in the masonry walls and/or mortar lines around the home. These conditions appear related to settlement of the foundation. Recommend you consider correction to avoid further deterioration and for cosmetic reasons.

Recommendation: Contact a qualified masonry professional.

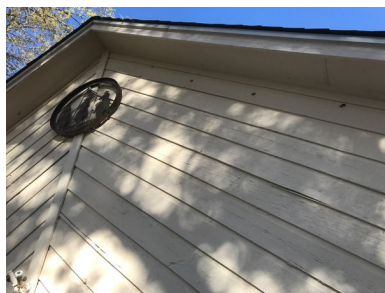
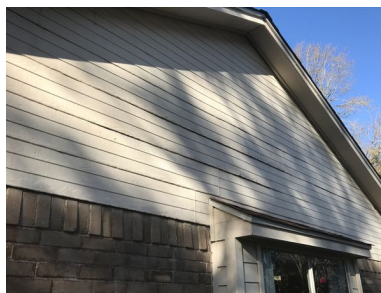
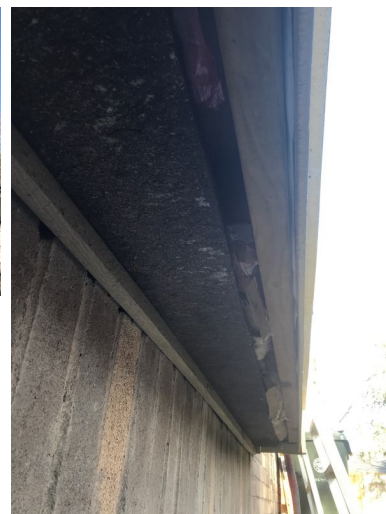
4: Exterior siding

Much of the siding around the home is still the original wood siding and trim including at the front and sides of the home. Several locations were observed that displayed excessive wear to the paint finish, minor damage to the siding, as well as areas that displayed moderate wood rot that may require replacement. A large void was observed in the siding finished at the area below the window at the right side of the home around the breakfast. Recommend you consult with a qualified contractor to fully evaluate all locations on the siding to determine the extent of necessary repairs.

Recommendation: Contact a qualified siding specialist.

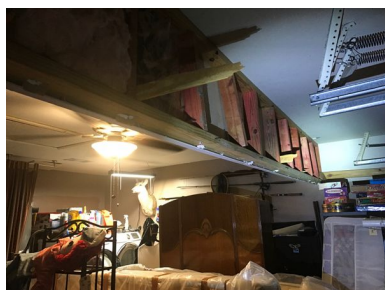
5: Garage wall

Inspector observed a drop down at the ceiling in the garage area that does not appear to be structural in nature and is missing the drywall. Recommend further evaluation and budgeting for repair or removal of this furdown. Several locations also observed in the garage that will require a repair to the drywall. Recommend further evaluation and quoting for repair by qualified contractor.

Recommendation: Contact a qualified professional.

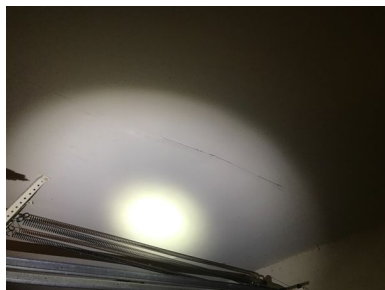
1: Ceiling: Cracked Tape Joints

Cracked taped joints and other cosmetic issues were observed on the ceiling finish at multiple locations. These cracks and cosmetic issues may be due to typical settlement of the foundation. I recommend repair as needed to prevent further deterioration and monitoring for additional movement.

Recommendation: Contact a qualified painting contractor.

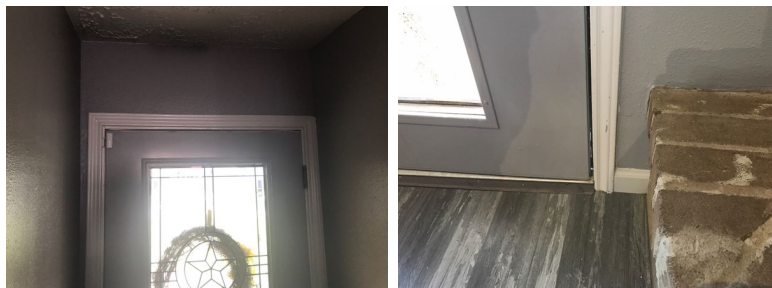
Gaps were observed in the weather seal around the exterior doors. Repair as needed to prevent moisture, pest, and air intrusion.

Recommendation: Contact a qualified professional.

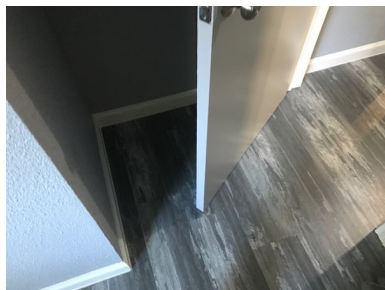
2: Interior Door Hardware: Missing Door Stops

One or more door stops were observed to be missing. Recommend adding door stops to prevent damage to drywall finish.

Recommendation: Contact a qualified professional.

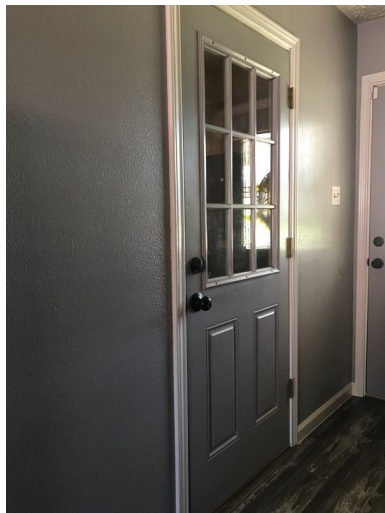
The door between the house and the garage has glass panels which does compromise the fire rating of the door. The door also does not have a self closing feature. Recommend you consider replacement of the door with a properly rated door and installation of a self closing feature.

Recommendation: Contact a qualified professional.

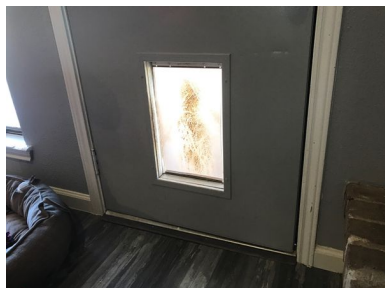
4: Back door

The back exterior door has had a pet door installed in it and I recommend you budget for repair or replacement if you do not desire this pet door. Gaps also observed around the weather seal as well as minor deterioration around the base of the door unit. Recommend repair to avoid draft or moisture intrusion.

Recommendation: Contact a qualified professional.

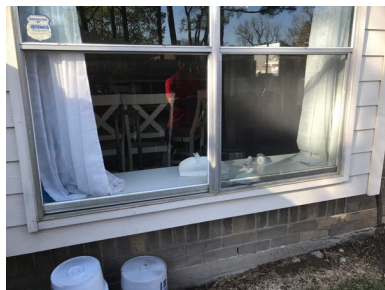
1: Missing/Damaged Screen(s)

One or more windows were observed to have missing/damaged screens. Recommend repair or replacement as needed.

Recommendation: Contact a qualified window repair/installation contractor.

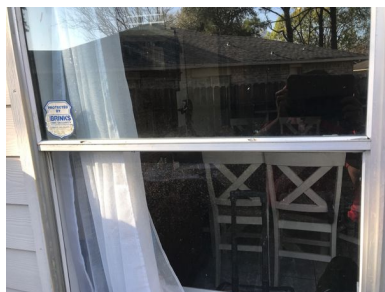
2: Glazings: Damaged

The glazings at the exterior of the window panes at multiple locations around the home show damage or displacement. Recommend correction as needed to prevent further deterioration or moisture penetration.

Recommendation: Contact a qualified professional.

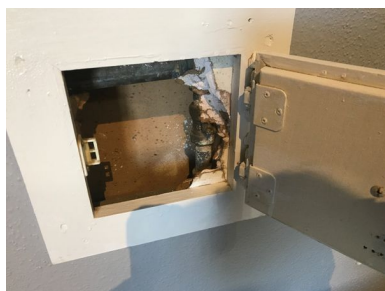
2: Valve handle

The valve handle for the gas valve at the fireplace is damaged or broken off. As a result inspector was unable to operate the unit. Recommend you budget for replacement of the valve.

Recommendation: Contact a qualified plumbing contractor.

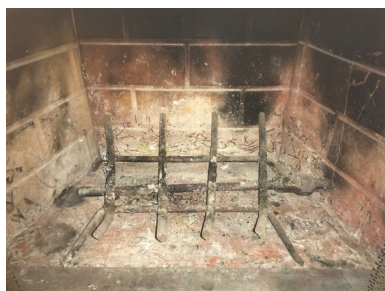
3: Fireplace brick

Inspector observed the “brick” walls at the fireplace area appear to be excessively damaged from years of use of the fireplace. I highly recommend you budget for replacement of these panels to ensure the integrity of the firebox.

Recommendation: Contact a qualified professional.

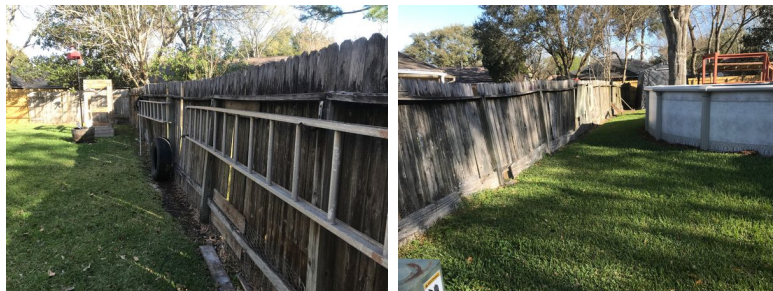
1: Fence: Loose, Damaged and Missing Boards

Loose, damaged and/or missing fence boards were observed at multiple locations around the property. Repair as needed for security and privacy purposes.

Recommendation: Contact a qualified professional.

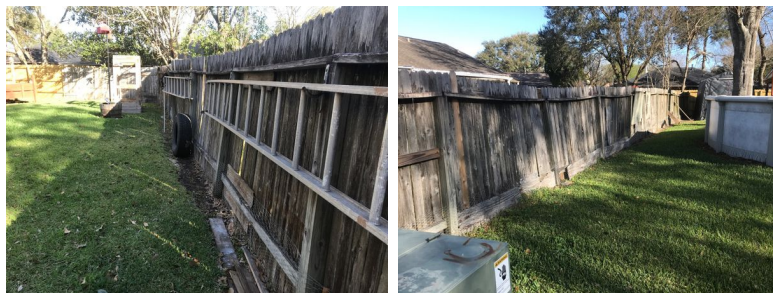
2: Fence: Leaning

The fence was observed to be leaning. Recommend repair to prevent further deterioration.

Recommendation: Contact a qualified professional.
