Her luxury house

Structural Engineering Services

July 12, 2019

This letter summarizes the results of my structural and foundation inspection and assessment for a single family home located at 508 Pine Rd, Clear Lake Shores, TX, 77565, subject to a planned purchase. The objective of this inspection was to verify the structural and foundation safety and integrity, especially regarding the foundation in this elevated home.

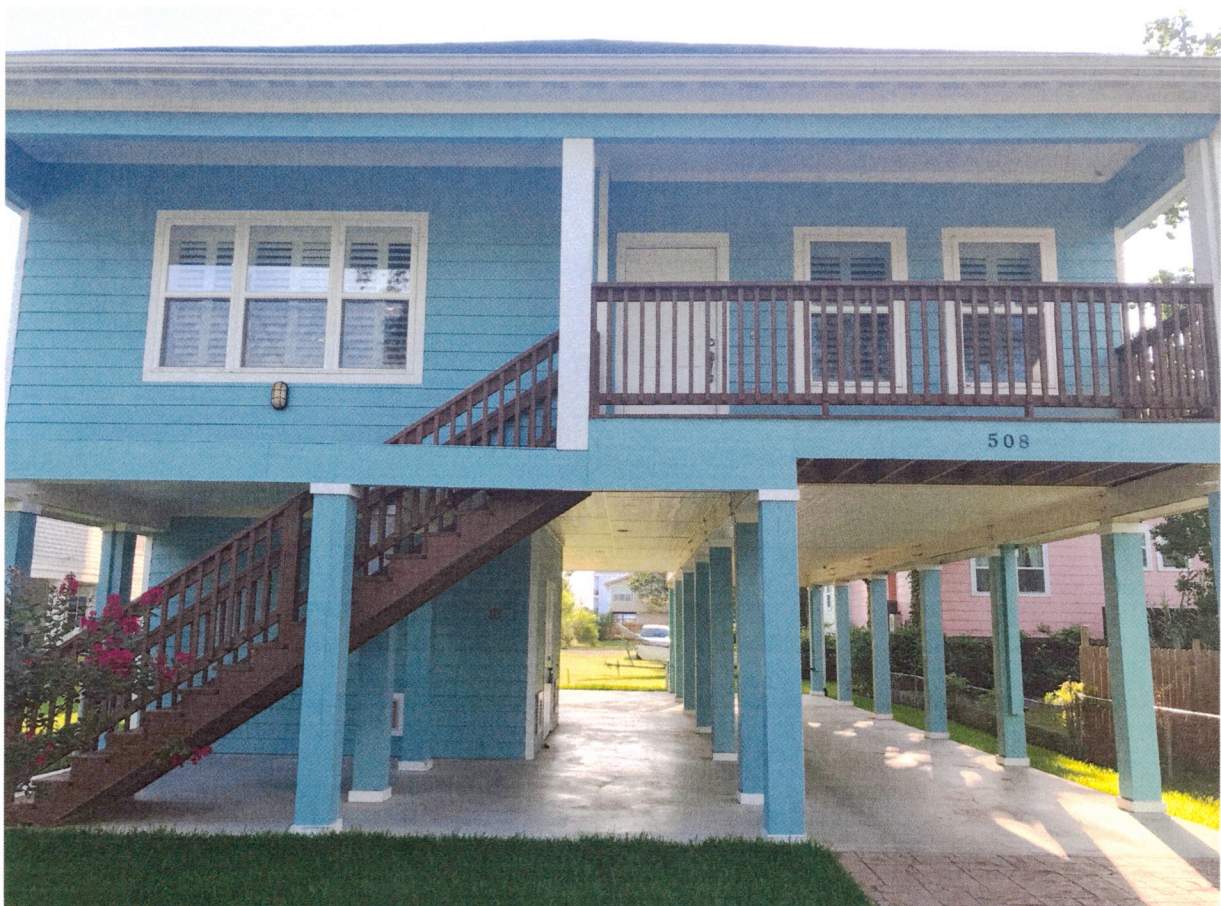
Inspections of the house did not suggest any immediate risks to the building and its residents. I especially measured the settlements in the foundation slab and the floor of the house. The maximum settlements remained under 0.25" on the slab and lower in the house floor, which are good numbers for this house (with slab and floor dimensions measured at of 33' and 58'). It is worth mentioning that the concrete slab does not serve as a critical part of the foundation as the house is built on 28 deep piers directly under the timber columns, per information provided by the real estate agent.

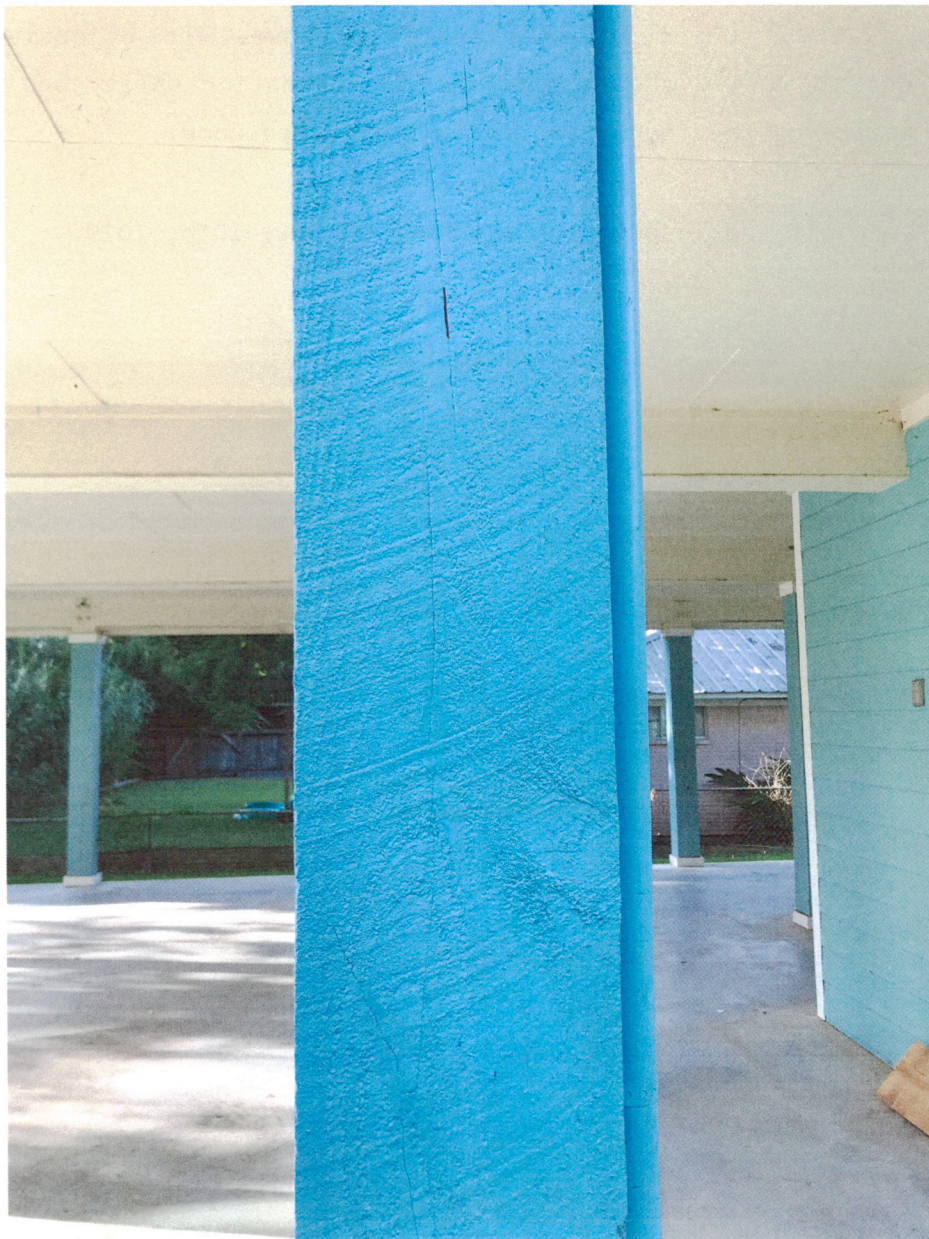
One issue I noticed during the visit was some longitudinal cracks on the wood columns. The cracks were visible on several of them. The width of these cracks were more and larger than those observed in another home built nextdoor, apparatntly at the same time and with the same exact properties. Hence, I conducted some research to see if there is any report about history of such cracks being an issues in the area or alarming guidelines by FEMA or other relevant authorities. My research did not find any concerning information. Given that the widths of these cracks (usually very small and at most around 1/8") and that the material type (timber) is crack-friendly and is known to perform well with cracks, my opinion is that they don't serve as a threat to the performance of the structural components.
