PROPERTY INSPECTION REPORT FORM

Karla Williams <i>Name of Client</i>	04/08/2022 <i>Date of Inspection</i>
4015 Shackleton Court , Rosharon, TX 77583 <i>Address of Inspected Property</i>	
Jonathan Tarpey <i>Name of Inspector</i>	TREC # 25195 <i>TREC License #</i>
<i>Name of Sponsor (if applicable)</i>	<i>TREC License #</i>

Home Inspection Report

Inspection No. 52288-1-530

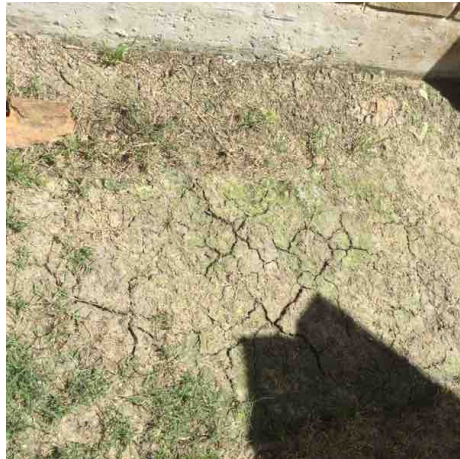
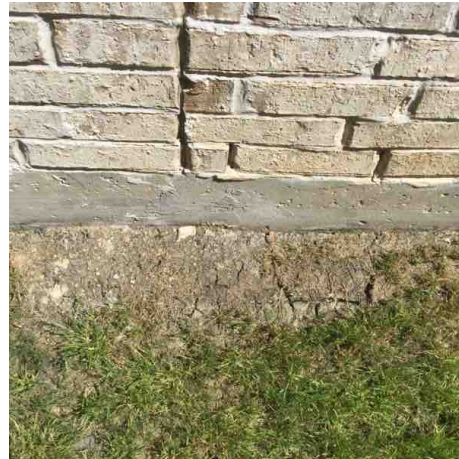
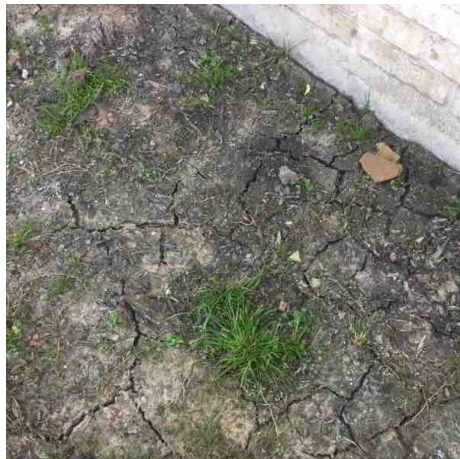
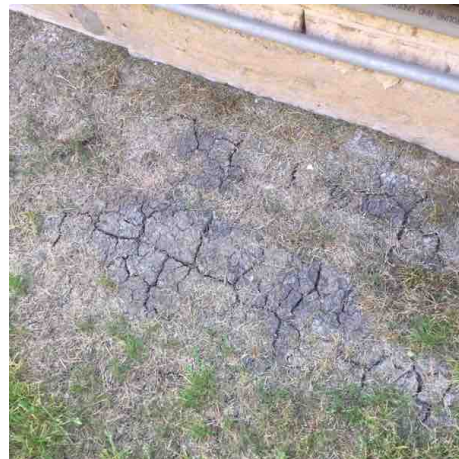
• Ground is very dry around the exterior and ground near the foundation has large cracks from lack of water, this issue needs immediate correction to reduce chance of movement issues with the foundation, this will effect the foundation.

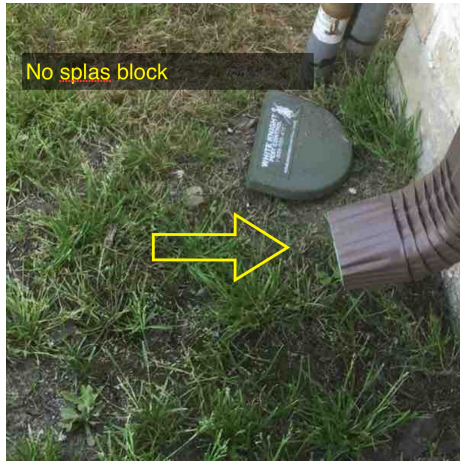
- Need to install splash blocks at the ends of the gutters to reduce potential erosion issues.

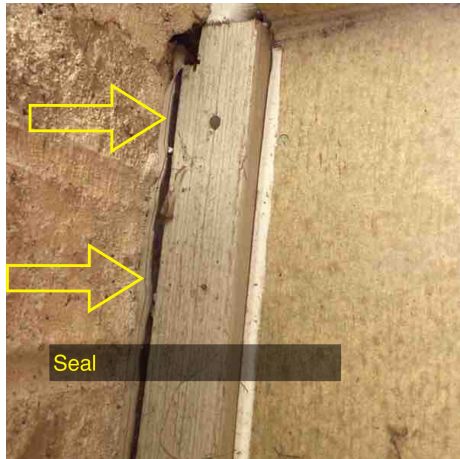
- Seal crack underneath breakfast area window to prevent moisture and insect intrusion.

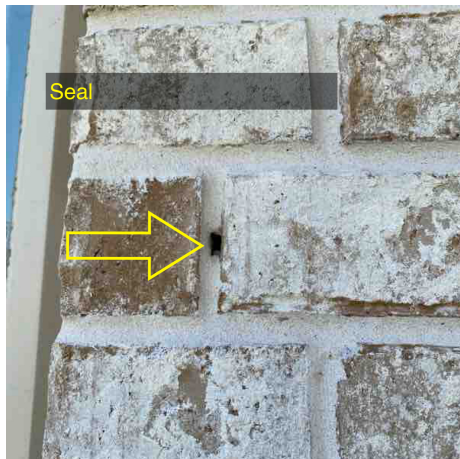
- Seal gap in brick to prevent moisture intrusion.

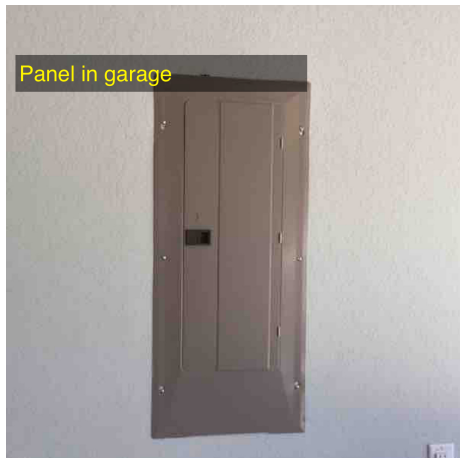
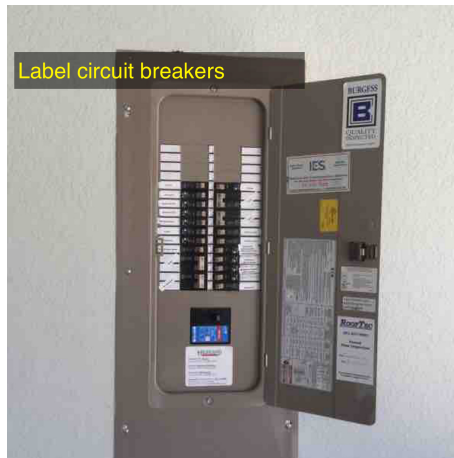
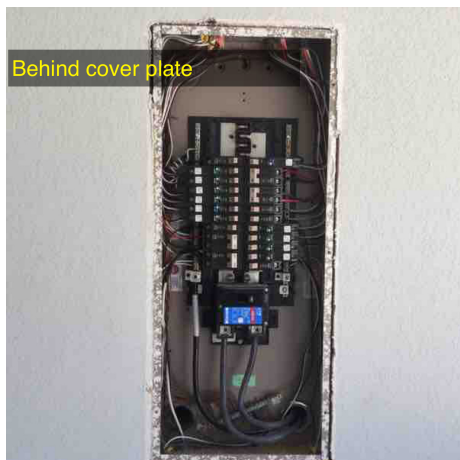
- Main panel is rated at 225 amps.

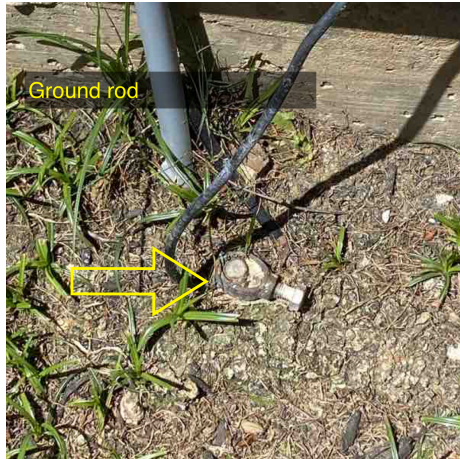
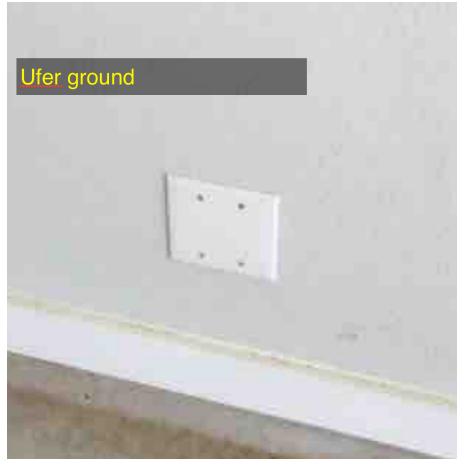
- There are 7 smoke alarms. Smoke alarms need to be tested at least once a year and batteries changed.
- Home is grounded by both ground rod and Ufer ground.

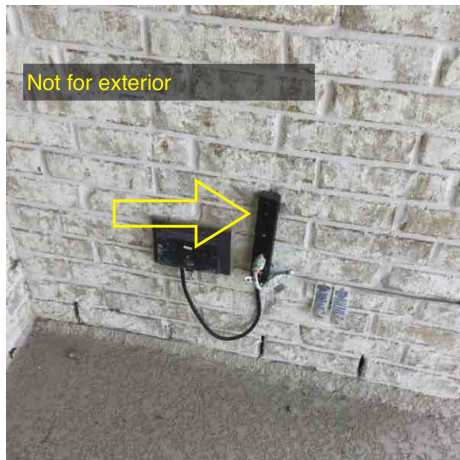
- Bathroom one GFCI reset is located in hallway bathroom
- **Extension plug should not be used on exterior for permanent wiring.**

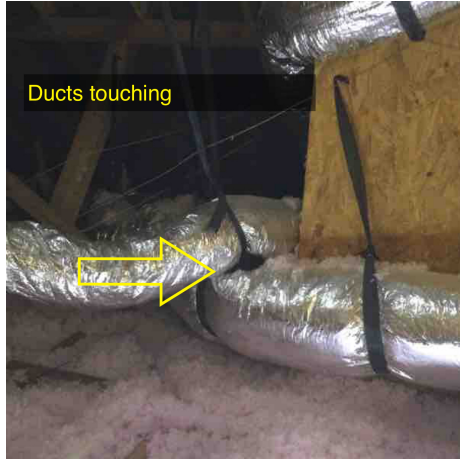
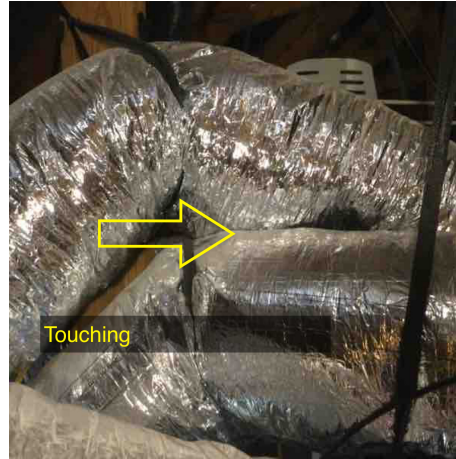
- Some of the ducts in the attic do not appear to be properly strapped because of them touching each other which can cause air flow restrictions and condensation issues, need to be repaired.

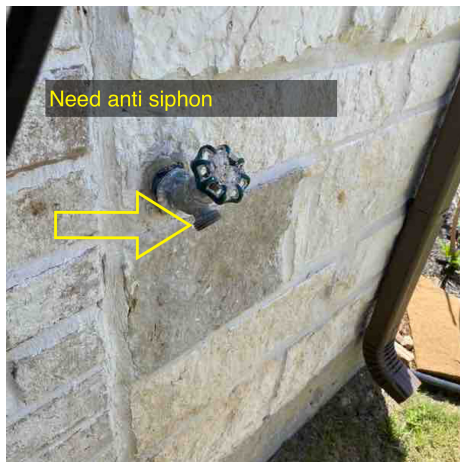
- At the time of this inspection, fixtures throughout residence were performing their intended function.
- **Need to install anti-siphon devices (back flow preventer) on all of the exterior water faucets.**

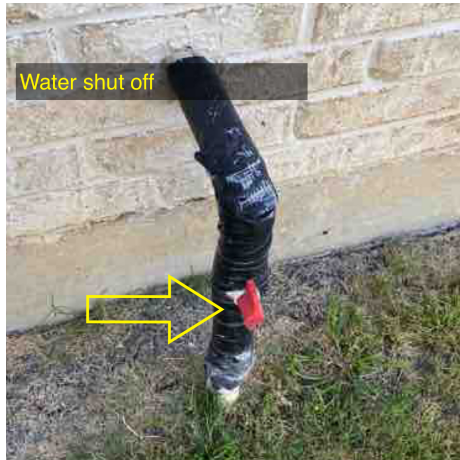
- The water shut off valve is located on the west side of the home.

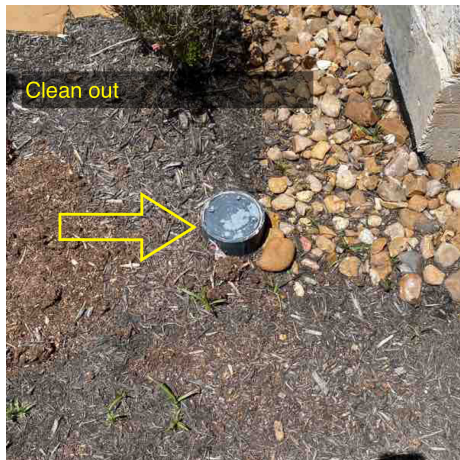
- Drain pipes are PVC where visible.
- In the opinion of this home inspector, the drains appear to flow normal at this time and appear to be performing their intended function at this time. No leaks observed at time of inspection.
- Main drain cleanout is located in the front left flowerbed.

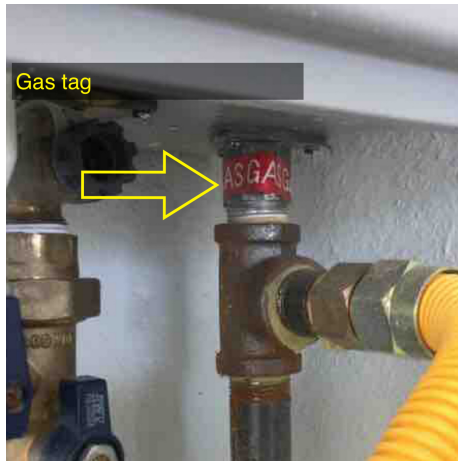
- Tank appears to be performing its intended function at this time in the opinion of this home inspector. The temperature and relief drain valve was not tested due to possibility that the valve will stick open causing water to leak out, recommend evaluation of valve. Valve should be tested at least several times a year and sometimes need to be replaced after several years. The drain pipe for the hot water tank was not tested for potential leak issues with the connection or leaks from the drain pipe.
- **There is a gas tag on the gas line into the bottom of the unit, per requirements by manufacturer, the gas tag is supposed to be removed when the gas volume, pressure is tested on the line at the unit, the presence of the gas tag may mean that the gas pressure was not tested by the installer, this needs further evaluation by a qualified plumbing contractor.**

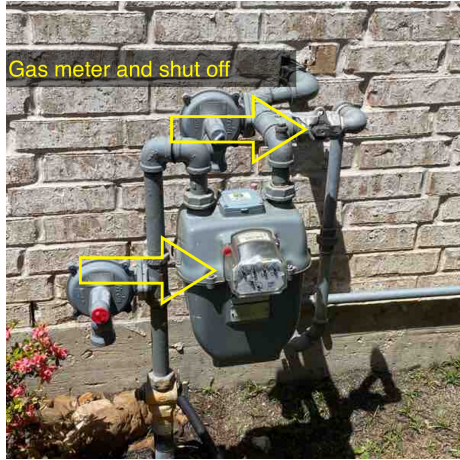
- Gas meter and shut off valve is located on the east side of the home.

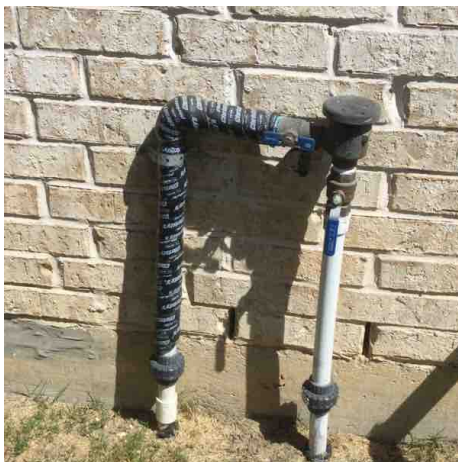
- Appears to be a 6 zone system, tested the zones manually at the control panel, zones were only run for several minutes on this test. Pipes under the ground are not visible, not able to check for leaks in the ground, this is beyond scope of this inspection, system should be evaluated further after all zones have run through their scheduled times to check for any potential leaks. You should expect occasional breakage on sprinkler heads, recommend to keep spare heads on hand for repairs. Control panels can be temperamental and sometimes need repair or replacement from electrical issues. Should insulate the back flow preventer and pipes exposed to reduce chance of freeze damage. Rain sensor was not tested.
- **Need to insulate sprinkler riser to protect from freezing.**
