BPG Inspection, LLC

**12043 Sela Lane
Houston TX 77072**

Client(s): Fuentes Vides
Inspection Date: 3/25/2022
Inspector: Ana Aponte , TREC #22375 (TX)

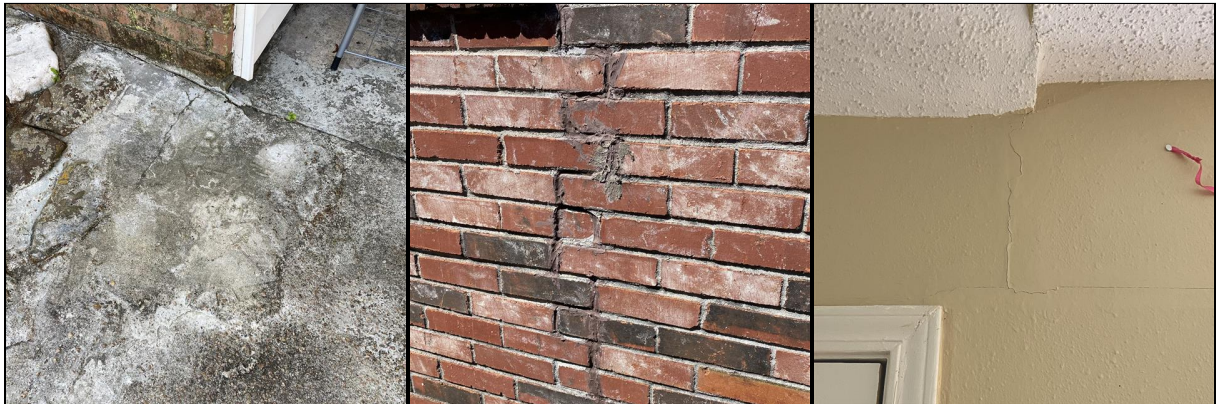
Previous repairs to the foundation have been disclosed and/or were detected. Refer to the seller for any documentation and possible warranties for further information.

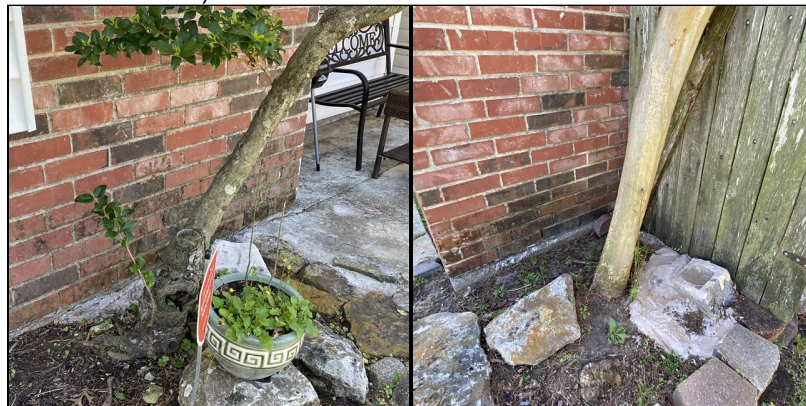
It is recommended that trees be placed no closer than 15ft from foundation structures. All tree roots that are growing beneath the slab should be severed to prevent foundation damage. (Root damming in this area will prevent future grow beneath the slab). Consult with an arborist if tree health is a concern.

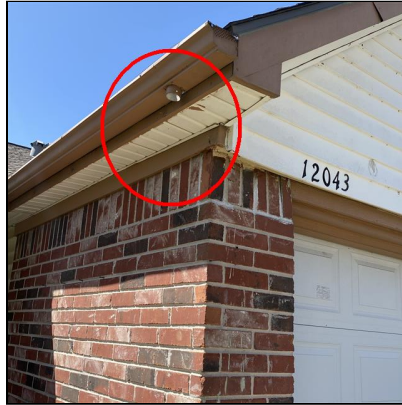
- There is a downspout and/or turnout missing. Replace the missing components and extend 3ft from foundation.

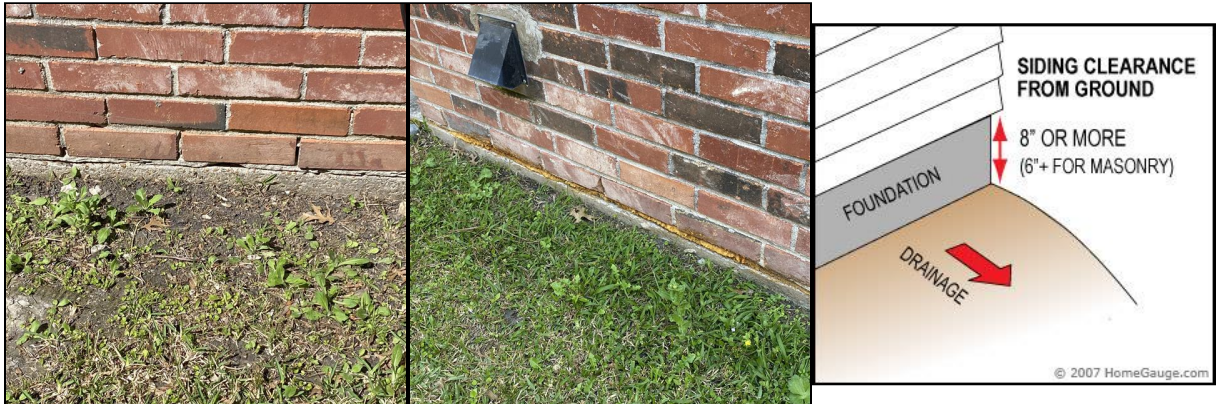
- Current building standards require at least four inches of foundation visible below masonry veneer and six inches of foundation below wood siding. Present condition is considered conducive to possible moisture and insect related issues.

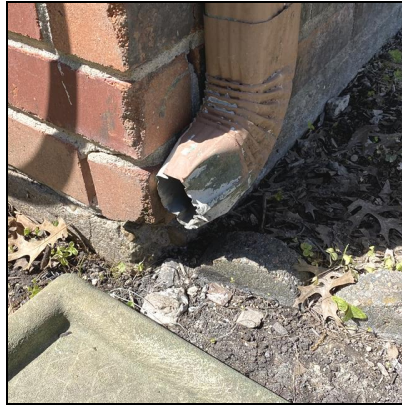
- Some downspouts are damaged/crushed at the exterior. Repair needed by a qualified contractor/ technician to prevent obstruction.

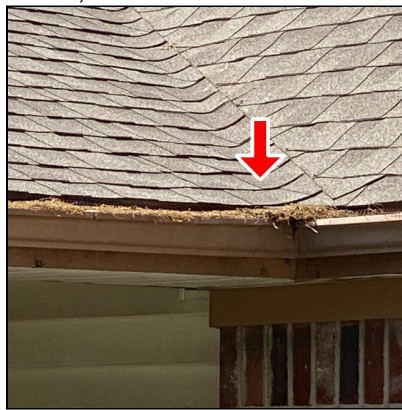
Debris was observed in the gutters. This condition prevents proper drainage of water off and away from structure. Debris in gutters can conceal rust, deterioration or holes that are not visible until cleaned.

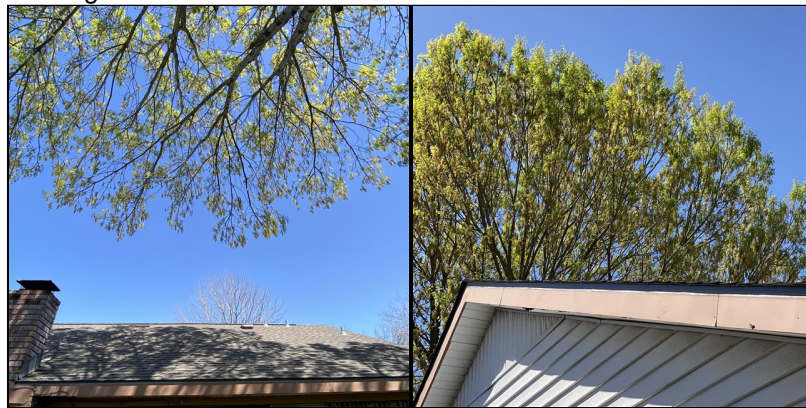
Tree limbs that are in contact with roof or hanging near roof should be trimmed back 3-5' to prevent any damage to the roof covering.

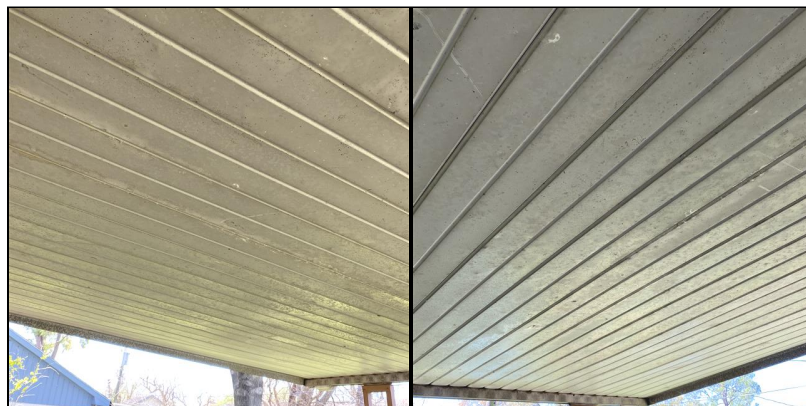
Metal roofs have an expected maintenance period of about every 8-10 years, where the deficient grommet seals on the roof fasteners are replaced as needed and loose fasteners are reset. Penetrations are replenished of sealant and/or jackboot flashings are replaced. The roof appears to be nearing the period where maintenance is recommended. Recommend query owner for record of last maintenance period. If none in last 7 years, a qualified metal roofer should be contacted and a maintenance check be performed.

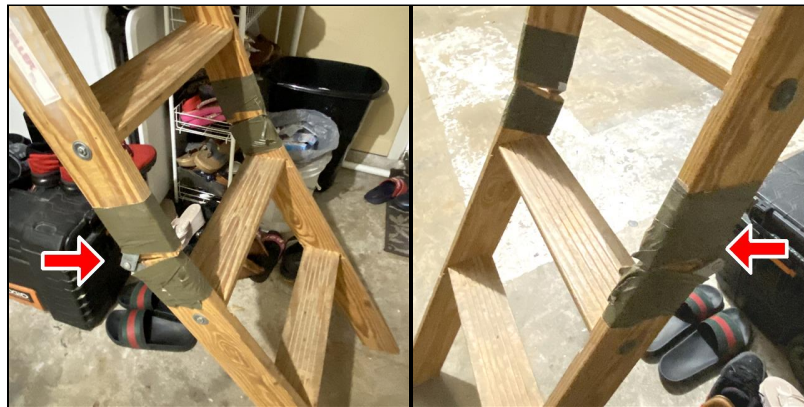
The attic pull down stairs hardware is loose and/or missing at hinges. Injury from use may occur if not repaired.

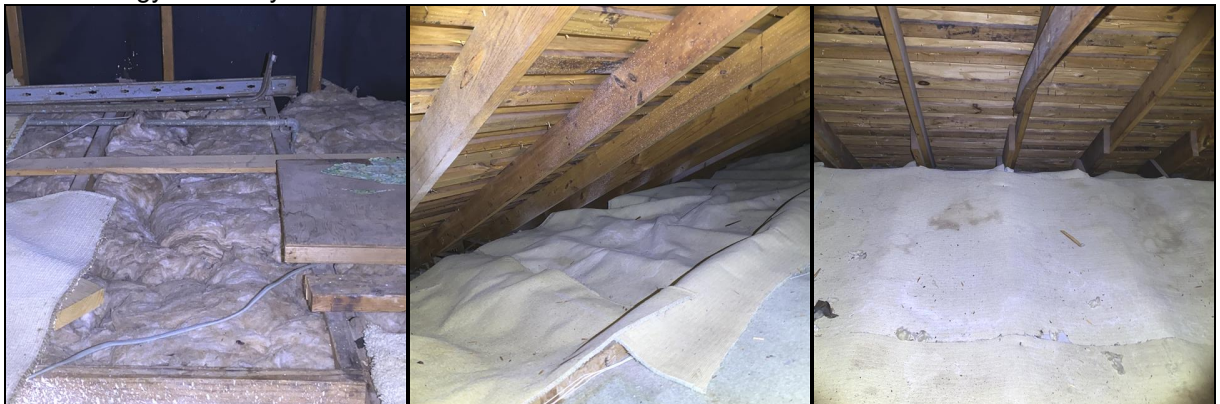
Insulation is deficient by current standards. Have contractor install additional insulation to R-30 for improved energy efficiency.

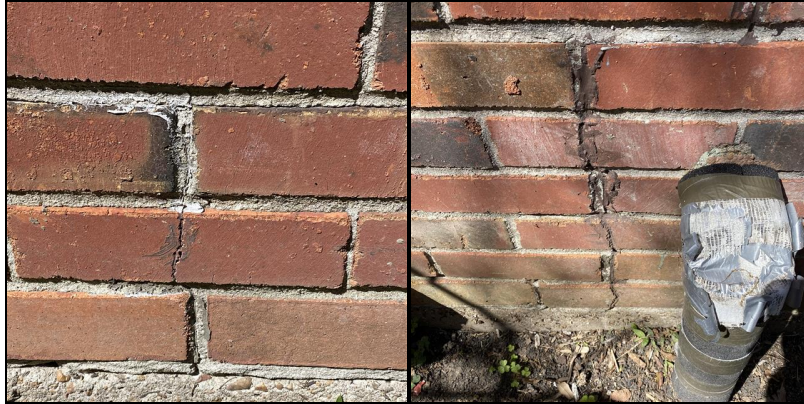
There are joint cracks on the walls in various locations. These cracks appear to be typical settlement/shifting joint cracks. Recommend sealing (mortar) crack to prevent moisture incursion and monitor for further settlement/separation

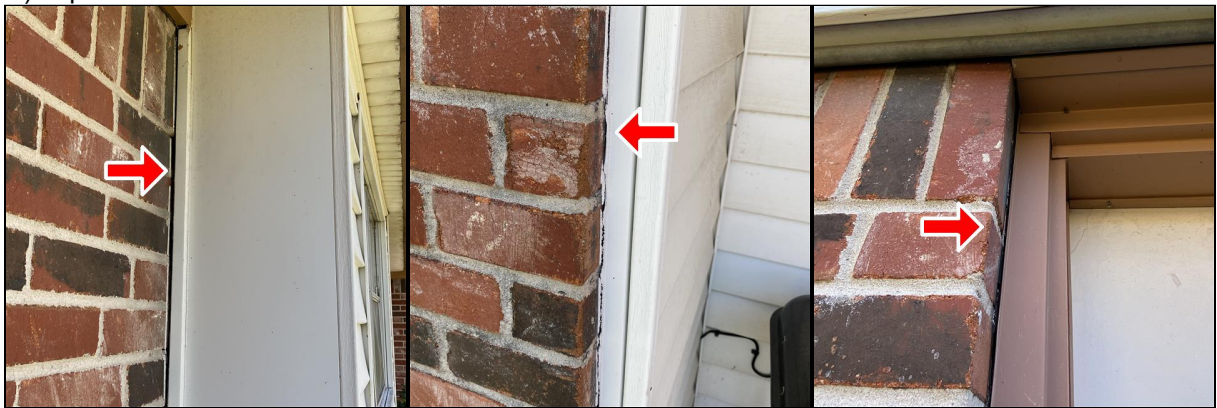
All exterior siding butt & transitional joints that are separated more then 1/8" should be re-sealed (caulk and paint) to prevent moisture incursion

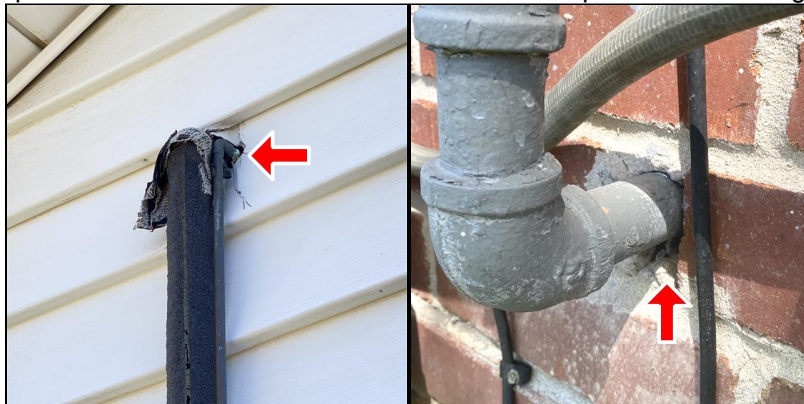
It is recommended that all protrusions through the exterior siding and fixtures mounted on the exterior be sealed in order to prevent moisture incursion. Using a quality exterior caulk type sealant around pipes, wires, light fixtures etc. can prevent moisture related failure of electrical components and siding materials.

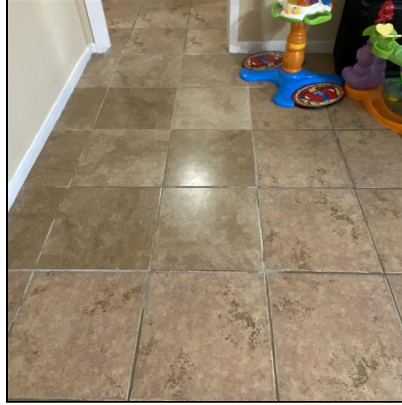
Loose tiles were observed in the living room. It appears to be following a pattern consistent with typical of foundation settlement. Repair as needed.

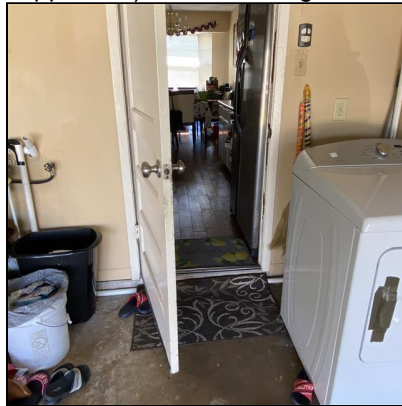
The occupant door leading from the attached garage into the house is not self closing. I recommend installing/adjusting self closing hinges on the door leading from the garage to the living space as a safety feature to prevent exhaust gases (car, appliance) from entering the house.

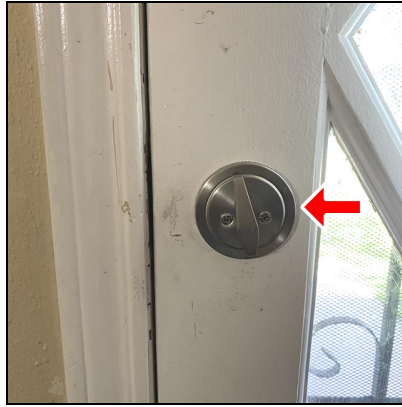
Rear door hardware missing/damaged. Repair as needed.

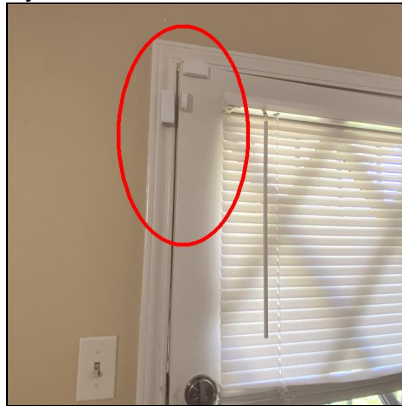
Door at rear does not close properly, binds in frames. Recommend carpenter to make adjustments.

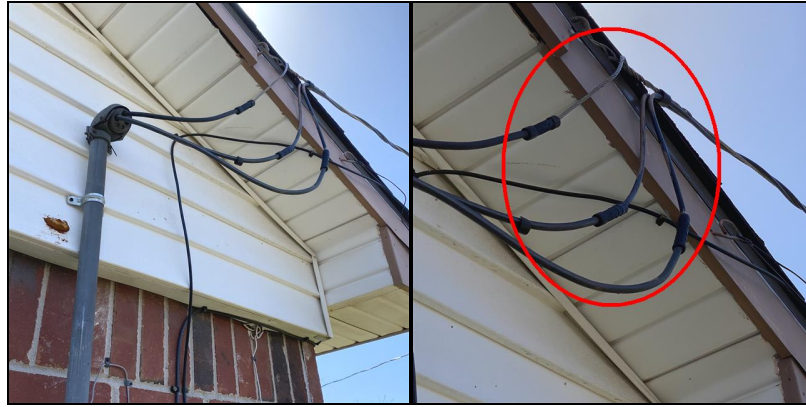
Main electrical service drop wiring is in contact with main structure. Recommend repairs by a professional to avoid circuit contact and damage.

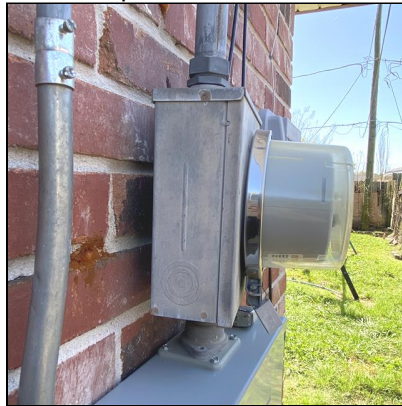
☒ The main panel outside has pulled loose from siding, which can allow debris and water to become trapped behind panel and will eventually deteriorate the siding. Have a contractor perform any necessary siding and/or structural repairs. A licensed electrician should perform work to secure electrical components.

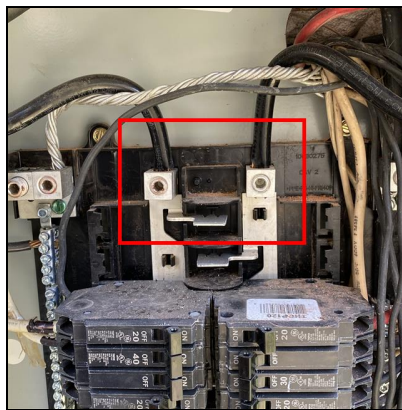
☒ The main service panel does not have a main disconnect breaker as called for by today's standards in service panels with more than 6 breakers

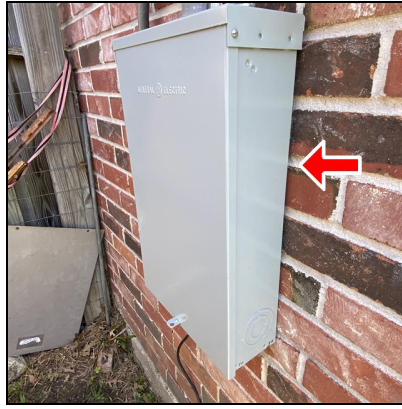
☒ Recommend sealant between panels/meters and wall to prevent moisture entry into wall.

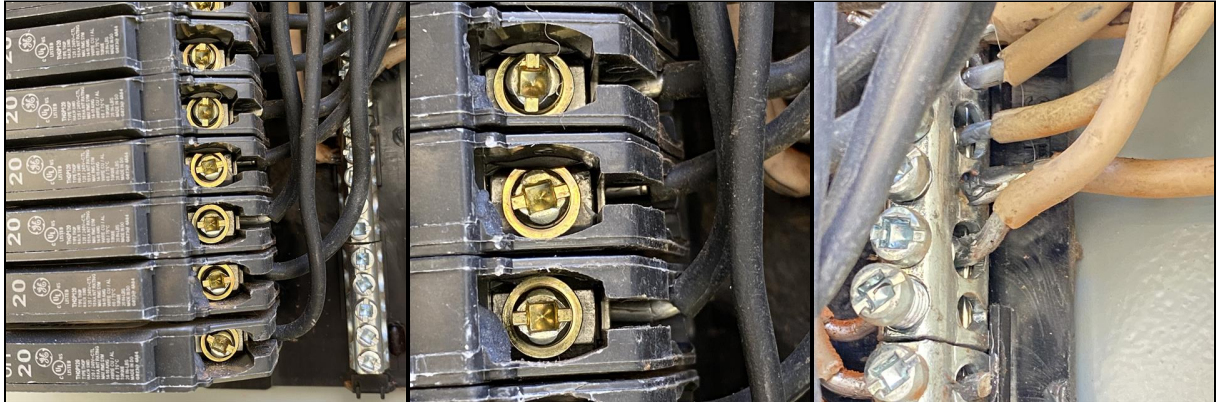
Aluminum wire is installed on 120 VAC branch electrical circuits in the subject house. These single strand, branch circuit aluminum wires were used widely in houses during the mid 1960s and 1970s. According to the U.S. Consumer Product Safety Commission, problems due to expansion can cause overheating at connections between the wire and devices (switches and outlets) or at splices, which has resulted in fires. For further information on aluminum wiring contact the U.S. Consumer Product Safety Commission via the Internet at <http://www.cpsc.gov/> . It is recommended that the electrical system be evaluated by a licensed electrician.

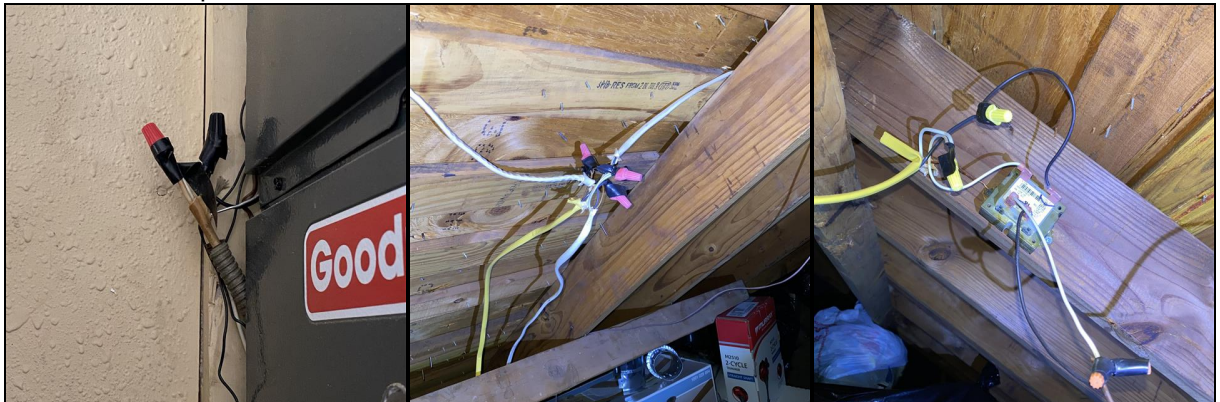
There were exposed connections, open boxes observed in the attic and in the garage. Secure, enclose in rated enclosures to prevent hazards.

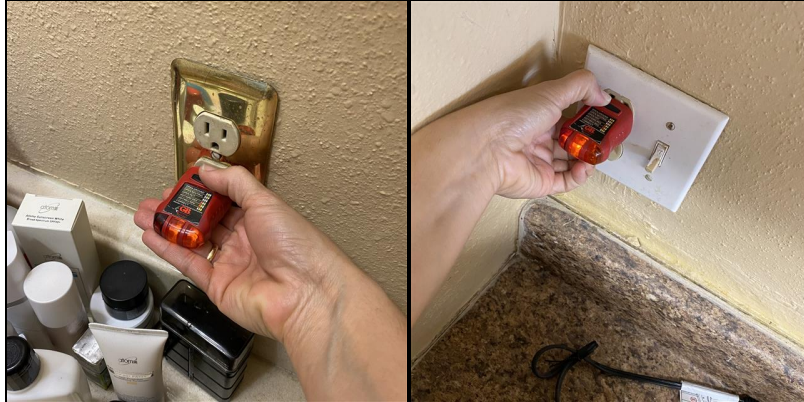
There are no GFCI (Ground Fault Circuit Interrupt) protected outlets in locations called for by today's standards: all kitchen, and baths,. I recommend updating to current standards.

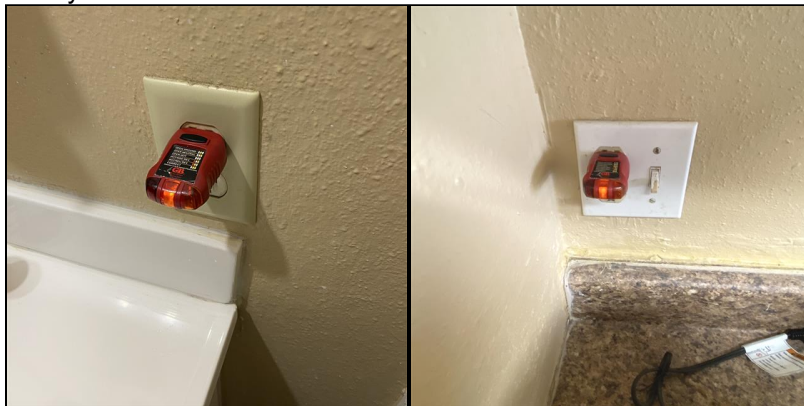
There was an ungrounded circuit observed in the guest bath and kitchen counter. The cause should be diagnosed and repaired by a licensed electrician.

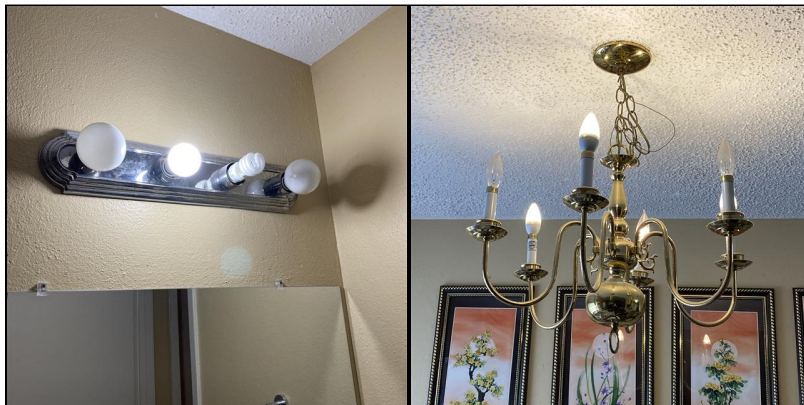
Some lights were not functioning. These are usually just a case of burned out bulbs. Recommend replacing bulbs before closing as needed. If fixtures are still not functioning, then a licensed electrician should diagnose for deficiencies.

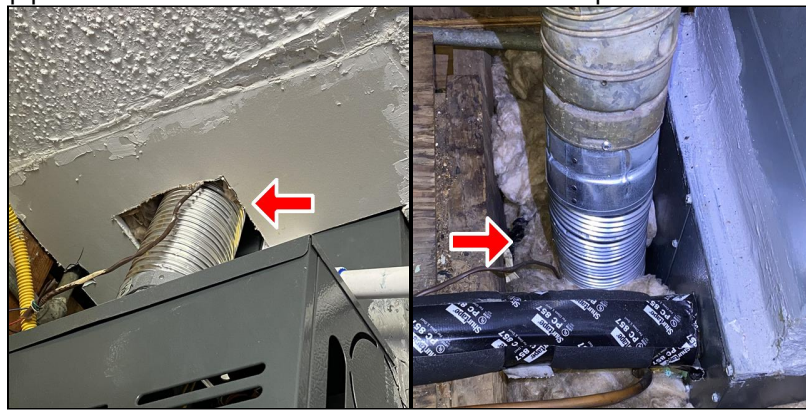
The heating system flue is in contact with building materials. Gas flues should have 1.5" of clearance surrounding the flue pipe. A heat shield should also be installed at the penetration.

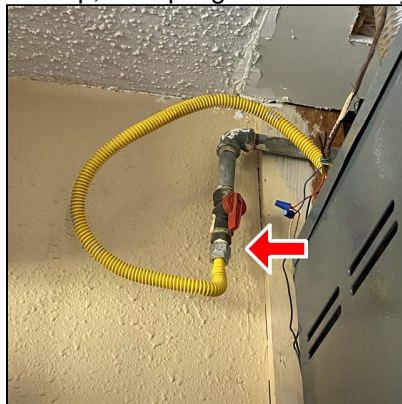
Gas supply to unit is missing a sediment trap, or drip leg as called for by current standards.

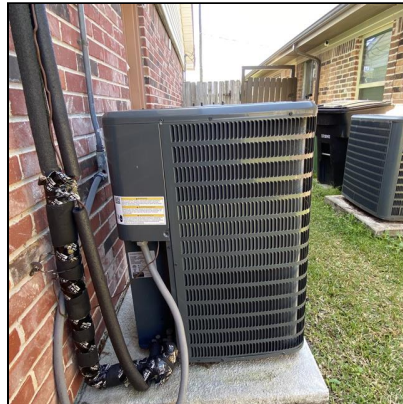
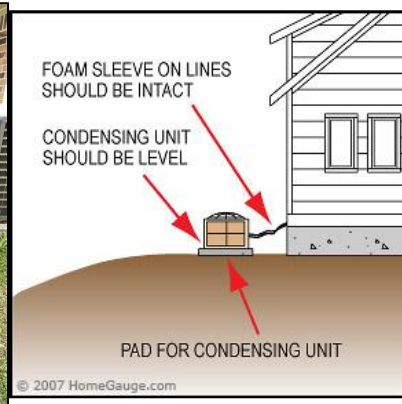
The condenser slab was observed to be out of level. Compressor oil may not properly lubricate the piston if compressor is not level causing premature failure. I recommend a qualified contractor make the necessary corrections.

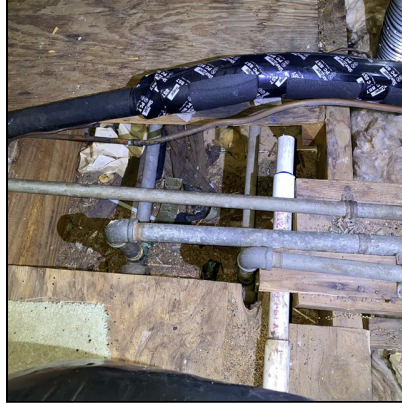
Supply pipes in attic space must be properly insulated.

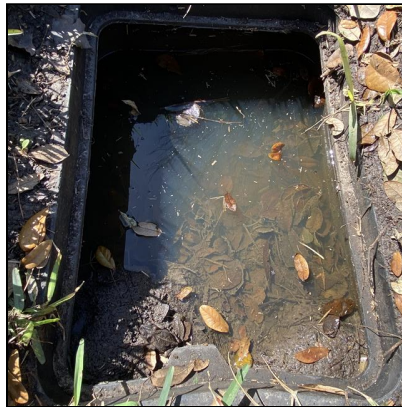
The main shutoff was buried in grade and water. Have soil removed, and ensure the device to be functional before taking occupancy.

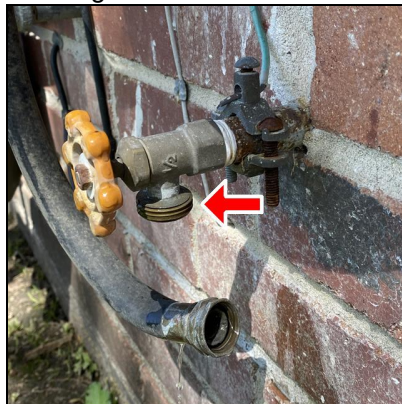
Some exterior hose bibs (faucets) are missing back-flow check valves as called for by today's standards

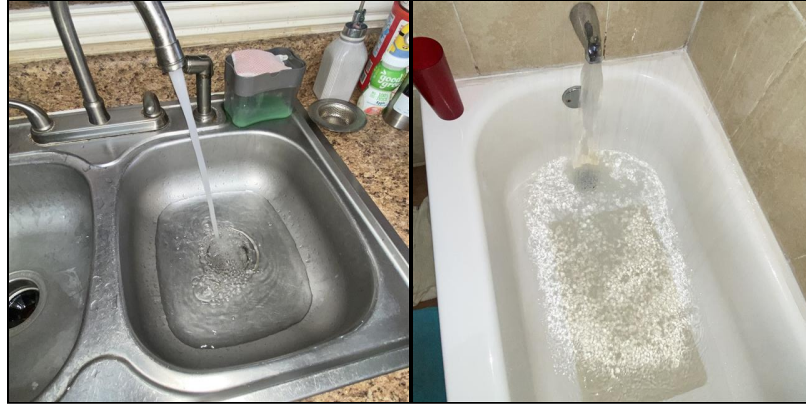
The drain was slow, and may be clogged in the kitchen sink and bath tub. I recommend repair by a plumber.

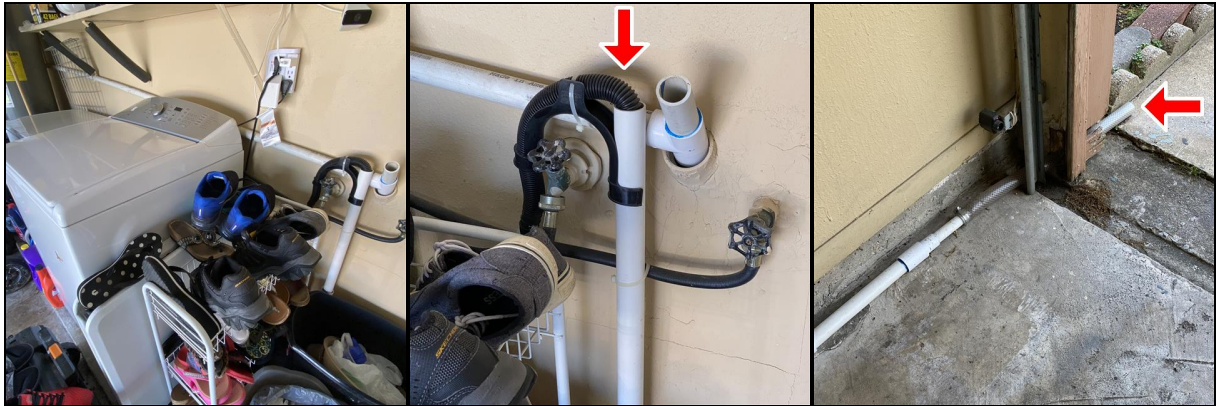
The washer drain is undersized and draining to the front of the home. There is an existing drain at the garage, but an improvised line was added. Have a licensed plumber evaluate for repairs and tap the drain to the main line.

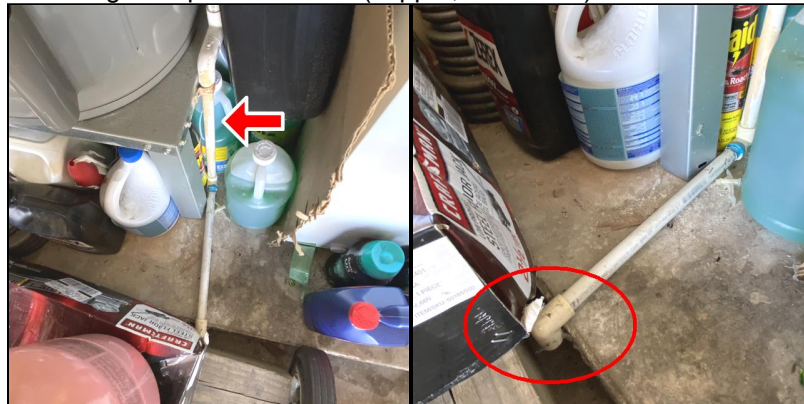
T&P valve does not drain to exterior as required. Injury may occur in the event of a high temperature/pressure discharge. Drains are required to discharge directly to exterior, directed downward to within 6-12" of grade. Drain lines must be high temperature rated (copper, CPVC etc).

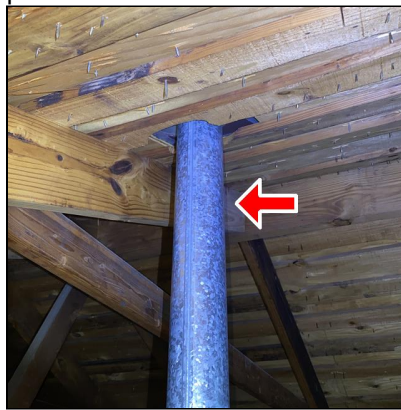
☒ The flue from water heater as it terminates through roof is not strapped to rafters. Recommend properly securing flue to rafters with metal straps at rafters.

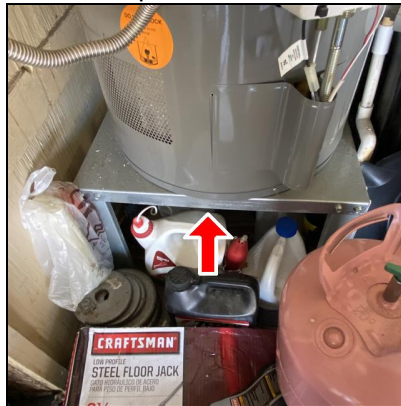
☒ The water heater abuts to an interior wall and there is no emergency leak catch pan installed. Today's standards now require a catch pan that is plumbed to the exterior in locations where tank leaks could cause interior water penetration. For interior installations there are retrofits available, with water leak detectors that shut of the water supply. Consult with a licensed plumber for viable solutions.

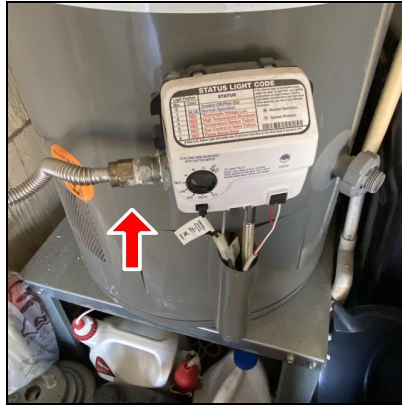
Gas supply to unit is missing a sediment trap, or drip leg as called for by current standards.

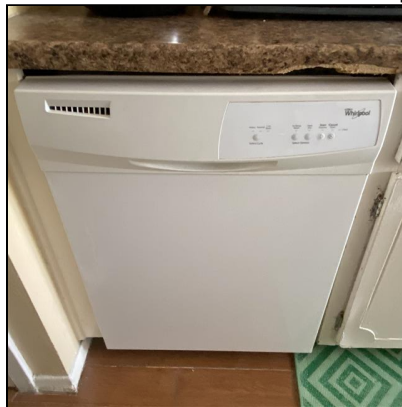
No power to the unit, appliance did not start and was not tested. Repair as needed.

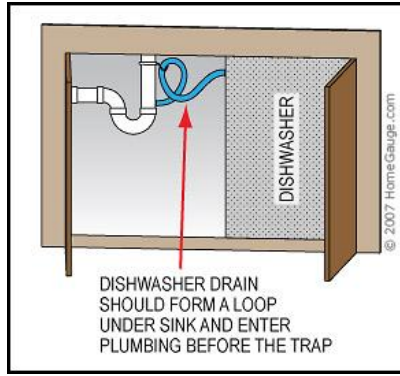
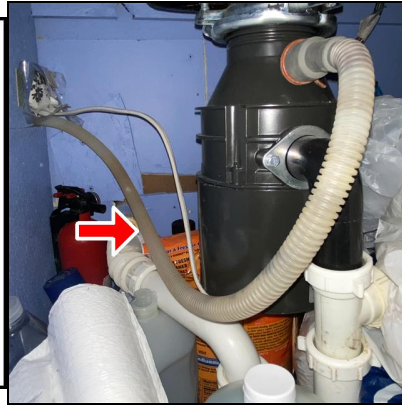
Dishwasher drain line does not have a sanitary anti-siphon line loop installed properly as called for by today's standards. An anti-siphon device prevents the wastewater from the dishwasher from being siphoned back into the dishwasher and contaminating its contents. A drain loop should be attached to highest possible point in the cabinet, or above the sink water line to prevent drain back from the sink and disposal.

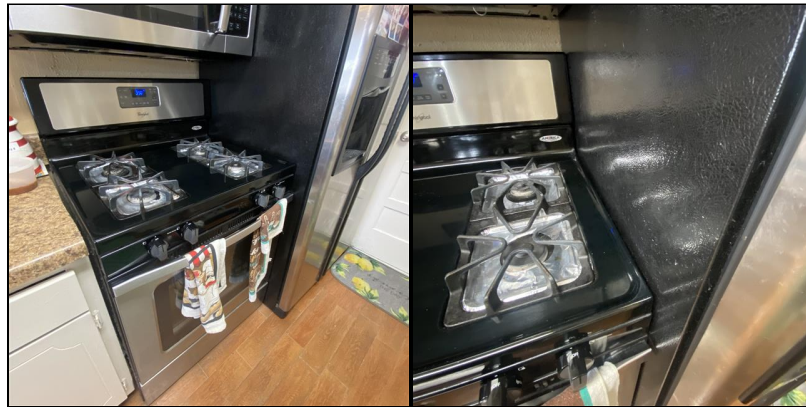
The distance between your range and the nearest sidewall should be twelve inches at a minimum, no matter the style of range you're having installed. This has to do with the heat coming from the cooktop. Gas range flames or intense heat from electric coils can pose some serious danger if they are close to a wall or another appliance.

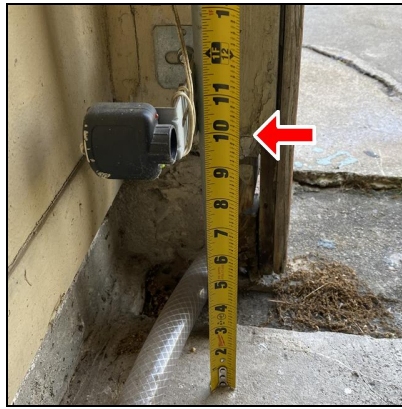
The garage door IR auto reversing sensors should be mounted no higher than 6" above the entry threshold
