Moisture Assessment Report

3011 Maxroy Street
Houston, TX 77008
02/18/2022

Summary Checklist

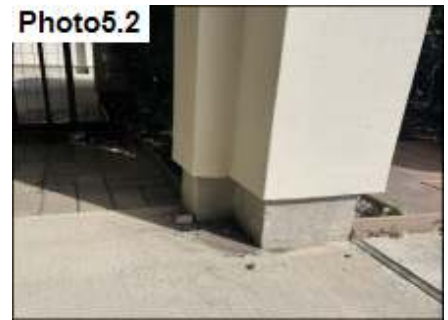
- Assess all windows, doors, flashing terminations, penetrations and seal with polyurethane caulk. Always maintain sealants.
- Column base is elevated and sitting on a concrete footing. This is a favorable detail. See detail #5.2.

Column base is elevated on a concrete footing.

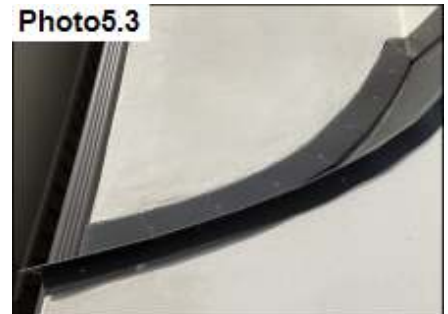
Metal cap is present on top of semi-flat wall.

- Metal cap is present on top of the exposed semi-flat wall. This is a favorable detail. It is suggested to reseal all metal cap terminations with the proper caulking as needed. See details #5.3 and #5.4.

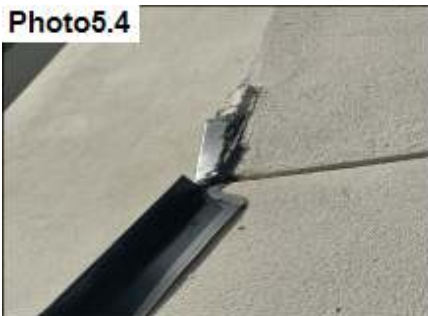
It is suggested to reseal metal cap terminations.

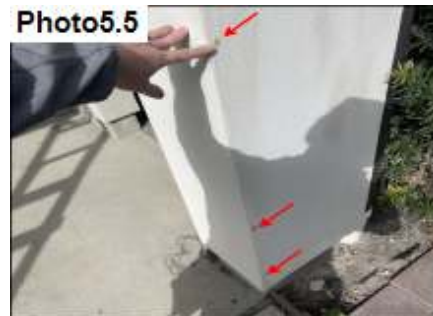
Glue / adhesive noted in stucco.

- Glue / adhesive noted on the stucco. This is a cosmetic concern. Seal / re-paint all as needed. See details #5.5 and #5.6.
- Cracking is present at the outside corners. It is suggested to seal all cracks at outside corners with polyurethane caulking as needed. See detail #6.2.

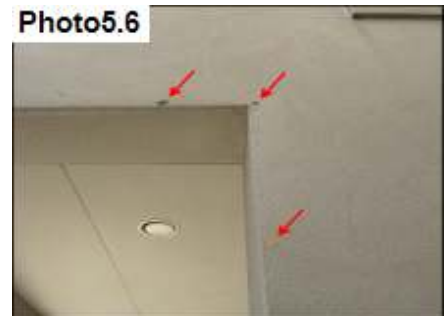
Glue / adhesive noted in stucco.

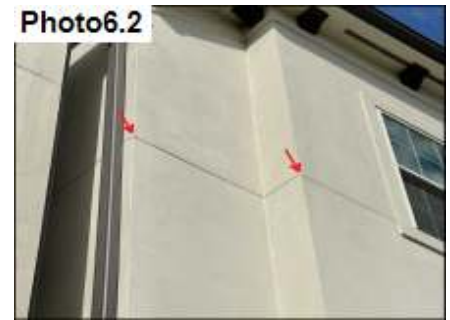
Cracking at outside corners noted.

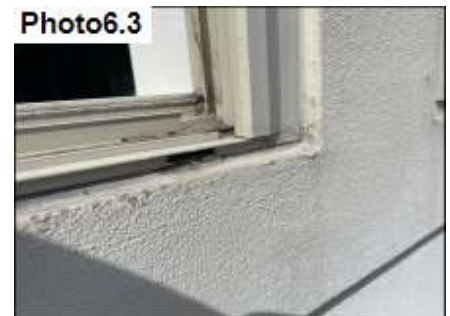
Sealant separation noted around window frames.

- Aged sealants with separation noted around window frames. It is suggested to reseal all window frames with polyurethane caulking as needed. See details #6.3 and #9.4.

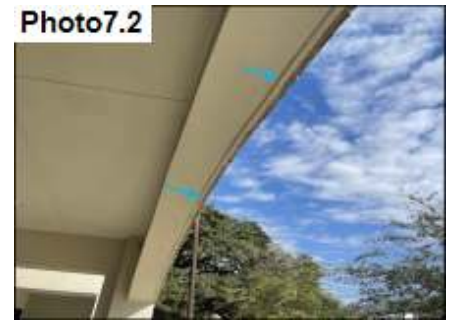
Photo7.2
 Weep relief is present at bottom of wall but is caulked shut.

- Weep relief is present at bottom of walls but appears to be caulked shut. A weep relief is a favorable detail that allows for proper moisture drainage. Clear out relief and always leave weep relief at bottom of walls open as needed. See detail #7.2.

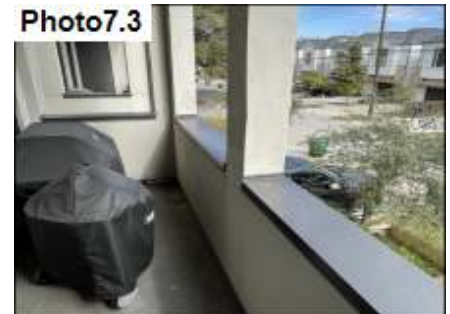
Photo7.3
 Metal caps are present on tops of balcony flat walls.

- Metal caps are present on tops of balcony flat walls. This is a favorable detail. It is suggested to reseal all metal cap terminations with the proper caulking as needed. See details #7.3 and #7.4.

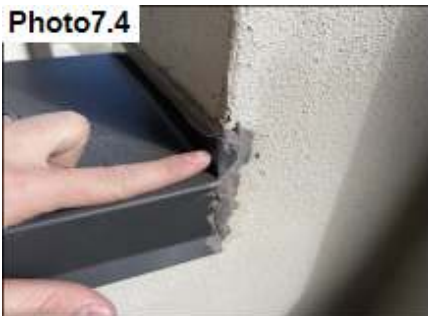
Photo7.4
 It is suggested to reseal all metal cap terminations.

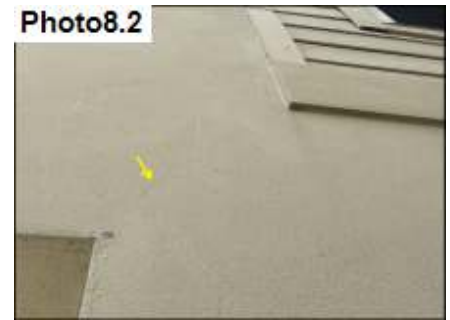
Hairline cracking is present.

- Hairline cracks are present. To temporarily cover cracks, it is suggested in the future to re-paint the entirety of home with an elastomeric paint. Hairline cracks are a cosmetic concern. Elastomeric paint will help protect the cracks and prevent future cracking. See detail #8.2.

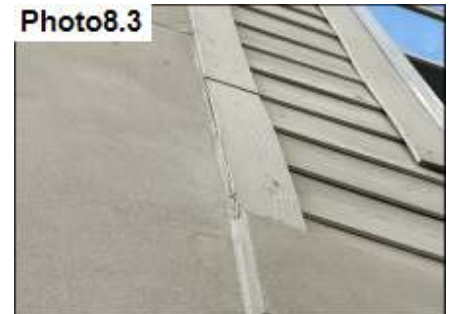
Sealant separation noted at siding transitions.

- Sealant separation noted at siding transitions. It is suggested to reseal all with polyurethane caulking as needed. See details #8.3 and #9.5.
- Sealant separation noted around balcony scupper flashing. It is suggested to reseal with the proper caulking as needed.

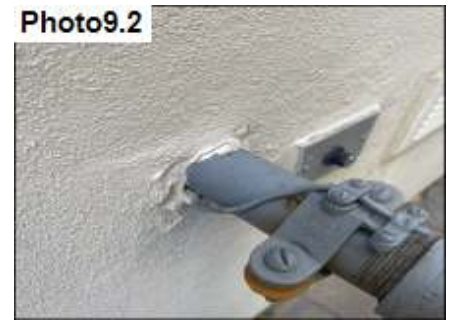
Sealant separation noted around penetrations.

- Sealant separation noted around penetrations. It is suggested to reseal all with polyurethane caulking as needed. See detail #9.2.
- No horizontal transitional flashing noted. Reverse lap is occurring at the horizontal transition. It is suggested to install a proper horizontal transition flashing to prevent future moisture intrusion from occurring. See detail #9.3.

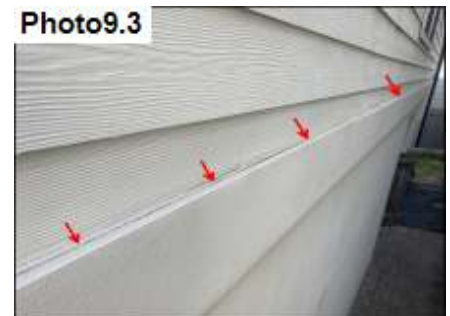
Reverse lap noted at horizontal transition.

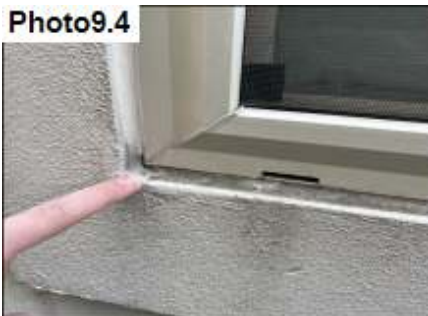
Sealant separation noted around window frames.

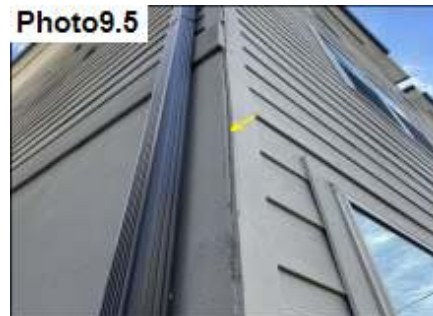
Sealant separation noted at siding transitions.

Yellow Arrow	Siding Transitions			Sealant separation noted at siding transitions. It is suggested to reseal all with polyurethane caulking as needed. See detail #9.5.	Ch 3.10
