HouseCheck Property Inspection Report

33 Violet Sunset Ln, Tomball, TX 77375 Inspection prepared for: Rich Newhart Real Estate Agent: Jane Hardcastle - Jane Hardcastle Realty

> Date of Inspection: 10/28/2019 Time: 9:00 AM Age of Home: 2019 Size: 4000 Weather: 70F Clear Order ID: 1407

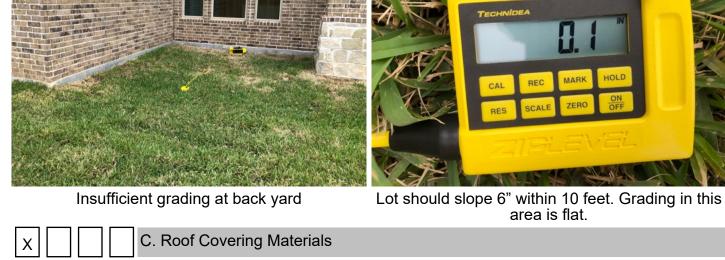
HouseCheck			33 Violet Sunset Ln, Tomball, TX
I=Inspected	NI=Not Inspected	NP=Not Present	D=Deficient
I NI NP D			
	of the foundation. Wa encourage growth of should slope 6" within should be at least 4" f materials. Grading an research, soil and top inspection. Any deficit condition and should concerns. • The grade of the growthe the flow of water away the residence. This case as the installation of a	Drainage: rainage away from the structure possible organic materials in the first 10' away from the for brick, stone, or fiber ce and drainage is inspected vi pographical studies are no be evaluated by a qualifie bund around the residence y from the property in the an be achieved by the ado	ucture is vital to the performance ood rot, attract insects and s. As a general rule, the ground he house. Clearance to wall siding ement and 6" for any other siding isually around the site. Flood plain t performed as a part of the indication of a more serious ad professional if there are e should be improved to promote following locations: back side of dition or removal of top soil as well ound should slope away from the he first 10 feet.

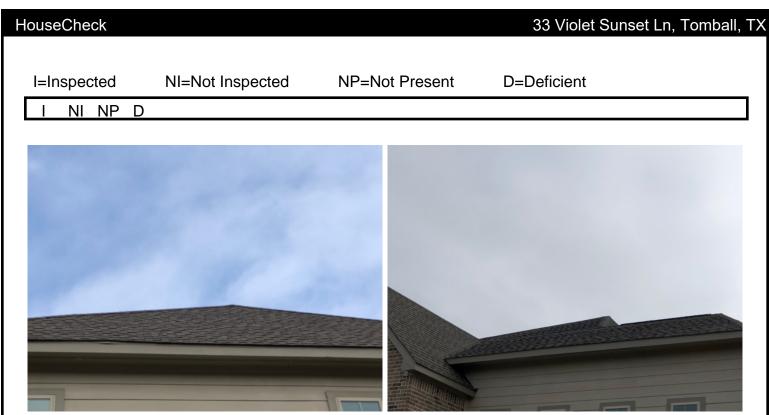
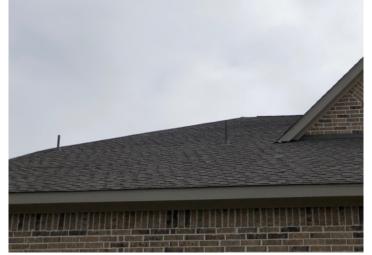
• The roof covering was inspected and no deficiencies were observed at the time of the inspection.

Left side roof slope

Rear roof slope

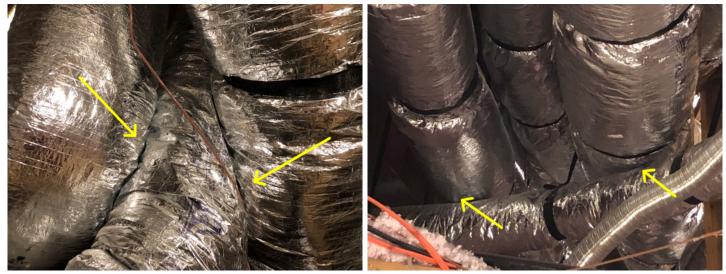
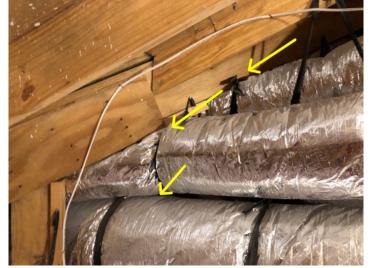
Ductwork compressed
