Inspection Report

Property Address:
105 Jordan Gage Ln
Lumberton TX 77657

PROPERTY INSPECTION REPORT FORM

Mr. Jeff Muckleroy	2/4/2022
<i>Name of Client</i>	<i>Date of Inspection</i>
105 Jorden Gage Ln, Lumberton, TX 77657	
<i>Address of Inspected Property</i>	
Joe Askew	TREC# 0010495
<i>Name of Inspector</i>	<i>TREC License #</i>
<i>Name of Sponsor (if applicable)</i>	<i>TREC License #</i>

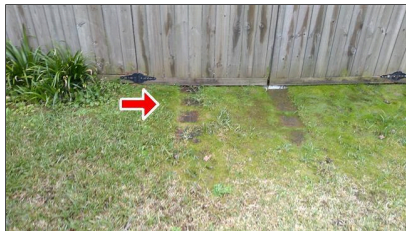
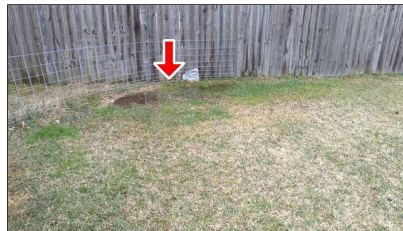
Rains occurred in the days before the inspection. Standing water was noted in some areas.

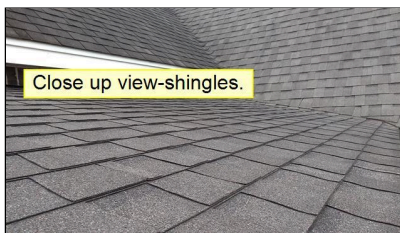
C. (Picture 1)

(1) Architectural shingles present. No shingles were forcefully lifted due to possible damage. Fasteners were evaluated from the attic/interior side of decking as best as possible. No drip edge flashing was installed.

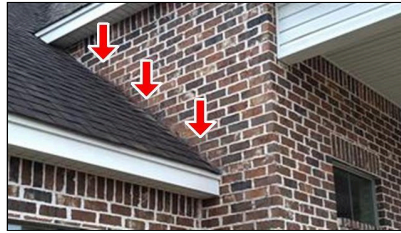
C. (Picture 2)

(2) Inspector did not observe a visible flashing at some of the roof-to-wall transitions.

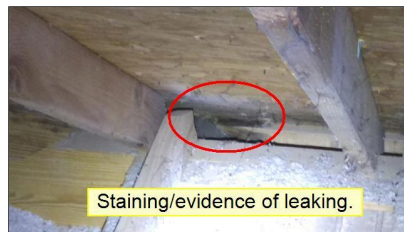
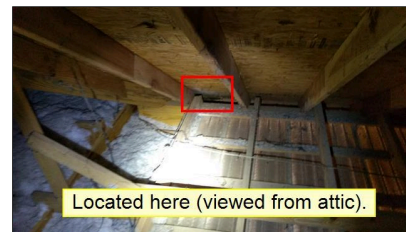
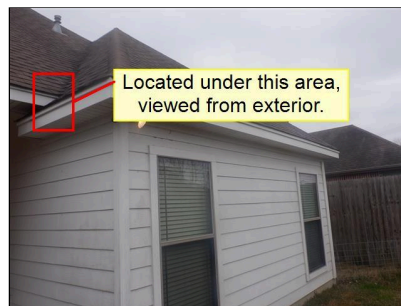
(3) Staining/evidence of leaking was noted in one area at the rear of the home (viewed from attic). See pictures for location. Client may wish to have checked.

C. (3) Staining/evidence of leaking was noted in one area at the rear of the home (viewed from attic). See pictures for location. Client may wish to have checked.

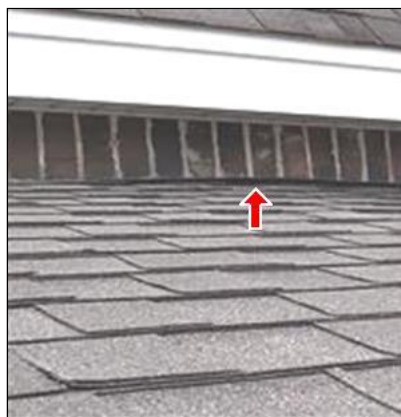
C. (Picture 6)

(4) One flashing at the front of the home was lifted in areas. Client may wish to have corrected.

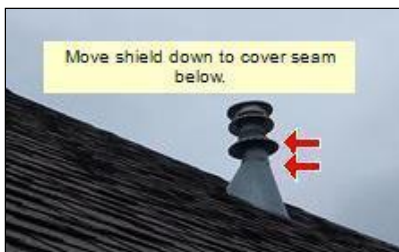
C. (Picture 7)

(5) The storm shield for the water heater flue pipe was not installed properly. It should be installed to cover

the seam below it. Recommend having corrected as necessary.

C. (5) The storm shield for the water heater flue pipe was not installed properly. It should be installed to cover the seam below it. Recommend having corrected as necessary.

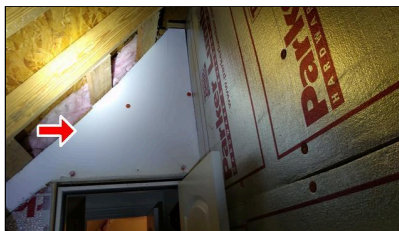
D. (Picture 1)

(1) Exposed styrofoam board insulation was noted in the attic. Although this is a commonly used material, TREC standards require inspectors to note this as a deficiency if not covered.

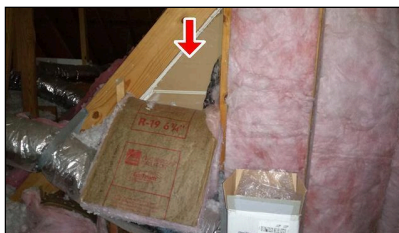
D. (Picture 2)

(2) Some of the hot wall insulation near the front of the kitchen had fallen out of place

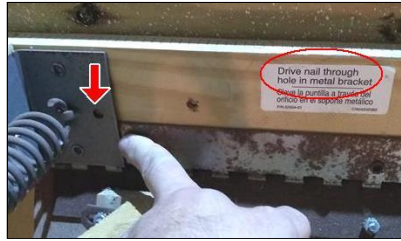
D. (Picture 3)

(3) The attic access ladder (left side of home) was not installed properly. The installer did not nail through the holes in the reinforcement brackets. This is a relatively easy fix.

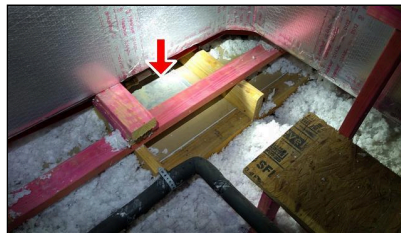
D. (Picture 4)

(4) Some missing insulation was noted over the primary bath area.

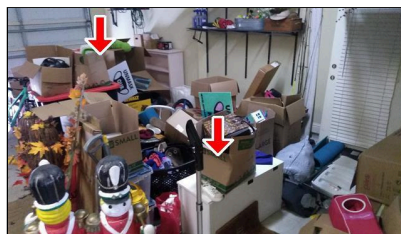
E. (Picture 1)

(1) The home/garage was filled with storage/belongings, blocking/preventing inspection of many areas. Items such as furniture, rugs, door mats, paintings, and wall coverings can conceal/obstruct large areas of the home. Storage areas such as cabinets and closets were also full.

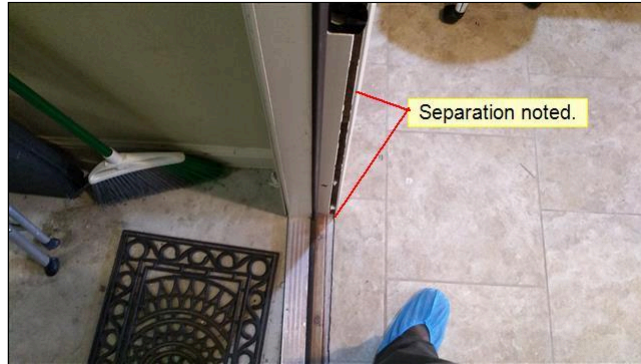
E. (Picture 2)

(2) Separation was noted in the framing/trim at the walk in door to the garage. Client may wish to have repaired.

E. (2) Separation was noted in the framing/trim at the walk in door to the garage. Client may wish to have repaired.

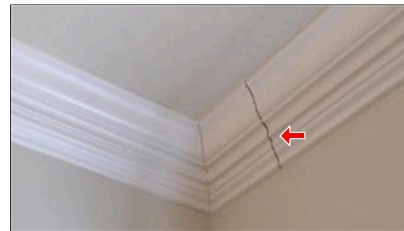
E. (Picture 4)

(3) The crown molding was separated in some locations. This is not a structural concern.

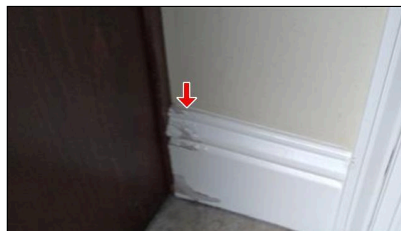
E. (Picture 5)

(4) Evidence of moisture intrusion was note at some of the baseboard trim adjacent to the front sink in the primary bath.

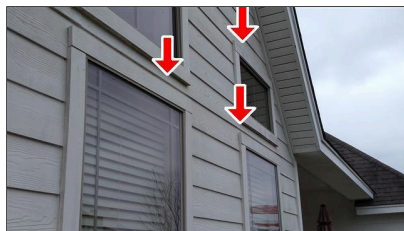
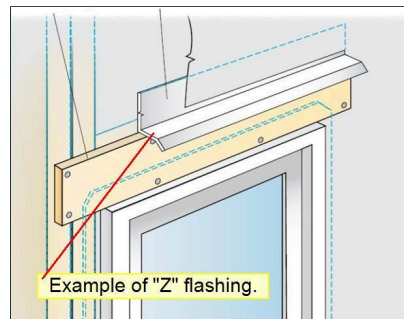
(5) The installer did not use a flashing above the windows at the rear of the home (a "Z" flashing would traditionally be installed in these locations). Local building standards vary.

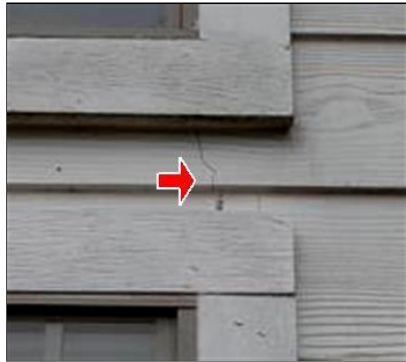
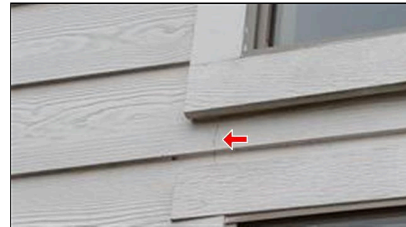
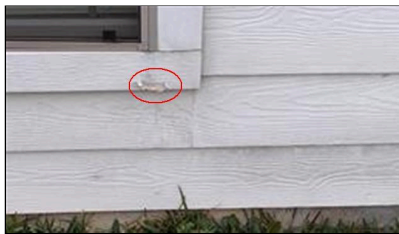
(6) Some cracked/damaged siding was noted at the rear of the kitchen.

E. (6) Some cracked/damaged siding was noted at the rear of the kitchen.

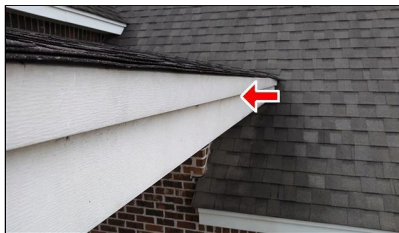
E. (Picture 11)

(7) A portion of the fascia siding near the front entry was loose.

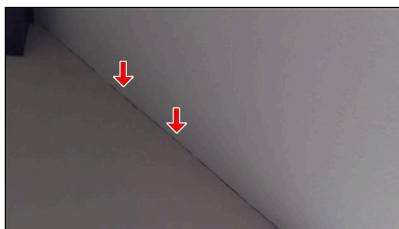
F. (Picture 1)

(1) A split drywall tape seam was noted at the ceiling to the rear of the kitchen.

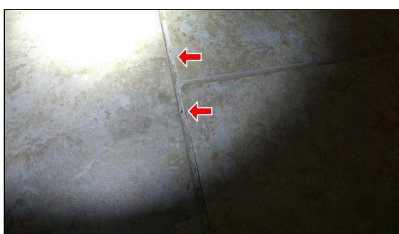
F. (Picture 3)

(3) Some damaged grout was noted at the rear left of the living room.

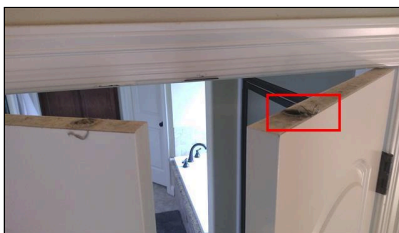
G. (Picture 1)

- (1) Inspector did not observe a sticker or label on the garage walk in door to indicate it is fire rated. It does appear to be a solid wood door.
- (2) One of the entry doors to the primary bath had a damaged catch.

G. (2) One of the entry doors to the primary bath had a damaged catch.

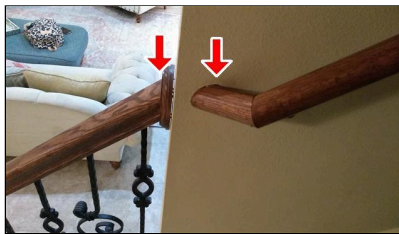
I. (Picture 1)

The hand rail at the staircase was not constructed "continuous" (per newer requirements).

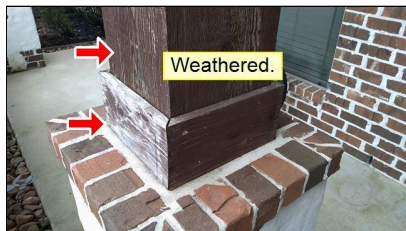
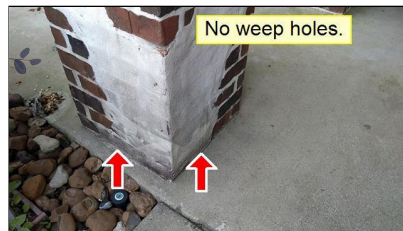
The porch posts were weathered/in need of maintenance.

In addition, the brick work around the base of these posts was installed without weep holes (generally recommended).

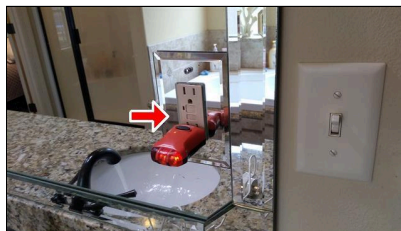
B. (Picture 1)

(1) The GFCI at the primary bath did not trip when tested. Recommend having checked/corrected as necessary.

B. (1) The GFCI at the primary bath did not trip when tested. Recommend having checked/corrected as necessary.

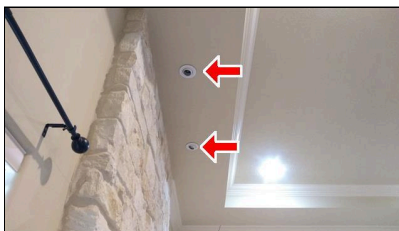
B. (Picture 2)

(2) Two lights above the fireplace did not turn on when tested. Client may wish to check function with new bulbs.

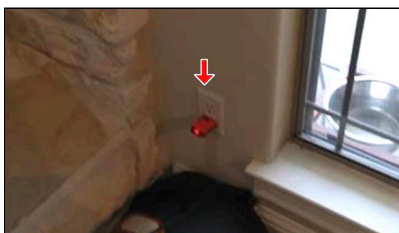
B. (Picture 4)

(5) The receptacle at the right side of the fireplace tested as "open ground". Recommend having checked.

B. (5) The receptacle at the right side of the fireplace tested as "open ground". Recommend having checked.

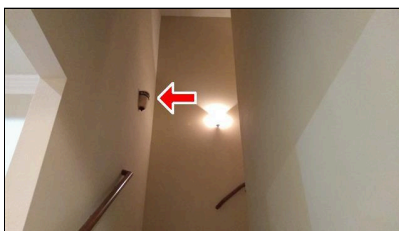
B. (Picture 5)

(8) One light over the stairs did not turn on when tested. Client may wish to check function with new bulb.

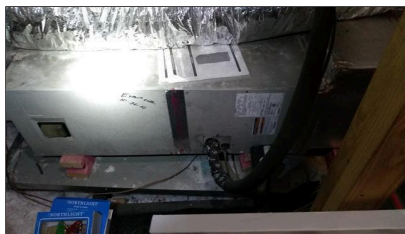
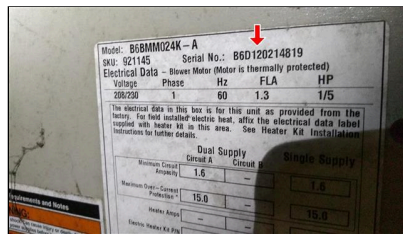
(4) **Upstairs unit:** An electric furnace was noted for the upstairs area. According to the serial number, it was manufactured in 2012.

-Inspector did not observe a service disconnect for this unit

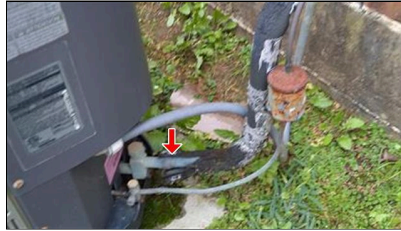
B. (Picture 1)

(2) Some of the insulation is worn/missing from the suction coolant line at the left side exterior HVAC unit. Recommend re-insulating (easy fix).

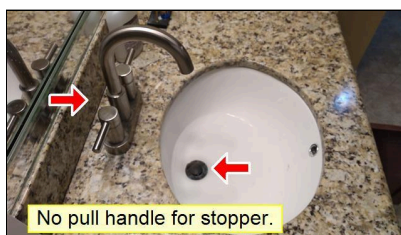
A. (Picture 1)

(3) The sink fixture at the front bath did not have a pull handle for the stopper.

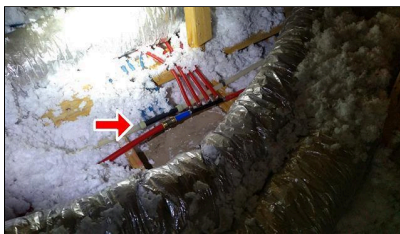
A. (Picture 2)

(4) Client may wish to insulate the exposed water supply lines in the attic.

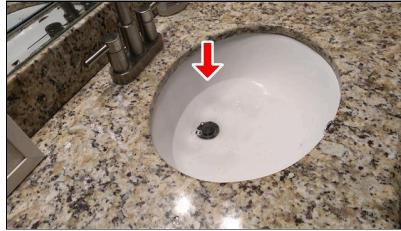
B. (Picture 1)

The sink at the front bath was slow to drain. Client may wish to have checked.

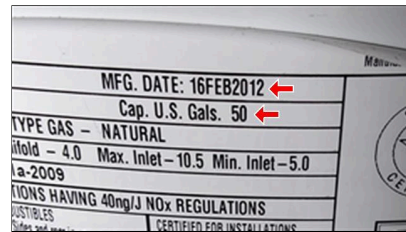
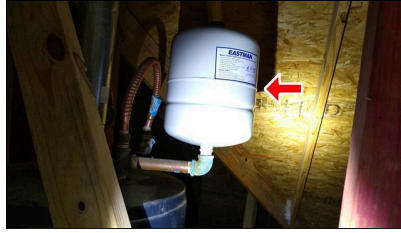
(2) Client may wish to install a strap or bracket to support the weight of the expansion tank. It is currently being supported by the supply line.

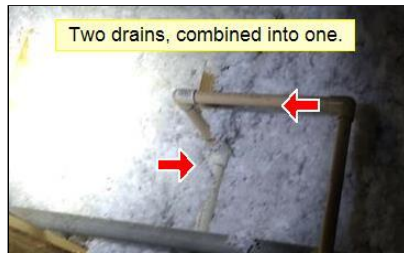
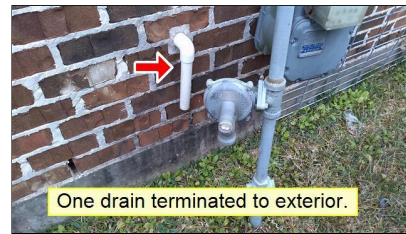
(3) The installer combined the drain pipe for the catch pan under the water heater with the drain for the T&P relief valve before terminating to the exterior. Current standards call for these two drains to be terminated to the exterior separately.

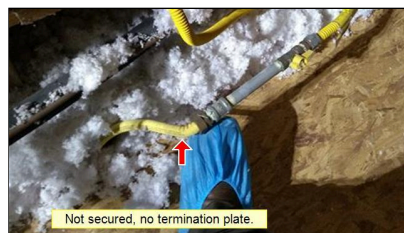
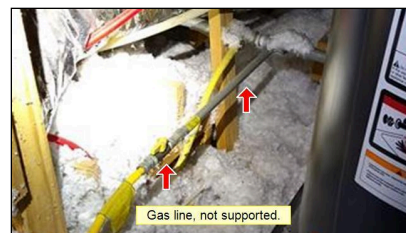
(1) The installer did not use termination plates for the CSST gas lines at the furnace and at the water heater (generally recommended).

One section of gas line near the water heater was not properly supported.

E. (1) The installer did not use termination plates for the CSST gas lines at the furnace and at the water heater (generally recommended).

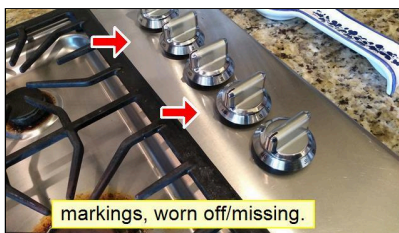
D. (Picture 1)

The markings were worn off the cook top.

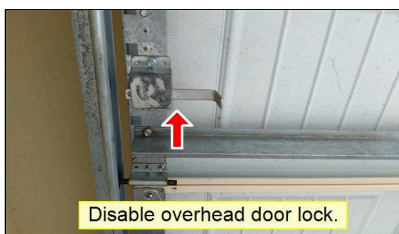
G. (Picture 1)

G. (1) The garage door still has the locking hardware in place. This can cause damage to powered garage doors if they are operated while locked. Recommend removing or disabling the manual locking hardware.

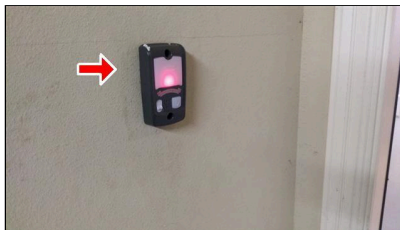
G. (Picture 2)

(3) The control pad for the overhead door was loose at the wall.
