MECHANICAL INSPECTION

10818 Piping Rock Ln
Houston, TX 77042

PROPERTY INSPECTION REPORT FORM

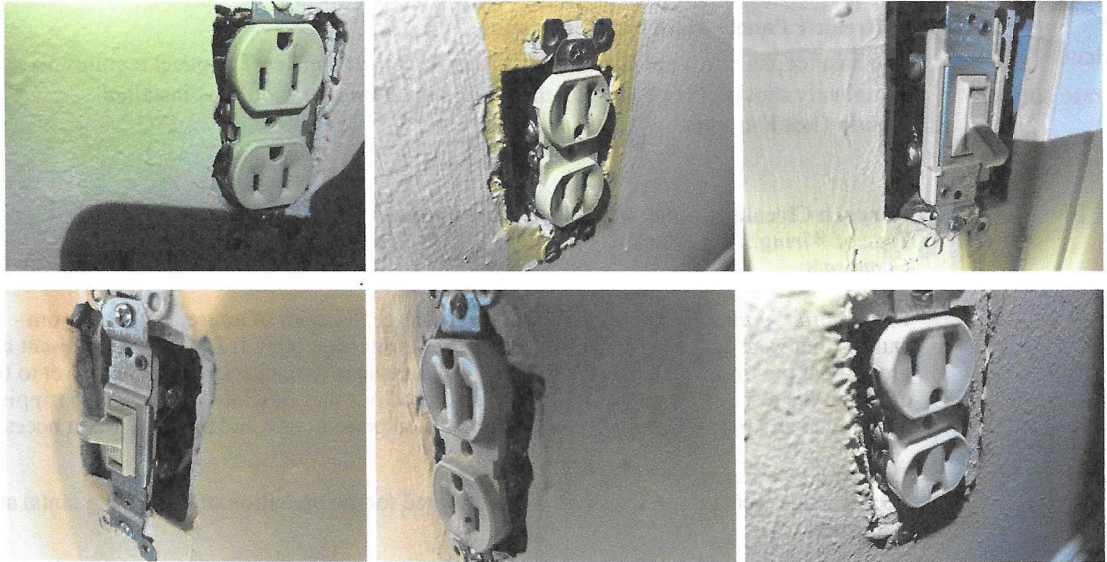
A GFCI device was not installed at one or more locations that are currently required to have GFCI protection. It is recommended that an electrician install GFCI devices at all of the currently required locations.

Recommendation: Contact a qualified professional.

all replaced

Electrician - have him verify & obtain cost estimate

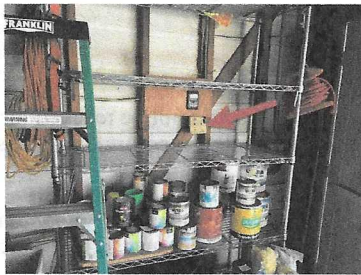
3: Cover Plate - Damaged/Missing

Garage

A missing or damaged cover plate was observed.

Obtain Cost Estimate

Handyman

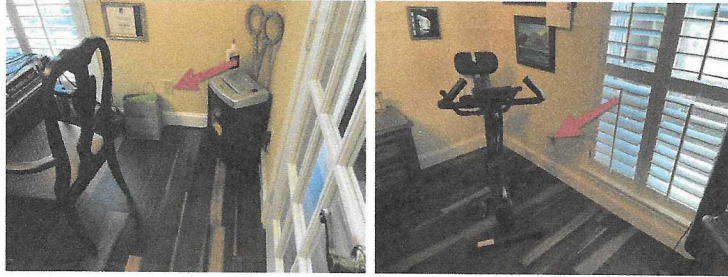
4: Outlets - Ungrounded at several locations

Office, Southeast Bedroom

Several three prong outlets that were not grounded properly and need to be repaired were observed. It is recommended that an electrician be contacted, and the necessary repairs made to the outlets.

Electrician - have him verify. This may simply be a loose connection.
Replaced

Obtain Cost Estimate

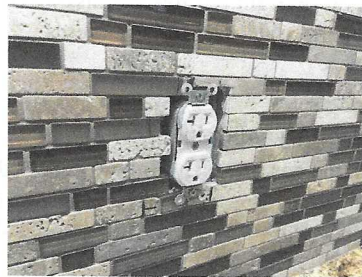
5: Outlets - Box extenders missing at backsplash

We observed outlets located in countertop backsplashes that were not protected by extender boxes. This is considered to be a fire hazard, and it is recommended that the extender boxes be installed.

Obtain Cost Estimate

Handyman
Replaced

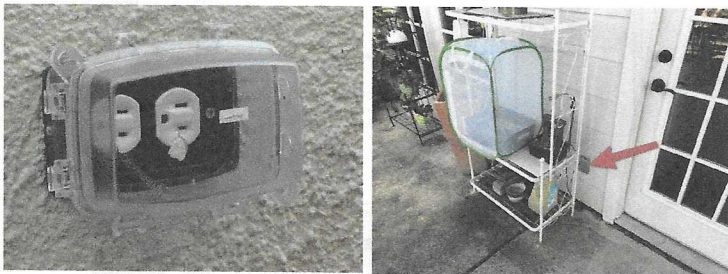
6: Exterior Outlet - No water tight cover

An exterior outlet that was not protected by a water tight cover plate was observed.

Obtain cost estimate

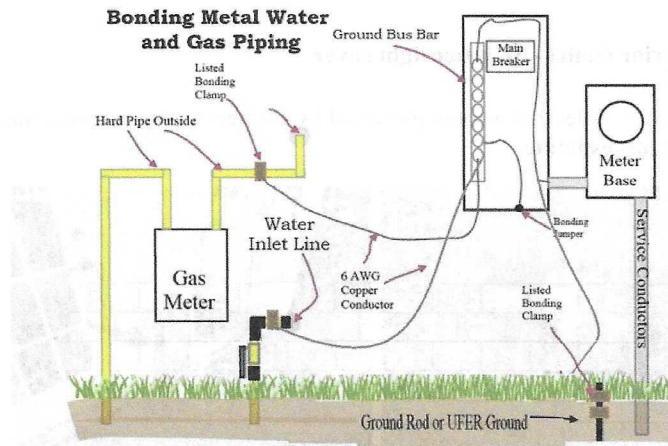
The location where the gas supply piping was bonded back to the electrical ground system was not visible at the time of the inspection. It is recommended that an electrician be contacted to determine if the plumbing in the house is properly bonded and to make any needed repairs.

Obtain Cost Estimate

Electrician

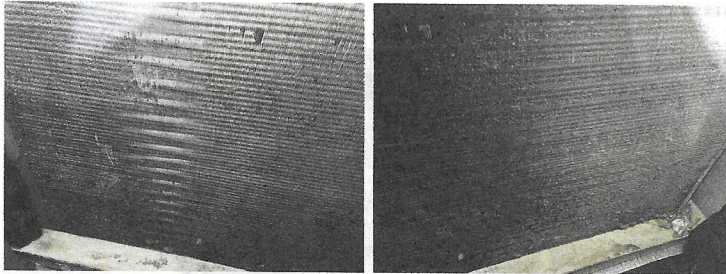
The coil was dirty and needs to be cleaned and serviced at this time. Have a service company clean the coils to allow for proper operation.

Obtain Cost Estimate

*Leak checked
George
HVAC*

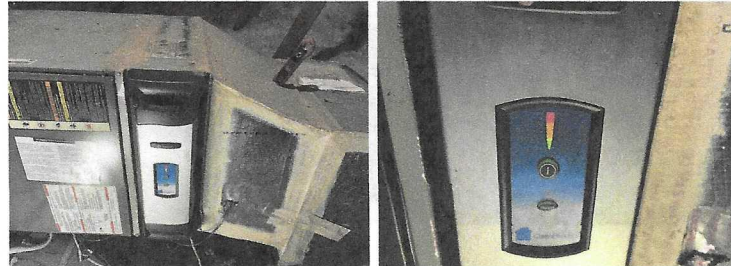
1: Electronic Air filter - dirty

The filter was dirty and needs to be cleaned. A dirty filter can allow the evaporator coil and air ducts to become dirty, which can affect the performance of the system.

Obtain Cost Estimate

Replace filter

(A/C or Handyman)

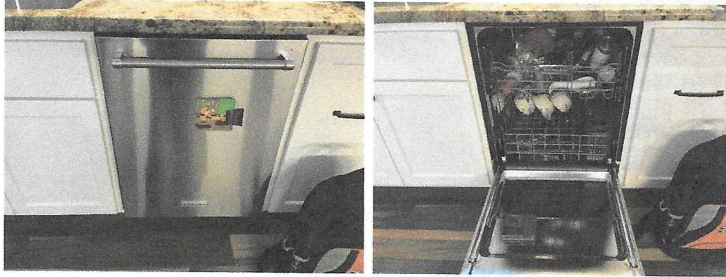
1: No Anti-Siphon

The drain line under the sink was not equipped with an anti-siphon device, nor was it looped up so that the top of the loop is at least six inches above the entrance of the drain line into the disposal. It is recommended at least that the drain line be looped to prevent the water from the garbage disposal from siphoning back into the dishwasher, or an anti-siphon device installed.

Obtain Cost Estimate

Handyman
Corrected
(Built in on new d/w)

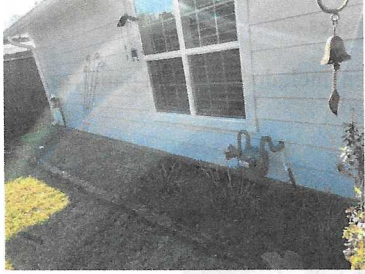
1: Adjust sprinkler head spray

Spraying rear of house -

The sprinkler head spray was in need of adjustment/repair.
Obtain cost estimate

Recommendation: Contact a qualified professional.
