Lone Star Stucco, LLC

Moisture Assessment Report

2815 Newman St

2/27/2020

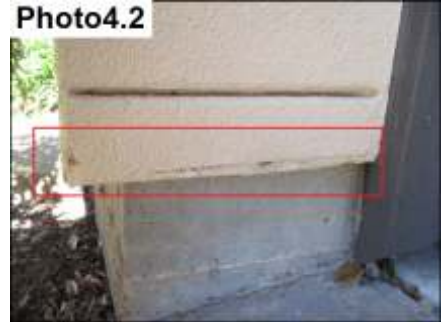
Photo4.2

Rusted Casing Bead/ Repair As

Grid Location	Item Description	Moisture Readings	Substrate Condition	Observations
Red Boxes	Impact And Rusted Casing Bead			The casing bead is rusted and broken. The inspector suggests to have a qualified stucco waterproofing contractor assess and repair this area was needed. Please refer to photos #4.2, #4.3, #4.4 and #4.5 for more detail.

- The casing bead is rusted and broken. The inspector suggests to have a qualified stucco waterproofing contractor assess and repair this area was needed. Please refer to photos #4.2, #4.3, #4.4 and #4.5 for more detail.

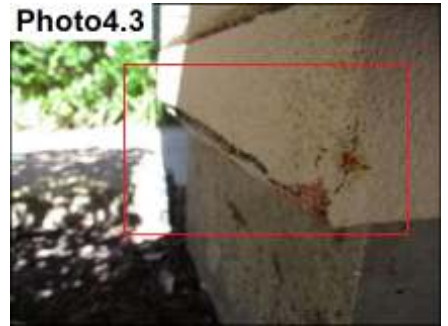
Photo4.3

Rusted Casing Bead/ Repair As

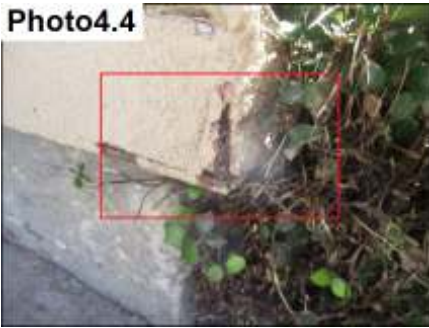
Photo4.4

Rusted Casing Bead/ Repair As

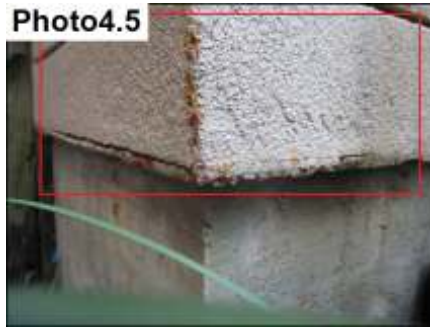
Photo4.5

Rusted Casing Bead/ Repair As

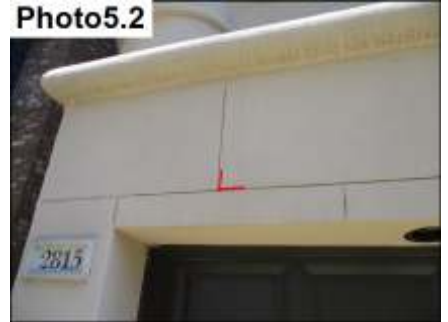
Photo5.2

Minor Cracks / Seal

Grid Location	Item Description	Moisture Readings	Substrate Condition	Observations
Red Lines	Cracks			A minor crack is noted at this location. The inspector suggests to have a qualified stucco waterproofing contractor further assess and seal then paint to prevent moisture intrusion. Please refer to photos #5.2 , #5.3 and #5.4 for more detail.

- A minor crack is noted at this location. The inspector suggests to have a qualified stucco waterproofing contractor further assess and seal then paint to prevent moisture intrusion. Please refer to photos #5.2 , #5.3 and #5.4 for more detail.

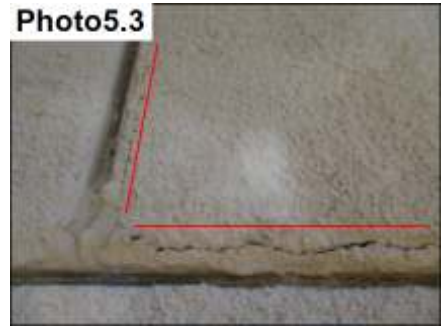
Photo5.3

Minor Cracks / Seal

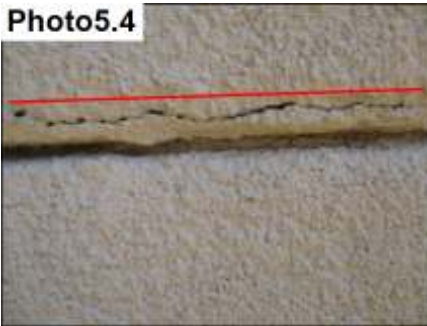
Photo5.4

Minor Cracks / Seal

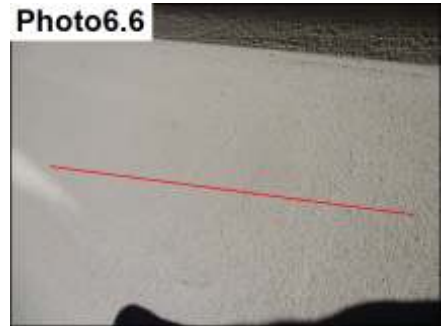
Photo6.6

Angled Accent / Elastomeric Paint

Grid Location	Item Description	Moisture Readings	Substrate Condition	Observations
Orange Line	Bottom Of Wall			The bottom of the wall does not have a relief, but the substrate is firm with no elevated moisture. The inspector suggests no modification at this time. Please refer to photos #6.2 for more detail.
Green Arrows	Door Trim			The door sealants are aged and separated. The inspector suggests to have a qualified stucco waterproofing contractor seal this area with a low modulus sealant in an effort to prevent moisture intrusion. These types of sealants are of high quality and compatible with stucco and other termination points. Please refer to photos #6.2 and #6.3 for more detail.
Red Line	Accent Wall			The angled accent wall paint is deteriorated with hairline cracks. The inspector suggests to have a qualified stucco waterproofing contractor paint this area with elastomeric paint in an effort to prevent moisture intrusion. Please refer to photos #6.4, #6.5 and #6.6 for more detail.

- The angled accent wall paint is deteriorated with hairline cracks. The inspector suggests to have a qualified stucco waterproofing contractor paint this area with elastomeric paint in an effort to prevent moisture intrusion. Please refer to photos #6.4, #6.5 and #6.6 for more detail.

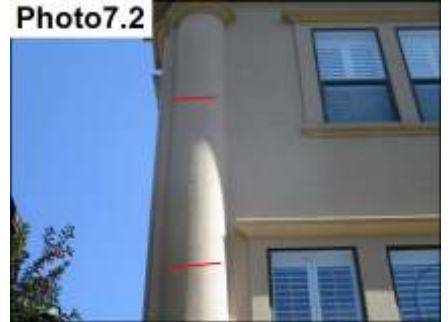
Photo7.2

Cracks Noted / Seal & Paint

Grid Location	Item Description	Moisture Readings	Substrate Condition	Observations
Red Lines	Cracks			Cracks are noted at these locations. The inspector suggests to have a qualified stucco waterproofing contractor further assess and seal then paint to prevent moisture intrusion. Please refer to photos #7.2 , #7.3 and #7.4 for more detail.

- Cracks are noted at these locations. The inspector suggests to have a qualified stucco waterproofing contractor further assess and seal then paint to prevent moisture intrusion. Please refer to photos #7.2 , #7.3 and #7.4 for more detail.

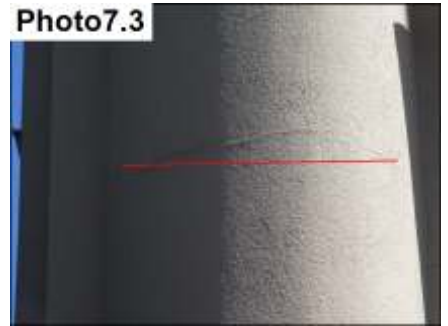
Photo7.3

Cracks Noted / Seal & Paint

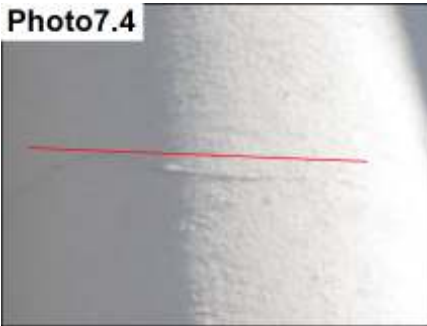
Photo7.4

Cracks Noted / Seal & Paint

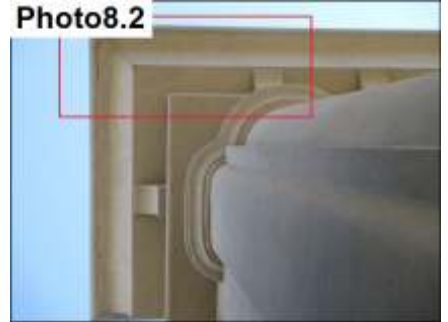
Photo8.2

Cracks /Further Assess And Repair As Needed

Grid Location	Item Description	Moisture Readings	Substrate Condition	Observations
Red Boxes	Cracks & Potential Moisture Intrusion			Cracks are noted at the bottom of the foam accent below the roof with evidence of moisture intrusion. The inspector suggests to have a qualified stucco waterproofing contractor further assess core sample and repair as needed. Please refer to photos #8.2 , #8.3, #8.4 and #8.5 for more detail.

- Cracks are noted at the bottom of the foam accent below the roof with evidence of moisture intrusion. The inspector suggests to have a qualified stucco waterproofing contractor further assess core sample and repair as needed. Please refer to photos #8.2 , #8.3, #8.4 and #8.5 for more detail.

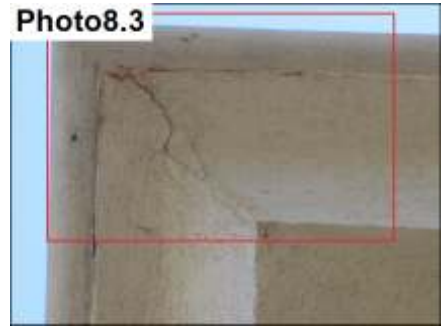
Photo8.3

Cracks /Further Assess And Repair As Needed

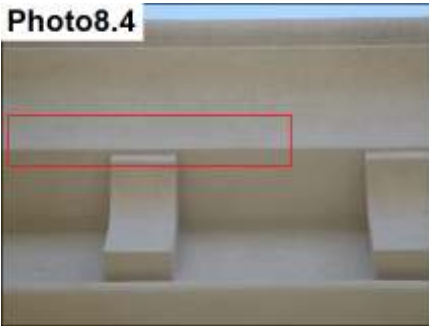
Photo8.4

Cracks /Further Assess And Repair As Needed

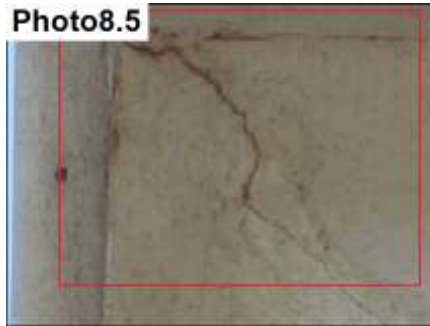
Photo8.5

Cracks /Further Assess And Repair As Needed

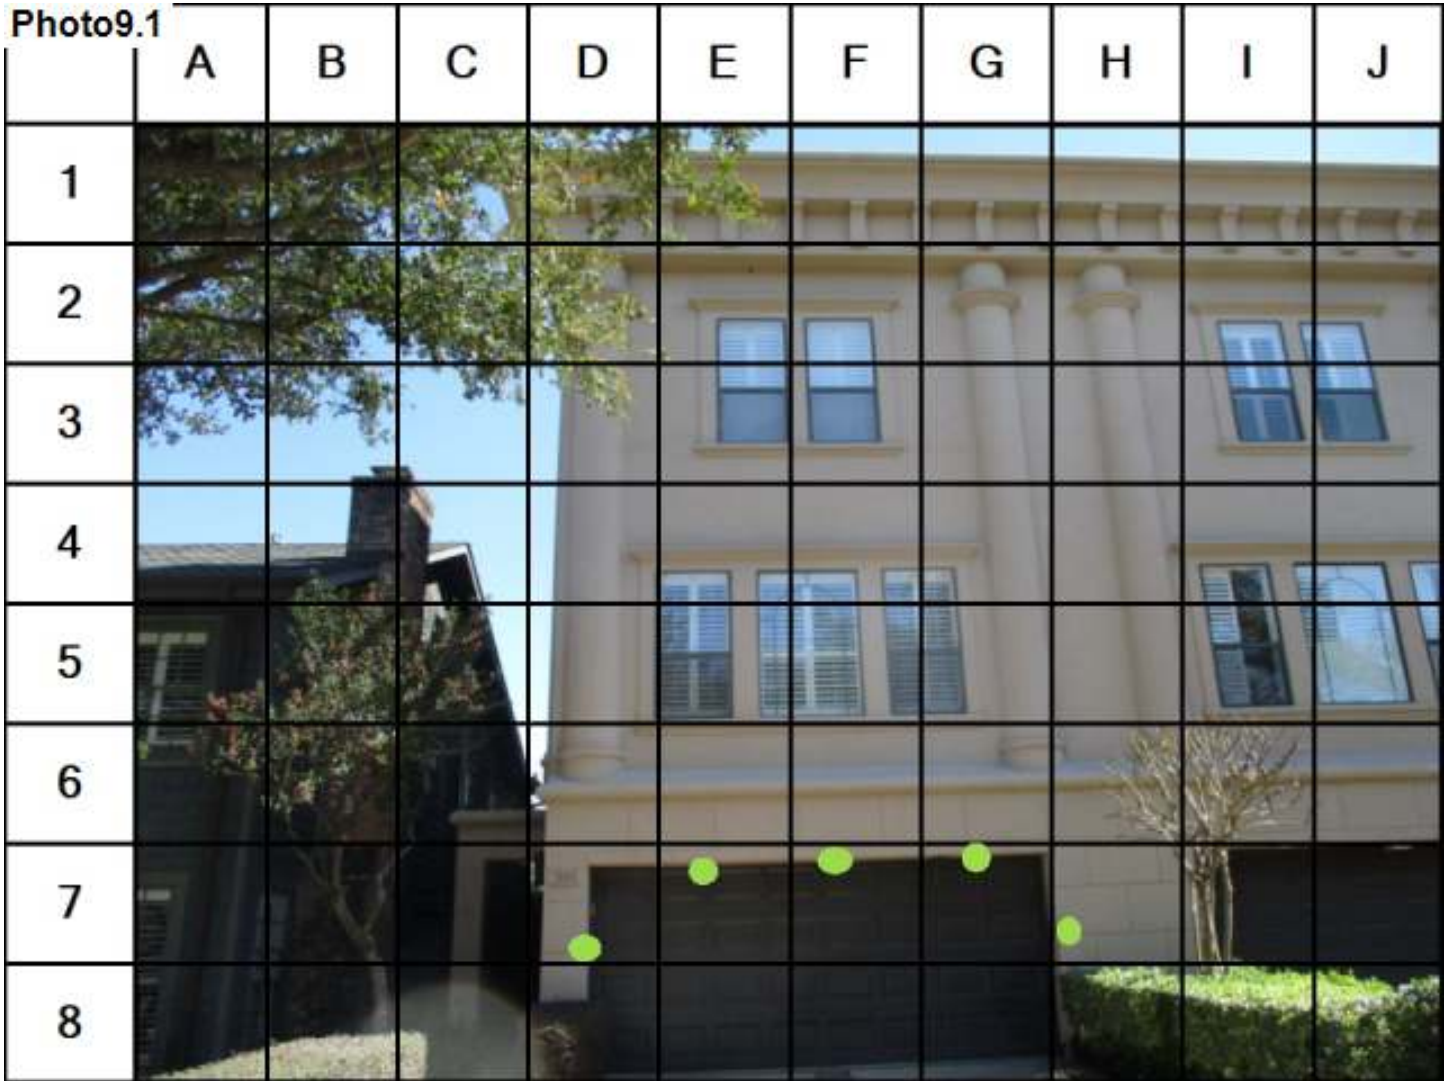
Photo9.1

Grid Location	Item Description	Moisture Readings	Substrate Condition	Observations
D7	Left Wall	16%	Firm	A moisture probe was made at the left wall. The substrate was firm and no damage was noted at this time.
H7	Right Wall	17%	Firm	A moisture probe was made at the right wall. The substrate was firm and no damage was noted at this time.
E7	Bottom Wall	18%	Firm	A moisture probe was made at the bottom wall. The substrate was firm and no damage was noted at this time.
F7	Bottom Wall	18%	Firm	A moisture probe was made at the bottom wall. The substrate was firm and no damage was noted at this time.
G7	Bottom Wall	17%	Firm	A moisture probe was made at the bottom wall. The substrate was firm and no damage was noted at this time.

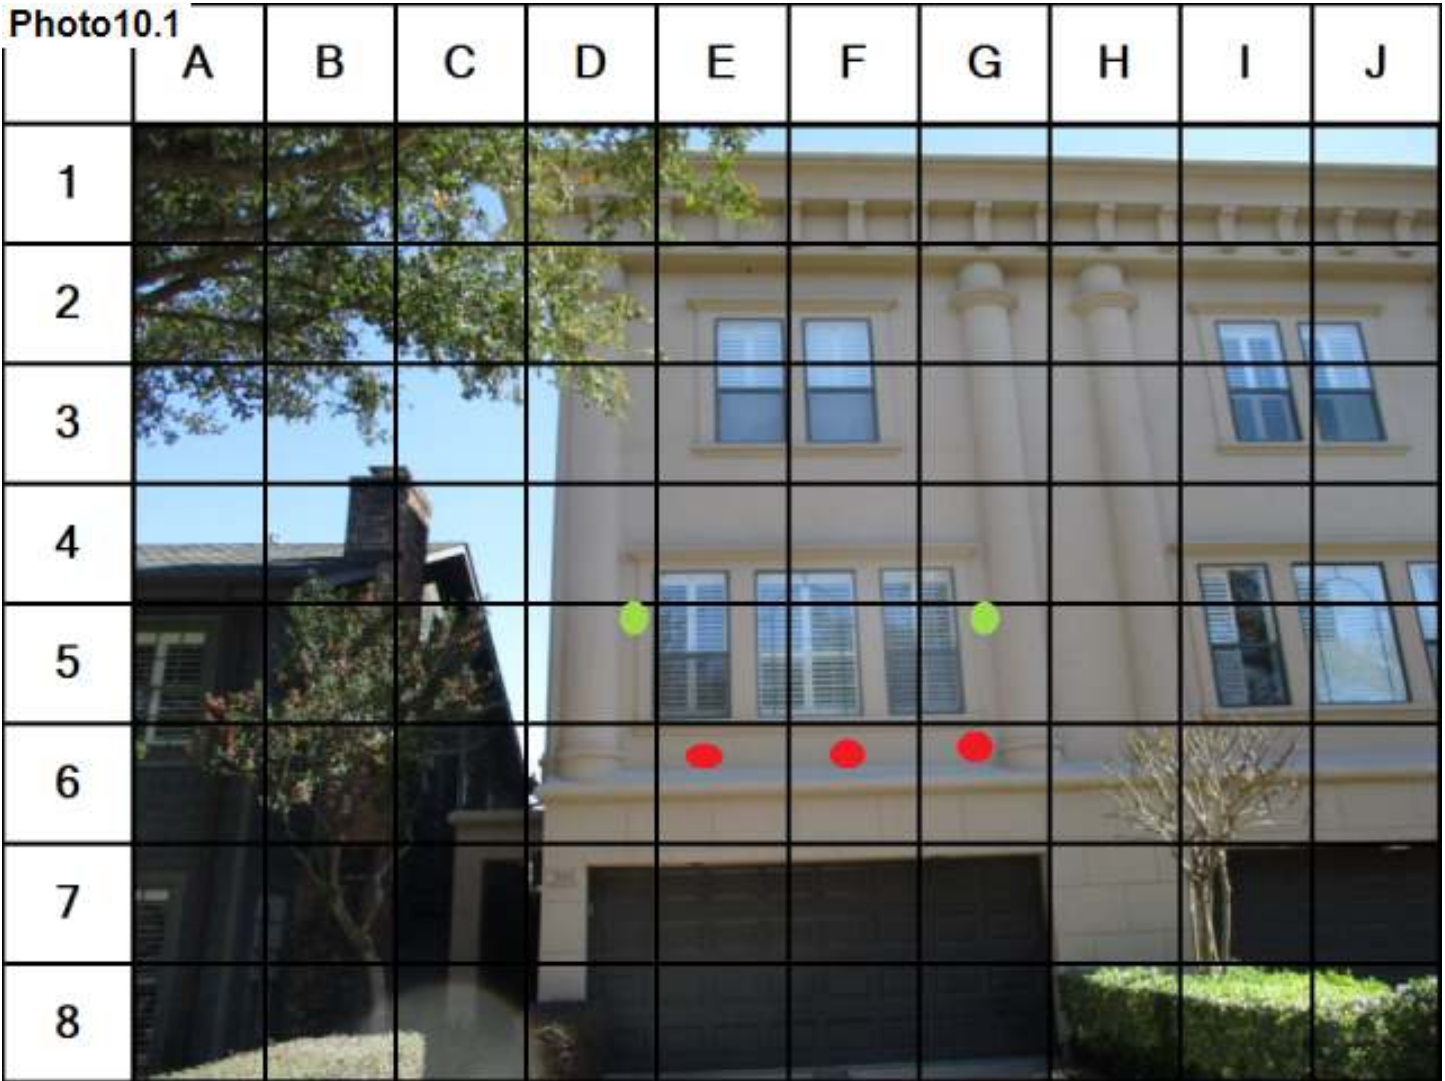
Photo10.1

Grid Location	Item Description	Moisture Readings	Substrate Condition	Observations
E6	Window Lower Left	20%	Firm	A moisture probe was made at the window lower left. An elevated moisture reading was noted with a firm substrate.
F6	Window Lower Left	21%	Firm	A moisture probe was made at the window lower left. An elevated moisture reading was noted with a firm substrate.
G6	Window Lower Left	20%	Firm	A moisture probe was made at the window lower left. An elevated moisture reading was noted with a firm substrate.
D5	Left Wall	16%	Firm	A moisture probe was made at the left wall. The substrate was firm and no damage was noted at this time.
G5	Right Wall	15%	Firm	A moisture probe was made at the right wall. The substrate was firm and no damage was noted at this time.

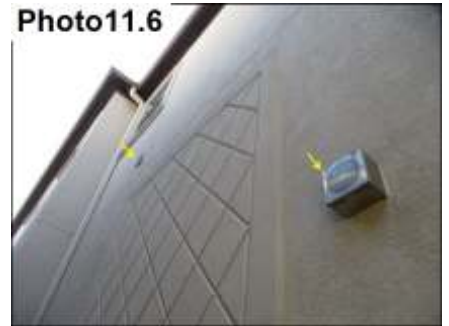
Photo11.6

Penetrations / Seal

Grid Location	Item Description	Moisture Readings	Substrate Condition	Observations
Yellow Arrows	Penetrations			The penetration sealants are aged. The inspector suggests to have a qualified stucco waterproofing contractor seal this area with a low modulus sealant in an effort to prevent moisture intrusion. These types of sealants are of high quality and compatible with stucco and other termination points. Please refer to photos #11.2, #11.3, #11.4, #11.5 and #11.6 for more detail.

- The penetration sealants are aged. The inspector suggests to have a qualified stucco waterproofing contractor seal this area with a low modulus sealant in an effort to prevent moisture intrusion. These types of sealants are of high quality and compatible with stucco and other termination points. Please refer to photos #11.2, #11.3, #11.4, #11.5 and #11.6 for more detail.

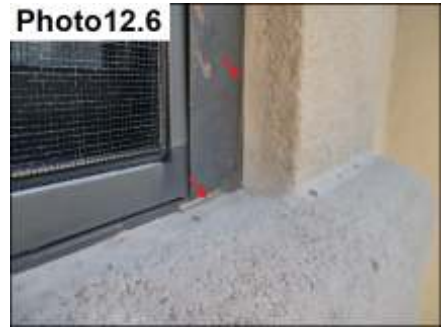
Photo12.6

Windows / Seal

Grid Location	Item Description	Moisture Readings	Substrate Condition	Observations
Red Arrow	Window Sealants			The window sealants are thin and aged. The inspector suggests to have a qualified stucco waterproofing contractor seal this area with a low modulus sealant in an effort to prevent moisture intrusion. These types of sealants are of high quality and compatible with stucco and other termination points. Please refer to photos #12.2, #12.3, #12.4 #12.5 and #12.6 for more detail.

- The window sealants are thin and aged. The inspector suggests to have a qualified stucco waterproofing contractor seal this area with a low modulus sealant in an effort to prevent moisture intrusion. These types of sealants are of high quality and compatible with stucco and other termination points. Please refer to photos #12.2, #12.3, #12.4 #12.5 and #12.6 for more detail.

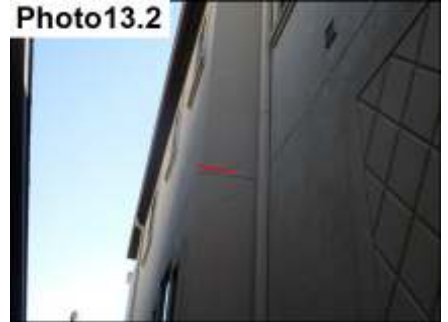
Photo13.2

Crack Noted / Seal Or Repair As Needed

Grid Location	Item Description	Moisture Readings	Substrate Condition	Observations
Red Line	Control Joint Crack			Cracks are noted at these locations. The inspector suggests to have a qualified stucco waterproofing contractor further assess and seal or repair as needed to prevent moisture intrusion. Please refer to photos #13.2 , #13.3, #13.4, #13.5 and #13.6 for more detail.

- Cracks are noted at these locations. The inspector suggests to have a qualified stucco waterproofing contractor further assess and seal or repair as needed to prevent moisture intrusion. Please refer to photos #13.2 , #13.3, #13.4, #13.5 and #13.6 for more detail.

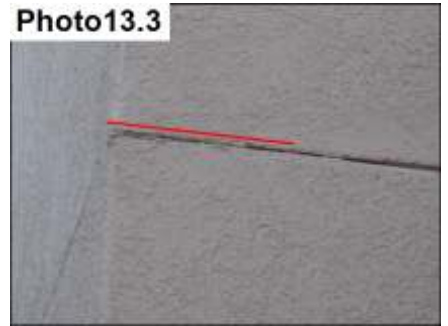
Photo13.3

Crack Noted / Seal Or Repair As Needed

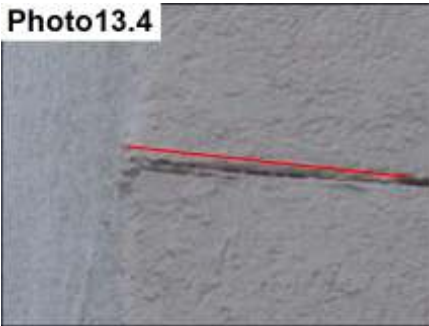
Photo13.4

Crack Noted / Seal Or Repair As Needed

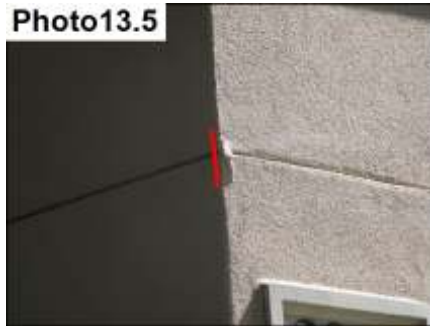
Photo13.5

Crack Noted / Seal Or Repair As Needed

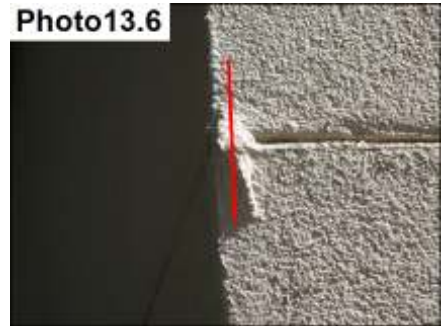
Photo13.6

Crack Noted / Seal Or Repair As Needed

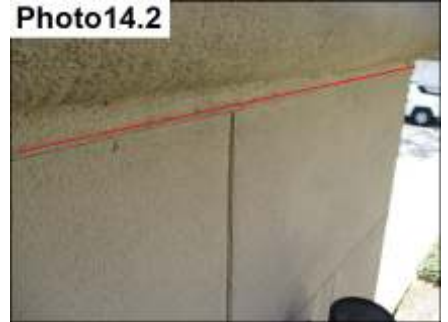
Photo14.2

Crack Noted / Seal Or Repair As Needed

Grid Location	Item Description	Moisture Readings	Substrate Condition	Observations
Red Line	Crack			Cracks are noted at these locations. The inspector suggests to have a qualified stucco waterproofing contractor further assess and seal or repair as needed to prevent moisture intrusion. Please refer to photos #14.2 , #14.3 and #14.4 for more detail.

- Cracks are noted at these locations. The inspector suggests to have a qualified stucco waterproofing contractor further assess and seal or repair as needed to prevent moisture intrusion. Please refer to photos #14.2 , #14.3 and #14.4 for more detail.

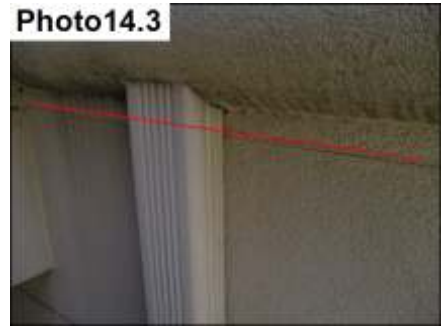
Photo14.3

Crack Noted / Seal Or Repair As Needed

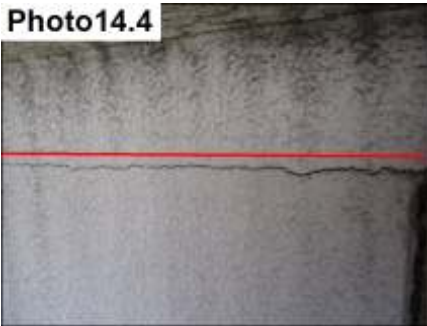
Photo14.4

Crack Noted / Seal Or Repair As Needed

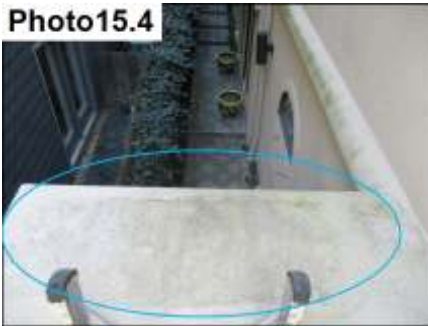
Photo15.4

Flat Accent / Elastomeric Paint Or A Metal Cap

Grid Location	Item Description	Moisture Readings	Substrate Condition	Observations
Blue Circle	Flat Accent			The entryway has a flat accent. It is recommended that a qualified waterproofing contractor further assess and either apply elastomeric paint or install a metal cap to prevent moisture intrusion. Please refer to photos #15.2, #15.3 and #15.4 for more detail.
D5	Left Entry Wall	17%	Firm	A moisture probe was made at the left entry wall. The substrate was firm and no damage was noted at this time.
D4	Bottom Entry Wall	21%	Firm	A moisture probe was made at the bottom entry wall. An elevated moisture reading was noted with a firm substrate.
E3	Bottom Entry Wall	23%	Firm	A moisture probe was made at the bottom entry wall. An elevated moisture reading was noted with a firm substrate.
F4	Bottom Entry Wall	18%	Firm	A moisture probe was made at the bottom entry wall. The substrate was firm and no damage was noted at this time.

- The entryway has a flat accent. It is recommended that a qualified waterproofing contractor further assess and either apply elastomeric paint or install a metal cap to prevent moisture intrusion. Please refer to photos #15.2, #15.3 and #15.4 for more detail.

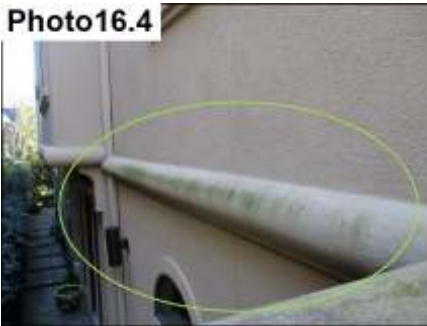
Photo16.4

Mildew / Clean

Grid Location	Item Description	Moisture Readings	Substrate Condition	Observations
Green Circle	Mildew Clean			Mildew is noted at this location. The inspector suggests to have a qualified stucco waterproofing contractor clean this area. Please refer to photos #16.2, #16.3 and #16.4 for more detail.

- Mildew is noted at this location. The inspector suggests to have a qualified stucco waterproofing contractor clean this area. Please refer to photos #16.2, #16.3 and #16.4 for more detail.

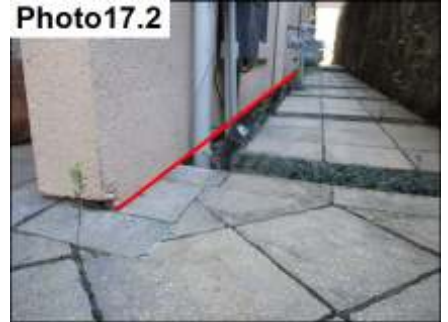
Photo17.2

Rusted Pilaster Stop / Repair As Needed

Grid Location	Item Description	Moisture Readings	Substrate Condition	Observations
Red Line	Rusted Pilaster Stop			The casing bead is rusted and broken. The inspector suggests to have a qualified stucco waterproofing contractor assess and repair this area was needed. Please refer to photos #17.2, #17.3, #17.4, #17.5 and #17.6 for more detail.

- The casing bead is rusted and broken. The inspector suggests to have a qualified stucco waterproofing contractor assess and repair this area was needed. Please refer to photos #17.2, #17.3, #17.4, #17.5 and #17.6 for more detail.

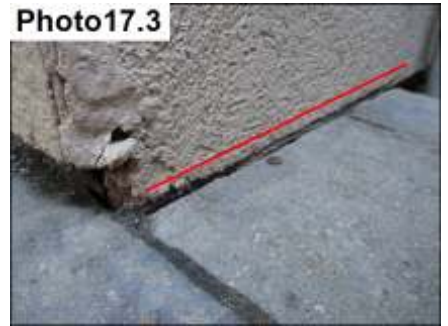
Photo17.3

Rusted Pilaster Stop / Repair As Needed

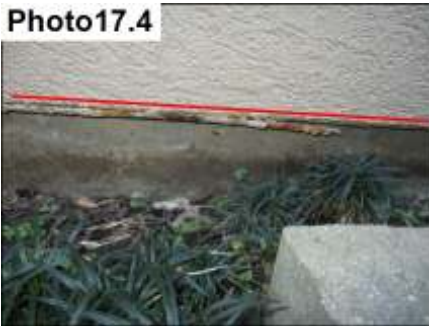
Photo17.4

Rusted Pilaster Stop / Repair As Needed

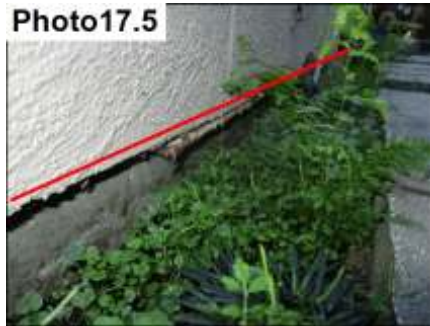
Photo17.5

Rusted Pilaster Stop / Repair As Needed

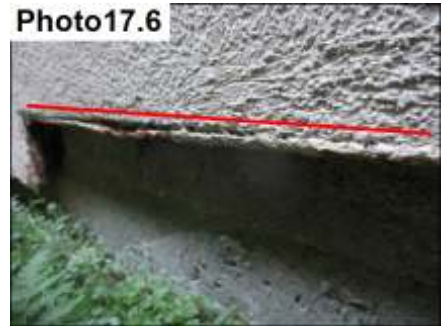
Photo17.6

Rusted Pilaster Stop / Repair As Needed

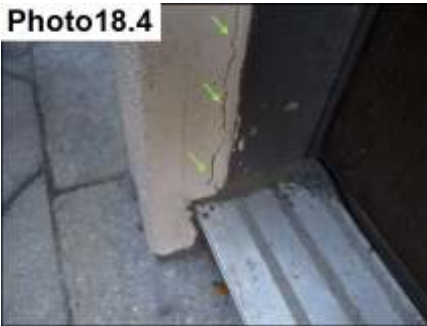
Photo18.4

Door Trim / Seal

Grid Location	Item Description	Moisture Readings	Substrate Condition	Observations
Green Arrow	Door Trim			The door sealants are aged and separated. The inspector suggests to have a qualified stucco waterproofing contractor seal this area with a low modulus sealant in an effort to prevent moisture intrusion. These types of sealants are of high quality and compatible with stucco and other termination points. Please refer to photos #18.2, #18.3 and #18.4 for more detail.

- The door sealants are aged and separated. The inspector suggests to have a qualified stucco waterproofing contractor seal this area with a low modulus sealant in an effort to prevent moisture intrusion. These types of sealants are of high quality and compatible with stucco and other termination points. Please refer to photos #18.2, #18.3 and #18.4 for more detail.

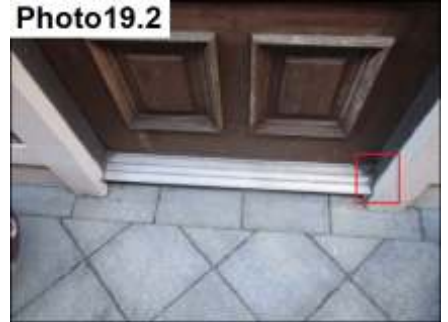
Photo19.2

Wood Rot / Repair

Grid Location	Item Description	Moisture Readings	Substrate Condition	Observations
Red Box	Wood Rot			Wood rot is noted at the door trim. The inspector suggests to have a qualified stucco waterproofing contractor repair this area. Please refer to photos #19.2 and #19.3 for more detail
Red Lines	Stucco Termination			The raised pavers and stucco termination is in close proximity. The inspector suggests to have a qualified stucco waterproofing contractor apply a kant bead to this area with a low modulus sealant in an effort to prevent moisture intrusion. These types of sealants are of high quality and compatible with stucco and other termination points. Please refer to photos #19.4 and #19.5 for more detail.

- Wood rot is noted at the door trim. The inspector suggests to have a qualified stucco waterproofing contractor repair this area. Please refer to photos #19.2 and #19.3 for more detail

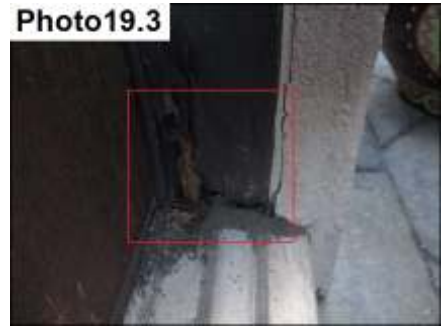
Photo19.3

Wood Rot / Repair

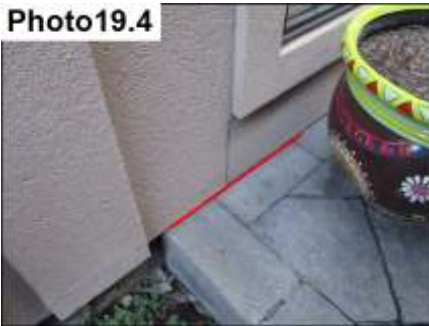
Photo19.4

Stucco Termination / Kant Bead

- The raised pavers and stucco termination is in close proximity. The inspector suggests to have a qualified stucco waterproofing contractor apply a kant bead to this area with a low modulus sealant in an effort to prevent moisture intrusion. These types of sealants are of high quality and compatible with stucco and other termination points. Please refer to photos #19.4 and #19.5 for more detail.

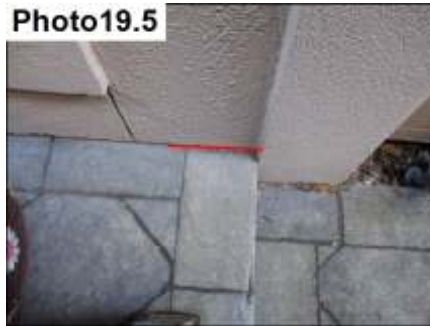
Photo19.5

Stucco Termination / Kant Bead

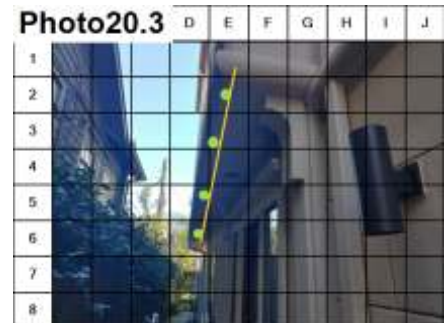
Photo20.2
Bumpout Wall / No Modification

Grid Location	Item Description	Moisture Readings	Substrate Condition	Observations
Orange Line	Bumpout Wall			The bottom of the wall does not have a relief, but the substrate is firm with no elevated moisture. The inspector suggests no modification at this time. Please refer to photos #20.2 and #20.3 for more detail.
F3	Bottom Wall	16%	Firm	A moisture probe was made at the bottom wall. The substrate was firm and no damage was noted at this time.
F4	Bottom Wall	15%	Firm	A moisture probe was made at the bottom wall. The substrate was firm and no damage was noted at this time.
F 4/5	Bottom Wall	16%	Firm	A moisture probe was made at the bottom wall. The substrate was firm and no damage was noted at this time.
F5	Bottom Wall	18%	Firm	A moisture probe was made at the bottom wall. The substrate was firm and no damage was noted at this time.

- The bottom of the wall does not have a relief, but the substrate is firm with no elevated moisture. The inspector suggests no modification at this time. Please refer to photos #20.2 and #20.3 for more detail.

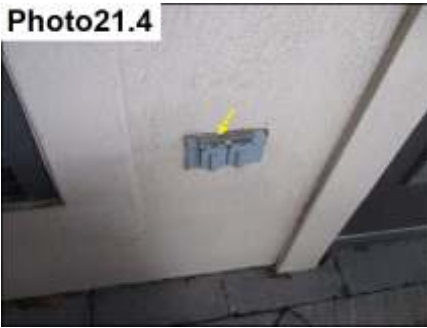
Photo21.4

Penetrations / Seal

Grid Location	Item Description	Moisture Readings	Substrate Condition	Observations
Yellow Lines	Penetrations			The penetration sealants are aged. The inspector suggests to have a qualified stucco waterproofing contractor seal this area with a low modulus sealant in an effort to prevent moisture intrusion. These types of sealants are of high quality and compatible with stucco and other termination points. Please refer to photos #21.2, #21.3 and #21.4 for more detail.

- The penetration sealants are aged. The inspector suggests to have a qualified stucco waterproofing contractor seal this area with a low modulus sealant in an effort to prevent moisture intrusion. These types of sealants are of high quality and compatible with stucco and other termination points. Please refer to photos #21.2, #21.3 and #21.4 for more detail.

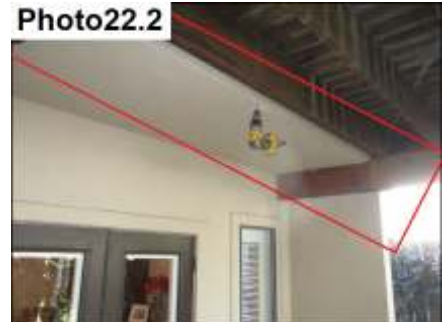
Substrate Damage / Repair

Grid Location	Item Description	Moisture Readings	Substrate Condition	Observations
Red Box	Substrate & Potential Framing Damage			The bottom of the wall below the door pan flashing is damaged. The inspector recommends a qualified waterproofing contractor further assess and repair and install a relief as needed. Please refer to photos #22.2, #22.3, #22.4 and #22.6 for more detail.
I6	Pilaster Wall	20%	Semi-Firm	A moisture probe was made at the pilaster wall. An elevated moisture reading was noted with a semi-firm substrate.
I3	Bottom Wall	21%	Semi-Firm	A moisture probe was made at the bottom wall. An elevated moisture reading was noted with a semi-firm substrate.
I2	Bottom Wall	22%	Semi-Firm	A moisture probe was made at the bottom wall. An elevated moisture reading was noted with a semi-firm substrate.
E3	Bottom Wall Below Door Threshold		None	A moisture probe was made at the bottom wall below the door threshold. No substrate was noted, modify as needed.

- The bottom of the wall below the door pan flashing is damaged. The inspector recommends a qualified waterproofing contractor further assess and repair and install a relief as needed. Please refer to photos #22.2, #22.3, #22.4 and #22.6 for more detail.

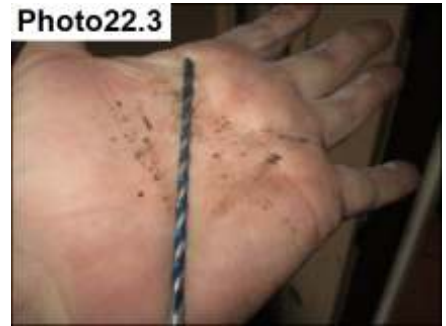
Substrate Damage / Repair

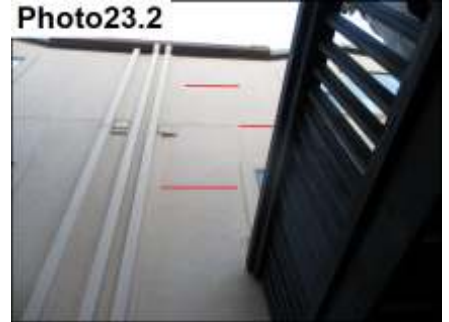
Photo23.2

Cracks / Assess & Seal As Needed

Grid Location	Item Description	Moisture Readings	Substrate Condition	Observations
Red Lines	Cracks			Cracks are noted at these locations. The inspector suggests to have a qualified stucco waterproofing contractor further assess and seal or repair as needed to prevent moisture intrusion. Please refer to photos #23.2 , #23.3 and #23.4 for more detail.
Red Arrows	Window Sealants			The window sealants are thin and aged. The inspector suggests to have a qualified stucco waterproofing contractor seal this area with a low modulus sealant in an effort to prevent moisture intrusion. These types of sealants are of high quality and compatible with stucco and other termination points. Please refer to photos #23.5 and #23.6 for more detail.

- Cracks are noted at these locations. The inspector suggests to have a qualified stucco waterproofing contractor further assess and seal or repair as needed to prevent moisture intrusion. Please refer to photos #23.2, #23.3, #23.4, #23.5 and #23.6 for more detail.

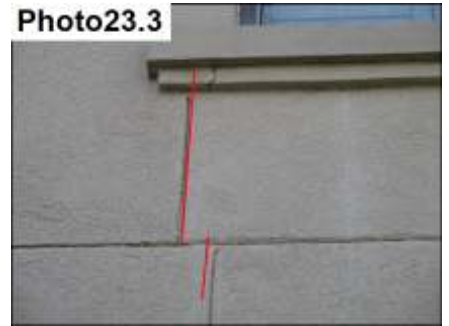
Photo23.3

Cracks / Assess & Seal As Needed

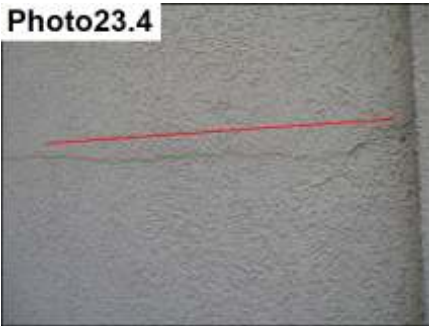
Photo23.4

Cracks / Assess & Seal As Needed

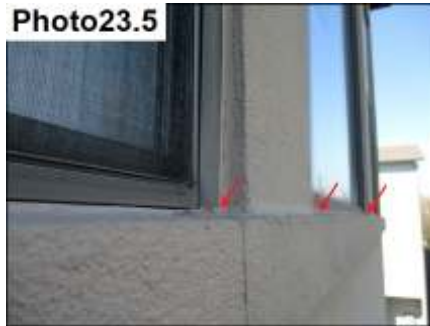
Photo23.5

Window Sealants / Seal

- The window sealants are thin and aged. The inspector suggests to have a qualified stucco waterproofing contractor seal this area with a low modulus sealant in an effort to prevent moisture intrusion. These types of sealants are of high quality and compatible with stucco and other termination points. Please refer to photos #23.5 and #23.6 for more detail.

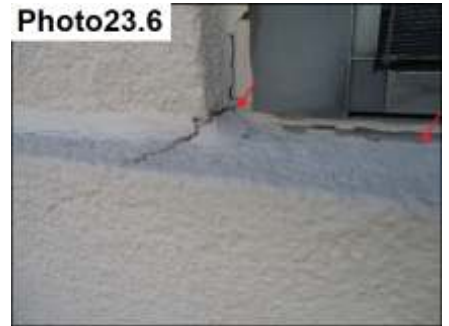
Photo23.6

Window Sealants / Seal

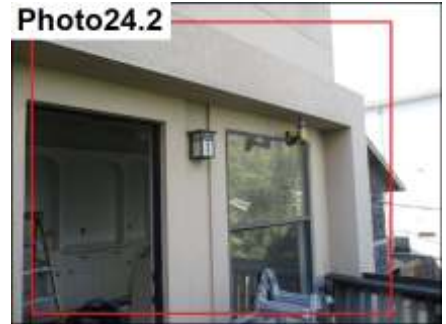
Photo24.2

Substrate Damage / Repair

Grid Location	Item Description	Moisture Readings	Substrate Condition	Observations
Red Box	Substrate Damage			The accent wall below the angled accent is cracked and damaged. The inspector recommends a qualified waterproofing contractor further assess and repair as needed to prevent moisture intrusion. Please refer to photos #24.2, #24.3 and #24.4 for more detail.
B7	Left Wall		None	A moisture probe was made at the left wall. No substrate was noted, modify as needed.
F5	Bottom Wall		None	A moisture probe was made at the bottom wall. No substrate was noted, modify as needed.
G/H 6	Right Wall	28%	Semi-Firm	A moisture probe was made at the right wall. An elevated moisture reading was noted with a semi-firm substrate.

- The accent wall below the angled accent is cracked and damaged. The inspector recommends a qualified waterproofing contractor further assess and repair as needed to prevent moisture intrusion. Please refer to photos #24.2, #24.3 and #24.4 for more detail.

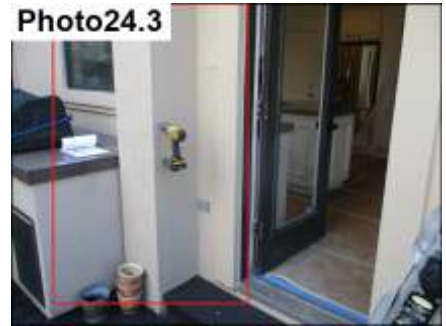
Photo24.3

Substrate Damage / Repair

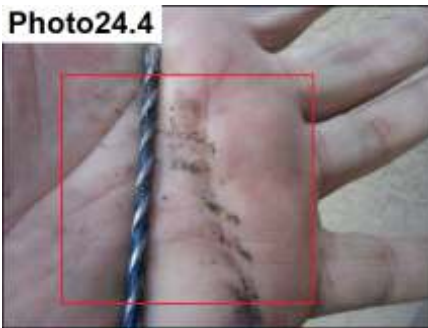
Photo24.4

Substrate Damage / Repair
