Inspection Report

Property Address:
19226 Cotton Gin Dr
Katy 77449

Li Geyang	4/13/2022
<i>Name of Client</i>	<i>Date of Inspection</i>
19226 Cotton Gin Dr, Katy, 77449	
<i>Address of Inspected Property</i>	
Jerry Brame	24113
<i>Name of Inspector</i>	<i>TREC License #</i>
<i>Name of Sponsor (if applicable)</i>	<i>TREC License #</i>

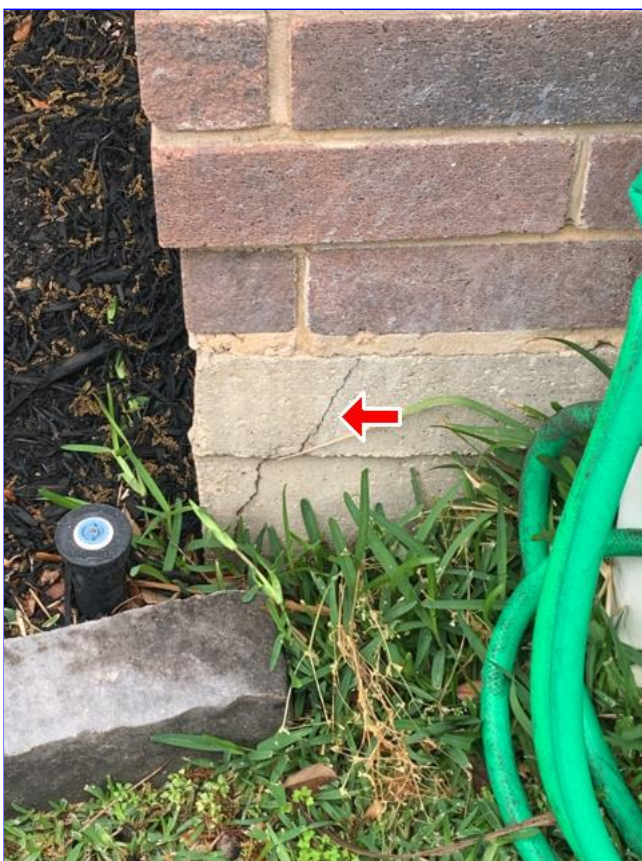
(2) Typical corner "pops" observed at foundation corners. This condition is cosmetic in nature and not structurally significant.

A. Item 1(Picture) Typical corner "pops" observed at foundation corners. This condition is cosmetic in nature and not structurally significant.

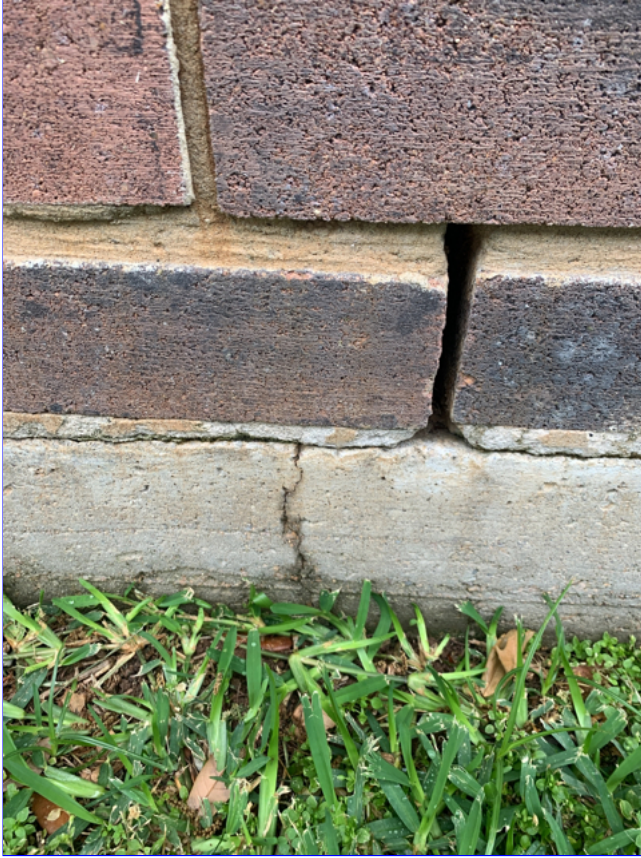
(3) There is some slab edge cracking. There is little to no deflection across the crack. This type of flexural crack is generally the result of seasonal variations in soil moisture causing the soils to shrink and/or swell exerting pressure on the foundation.

This type of crack is not structurally significant.

A. Item 2(Picture) There is some slab edge cracking.

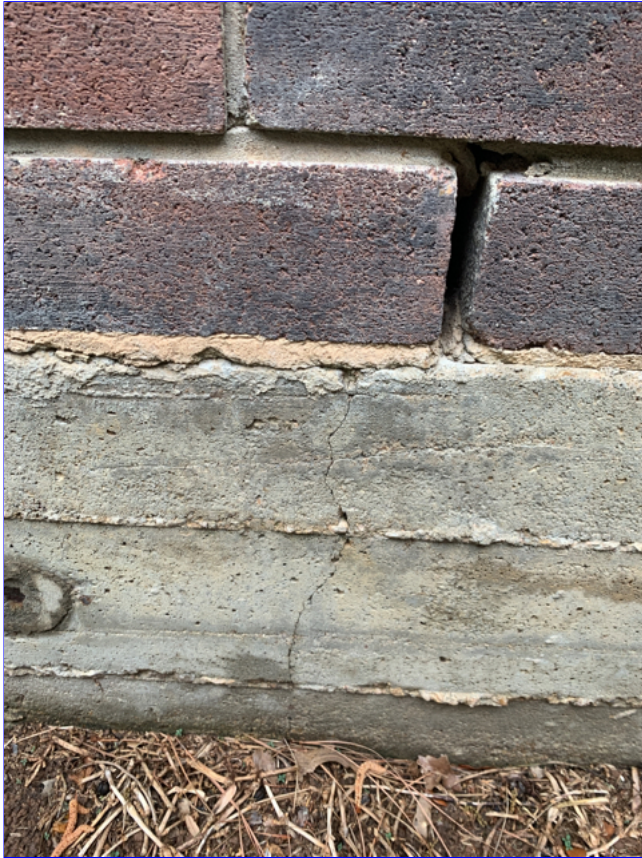
A. Item 3(Picture) There is some slab edge cracking.

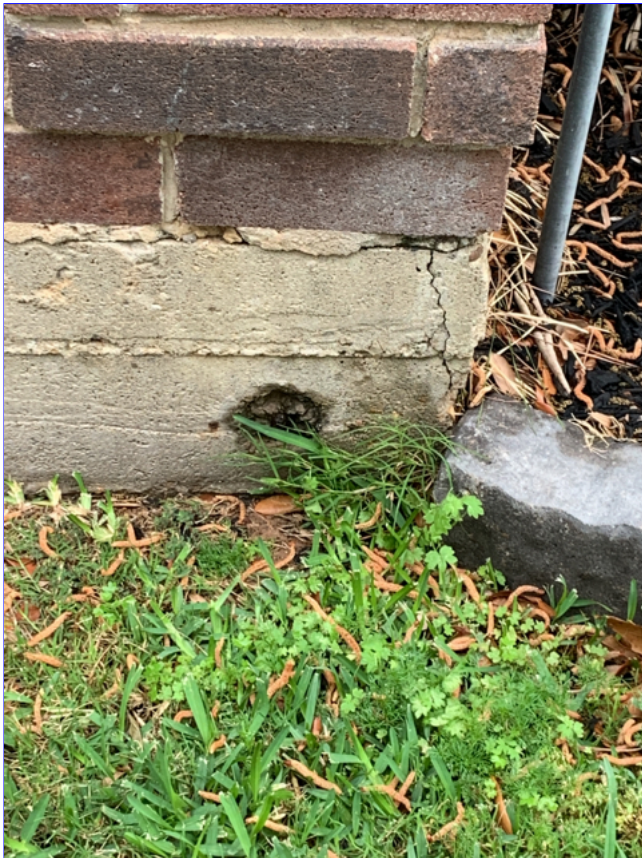
(4) Exposed post tension cable ends were observed. I recommend all exposed post tension cable ends be treated and sealed with cementitious epoxy to prevent further deterioration.

A. Item 4(Picture) Exposed post tension cable ends were observed.

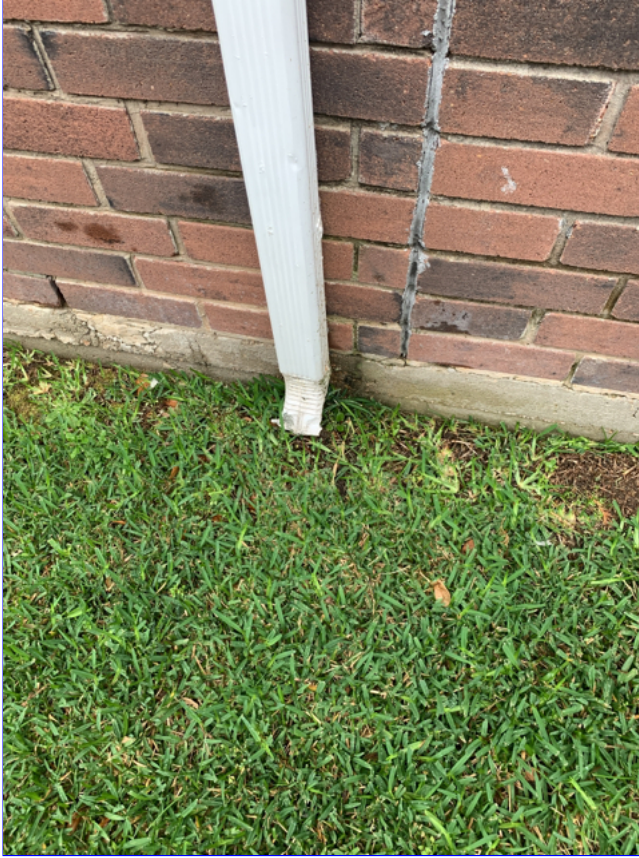
(1) Concrete splash blocks or downspout extensions, are absent at some gutter downspouts. Gutter downspouts should discharge a minimum of 18" away from the foundation.

B. Item 1(Picture) Concrete splash blocks or downspout extensions, are absent at some gutter downspouts.

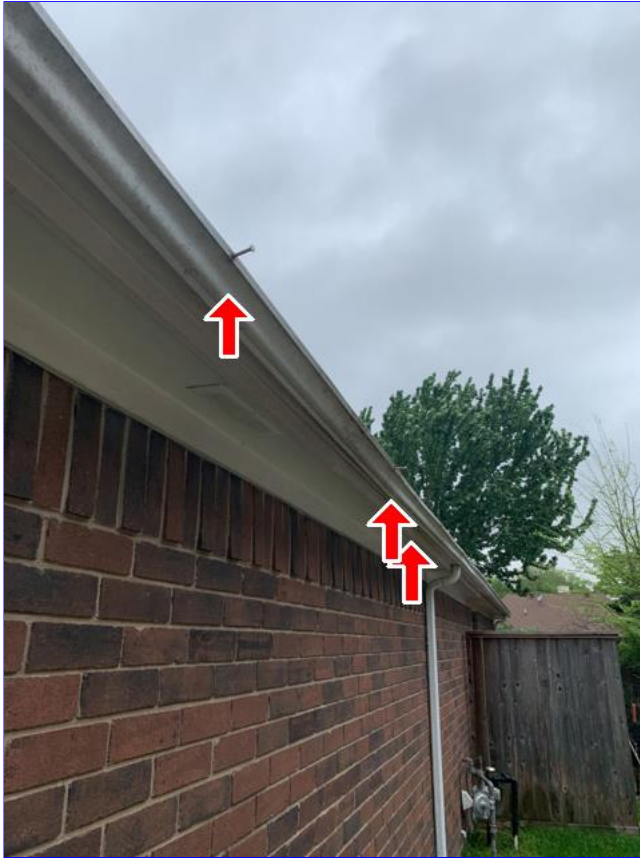
(2) The gutters hold water, sag, leak and are in a general state of disrepair. Recommend remove or replace as needed.

B. Item 2(Picture) The gutters hold water, sag, leak and are in a general state of disrepair. Recommend remove or replace as needed.

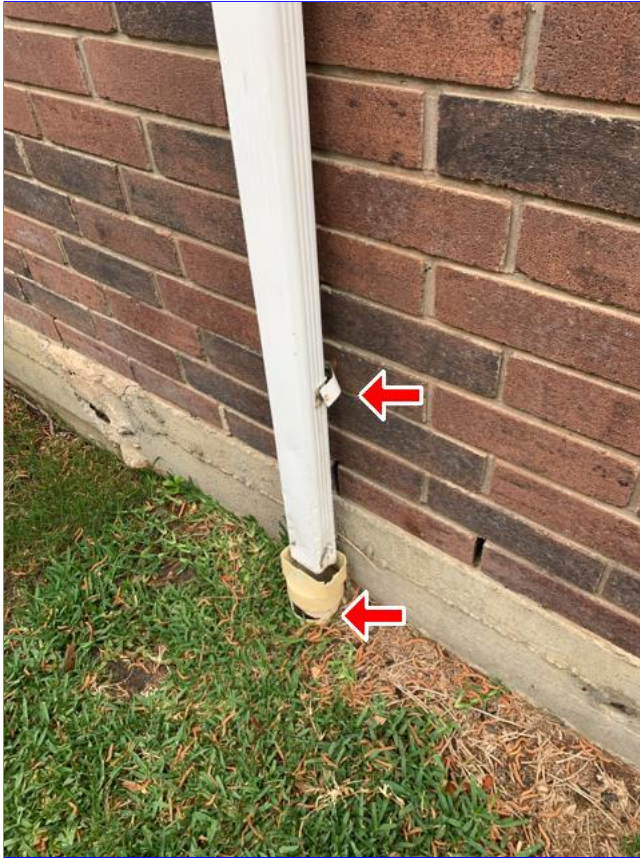
B. Item 3(Picture) The gutters hold water, sag, leak and are in a general state of disrepair. Recommend remove or replace as needed.

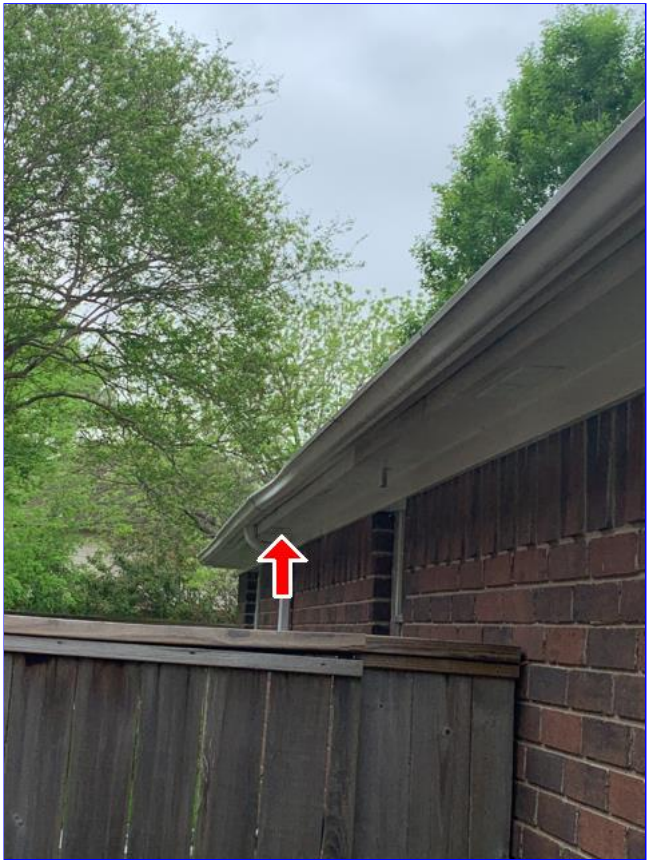
B. Item 4(Picture) The gutters hold water, sag, leak and are in a general state of disrepair. Recommend remove or replace as needed.

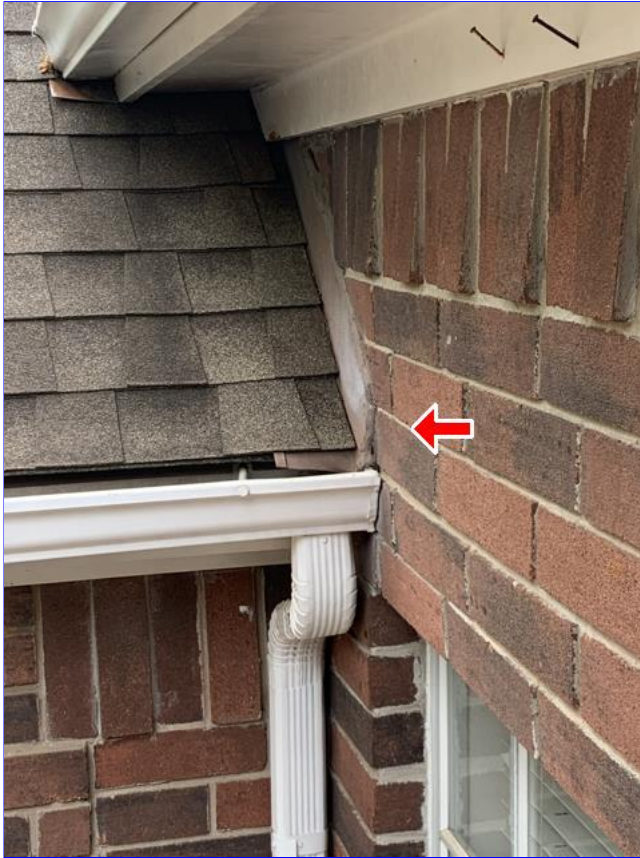
B. Item 5(Picture) No kick out flashings are observed at gutters where roof line and vertical wall flashings meet gutters.

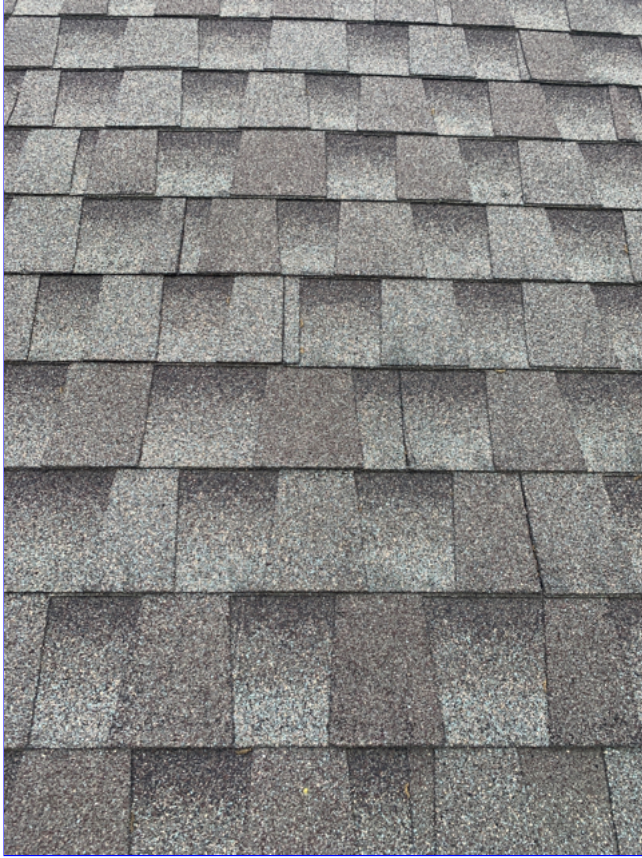
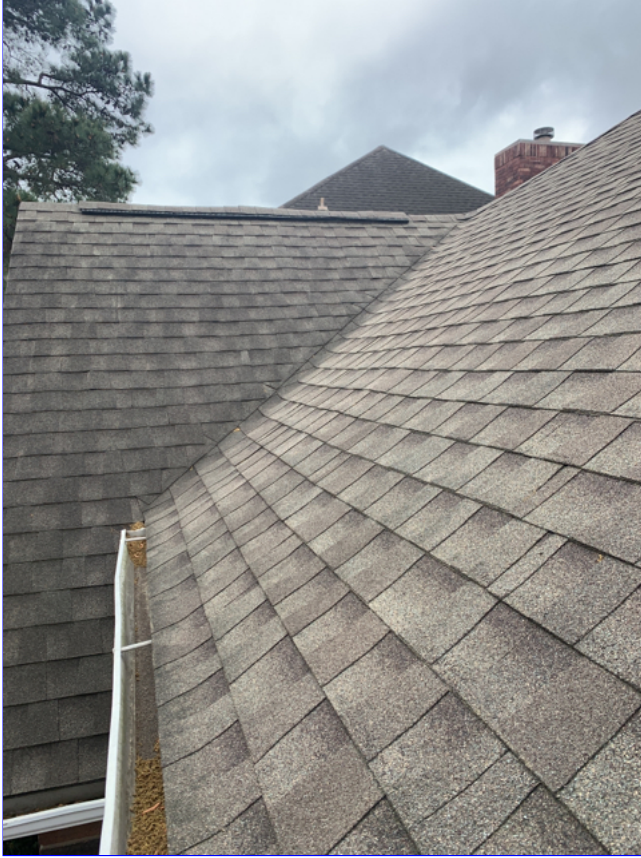
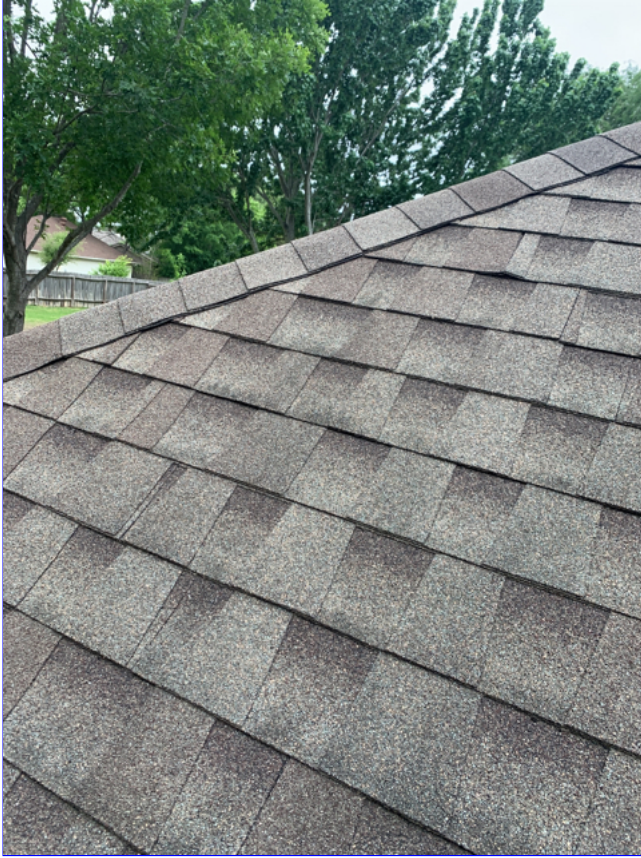
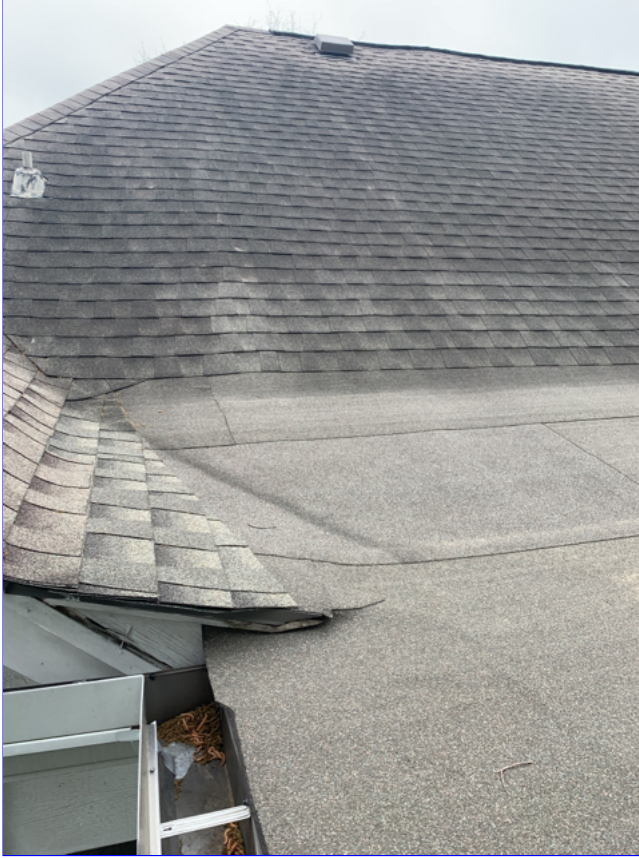
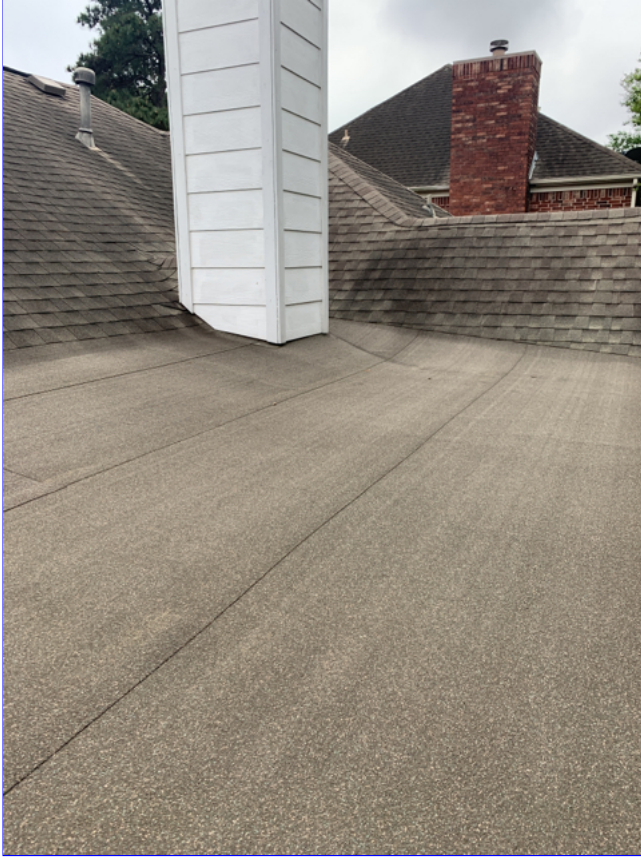
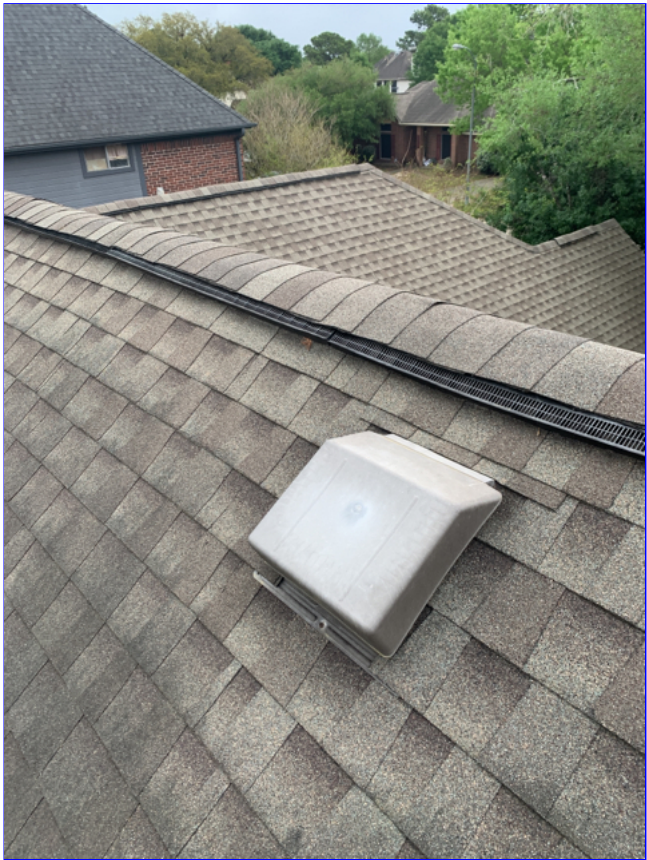
(1) The roof covering, is not new and shows signs of wear consistent with its age. The overall condition of the roof covering appears to be acceptable and no signs of any current moisture penetration into the structure were observed. This roof covering is probably around 8 to 10 years old. This type of architectural style composition shingles typically lasts about 20 years in this climate.

C. Item 1(Picture) The roof covering, is not new and shows signs of wear consistent with its age.

A general seal up of roof penetrations, exposed nail heads and flashings is recommended as routine maintenance.

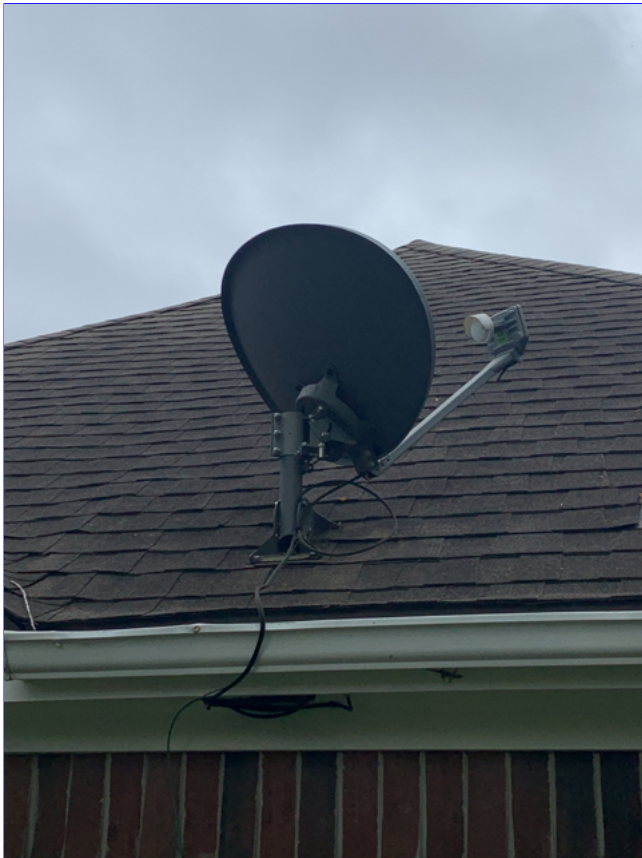
(2) The satellite dish was observed mounted on the roof covering. The securing screws penetrate the roof covering, underlayment and sheathing. Over time, this installation will most likely leak water into the structure causing water damage. A better installation might be to bolt the dish to a vertical structural element and seal the bolts/screws to insure that water does not penetrate the building envelope. If you choose to remove the dish from its current location, immediate repair to the roof covering is recommended.

C. Item 7(Picture) The satellite dish was observed mounted on the roof covering.

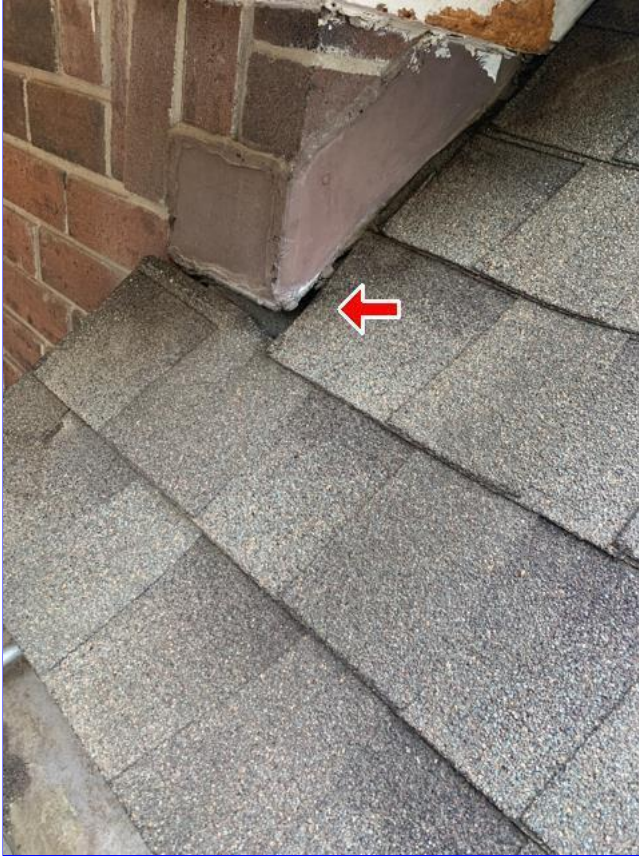
C. Item 8(Picture)

(3) Area of roof needs to be sealed by front door.

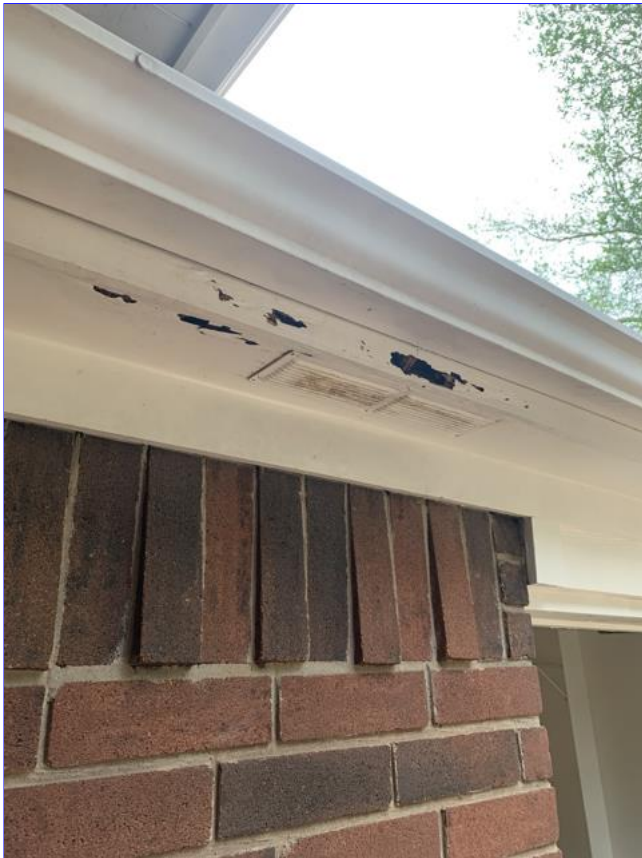
(1) Wood rot was observed on the soffit and fascia by the front door.

D. Item 1(Picture) Wood rot was observed on the soffit and fascia by the front door.

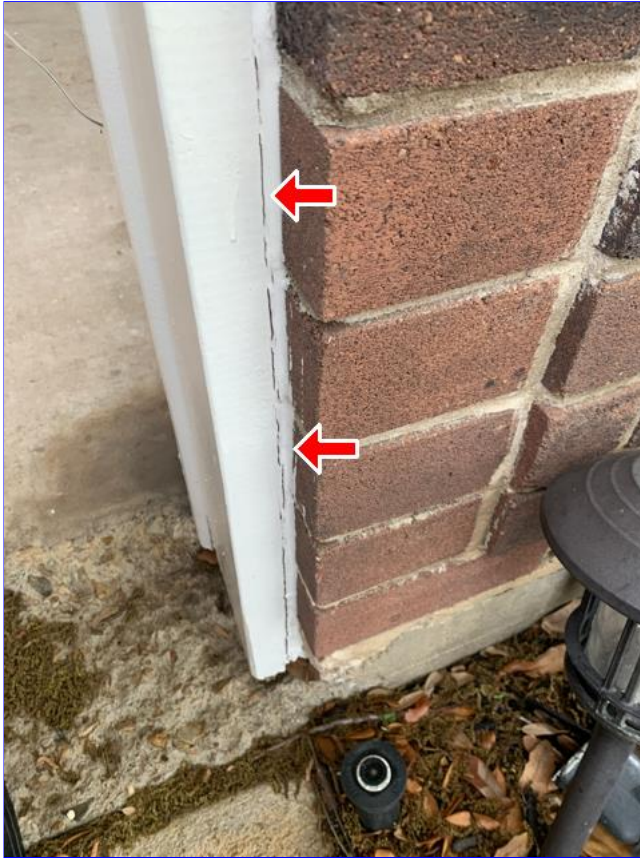
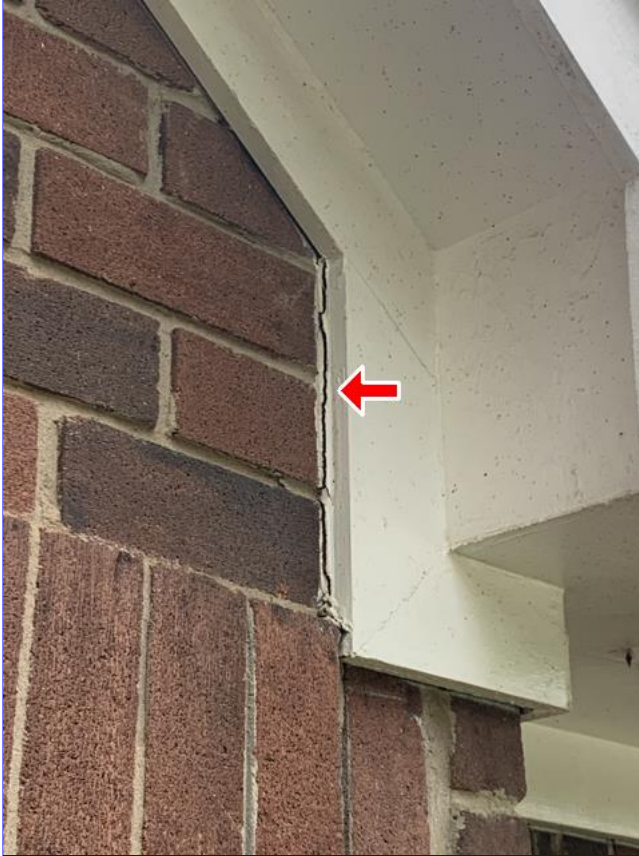
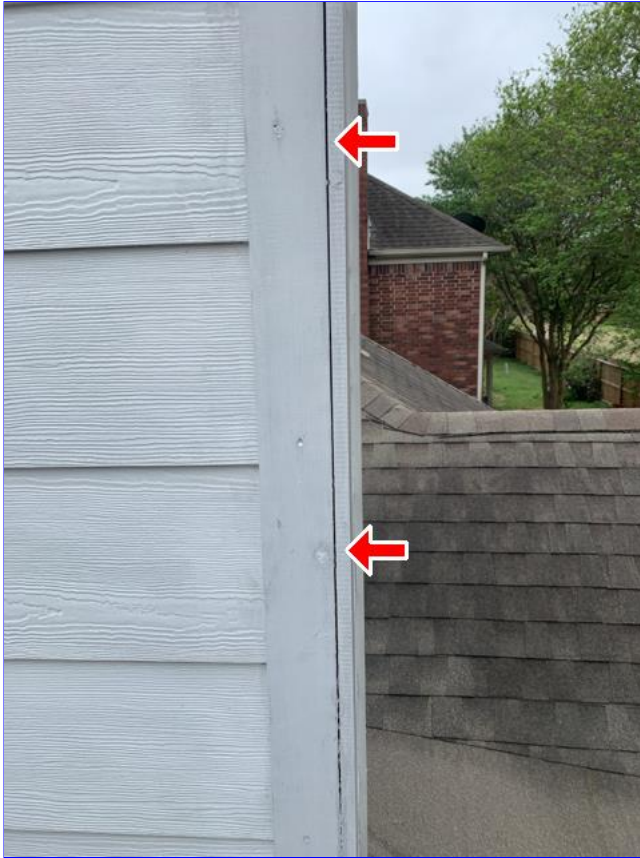
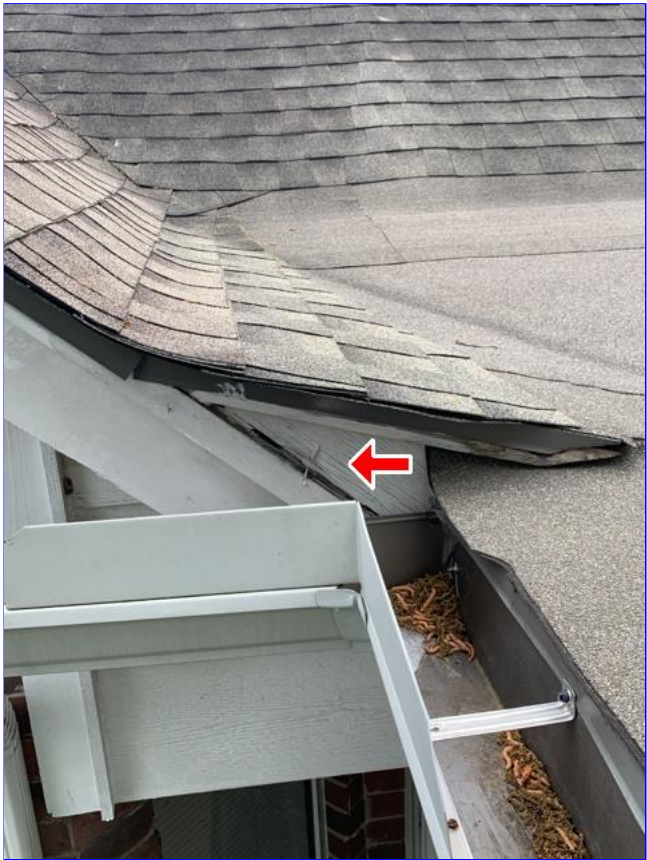
E. Item 1(Picture) Areas around the home where are the brick, trim, and siding meet, need to be caulked and sealed.

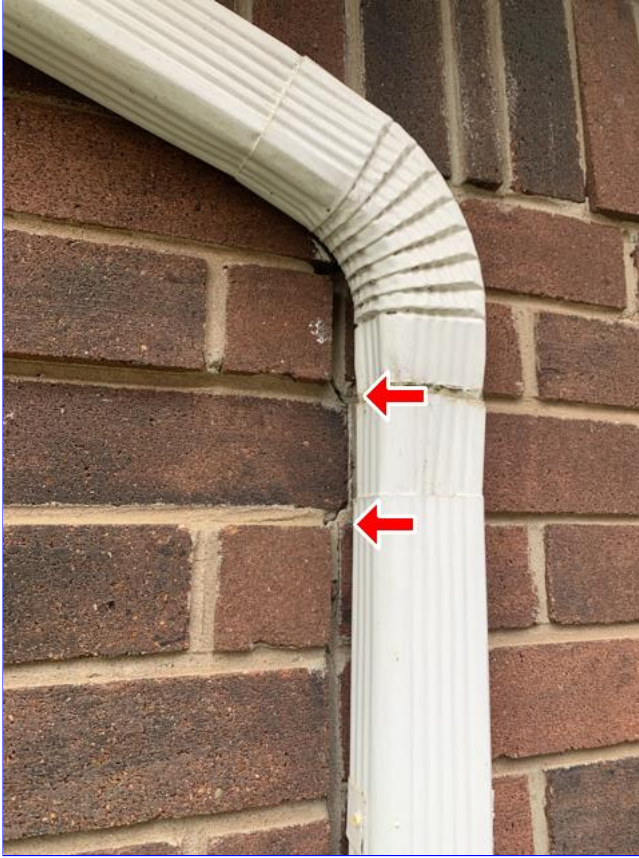
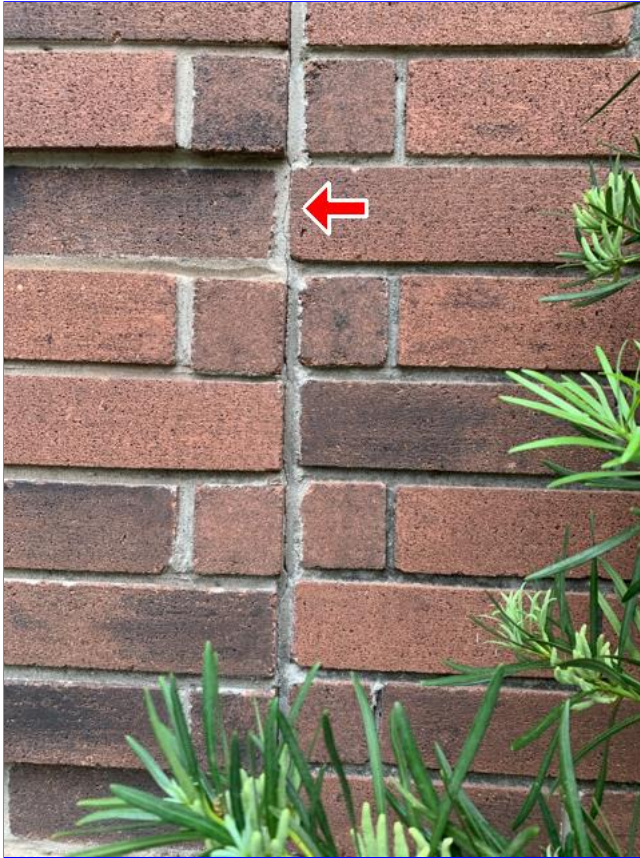
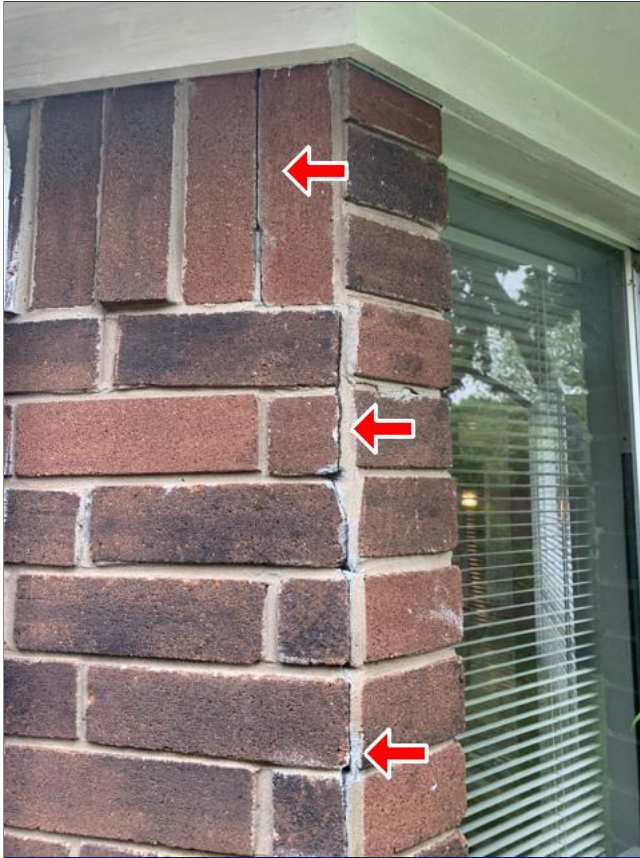
(2) Brick veneer mortar cracks were observed. This condition is cosmetic in nature and not structurally significant. The cracking of the brick veneer is likely due to flexing of the foundation during repeated seasonal changes. The expansive clay soil in the area is prone to excessive swelling during rainy periods and shrinkage during dry periods.

E. Item 5(Picture) Brick veneer mortar cracks were observed.

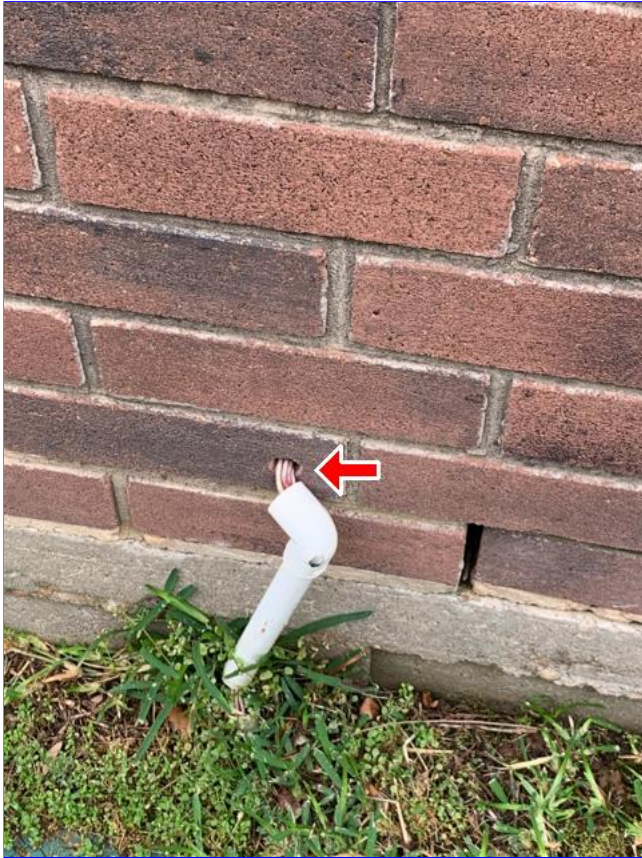
(3) Penetrations for sprinkler wiring into the wall should be sealed.

E. Item 8(Picture) Penetrations for sprinkler wiring into the wall should be sealed.

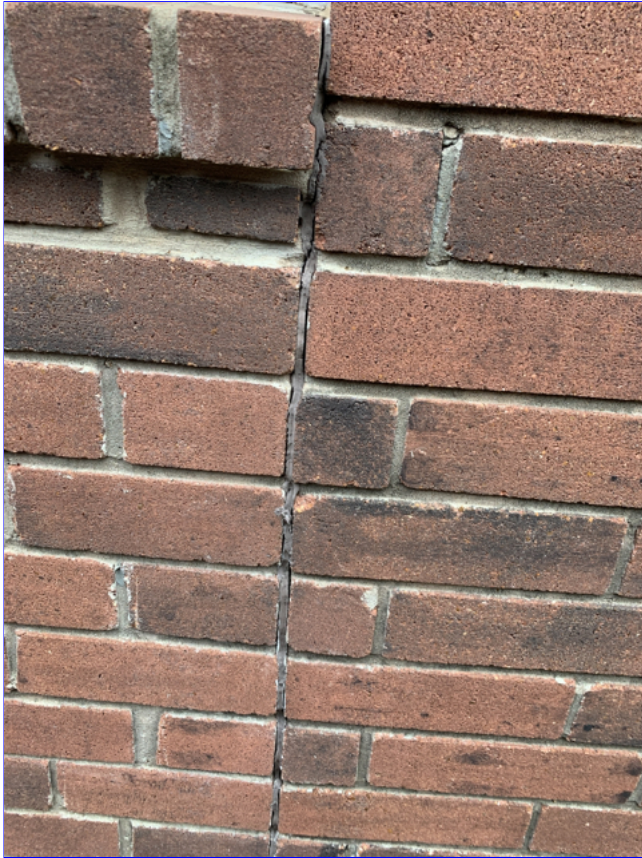
(4) The brick veneer expansion joint sealant has failed/missing, or not properly installed. Recommend correction.

E. Item 9(Picture) The brick veneer expansion joint sealant has failed/missing, or not properly installed. Recommend correction.

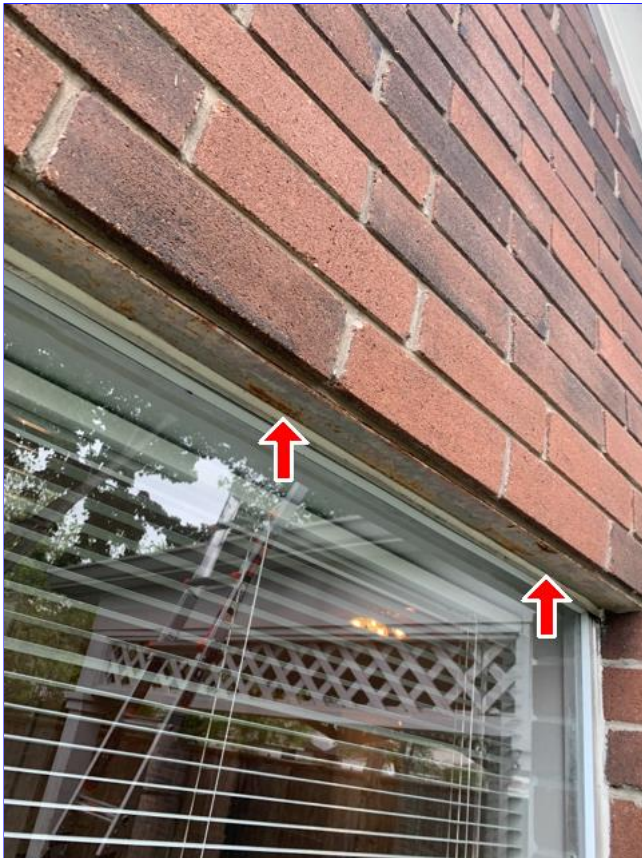
(5) Steel lintils above windows have rust and need to be painted.

E. Item 10(Picture) Steel lintils above windows have rust and need to be painted.

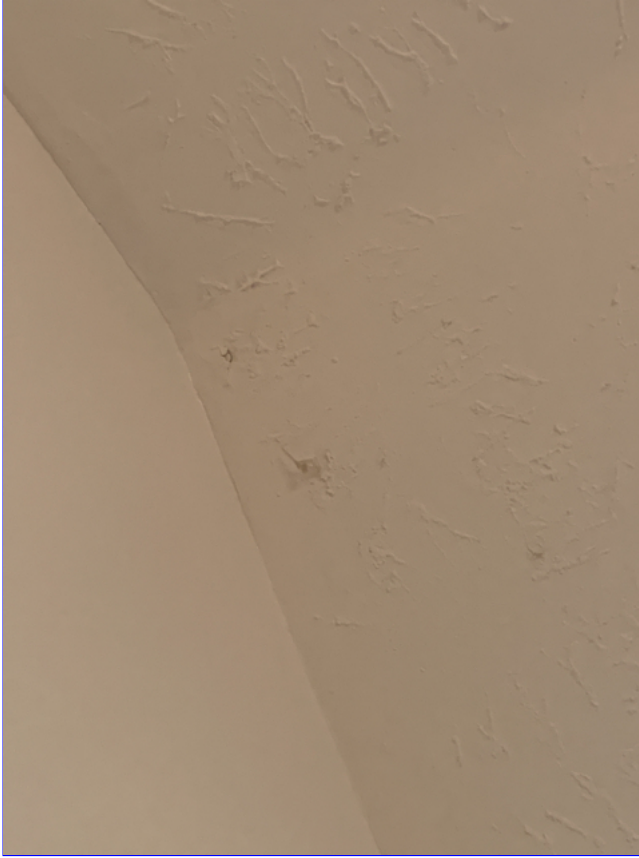
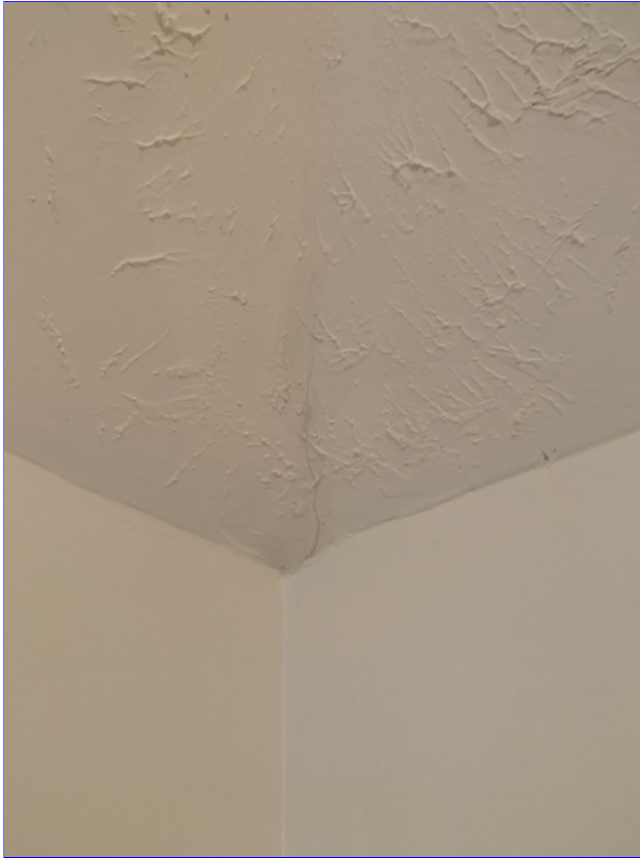
(1) Drywall tape joint cracks and/or nail pops were observed around the home. These are cosmetic in nature, and can be repaired as needed.

F. Item 1(Picture) Drywall tape joint cracks and/or nail pops were observed around the home.

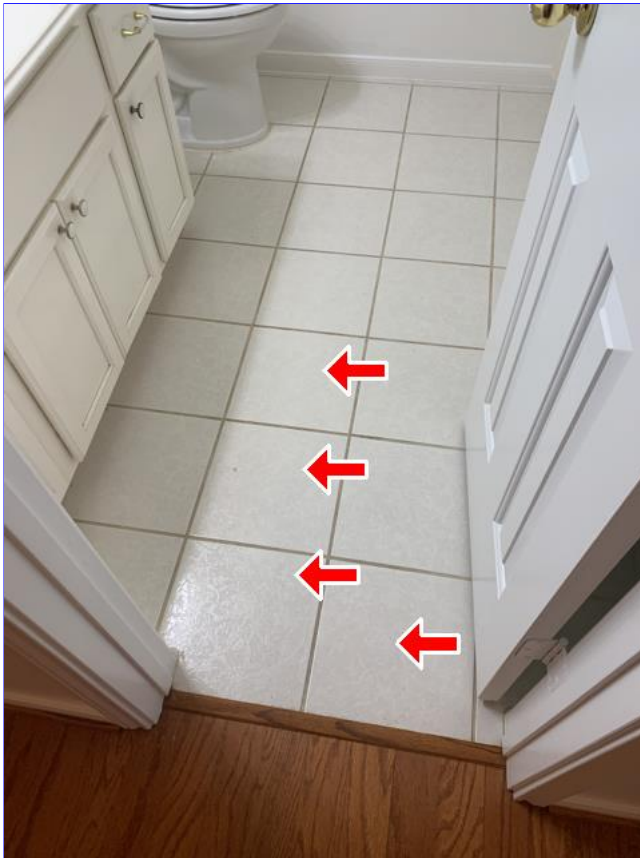
(2) Some floor tiles are not fully set to slab. This is suggested by hollow sound coming from tiles when tapped with a hard object. The tiles may become loose and the grout surrounding them may begin to crack over time. Recommend correction as needed.

F. Item 3(Picture) Some floor tiles are not fully set to slab.

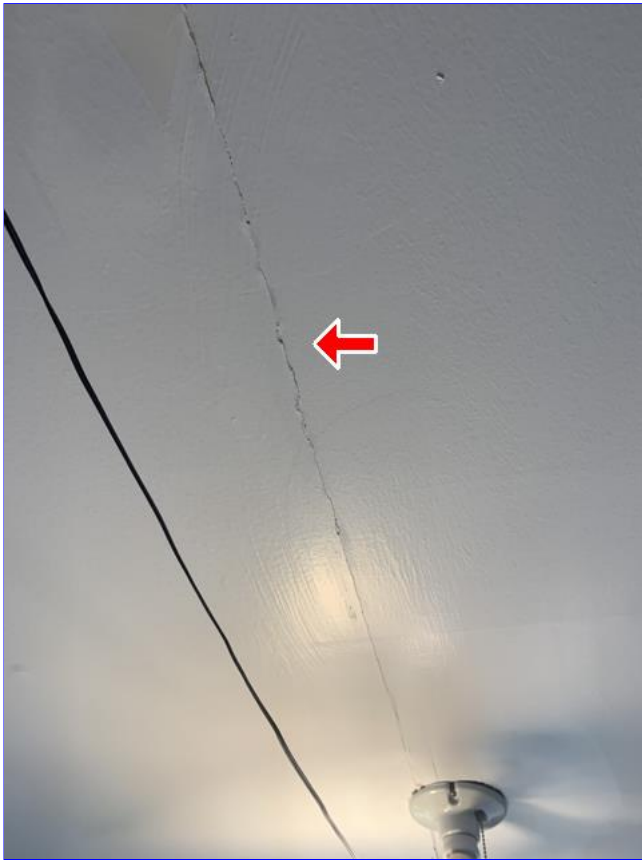
(3) Drywall tape joint crack observed in the garage.

F. Item 4(Picture) Drywall tape joint crack observed in the garage.

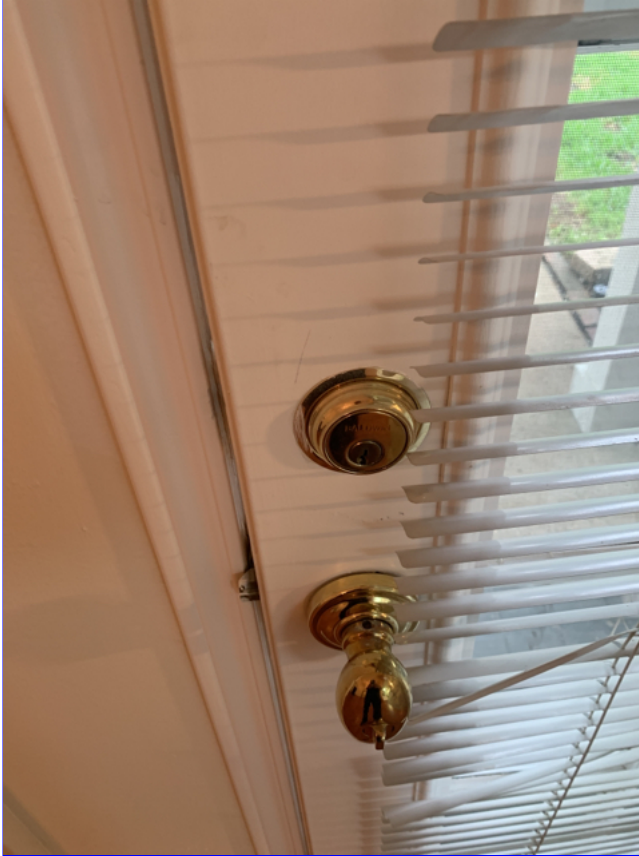
(1) Some exit doors, have interior key operated dead bolts. I recommend that these be changed out to hardware that can be opened from the inside without the use of a key for safety/fire escape reasons.

G. Item 1(Picture) Some exit doors, have interior key operated dead bolts.

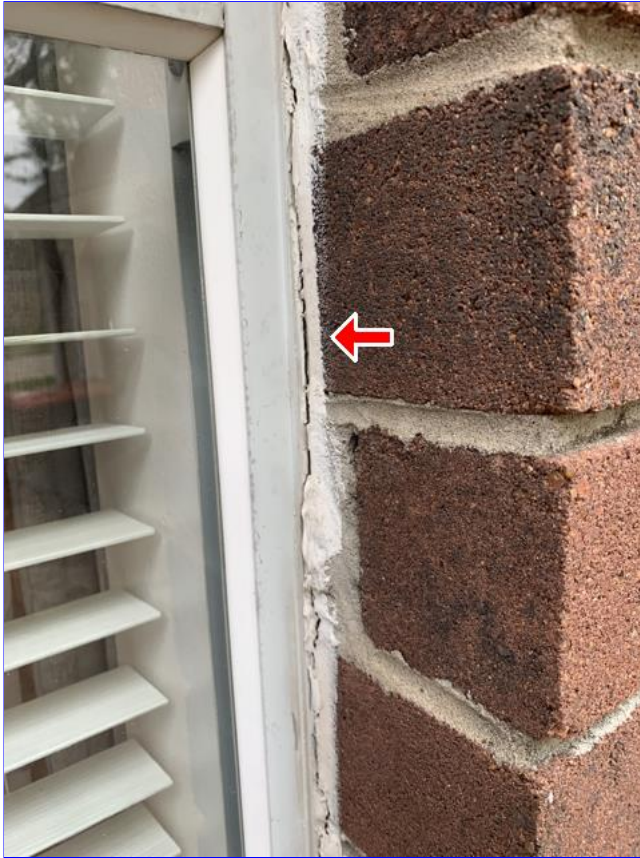
(2) The perimeter sealant, has failed on some windows.

H. Item 1(Picture) The perimeter sealant, has failed on some windows.

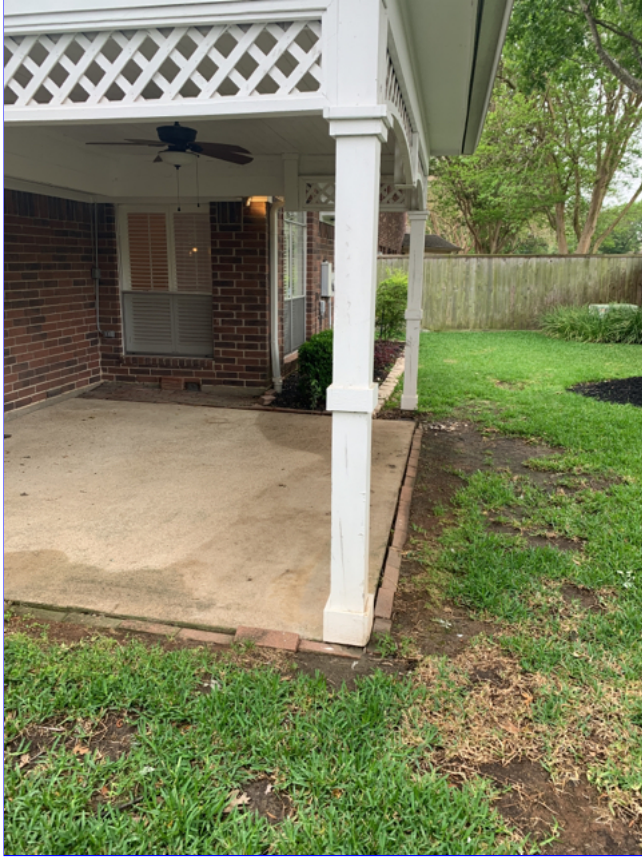
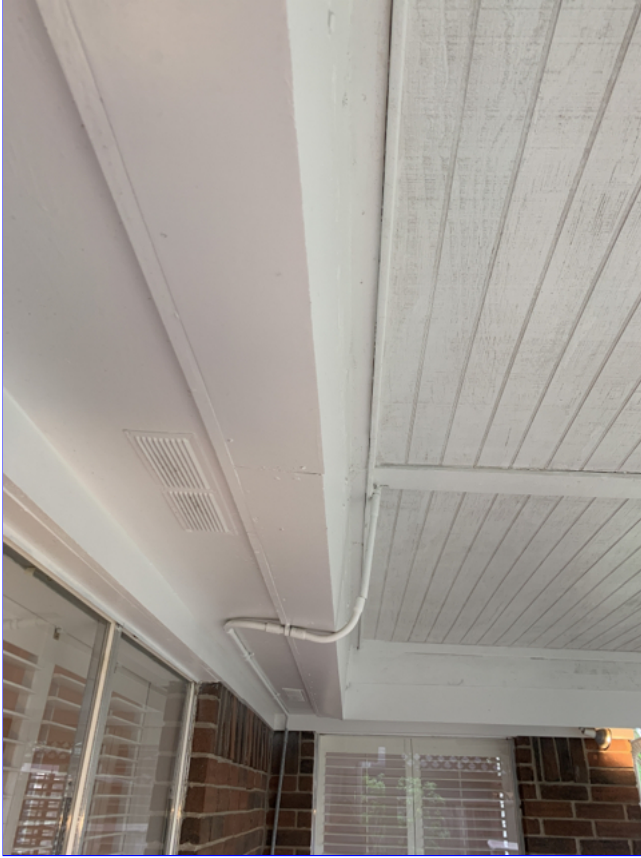
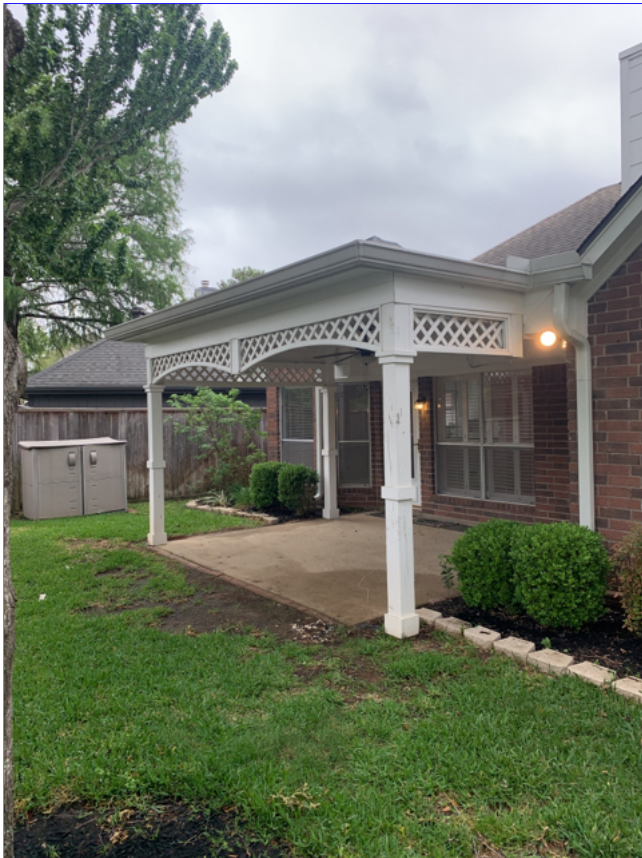
K. Item 1(Picture) Impossible to know whether the proper footers were used under the post or if the patio cover was attached to the home properly.

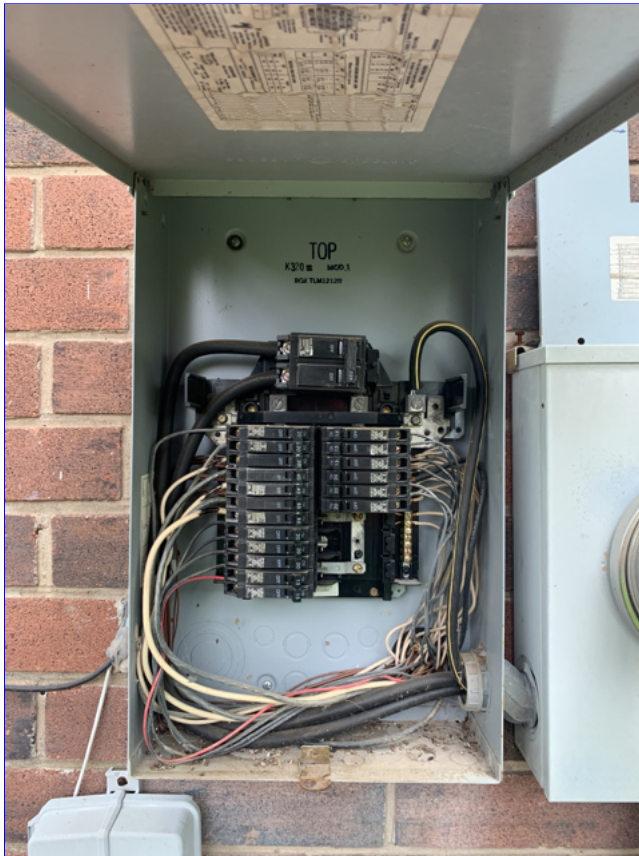
(1) The main electrical service panel, shown with dead front cover removed for inspection purposes. The panel inspected okay.

A. Item 1(Picture) The main electrical service panel, shown with dead front cover removed for inspection purposes. The panel inspected okay.

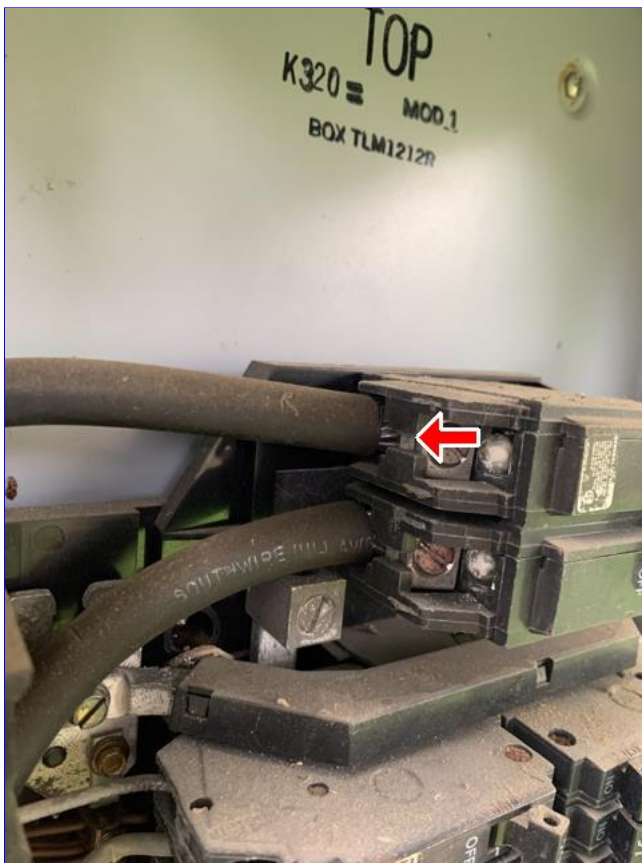
(2) Anti-oxidant paste, was not observed on service entrance conductor terminations. Anti-oxidant paste is recommended to prevent corrosion at the terminations.

A. Item 2(Picture) Anti-oxidant paste, was not observed on service entrance conductor terminations.
