Inspection Report

Property Address:
19226 Cotton Gin Dr
Katy 77449

Li Geyang	4/13/2022
<i>Name of Client</i>	<i>Date of Inspection</i>
19226 Cotton Gin Dr, Katy, 77449	
<i>Address of Inspected Property</i>	
Jerry Brame	24113
<i>Name of Inspector</i>	<i>TREC License #</i>
<i>Name of Sponsor (if applicable)</i>	<i>TREC License #</i>

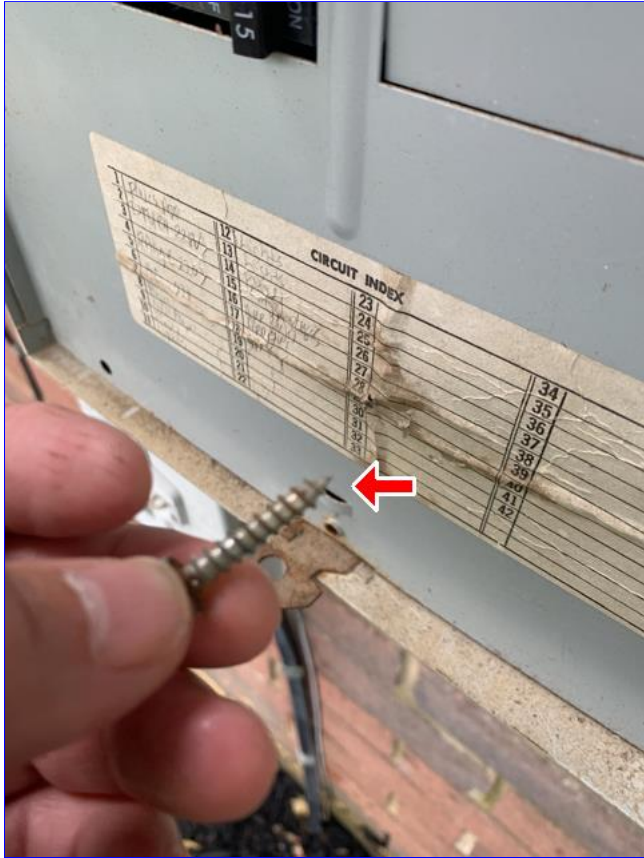
(3) Pointed screws used to secure panel dead front cover.

A. Item 3(Picture) Pointed screws used to secure panel dead front cover.

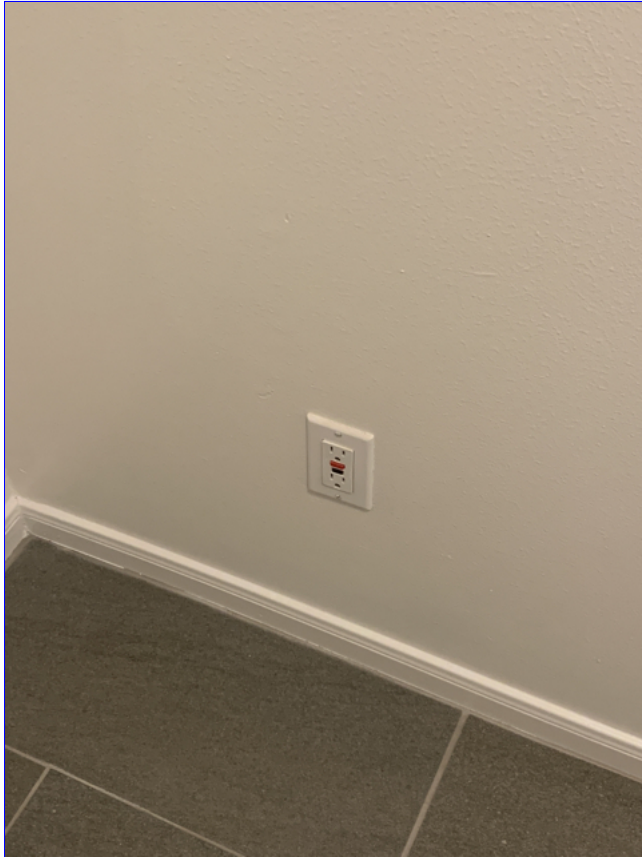
(5) GFCI outlet in bathroom closet does not reset.

B. Item 1(Picture) GFCI outlet in bathroom closet does not reset.

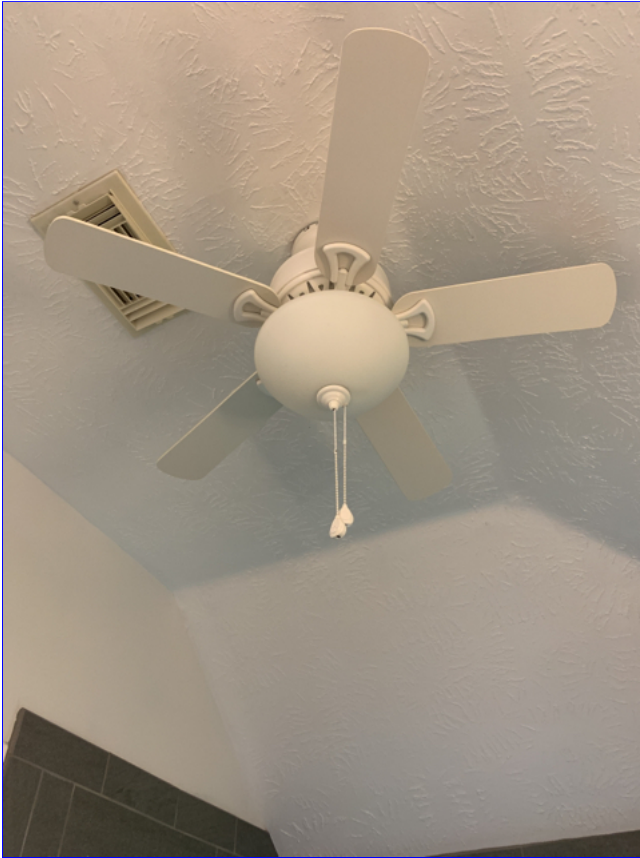
B. Item 2(Picture) The ceiling fan light in the master bathroom does not turn on with the switch.

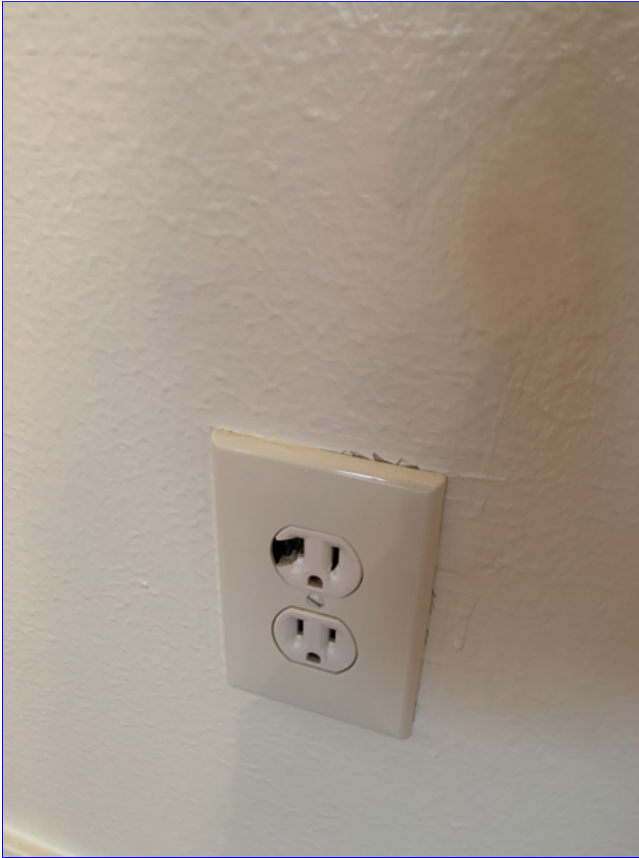
(7) Outlet is damaged in the master bedroom. Recommend replacement.

B. Item 3(Picture) Outlet is damaged in the master bedroom. Recommend replacement.

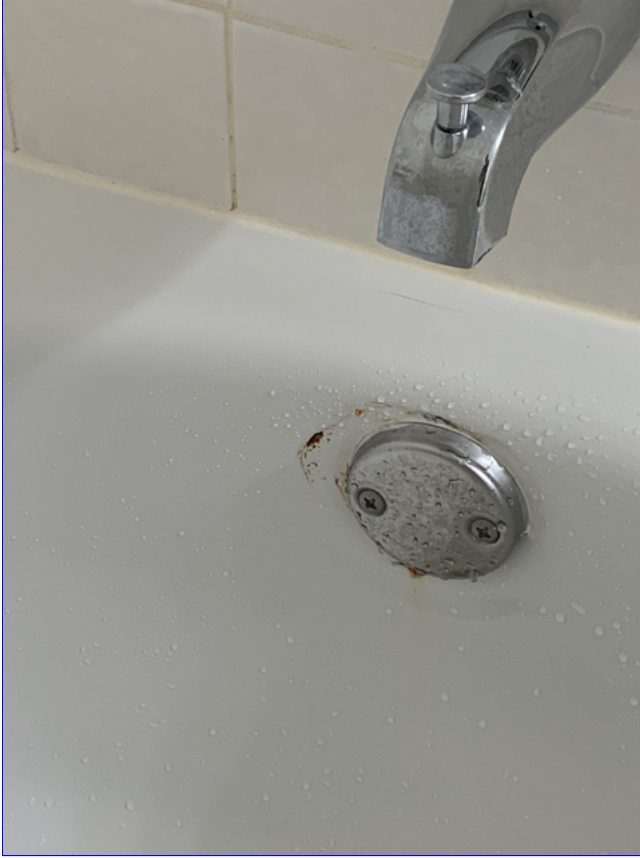
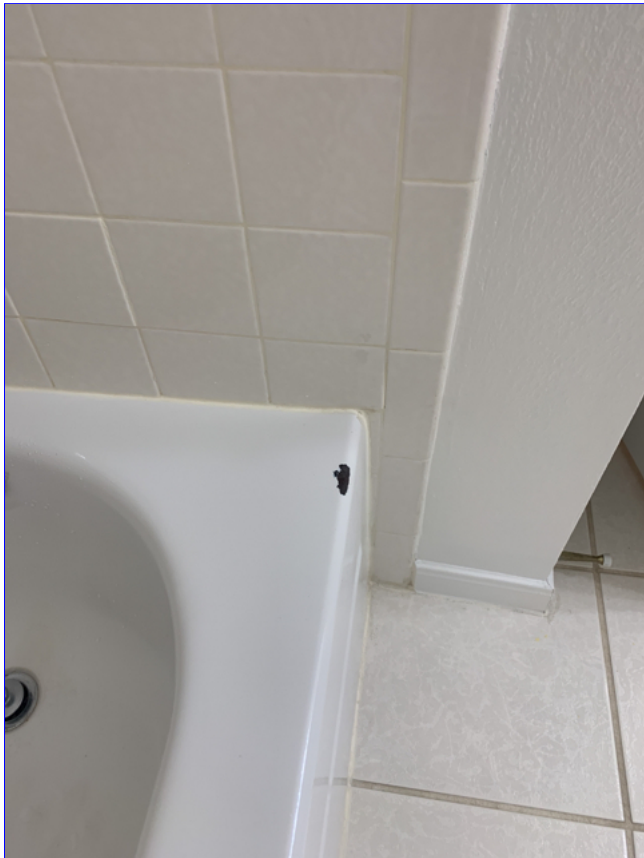
A. Item 1(Picture) Rust and chipped areas were observed on the tub in the guest bathroom.

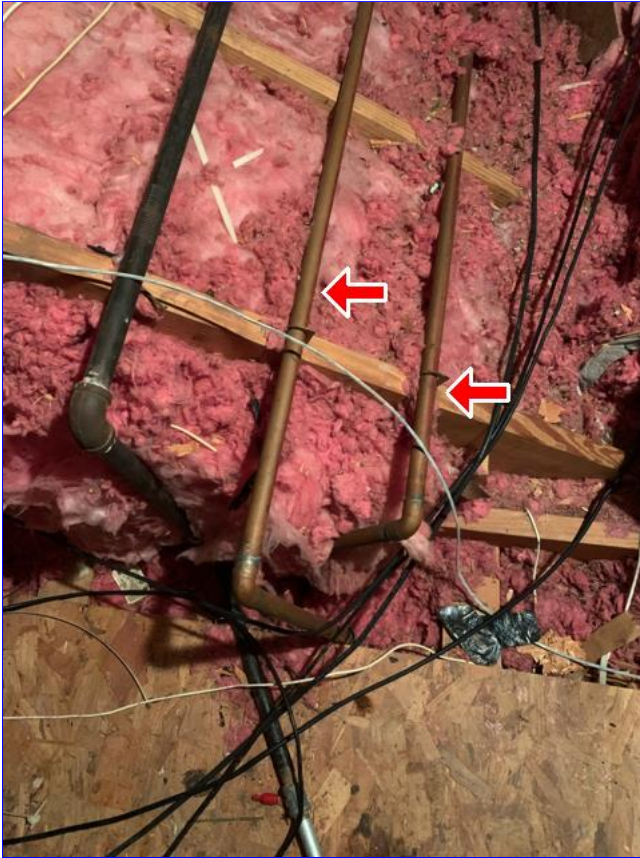
A. Item 3(Picture) Exposed water pipes observed in the attic space are not properly protected from freezing.

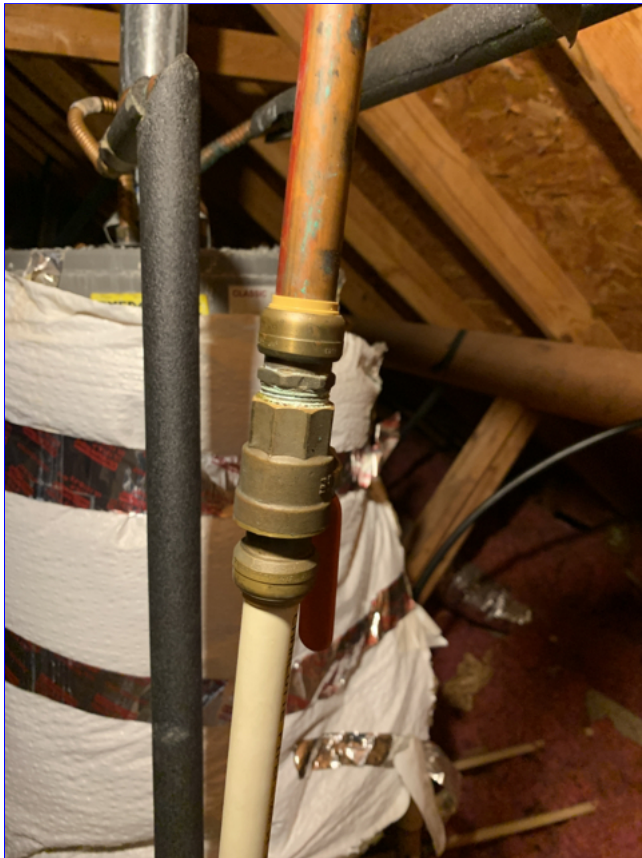
A. Item 4(Picture) Shark bite plumbing fittings where observed.

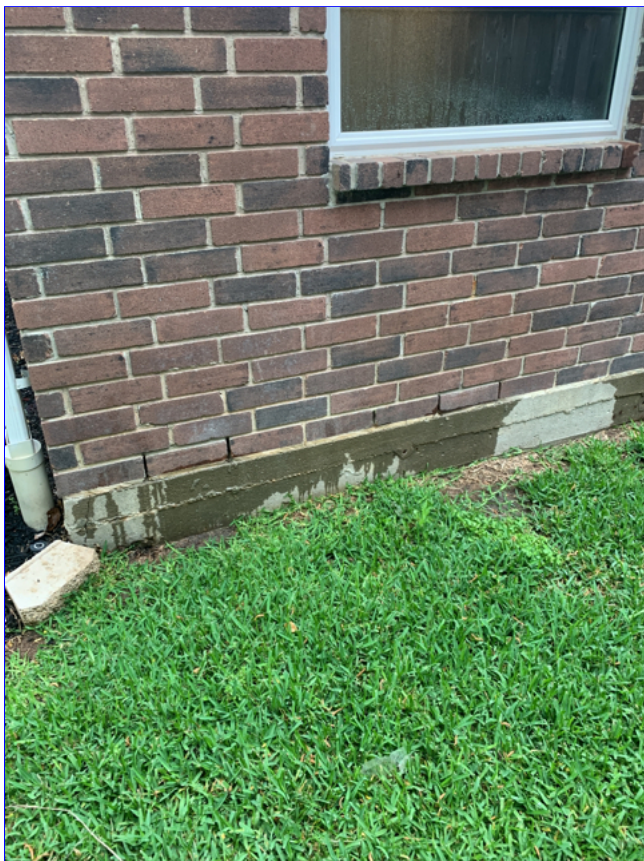
B. Item 1(Picture) Moisture was observed coming from the outside wall at the master bath.

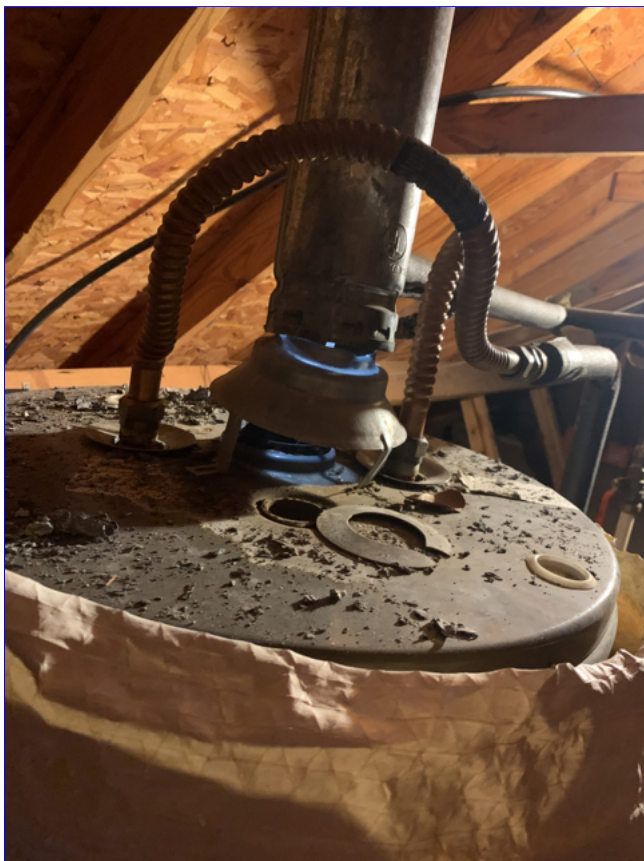
C. Item 2(Picture) The exhaust vent for the water heater is not lined up correctly. Exhaust gases can be released into the attic space.

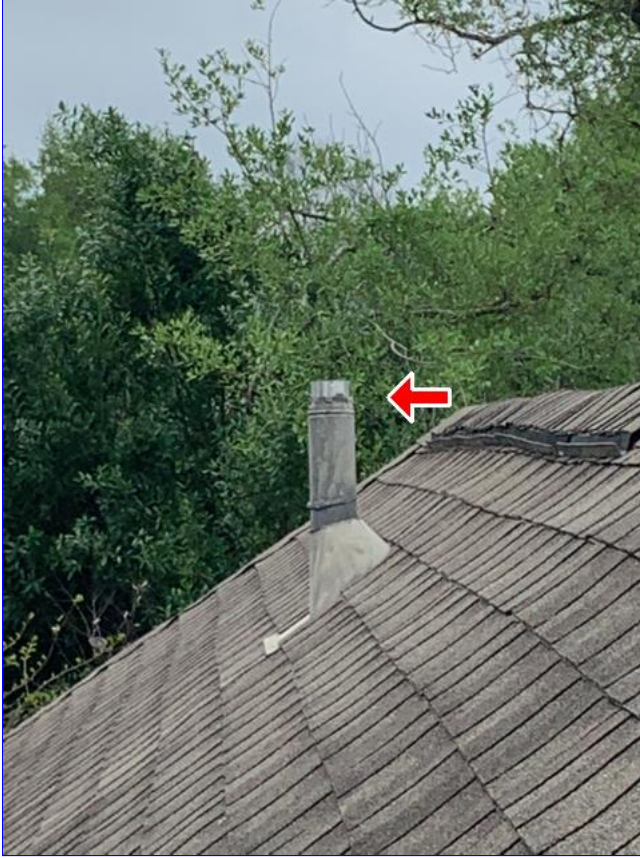
C. Item 3(Picture) The vent for the water heater does not have a rain cap.

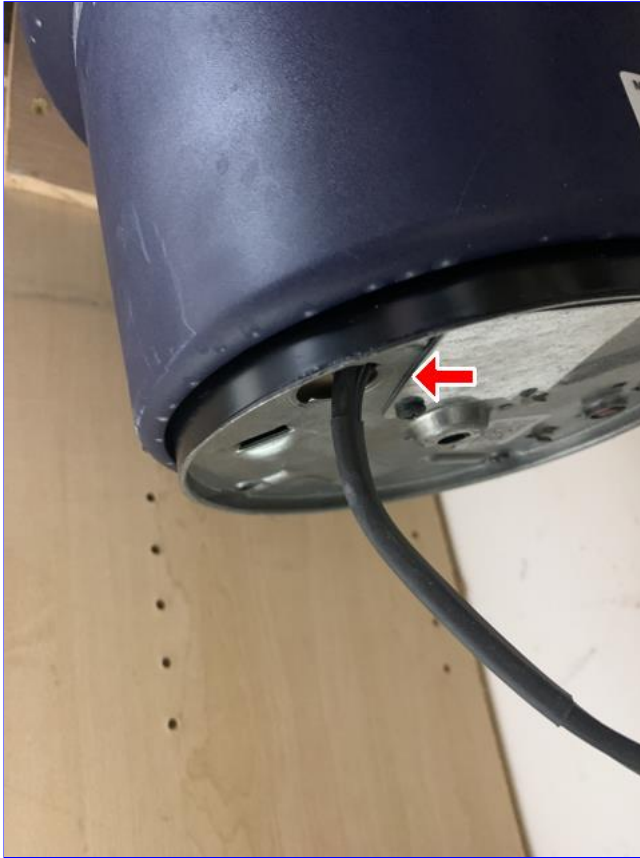
B. Item 1(Picture) The food disposer wiring is missing a clamp connector (anti-strain device). I recommend repair as needed.

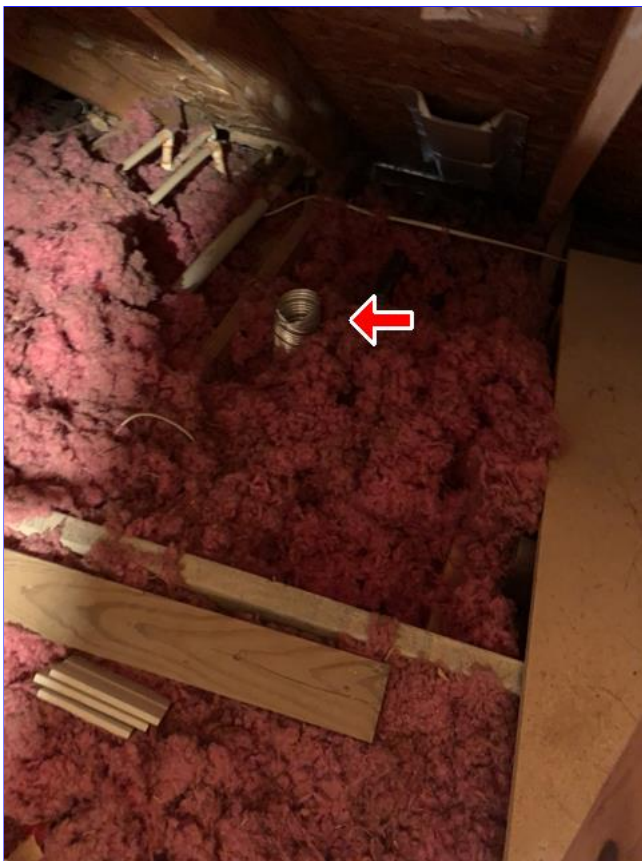
F. Item 1(Picture) Exhaust fans terminating into attic space.

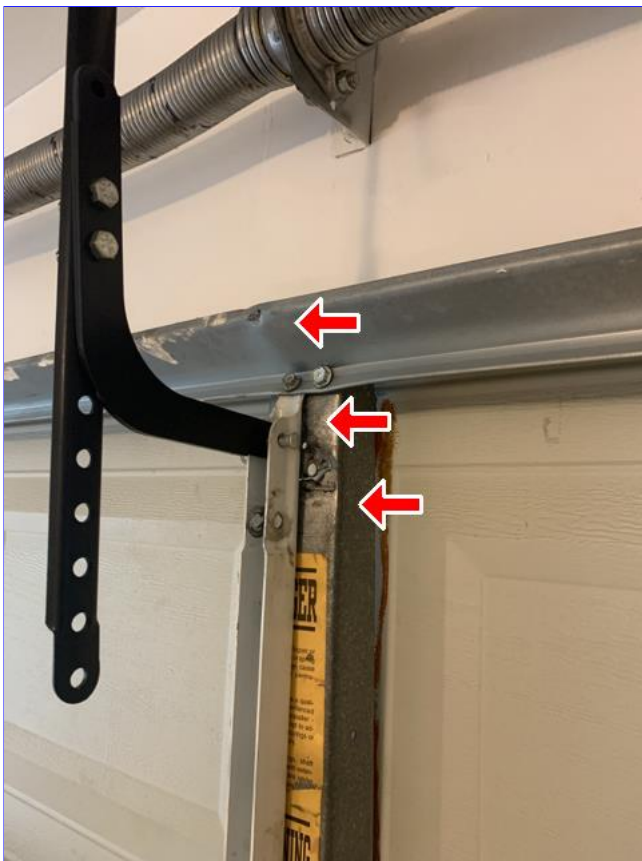
G. Item 1(Picture) Damage observed to the top of the garage door. Auto reverse on the garage door was not tested because of the damage.

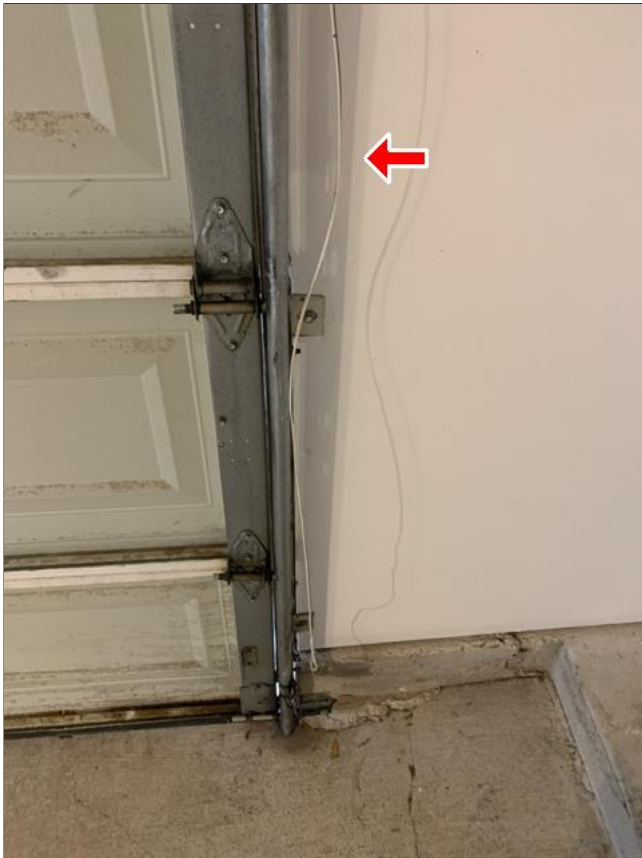
G. Item 2(Picture) The wires for the garage door sensors or not secure.

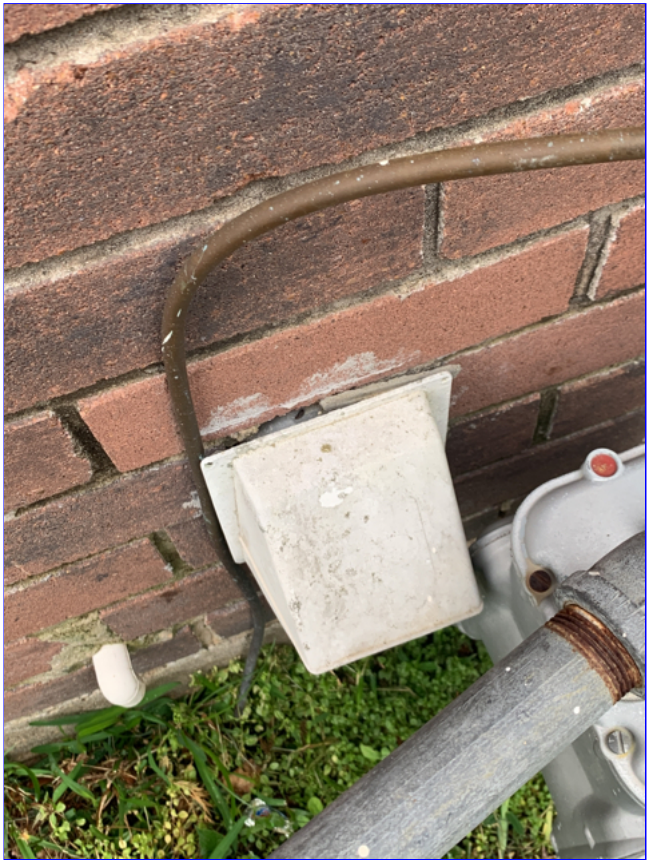
H. Item 1(Picture) The dryer exhaust vent should be caulked to the wall.

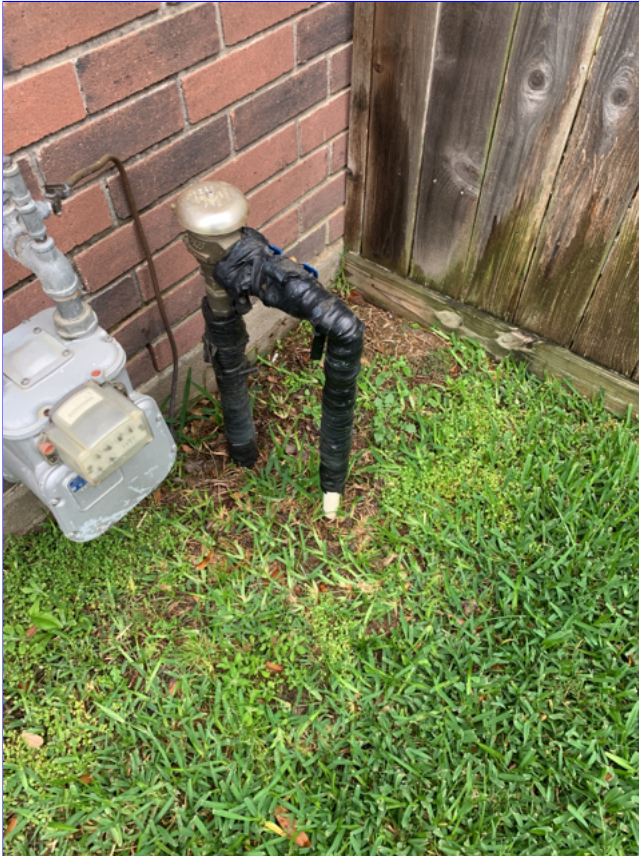
The irrigation system backflow prevention device (vacuum breaker), is not properly supported. I recommend it be attached to the wall or supported on metal posts.

B. Item 1(Picture) The irrigation system backflow prevention device (vacuum breaker), is not properly supported. I recommend it be attached to the wall or supported on metal posts.

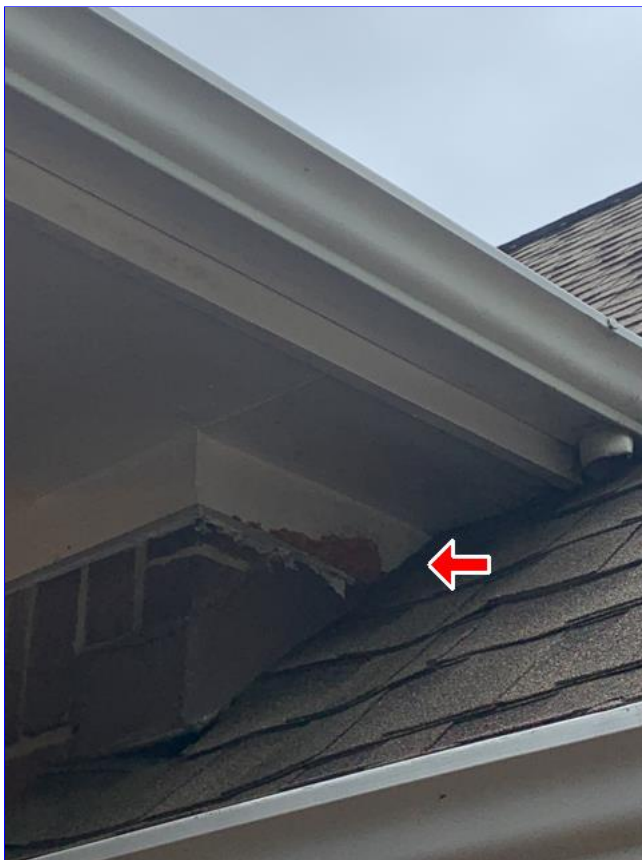
Pest chewing on wood exterior of home observed.

C. Item 1(Picture) Pest chewing on wood exterior of home observed.
