RedFish Inspections

Property Inspection Report

4327 Croft Creek Dr, Spring, TX 77386
Inspection prepared for: Harold Andrew
Real Estate Agent: -

Date of Inspection: 12/12/2018 Time: 11:00 AM - 1:00 PM
Age of Home: New Size: 2738 sqft
Weather: Sunny

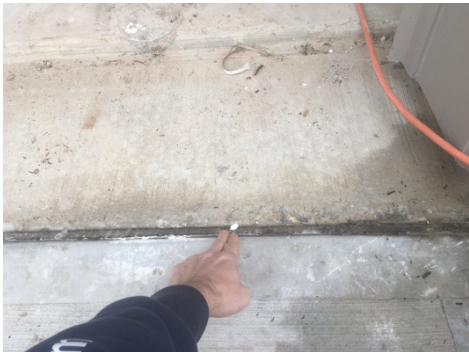
The structure had attaching slabs “expansion joints” between the driveway and the garage/house. This is a location for wood destroying insects (termites) to enter the home. Home owner needs to perform frequent inspections of these areas.

Driveway/walk to foundation:
Monitor area for insect activity

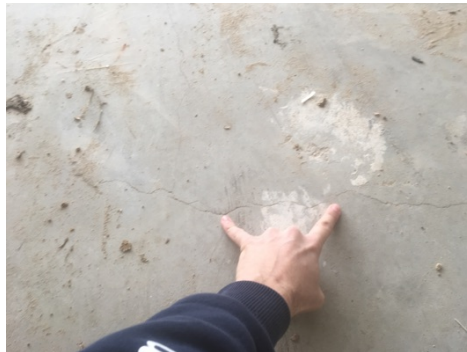
Hairline cracks were on the foundation. Cracking in post tensioned slabs prior to tensioning the strands/tendons is very common and this situation has a specific name called “Restrained to Shortening” or RTS cracks. As concrete shrinks during the drying process it would not crack if it were supported by a perfectly smooth frictionless surface, but in reality this is not the case. The ground surface the slab is poured on will restrain the concrete from sliding, which develops stresses in the concrete causing cracks to develop, i.e. RTS cracking. If reinforcing steel or wire mesh were added near the surface (1.5” to 2” below the top) it would strengthen the concrete and help resist the dry shrinkage forces that develop, however most post tensioned residential slabs typically do not have any reinforcement other than the post tension cables, which are not designed for dry shrinkage. The good news is these RTS cracks are typically harmless and may partially close up if not too much debris has fallen in these cracks before the cables are tensioned. These cracks were located in the garage.

Garage: RTS hairline crack

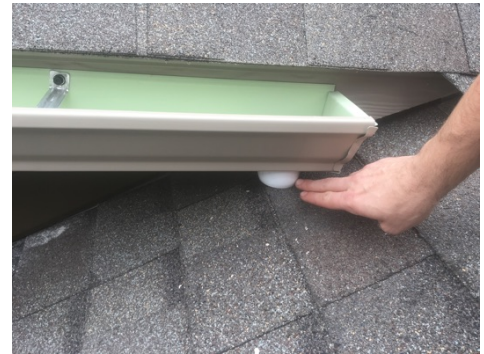
Downspout extension missing, discharge on roof

RECOMMENDATION: This structure had an incomplete gutter system. We recommend gutters to be used under all roof sides to redirect water from the roof to the downspouts and extensions 5 feet away from the foundation.

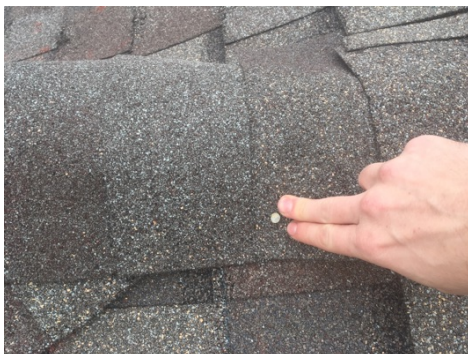
Exposed nail heads were noted at the roof protrusions and/or ridge shingles. Nail heads at either the vent & roof flashing or at the composition shingles can allow water to penetrate past the roof covering given enough time. As the exposed portion of the nail rusts, more space will become available between the nail and the roofing material for water to penetrate. This condition can usually be remedied by sealing or caulking affected areas.

Exposed nail heads

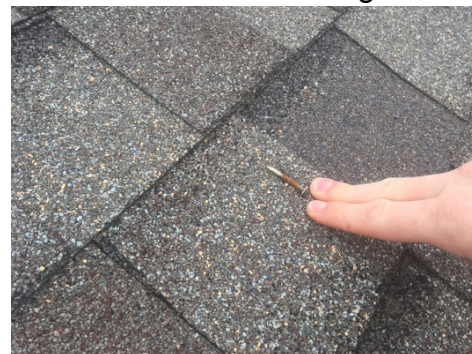
Debris was noted on the roof in the rear and should be removed. All nails should be removed. As the sun heats the shingles, the nail heads will sink into the roof covering which will leave indentations. We recommend cleaning to prevent damaging the shingles.

Remove debris

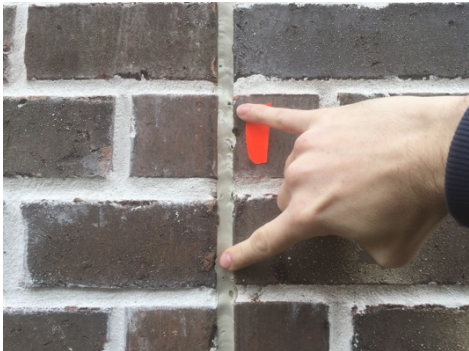
An expansion joint on the exterior brick wall was missing caulk. We recommend caulking to prevent excessive moisture and insect intrusion. This was noted on the left, right, rear.

Left: incomplete caulk at expansion joint

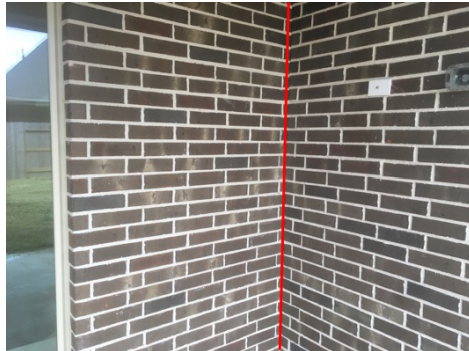
Rear: missing caulk at expansion joint

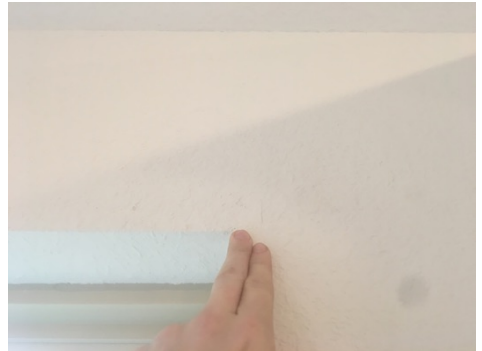
Hairline/shrinkage cracks were noted in the interior walls. This condition was mainly cosmetic in nature and should be patched. This was noted in the breakfast nook.

Breakfast nook: hairline crack

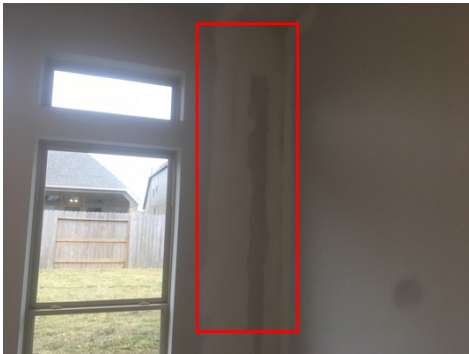
Wall patching was noted. This indicates previous work was performed and we recommend monitoring the area. This was observed in the bedroom 1.

Bedroom 1: patching

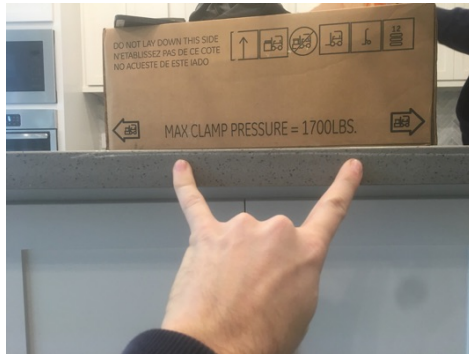
Multiple chips/scratches were noted in the kitchen countertops. We recommend consulting with the manufacturer and following their instructions for proper repairs.

Kitchen: scratches in counter top

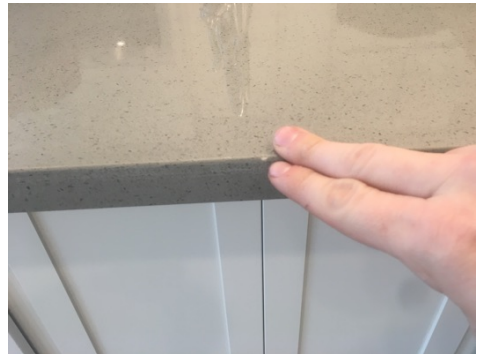
Kitchen: chips in counter top

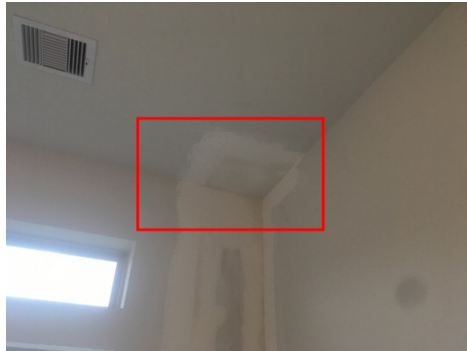
Evidence of patching was detected which indicates previous work performed. We recommend monitoring. This was observed in the bedroom 1.

Bedroom 1: patching

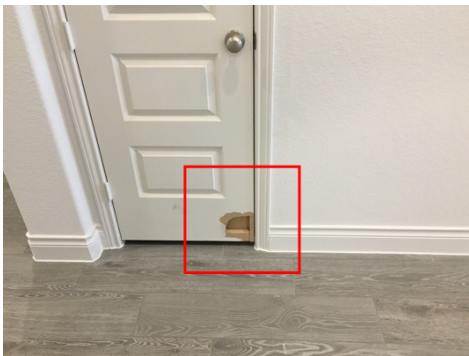
A damaged door was noted within the house. We recommend having this repaired. This was observed in the foyer/hallway.

Foyer/hallway: damaged door

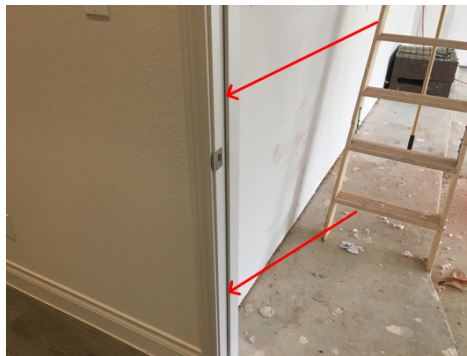
Missing weather stripping was noted on an exterior door. We recommend having this repaired to reduce air and moisture infiltration. This was observed at the garage man door and the back door.

Garage man door: missing weatherstripping

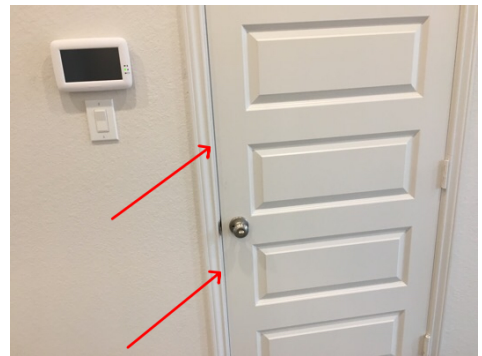
Daylight was observed coming through an exterior door when closed. We recommend having this adjusted or additional weather stripping be added to prevent air infiltration. This was observed at garage man door and the back door.

Garage man door: daylight coming through

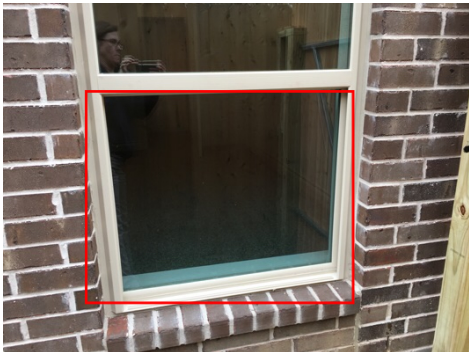
It may be desirable to replace window screens where missing. We recommend consulting with the owner regarding any screens that may be in storage. This was observed around the house.

Around the house: missing screens

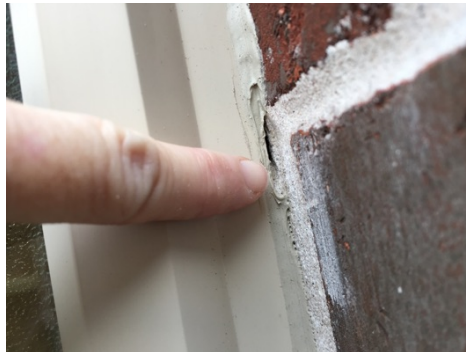
The exterior and interior caulk around the windows was deteriorated. We recommend repair. Exterior caulking is the first energy efficient measures to install. The purpose of exterior caulking is to minimize air flow and moisture through cracks, seams, utility penetrations and openings. Controlling air infiltration is one of the most cost effective measures in modern construction practices, a home that is not sealed will be uncomfortable due to drafts and will use about 30% more heating and cooling energy than a relatively air-tight home. In addition, good caulking and sealing will reduce dust and dirt in the home and prevent damage to structural elements.

Around the house: additional caulk needed

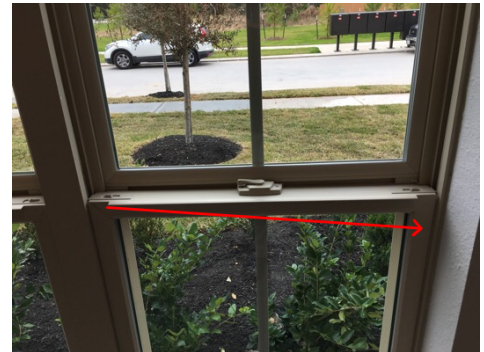
A window was out of square however it still operated as designed. We recommend monitoring this for future movement. This was observed the office 1.

Office 1: window out of square

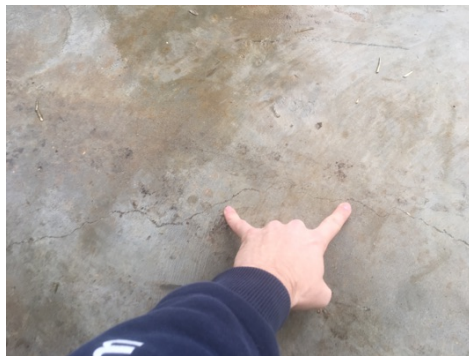
Hairline cracks were observed in the porch slab. These are not uncommon, where under 1/4 inch wide and should be monitored.

Back porch: hairline crack

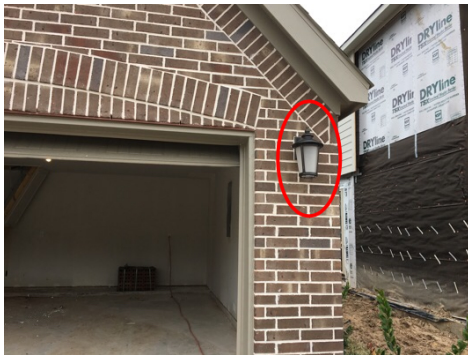
An inoperative light fixture was noted in the house. We recommend replacing the bulb. Should this not resolve the issue, we recommend having the fixture repaired/replaced. This was observed in the front right, pantry.

Front right: inoperative fixture

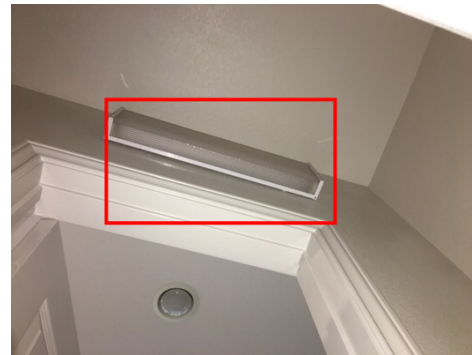
Pantry: inoperative fixture

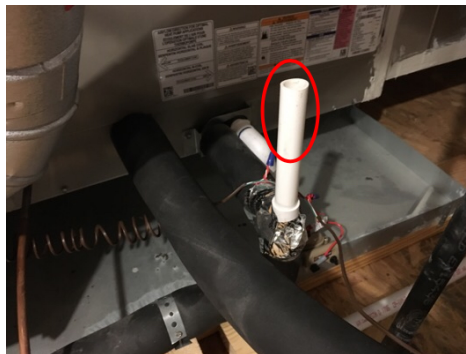
The primary condensate drain line cleanout did not have cap. We recommend adding one to prevent debris from clogging the line.

Cap missing on primary condensate drain line cleanout

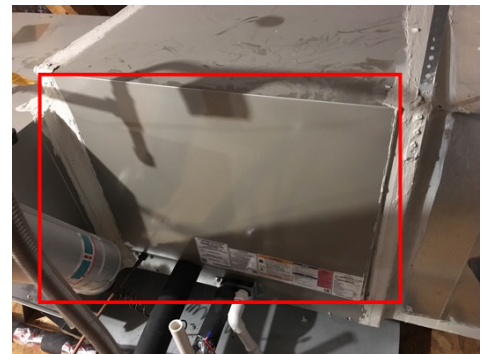
The evaporating coils had been sealed. Cutting the seal goes beyond the scope of the home inspection. We were unable to view the condition of the coils.

Attic: Evaporating coils sealed/unable to view coils

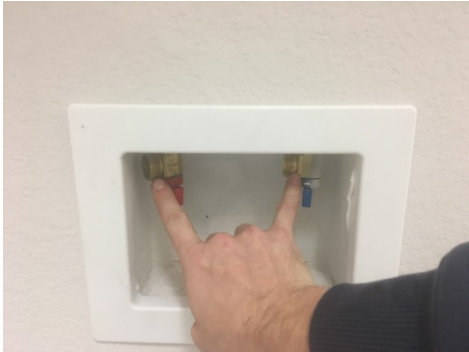
The washing machine supply connections were oriented in such a way that may make it difficult to connect an appliance. We recommend having this corrected to prevent damage to the supply lines during connection.

Laundry room: washing machine connections improperly oriented

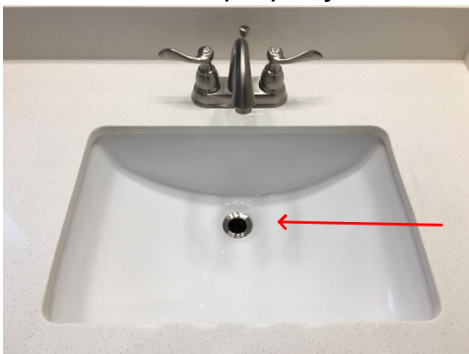
Stoppers were noted missing at a bathroom lavatory/tub. We recommend having stoppers installed to prevent damage to the drainage system from foreign objects. This was observed in bathroom 2 at the right lavatory.

Bathroom 2: missing stopper at right lavatory

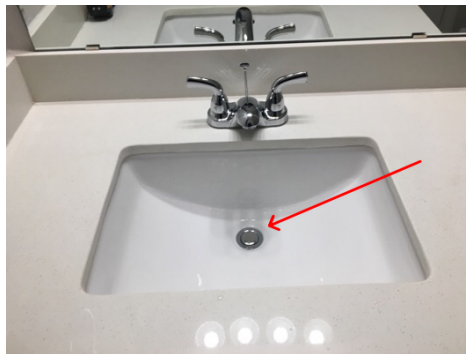
Bathroom 3: inoperable stopper

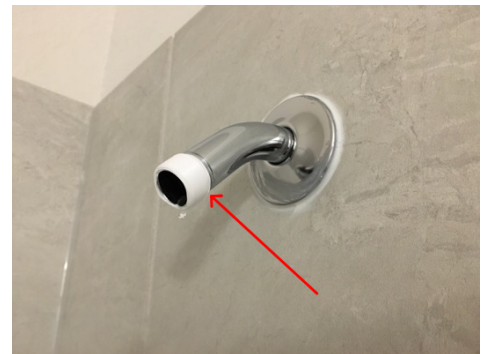
There was missing hardware to a bathtub/shower. We recommend having these fixtures further evaluated and repaired as needed once installation is complete . We observed this in each bathroom.

Bathroom 1: missing hardware

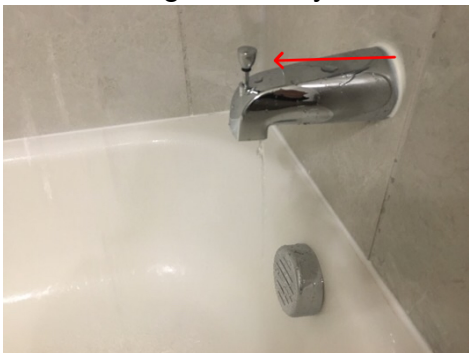
The bathroom shower diverter did not fully divert the water from the spout to the shower head. We recommend having this adjusted so as to operate as intended. This was observed in the bathroom 1.

Bathroom 1: diverter not ok

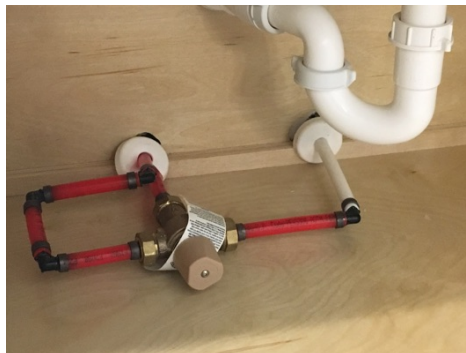
A loose supply line was noted under a bathroom lavatory. We recommend having this secured. This was observed in bathroom 2 at the right lavatory.

Bathroom 2: loose supply line

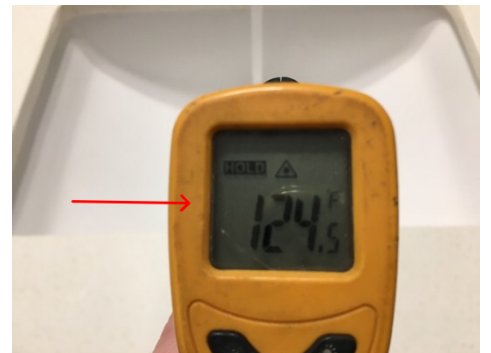
The water temperature was measured at 124 degrees. This is scalding. We recommend reducing the temperature at the water heater to maximum 120

degrees.

Hot water temperature: Scalding

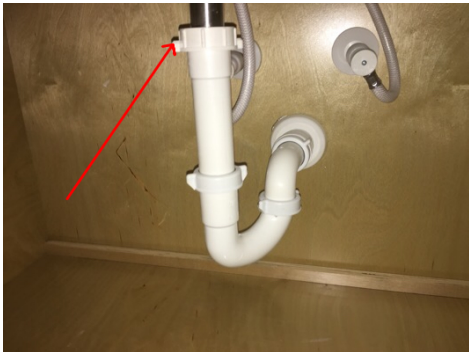
A leak was noted under a lavatory at the drain. We recommend having this repaired. This was observed in bathroom 3.

Bathroom 3: leak at drain connection

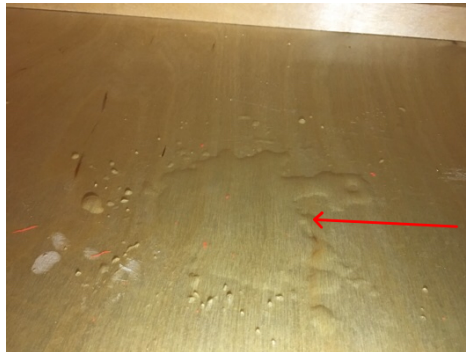
Bathroom 3: water on cabinet floor from leak at drain

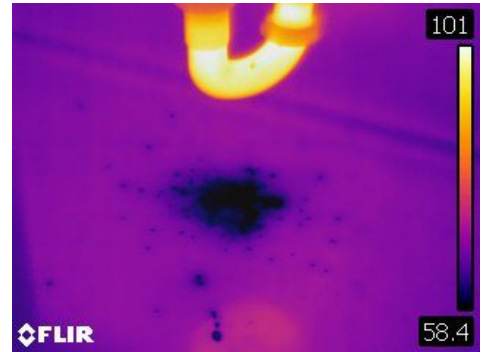
Bathroom 3: Thermal image of water on cabinet floor from leak at drain

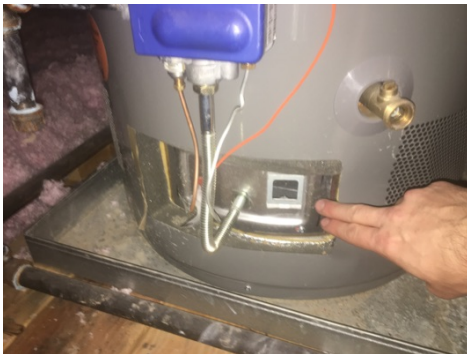
The unit 1 (rear) water was missing the shield/cover at the burn chamber opening. We recommend having this replaced.

Unit 1: missing shield

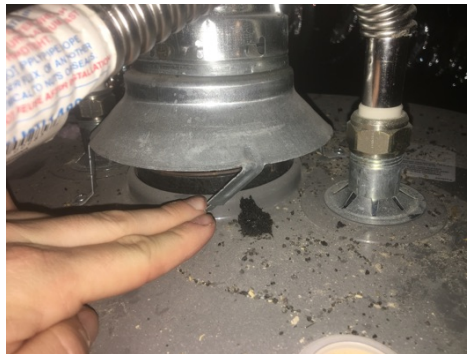
Unit 1: loose diverter leg

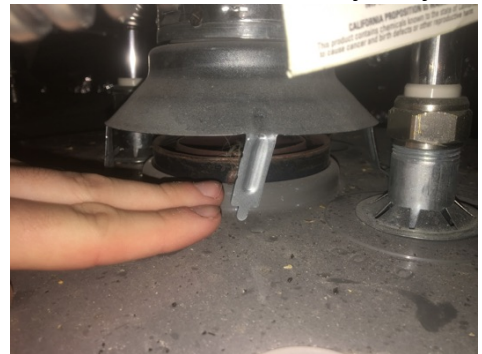
Unit 2: loose diverter leg

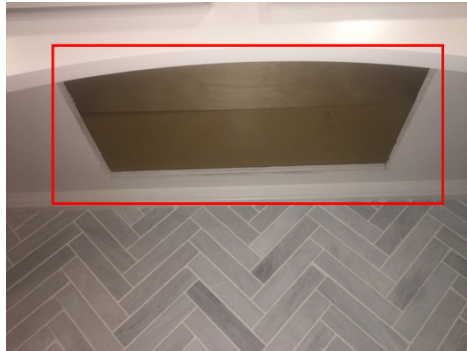
Range hood not installed

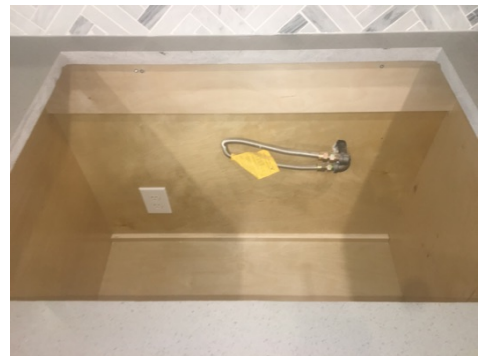
The cooktop installation was incomplete at the time of the inspection.

Cooktop not installed
