HEDDERMAN ENGINEERING, INC.

REF: CONDITION OF PROPERTY SURVEY

3601 Wakeforest Street

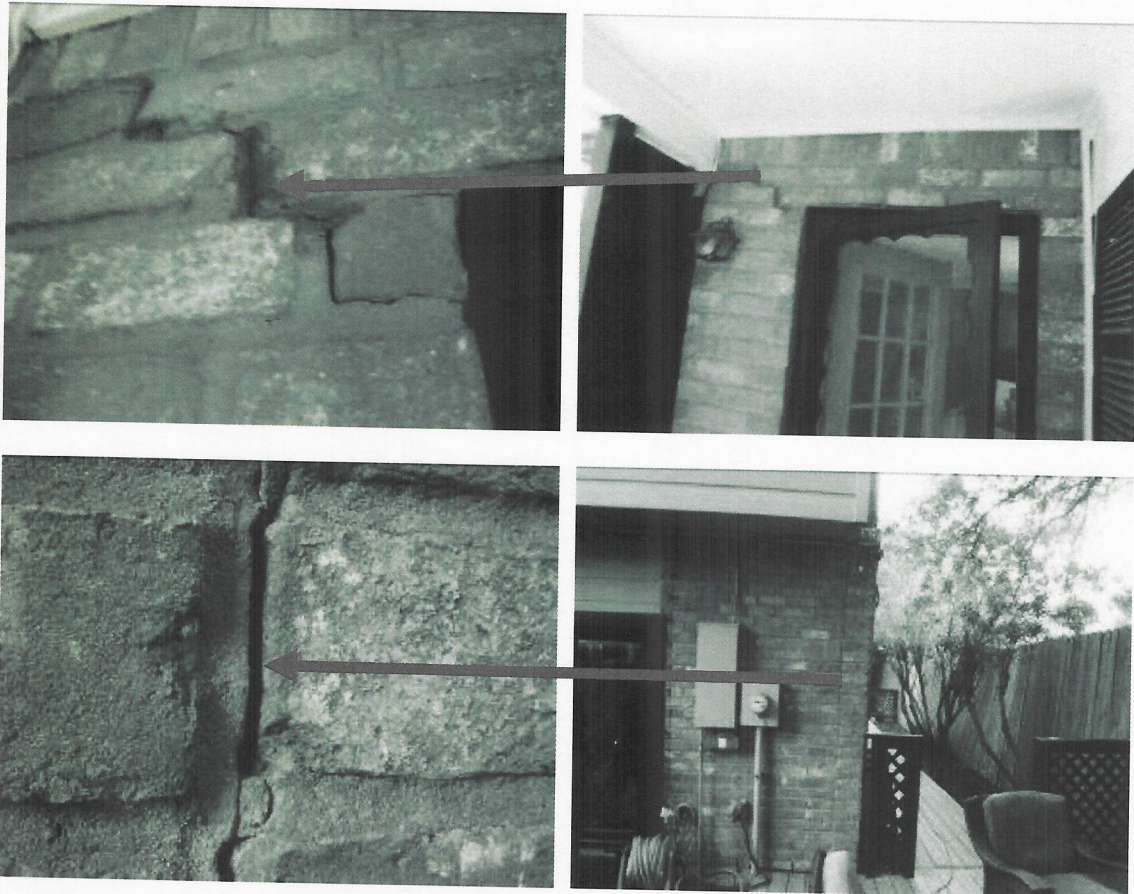
Cracks and/or patches were observed in the exterior veneer.

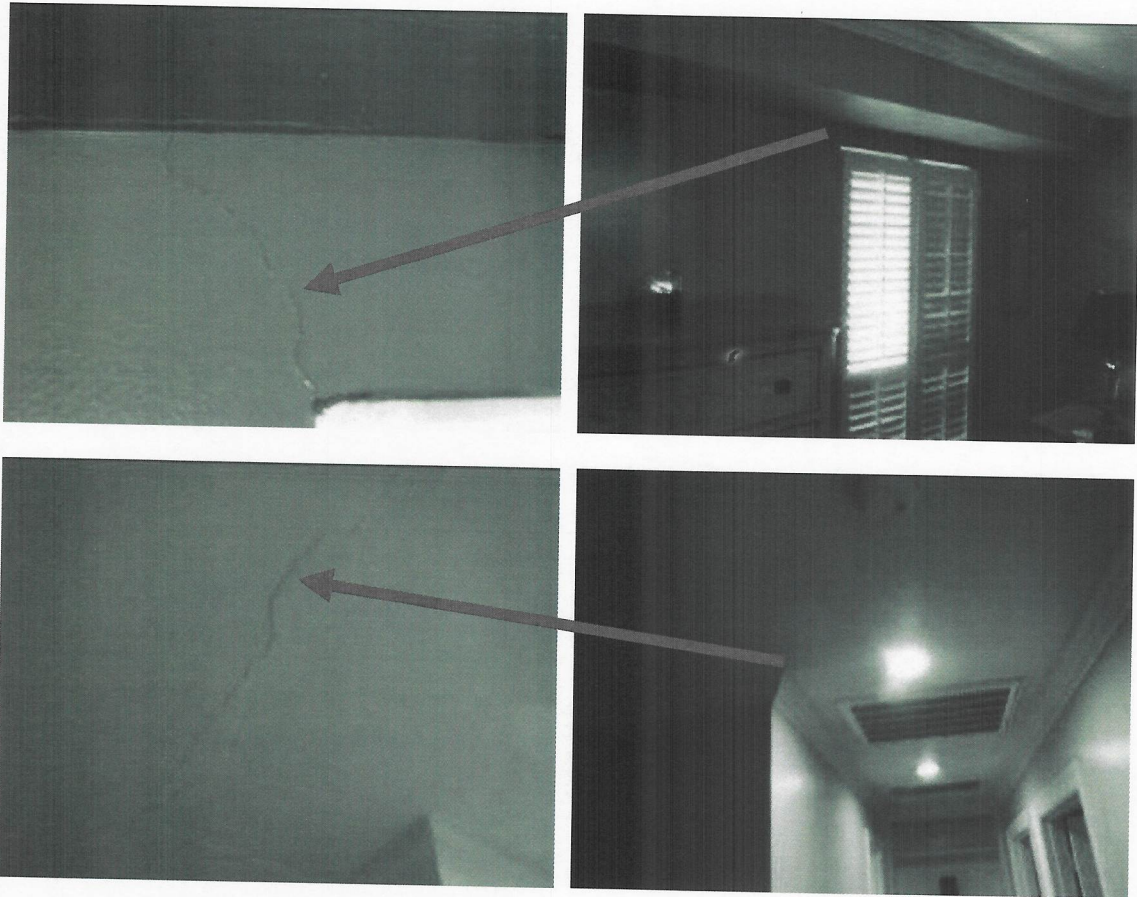
Sheetrock cracks, patches, and/or compression ridges were observed, including at the 2nd floor hallway, and the master bedroom. It is recommended to repair all the visible cracks.

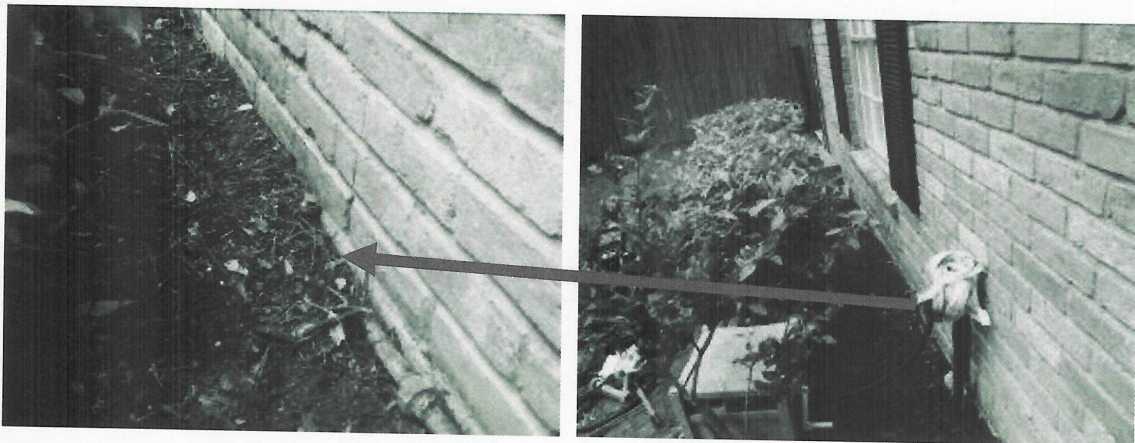
The flower bed and/or perimeter grading was too high at some areas, and was graded near or above the top of the foundation. It is recommended that the beds/soil be regraded as needed to prevent water penetration into the house, and to allow for proper drainage.

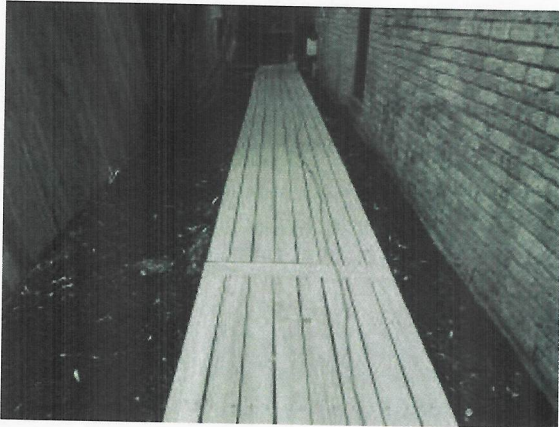
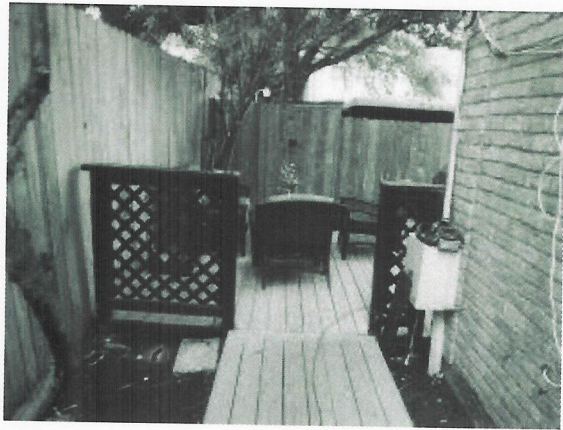
We could not determine if any provision has been made at the rear of the house for drainage under the wood deck. It is recommended that you check with the owner to determine if there are any drainage problems at the deck area, and if any provision for drainage has been made.

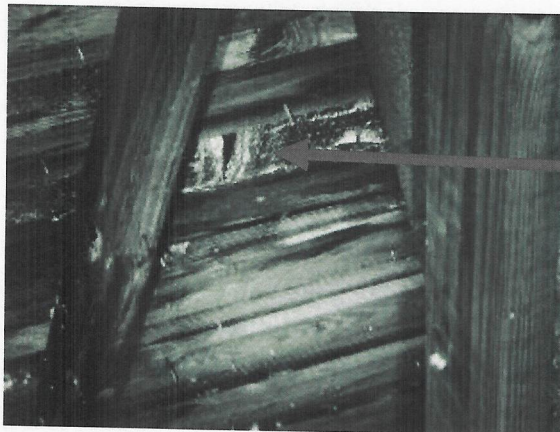
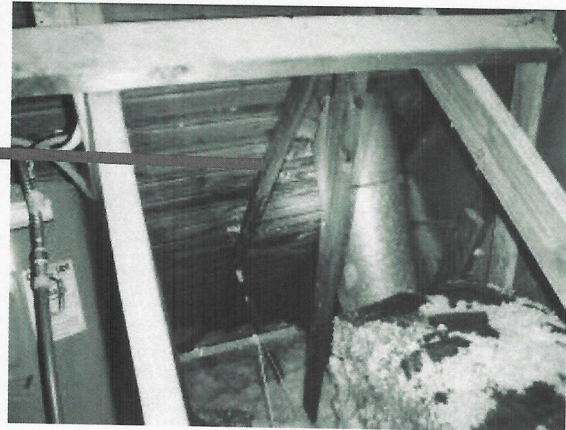
After observing the interior of the structure, evidences of roof leaks were visible in the attic, where the roof decking was rotted. It is recommended that a roofing contractor be contacted to find the source of the leaks, and to make any needed repairs.

Locations included: Near the chimney.

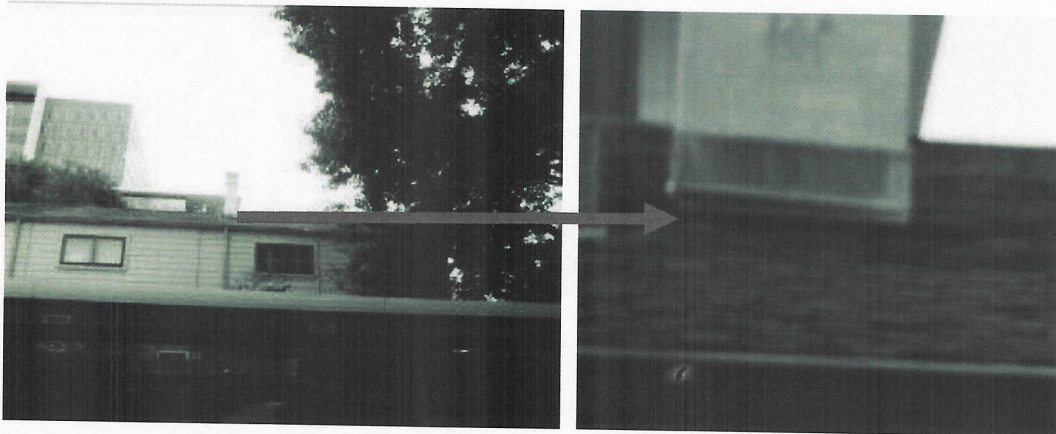
- * We observed from the attic space that the shingles were nailed rather than stapled, and that the nails had an adequate penetration through the roof deck.
- * It was observed that the old wood shingles were removed, and the roof was redecked when the current composition roof was installed. Therefore, this roof is not an overlay, but has one layer of shingles.
- * Due to the height of the roof, the roof was not viewed from its surface, but was viewed from the ground and with a drone.
- * The metal flashing at the chimney was not secured properly, and can allow wind-blown water to enter the living space. The flashing needs to be resecured to the roof.
Obtain Cost Estimate

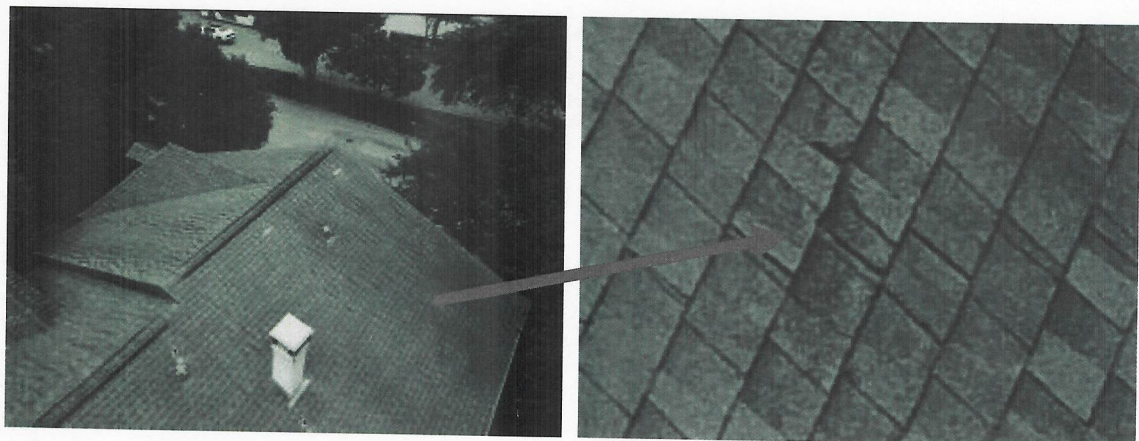
- * Damaged shingles were observed at the rear north area of the roof. The damage appeared to be related to tree branches rubbing the roof surface. It is recommended to replace the damaged shingles.
Obtain Cost Estimate

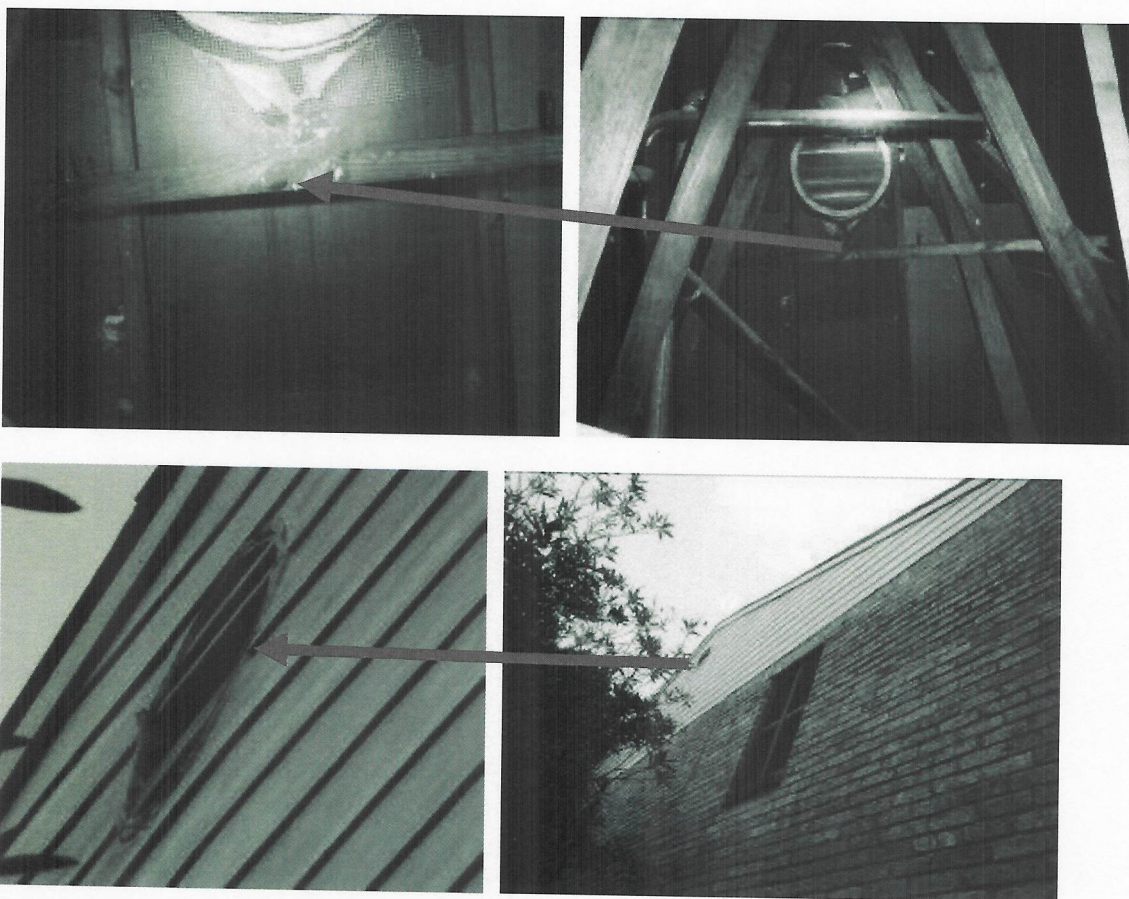
1. North gable vent, where water stains were observed below the gable vent. The source of the water penetration appears to be related to the damaged gable vent. It is recommended that the cause of the water penetration be determined, and the necessary repairs made to stop the water penetration, and repair any secondary damages.

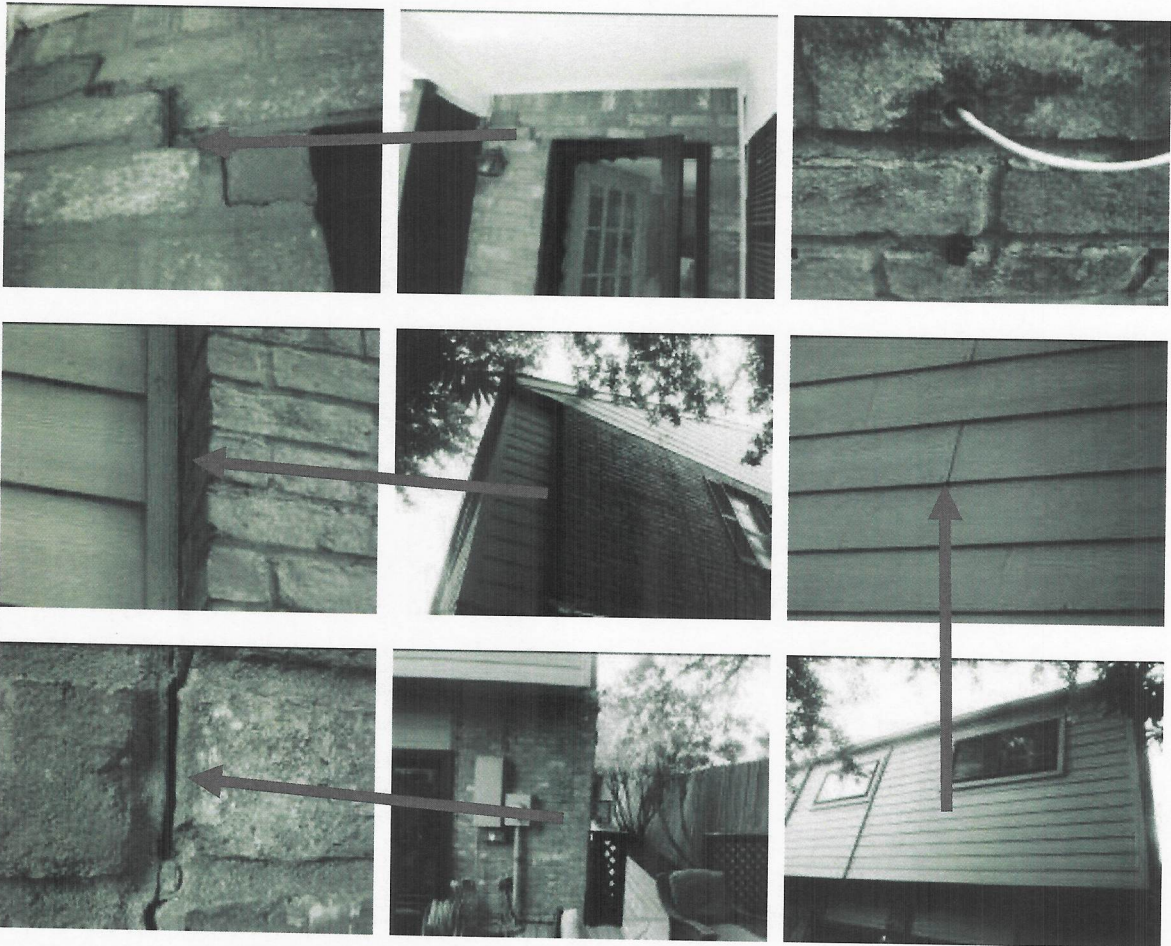
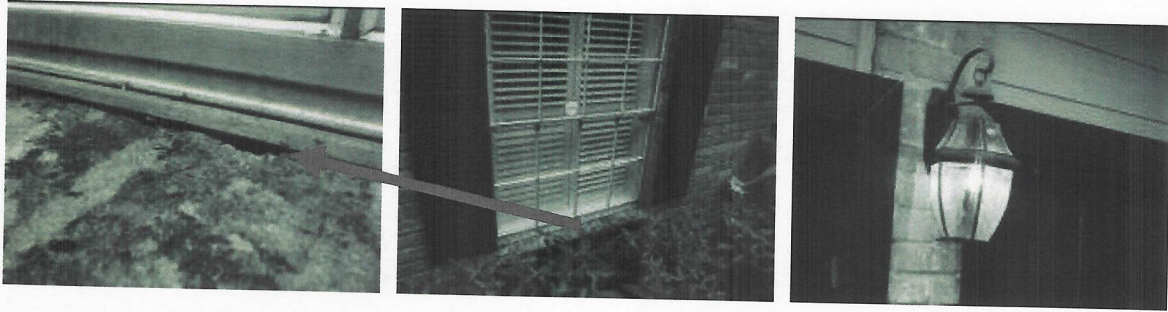
A substantial vulnerability to water penetration was observed at penetrations/openings through the exterior building envelope, and it is recommended that all penetrations/openings be sealed against water penetration. Below is a representative sample of locations and/or photographs showing some, but not necessarily all, locations where there is a vulnerability to water penetration.

- The exterior light fixtures have not been caulked.
- Windows and doors where the caulking was cracked and/or missing.
- Piping penetrations.
- Wiring and/or conduit penetrations.
- The brick veneer, where cracks were visible that can allow water penetration.
- Joints in between the brick veneer and the siding.
- Vertical joints at the siding.

Have a contractor provide a cost estimate to seal all vulnerable areas against water penetration.

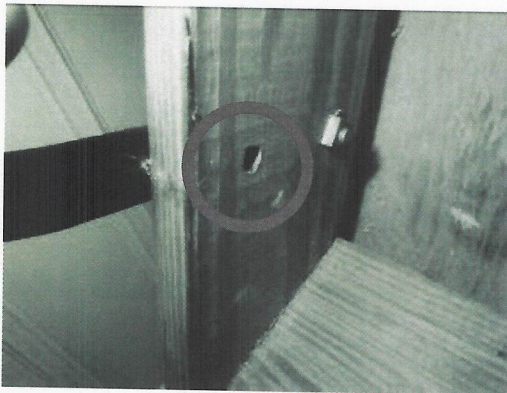
The stair assembly was not properly installed or secured to the framing members, and repair is needed for safety purposes. The condition(s) can be a safety hazard, and repair is needed, as an improperly installed stair assembly can possibly collapse. Defective conditions we observed included the following:

- The hardware for the ladder was missing some nuts and/or bolts, and the missing hardware needs to be replaced.

- The nuts and bolts securing the ladder were loose and the nuts and bolts need to be tightened.

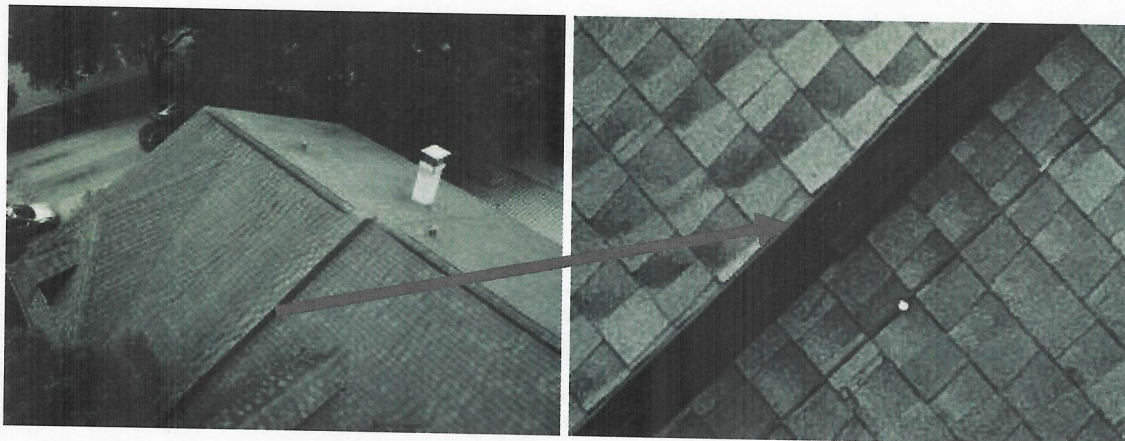
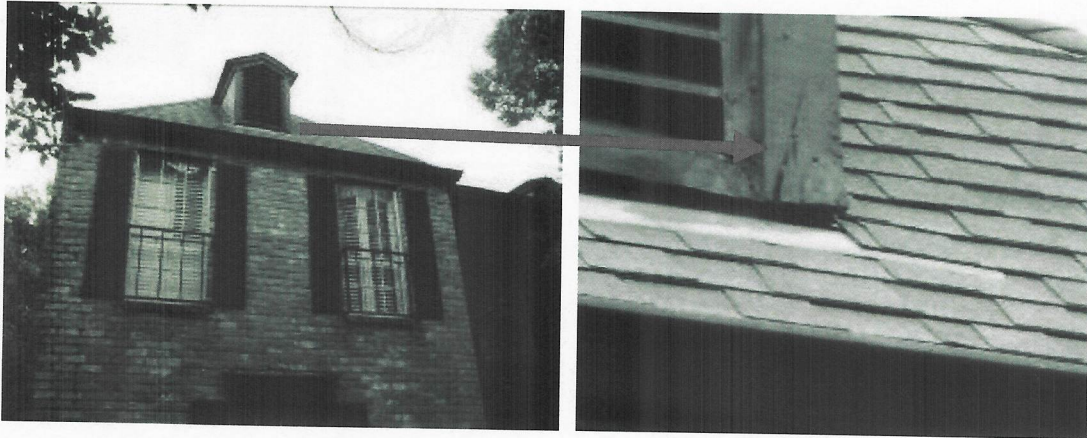
Wood rot was observed and it is recommended that the damaged wood be replaced. It is pointed out that additional damage could be present under the rotted material that will not be visible until the outer rotted materials are removed.

Locations included: Fascia board at the roof intersections, and wood trims around the front gable vent.

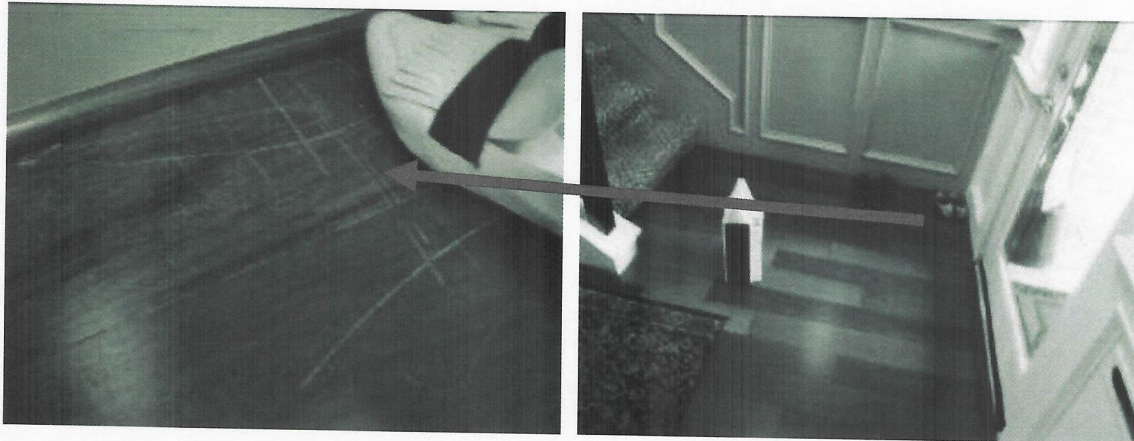
Scratches were observed on the wood floor at the foyer area and the living room area.
Obtain Cost Estimate

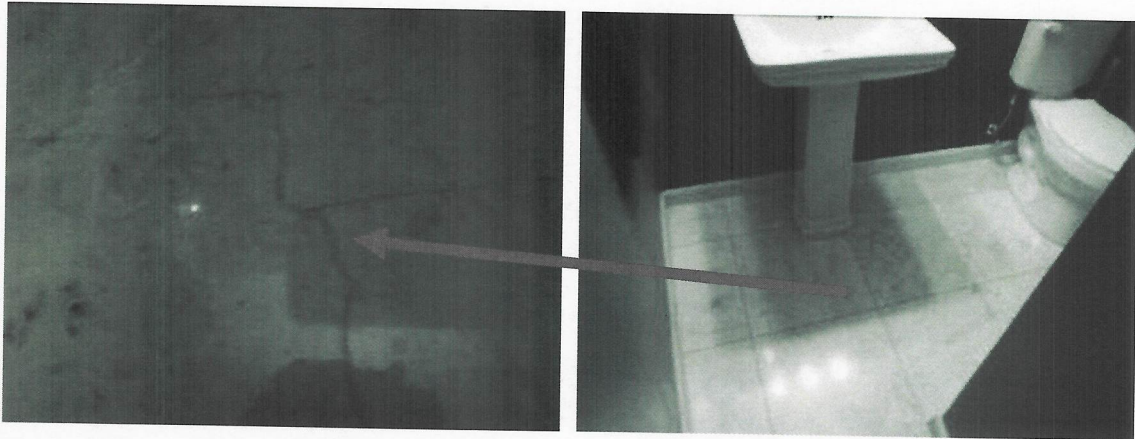
Floor tiles were cracked at the powder room.
Obtain Cost Estimate

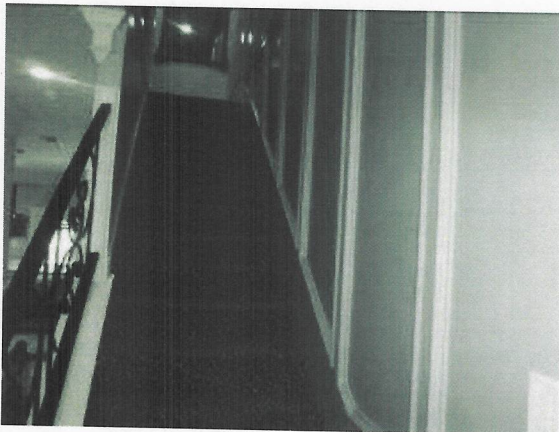
No handrail was present at the stairway, which can be a hazardous condition, and it is recommended that a handrail be installed for safety purposes. Handrails are required whenever a flight of stairs has four or more risers.

R311.5.6

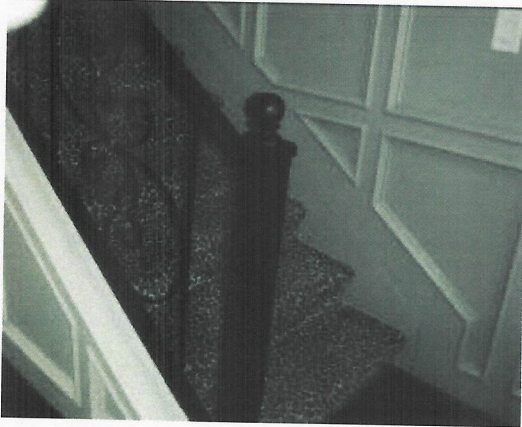
The guardrail was not constructed according to the current building code standards. Therefore, the width between the balusters is greater than four inches.

R312.2 Guard opening limitations

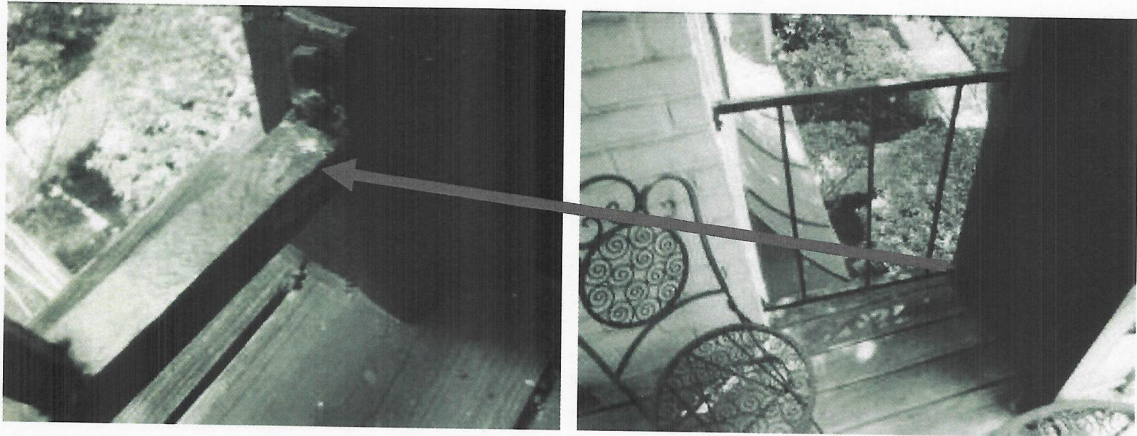
The metal guardrail was rusted. It is recommended the rust be cleaned and the guardrail painted to prevent further damage.
Obtain Cost Estimate

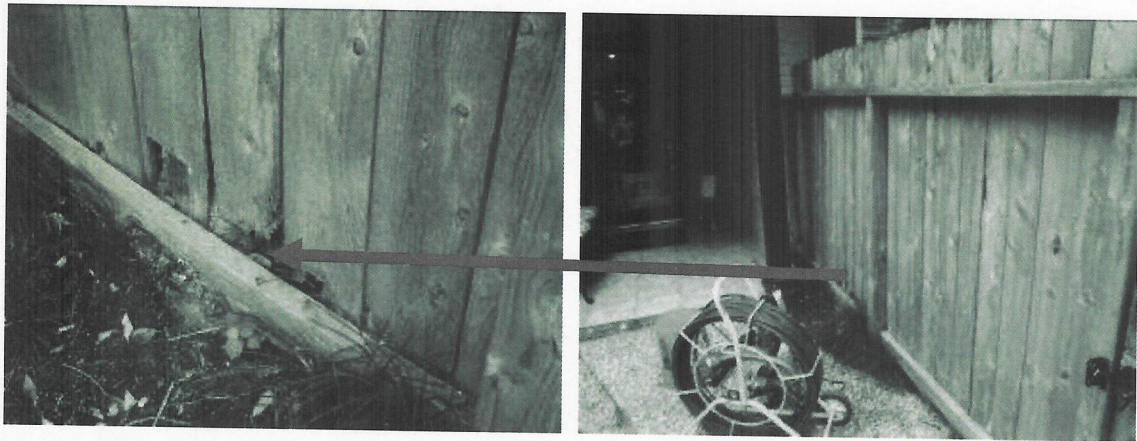
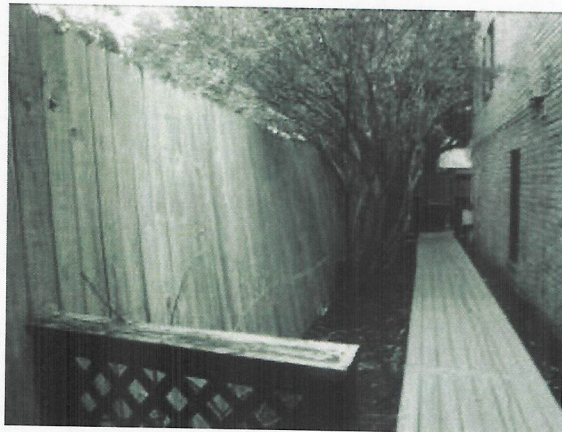
The wood fence had rotted boards and was leaning at some areas. The fence is in need of repairs.
Obtain Cost Estimate

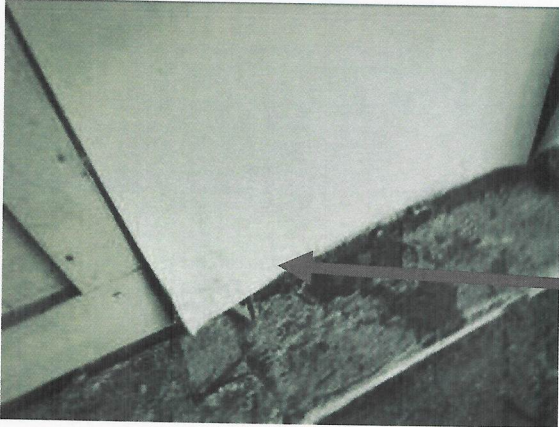
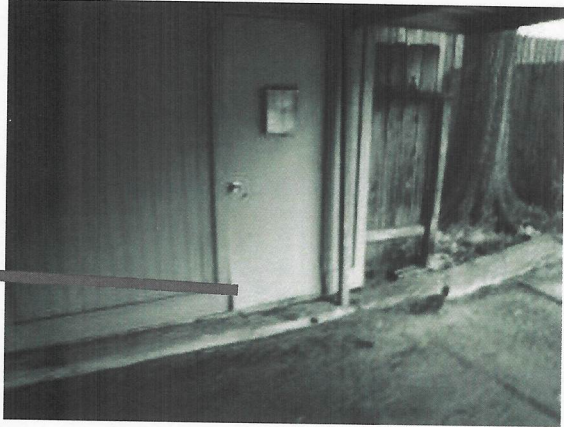
The shed door was damaged and it is recommended to be repaired.
Obtain Cost Estimate

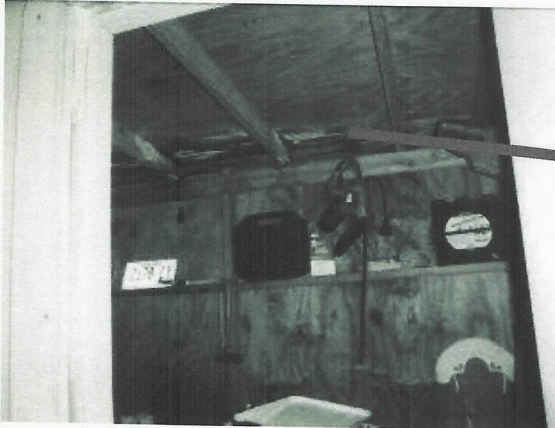
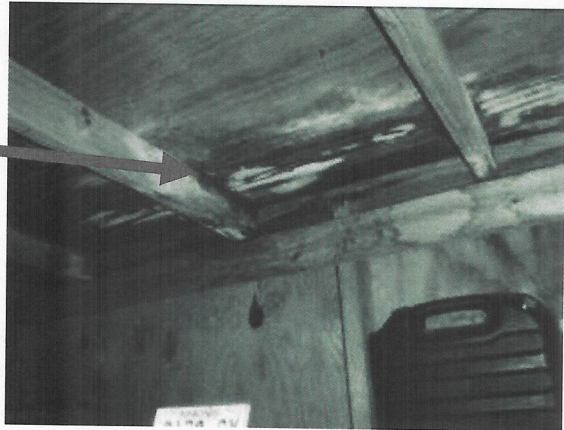
The roof decking of the shed was rotted due to roof leaks. It is recommended provide the needed repairs.
Obtain Cost Estimate
