PROPERTY INSPECTION REPORT

Concerning: 3601 Wakeforest Street, Houston, TX 77098
(Address or Other Identification of Inspected Property)

By: Daniel Koteles #21157 05-29-18
(Name and License Number of Inspector) (Date)

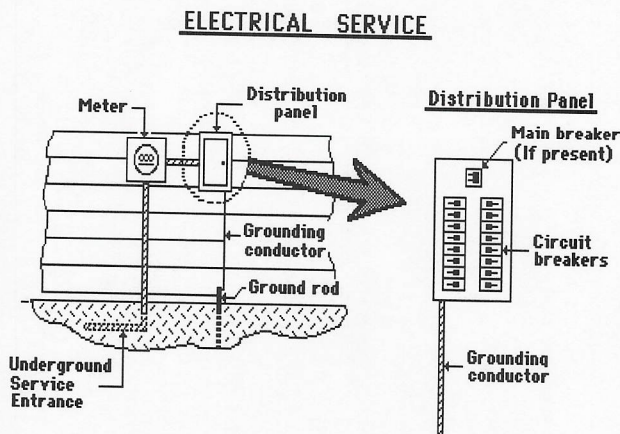
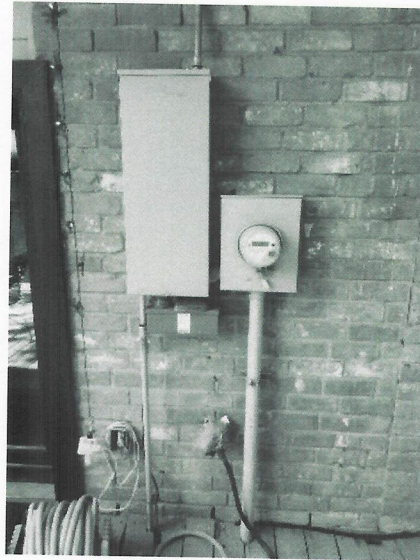
The ground rod was sticking out of the ground a few inches, and, since ground rods are typically 8 feet long and all 8 feet of the rod are required to be in the ground, it is recommended that the ground rod be pounded down flush with the top of the ground. The clamp on the rod should be an acorn clamp is approved for direct burial in the ground.

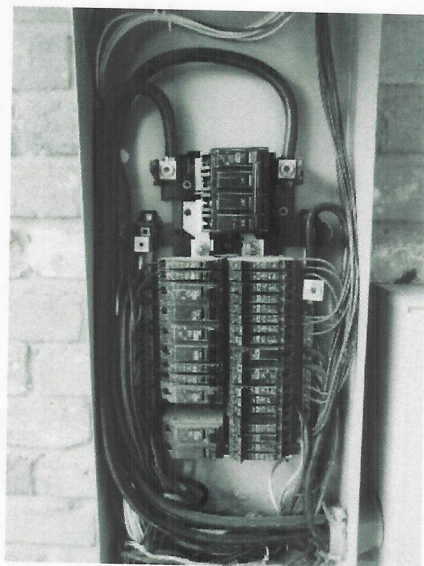
The breaker panel(s) did not contain any Arc Fault Circuit Interrupters (AFCI's). This is an "as-built" condition, that does not meet current building code standards. AFCI's devices are intended to protect against fires caused by electrical arcing in the wiring, by shutting off the power to the circuit when an electrical arc is detected in the circuit. Homes built prior to 2002 were not required by the National Electrical Code (NEC) to be protected by AFCI's. Since this house was built prior to 2002, the breaker panel is "grandfathered", and is not required by the NEC to be equipped with AFCI's. However, you may want to consult with an electrician and consider having the combination type AFCI's installed for safety purposes.

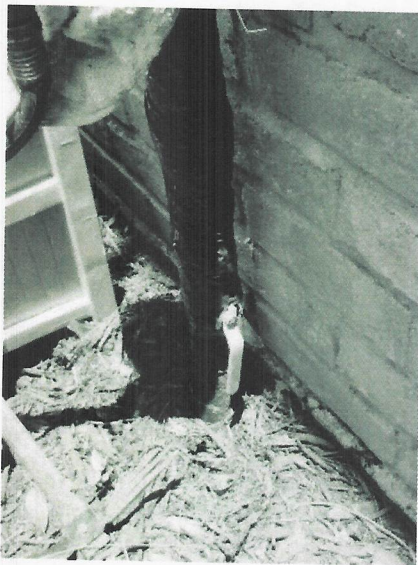
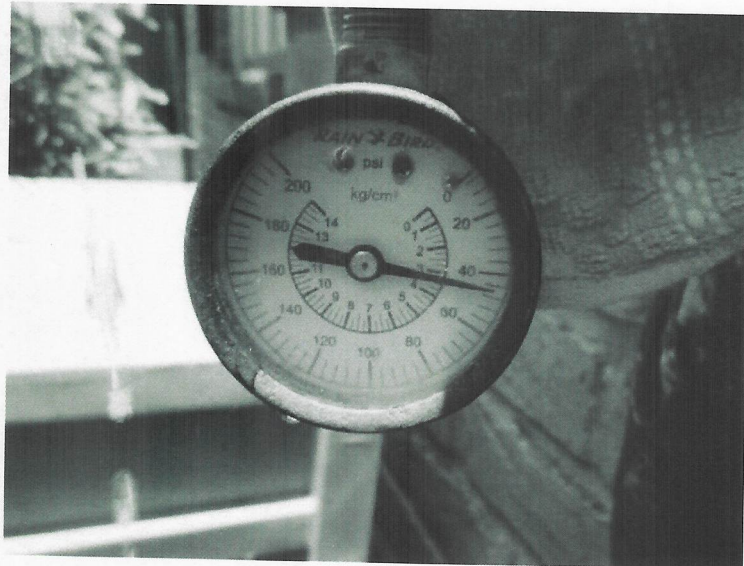
The shut-off valve for the main inlet water line was located at the exterior of the house at the front of the house.

The water pressure to the house at the time of the inspection was checked with a pressure gauge at the hose bibb nearest the shut off valve, and the pressure was observed to be 50 psi.

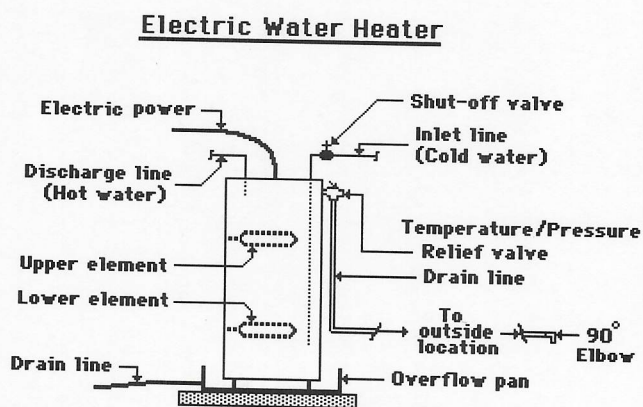
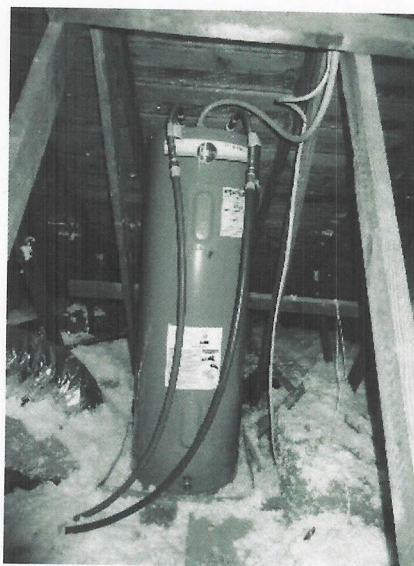
The temperature of the hot water was measured to be 134 degrees at the kitchen sink at the time of the inspection. Normally, 120-125 degrees is the recommended maximum temperature of hot water to prevent accidental scalding. See the chart below for more information about hot water burns, as taken from the International Residential Code, 2006.

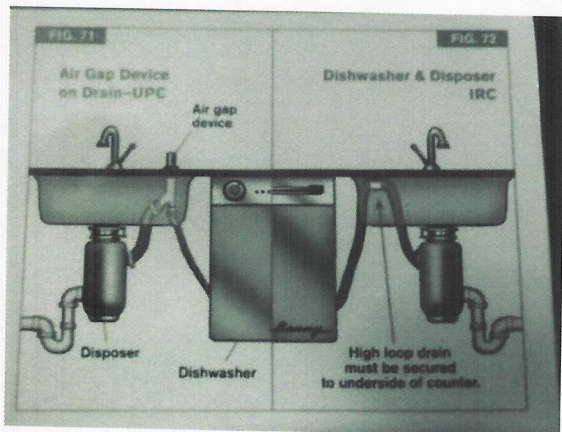
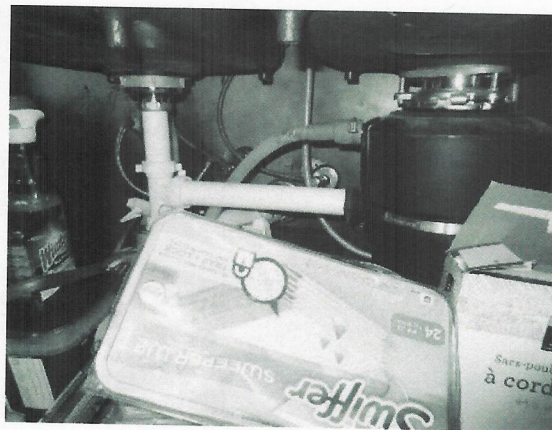
The drain line under the sink was looped up so that the top of the loop was higher than the point where the drain line connected to the disposal. This will help to prevent garbage from running down the drain line into the dishwasher.
