9515 Chaddington Ct
Tomball, TX 77375

PROPERTY INSPECTION REPORT

Concerning: 9515 Chaddington Ct, Tomball, TX 77375
(Address or Other Identification of Inspected Property)

By: Joe Budzinski, Lic #23245 06/17/2019
(Name and License Number of Inspector) (Date)

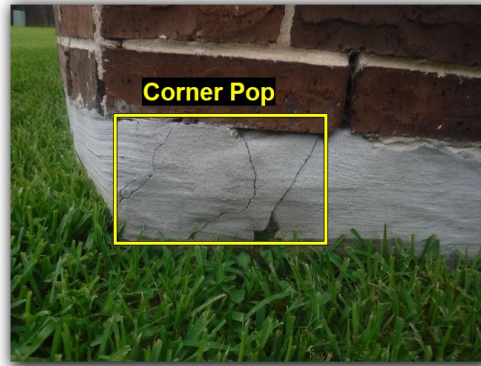
Spalling (i.e., corner pops) at one or more corner(s), Corner spalling is common to slab foundations and does not affect the structural integrity of the foundation.

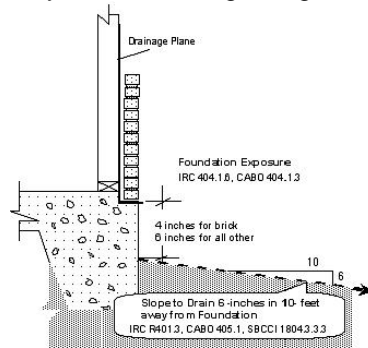
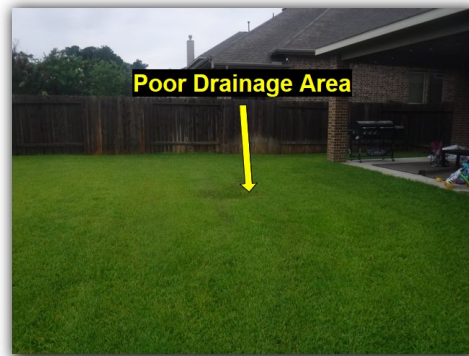
Observed the grading did not slope away from the home in one or more areas around the exterior. Current standards call for the grading to slope away from the home at least 6 inches per 10 feet. This is to prevent water from pooling close to the foundation which can cause damage. Remedies may include adding rain gutters, French drains or re-grading around the home.

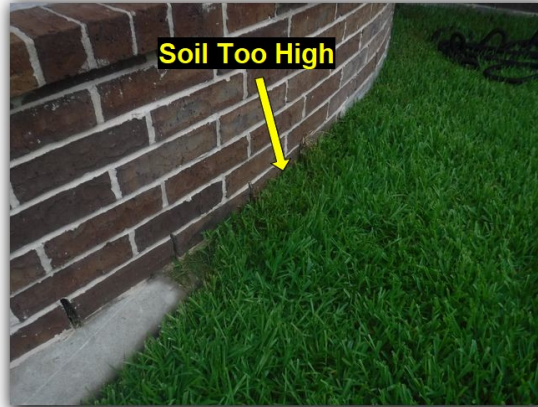
Observed soil levels too high around the foundation in one or more areas. High soil levels are considered a conducive condition to termite activity and water penetration.

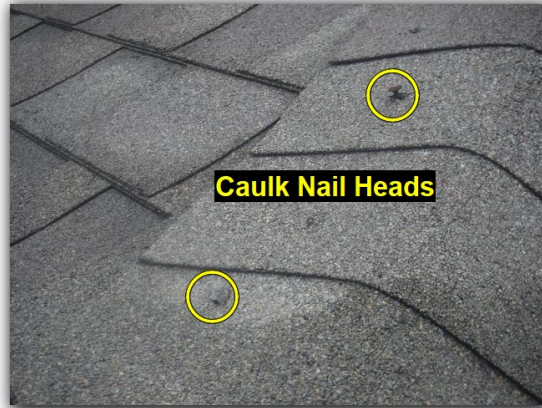
Observed one or more exposed nail heads that need to be caulked.

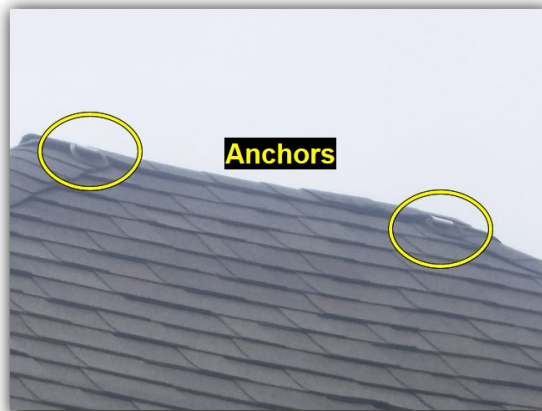
Observed roof anchors attached to the roofs surface. This is common to find and usually does not effect the roofs ability the shed water.

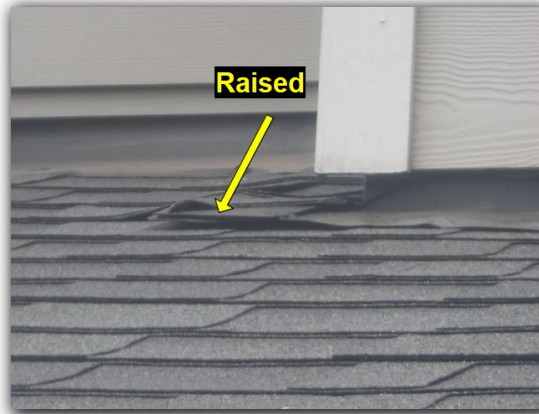
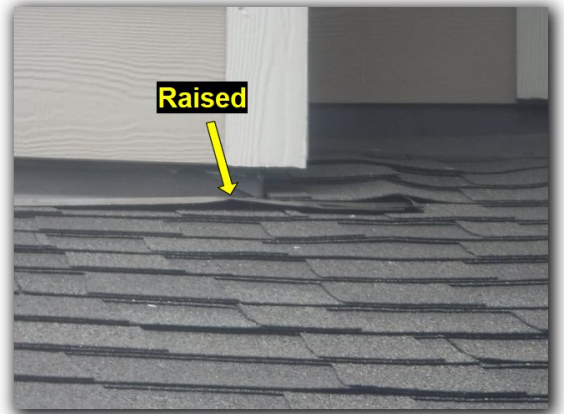
Observed bent/raised flashing in one or more areas. Recommend securing all flashing to prevent water penetration from wind driven rain.

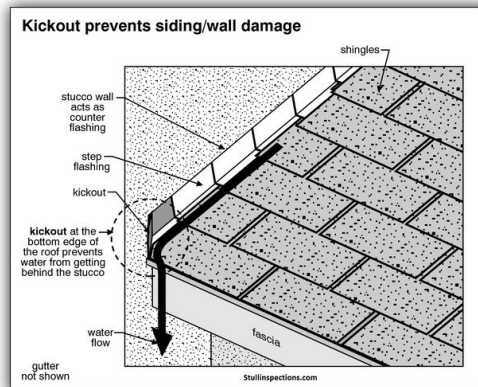
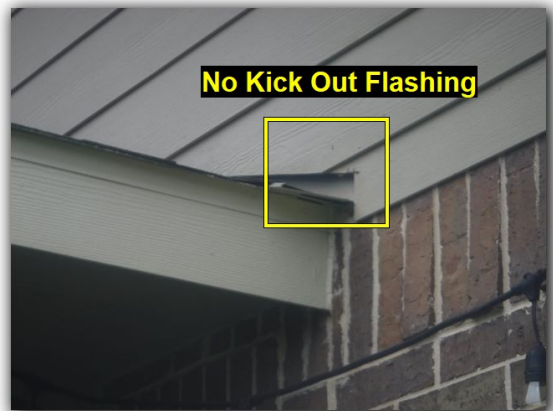
Did not observe kick out flashing installed in one or more areas. Kick out flashing is most important when the siding is made of stucco (this home has brick siding). I have never observed a problem with the lack of kick out flashing on a brick home, but current standards call for kick out flashing to be installed as a preventative measure.

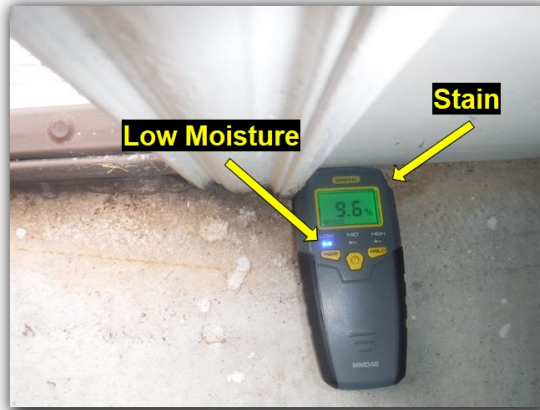
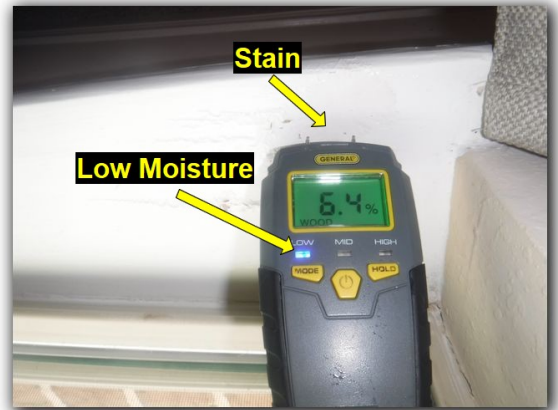
Observed water stains on the wall in the garage beside the walk-thru door leading from the garage to the back yard and master bedroom window sill. Moisture readings were low at time of inspection which usually indicates the stains are from previous leaks, but I could not be certain. Recommend asking the seller about previous leaks that may have been repaired or having further evaluation by a contractor.

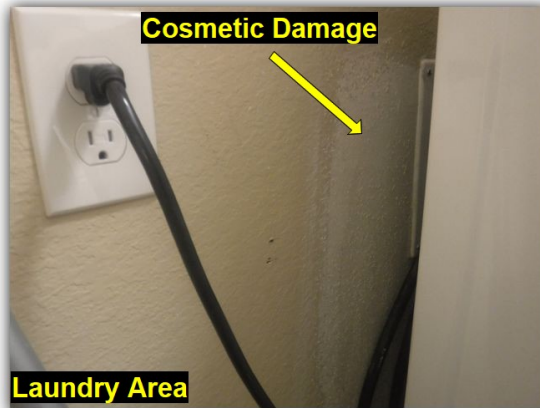
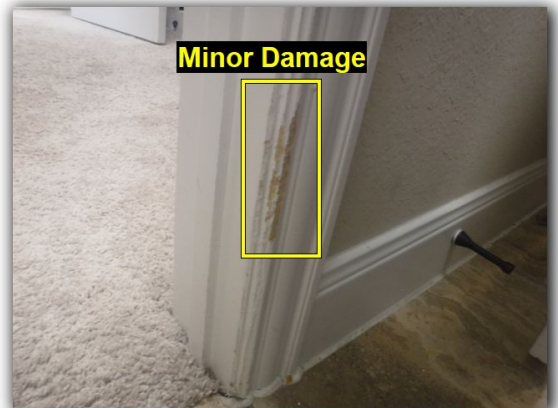
Observed minor cosmetic issues.

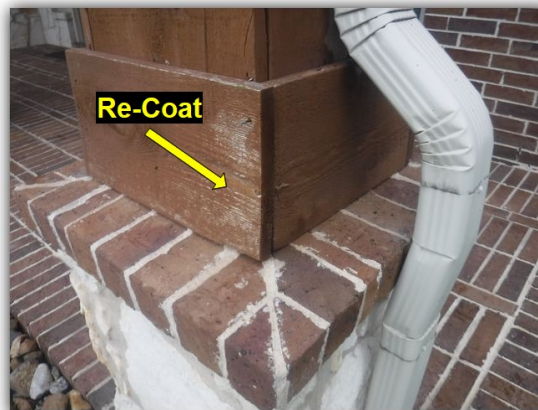
Observed wood deterioration to multiple areas of the trim boards. Recommend coating with a weather resistant coating to slow the deterioration process.

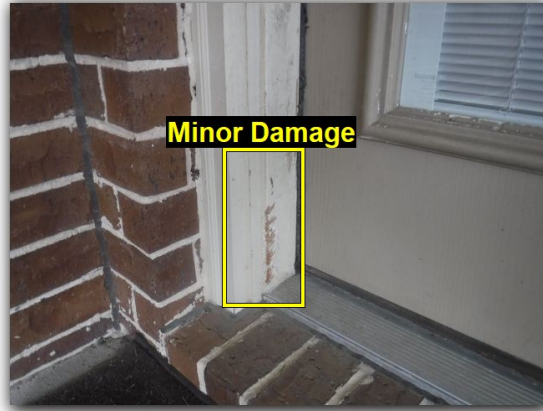
Observed minor damage to exterior door trim boards in one or more areas.

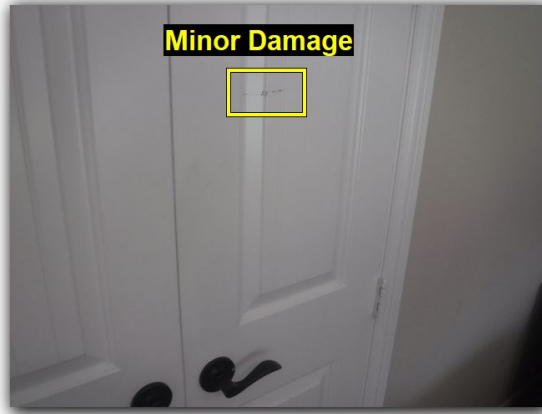
Observed minor cosmetic damage to one or more doors.

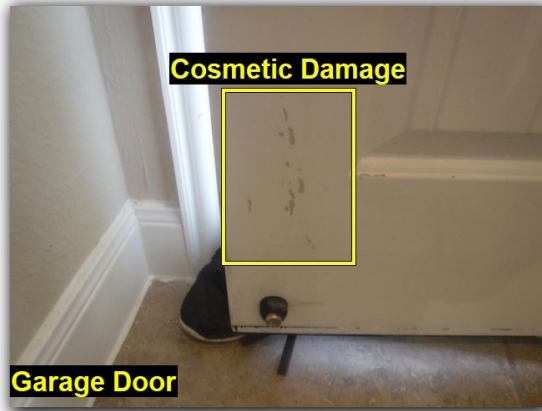
Observed minor cosmetic damage in one or more areas.

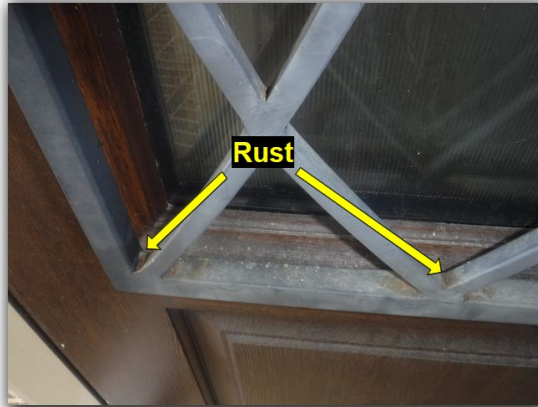
Observed the front door decorative grill is beginning to rust. Recommend coating with a weather resistant coating to slow the deterioration process.

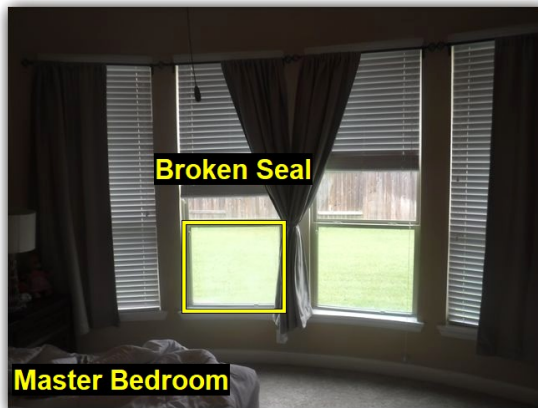
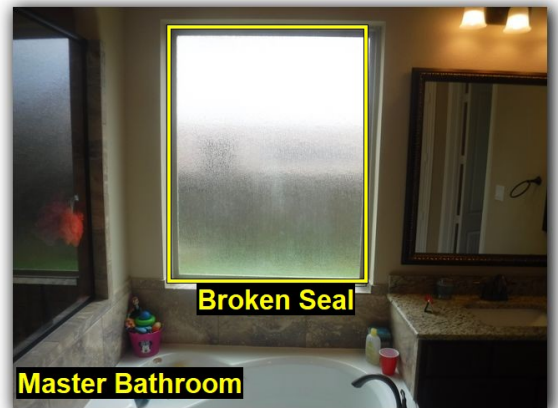
Observed the thermal seal was broken on one or more windows. A broken seal allows condensation to form between the panes which causes a cloudy film to develop. This cloudiness will continue to get worse until it is difficult to see out of the window.

Note: It is sometimes difficult to determine if a seal is broken. Recommend consulting a window professional to determine the exact number of broken seals.

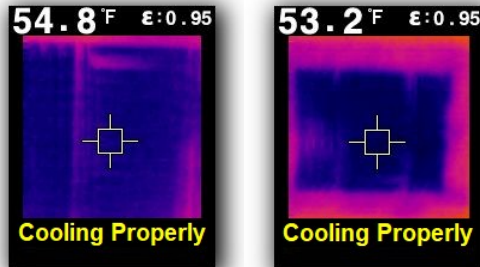
A thermal image of the air vents show the air conditioning unit(s) was / were cooling properly at time of inspection.

TEMPERATURE DIFFERENTIAL: 18 degrees (73, 55) **GOOD**

TEMPERATURE DIFFERENTIAL: 18 degrees (71, 53) **GOOD**

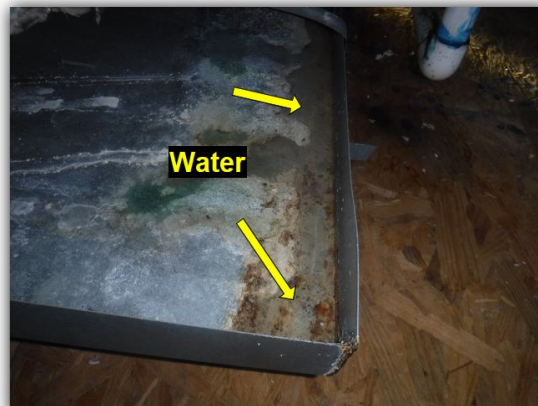
Observed water in the drain pan. This usually means the primary line has become clogged or blocked. Recommend further evaluation by a licensed HVAC technician.

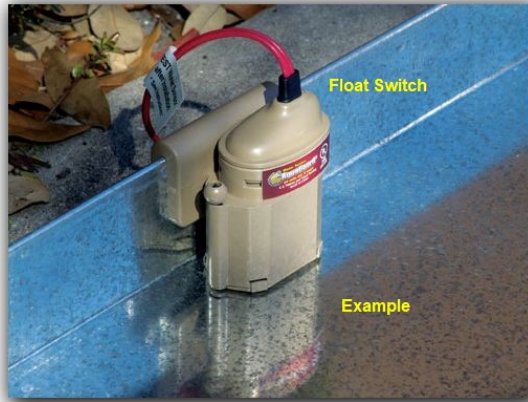
Did not observe a float switch installed for the A.C. drain pan. Although not required, I recommend adding a float switch to help prevent accidental flooding of the attic if a leak occurs.

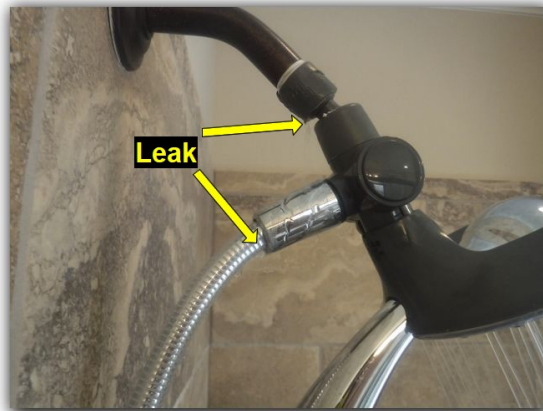
Observed the showerhead leaking in the master bathroom shower. In need of repair.

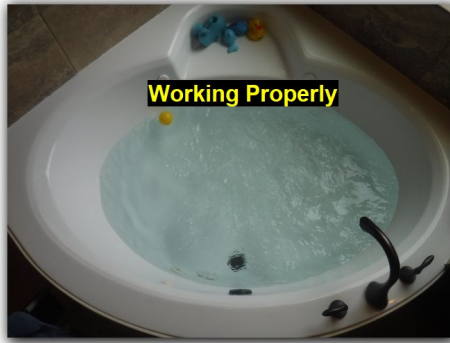
Was not able to access motor for visual inspection. Current standards call for hydro massage bathtub electrical equipment to be accessible without damaging the building structure or building finish.

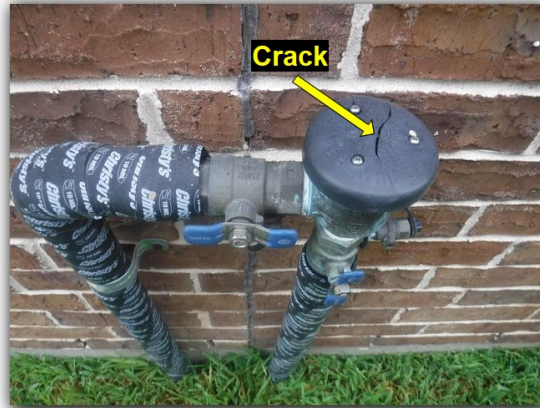
Observed a crack in the top cover of the sprinkler back flow valve.
