NationSpec Home Inspection

23615 San Servero Dr, Katy, TX 77493

Date of Inspection: 4/13/2022 Time: 2:00 PM

PROPERTY INSPECTION REPORT

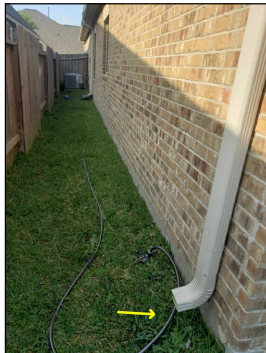
B.2. Missing downspout splash blocks noted in multiple locations

Right side grade, missing splash blocks in multiple locations

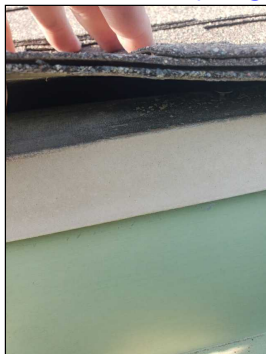
C.5. Underlayment was not covering drip edge and/or is installed under the drip edge at one or more eaves. Underlayment shall be installed over the drip edge along the eaves and under the drip edge along the rakes.

Underlayment not properly installed over drip edge

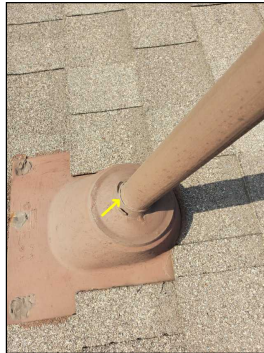
Recommend adding sealant to all plumbing vents at the boot/pipe interface

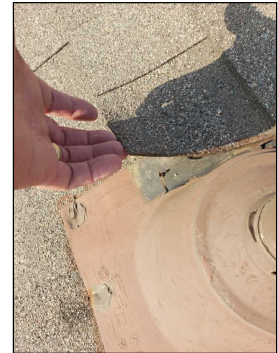
C.4. Flashing repairs, paint, and/or sealant need in areas, (See photos). Recommend repairs by a qualified roofing contractor.

Some shingles would lift up around vent flashing, needs sealant

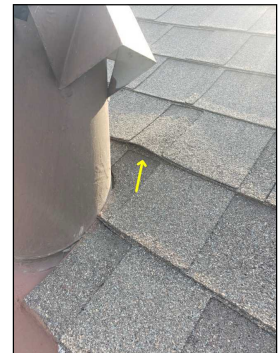
C.3. Some shingles appear loose, missing, damaged, not properly adhered, curling and/or lifting at one or more areas. See photos

Nail pop noted

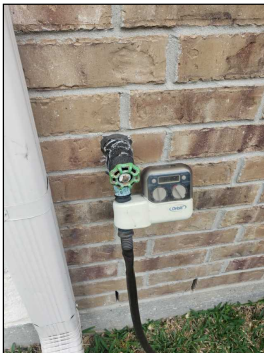
E.5. The areas between the exterior cladding / veneer and ALL wall penetrations need to be properly sealed such as utility connections, downspouts, hose bibs, lighting fixtures, receptacles, etc with an exterior grade elastomeric sealant

Right side, properly seal all wall penetrations

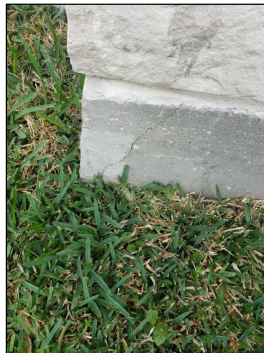
A.3. Corner Pop observed. This is not a structural issue. It is caused by the thermo-expansion of the brick and that expansion of the brick, cracks the corner of the foundation which is the weakest area. Recommend repairing this area with an approved material for this type of application (generally "epoxy based cement")

Front right, corner pop noted

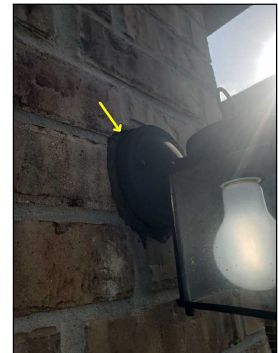
Front, reseal around outdoor light fixture

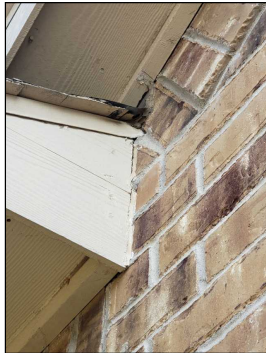
E.2. Elastomeric caulking improvements are recommended between the exterior veneer and the window frames. See photos.

Front, needs caulking improvements

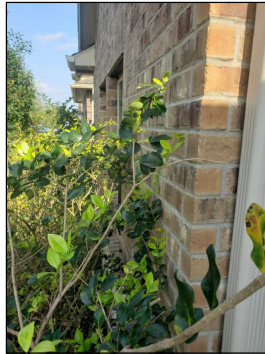
E.1. NOTE: The heavy foliage growing on, over or around the exterior walls of the structure should be trimmed back at least {18"}. The heavy plant material may limit the Inspectors visual observation of the existing surfaces

Front, heavy foliage noted

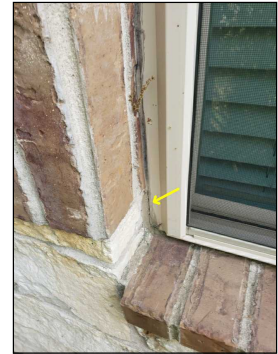
Front, needs caulking improvements

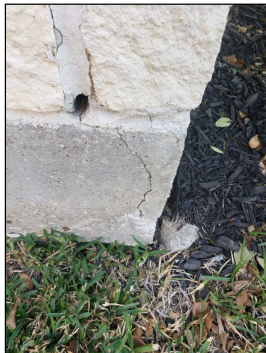
Front left, corner pop noted

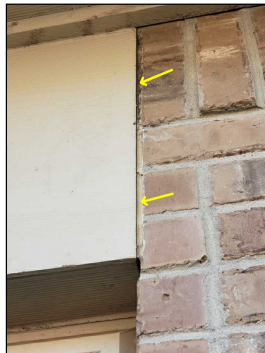
Left side, needs caulking improvements

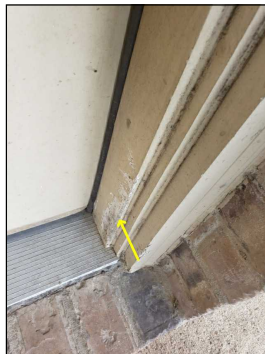
E.6. It was observed that one or more areas of the exterior surfaces was in need of repair and/or painting

Back side, pet damage noted and needs paint

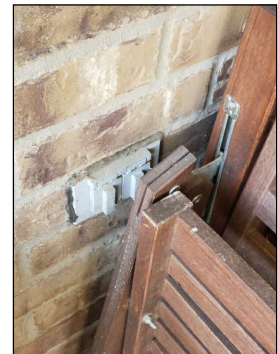
Back side, ALL outdoor outlets should have bubble covers and caulked around base

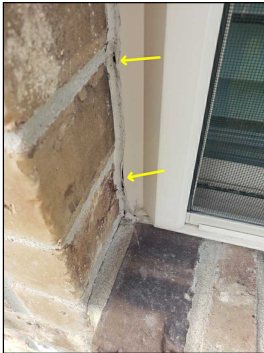
Back side, needs caulking improvements

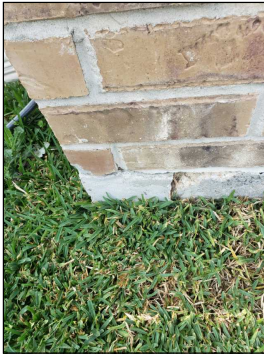
Back right, corner pop noted

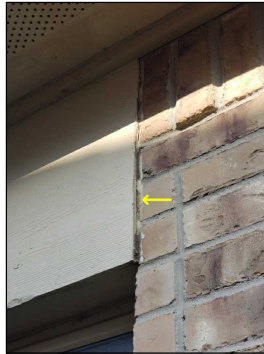
Right side, needs caulking improvements

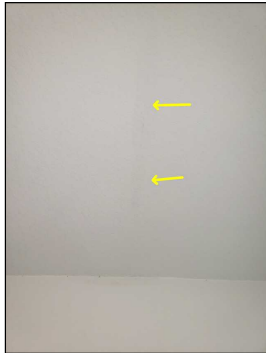
F.2. Possible water stains were observed on the ceiling. The cause and remedy should be further evaluated and corrected as necessary

Primary bathroom, possible water stain noted

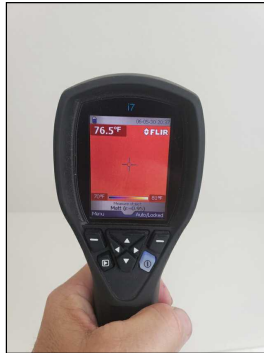
Area appeared dry at the time of inspection using infrared camera

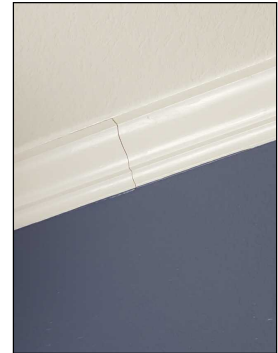
Primary bedroom, caulking cracks noted

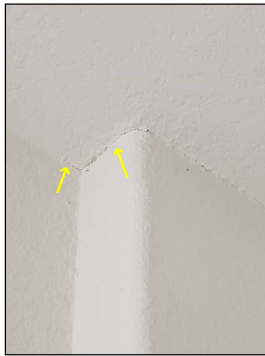
F.1. Ceiling stress and/or joint cracks were observed

Hall bathroom, sheetrock cracks noted

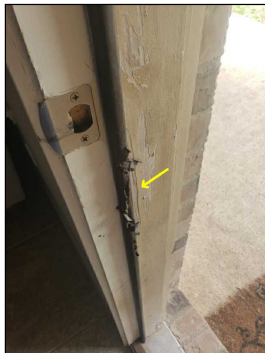
G.1. Exterior doors at one or more locations were observed to need proper weatherstripping and/or bottom sweep

Back door, damaged weather stripping noted

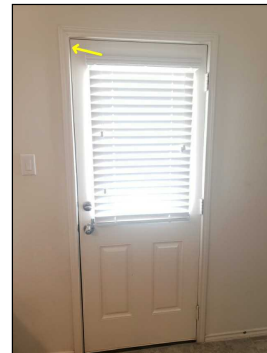
G.2. Some doors were observed to be sticking, not closing properly, out-of-level, frame damage or missing and/or non-functional hardware

Back door sticks at top

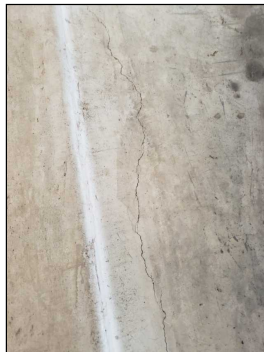
K.1. Cracking was observed in the concrete garage or patio surface

Minor cracks in garage floor noted

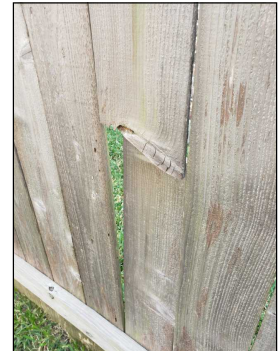
L.1. One or more wood pickets damaged, partially detached, and/or missing in fence line

Damaged pickets noted

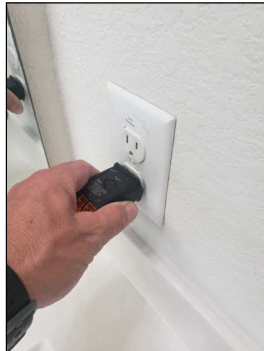
B.1. One or more outlets were loose in wall and should be corrected

Primary bathroom, outlet is loose in wall and should be corrected

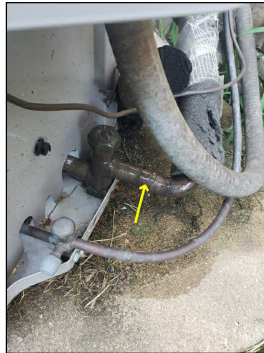
B.3. Refrigerant lines are missing insulation at the **A/C** unit

Missing insulation noted

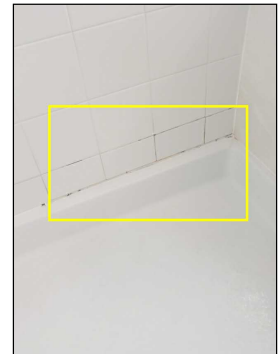
A.3. Missing and or damaged grout was observed in the shower area and should be corrected to avoid future water penetration

Primary bathroom shower, damaged grout noted

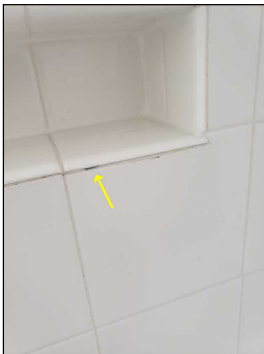
Hall bathroom, cracked or missing grout noted

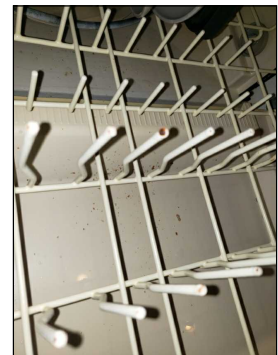
A.2. Some rusting and/or corrosion was evident on the interior of the unit

Corrosion noted on dish racks

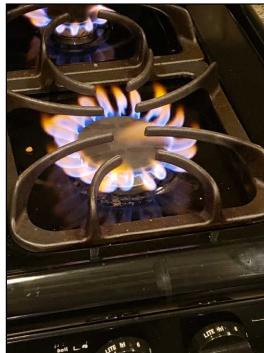
D.2. Orange flame on all burners noted and is the result of incomplete combustion and generation of carbon monoxide. Recommend further review by a appliance technician

Orange flame on all burners noted and is the result of incomplete combustion and generation of carbon monoxide. Recommend further review by a appliance technician
