# **Inspection Report**

**Property Address:** 23855 Single Oak St Spring Texas 77373

# PROPERTY INSPECTION REPORT FORM

AmeriSpec - HomePartners	4/19/2022	
Name of Client	Date of Inspection	
23855 Single Oak St, Spring, Texas 77373		
Address of Inspected Property		
Zachary T. Ramirez	24196	
Name of Inspector	TREC License #	
Name of Sponsor (if applicable)	TREC License #

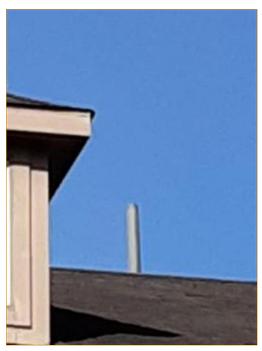
A. Item 7(Picture)

(4) Furnace would not function at time of inspection. Recommend that a qualified contractor evaluate all issues and repair as needed.
