# Inspection Report

# PROPERTY INSPECTION REPORT

Concerning: **1243 Creekside Acres Ct., Houston, TX 77008**

By: **Paul Ashlock - TREC#20340**

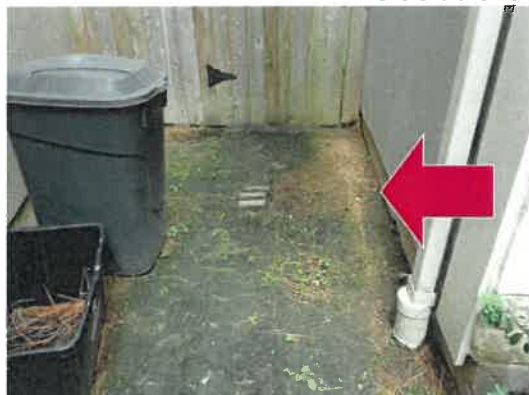
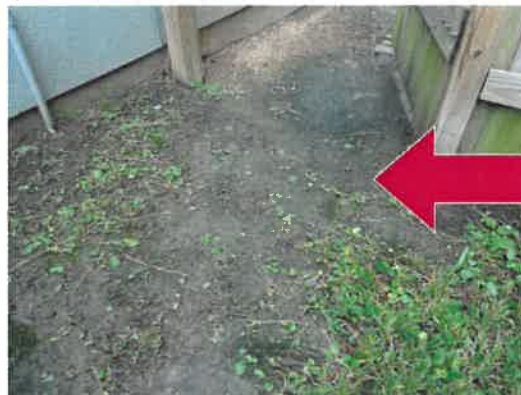
**Left side of the home**

**Yard area(s) next to the home's foundation appear to drain slowly- (standing water/grass not growing/moss growing) - This condition may cause the homes foundation to move and/or fail.**

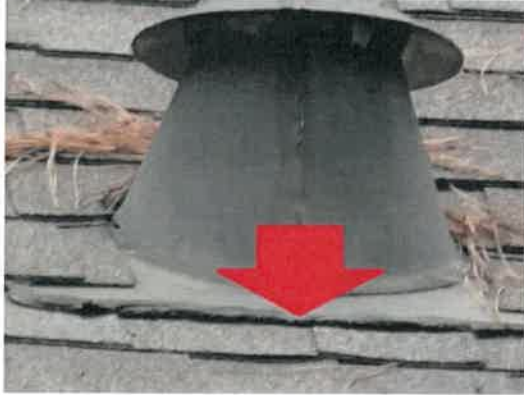
**Flashing/Roof Jacks need to be sealed up and nailed back down:  
Front of the home**

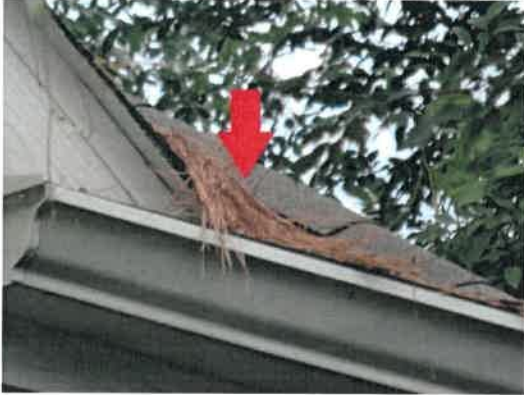
**Gutters full of debris: Around the home.**

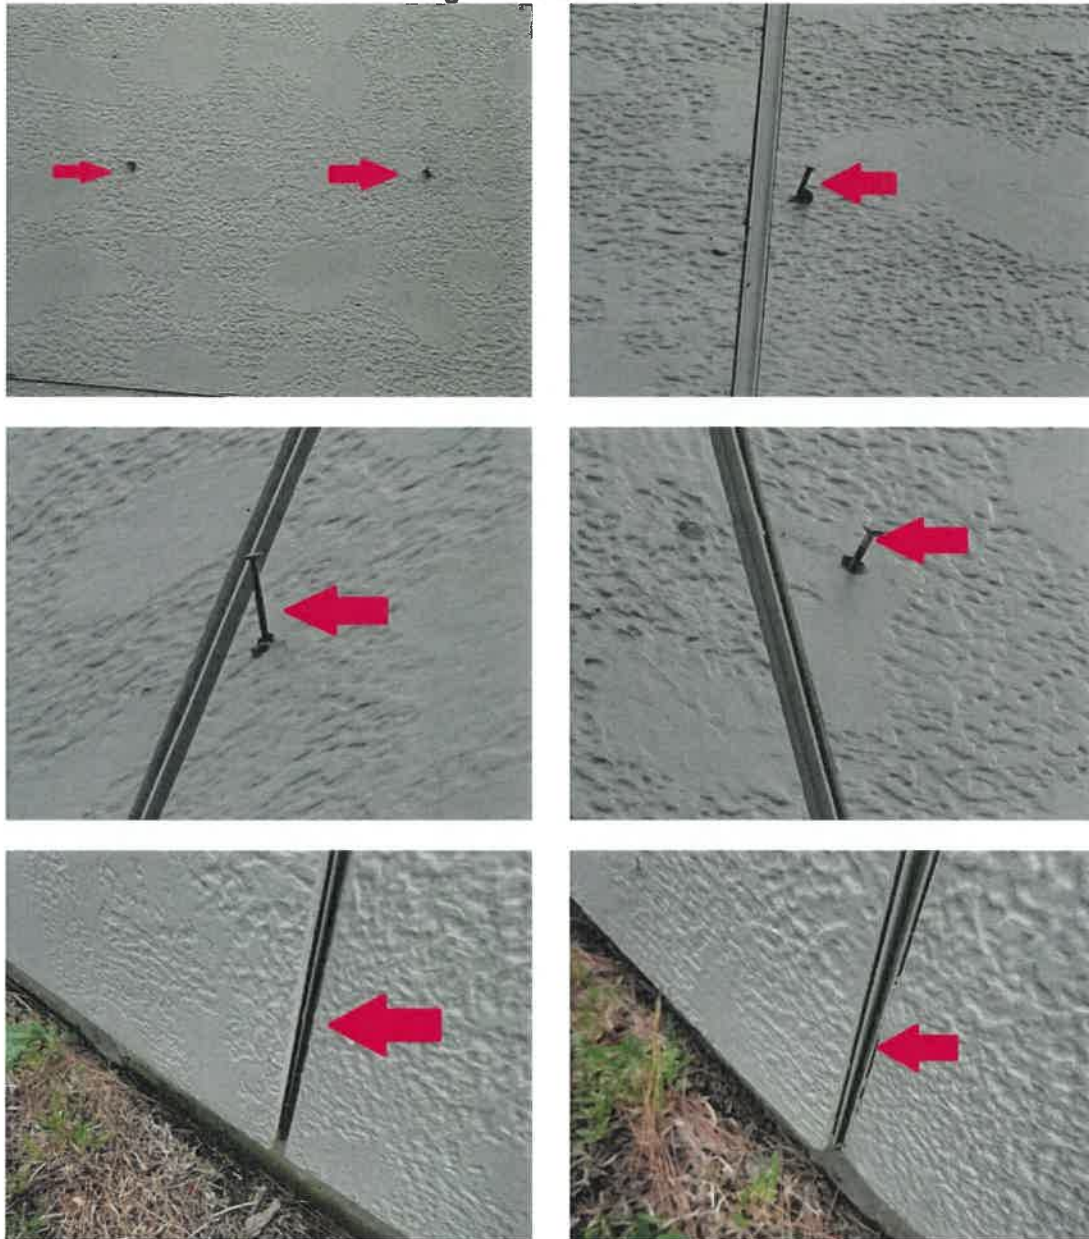
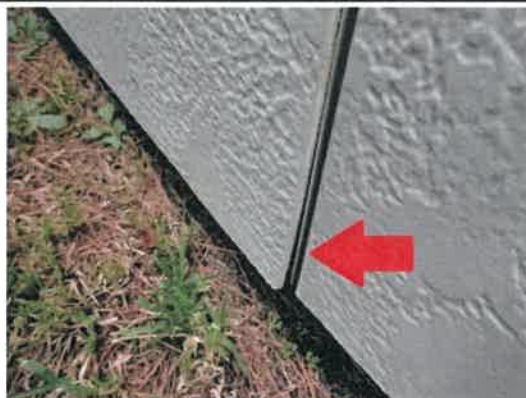
Left and right side of the home

**Exposed nails and siding need to be secured to the structure - Further evaluation and repairs is needed by a qualified contractor.**

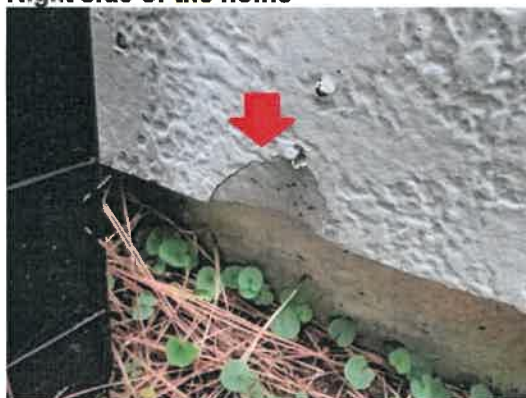
**Damaged Siding.**  
Right side of the home

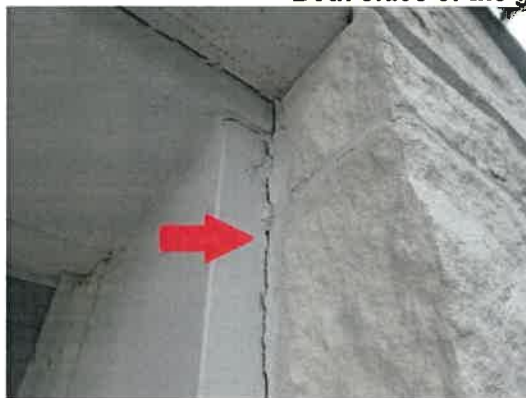
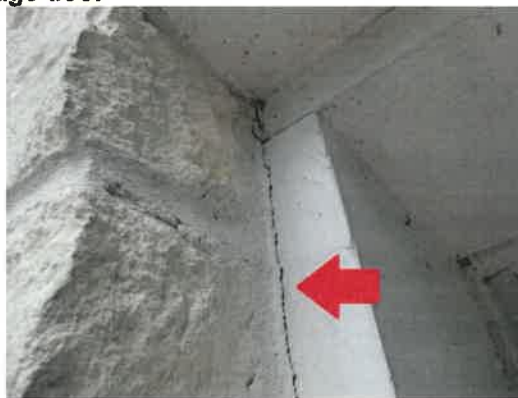
**Seal up siding/bricks around the home to prevent moisture penetration:**  
Both sides of the garage door

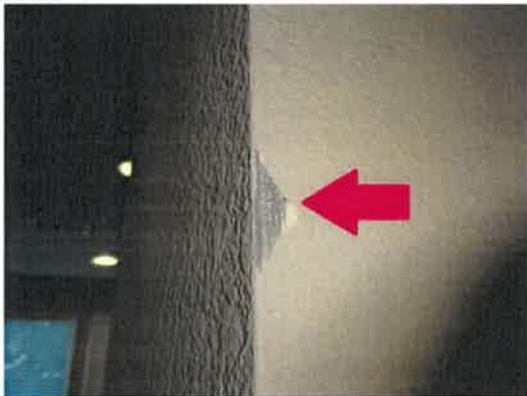
**Stair well**

**The interior walls were damaged at the time of the inspection.**

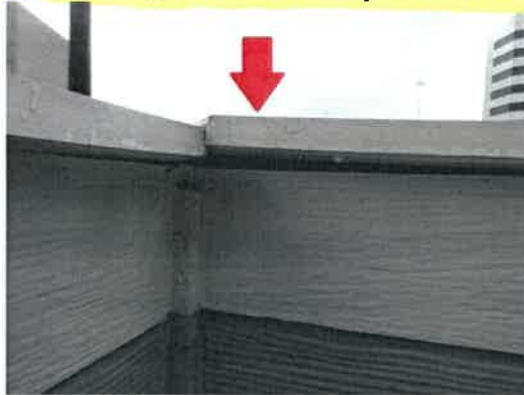
**Rail needs to be secured - Upstairs deck**

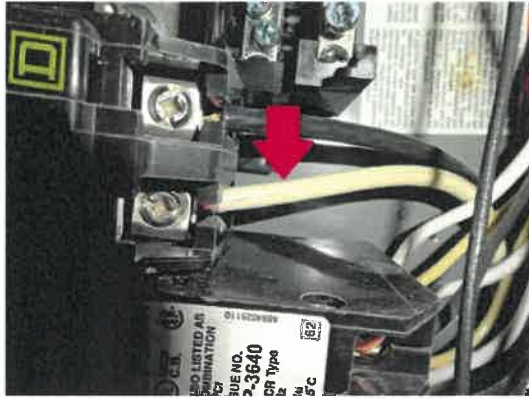
**The white A/C wire was not tagged with black tape or paint as required when a white wire is connected to a breaker.**

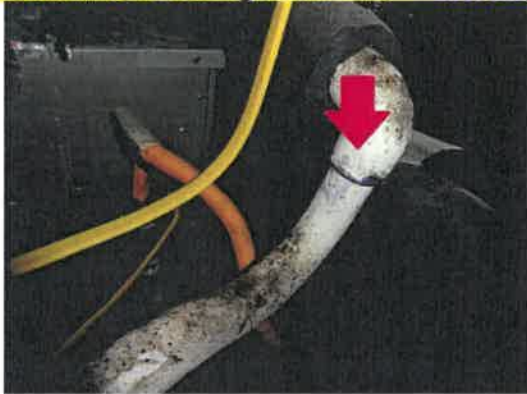
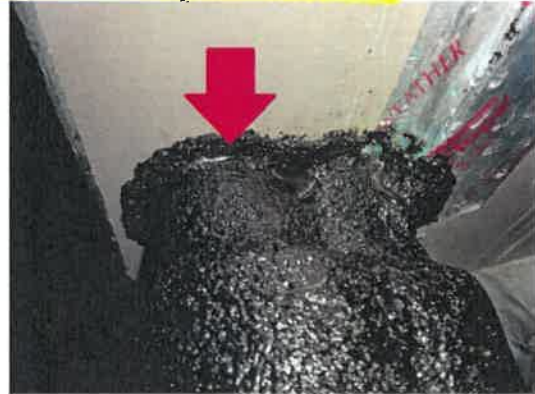
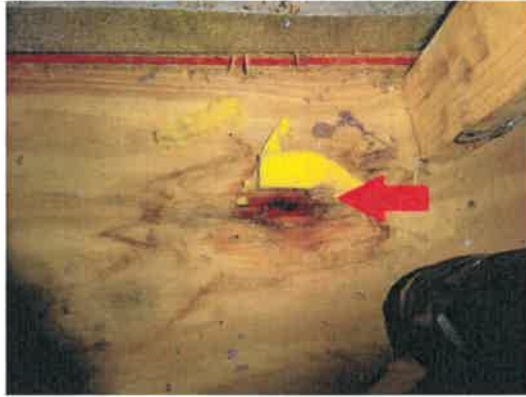
**3rd floor cooling system was inoperative at the time of inspection - Further evaluation is needed by a licensed HVAC Contractor.**

**Drain line is leaking in the attic - Further evaluation and repair sis needed.**

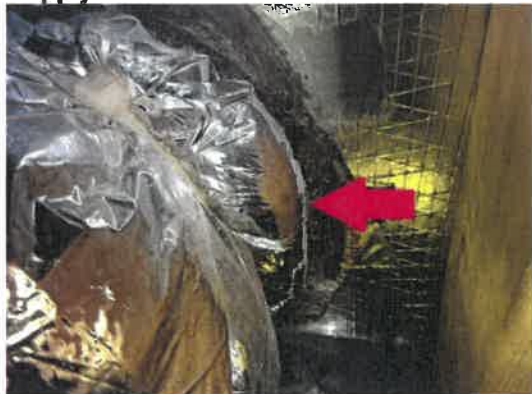
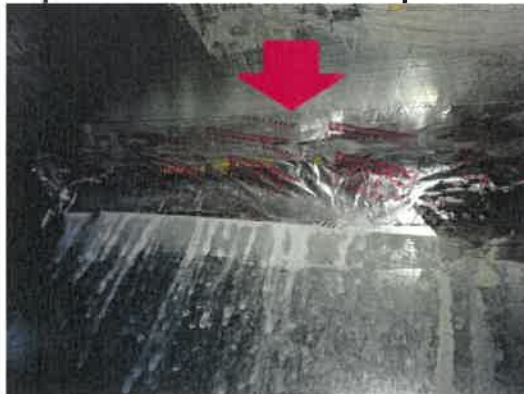
Supply box and duct hoses need to be sealed up - Further evaluation and repair si needed.
