1st Rate Inspections

Property Inspection Report

13292 Morgan Dr, Splendora, TX 77372
Inspection prepared for: Daniel Maestas
Real Estate Agent: David Kelley - AVO Realty, LLC

Date of Inspection: 5/22/2021 Time: 1:30 PM
Age of Home: 1960 Size: 2700
Order ID: 18397

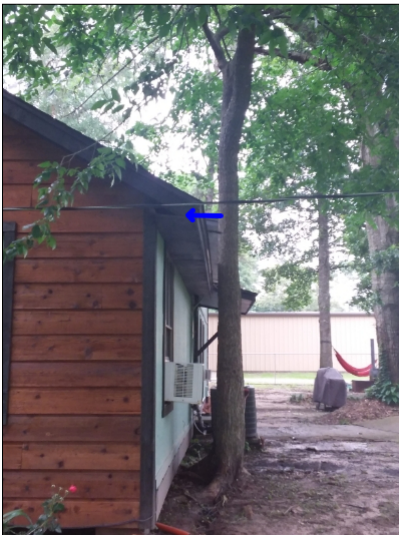
-All trees should be located no closer than 15' from structure to help prevent foundation movement. You may want to keep larger trees trimmed to help slow further root growth and future foundation movement as removing older trees may cause voids under the slab from dyeing root systems.

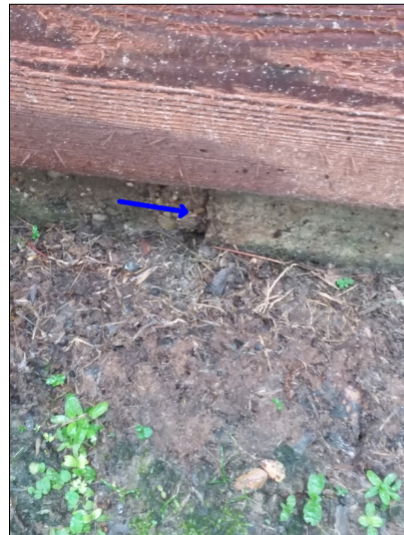
A.2. -Expansion cracks were noted in the slab. Mainly at - left side

-Expansion cracks were noted in the slab. Mainly at - left side

A.3. -Prior to closing, the foundation should be inspected by a qualified structural engineer or foundation expert familiar with the soils and construction methods of the region, in order to determine if permanent repairs are required.

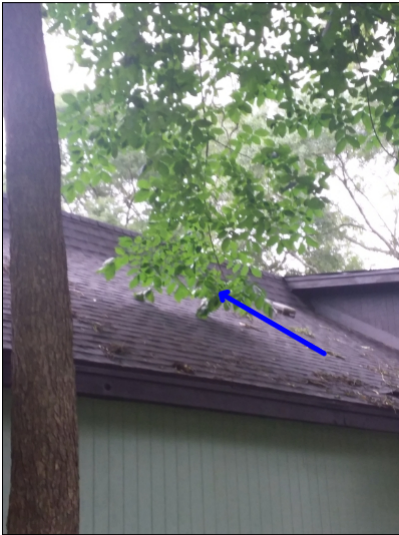
C.1. -Tree limbs should be kept trimmed at least 5' from roof to help prevent damage to the roof during windy conditions.

-Tree limbs should be kept trimmed at least 5' from roof to help prevent damage to the roof during windy conditions.

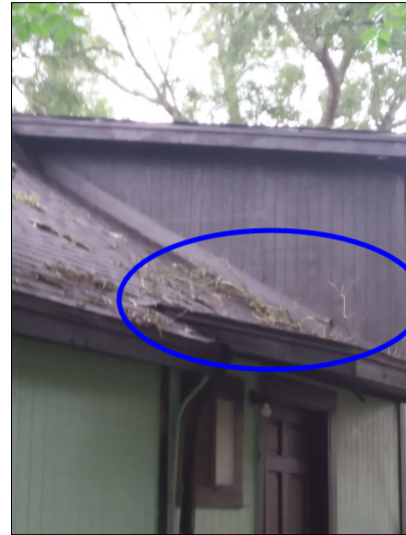
C.3. -Debris were noted on the roof which can cause water to back up on the roof and allow water to penetrate through the roofing materials, recommend removing debris from roof. Unable to fully inspect roof covering as debris limit the visibility of the roof surface.

-Debris were noted on the roof which can cause water to back up on the roof and allow water to penetrate through the roofing materials, recommend removing debris from roof. Unable to fully inspect roof covering as debris limit the visibility of the roof surface.

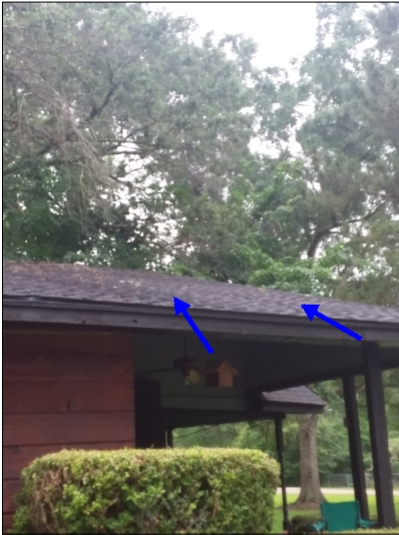
C.2. -The decking is buckling on the roof, this is often caused by an improper gap for expansion of the decking materials, recommend consulting a roofing contractor for evaluation and repairs as needed.

-The decking is buckling on the roof, this is often caused by an improper gap for expansion of the decking materials, recommend consulting a roofing contractor for evaluation and repairs as needed.

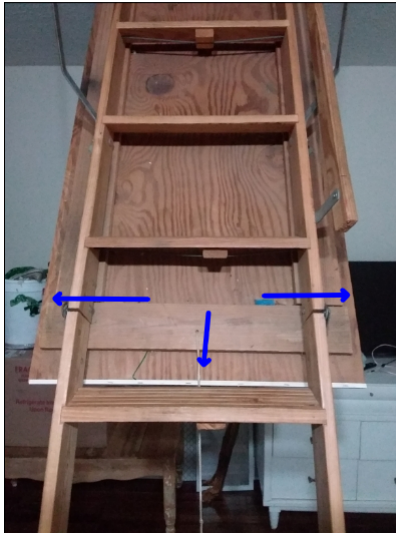
D.1. -Weather stripping should be installed around the edge of the door on the attic stairway to help prevent attic air from entering the home or conditioned air from entering the attic and to help slow the spread of fire.

-Weather stripping should be installed around the edge of the door on the attic stairway to help prevent attic air from entering the home or conditioned air from entering the attic and to help slow the spread of fire.

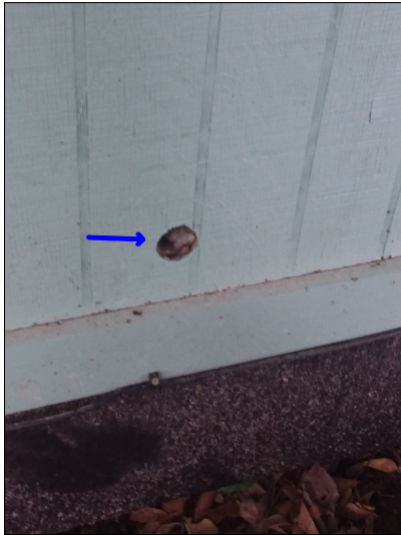
-Seal gaps and holes in siding to help prevent water penetration. Mainly at - right side

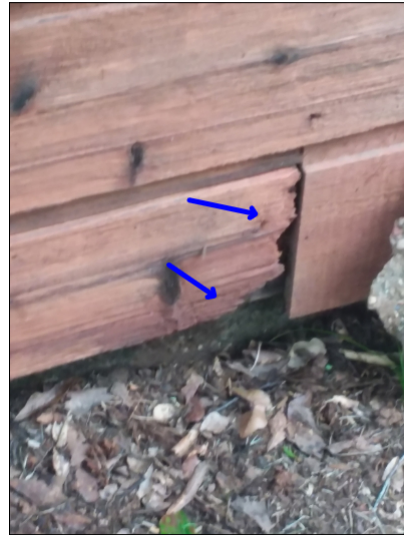
E.3. -Deterioration was noted at the siding, recommend replacing all deteriorated siding to help prevent further deterioration and water penetration. Unable to determine the condition of the underlying materials. Mainly at - left side

-Deterioration was noted at the siding, recommend replacing all deteriorated siding to help prevent further deterioration and water penetration. Unable to determine the condition of the underlying materials. Mainly at - left side

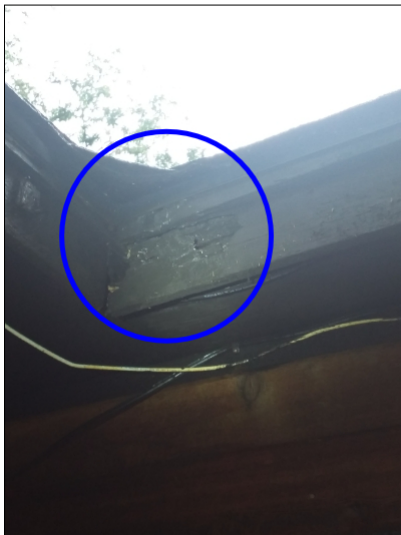
-Seal gaps and holes in trim to help prevent water penetration or rodent intrusion. Mainly at - left side

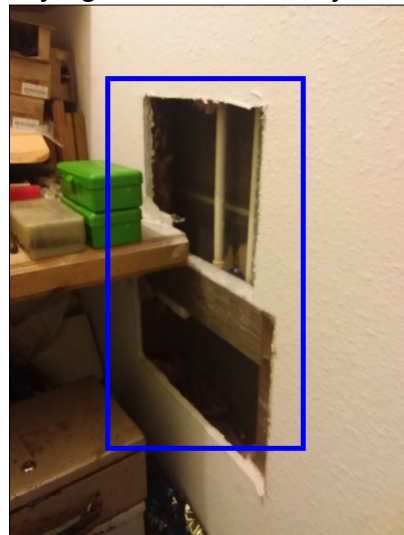
E.8. -There is damage to the drywall, recommend repairs as needed. Mainly at - master bath

-There is damage to the drywall, recommend repairs as needed. Mainly at - master bath

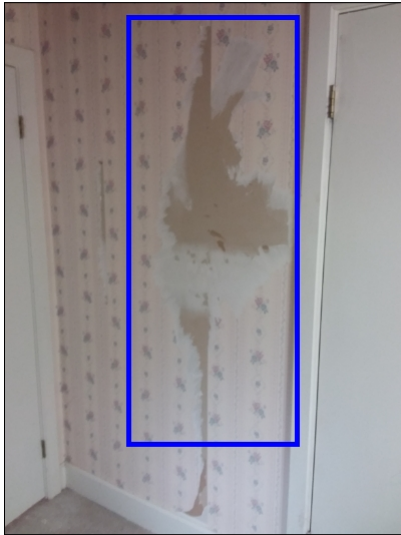
E.9. -Torn wall paper was noted. Mainly at - master bath

-Torn wall paper was noted. Mainly at - master bath

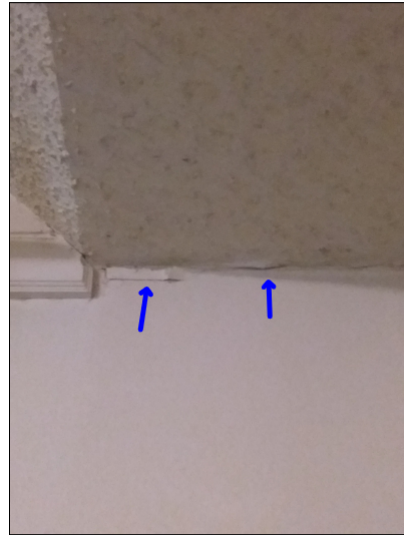
E.7. -Settlement cracks were noted at the tape joint in the drywall. Mainly at - master bedroom

-Settlement cracks were noted at the tape joint in the drywall. Mainly at - master bedroom

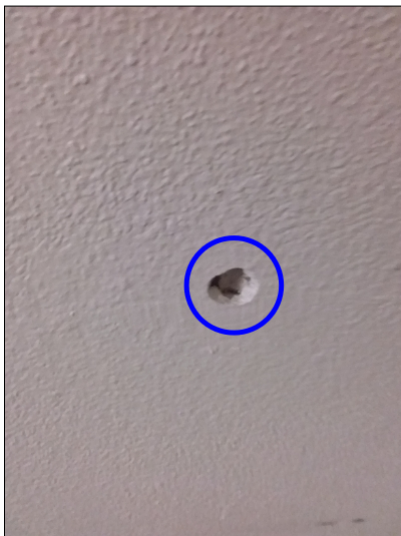
-There is damage to the drywall, recommend repairs as needed. Mainly at - right middle bedroom

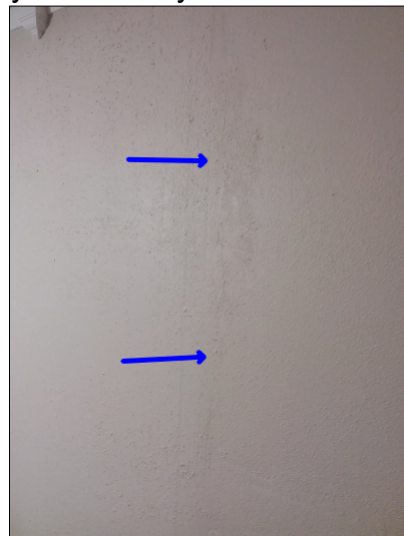
-Previous repairs were noted in the wall. Mainly at - right middle bedroom

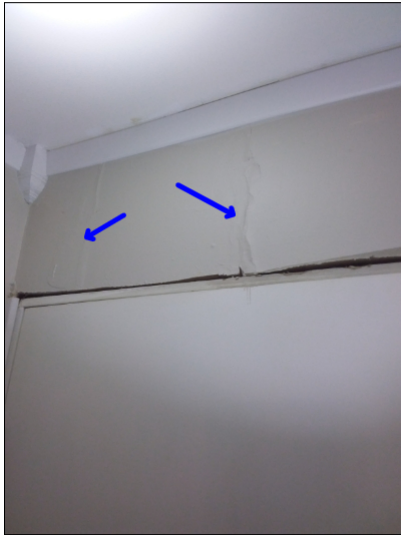
-Settlement cracks were noted in the drywall. Mainly at - right middle bedroom

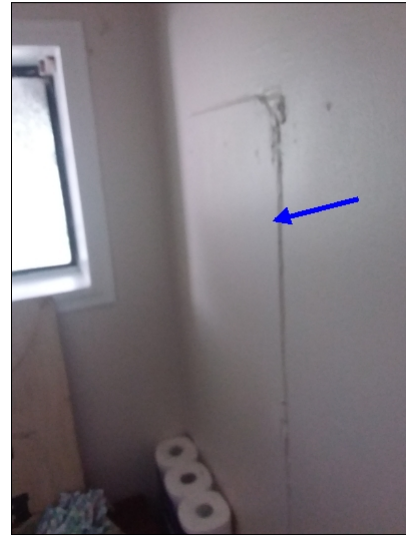
-Previous repairs were noted in the wall. Mainly at - right side bath

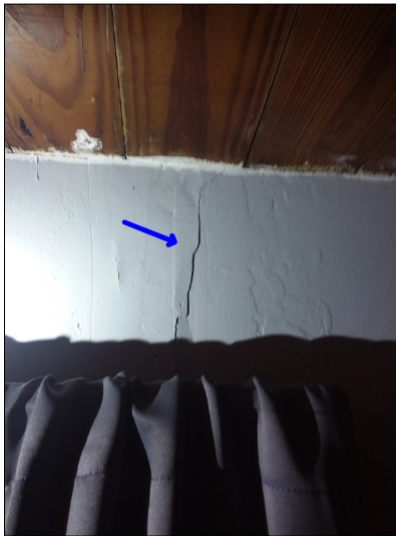
-Settlement cracks were noted in the drywall. Mainly at - right front bedroom

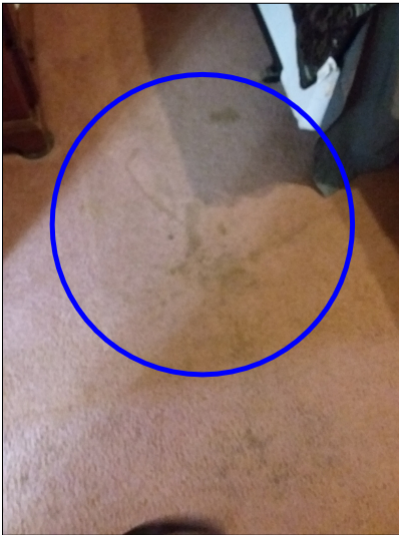
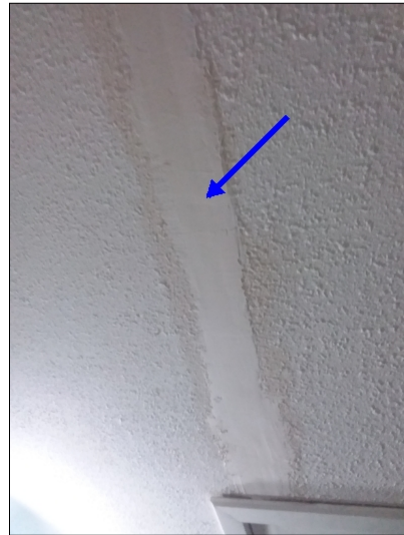
-The carpet is stained. Mainly at - master bedroom -Previous repairs were noted in the ceiling. Mainly at - rear right bedroom

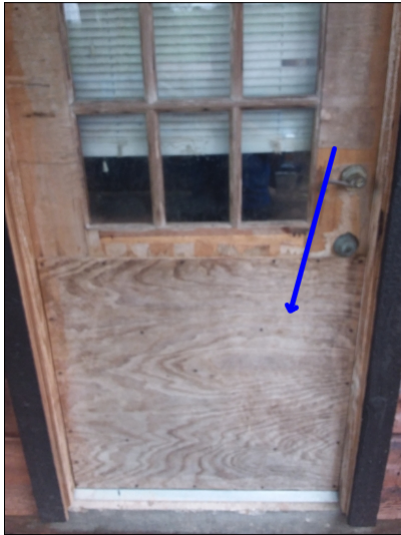
G.1. -Deterioration was noted mainly along the door, recommend repair or replacement to help prevent water penetration. Unable to determine the condition of the underlying materials. Mainly at - left side

-Deterioration was noted mainly along the door, recommend repair or replacement to help prevent water penetration. Unable to determine the condition of the underlying materials. Mainly at - left side

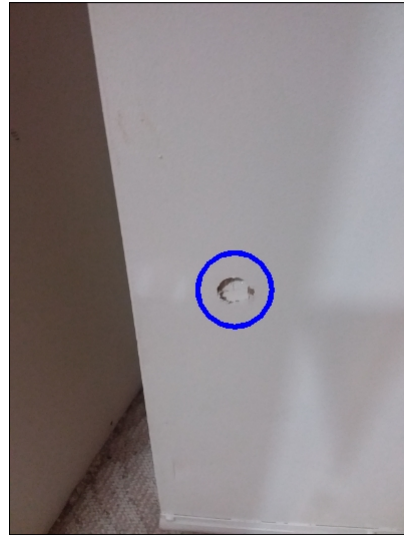
-Deterioration was noted mainly along the door, recommend repair or replacement to help prevent water penetration. Unable to determine the condition of the underlying materials. Mainly at - right middle bedroom

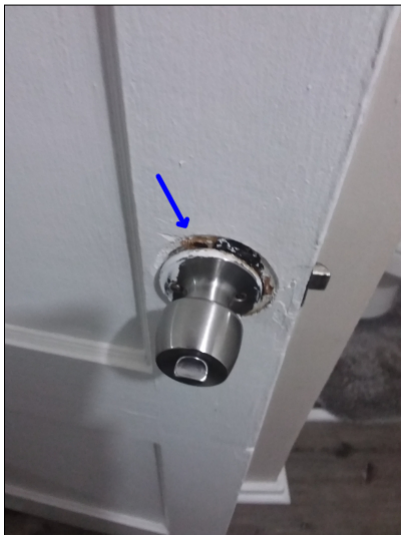
G.3. -The door knob is loose. Mainly at - front right bath

-The door knob is loose. Mainly at - front right bath

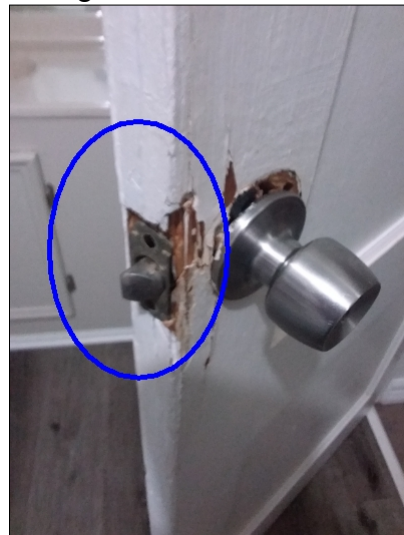
-Deterioration was noted mainly along the door, recommend repair or replacement to help prevent water penetration. Unable to determine the condition of the underlying materials. Mainly at - right side bath

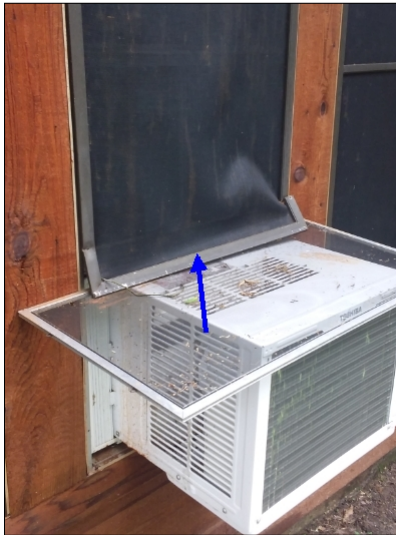
H.1. -Window screens are bent or damaged on the home. Mainly at - numerous locations

-Window screens are bent or damaged on the home. Mainly at - numerous locations

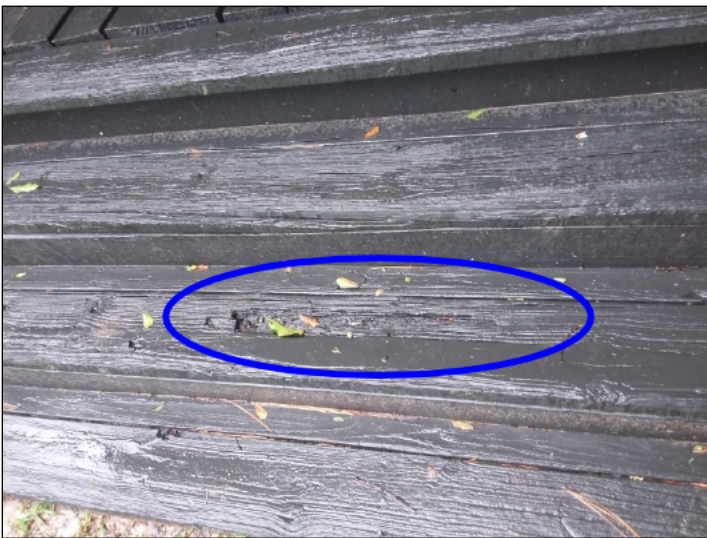
K.2. -The deck is showing signs of deterioration, recommend repair or replacement.

-The deck is showing signs of deterioration, recommend repair or replacement.

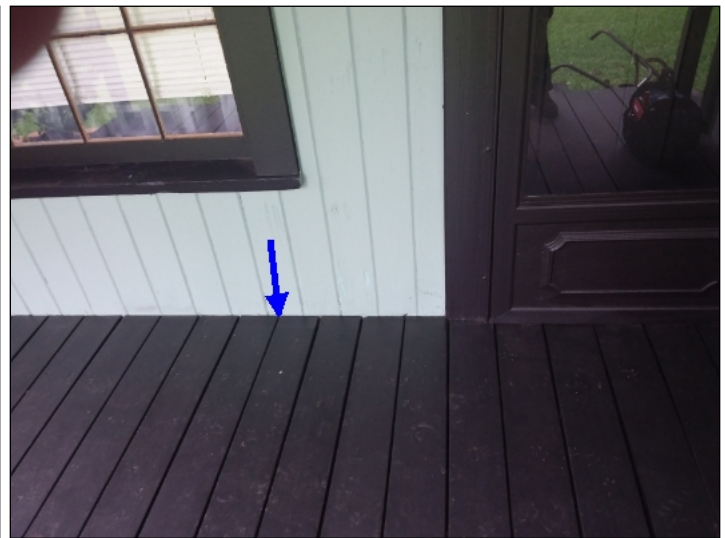
K.1. -The deck is installed against the house. Recommend all decks be separated from the structure to help prevent conducive conditions for wood destroying insects.

-The deck is installed against the house. Recommend all decks be separated from the structure to help prevent conducive conditions for wood destroying insects.

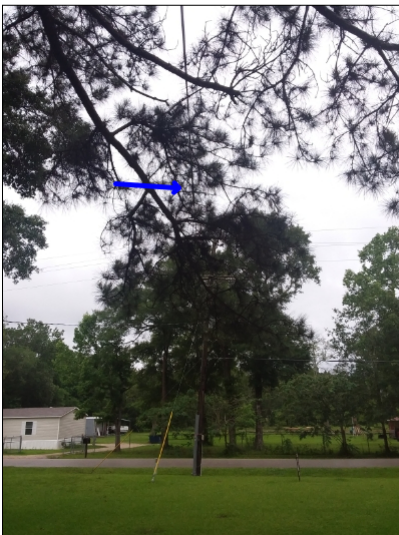
A.4. -Electrical feeds were running through the trees, recommend trimming limbs from wires.

-Electrical feeds were running through the trees, recommend trimming limbs from wires.

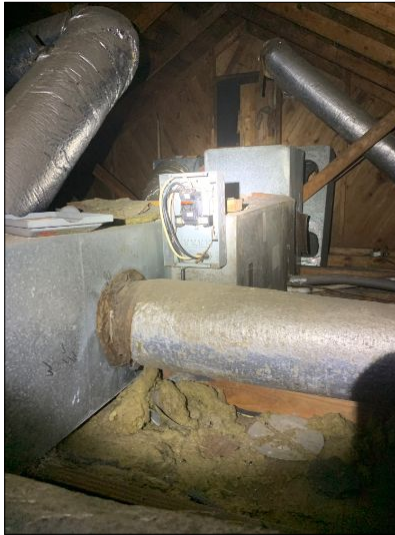
A.1. -There is not an adequate workspace and/or pathway to the furnace , located in the attic as recommended.

-There is not an adequate workspace and/or pathway to the furnace , located in the attic as recommended.

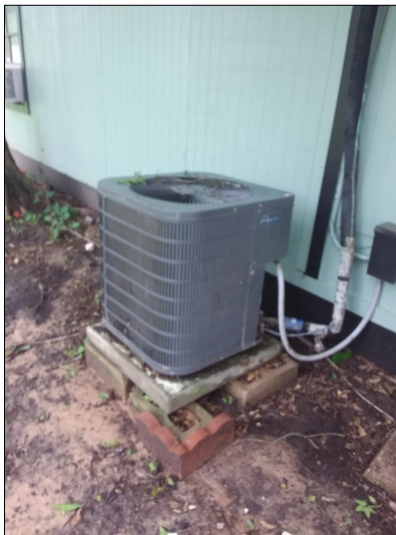
B.1. Seller claims central HVAC unit has never been turned on, window units are installed in most rooms. Seller says attic HVAC unit will need to be replaced due to damage.

Seller claims 1st floor HVAC unit has never been turned on, window units are installed in most rooms. Seller says upstairs HVAC will need to be replaced due to damage.

B.2. -Recommend consulting an A/C and Heating specialist for further evaluation/repair and to check for other repairs that may be needed at that time.

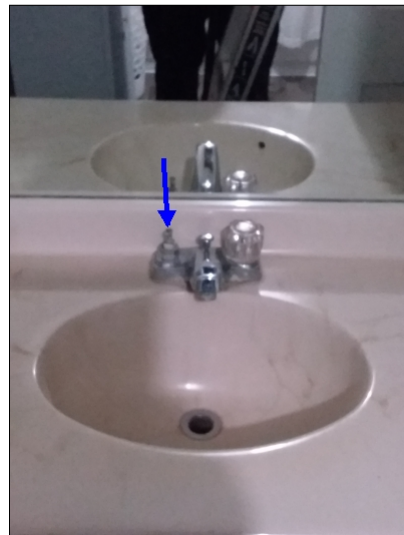
-There is a missing/broken shut off handle. Mainly at - right side bath

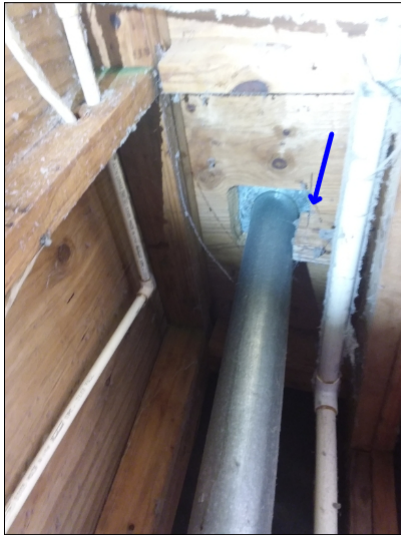
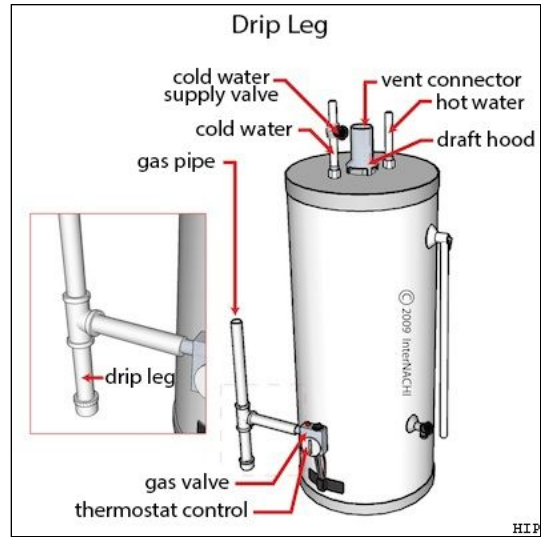
-Improper clearance to combustibles at flue pipe.
 Recommend cutting wood or other combustible material back at least 1" away from the flue pipe.
