Inspection for Property located at 22311 Rolling Meadow Ln
08/04/2021
Prepared for : Cathal and Ina Quinn

PROPERTY INSPECTION REPORT

Concerning: 22311 Rolling Meadow Ln, Katy, TX 77450
(Address or Other Identification of Inspected Property)

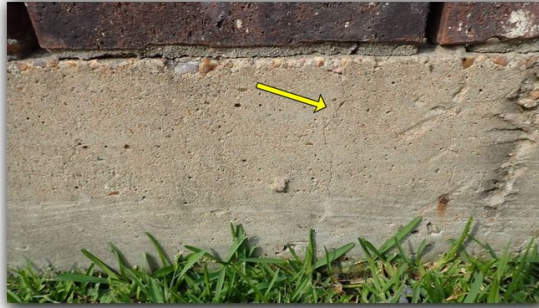
Observed one or more small cracks in the foundation slab. The cracks do not appear to transfer to surrounding structures and are likely surface cracks. For further information about slab on grade foundations, I highly suggest downloading and reading the e-book by R Michael Gray P.E. called "[Buyer's guide to slab on grade foundations](#)".

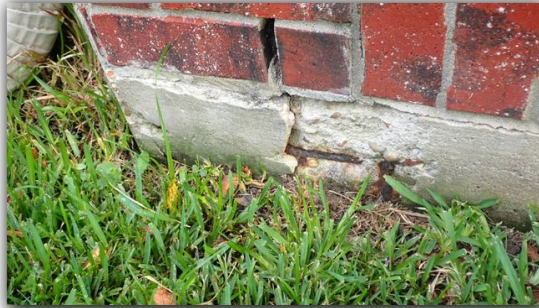
Spalling at one or more locations around house / garage. Generally due to not enough concrete (Minimum 2") coverage over steel in foundation which causes steel to rust and spall / pop off concrete.

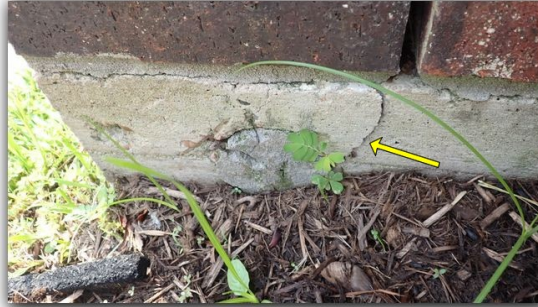
Spalling (i.e., corner pops) at one or more corner(s). Corner spalling is common to slab foundations and does not affect the structural integrity of the foundation. However, if the spalling crack extends into the soil it should be monitored as a possible termite entry point.

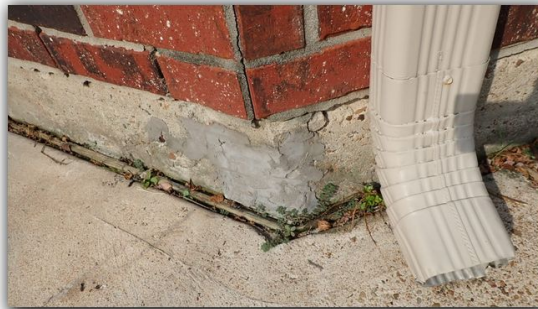
Slab dressing observed at one or more areas of foundation. Slab dressing is usually applied for cosmetic reasons but may be covering defects.

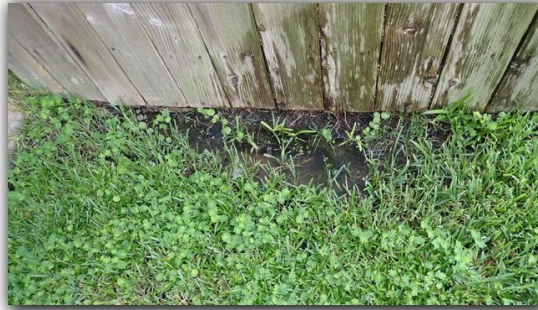
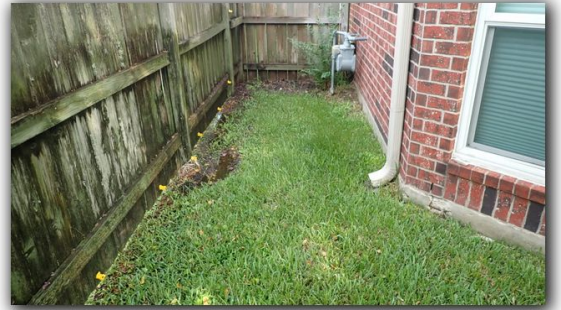
Comments: Drainage swale is not continuous at all sides The drainage swale must be clear and continuously sloped in order to drain water properly.

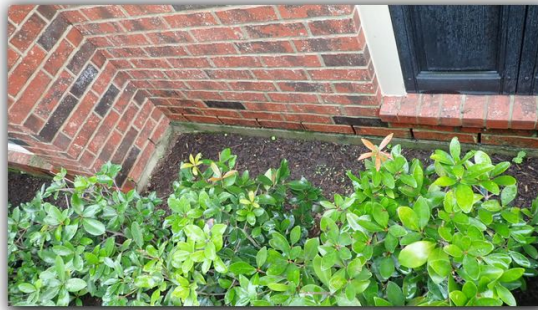
Buyer's note: inspector observed flower bed / soil has been trenched around some areas of house/garage. It is our experience that the soil soon fills up the trench resulting in soil at/above/in contact with house siding and foundation resulting in wood rot and/or water entry during heavy rains.

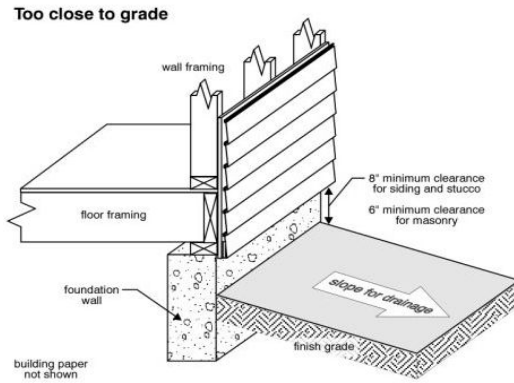
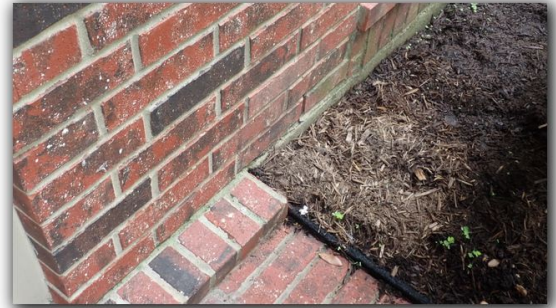
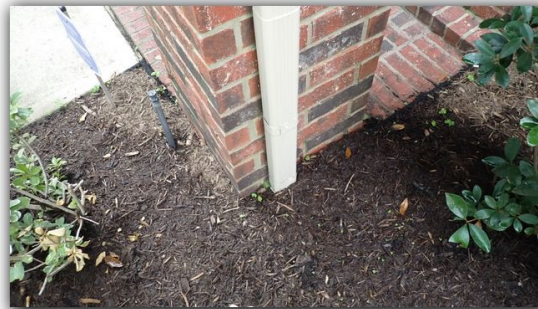
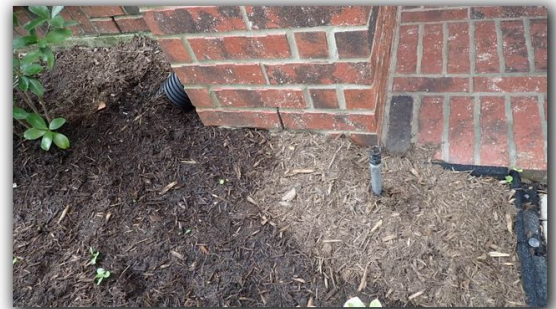
Soil level too high around areas with brick siding at front flower beds . Common industry practice requires a clearance of at least 4 inches from bottom of brick veneer to soil. High soil level near brick siding promotes wood rot and is considered a conducive condition to termite activity and water penetration.

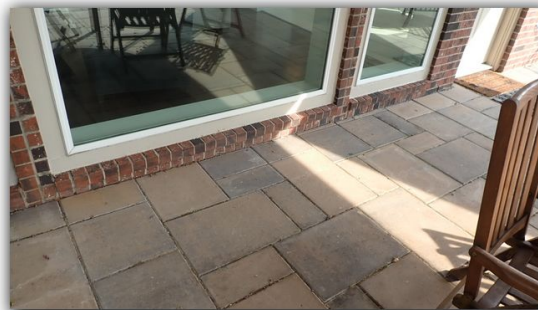
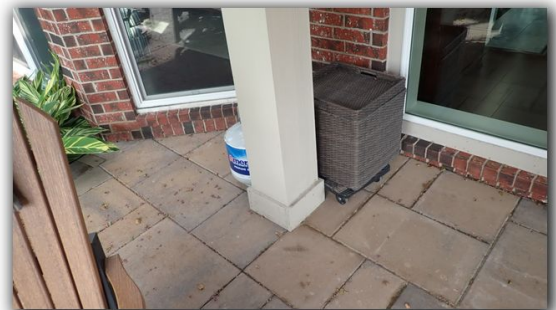
Patio is too high on the wall. Cannot inspect foundation and is considered a conducive condition to wood destroying insects.

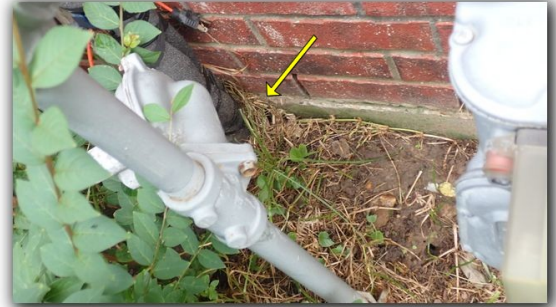
Heavy foliage next to house make it difficult to inspect the foundation and is considered a conducive condition to wood destroying insects such as termites.

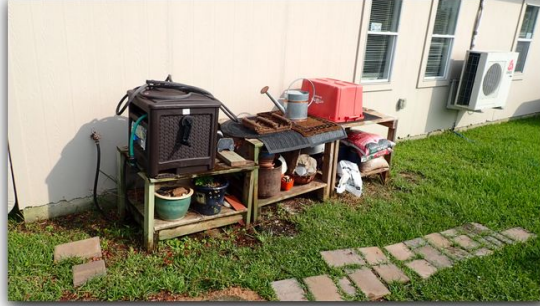
Bricks, stone, etc. should not be stored near house or garage, can hide evidence of wood destroying insect activity, recommend relocating away from house / garage.

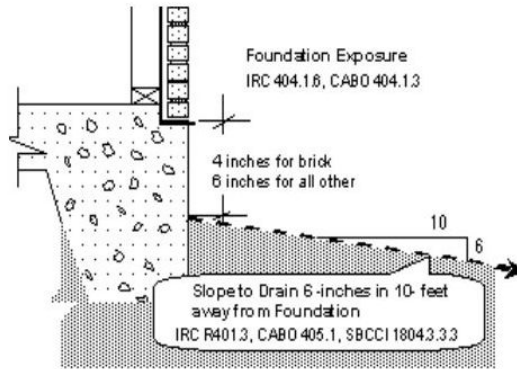
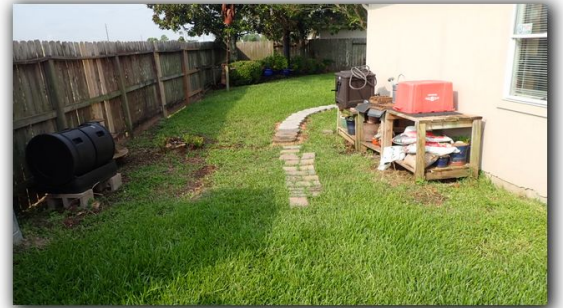
Soil grade and drainage patterns around some areas of house do not appear to properly direct water away from foundation to aid in controlling runoff water and could cause differential movement of the foundation or water penetration during heavy rains.

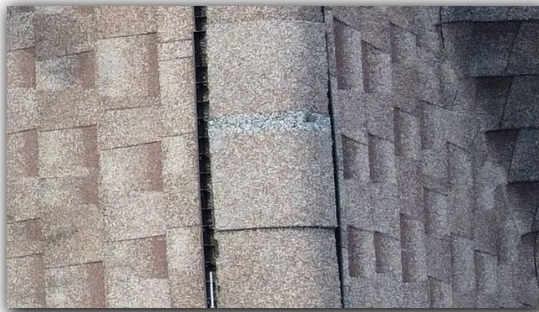
Comments: Missing shingles observed at one or more locations.

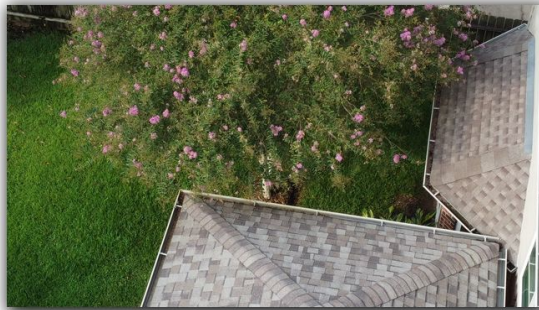
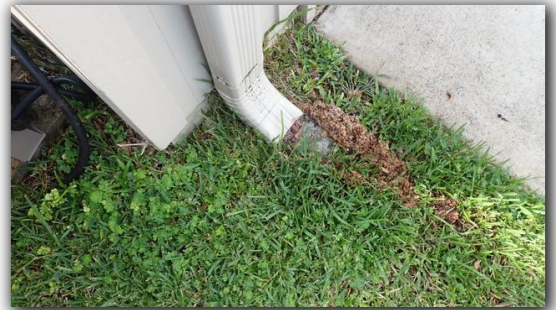
The gutters have areas full of debris and/or holds standing water. Needs to be cleared and possibly re-hung to slope toward downspout drains.

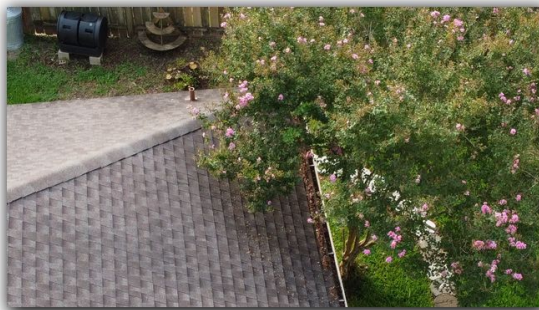
Tree limbs in contact with roof can/ will damage the roof.

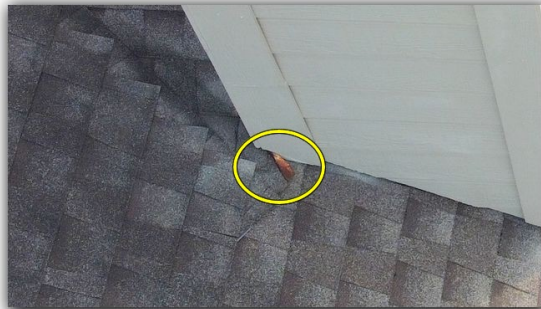
Rusted flashing can be a potential location of wind driven rain entry.

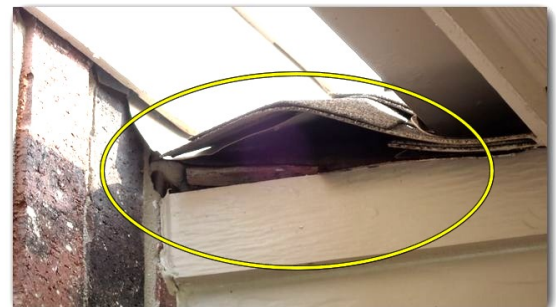
Lower side of flashing is not sealed down, wind driven rains can cause water penetration.

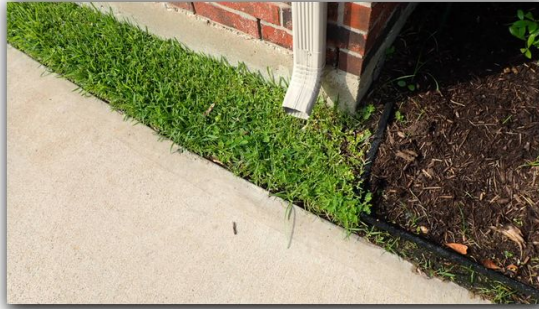
Downspouts need splash blocks at bottoms to prevent soil erosion.

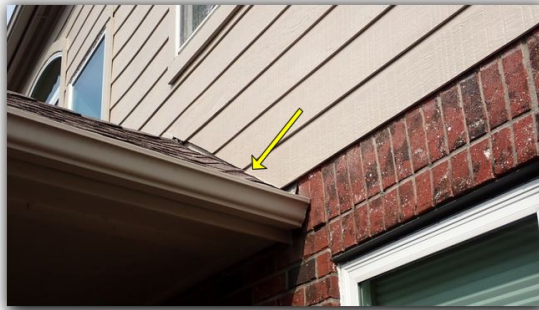
Insufficient gap where vertical wall meets roof. Roofing and siding manufacturers require 2 inch gap to allow leaves/debris a path to wash down. Insufficient gap can also cause water to penetrate via capillary action.

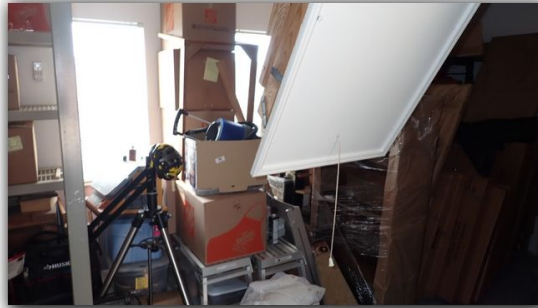
Comments: Could not inspect the attic in the garage due to personal belongings obstructing access.

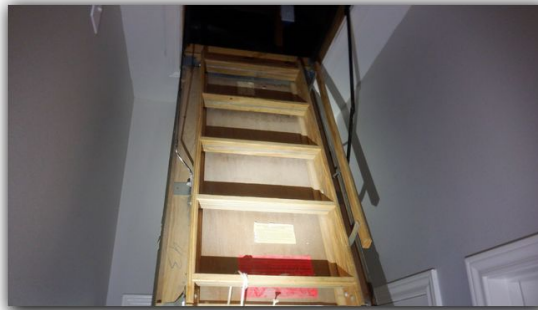
Stairway to attic is missing insulation on stairway.

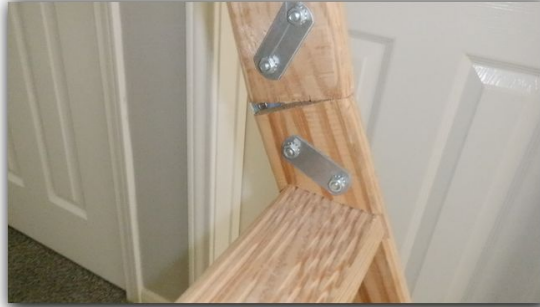
Attic ladder not cut to fit properly, which puts undue stress on ladder; there should be no gaps at section ends.

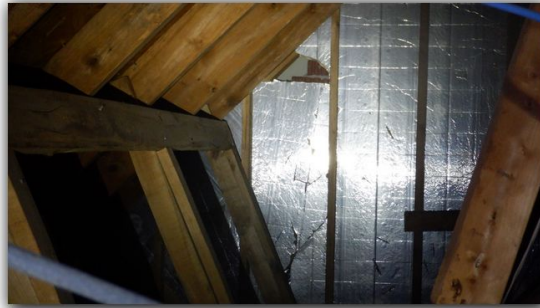
Damaged weather barrier in attic.

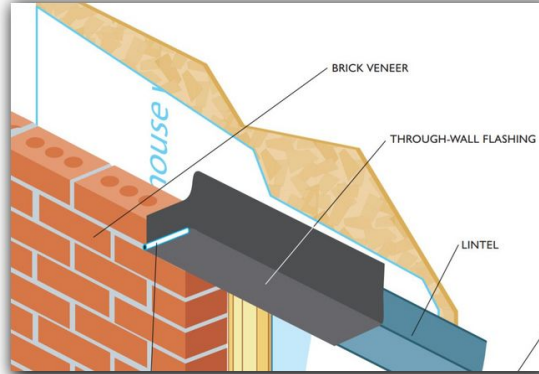
Metal lintel(s) over window/door openings do not appear to be flashed as required by current building standards. flashing is required to direct water out of the weepholes, create a chemical barrier between the metal lintel and the caustic mortar (reduces rust), and also to create a bond break to reduce cracks. Ref:IRC 2015 Section R703.8.5 For more information, please view this video

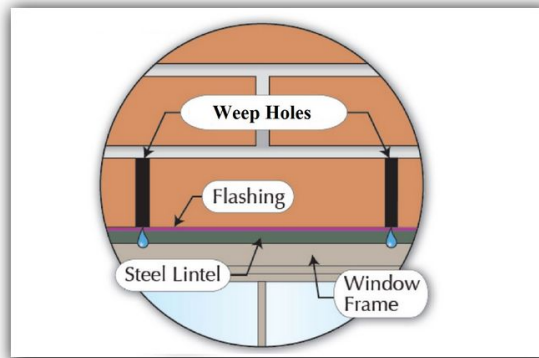
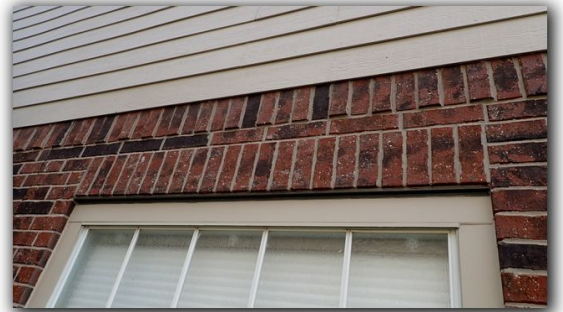
Brick veneer siding missing required weep holes above Lintels to prevent moisture buildup in exterior walls and prevent wood rot / decay.

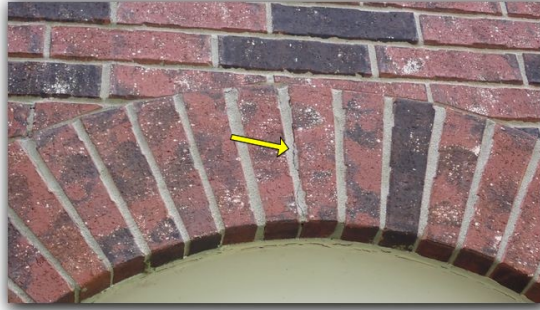
Cracks in brick veneer and/or repairs, one or more locations, Recommend having cracks repaired, then take photographs of cracks, their location, and width [ruler across the crack] with a high resolution camera that has a date stamp for future reference.

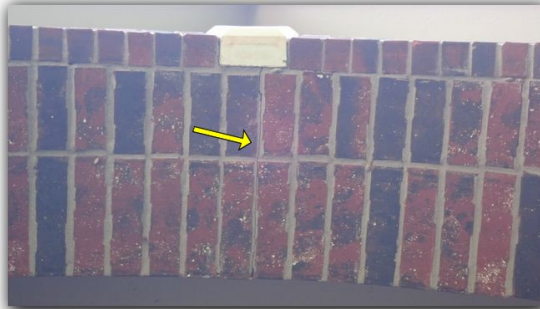
Cracks in brick arch observed, loose bricks are hazardous.

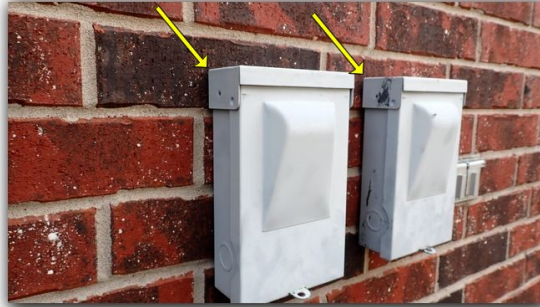
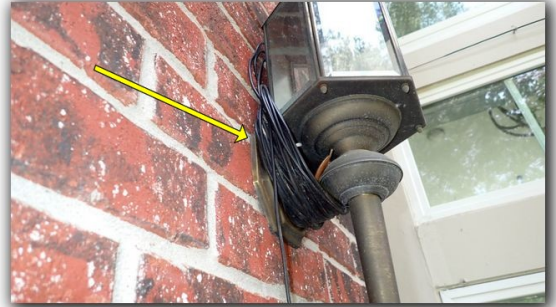
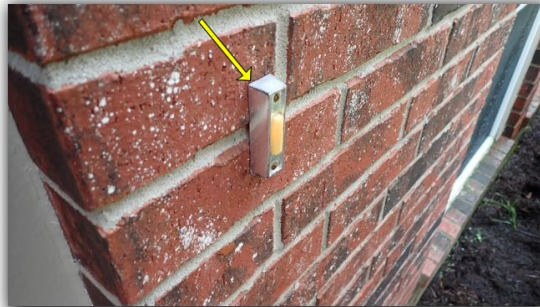
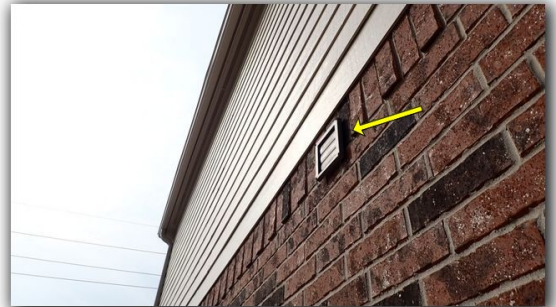
Need sealing / caulking around all holes and exterior siding penetrations on top and both sides, (leave bottom open) to prevent water entry. Including but not limited to dryer, bath and range top vents, light fixtures, etc.

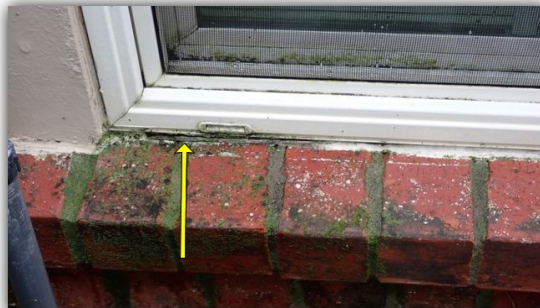
Caulking deficient around one or more windows, will allow water penetration during heavy / wind driven rains.

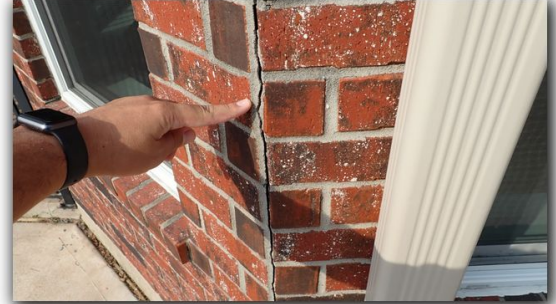
Expansion joint(s) and / or inside corners in brick veneer need caulking. Ensure any mortar present in expansion joint is first removed before sealing.

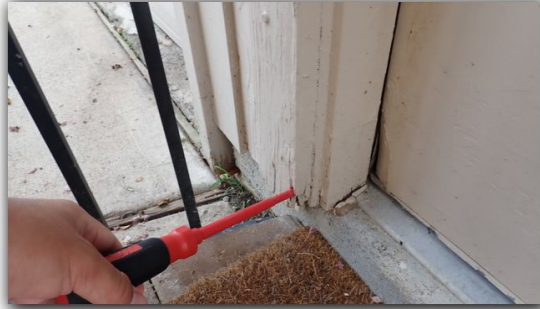
Wood rot observed on areas of house / garage.

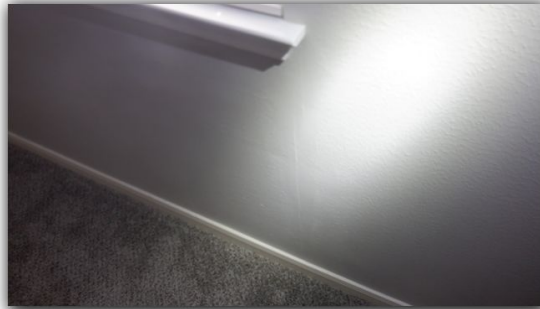
Cosmetic cracks and/or repaired cracks in sheetrock observed over Some doors, windows, and/or corners.

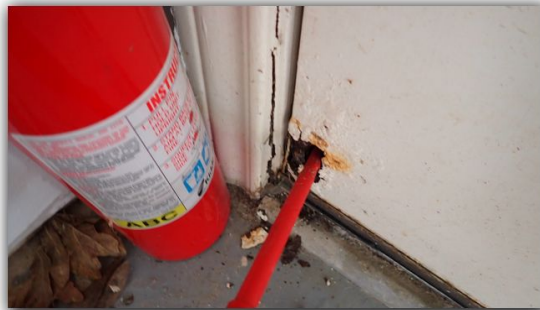
Comments: Base of the metal garage door is rusted, damaged.

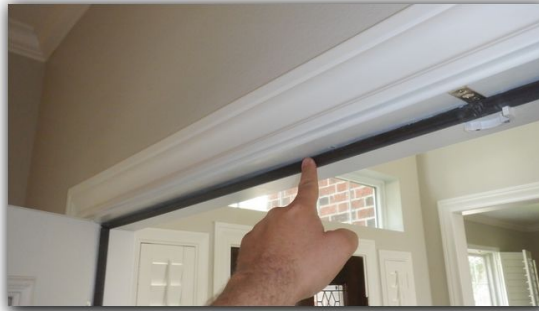
Recommend removal of gasket around office door to prevent air return restriction.

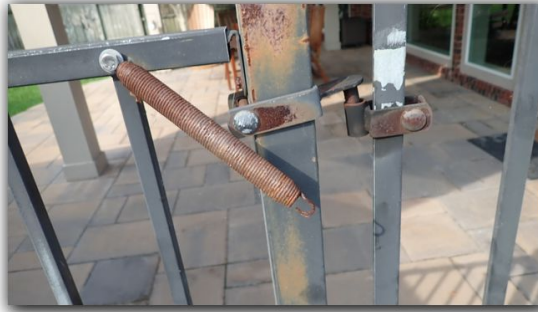
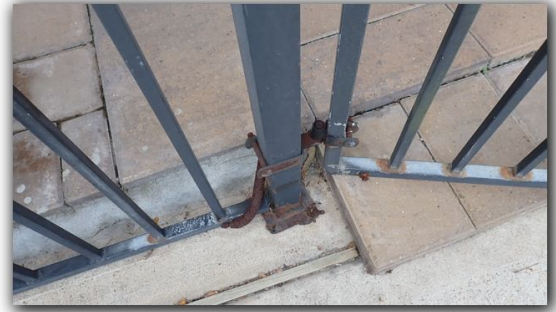
Comments: Backyard gate springs were broken, disconnected.

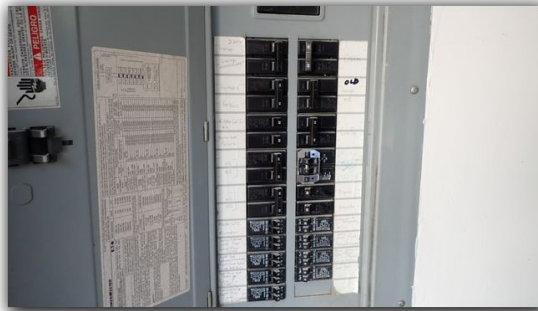
Comments: Did not observe installed AFCI (Arc Fault Circuit Interrupt) device protection, as required by current building standards, for all: family rooms, dining rooms, living rooms, parlors, libraries, dens, bedrooms, sunrooms, recreations rooms, closets, hallways, or similar rooms or areas. AFCI devices are intended to protect against fires caused by electrical arcing faults in the home's wiring. Arc faults are a common cause of residential electrical fires. Arc faults can be created by damaged, deteriorated, or worn electrical plugs, cords, and/or branch circuit conductors. As of September 1, 2008, the State of Texas has adopted the 2005 NEC, which includes this requirement, as the "minimum standard" for all non-exempt electrical work. Homes built prior to 2002, generally were not required to have arc fault protection. However, the current TREC standard of practice requires inspectors to indicate that a hazardous or deficient condition exists if any home does not have this protection, regardless of date the home was constructed.

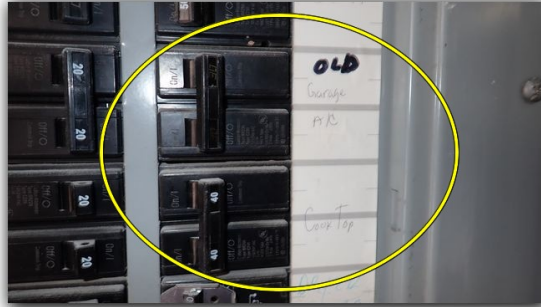
One or more breaker(s) were off at time of inspection. Inspector does not turn on breakers found in off position due to potential short / electrical problem, recommend inquiring seller regarding information regarding any / all breaker(s) found in off position.

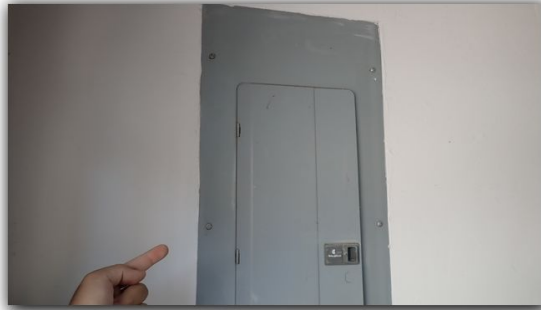
Dead front was painted to the wall and was not removed for inspection because removing the cover may damage the wall finish.

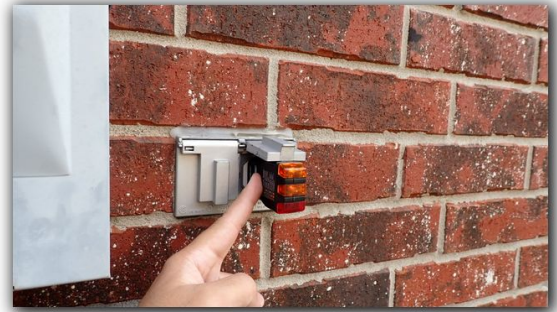
Comments: Did not observe GFCI protection of all outlets in required locations, including but not limited to the location marked below. This condition is a recognized safety hazard and is in need of repair.

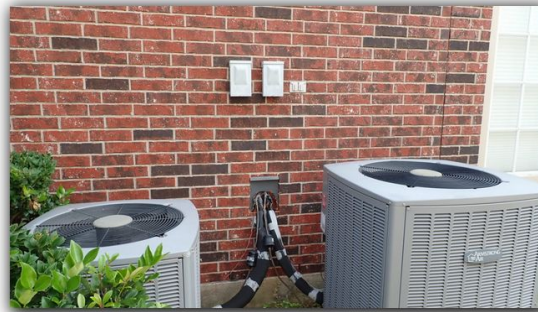
Air conditioning disconnects should not be located directly behind the condenser units. Sufficient access and working space (36" minimum) shall be provided and maintained around all electrical equipment (disconnects) to permit ready and safe operation and maintenance of such equipment in accordance with IRC Section E3405.1.

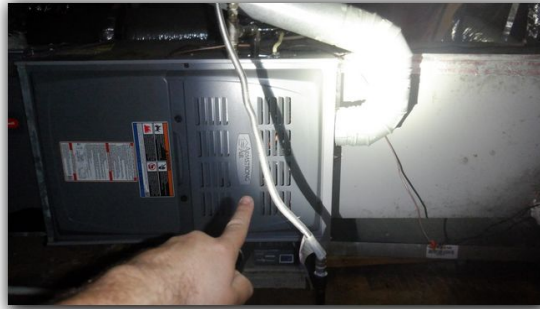
Comments: Noisy operation; First floor heater.

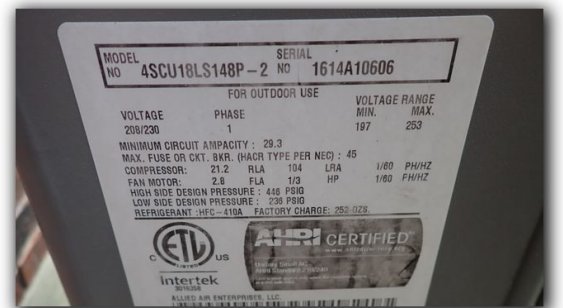
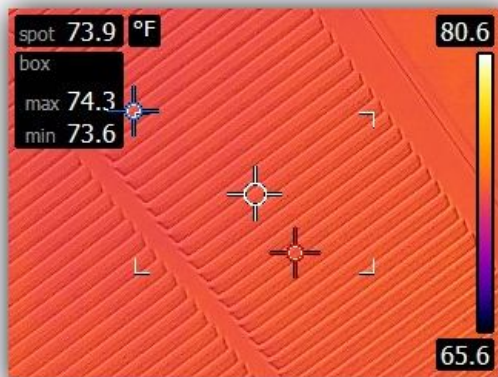
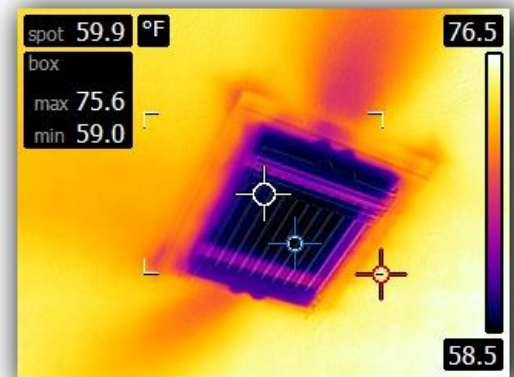
The first floor air conditioner produces a differential temperature of 15.3 degrees F.

The condenser has a 4 ton cooling capacity and was manufactured by Air Armstrong in 2014.

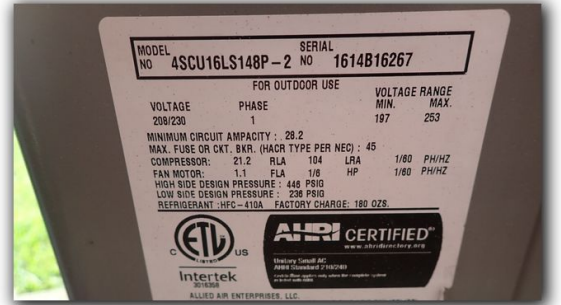
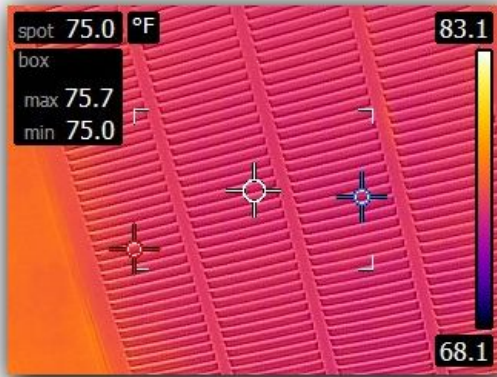
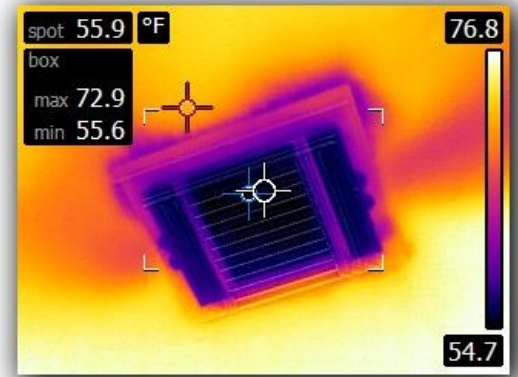
The second floor air conditioner produces a differential temperature of 20.1 degrees F.

The condenser has a 4 ton cooling capacity and was manufactured by Air Armstrong in 2014.

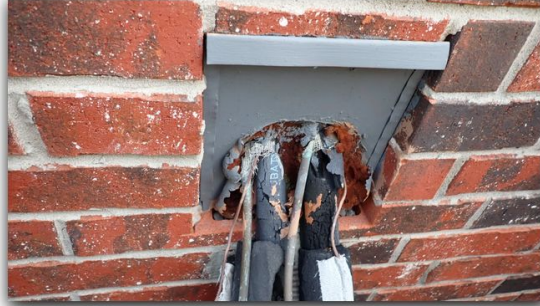
Recommend painting expanding foam sealant where A/C Freon lines pass through wall to protect it from degradation due to UV light exposure.

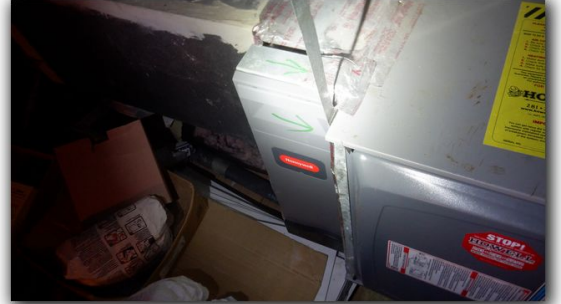
Media air filter(s) located in attic that requires changing/cleaning every 6 months, recommend checking guide for proper maintenance information.

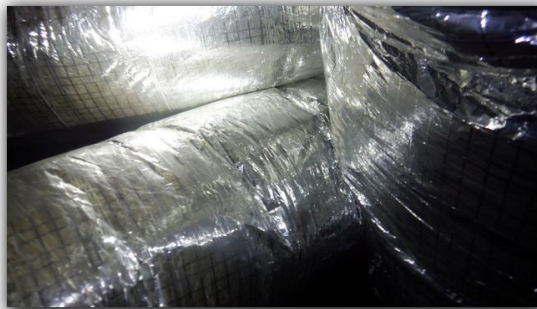
Observed several / multiple areas in attic where flex duct touch and are missing required 1" clearance from other ducts to prevent condensation between ducts that touch. Recommend general maintenance to flex ducts in attic, Re-support where needed, seal/tape minor air leaks, repair torn/damaged vapor seal, etc.

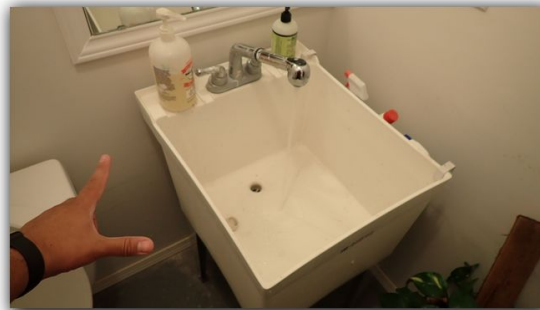
Sink in the garage was loose.

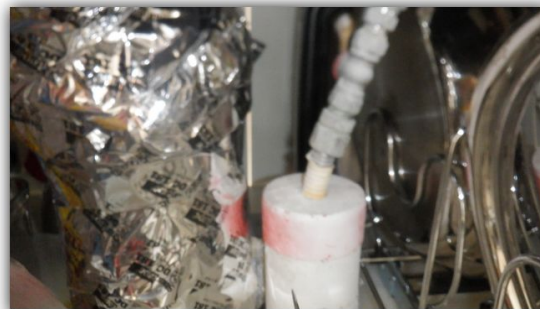
Portions of the gas piping system in this home is comprised of Corrugated Stainless Steel Tubing also known as CSST. CSST has recently been alleged to cause increased risk of fire (over conventional black iron piping) in the event of a lightning strike. There has been a class action lawsuit and settlement agreement. The manufacturers indicate that the risk occurs when CSST is not adequately bonded. Please read the CSST Settlement <http://www.pddocs.com/csst> for additional information regarding the alleged safety issues, lawsuit and settlement. Recommend further evaluation by a licensed electrician and the installation of any necessary safety enhancements regarding the proper grounding, bonding, and or lightning protection of this particular installation.

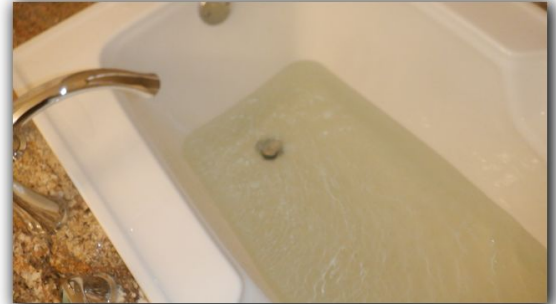
Some rusty water observed when tub was ran, cleared up over time.

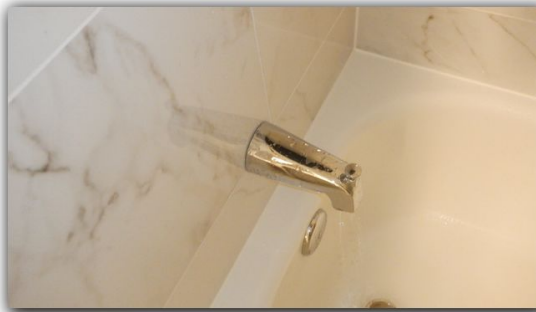
Recommend caulking around all tub/shower faucets and spouts to prevent water entry behind wall.

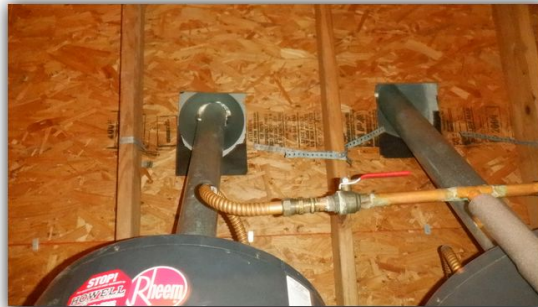
Daylight visible at vent/roof connection.

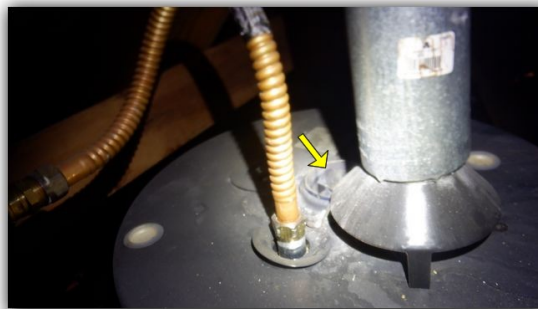
The vent hood is not properly aligned with the vent pipe. This condition allows dangerous combustible gases to enter the structure instead of properly venting to the exterior.

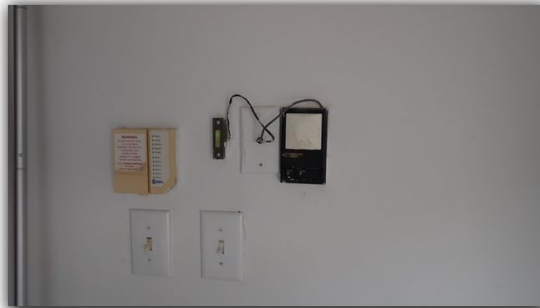
Comments: Missing required safety sticker / decal next to operator button.

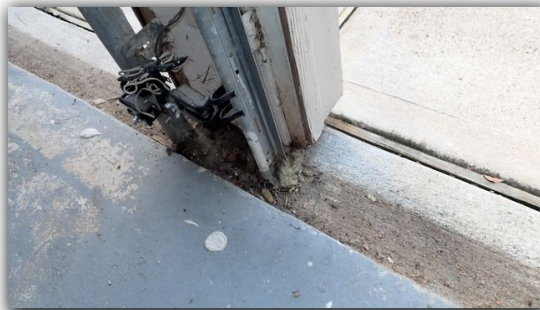
Electronic sensing eyes are improperly installed; should be no more than 6 inches above floor.
