Mimi Fang
4329 Eigel St
Houston, TX 77007

April 21, 2022

PROPERTY INSPECTION REPORT FORM

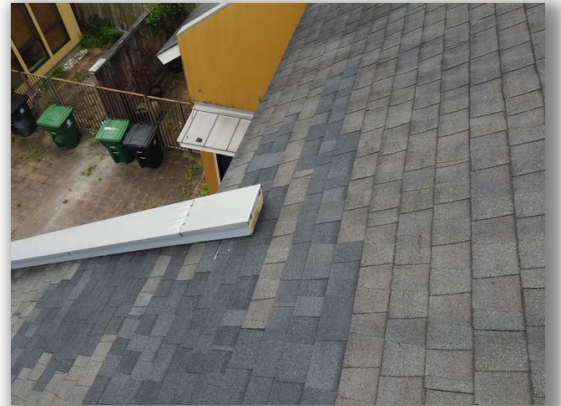
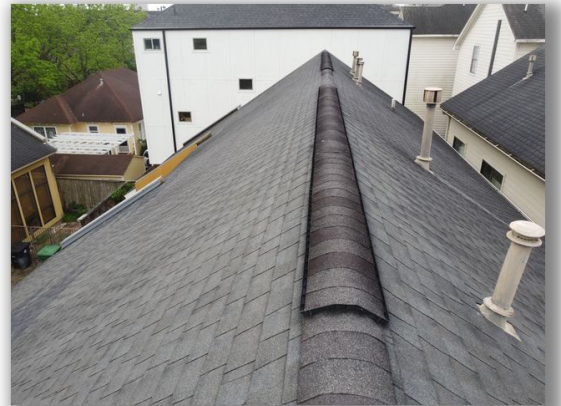
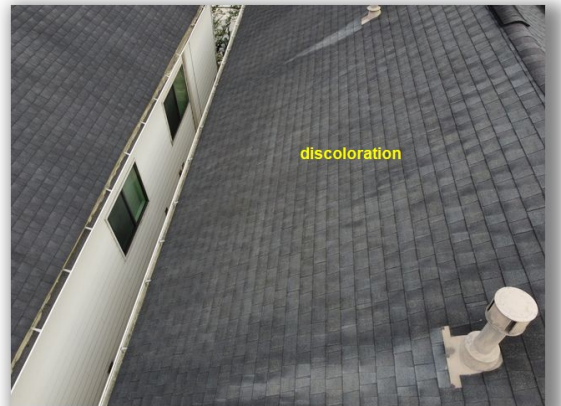
- The roofing material appears to be reaching the end of its serviceable life expectancy.
- Damaged shingles were observed on the east side of the roof structure.
- Some cracking and cupping of the roofing material was observed.
- The composition roofing material has experienced granular loss in various locations throughout the roof.

Note: It appears that tar has been used to perform previous roof repairs in one or more locations on the roof. This type of repair is temporary in nature and is not considered to be a long term solution to an existing roofing problem.

Note: Prior repairs to the roofing material and/or flashing were observed in one or more locations.

Note: Some discoloration of the roofing material was observed.

You are strongly encouraged to have a properly certified roofing contractor to physically inspect the roof, prior to the expiration of any time limitations such as option or warranty periods, to fully evaluate the condition of the roofing material. The observation made to support the rendering of this opinion are listed but not limited to the following:

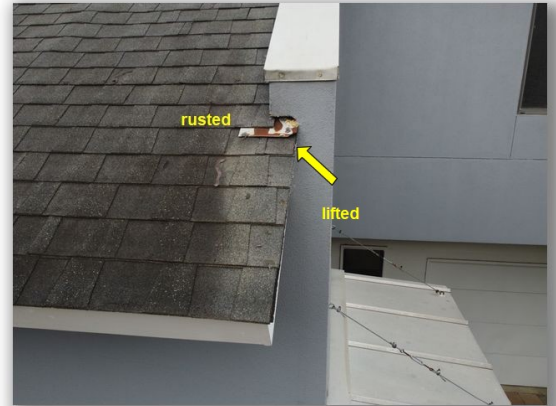
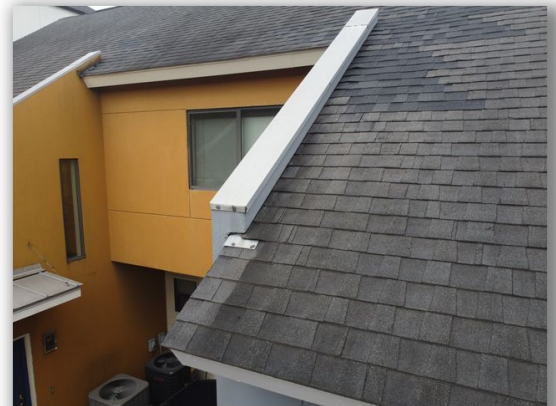
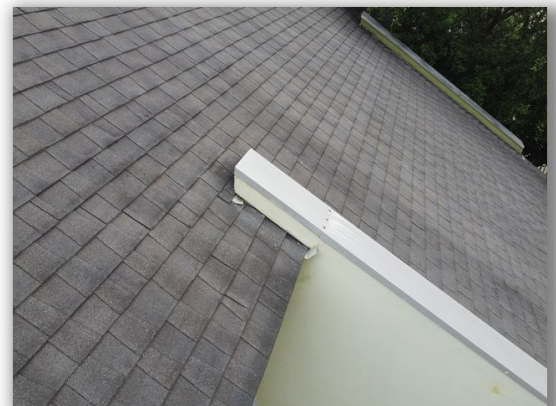
Flashing Details

- One or more of the roof level plumbing vent stack flashing details have some damage to the rubber seal around the stack. This condition could allow water penetration at this point. It is recommended to replace 1 rubber seals.
- The exterior flashing needs to be painted to prevent UV/ Rust damage .
- Some of the metal flashing details were observed to be rusted and should be corrected as necessary.
- The flashing is lifting and/or pulling loose and should be re-secured on the east side of the roof structure.

The flashing details needs to be checked, reset or repaired as necessary. The observations made to support the rendering of this opinion are listed but may not be limited to:

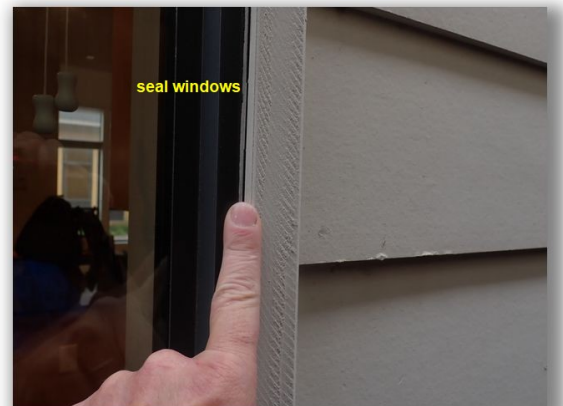
- Caulking improvements are recommended for the area between the exterior veneer and the window frames. It is recommended to use an elastomeric caulking.
- The area between the exterior cladding / veneer and all of the wall penetrations / openings need to be properly sealed. Areas such as utility connections, downspouts, hose bibbs, lighting fixtures, receptacles etc. It is recommended to use an elastomeric caulking / sealant.
- All joints between two different types of siding should be properly sealed. It is recommended to use elastomeric sealant.
- The exterior veneer / cladding has some deterioration and/or damage on the west side of the structure.

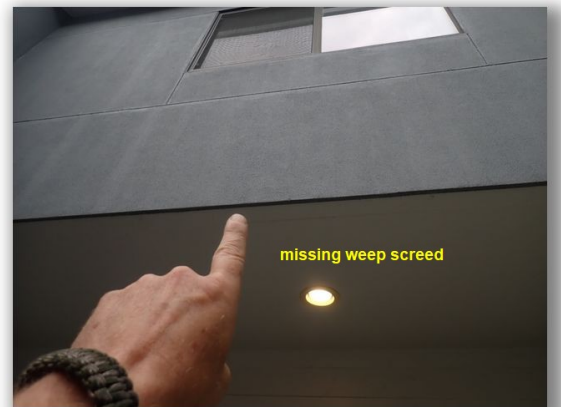
- The area between the exterior cladding / veneer and all of the wall penetrations / openings need to be properly sealed. Areas such as utility connections, downspouts, hose bibbs, lighting fixtures, receptacles etc. It is recommended to use an elastomeric caulking / sealant.

- All joints between two different types of siding should be properly sealed. It is recommended to use elastomeric sealant.

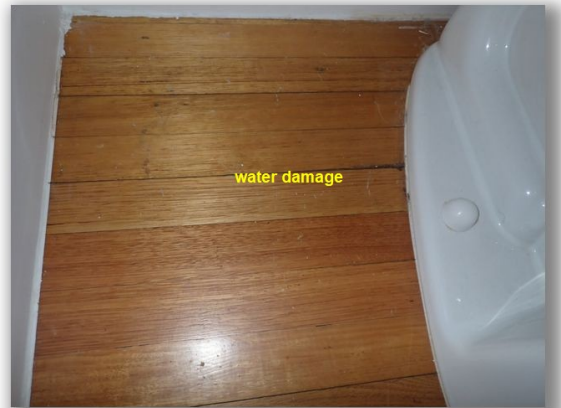
Floors

- The floor covering is worn and/or damaged in one or more locations of the home.
- The floor covering was observed to be water damaged in the half bathroom.
- The floors were observed to be out-of-level in some areas of the house.

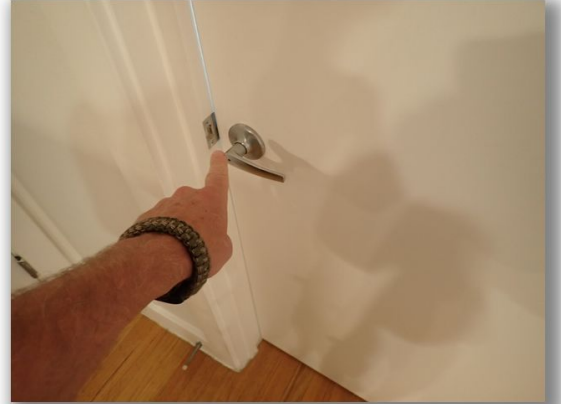
Interior Doors

- The door is not latching properly to the half bathroom, guest bathroom.
- The exterior door frame has some deterioration and/or damage to the front entry door(s).
- The door is missing to the front entry closet.

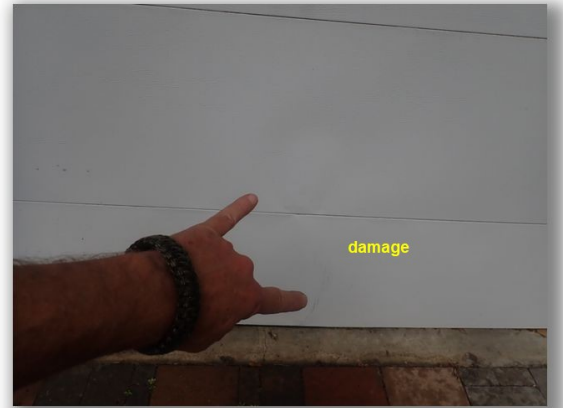
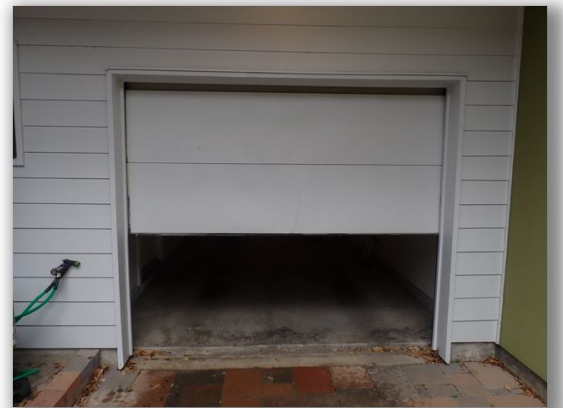
Overhead Garage Door

- The weather-stripping at the bottom of the overhead garage door is damaged and repairs or replacement may be necessary.
- The overhead garage door panel(s) and/or panel trim has some deterioration and/or damage.

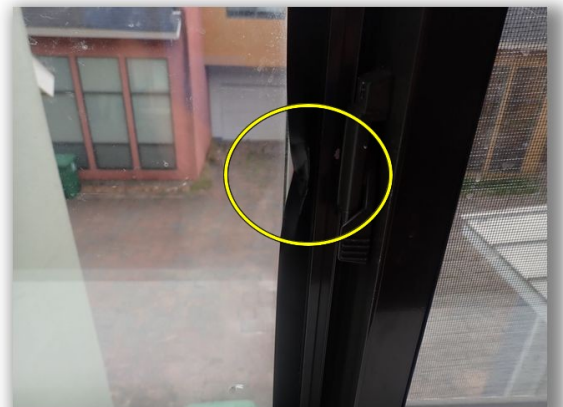
- The window weather-stripping is damaged and/or missing at one or more of the windows and improvements are recommended.
- The window sill(s) have some deterioration and/or damage to the primary bedroom.
- One or more of the window blinds were observed to be damaged in the primary bedroom.

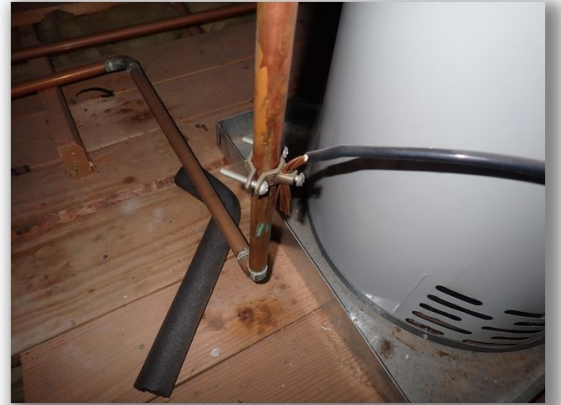
electrical system. This condition should be further investigated and corrected if necessary.

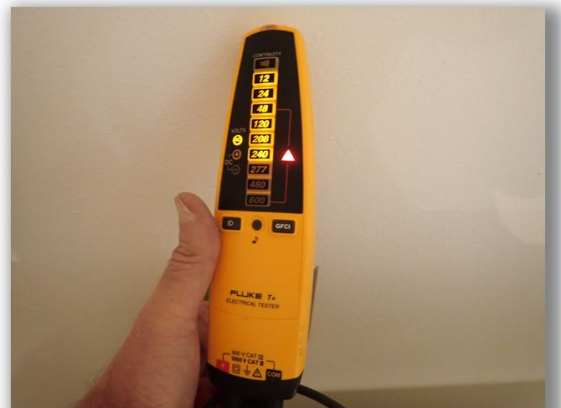
Receptacle Outlets

- There are no tamper resistant receptacles installed at the time of inspection. Under current building standards, all receptacles that are less than five and a half feet above the floor should be tamper resistant. This is an "as built" condition, but per TREC standards of practice, we are required to report this condition as deficient. Tamper Resistant outlets are required per the 2008 National Electric Code. You may consider corrective measures for improved safety.
- The laundry room area receptacles do not appear to be connected to a ground fault circuit interrupter (GFCI) device. Under current electrical standards, all of the receptacles in the laundry room area should have GFCI protection.

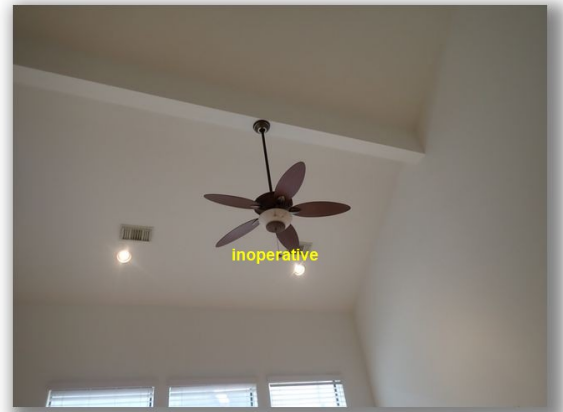
Fixtures

- The ceiling fan appears to be inoperative in the family room.
- One or more of the light fixtures appear to be inoperative in the front porch. This may be due to a bad bulb or some other unknown condition. This condition should be further evaluated and corrected as necessary.
- One or more of the light fixture globes and/or covers are missing in the front porch.

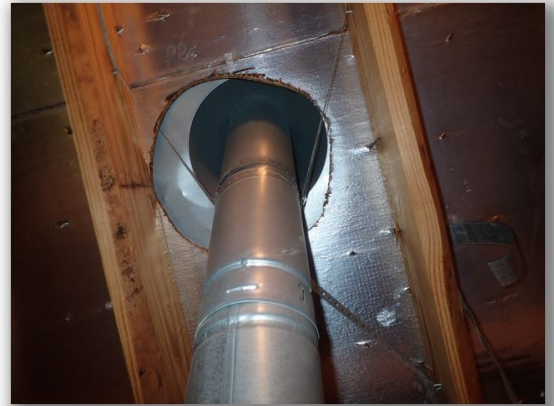
- The heating equipment appears to be inoperative at the time of the inspection.

Note: The gas service was turned off to the structure at the time of this inspection. I was unable to check the gas operation of this component at this time. A limited visual survey will be performed and if any deficiencies are found they will be listed within this section.

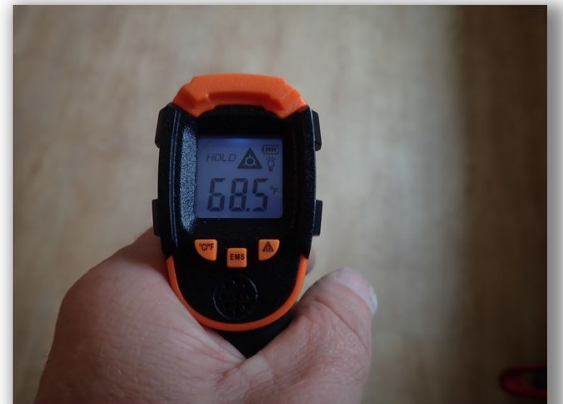
It would be wise to budget for replacement of the older freon system and to make a conversion over to a newer type of freon system as soon as it is financially feasible.

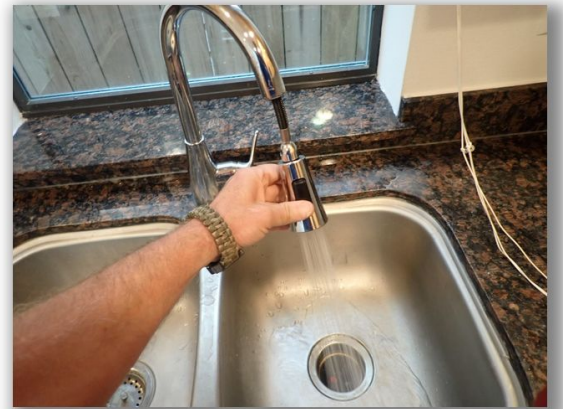
Note: Previous water leaks were observed at and/or around the drain connections under the sink. This would indicate previous problems and should be closely monitored and corrected when necessary.

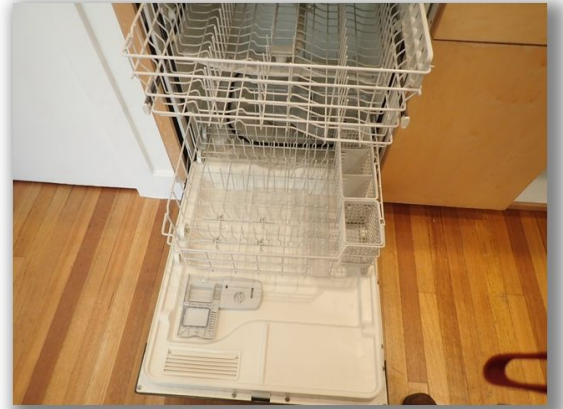
- Some rusting of the dishwasher interior components was observed.

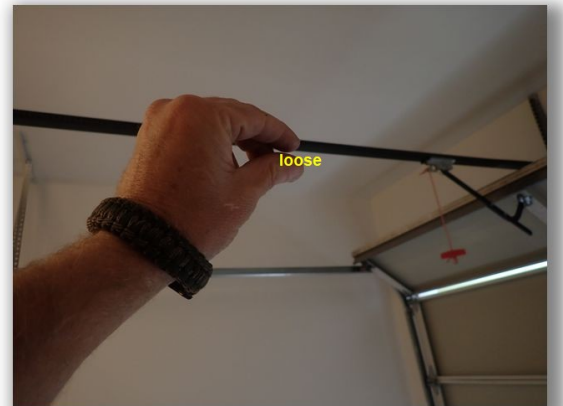
G. Garage Door Operators

- The garage door opener chain is loose and needs to be better secured and/or adjusted.
