Dukes Home Inspections Property Inspection Report

70 Warbonnet Dr, Conroe, TX 77304 Inspection prepared for: Angela Leims Real Estate Agent: Sherry Fulton - Coldwell Banker United, Willis

Date of Inspection: 3/22/2022 Time: 2:00 PM Size: 1863 Weather: Clear and 66 degrees Home faces south Home occupied Owner & agent Sherry Fulton present.

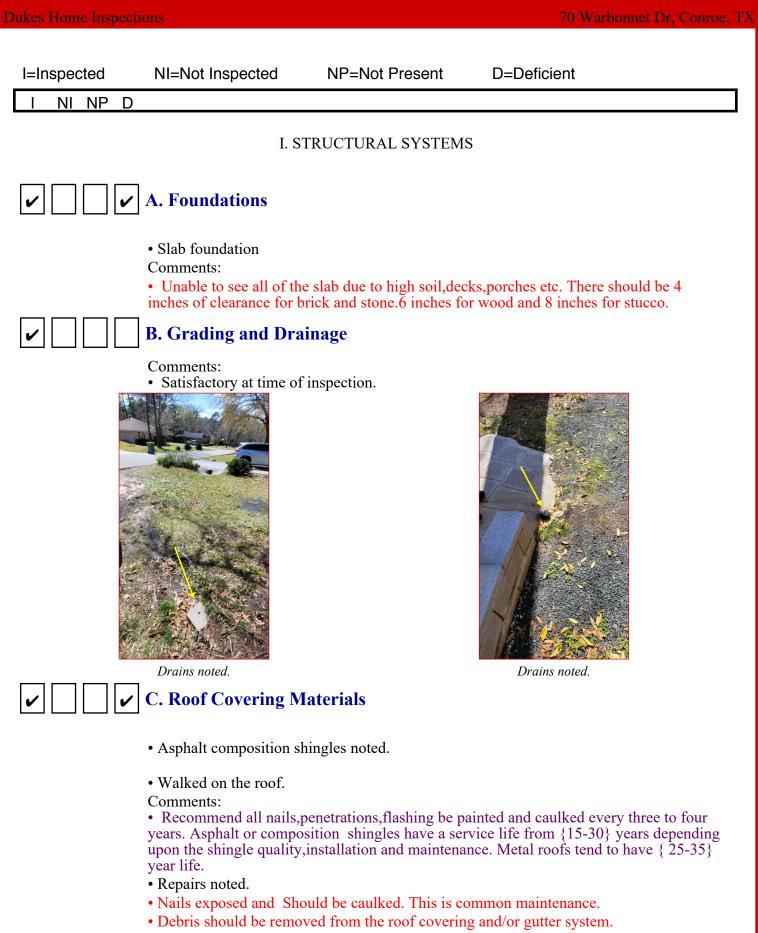
- Nails missing from flashing.
- Cricket flashing needed.

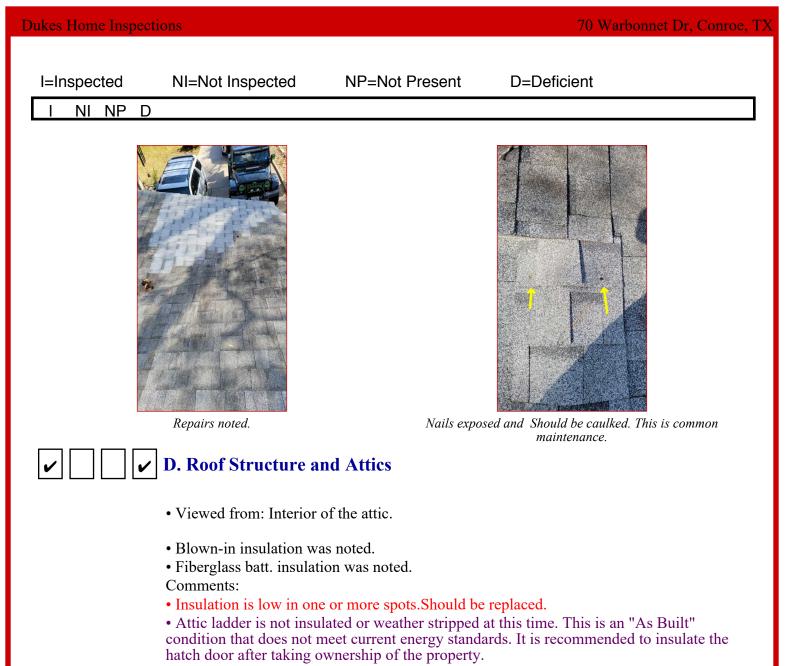
• One or more of the attic ladder components were observed to be damaged and should be corrected for safety reasons.

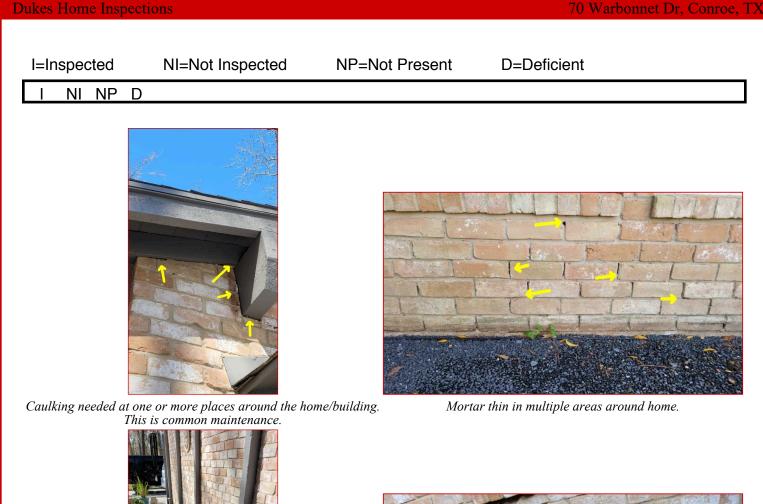
Earth to siding contact was observed on the exterior siding and should be a minimum of {4"} clearance from the ground for brick/stone {6"} for wood and {8"} for stucco. Common in older homes.

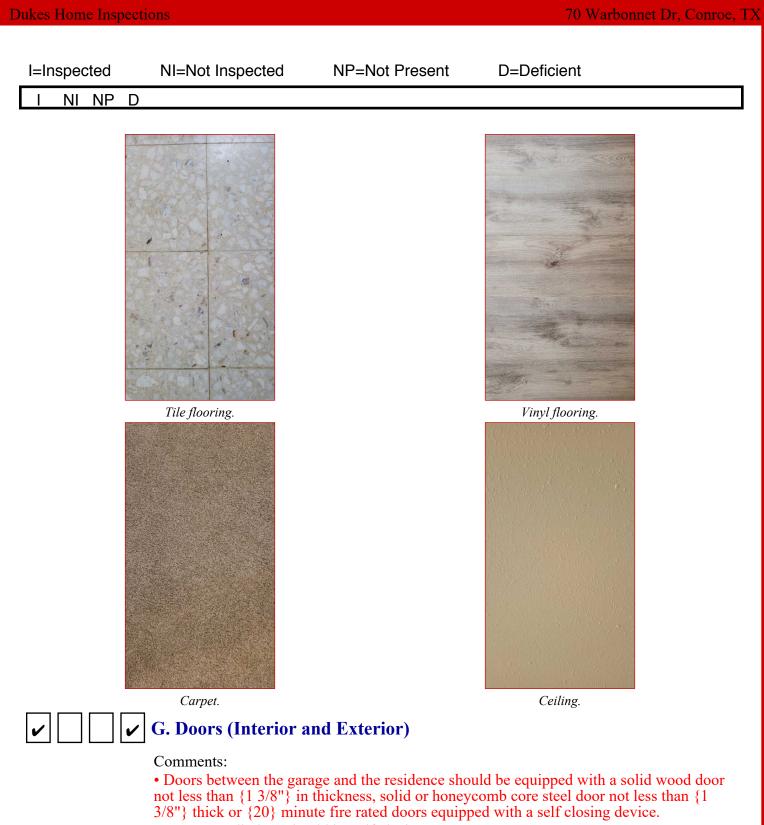
- Garage walk door should be self closing.
- Some doors were observed to be sticking, not closing properly, out-of-level, frame damage or missing and/or non-functional hardware. Not uncommon in older homes.
- One or more doors were closing on there on.May need adjusting.Common in older homes.

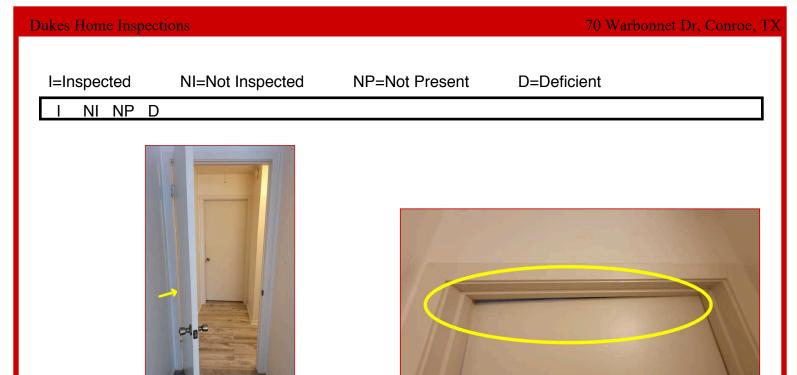
One or more doors were closing on there on. May need adjusting. Common in older homes.

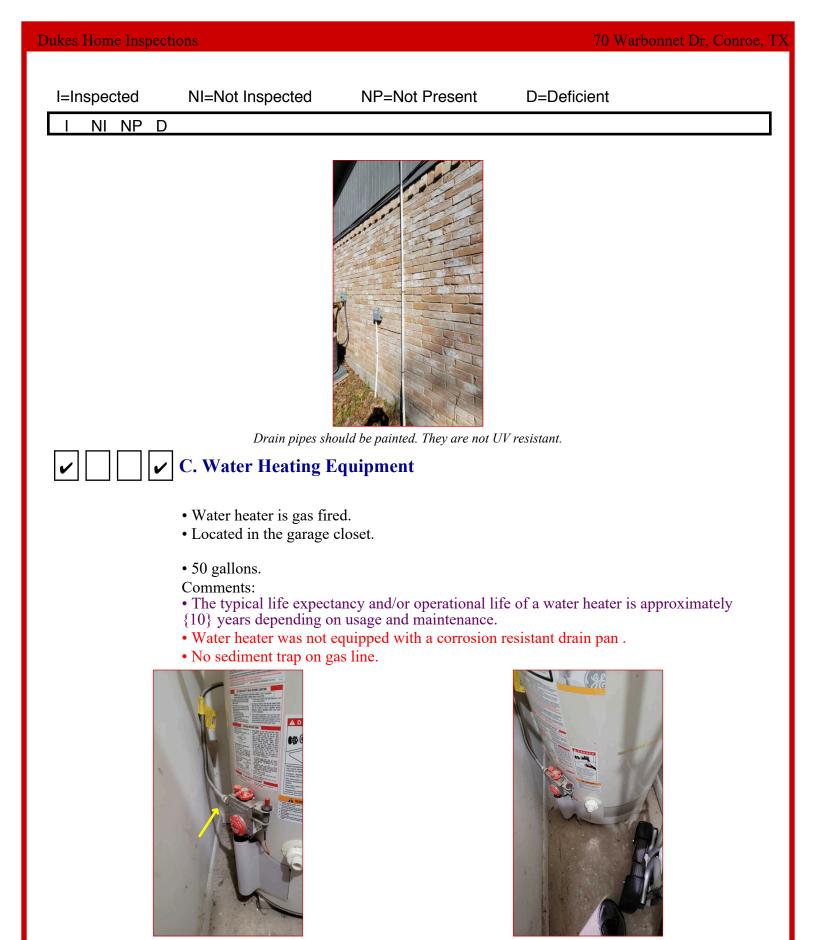
No sediment trap on gas line.

Water heater was not equipped with a corrosion resistant drain pan .
