REDSTAR RESIDENTIAL INSPECTION

705 Fowler St
Houston TX 77007

PROPERTY INSPECTION REPORT

Concerning: 705 Fowler St, Houston TX 77007

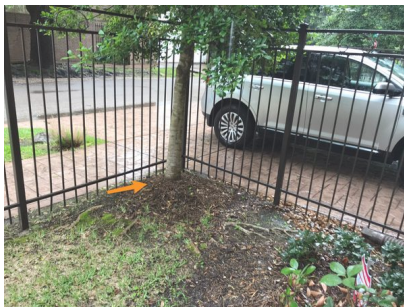
1: Tree near foundation

Area observed where trees are planted/growing near foundation. Trees adjacent to foundations can cause issues over time and recommend removal or proper maintenance/monitoring to avoid issues.

Recommendation: Contact a qualified tree service company.

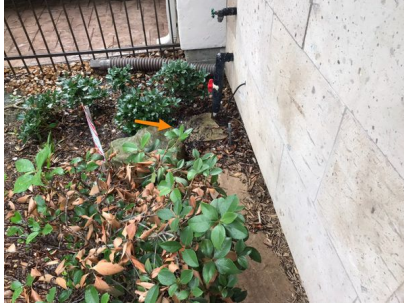
1: Grading and Drainage: Inadequate/Improper slope

Improper slope was observed at the above stated locations. Improper drainage can result in excessive

structural movement and potential standing water issues. Recommend further evaluation of these areas to determine the best method of repair.

Recommendation: Contact a qualified landscaping contractor

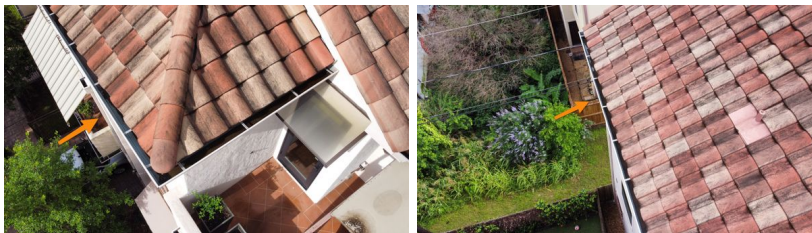
2: Gutters: Improper Slope/Loose

Gutters at multiple locations were observed to be loose or not sloped properly towards the downspouts. This condition can lead to standing water or potential damage to the home. Recommend further evaluation to determine extent of necessary repairs.

Recommendation: Contact a qualified gutter contractor

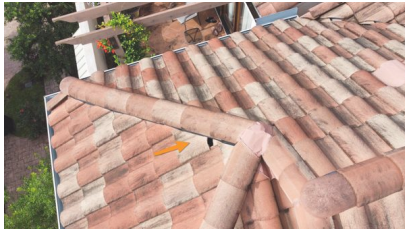
1: Tile Roof: Cracked/Broken tiles

Inspector observed areas with cracked/broken tiles on the roof covering at the front left. These areas should be evaluated by qualified contractor and repaired or replaced as needed.

Recommendation: Contact a qualified roofing professional.

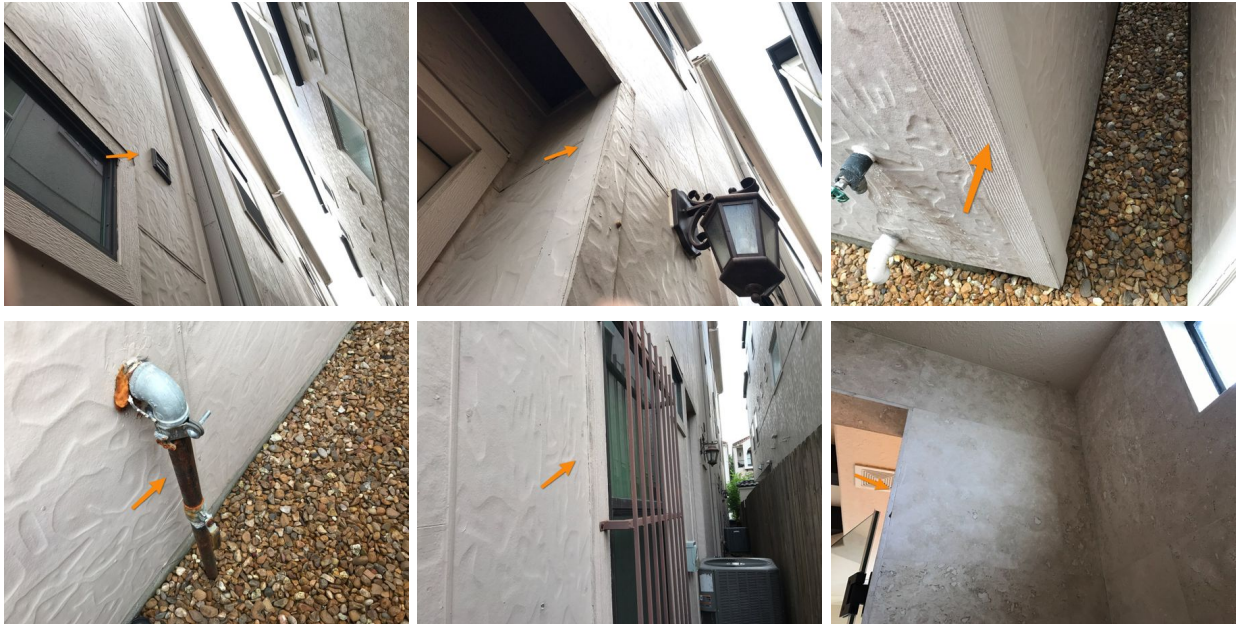
2: Caulking and Sealing Needed

Vent caps, Various locations on trim and siding, Plumbing penetrations, Shower enclosures -
The above stated locations were identified as areas in need of proper caulking and sealing, or maintenance to the existing sealant. Recommend further evaluation of these areas and all others to determine the extent of needed repairs.

Recommendation: Contact a qualified handyman.

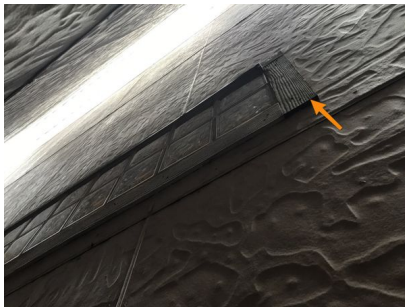
3: Siding: Paint/Finish Issues

There were some areas of the exterior siding or trim on the left side that needs painting or staining to prevent premature weathering of building materials. Remedy as needed.

Recommendation: Contact a qualified professional.

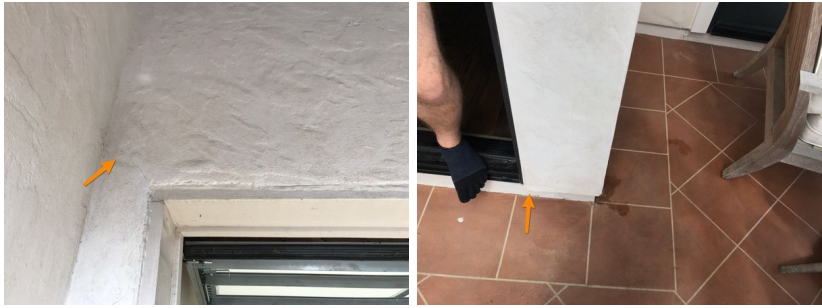
4: Stucco: Cracks

Cracks were observed to the stucco in one or more areas of the house. It is important to seal any cracks in stucco walls to prevent moisture from penetrating into the wall. Recommend further evaluation by a stucco professional.

Recommendation: Contact a stucco repair contractor

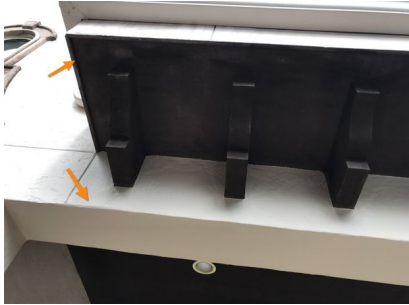
5: Stucco: No Weep Screed

No weep screed was observed at the base of the Stucco finish at the overhang locations. Recommend further evaluation and repair as these allow any moisture that accumulates behind the veneer to wick out.

Recommendation: Contact a qualified professional.

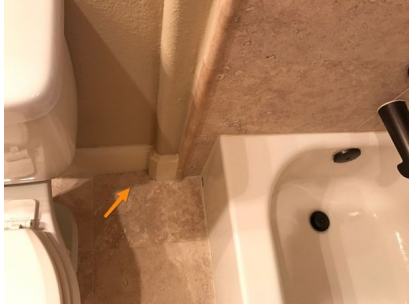
6: Interior Walls: Moisture near shower

Minor moisture damage observed to the wall and trim near some of the shower areas. This appears related to water escaping the shower when in use, and no signs of leaking or other issue was observed. Recommend cosmetic repair as desired.

Recommendation: Contact a qualified professional.

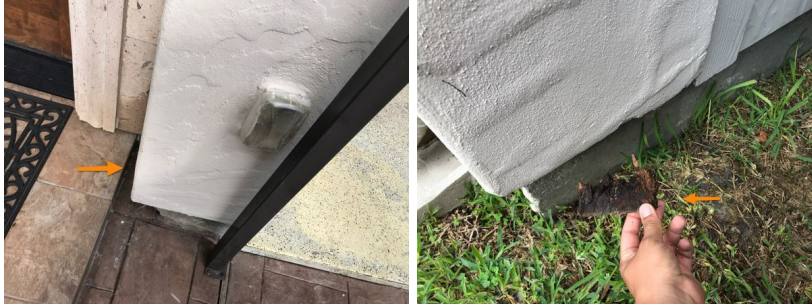
7: Stucco: Moisture Damage Sheathing

Moisture damage was observed to the OSB sheathing under the stucco finish. Recommend a qualified stucco contractor further evaluate to determine extent of moisture issues and determine what repairs are needed.

Recommendation: Contact a qualified professional.

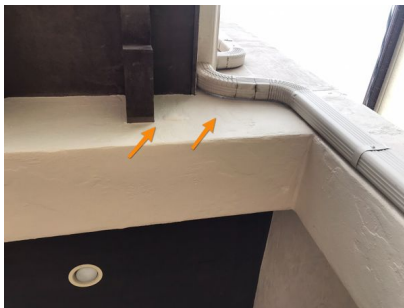
8: Stucco: Paint Bubbled

Portions of the paint finish for the stucco at the front was observed to be bubbled. This indicates a potential moisture intrusion issue. Repair as needed.

Recommendation: Contact a qualified professional.

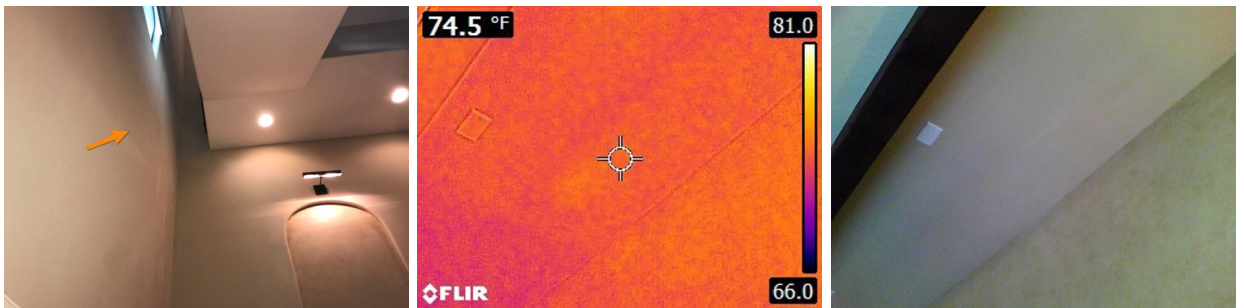
1: Note: Patched Ceilings

A patched ceiling area was observed at the above stated location at the time of the inspection. Recommend you consult with seller to try and determine any previous issues at this location. Thermal imaging and inspection of this area did not reveal any active issues at the time of inspection. Recommend cosmetic repair as desired, and further monitoring of this location.

Recommendation: Contact a qualified professional.

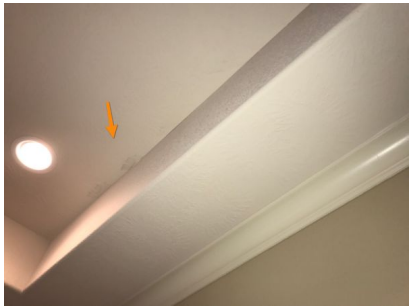
Water staining observed at the interior of the home at the ceiling at the first floor bedroom. Thermal imaging revealed no signs of active moisture at these locations, and it appears these stains are related to a previous issue. Recommend consulting with the seller to determine any previous issues at these locations, and recommend cosmetic repair and further monitoring to help ensure no leaking is present.

Recommendation: Contact a qualified professional.

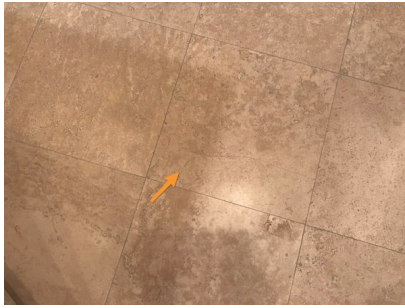
4: Flooring: Tiles Cracked or Chipped

Floor tiles are cracked or chipped at various locations at the first floor hallway. Recommend you budget for repair or replacement as desired.

Recommendation: Contact a qualified flooring contractor

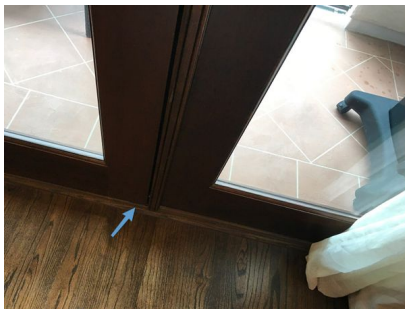
1: Exterior Door: Gaps in Weather Seals

Gaps were observed in the weather seal around the exterior doors. Repair as needed to prevent moisture, pest, and air intrusion.

Recommendation: Contact a qualified professional.

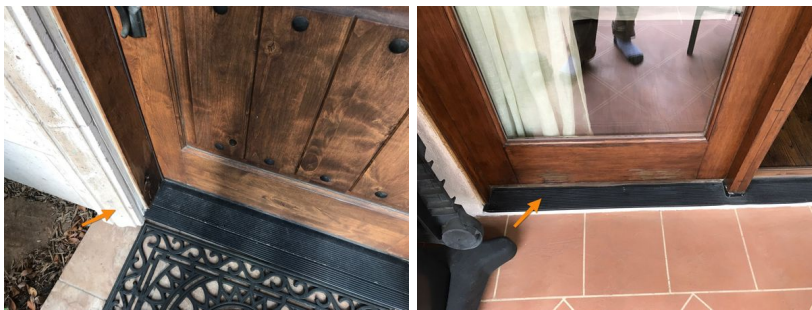
2: Exterior Door: Moisture Damage at Base of Frame

Moisture damage observed to the base of the first floor front and the second floor front balcony doors. Recommend further evaluation and correction as needed to prevent further deterioration or moisture intrusion.

Recommendation: Contact a qualified professional.

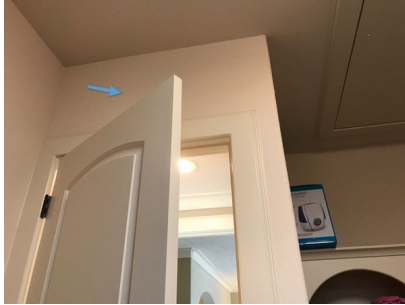
3: Interior Doors: Door Rubs Frame

The master bedroom closet door was observed to be rubbing against the frame. Recommend adjustment to allow for easier operation.

Recommendation: Contact a qualified professional.

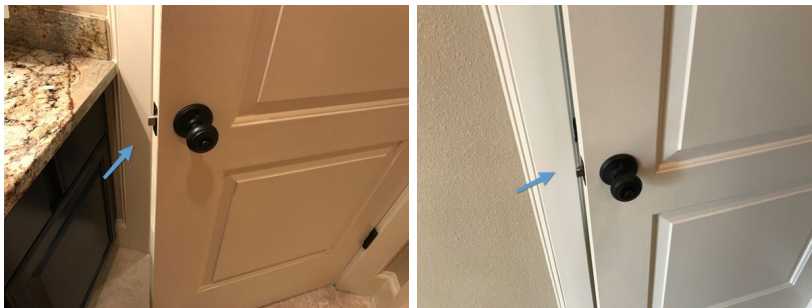
4: Interior Doors Hardware: Doesn't Latch at Hardware

Second floor bathroom door and the Master bathroom doors did not latch at the hardware at the time of the inspection. Adjustment is recommended to correct latching ability.

Recommendation: Contact a qualified professional.

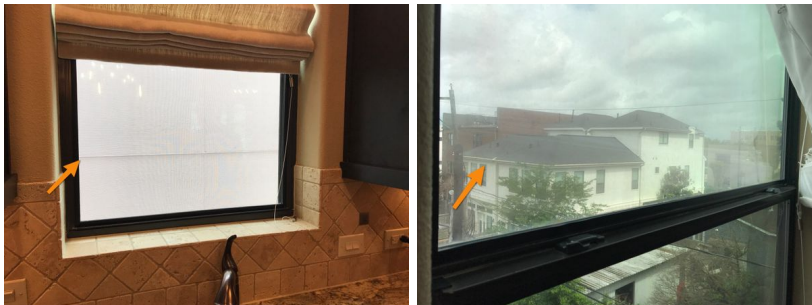
1: Failed Seal

The seal appears compromised on the double pane window glass at the above stated locations. This condition is indicated by build-up observed between the panes of glass and will potentially require replacement of the glass. Recommend further evaluation and correction as needed.

Recommendation: Contact a qualified window repair/installation contractor.

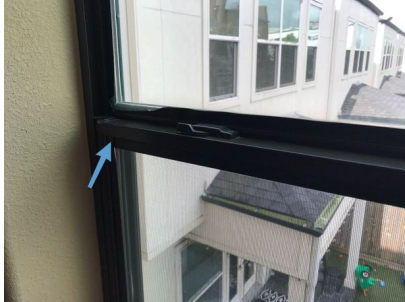
2: Glazings: Damaged

The plastic glazings at the second floor bedroom window pane was damaged. Recommend

correction as needed to prevent further deterioration and to allow for easier operation.

Recommendation: Contact a qualified professional.

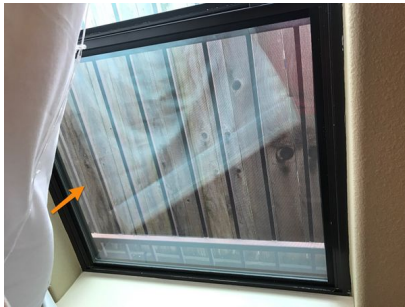
3: Security Gates

Security gates were observed to have been installed for the First floor bedroom windows, this can be an issue for egress in the event of an emergency. Recommend further evaluation and repair for safety purposes.

Recommendation: Contact a qualified professional.

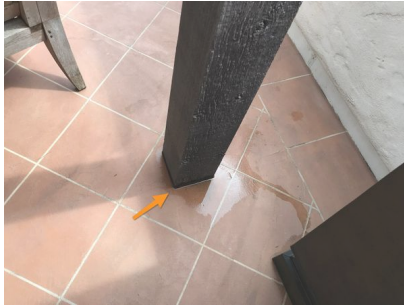
Evidence of water ponding was observed on the Third floor balcony, recommend further evaluation and

repair as needed to prevent moisture damage to the pergola and home over time.

Recommendation: Contact a qualified professional.

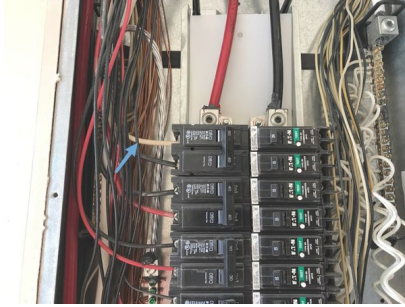
White wires were observed connected to breakers. White wires are typically neutral but when they are connected to a breaker they become hot/live and should be marked as such. Recommend to have an electrician evaluate for remedy.

Recommendation: Contact a qualified professional.

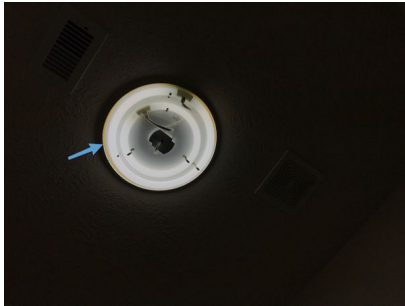
1: Light: Missing Globe

The protective globe was missing from the light fixture in the laundry room. Remedy as needed.

Recommendation: Contact a qualified handyman.

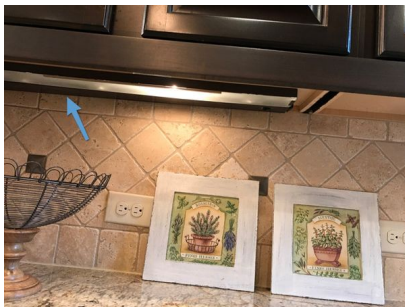
2: Light: Inoperable

Portions of the under mount kitchen cabinet light fixtures did not function, possibly bulb related. Correct as needed.

Recommendation: Contact a qualified electrical contractor.

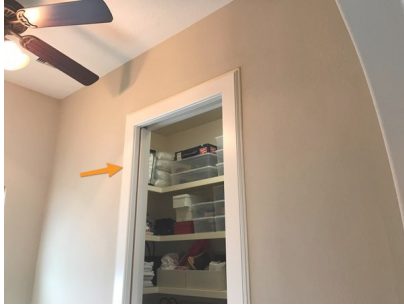
3: Fixture: No Observable Switch

No observable switch was found for the Master closet light. It may have been concealed. Recommend inquiring with the homeowner.

Recommendation: Contact a qualified professional.

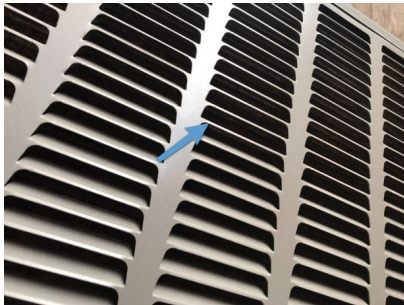
1: Condenser: Dirty Fins

Recommend cleaning fins around the condenser unit to allow it to operate efficiently.

Recommendation: Contact a qualified professional.

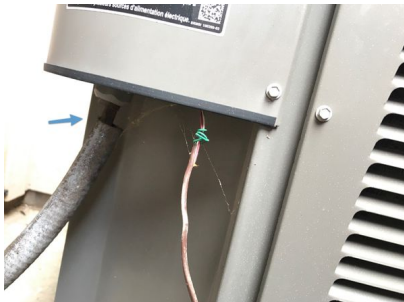
2: Condenser Unit: Loose Conduit

Conduit for the electrical supply wires at the condenser unit was loose. Repair as needed to prevent damage to the wires.

Recommendation: Contact a qualified professional.

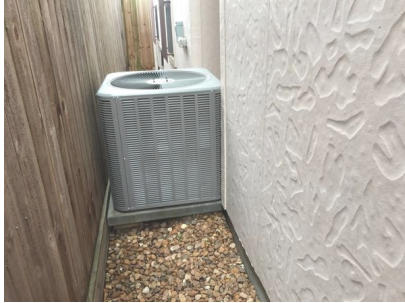
3: Hissing Noise

A hissing noise was observed at the Condenser unit when it was shut off, this can indicate a potential issue with the unit. Recommend further evaluation and repair to determine what if any repairs are needed.

Recommendation: Contact a qualified professional.

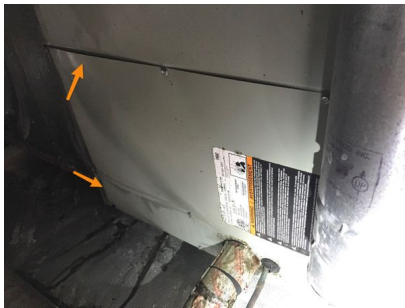
Excessive condensation was observed around the air handler from air leaking at the transitions. Recommend sealing all penetrations and transitions around the air handler to prevent conditioned air from leaking into the attic space.

Recommendation: Contact a qualified professional.

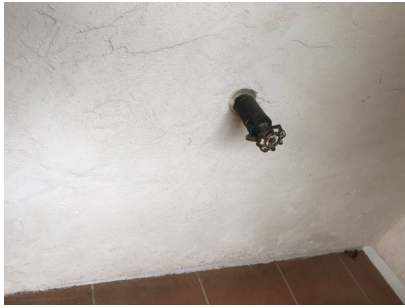
1: Hose Bibb (outdoor faucet): Backflow Prevention Missing

The second floor balcony hose bib was Missing a backflow preventer. These devices are inexpensive, easily installed and help prevent contamination of potable water. Repair as needed.

Recommendation: Contact a handyman or DIY project

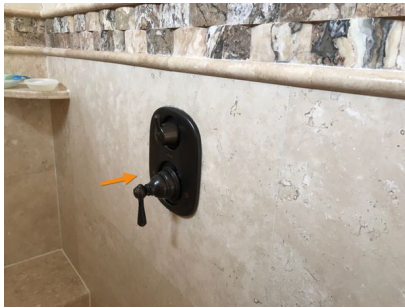
2: Fixture: Hot and Cold Reversed

The hot and cold water controls were reversed for the master bathroom shower. The Hot should be on the left side of the fixture. Recommend further evaluation by a plumbing contractor.

Recommendation: Contact a qualified plumbing contractor.

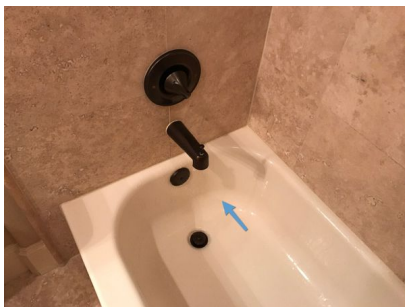
3: Showers: Diverter Leaks

The Diverter valve for the downstairs and second floor bathroom showers did not seal fully when the pin was pulled. Repair as needed for water conservation purposes.

Recommendation: Contact a qualified professional.

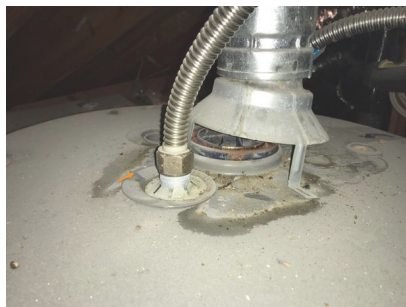
1: Flue: Displaced

The flue for the water heater was observed to be slightly displaced. Recommend adjusting to allow the combustion gases to exit the home properly.

Recommendation: Contact a qualified professional.
