Home Inspection Report

17203 Gold Panning Ct
Magnolia , Texas 77355

PROPERTY INSPECTION REPORT

Inspection Date: 6/1/2020

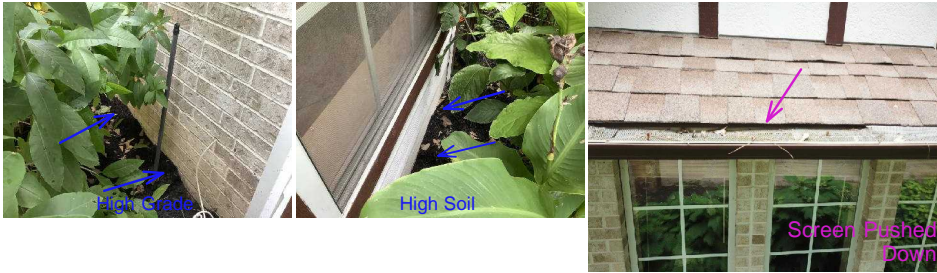
☒☐☐☒ B. Grading and Drainage - Comments:

1. High soil, it was completely covering the slab in many areas in the front and right side.
 2. Debris screen pushed down in the front.

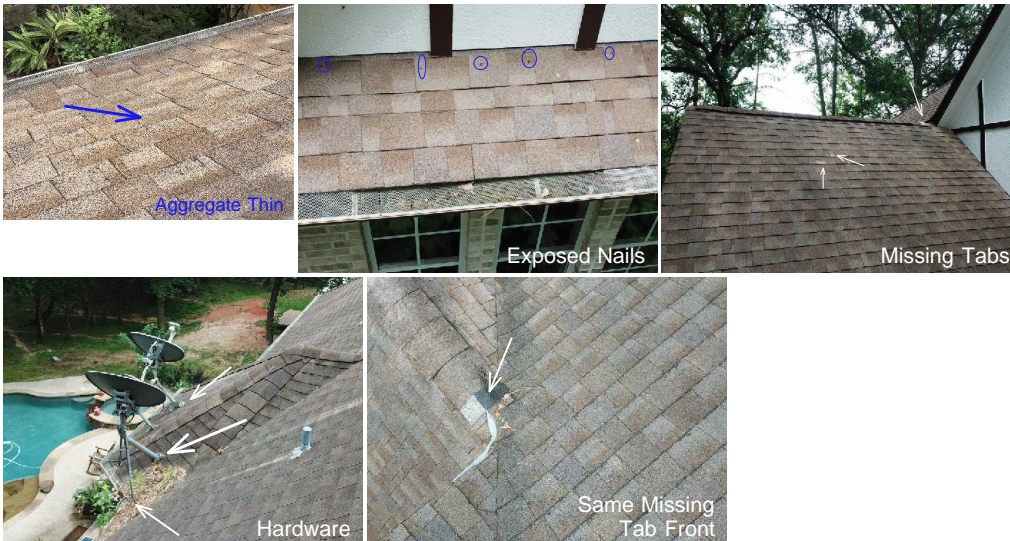
☒☐☐☒ C. Roof Covering Materials

1. The aggregate was thin and the roof was showing age. There was a bit of damage in the front elevation where there was a missing tab at the ridge and a couple of torn away portions of two tabs in the front also.
 2. Some exposed and rusty nail heads in the a few areas.
 3. The shingles and deck were breached with installed satellite hardware, I suggest removing the antenna portion if the antenna is not to be used.
 4. The roof was as old as the home in my estimation, some of the aggregate had worn away over time and the covering had to have gone through storms due to being in S.E. TX, but it was performing at the time of the inspection.

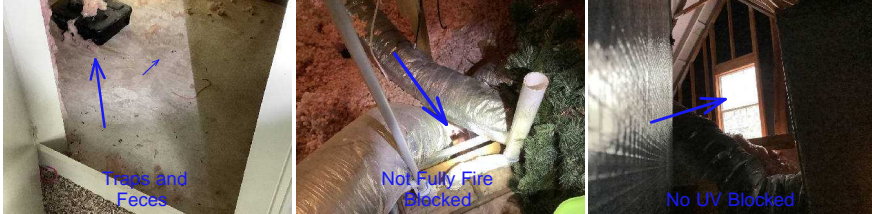
☒☐☐☒ D. Roof Structures and Attics

1. Evidence of rodent activity in the attic.
2. The floor of the attic was not fully fire-blocked from the story below.
3. The attic window was not block to prevent UV damaging light to enter the attic. UV light breaks down plastics.

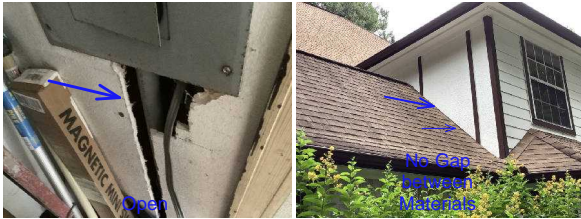
☒☐☐☒ E. Walls (Interior and Exterior) - Comments:

1. Wall open in the garage removing the fire rating of the garage.
2. No gap between the upper wall and lower proof line where they meet, there should be a minimum of a 1 inch gap.

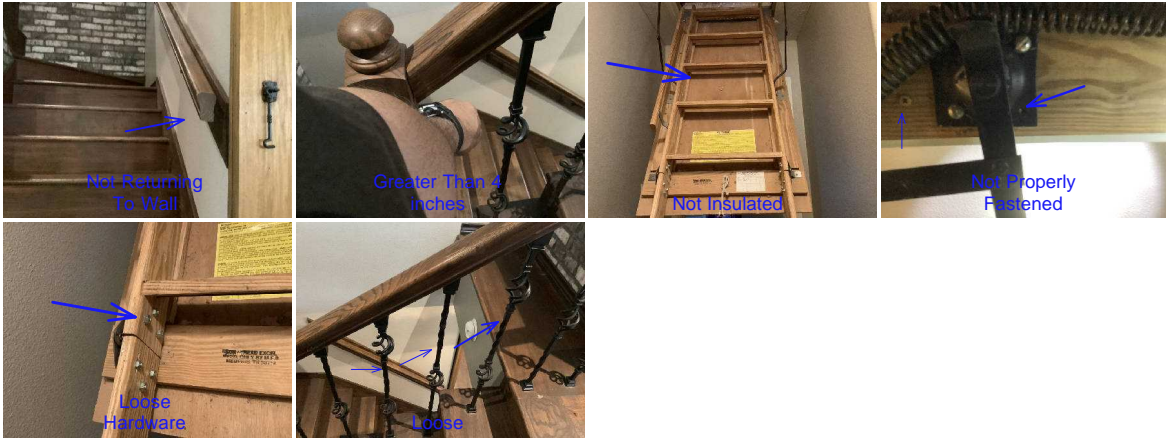
I. Stairways (Interior and Exterior) - Comments:

1. The hand rail at the stairs did not return to the wall, this is a snag hazard.
2. The distance between the intermediate balusters was greater than 4".
3. The attic access ladder inside the house was not fully insulated or fire rated.
4. The attic access ladder was not installed to the manufacturer's recommended procedures, there were not enough of the proper size fasteners.

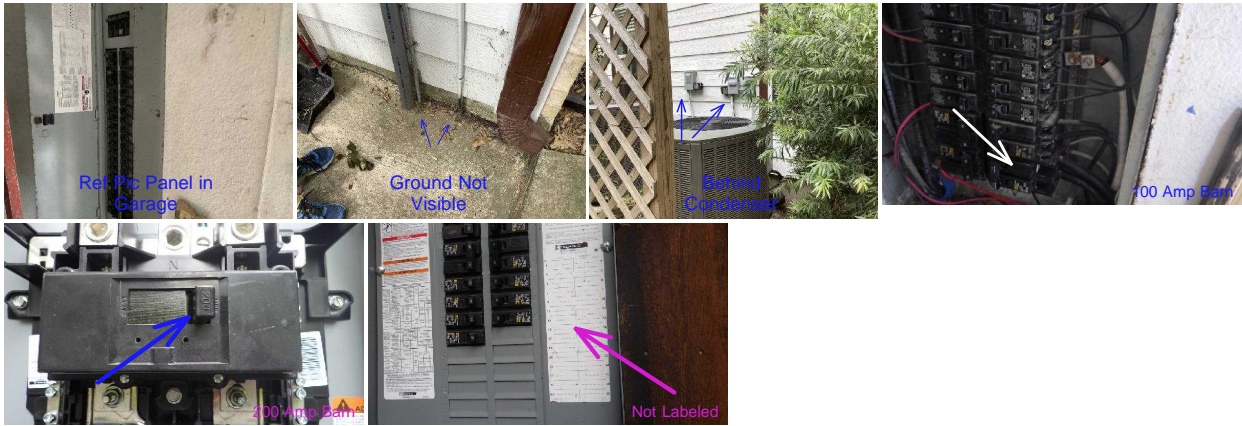
☒☐☐☒ A. Service Entrance and Panels - Comments: 200 Amp Main,

1. I could not see the ground rod. Everything indicated a ground.
2. AC electrical isolate panel installed behind the condenser unit, those panels should conform to standard panel clearances.
3. AC electrical isolate panel installed behind the condenser unit, those panels should conform to standard panel clearances.
4. No installed AFCI breakers, they were not required when the unit was built, but are a notable safety device.
5. The panel at the barn had a 200 Amp main breaker wired to a 100 Amp breaker at the main panel. The 100 should be the limit for the load. The wires (conductors) appeared to be #2 . I recommend the electrician recommended in branch circuits also check the matching of the breakers and wire size for the garage panel.

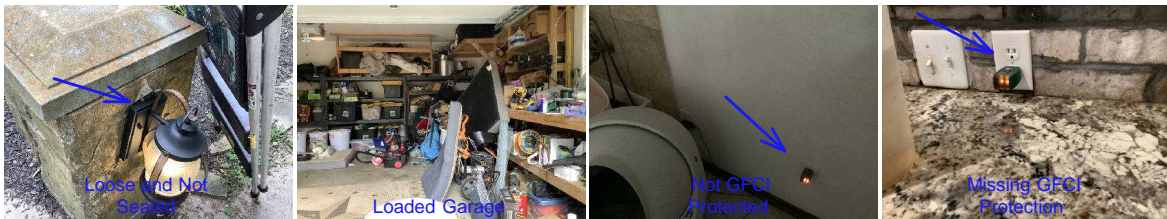
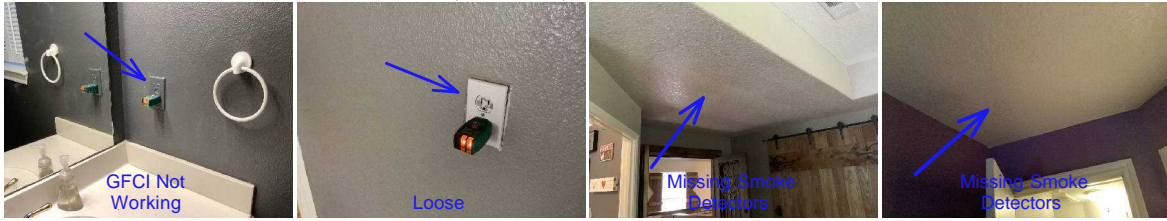
☒☐☐☒ B. Branch Circuits, Connected Devices, and Fixtures

1. Carriage light loose and not sealed.
2. I did not test exterior GFCI protection due to the likelihood of not finding the reset.
3. Missing GFCI protection for outlets in required locations, kitchen bathroom, exterior and all others.
4. Loose receptacle in upstairs hall.
5. Smoke detectors missing in required locations, bedrooms. System did not meet the newest code.
6. Panel at the barn was not clearly and fully labeled.
7. I did not see a carbon monoxide detector installed, two are required, on per story.
8. A licensed electrician is recommend to evaluate the system for repairs of deficiencies listed herein and any others that they may find.

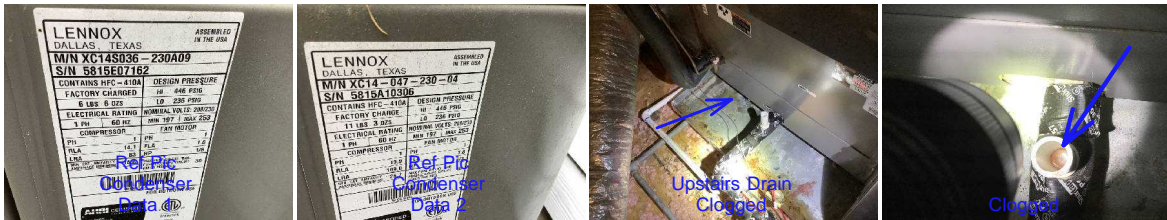
B. Cooling Equipment

Type of Systems: Central Forced Air X2
 Comments:
 1. Upstairs unit primary condensate drain line clogged. Condensation dripping in overflow pan.
 2. Same drain pan Rusty.

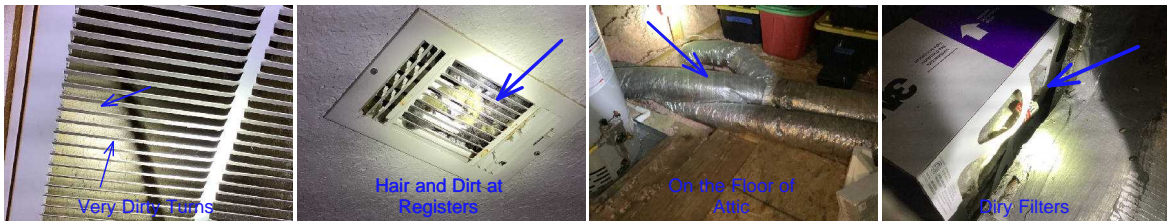
C. Duct Systems, Chases, and Vents - Comments:

1. Return grills, ducts, filters and service duct all the way to the grills were dirty and built up with animal hair.
2. Some of the ducts were not suspended above the attic floor as required.
3. Given the the amount of obvious dirt and hair buildup in the systems I recommend a duct and coil cleaning.

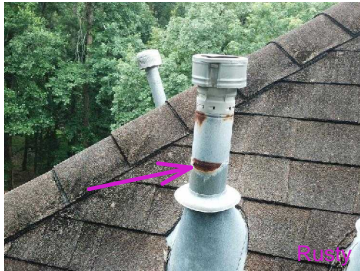
☒☐☐☒ B. Drains, Wastes, and Vents - Comments:

1. Some of the duct above the roof were rusty, otherwise visible drains, wastes and vents were in good order. I can not inspect any concealed drains wastes or vents.

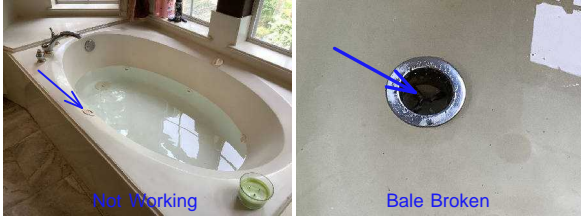
D. Hydro-Massage Therapy Equipment (continued)

1. Tub pump did not turn on (work) for me.
2. Bale for the drain stopper was broken.

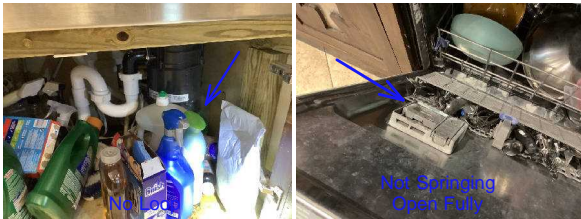
A. Dishwashers - Comments:

1. No obvious loop or anti-siphon device installed for drain line.
2. Soap dispenser not latching open fully. Otherwise the unit worked well and was in good order.

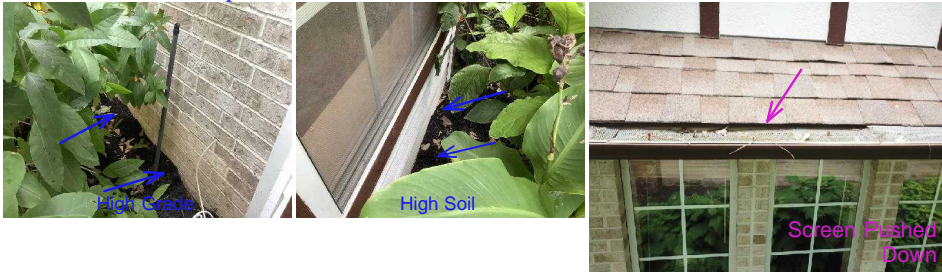
B. Grading and Drainage

1. High soil, it was completely covering the slab in many areas in the front and right side.
2. Debris screen pushed down in the front.

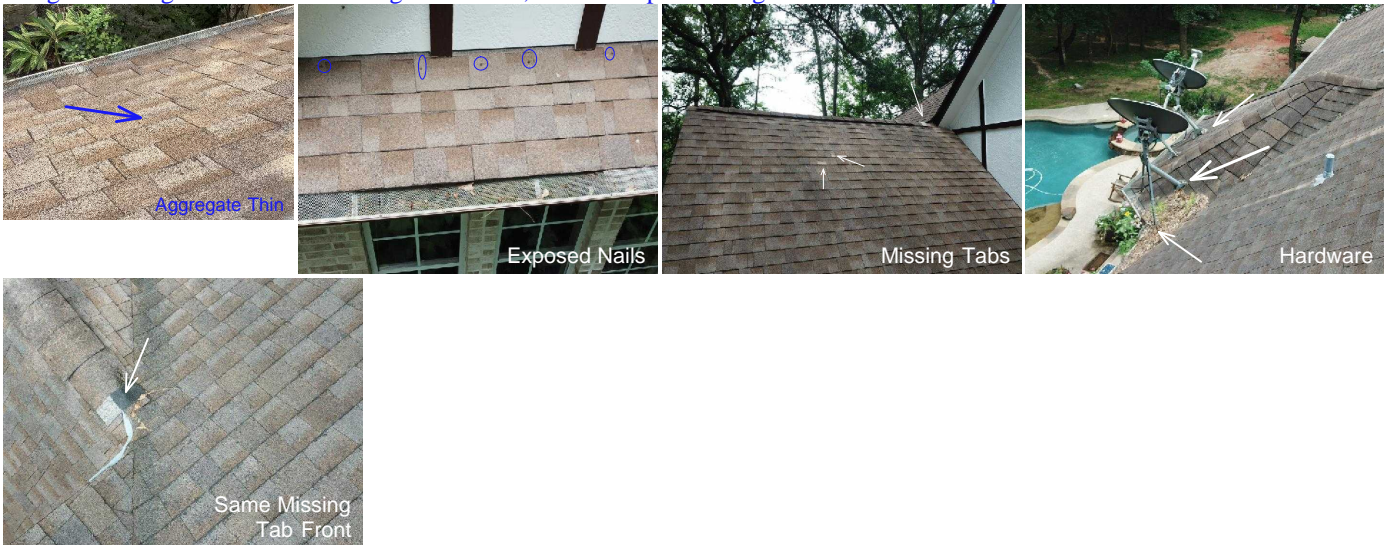
C. Roof Covering Materials

1. The aggregate was thin and the roof was showing age. There was a bit of damage in the front elevation where there was a missing tab at the ridge and a couple of torn away portions of two tabs in the front also.
2. Some exposed and rusty nail heads in the a few areas.
3. The shingles and deck were breached with installed satellite hardware, I suggest removing the antenna portion if the antenna is not to be used.
4. The roof was as old as the home in my estimation, some of the aggregate had worn away over time and the covering had to have gone through storms due to being in S.E. TX, but it was performing at the time of the inspection.

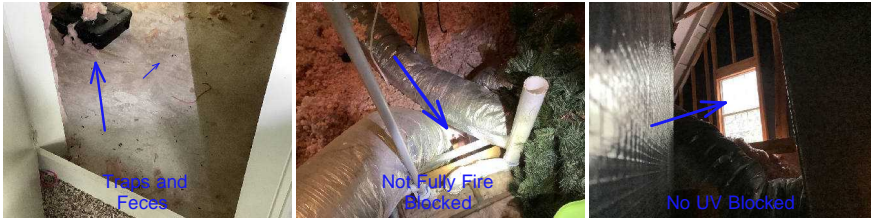
D. Roof Structures and Attics (continued)

1. Evidence of rodent activity in the attic.
2. The floor of the attic was not fully fire-blocked from the story below.
3. The attic window was not block to prevent UV damaging light to enter the attic. UV light breaks down plastics.

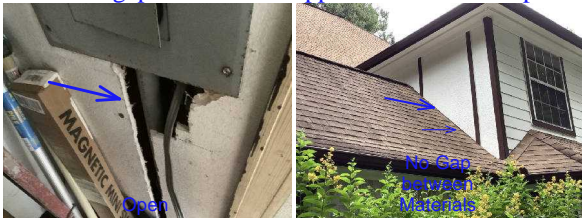
E. Walls (Interior and Exterior)

1. Wall open in the garage removing the fire rating of the garage.
2. No gap between the upper wall and lower roof line where they meet, there should be a minimum of a 1 inch gap.

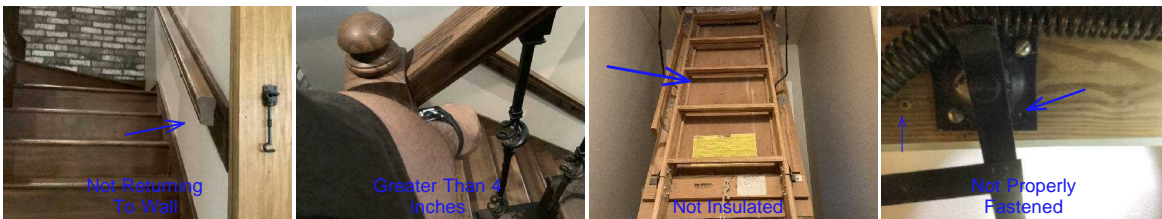
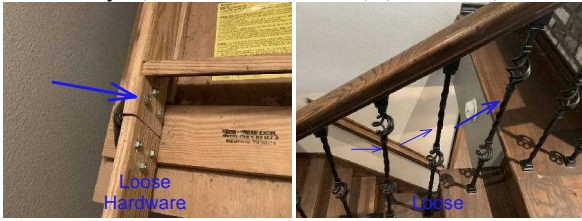
I. Stairways (Interior and Exterior)

1. The hand rail at the stairs did not return to the wall, this is a snag hazard.
2. The distance between the intermediate balusters was greater than 4".
3. The attic access ladder inside the house was not fully insulated or fire rated.
4. The attic access ladder was not installed to the manufacturer's recommended procedures, there were not enough of the proper size fasteners.

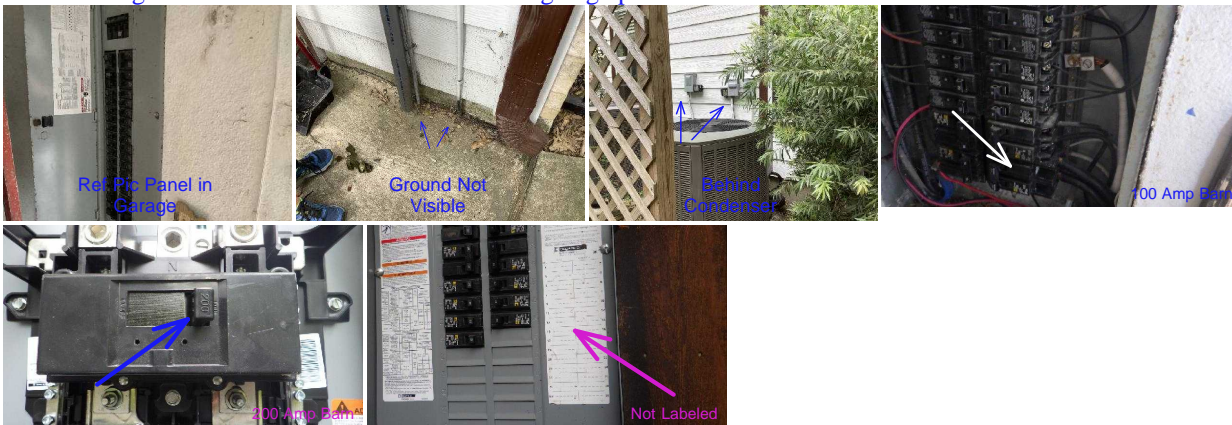
A. Service Entrance and Panels 200 Amp Main,

- 1. I could not see the ground rod. Everything indicated a ground.
- 2. AC electrical isolate panel installed behind the condenser unit, those panels should conform to standard panel clearances.
- 3. AC electrical isolate panel installed behind the condenser unit, those panels should conform to standard panel clearances.
- 4. No installed AFCI breakers, they were not required when the unit was built, but are a notable safety device.
- 5. The panel at the barn had a 200 Amp main breaker wired to a 100 Amp breaker at the main panel. The 100 should be the limit for the load. The wires (conductors) appeared to be #2 . I recommend the electrician recommended in branch circuits also check the matching of the breakers and wire size for the garage panel.

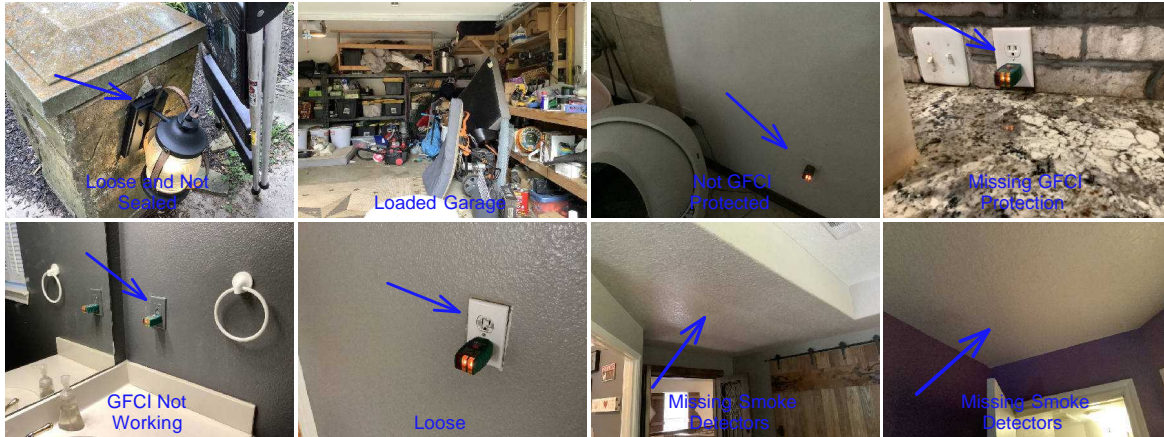
B. Branch Circuits, Connected Devices, and Fixtures (continued)

- 1. Carriage light loose and not sealed.
- 2. I did not test exterior GFCI protection due to the likelihood of not finding the reset.
- 3. Missing GFCI protection for outlets in required locations, kitchen bathroom, exterior and all others.
- 4. Loose receptacle in upstairs hall.
- 5. Smoke detectors missing in required locations, bedrooms. System did not meet the newest code.
- 6. Panel at the barn was not clearly and fully labeled.
- 7. I did not see a carbon monoxide detector installed, two are required, on per story.
- 8. A licensed electrician is recommend to evaluate the system for repairs of deficiencies listed herein and any others that they may find.

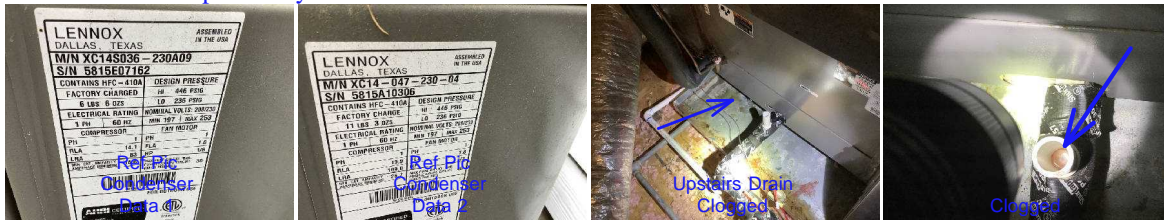
B. Cooling Equipment

1. Upstairs unit primary condensate drain line clogged. Condensation dripping in overflow pan.
2. Same drain pan Rusty.

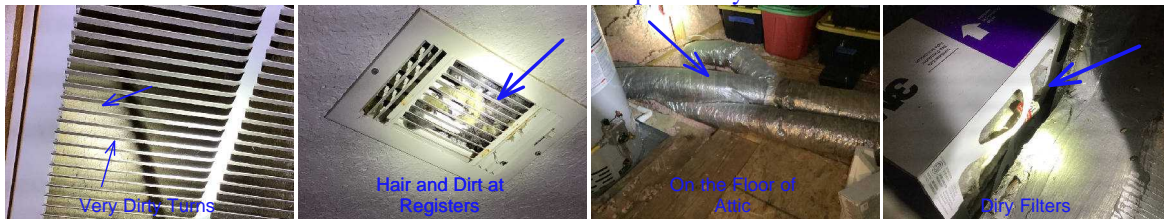
C. Duct Systems, Chases, and Vents

1. Return grills, ducts, filters and service duct all the way to the grills were dirty and built up with animal hair.
2. Some of the ducts were not suspended above the attic floor as required.
3. Given the the amount of obvious dirt and hair buildup in the systems I recommend a duct and coil cleaning.

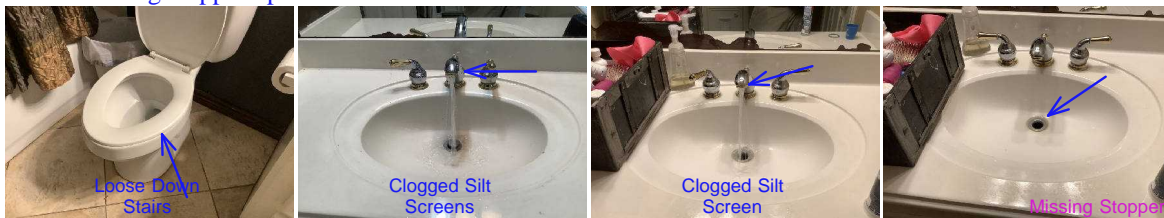
A. Plumbing Supply, Distribution Systems and Fixtures Copper,

1. Toilet in downstairs a was loose on the floor mounts.
2. Many of the silt screens were clogged causing diminished and interrupted water flow.
3. Missing stopper upstairs bathroom.

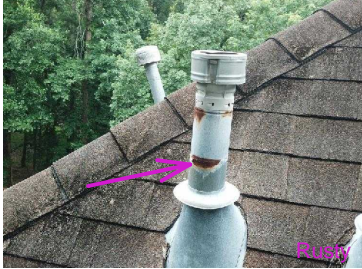
B. Drains, Wastes, and Vents

1. Some of the duct above the roof were rusty, otherwise visible drains, wastes and vents were in good order. I can not inspect any concealed drains wastes or vents.

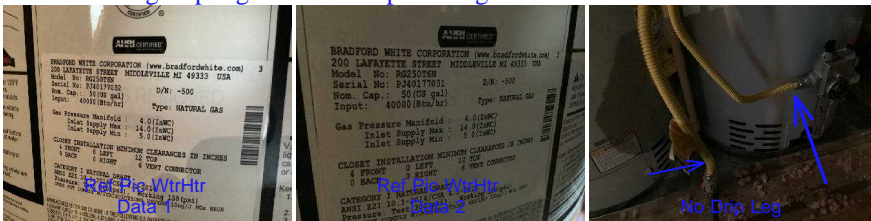
C. Water Heating Equipment Bradford White 2017 Both,

1. Missing drip-leg/sediment traps from gas service lines to he units. Otherwise the units were in good order and working well.

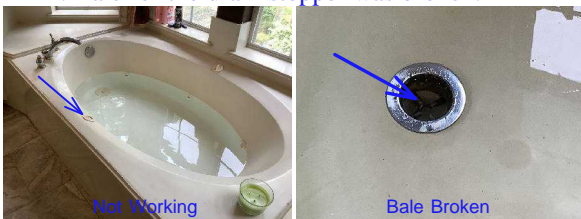
D. Hydro-Massage Therapy Equipment

1. Tub pump did not turn on (work) for me.
2. Bale for the drain stopper was broken.

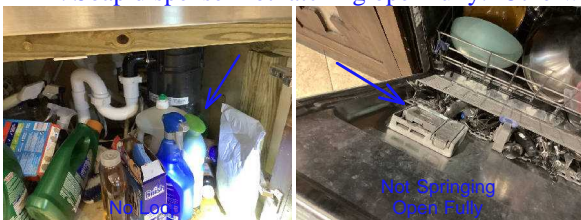
A. Dishwashers

1. No obvious loop or anti-siphon device installed for drain line.
2. Soap dispenser not latching open fully. Otherwise the unit worked well and was in good order.
