## HEDDERMAN ENGINEERING, INC.

REF: CONDITION OF PROPERTY SURVEY

**10907 Leigh Woods Drive**

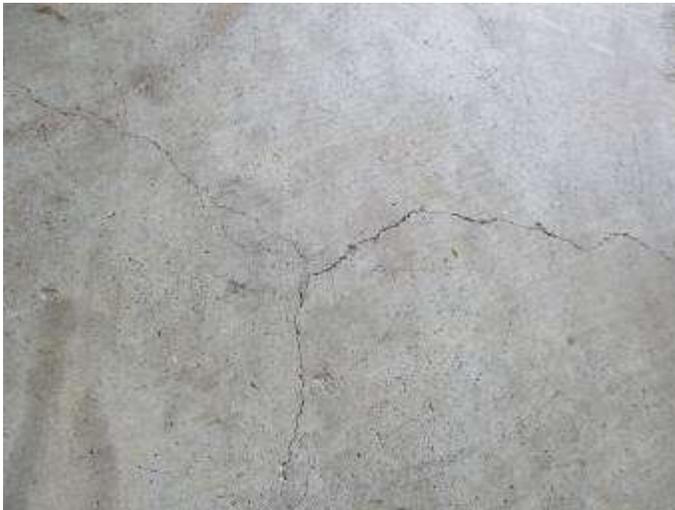
Cracking of the foundation concrete exists in virtually all foundations. It is pointed out that cracking is a normal property of concrete and other brittle materials, and Hedderman Engineering, Inc. assumes no responsibility should cracks be found that are not mentioned in this report. Some cracking was observed in this concrete foundation, including at the garage floor.

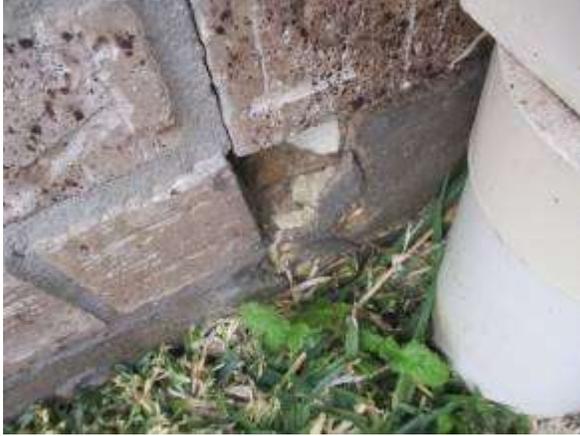
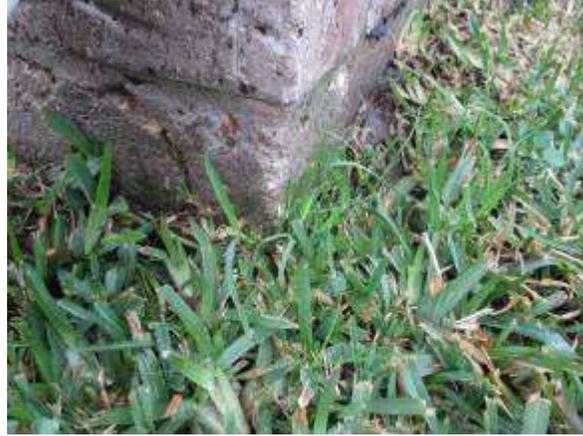
The corner of the foundation was observed to be chipped at the south side and northwest corner of the house. This condition is typically caused by differences in thermal expansion between the brick veneer and the concrete foundation. Also, this condition can be caused by a lack of reinforcement in the corner of the foundation during original construction. In our opinion, this condition does not affect the overall structural integrity of the foundation.

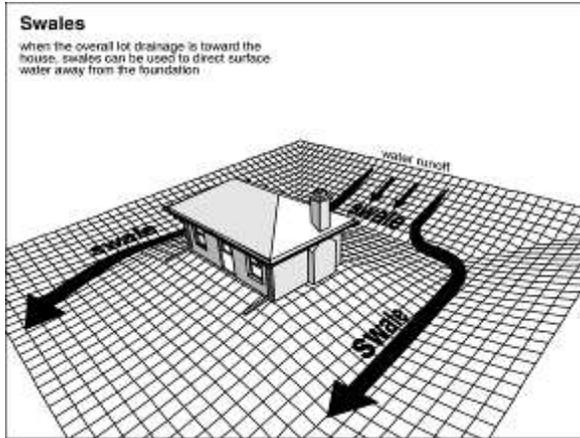
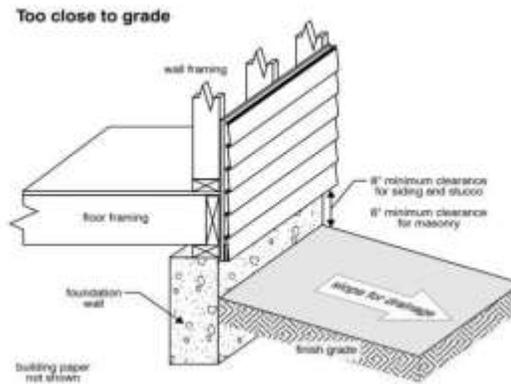
The perimeter drainage was observed to be poor at some areas where the lot is not sloped away from the house (6 inch drop in the first 10 feet) and it appears that water will pond. It is recommended that a company specializing in drainage solutions be contacted to provide a recommended solution, along with a cost estimate to provide proper drainage.

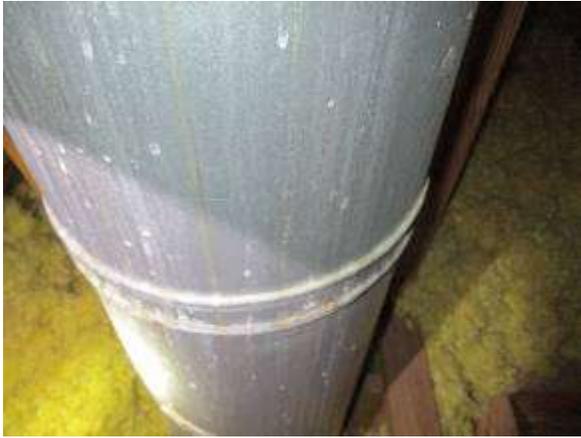
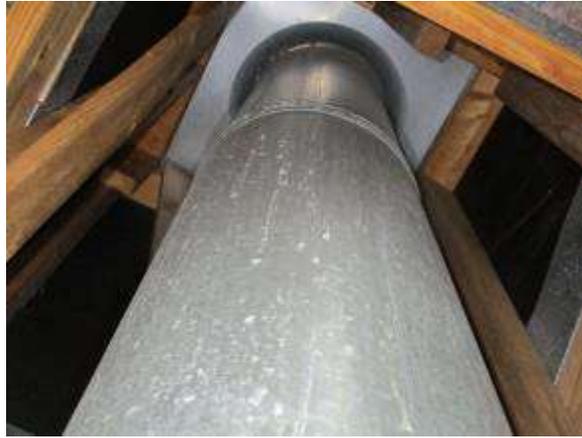
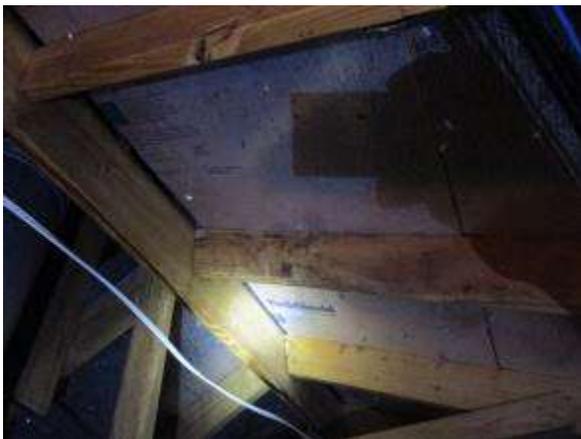
Locations included: Chimney flue

After observing the interior of the structure, evidences of roof leaks were visible in the attic, where the roof decking and/or roof framing members were water stained. It is recommended that a roofing contractor be contacted to find the source of the leaks, and to make any needed repairs.

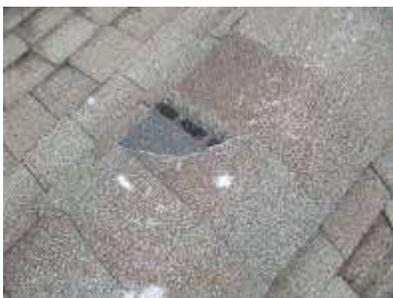
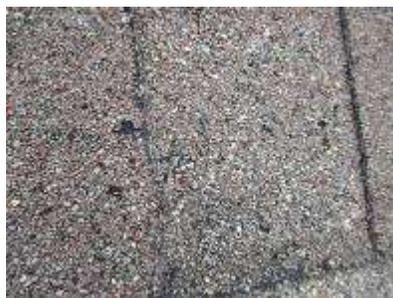
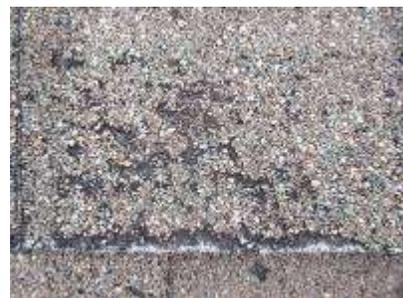
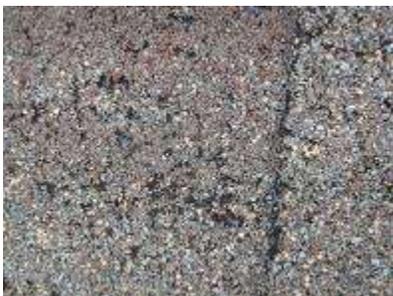
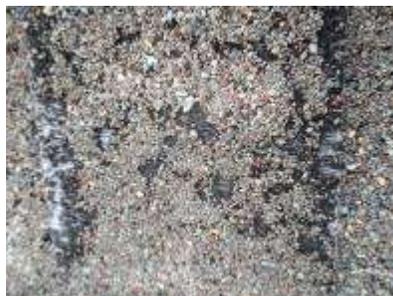
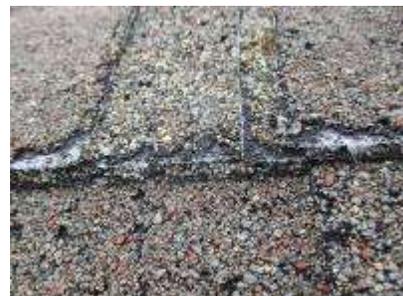
The composition roof surface was showing evidences of premature deterioration, including the majority of shingles that were brittle, discolored, curling on the edges, cracked, and losing their aggregate.

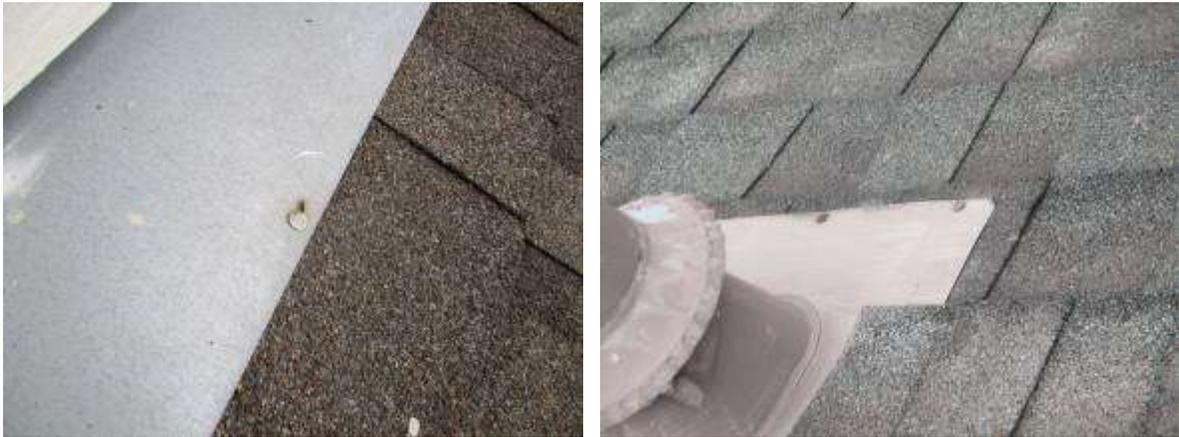
We observed rust on some of the metal roof accessories, and although the accessories are still performing their intended function, it is recommended that the rust be removed. Locations included: Metal valleys

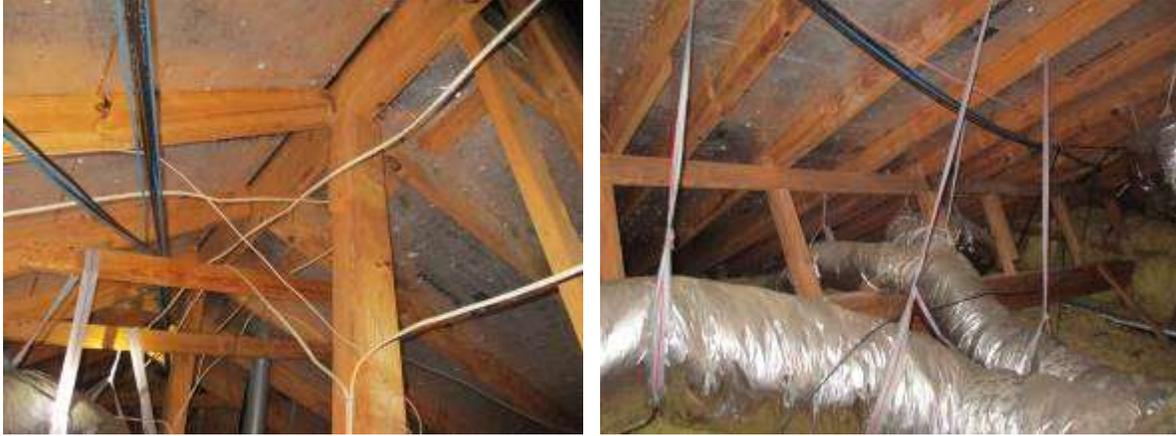
We did not observe metal hurricane clips/straps installed at the attic framing members. These clips/straps provide a stronger structure that will be more resistant to wind uplift from hurricane and tornadoes.

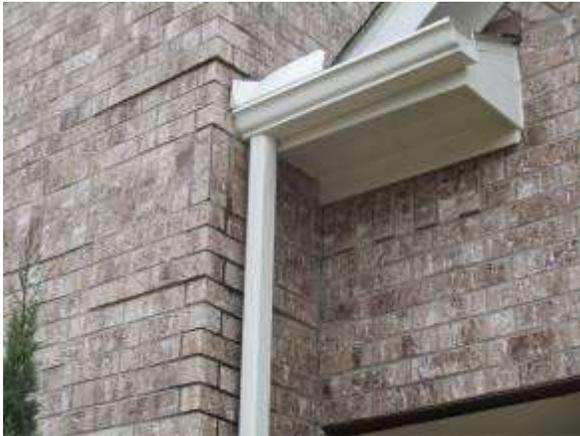
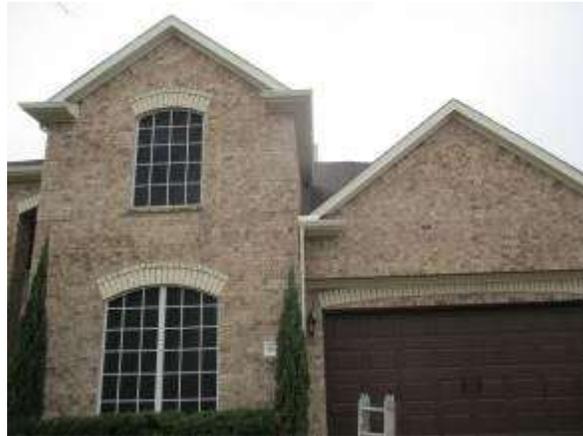
**Leaking gutters/Dead valleys**

A substantial vulnerability to water penetration was observed at penetrations/openings through the exterior building envelope, and it is recommended that all penetrations/openings be sealed against water penetration. Typical examples on a structure may include light fixtures, air conditioning refrigerant lines, water piping, gas piping, vent caps, windows, doors, expansion joints, etc. Below is a representative sample of locations and/or photographs showing some, but not necessarily all, locations where there is a vulnerability to water penetration. Have a contractor provide a cost estimate to seal all vulnerable areas on the exterior building envelope against water penetration and/or open up any clogged weepholes in the veneer.

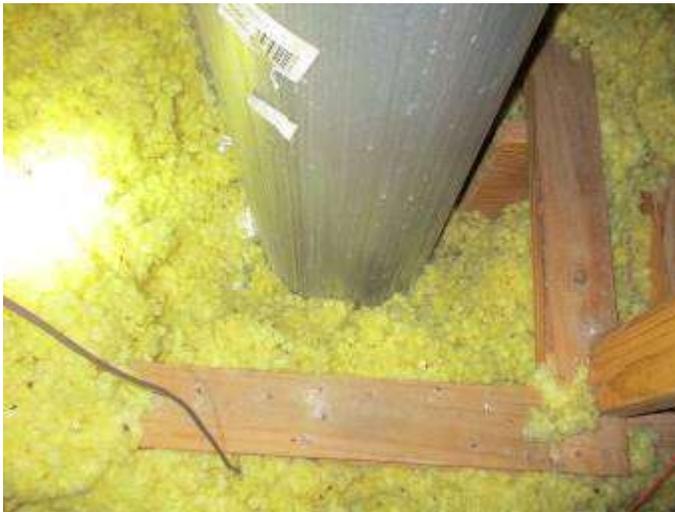
It was observed from the attic that the metal chimney flue pipe was in contact with insulation, which can be a fire hazard, and the insulation needs to be removed from the flue pipe, and a two inch air space provided around the vent pipe.

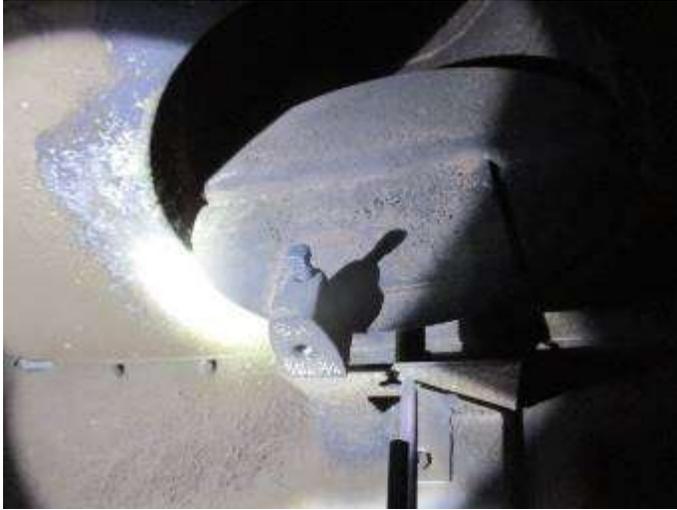
The firebox and/or flue pipe was observed to be coated with soot. This can be a fire hazard, and it is recommended that the soot be removed before using the fireplace again. Contact a fireplace service company to remove the soot.

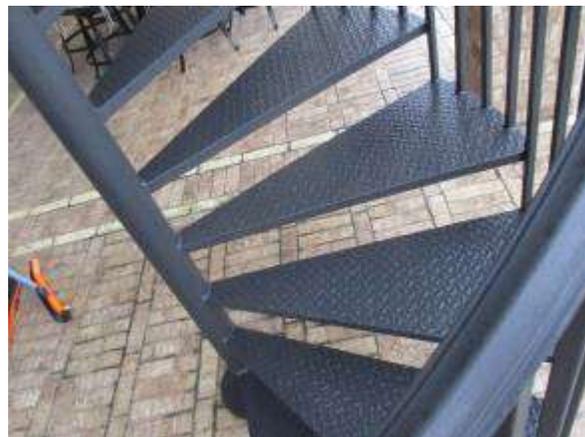
The stairs were not constructed to the latest revision of the building code, and had steps with treads that were less than six inches wide at the narrowest point.

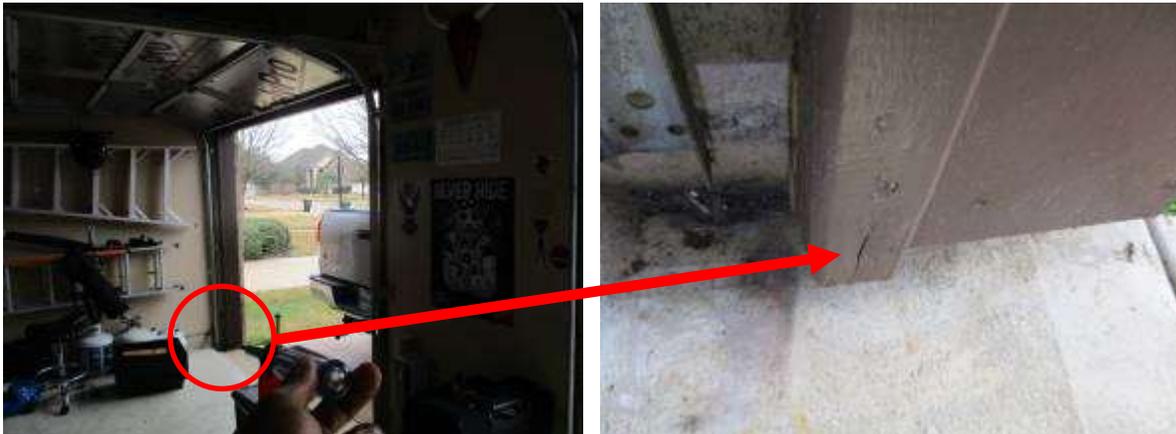
Locations included: 2-Car Garage vehicle door trim

Wood rot was observed and it is recommended that the damaged wood be replaced. It is pointed out that additional damage could be present under the rotted material that will not be visible until the outer rotted materials are removed. Have a service company determine the entire scope of wood rot throughout the house, and provide a cost estimate to replace all rotted wood.

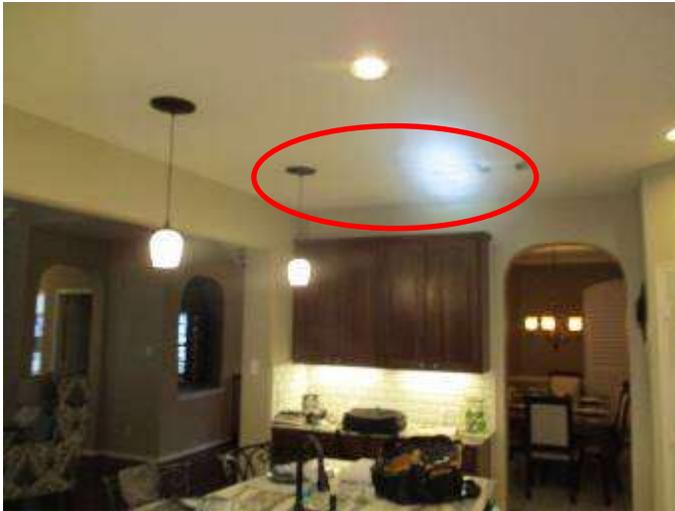
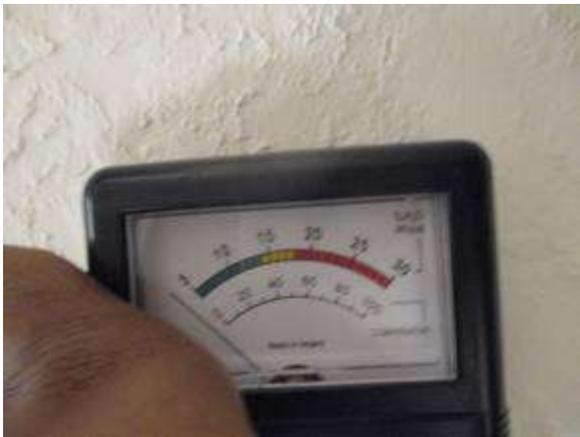
Locations included: Kitchen ceiling and rear living room wall

Patches in the sheetrock were observed. The patched areas were checked with an electronic moisture meter and were dry at the time of inspection. The cause of the patching could not be determined at the time of the inspection, and further investigation into the cause of the patch with the homeowner is recommended.

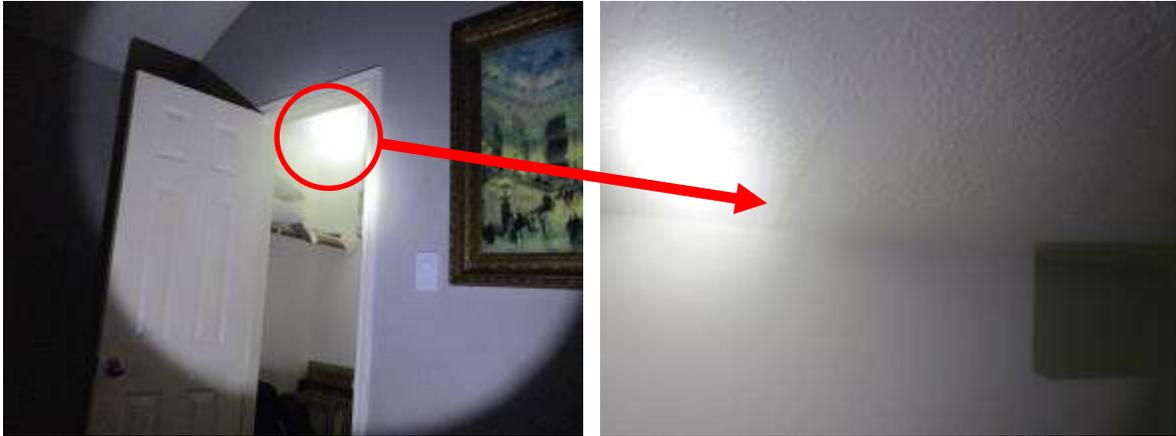
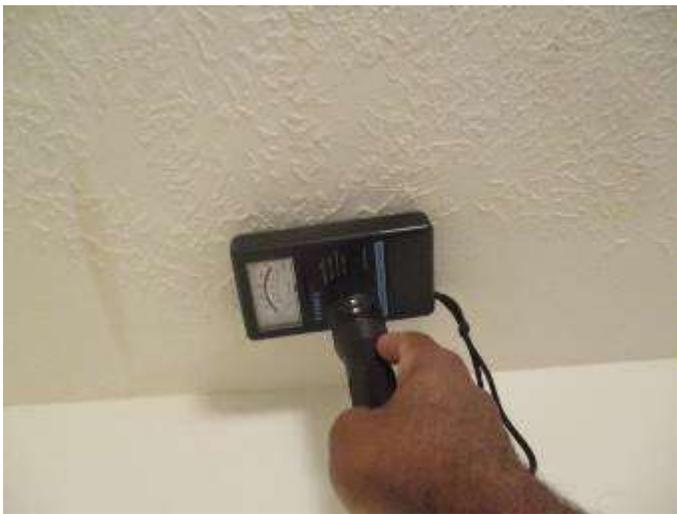
Locations included: upstairs northeast bedroom closet

Water stains were observed on the walls. The stains were checked with a moisture meter, and no higher than normal moisture readings were found at the time of the inspection. The source of the water stains could not be determined at the time of the inspection, and further investigation is recommended with the homeowner and/or a service company.

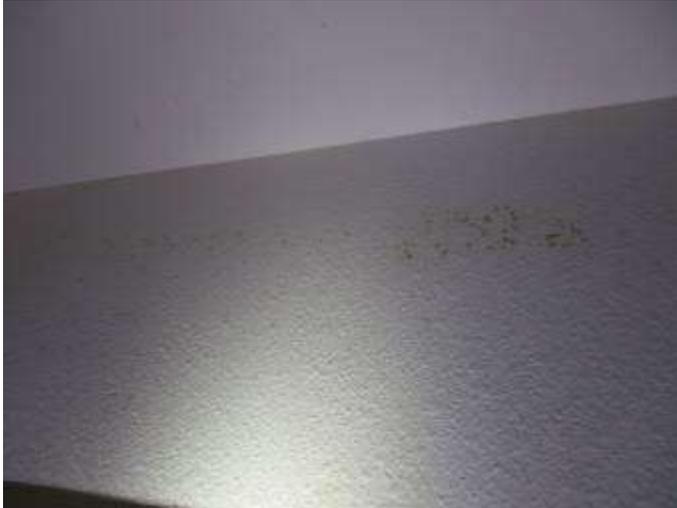
Locations included: Closet off the upstairs Hollywood bathroom

A microbial growth was observed, and further investigation is recommended with a service company to determine the cause of the growth, and to provide a cost estimate for any needed repairs.

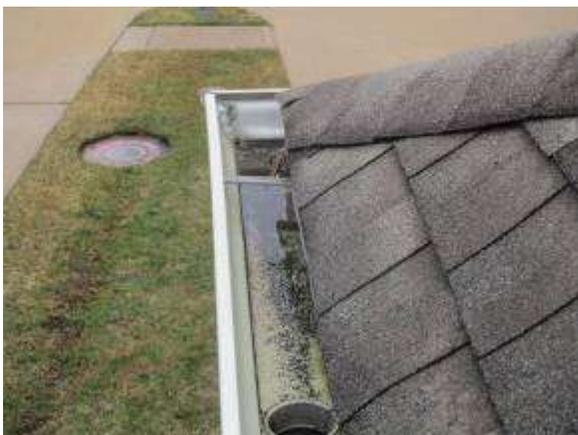
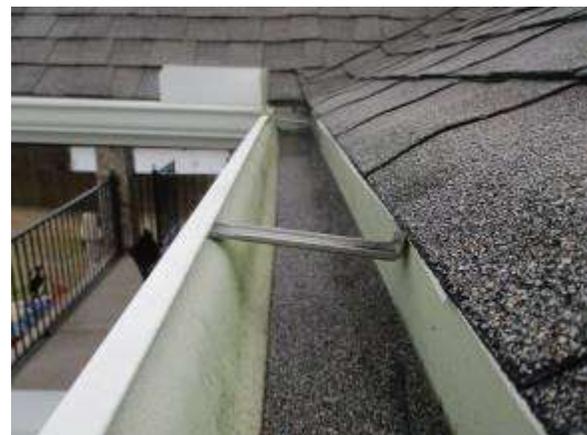
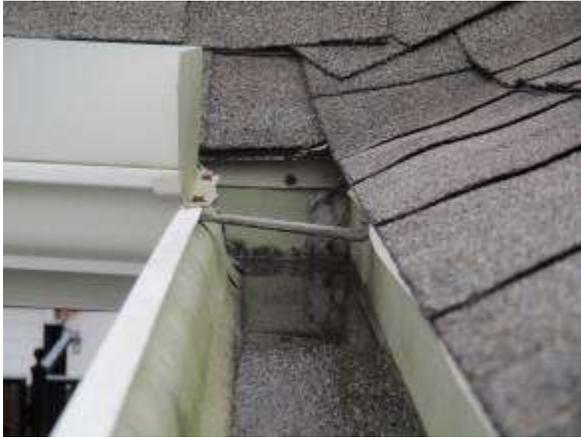
The gutters were observed to have debris and standing water in them and are in need of cleaning and adjustment.

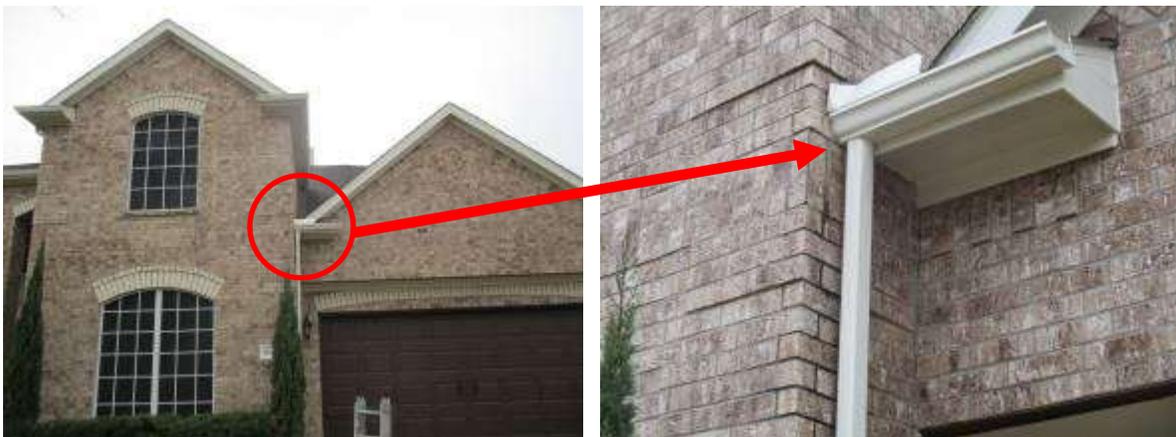
Locations included: Front garage

The gutter has apparently been leaking water behind the gutter as evidenced by the stains on the fascia board. Further investigation with a service company is recommended to determine the cause of the problem, and to provide a cost estimate for any needed repairs.
