# PROPERTY INSPECTION REPORT

Concerning: **10907 Leigh Woods Drive, Cypress, Texas 77433**

By: **Scott Gillis # 22819**

**February 4, 2019**

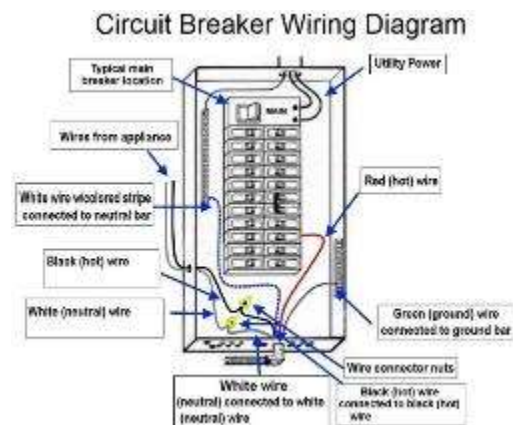
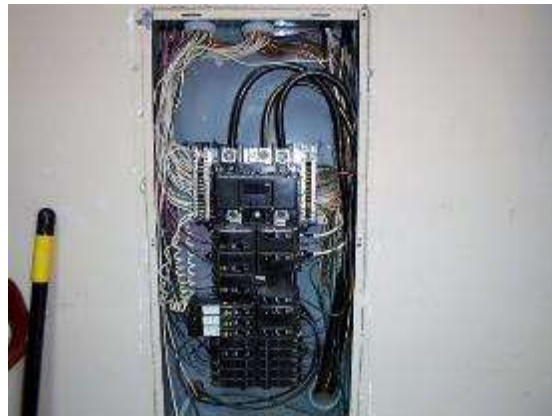
The electrical service is provided by a 120/240 volt, single-phase, 150-ampere underground service to a meter located at the north side of the house, and then to a breaker panel located inside the garage. The breaker panel was manufactured by Square D, and was rated at 200-amperes. The size of the service entrance conductors into the breaker panel were observed to be #2/0 aluminum, and the branch circuit wiring from the panel(s) was copper. The wiring in the house was a 3-wire grounded system. (Information)

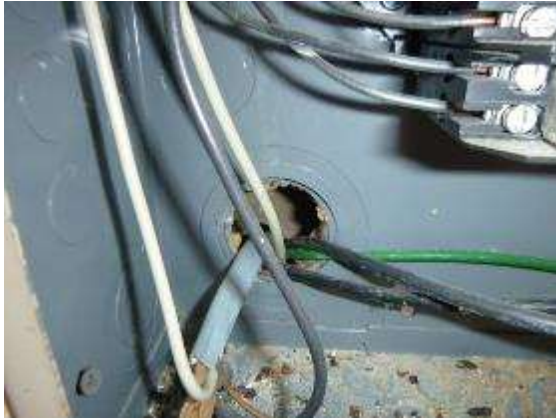
The holes in the panel where the individual circuit enter the panel did not have a bushing or clamp to protect the conductors from the sharp edges of the knock out hole provided and needs repair.

**Obtain Cost Estimate**

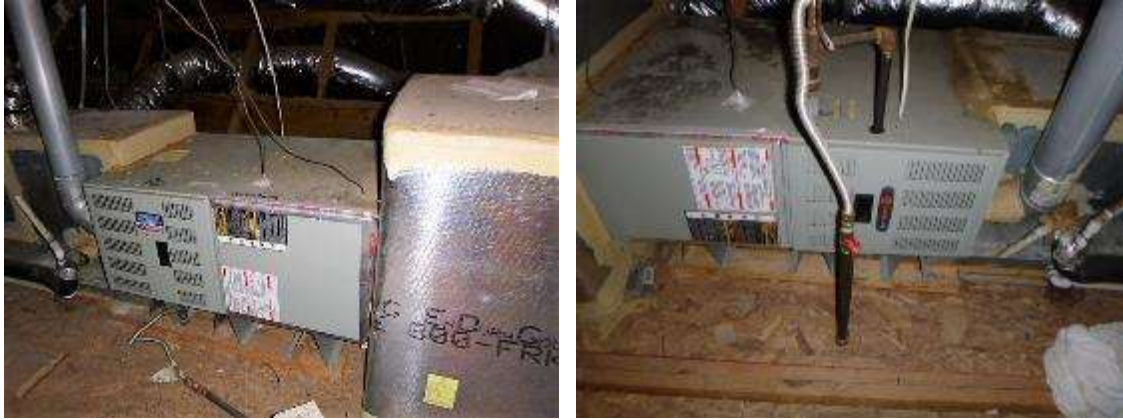
The heating for the house was provided by two gas-fired horizontal furnaces located in the attics. The equipment for the individual zones was as follows:

Zone	Size	Manufact.	Date
Downstairs	80,000-BTU	Trane	2006
Upstairs	60,000-BTU	Trane	2006

The furnaces were operationally checked at the time of the inspection, and no repairs were indicated to the operation of the furnaces. The furnaces responded to the thermostats, and the burners came on, and were heating.

Due to the age and/or condition of the equipment, it is the opinion of the inspector that the units have only a limited amount of remaining life. Therefore, it is recommended that a service company be contacted to dismantle the furnaces, and view the heat exchangers for cracks.

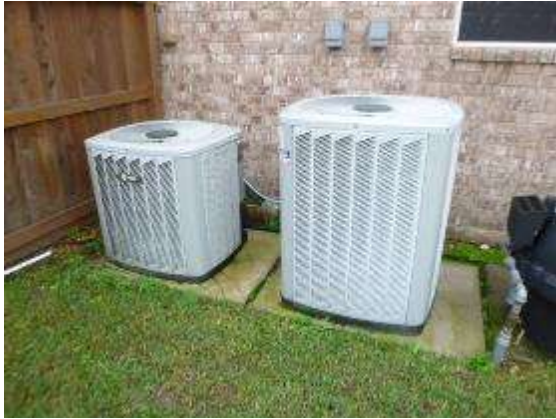
## Condensing Unit

No items requiring repair were observed at the time of the inspection for the operation of the condensing unit(s).  
(Information)

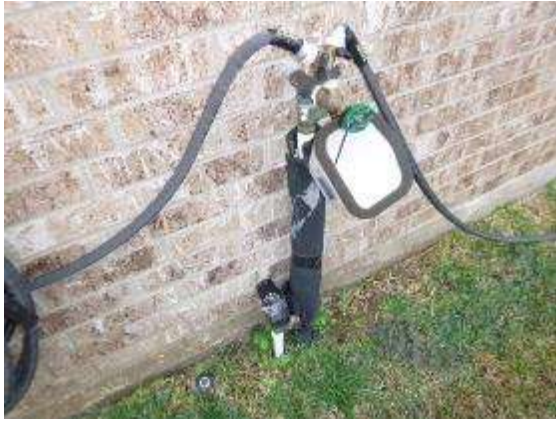
## Supply Piping

The shut-off valve for the main inlet water line was located at the exterior at the north side of the house. The water meter was located at the front curb. (Information)

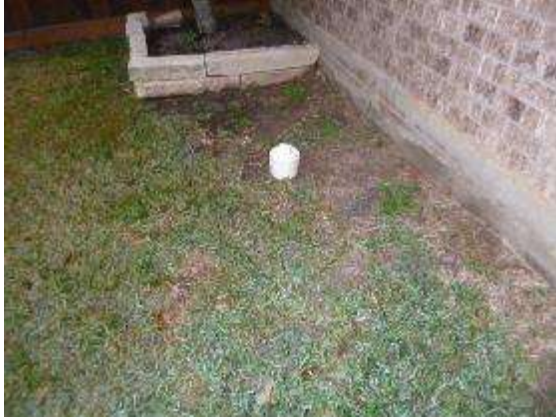
The main sewer PVC clean out was located at the south side of the house. The clean out is needed in the event of a stoppage in the main sewer drain line, and the clean out is where a sewer snake would be installed to remove the clog in the drain line.

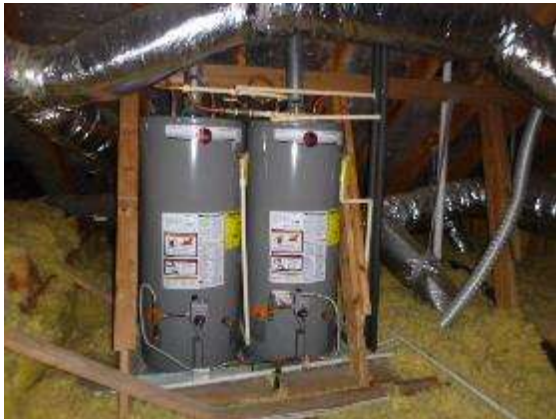
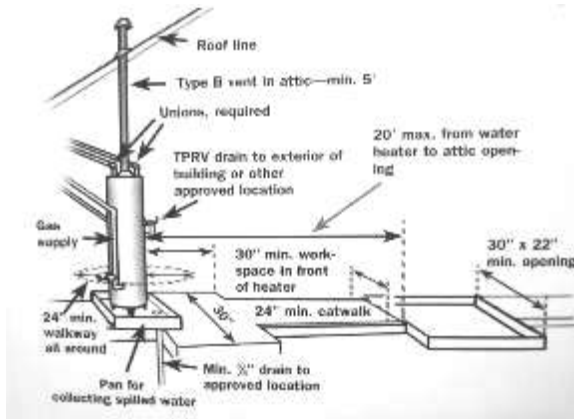
The hot water for the house was provided by two 40-gallon natural gas fired water heaters, both manufactured by Rheem in 2018, and were located at the attic. The water piping from the water heaters was observed to be CPVC, and the piping was connected in parallel. (Information)

No items requiring repair were visible at the time of the inspection for the operation of the water heaters. The water heaters were functional at the time of the inspection, and were providing hot water throughout the house.

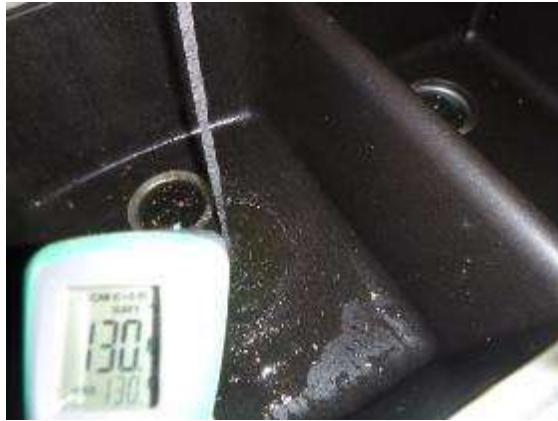
The water temperature was checked at the kitchen sink. The water temperature was observed to be hotter (130F) than recommended (120F) and this is considered a scald risk. The risk of serious injury is higher when the water heater thermostat is set above 120F. It is recommended that the water heater thermostat be adjusted to prevent safety hazards. (Information)

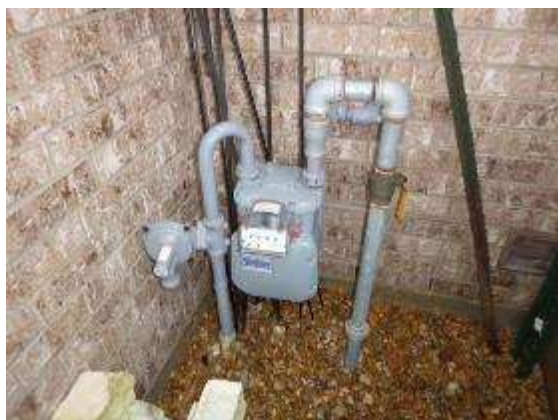
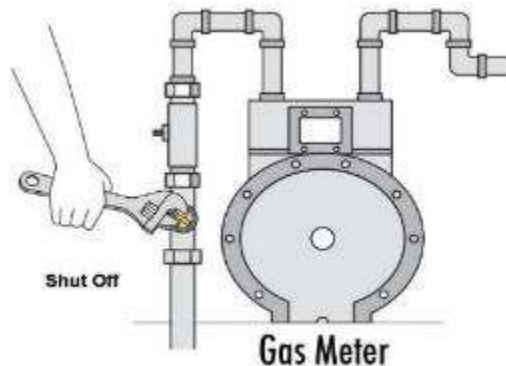
The gas meter that was connected to the gas valve was located at the north side of the house. No items requiring repair were visible at the time of the inspection. (Information)

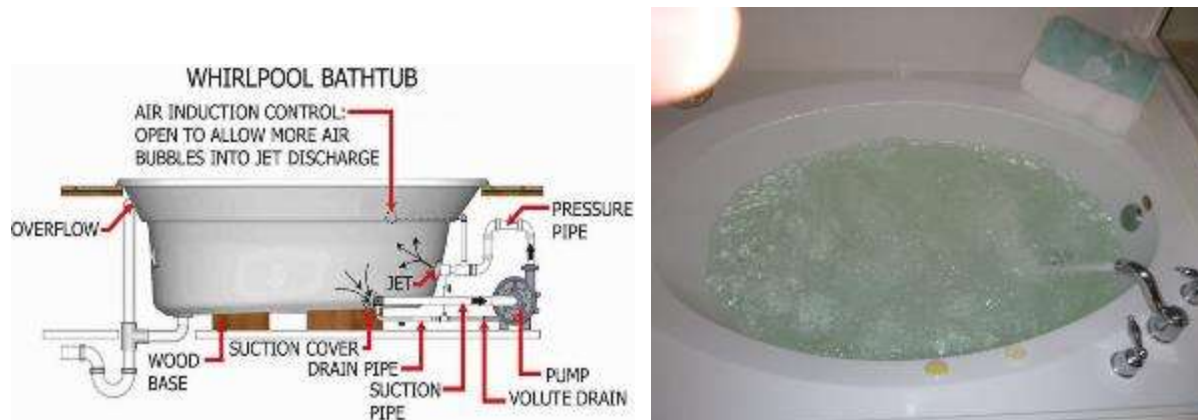
The whirlpool tub was functional at the time of the inspection, however the on/off push button for the whirlpool tub sticks and needs to be repaired.

**Obtain Cost Estimate**

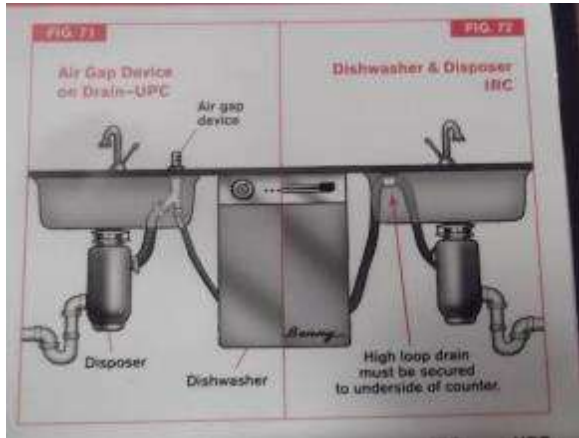
The drain line under the sink was looped up so that the top of the loop was higher than the point where the drain line connected to the disposal. This will help to prevent garbage from running down the drain line into the dishwasher.

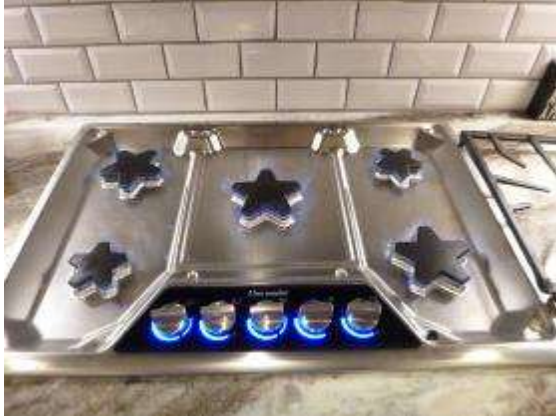
No items requiring repair were visible at the time of the inspection for the gas cooktop. All of the burners and controls were operating properly at the time of the inspection.

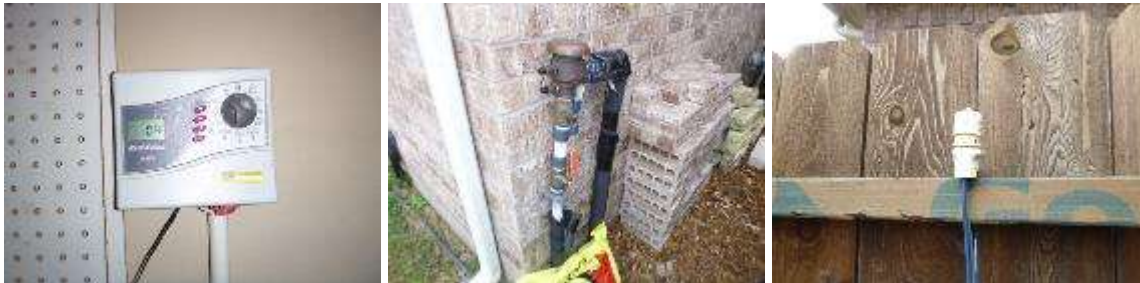
Heads were spraying the house, and need to be adjusted around the perimeter of the house.

**Obtain Cost Estimate**

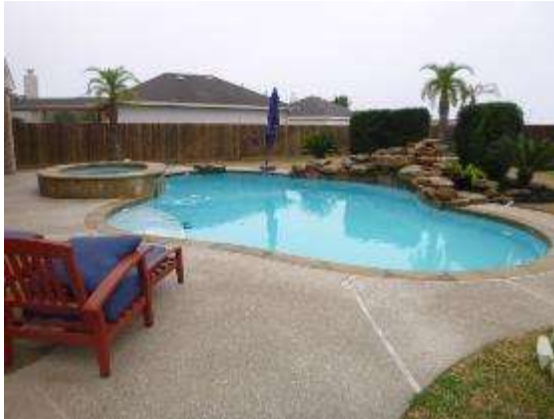
The swimming pool was an in-ground concrete pool covered by a plaster finish. The pool equipment was located at the north side of the house.

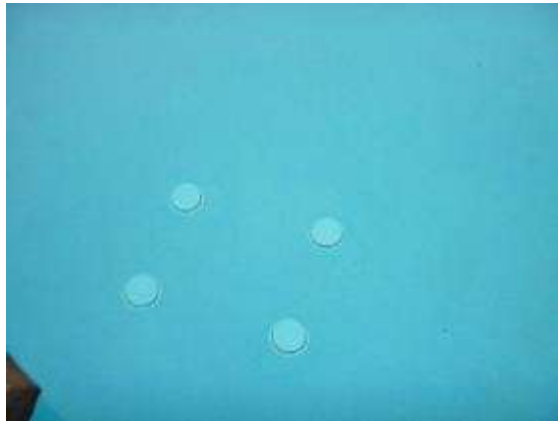
The bottom drains for the pool contained four inlets, which reduces the potential hazard for entrapment.

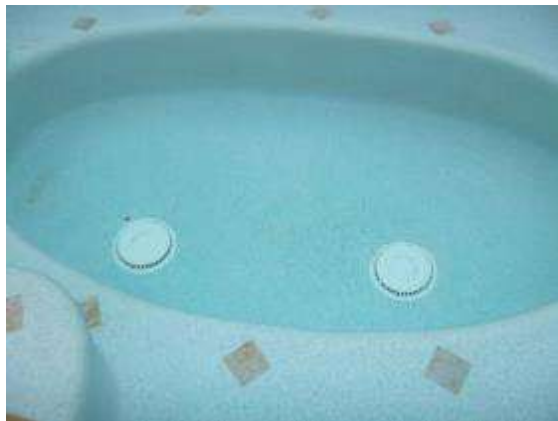
The bottom drains for th spa contained two inlets, which reduces the potential hazard for entrapment.

We observed that the bottom drains were equipped with a raised type of cover that reduces, but does not eliminate, the potential for entrapment.

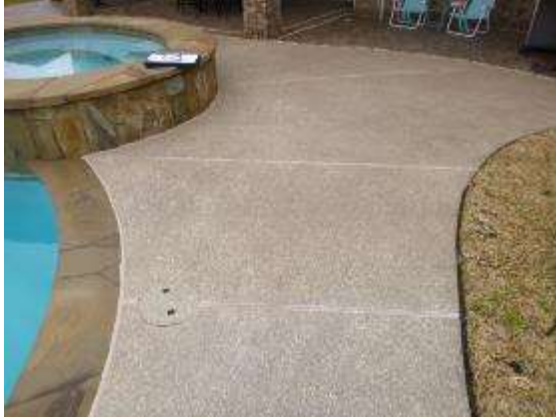
## **Pool Deck**

The concrete deck was in generally good condition at the time of the inspection, with no repairs needed.

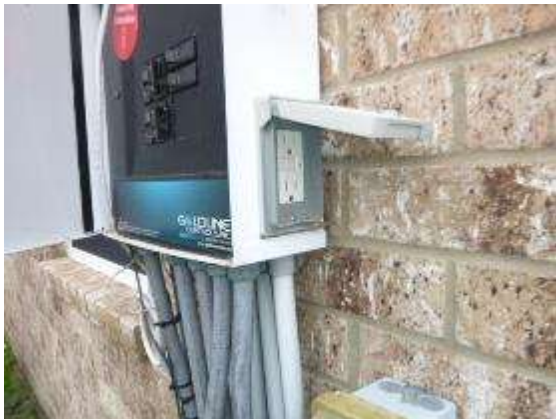
## **Lights and GFCI Devices**

The pool and spa lights were functional at the time of the inspection, and were protected by a Ground Fault Circuit Interrupt device, which was also functional at the time of the inspection.  
(Information)

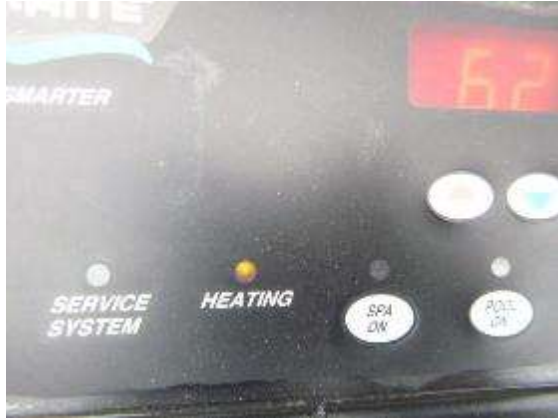
### **Pool Heater**

The furnace was operationally checked at the time of the inspection, and the burners did come on, and were operated for approximately 5 minutes. The furnace was manufactured by Hayward, and no repairs were observed to be needed.

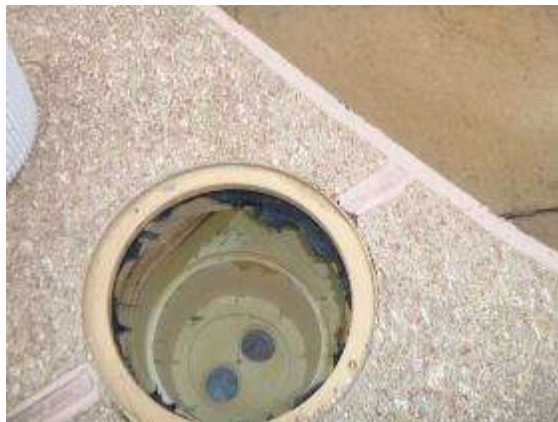
### **Skimmers**

No items requiring repair were observed at the time of the inspection for the operation of the skimmers. (Information)

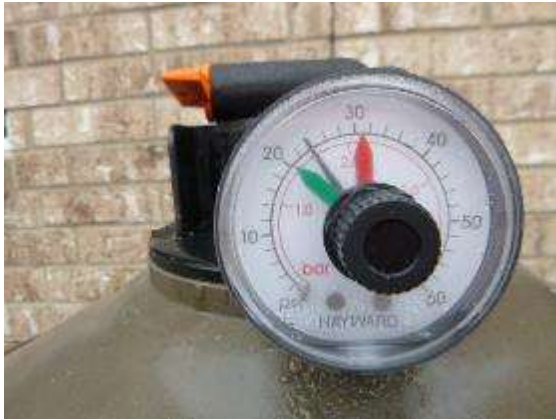
### **Filtration System**

The pool filter was a cartridge filter that was functional at the time of the inspection, and showed an operating pressure of 22 psi. This is within a normal range of operation, and no repairs are recommended.

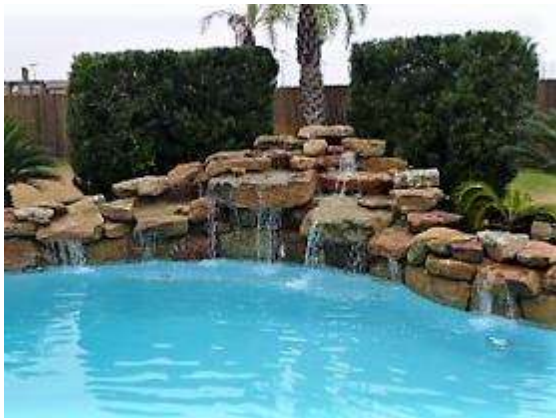
### **Water Feature**

No items requiring repair were visible at the time of the inspection for the operation of the water feature. (Information)

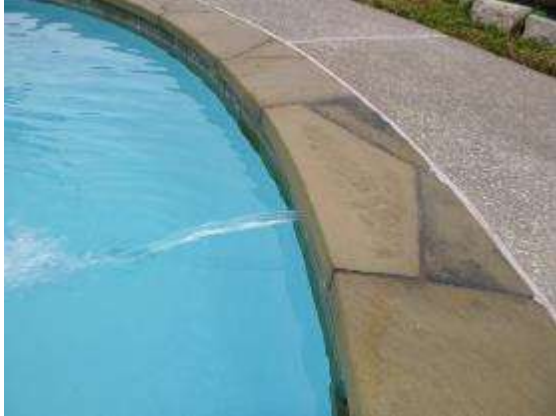
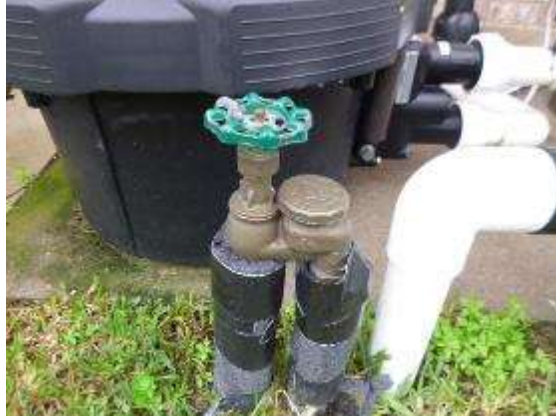
The pool fill line was functional at the time of the inspection, and was equipped with a backflow preventer device. No leaks were present at the time of the inspection.

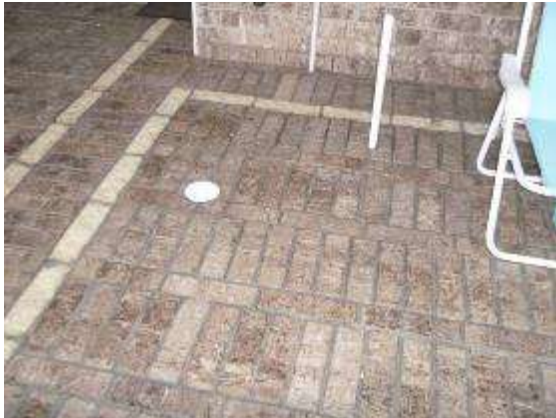
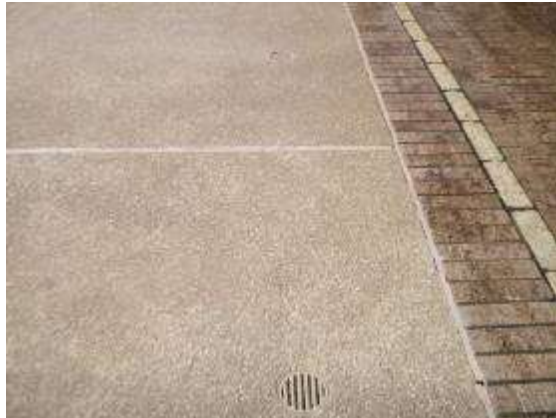
The patio and pool deck on the east side of the pool were equipped with drains that were part of the grade drain system.

The grading of the yard appeared sufficient to channel rain water away from the pool.
