## **Property Inspection Report**

3010 Heather Lake Ct.  
Kingwood, TX 77345

**Concerning:** 3010 Heather Lake Ct., Kingwood, TX 77345  
(Address or Other Identification of Inspected Property)

**By:** Larry Fleming, Lic #4860 06/17/2019  
(Name and License Number of Inspector) (Date)

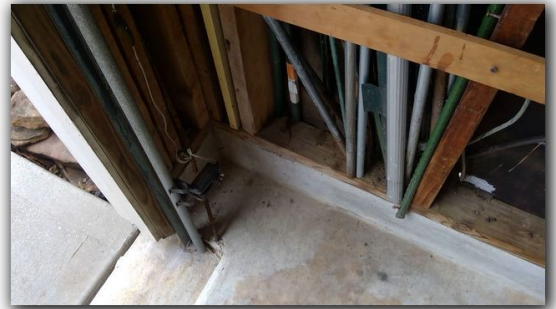
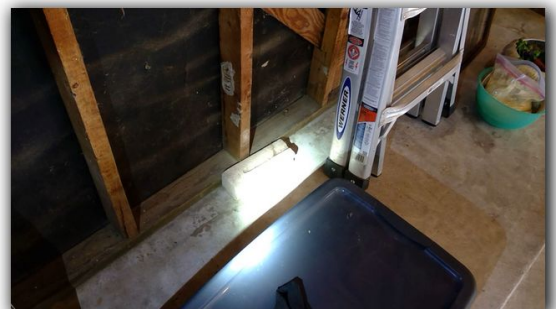
Nuts and washers need to be installed on j-bolts connecting the sill plate to the concrete foundation (multiple locations). (IRC 2015, R403.1.6)

Would recommend that a licensed and / or qualified contractor be consulted to make any further recommendations and / or repairs

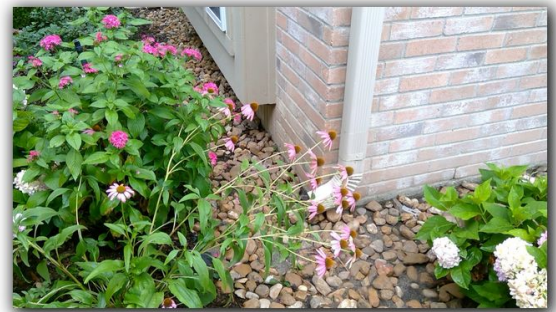
requiring a 4" slab exposure between the finished grade and exterior brick

Would recommend that a licensed and / or qualified contractor be consulted to make any further recommendations and / or repairs

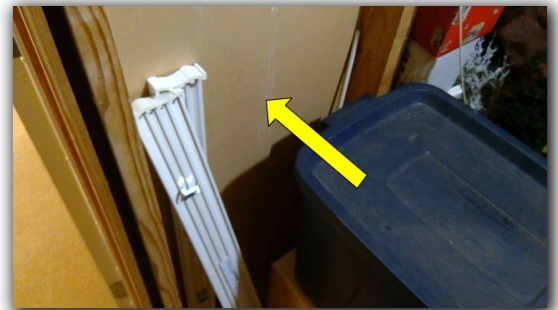
Voids observed in insulation at knee walls in attic space at one or more locations.

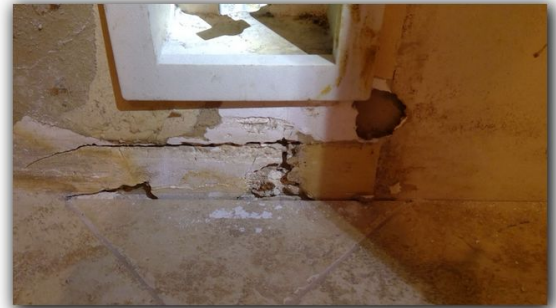
Evidence of previous termite damage / trails observed in wall behind the refrigerator area. Consult pest control professional and independent WDI report for further recommendations.

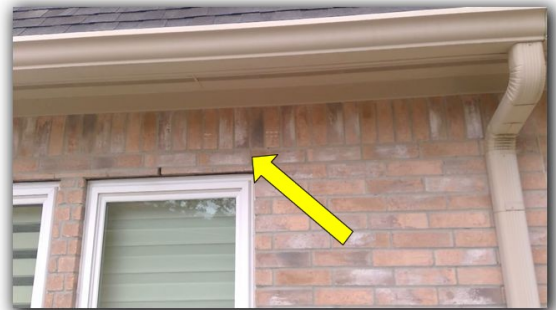
Mortar is separated, cracked or missing in some areas. See left front corner of house.

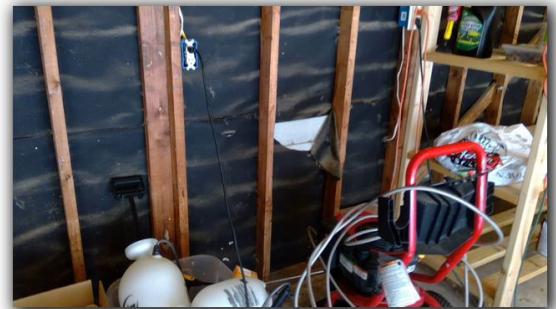
Moisture barrier damage observed behind the exterior siding of the garage. Observable from the garage space.

**Would recommend that a licensed and / or qualified contractor be consulted to make any further recommendations and / or repairs.**

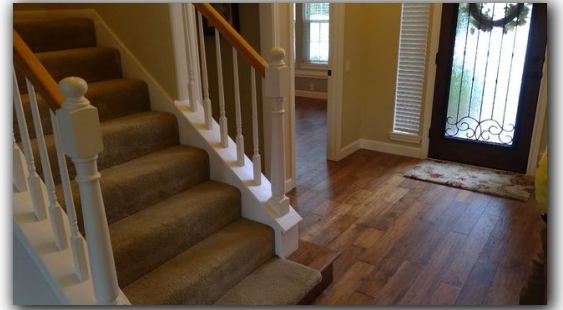
Hand railing does not properly terminate by turning into the wall at handrail ends per current code. (See IRC 2015, R311.7.8.2)

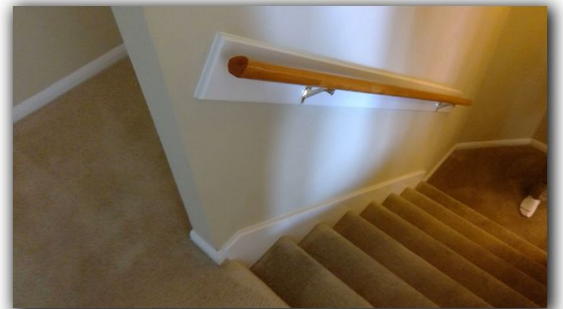
Hand railing not at proper height: Current code requires handrail to be installed 34" to 38" measured vertically from the bullnose of the stairs. (See IRC 2015, R311.7.8.1)

**Would recommend that a licensed and / or qualified contractor be consulted to make any further recommendations and / or repair**

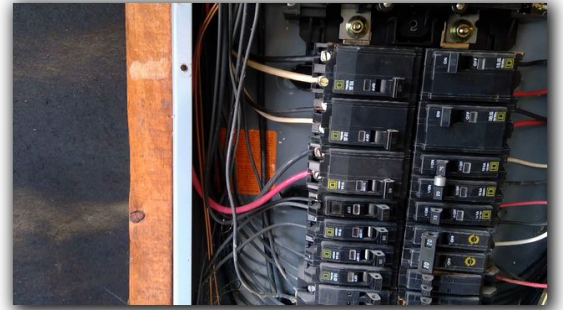
White "neutral" type wiring is required by current code to be individually secured into individual holes in "neutral" buss bar. Double wiring and securing two or more wires to a single set screw is not allowed per current code on the "neutral buss bar."

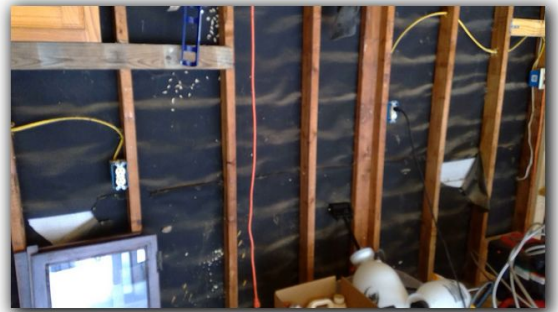
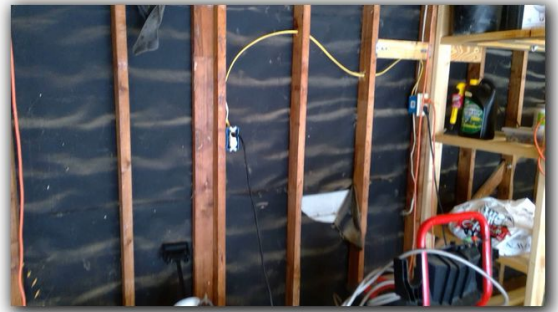
Loose, damaged, missing outlets / switches / covers at one or more locations.

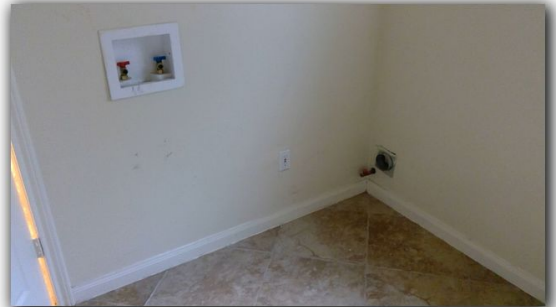
- It appears that the utility room has been relocated to the master closet area from another location. It does not appear the washing machine area and the dryer area are serviced with an appropriate electrical circuit. It appears that the dryer connections are gas only and that the plug for the master hydro-massage therapy equipment is being used to ignite the dryer. The washing machine appears to be using the same circuit as the hydro-massage therapy equipment also.

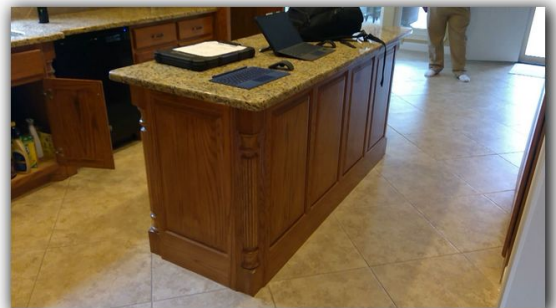
- Current code requires a minimum of one receptacle at a kitchen island. No receptacle was observed at the time of the inspection.

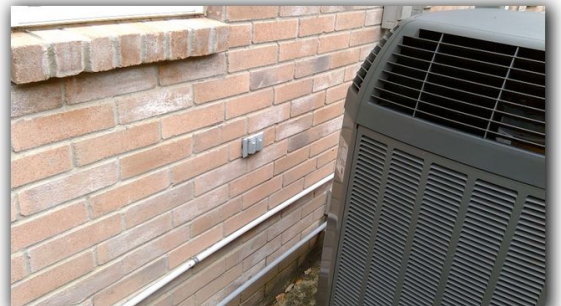
No GFCI protection at one or more location. This is considered a recognized safety hazard: All kitchen, bathroom, garage, exterior, washing machine, dishwasher, disposer and wet bar locations are required by current code to be GFCI protected.

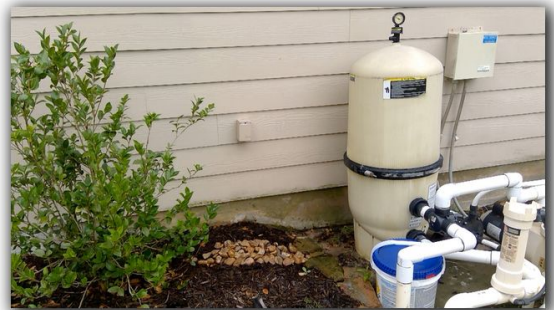
GFCI are not properly installed or operate properly at one or more locations.

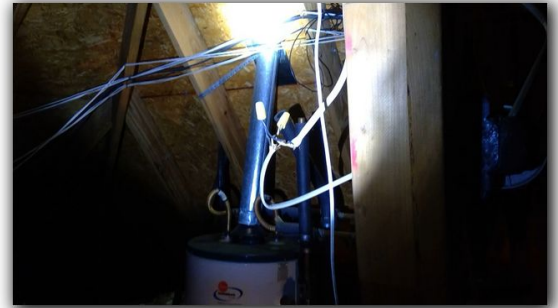
Electrical Romex type wiring has not been properly stapled above panel boxes and junction boxes at some observable locations

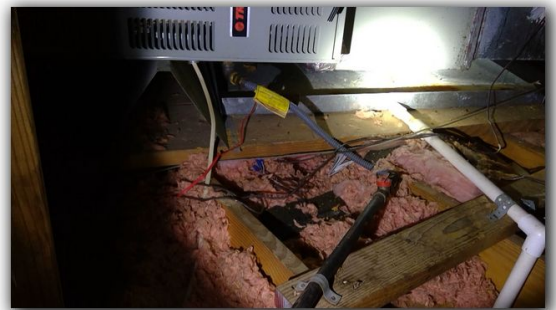
- No sediment trap observed in gas line of HVAC system

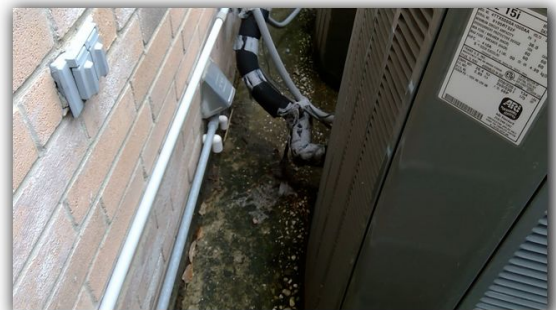
Dryer vent is installed too close to exterior HVAC condensing unit. Lint from the dryer unit can potentially block the ventilation fins of the condensing unit.

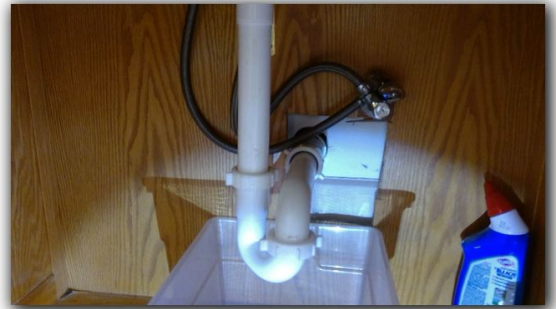
- No hot water present at the pool bathroom.

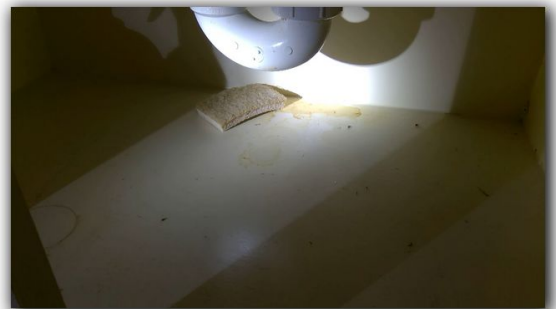
- Evidence of previous water leaks present under bathroom sink locations.

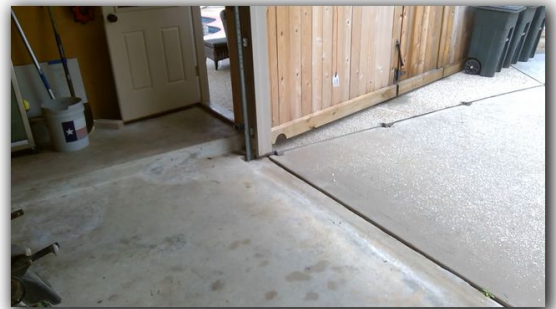
Laser reverse system (electronic sensors) is / are installed at improper height for garage door operator. TREC standards require that the sensors be labeled as Deficient if the sensors were installed higher than 6" from floor.

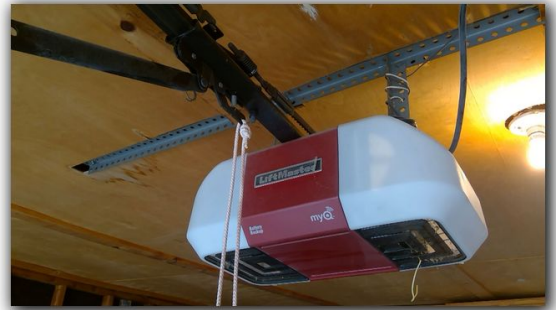
Garage door operator light was missing / did not operate properly.

**Would recommend that a licensed and / or qualified contractor be consulted to make any further recommendations and / or repair**

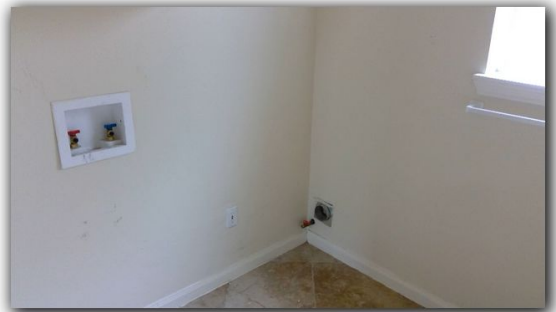
It is recommended that the dryer vent be properly cleaned by a professional prior to using vent. There are components of the dryer exhaust vent system that are not accessible and cannot be inspected.

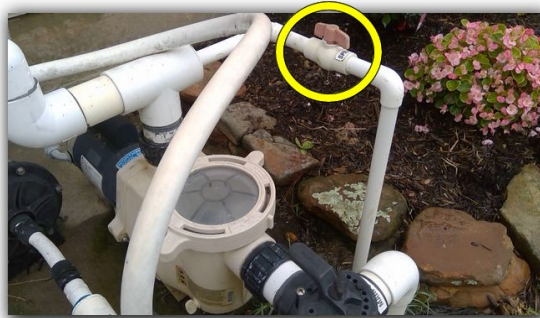
**EXIT ALARM:**  Absent. Current standards require an exit alarm at all exterior doors that enter the pool area.  
 Water leaks in above-ground pipes and/or equipment. See valve to the spray heads on the pool equipment.

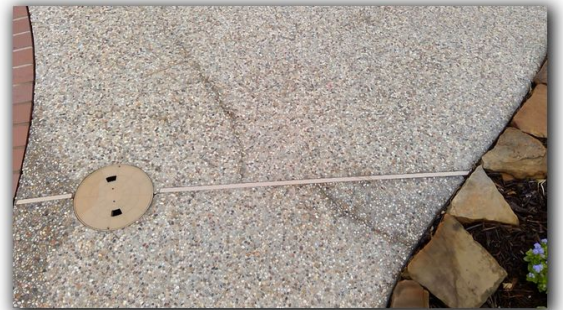
Cracks observed in swimming pool deck at one or more locations.

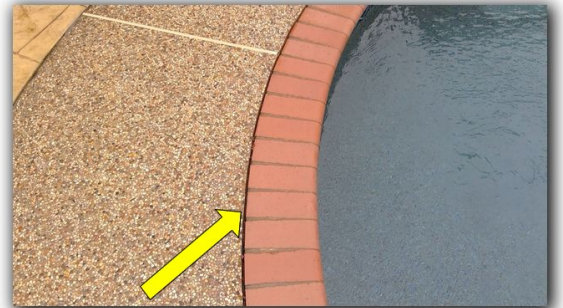
Cracks observed in the mortar / grout joints / tile of the swimming pool tile. Cracks should be filled to prevent erosion between the swimming pool deck and coping.
