Inspection Report

Property Address:
13127 Hollowcreek Park Dr.
Houston TX 77082

GOLDEN SCOPE INSPECTION SERVICES

PROPERTY INSPECTION REPORT

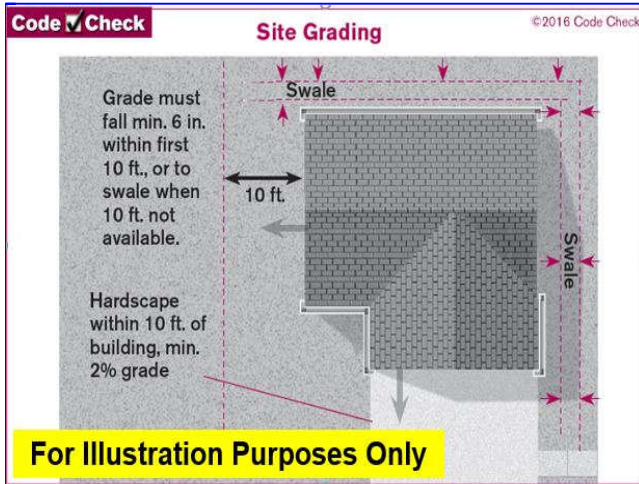
B. Item 1(Picture) Grading

General grade improvements are needed to prevent ponding/standing water. Proper drainage is needed to help prevent water from standing and/or ponding next to the foundation. Corrective measures may be needed if the water stands within 10-feet of the foundation for more than 24-hours. Grading improvements are needed to direct run off water away from the structure. Any area where the ground or grade does not slope away from the structure is to be considered an area of improper drainage. The recommended slope away from the foundation is 6 inches per 10 feet.

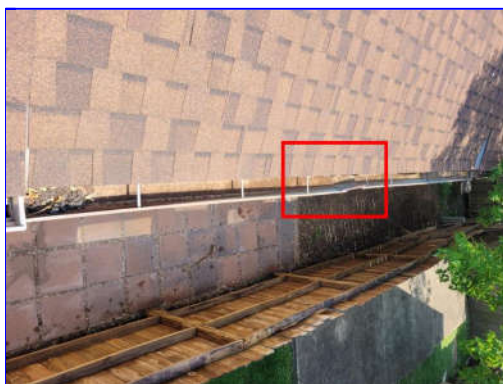
B. Item 9(Picture)

The gutters were observed to be in need of repair(s). Loose gutters should be properly secured and checked for proper slope to drain. Any damaged or deteriorated sections of gutter and down spouts should be replaced on as needed bases. Defective gutters may create leakage into the roof eave causing structural damaged into the home.

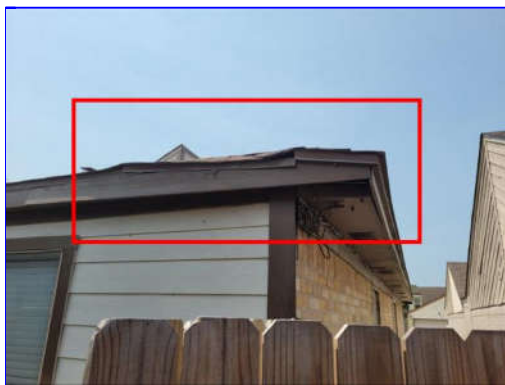
C. Item 1(Picture)

The drip edge flashing was observed to be damaged and improperly installed at various locations. Repairs are needed

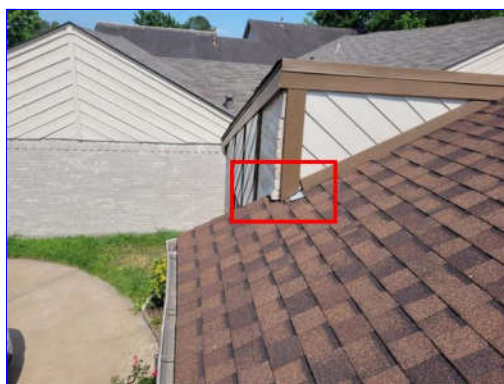
C. Item 9(Picture)

Flashing was observed to be missing at the front roof. Additional flashing to be installed

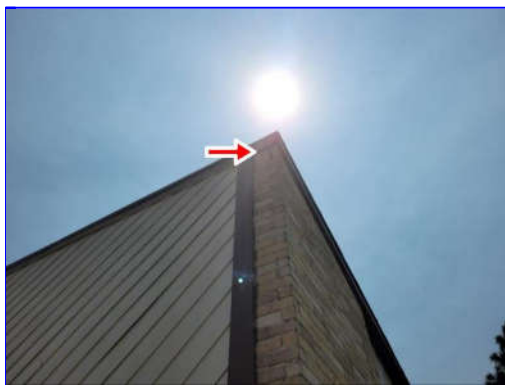
E. Item 1(Picture)

Masonry (brick / stone) cracks were observed. These cracks are potentially related to structural movement. Cracks should be repaired and/or monitored over time for further movement.

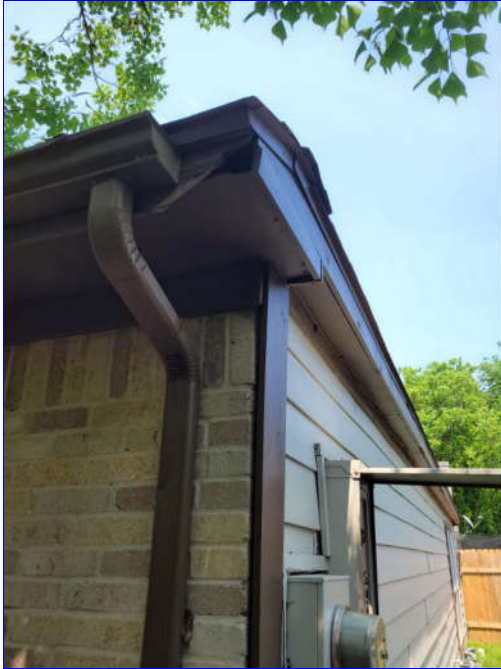
E. Item 29(Picture)

The siding at the rear of the house are not properly installed, loose and falling off. A qualified, verified exterior/interior contractor should be consulted regarding this condition and possible repair or replacement.

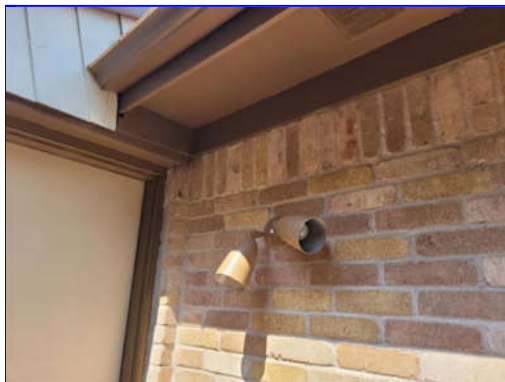
E. Item 34(Picture)

Caulking at the brick, siding, doors, expansion joints, exterior light(s), exterior penetrations into home, fascia, garage door, trim, hose bib penetrations, vent terminations and windows in various locations, was observed to need improvement. Make improvements as needed.

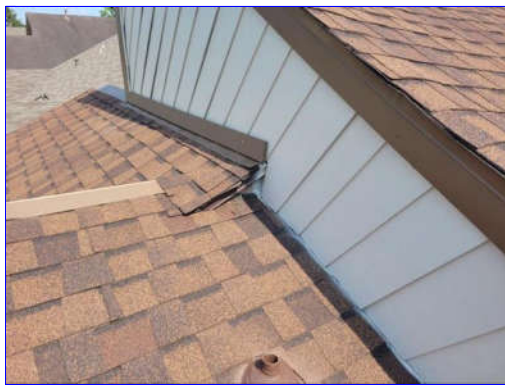
E. Item 51(Picture)

Siding is missing at the roof. It should be installed

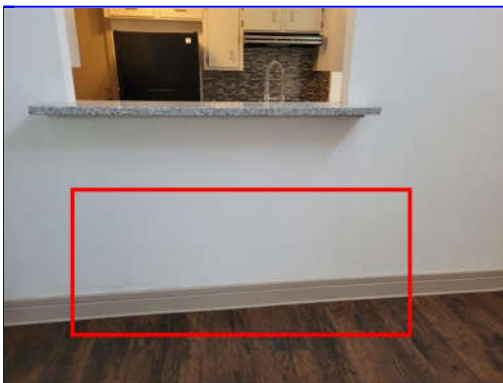
E. Item 63(Picture)

The wall(s) was/were observed to have the following defect(s): wet stains indicating moisture or intrusion has or may continue to occur. Some moisture was confirmed with a moisture meter. Repair is needed. A qualified, verified contractor should be consulted. Sheetrock and insulation affected by moisture should be removed and replaced. Preventive measures for microbial hazards should be undertaken by a qualified, verified professional.

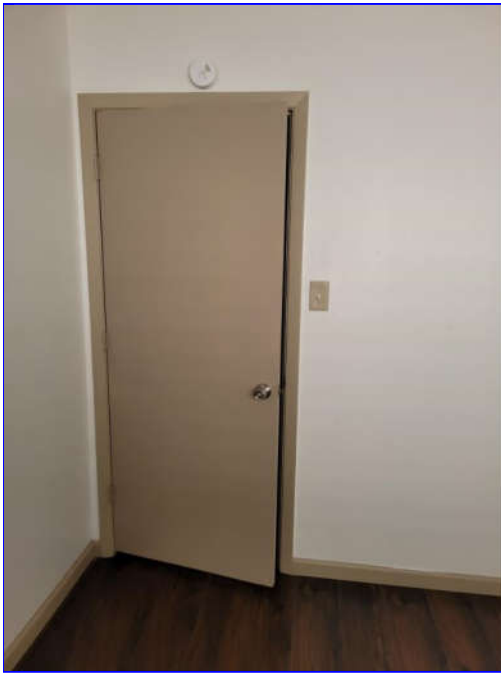
G. Item 1(Picture)

The interior door(s) at the front bedroom was/were observed to have the following defect(s): does not latch.

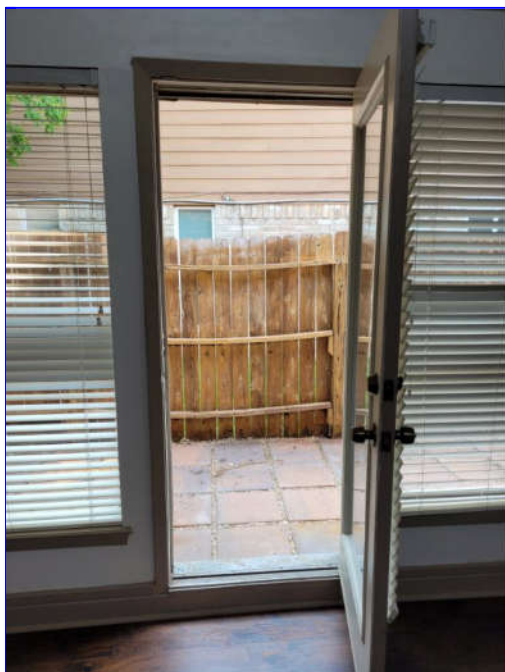
G. Item 3(Picture)

The exterior door(s) at the at the side entrance was/were observed to have the following defect(s): excessive air gaps, missing weather-stripping. Repair or replacement is needed.

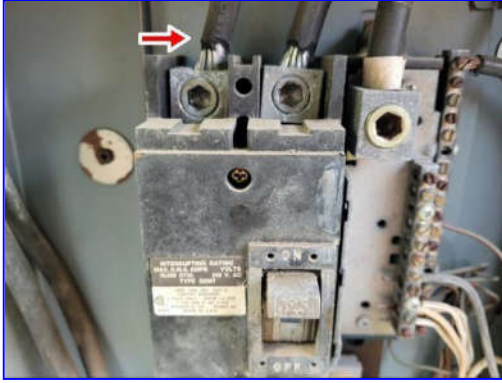
A. Item 9(Picture)

Breaker labeling was observed to be missing. This is considered to be a potential safety hazard. Breakers should be identified and labelled accordingly. Without proper labelling the inspector cannot determine the proper amperage for appliances such as the HVAC condensing unit(s).

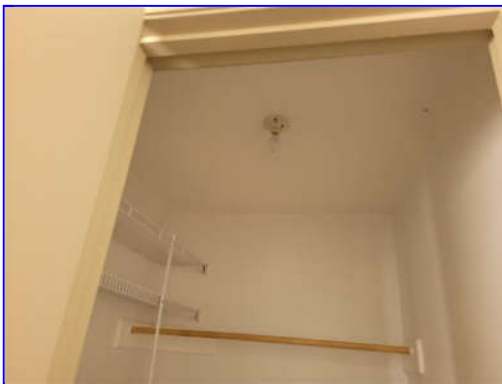
B. Item 1(Picture)

Many light fixtures are inoperative. They should be replaced

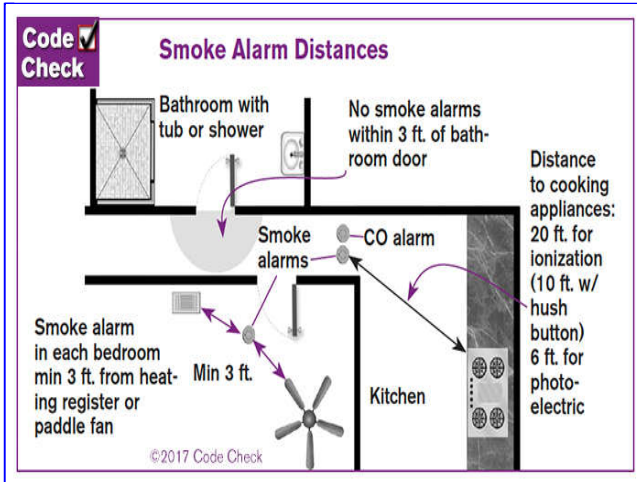
B. Item 9(Picture) Smoke Alarm Distances

Smoke detector(s) was/were observed to have the following defect(s): is/are not installed in all required locations in the home. Smoke detectors are critical to occupant safety and should be repaired as needed. By current standards smoke detectors are required in each sleeping area, in the vicinity outside the sleeping area, and one each inhabitable level of the home. Smoke detectors in newer homes are required to be hard wired to the electrical system, have battery backup, and be interlinked to activate all smoke detectors in the home if one is activated. All smoke detectors should have batteries replaced upon moving into the home. This ensures all batteries are new and in working order.

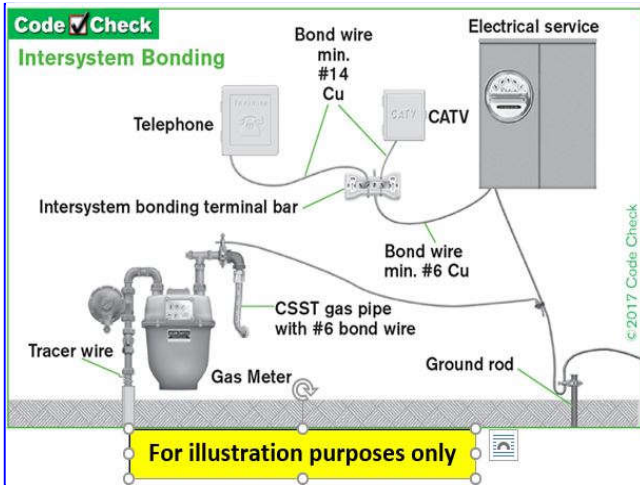
E. Item 1(Picture) Gas Meter Bonding

Gas Meter was observed to not be bonded. Proper bonding should be metal to metal. Paint may have to be removed to ensure proper bonding. The utility company should be contacted regarding this condition.

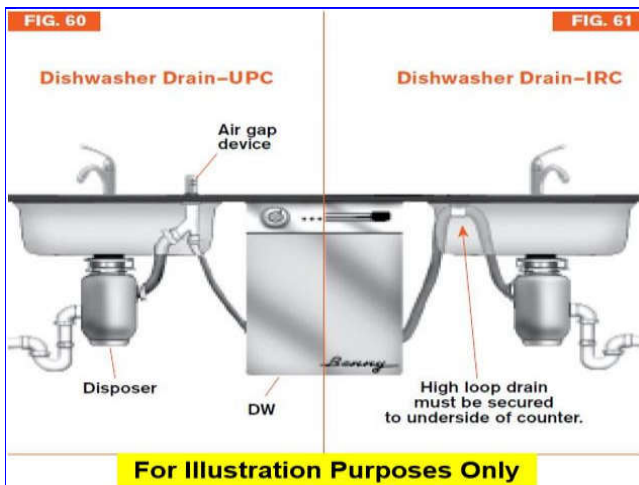
A. Item 5(Picture) Air Gap/High Loop

The dishwasher was observed to not be equipped with an air gap valve or high loop. Air gap valves/high loops prevent contaminated water from the sink from passing down the drain line and into the dishwasher.
