## REDSTAR RESIDENTIAL INSPECTION

4205 Cline St #C  
Houston TX 77020

# PROPERTY INSPECTION REPORT

Concerning: 4205 Cline St #C, Houston TX 77020

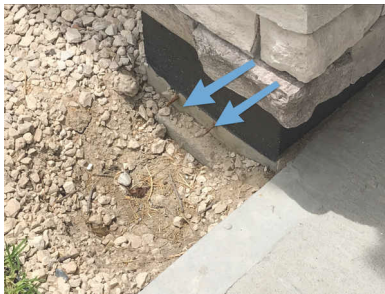
Front Left

**1: Slab: Nails protruding from sidewall**

Nails were observed protruding from the foundation side wall at various locations around the exterior of the home. Recommend these nails be cut flush to avoid potential injury.

Recommendation: Contact a qualified professional.

Protruding nails  
will be  
addressed.

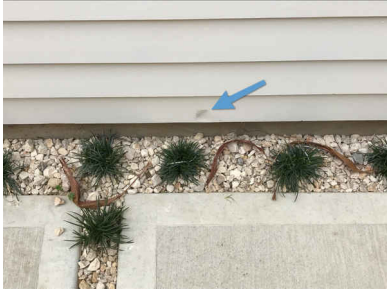
**1: New Home Cosmetic Issues**

Cosmetic deficiencies (dings, dents, missing paint, etc.) were observed at various locations around the home. Cosmetic issues are not included in the scope of this inspection, and these items should be addressed during your builder walkthrough.

Recommendation: Contact your builder.

All cosmetic deficiencies will be addressed.

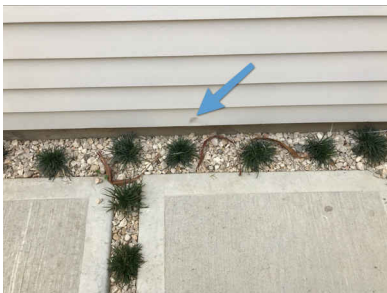
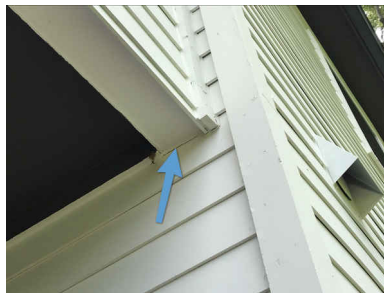
Right Exterior

**2: Minor cosmetic/maintenance Issues**

Paint finish damaged or worn, Trim paint/caulking worn -

The above listed items were observed to be in need of minor repair or maintenance. These items are related to cosmetic issues or typical maintenance due to expected wear and tear. Recommend you budget for repair of these issues for cosmetic reasons, or to avoid further deterioration.

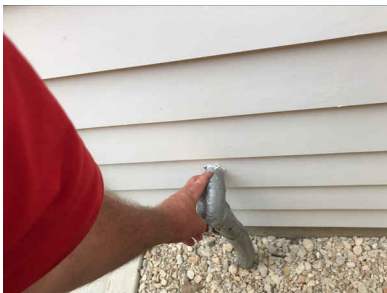
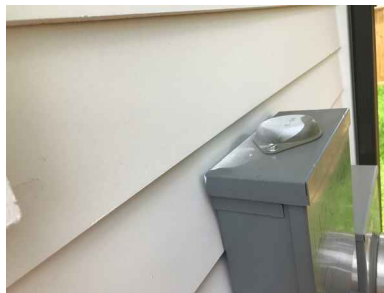
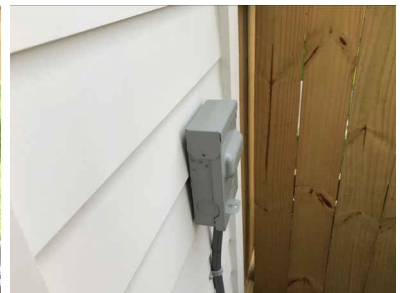
**3: Caulking and Sealing Needed**

Plumbing penetrations, Light fixtures and outlets, Electrical panel box -

The above stated locations were identified as areas in need of proper caulking and sealing, or maintenance to the existing sealant. Recommend further evaluation of these areas and all others to determine the extent of needed repairs.

Recommendation: Contact a qualified handyman.

All penetrations will be sealed/repared as needed.

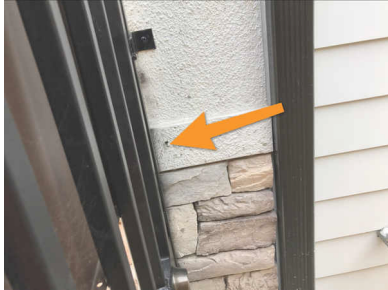
**4: Stucco: Damage Observed**

Damaged area was observed at stucco veneer at front right gate area. This could allow water to penetrate behind the stucco and cause premature rot of the stucco system. Recommend further evaluation by a stucco contractor for remedy.

Recommendation: Contact a stucco repair contractor

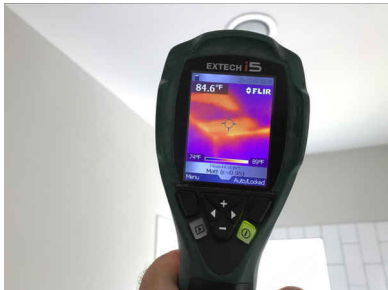
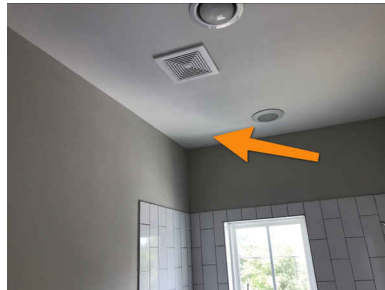
2nd Floor Front Bathroom

**1: Ceiling: Missing Insulation**

The thermal imaging camera showed an indication of missing insulation at the ceiling. Repair as needed for energy efficiency purposes.

Note: The yellow/orange color in the thermal image shows where this missing insulation is located.

Will be inspected and any missing insulation will be installed.

Recommendation: Contact a qualified professional.

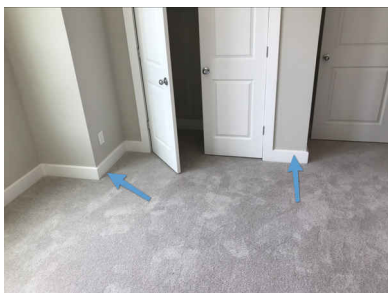
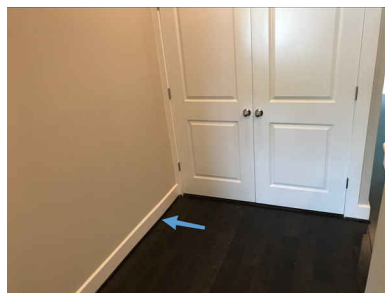
2nd Floor Multiple Locations

**1: Interior Door Hardware: Missing Door Stops**

One or more door stops were observed to be missing. Recommend adding door stops to prevent damage to drywall finish.

Missing doorstops will be installed.

Recommendation: Contact a qualified professional.

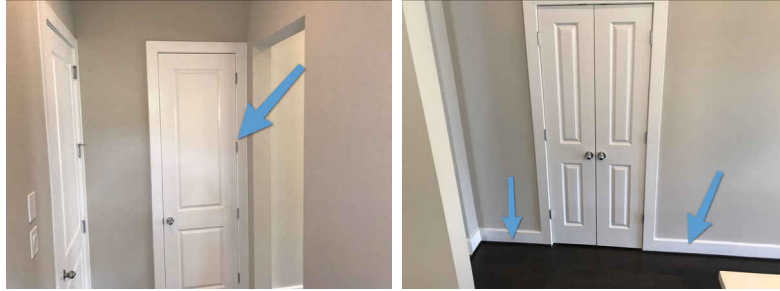
1st Floor Multiple Locations

**2: Interior Door Hardware: Missing Door Stops**

One or more door stops were observed to be missing. Recommend adding door stops to prevent damage to drywall finish.

Recommendation: Contact a qualified professional.

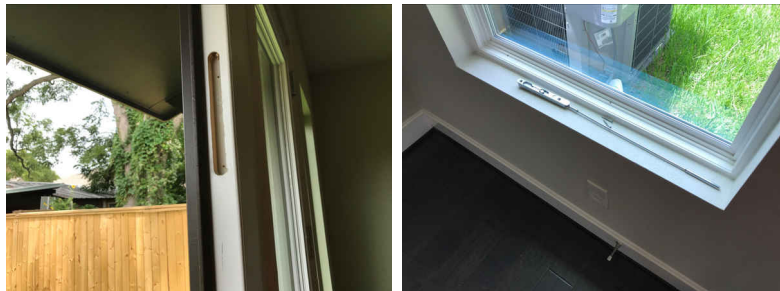
Rear Patio

**3: Exterior Door: Missing Upper Locking Mechanism**

The inspector observed the rear French exterior door to be missing upper locking mechanism. Remedies needed for security.

Missing lock mechanism will be installed.

Recommendation: Contact a handyman or DIY project

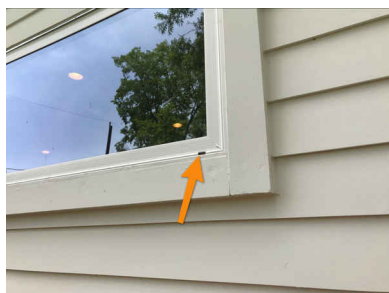
Right Exterior

**1: Weep Hole Cover: Missing**

The weep holes at the base of the exterior of the windows were observed to be missing . Recommend further evaluation and correction as needed to ensure the covers are present and free of obstruction.

Recommendation: Contact a qualified window repair/installation contractor.

Will be inspected and addressed

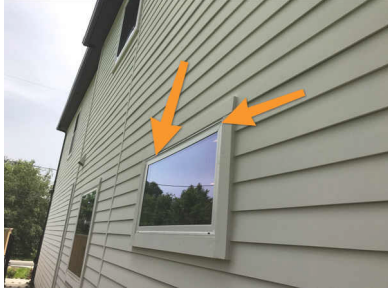
Right 1st Floor Exterior

**2: Flashing @ Window: Not Painted**

Upper flashing was observed not painted as intended. Recommend further evaluation and painting to prevent possible deterioration at area.

Recommendation: Contact a qualified professional.

Will be addressed.

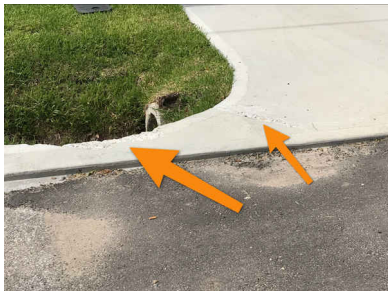
**1: Driveway @ Street: Damage Observed**

The driveway was observed to be damaged at multiple locations. Recommend further evaluation and repair to prevent further deterioration at area.

Recommendation: Contact a qualified concrete contractor.

Will be inspected and any necessary repairs will be made.

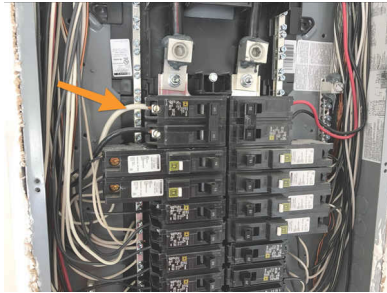
**1: White Wires not Marked**

White wires were observed connected to breakers. White wires are typically neutral but when they are connected to a breaker they become hot/live and should be marked as such. Recommend to have an electrician evaluate for remedy.

Recommendation: Contact a qualified professional.

Will be inspected and any necessary corrections will be made.

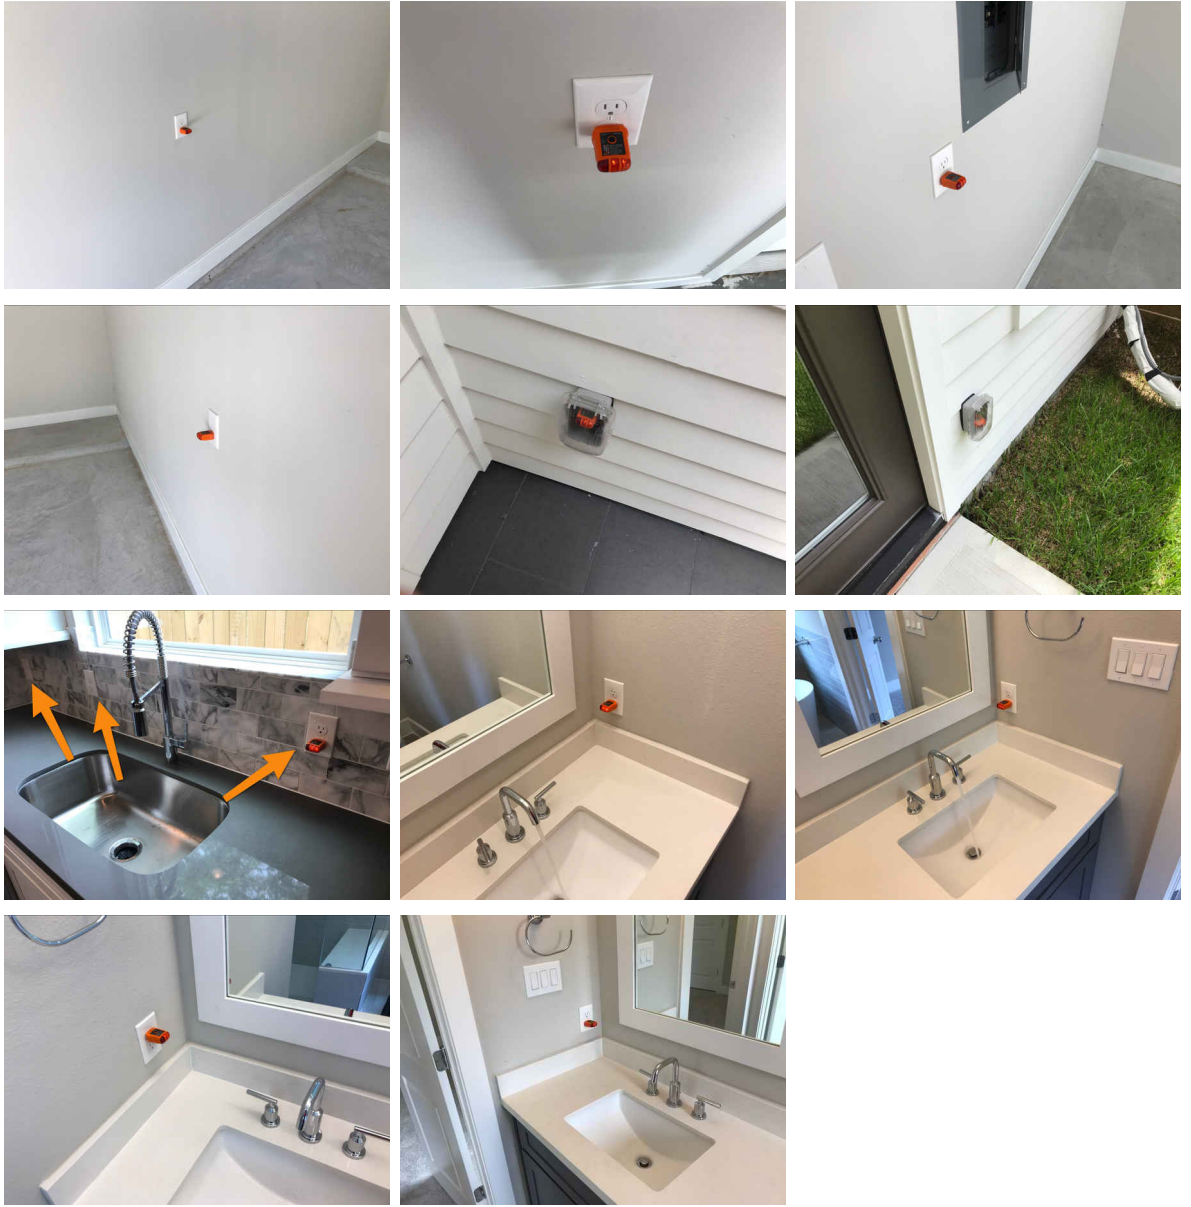
Multiple Locations

**1: Outlets: GFCI Protection Inadequate/Missing**

Garage, Exterior, All Kitchen Countertop, All Outlets within 36 inches of a water source, Bathrooms -

- No GFCI protection was observed at these required locations. Recommend addition of GFCI protection for safety purposes as intended.

Recommendation: Contact a qualified professional.

Will be inspected and the necessary corrections will be made.

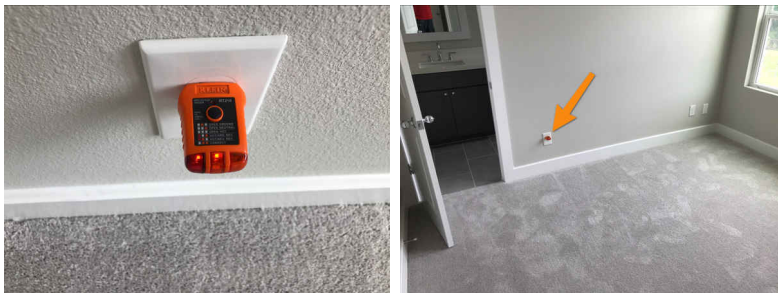
2nd Floor Front Bedroom

**2: Outlet: Hot Neutral Reversed**

The hot and neutral wires are reversed on the outlet. Recommend to have an electrician evaluate and remedy.

Will be inspected and the necessary corrections will be made.

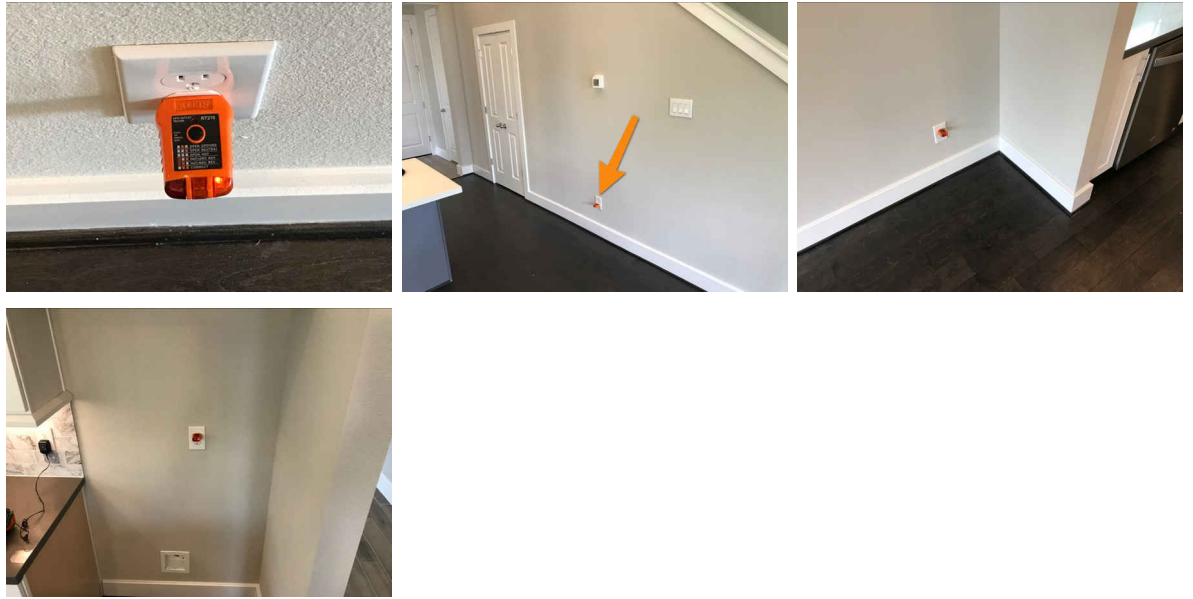
1st Floor Multiple Locations

**3: Outlets: Open Neutral**

Outlets are not wired correctly. Recommend further evaluation by an electrician.

Recommendation: Contact a qualified electrical contractor.

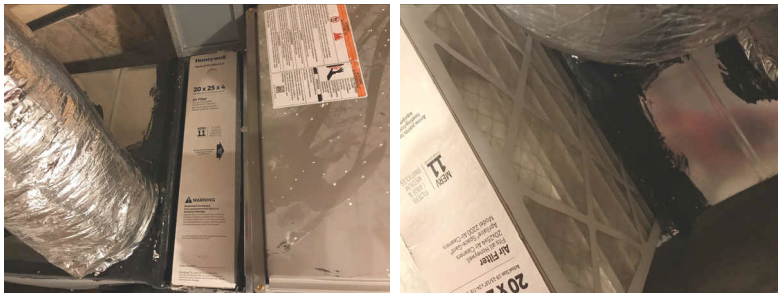
**1: Filters: Media Filter Dirty**

The return air filters were observed to be dirty, recommend they be removed at the return air registers as there is a large media filter placed at the air handler in the attic. This will prevent air flow restriction and the allow the unit to operate properly.

Return air filters will be removed.

Recommendation: Contact a qualified professional.

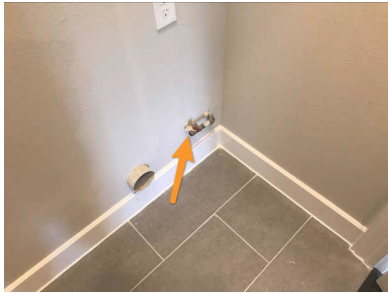
**1: Gas Piping: Un-Capped Gas Supply**

An uncapped gas supply line was observed. Gas lines that are not in use should be capped for safety. Remedy as needed.

Gas supply line will be capped.

Recommendation: Contact a handyman or DIY project

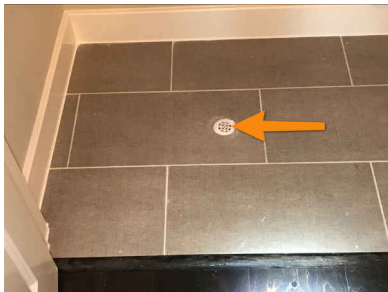
**1: Washer Drain Termination: Not Observed @ Exterior**

Termination point for Second floor Utility Room floor drain was not observed at exterior of home. Recommend further evaluation and inspection by a professional plumbing contractor, to confirm drain exits to exterior as intended.

Recommendation: Contact a qualified professional.

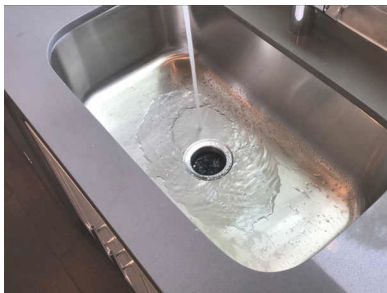
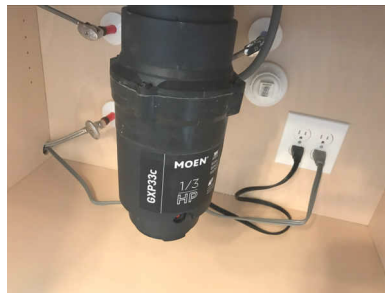
#### 1: Debris in Unit

The unit was observed to be excessively noisy during operation at the time of the inspection. This condition is likely related to debris or other articles inside the appliance. Recommend further evaluation and correction as needed.

Will be inspected and any necessary corrections will be made.

Recommendation: Contact your builder.

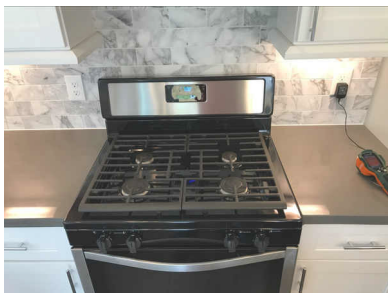
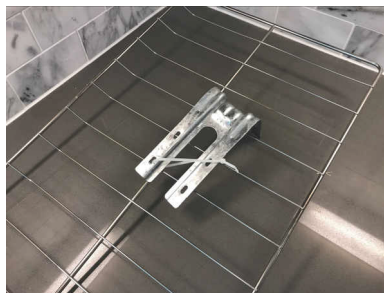
**1: Anti-Tip Device Missing**

The oven should have an anti-tip device installed for the rear legs of the cook top to prevent it from tipping over when the door is open. Repair as needed for safety purposes.
