# Your Inspection Report

7109 Delesandri Dr  
Hitchcock, TX 77563

Wednesday, May 11, 2022

# PROPERTY INSPECTION REPORT FORM

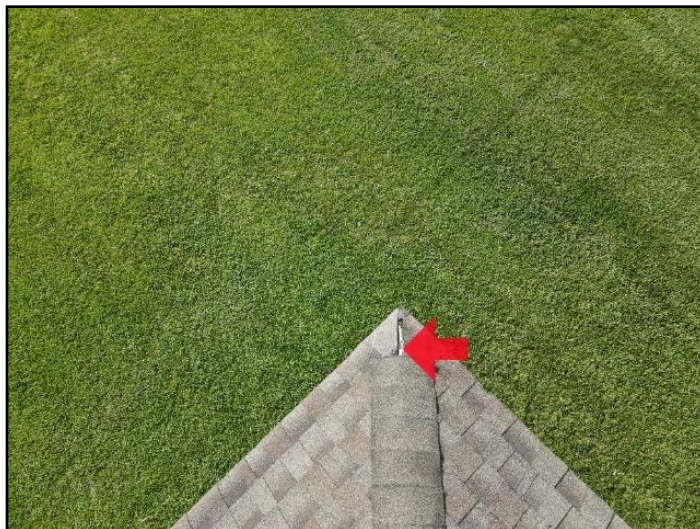
3. Damage

Implication(s): Chance of water damage to structure, finishes and contents

Location: Front Left Roof

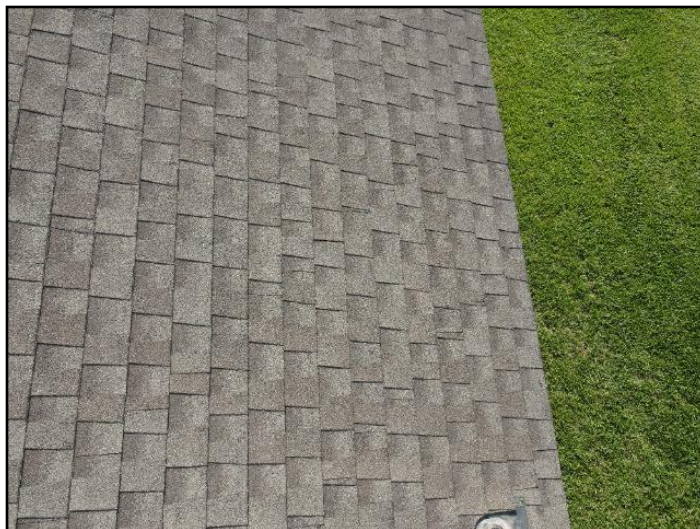
4. Damage

2. Condition: • [Damage](#)

Implication(s): Chance of water damage to structure, finishes and contents

Location: Various Right Roof

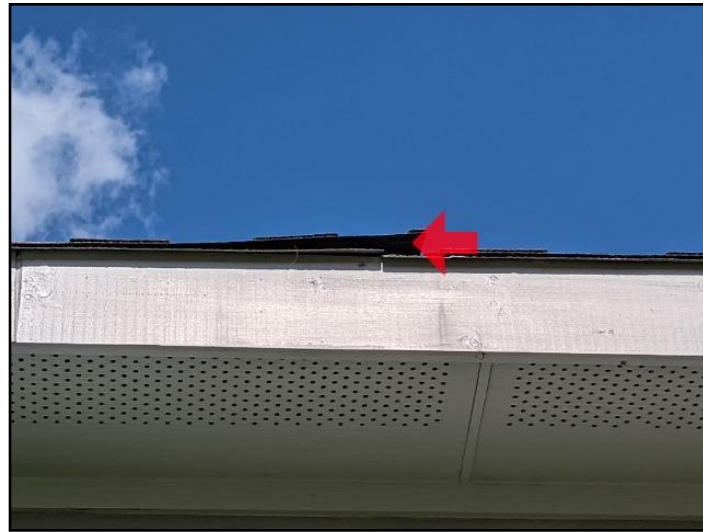
5. Loose pieces

3. Condition: • [Missing, loose or torn](#)

**Location:** Front Middle Roof

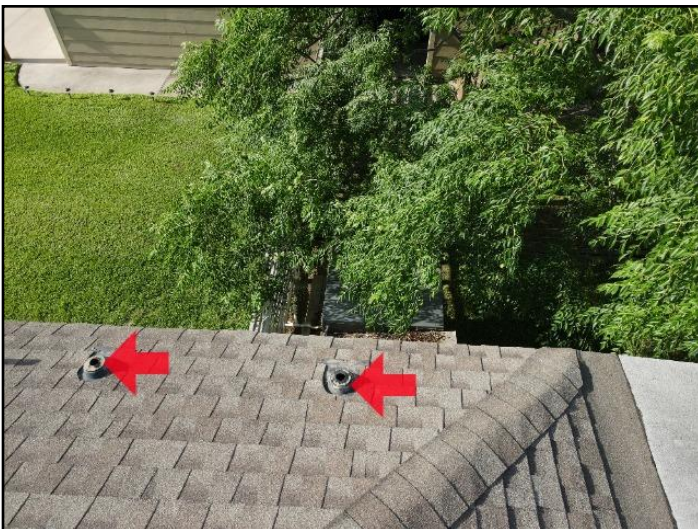
9. Installation incorrect (top exposed or...

Implication(s): Chance of water damage to structure, finishes and contents

Location: Various Left Side Roof

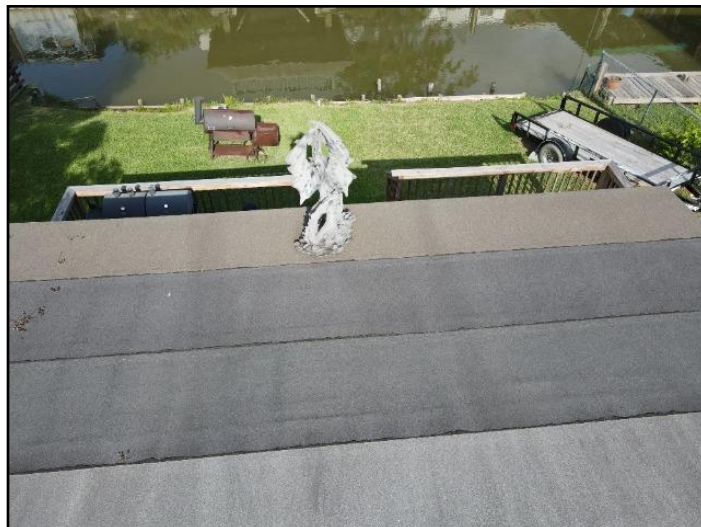
13. *Blisters*

Implication(s): Chance of water damage to structure, finishes and contents

Location: Various Rear Roof

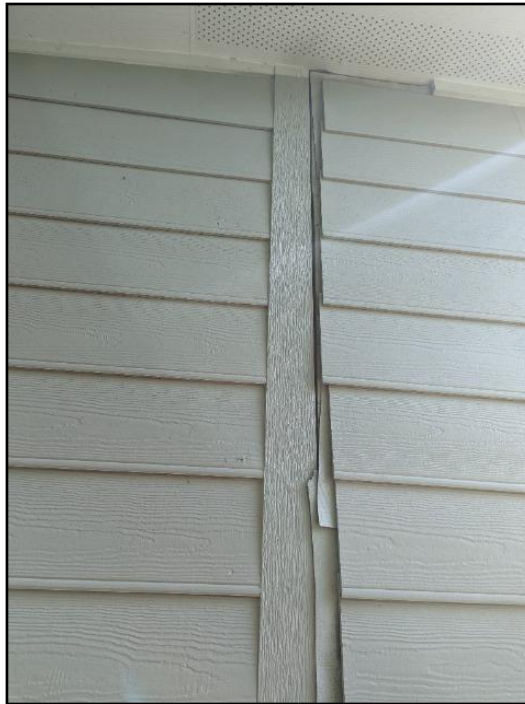
14. Loose

12. Condition: • [Loose](#)

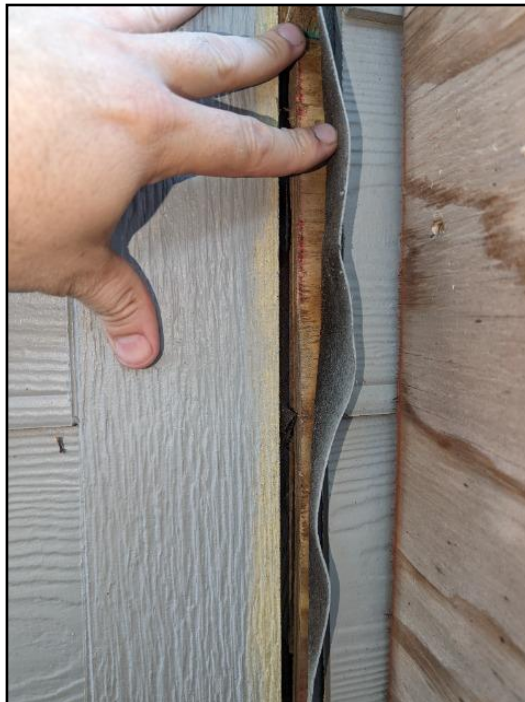
15. Inner-Seal brand

13. Condition: • [Inner-Seal brand](#)

Implication(s): Chance of water damage to structure, finishes and contents | Material deterioration

Location: Left Side Exterior Wall

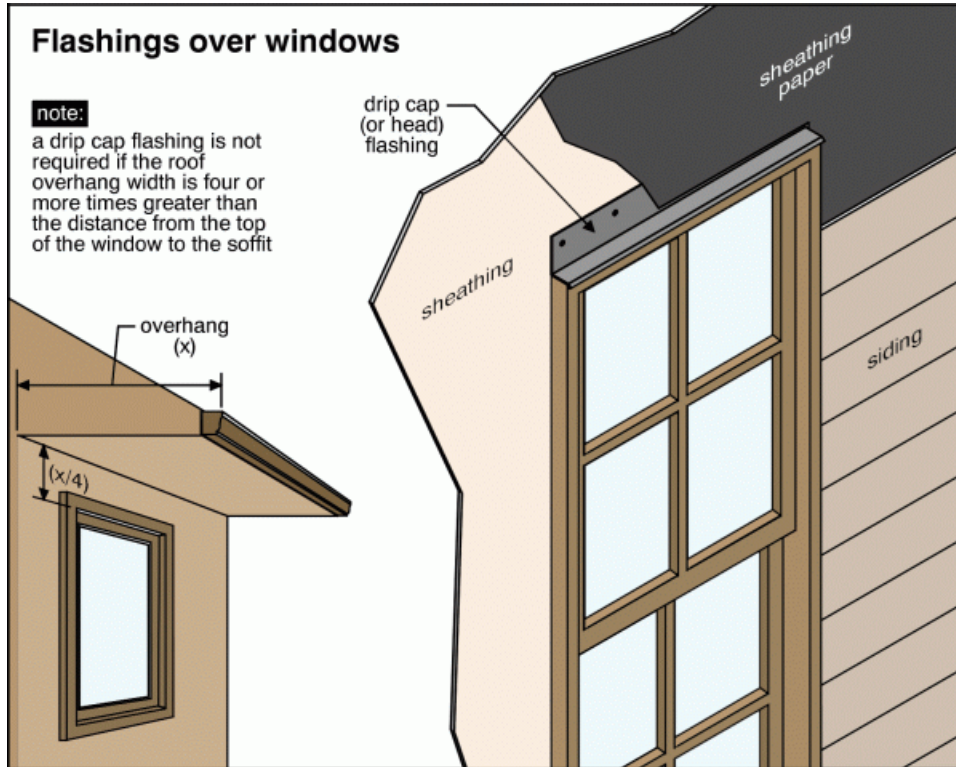
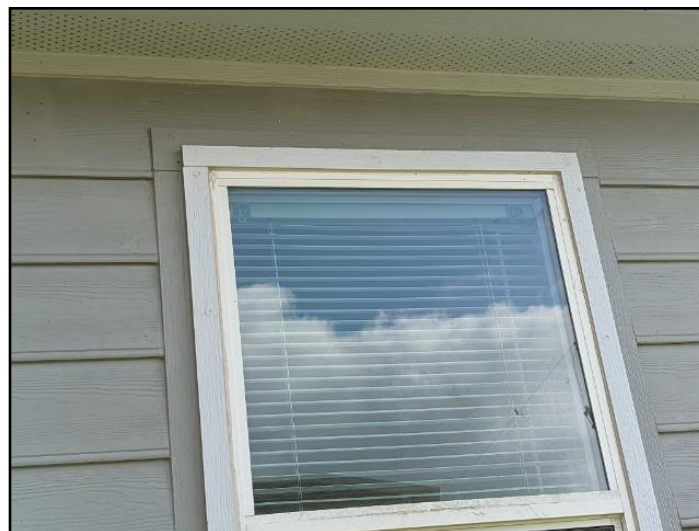
16. Missing

Implication(s): Chance of water damage to structure, finishes and contents

Location: Various Windows

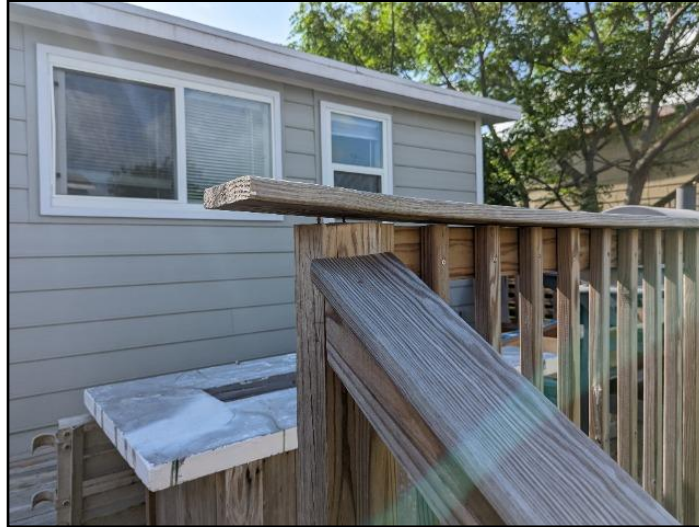
17. *Loose*

**Implication(s):** Fall hazard

**Location:** Rear Deck

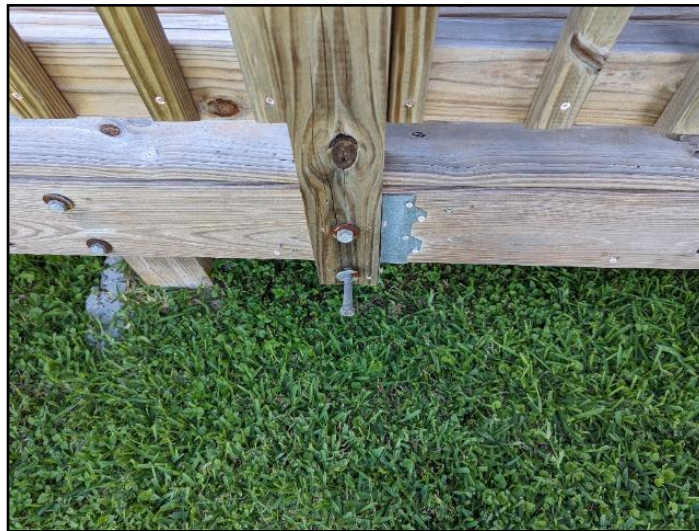
18. *Anchor Bolts Not Tightened Down*

**16. Condition:** • Anchor Bolts Not Tightened Down

**Implication(s):** Loose Handrails and Guards

**Location:** Rear Exterior Deck

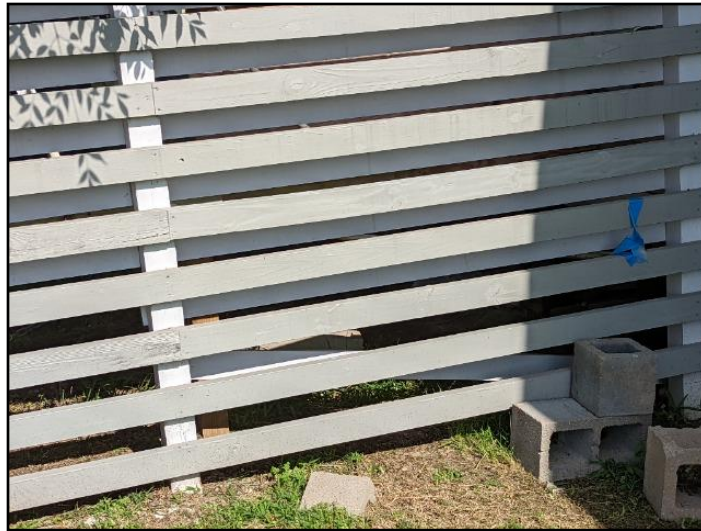
20. Boards damaged

- Landscaping\Fence: **Boards damaged** Location(s): **Left Side Yard**
- Recommendations\Overview: **Key Note: Some of the columns for the foundation beams appear to have been replaced but not by a professional foundation company. It appears some of the columns are missing, not attached with proper anchorage, and leaning.**

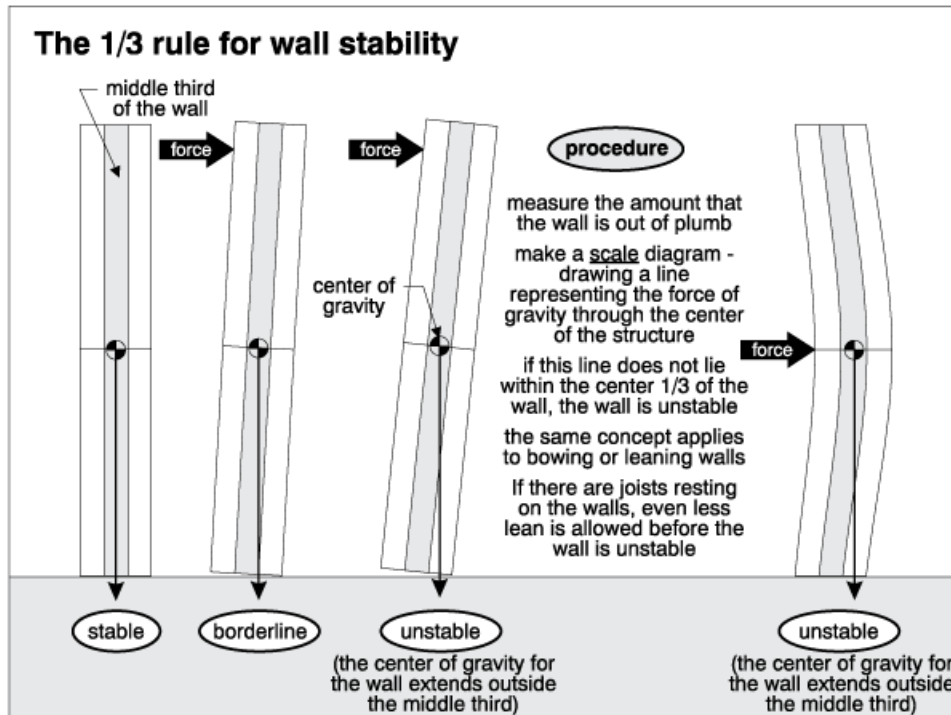
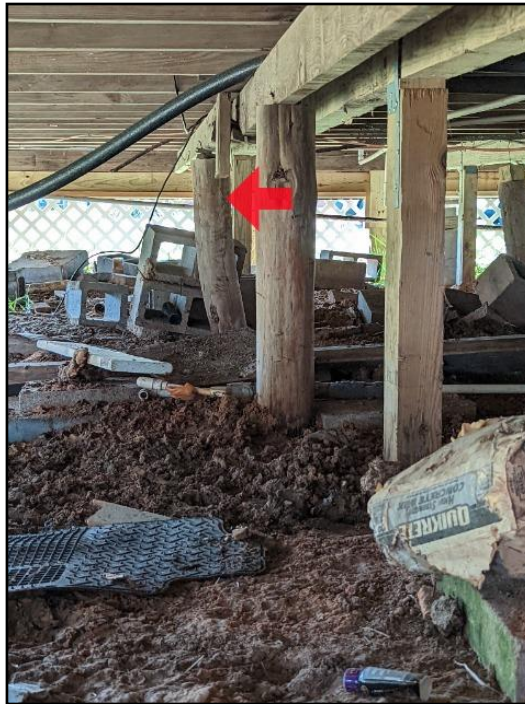
21. Leaning

**Condition:** • Key Note: Some of the columns for the foundation beams appear to have been replaced but not by a professional foundation company. It appears some of the columns are missing, not attached with proper anchorage, and leaning.

21. Condition: • Leaning  
 Implication(s): Weakened structure | Chance of structural movement  
 Location: Middle Crawl Space

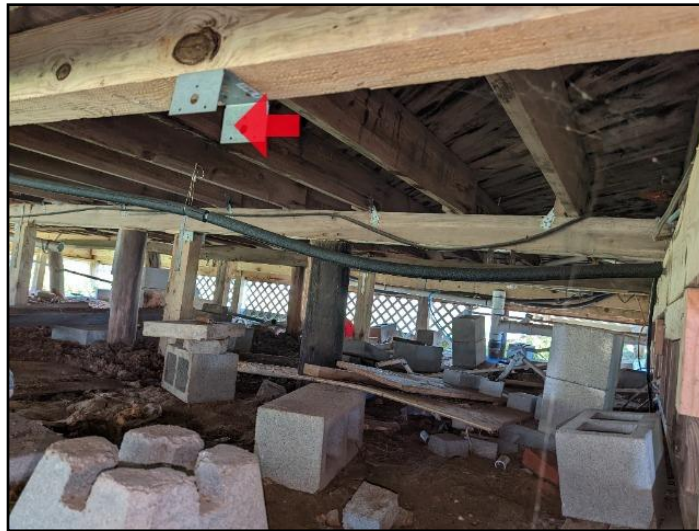
24. Missing

Implication(s): Chance of structural movement

Location: Middle Crawl Space

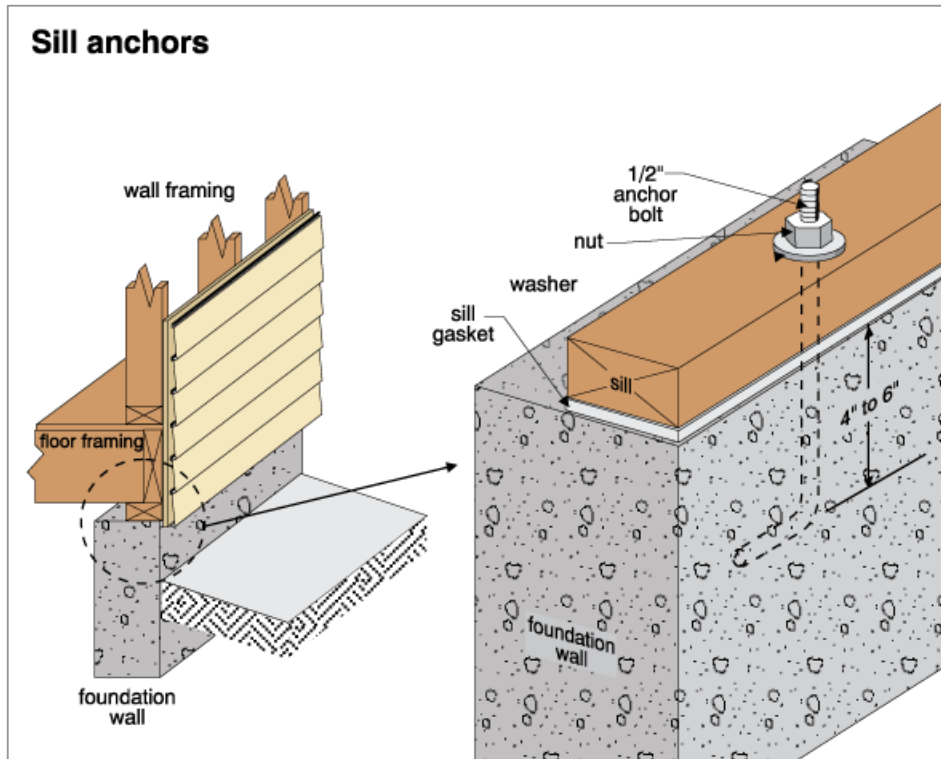
25. Anchors not centered in sill

Location: Various Exterior

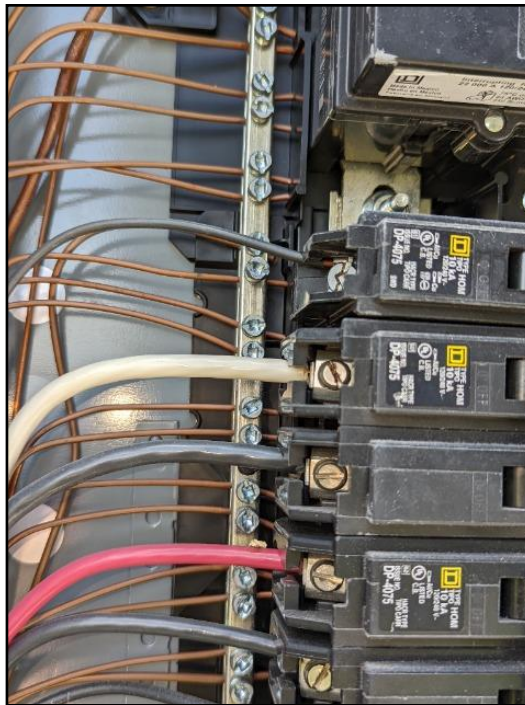
29. White wires connected to breakers not...

**26. Condition:** • White wires connected to breakers not identified as hot/live/ungrounded

**Location:** Right Side Exterior Wall

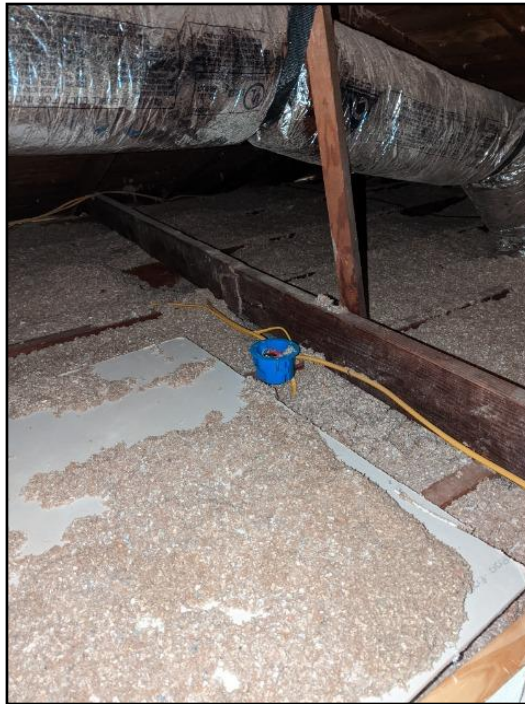
30. Cover loose or missing

**Location:** Various Attic

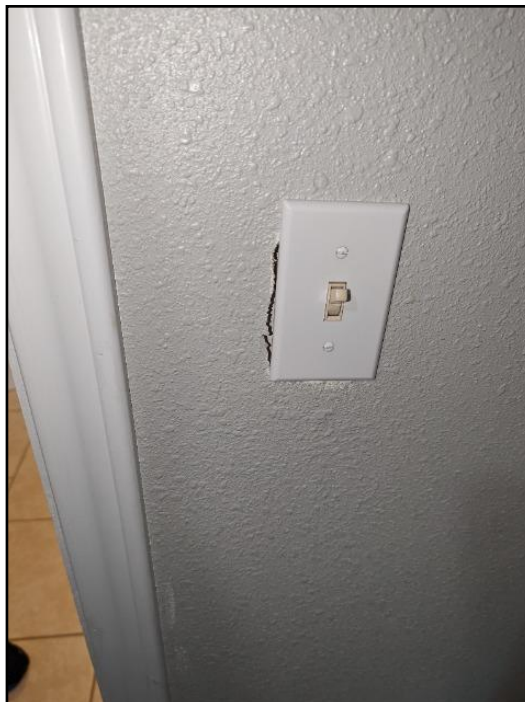
31. Loose

Implication(s): Electric shock

Location: Left Side Laundry Area

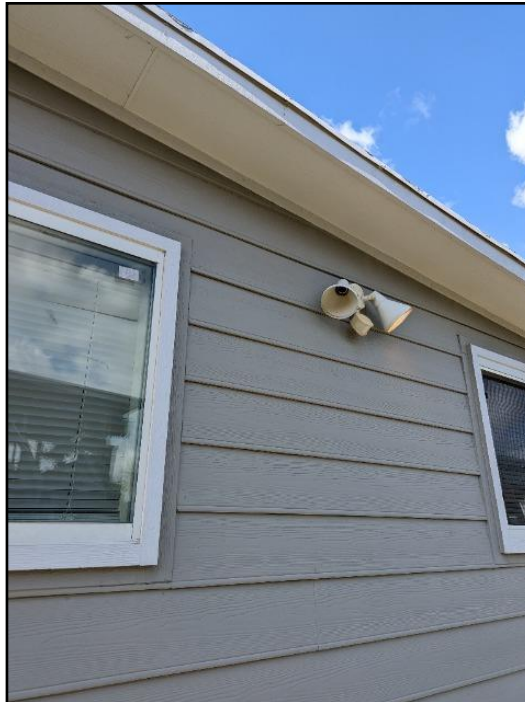
32. *Inoperative*

Implication(s): Inadequate lighting

Location: Right Side Exterior Wall

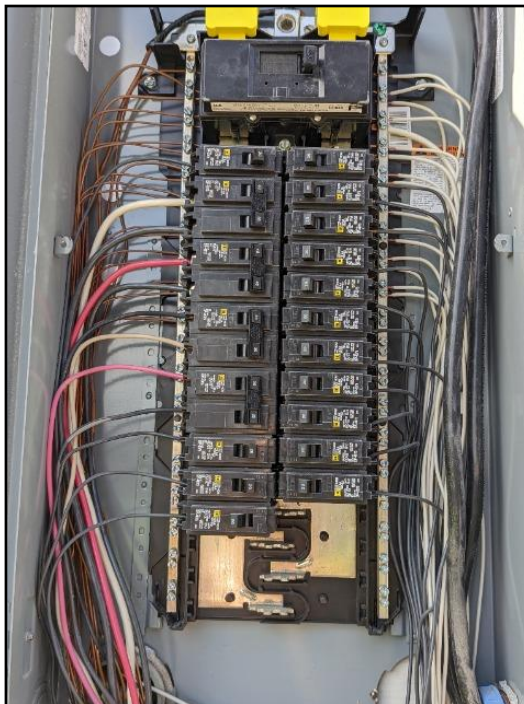
39. Wrong fuse or breaker size

**Location:** Right Side Exterior Wall

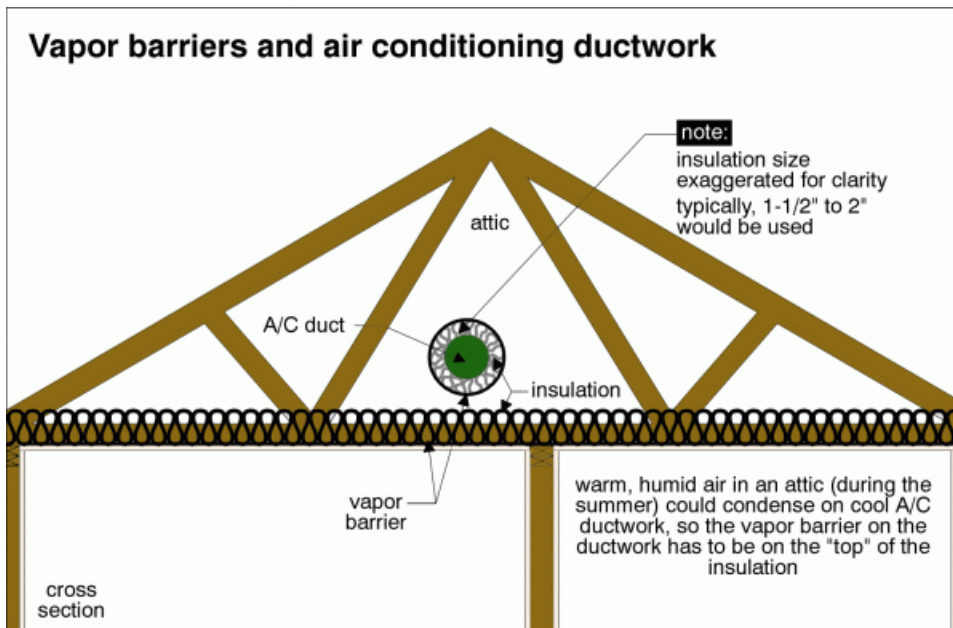
Implication(s): Chance of condensation damage to finishes and/or structure | Increased heating and cooling costs | Reduced comfort

Location: Left Side Exterior Wall

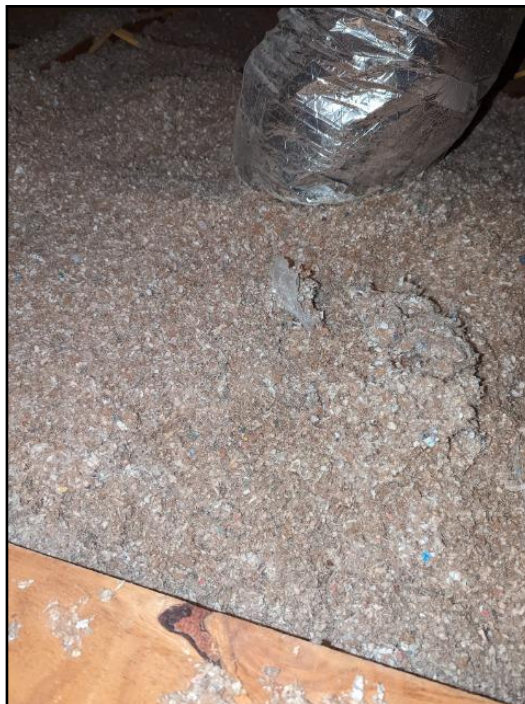
41. Amount inadequate

**Implication(s):** Increased heating and cooling costs

**Location:** Various Attic

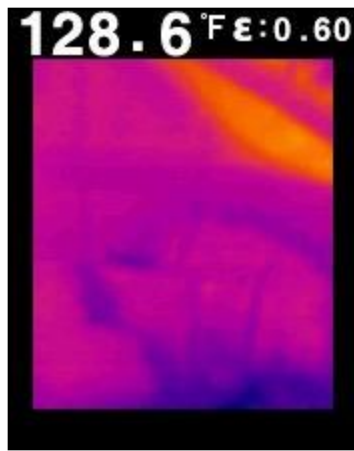
42. 130°

35. Condition: • Attic ventilation suspect

Location: Attic

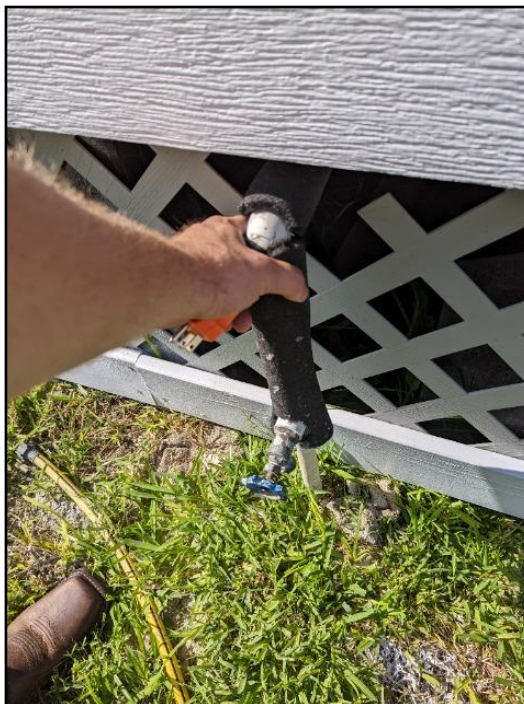
49. Poor support

**Implication(s):** Chance of water damage to structure, finishes and contents | Leakage

**Location:** Right Side Exterior

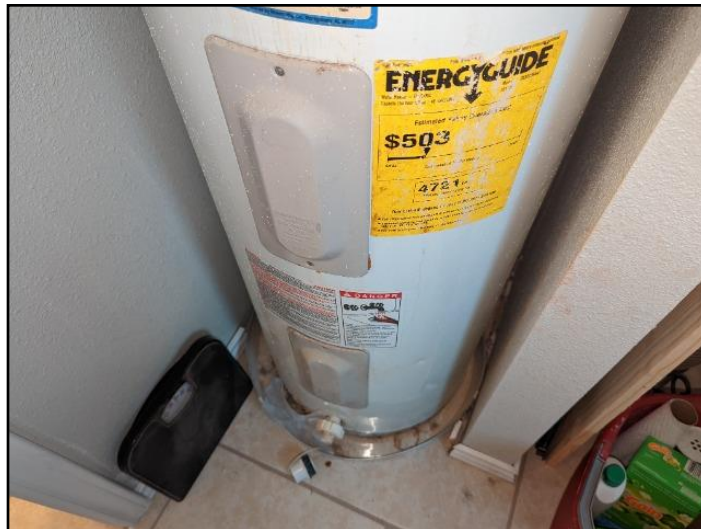
51. Safety pan and drain defect

**Implication(s):** Chance of water damage to structure, finishes and contents | Damage to equipment

**Location:** Laundry Area

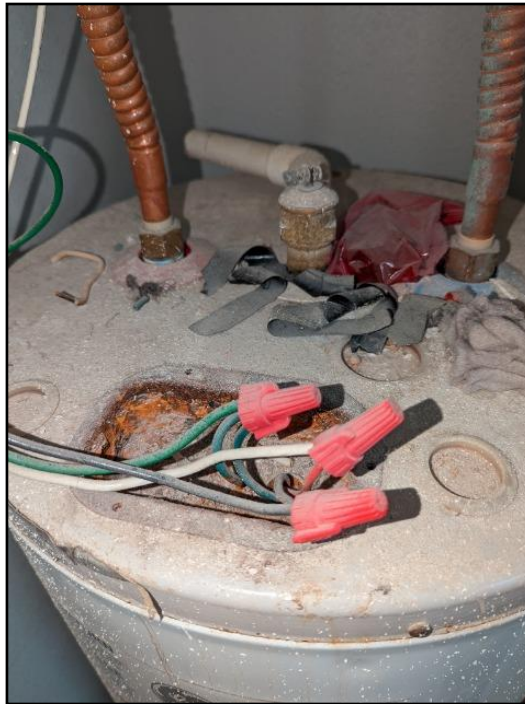
54. Damage

**Location:** Laundry Area

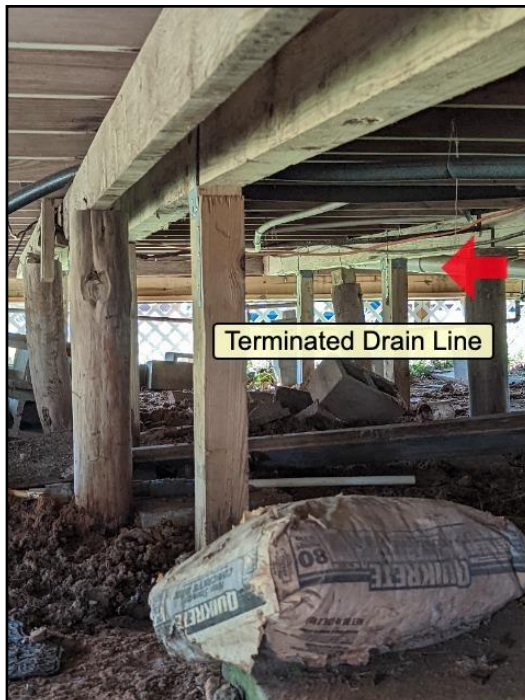
55. Nonstandard materials and patches

Implication(s): Chance of water damage to structure, finishes and contents | Sewage entering the building

Location: Front Middle Crawl Space

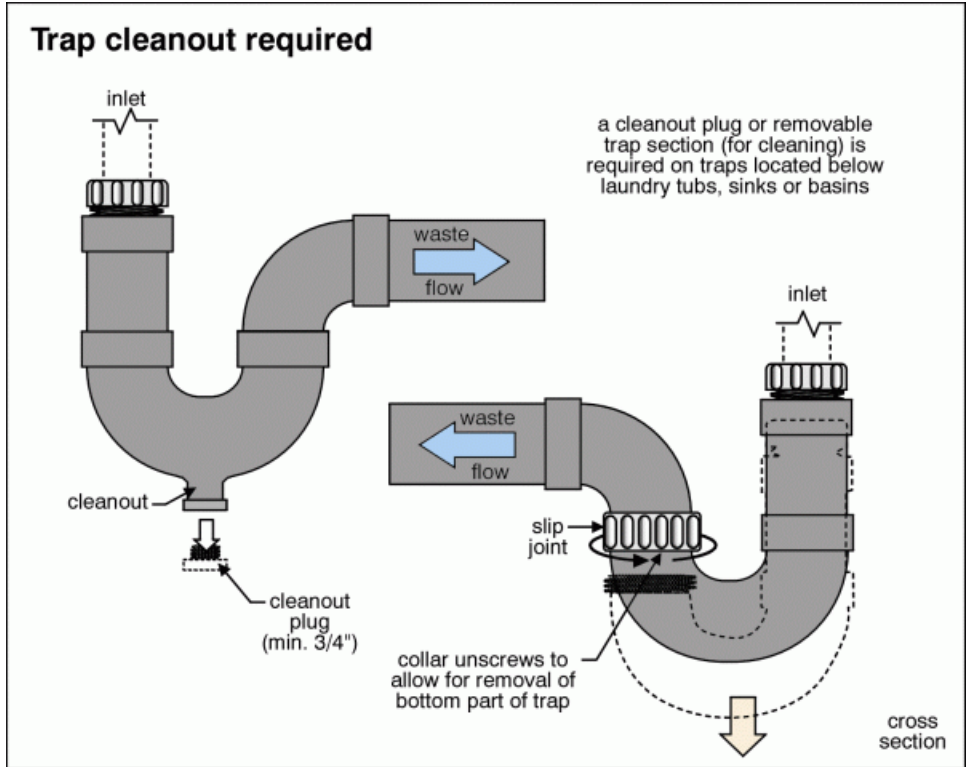
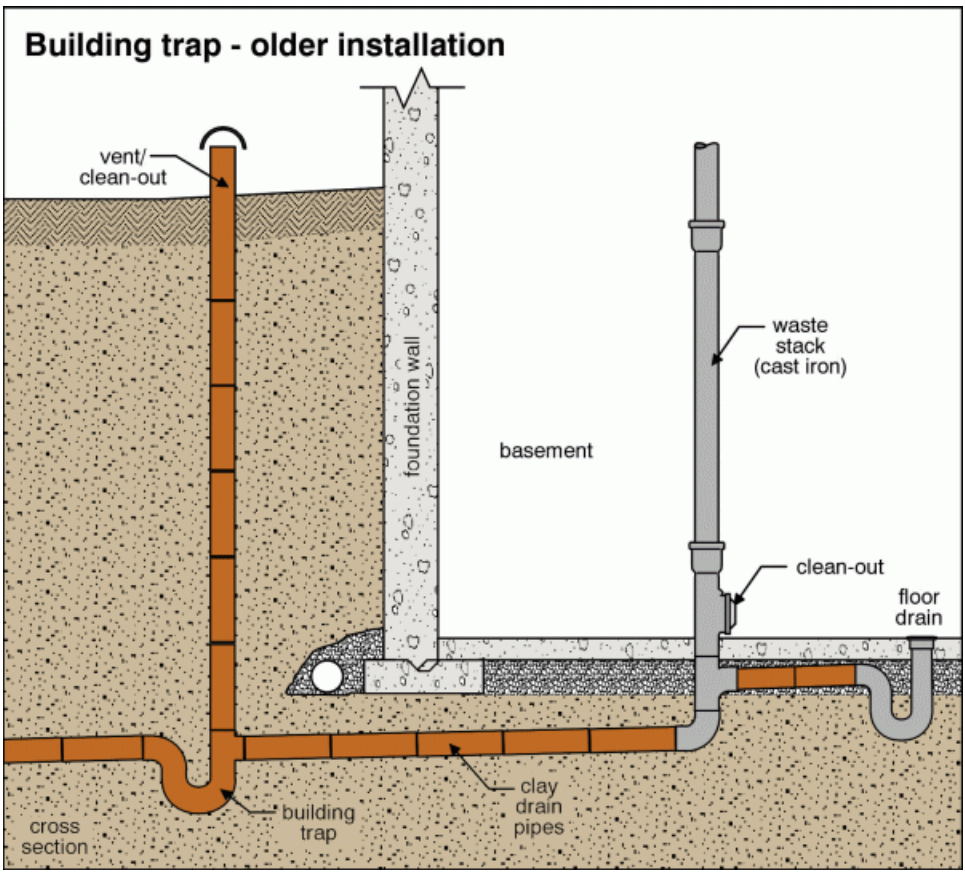
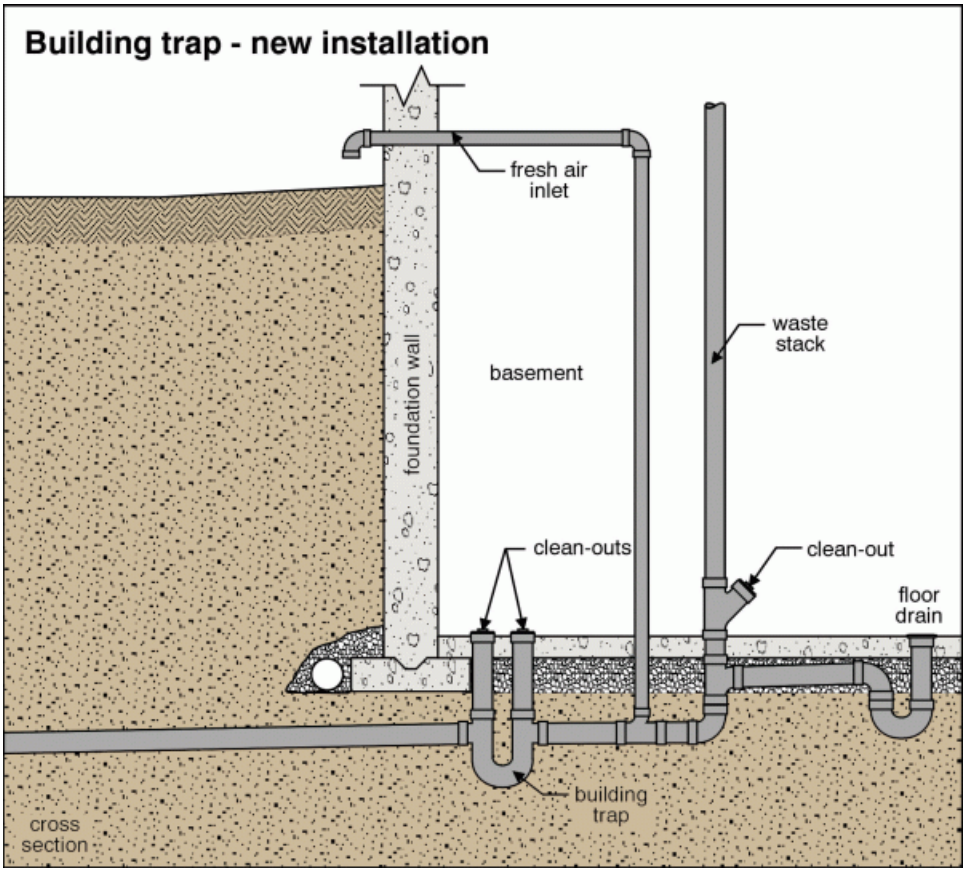
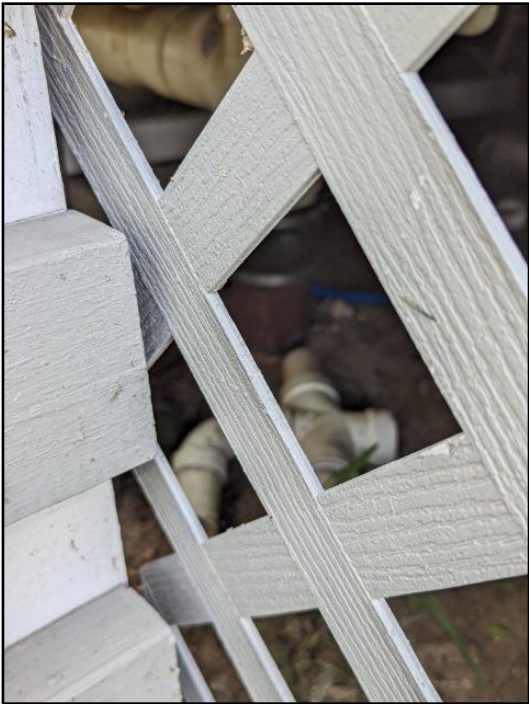
56. Clean-outs missing or inaccessible

Implication(s): Increased maintenance costs | Difficult to service

Location: Left Side Middle Crawl Space

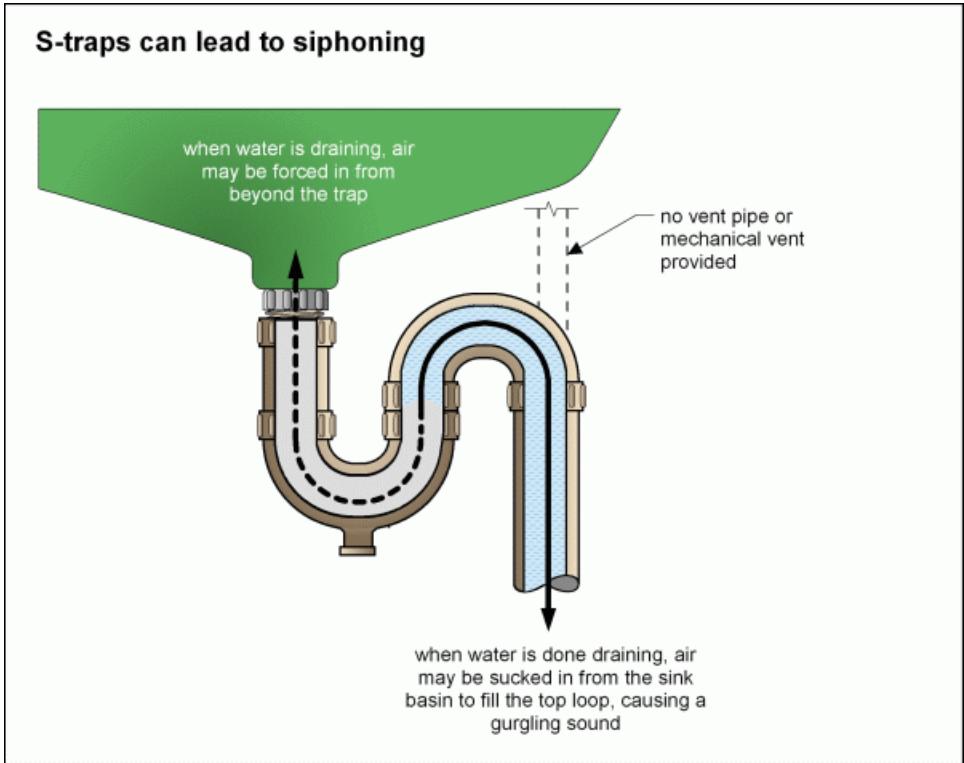
57. Nonstandard shape or material

Implication(s): Reduced operability | Fixtures slow to drain

Location: Hallway Bathroom

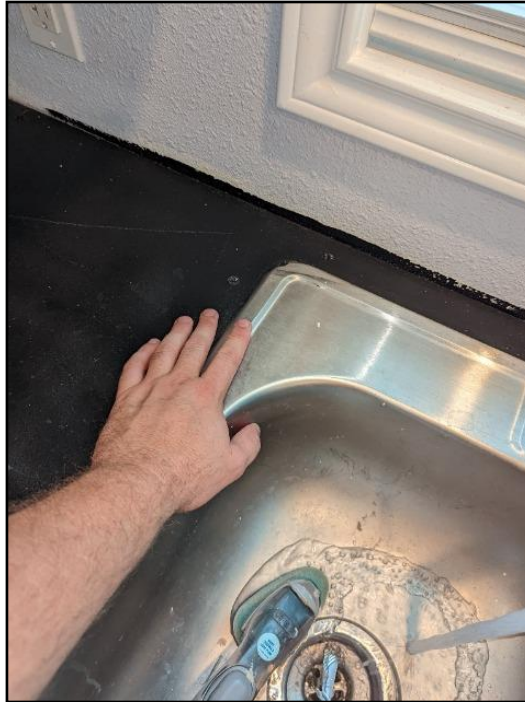
58. Loose

**Implication(s):** Chance of water damage to structure, finishes and contents | Damage or physical injury due to falling materials | Sewage entering the building

**Location:** Kitchen

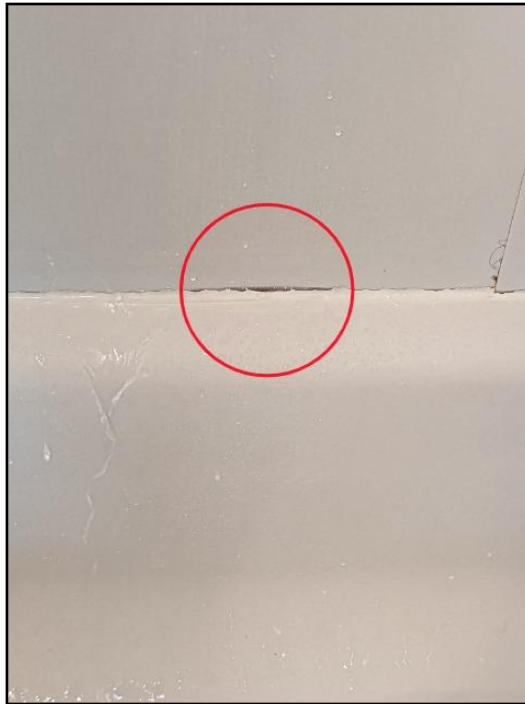
59. *Caulking loose, missing or deteriorated*

**Location:** Middle Bathtub

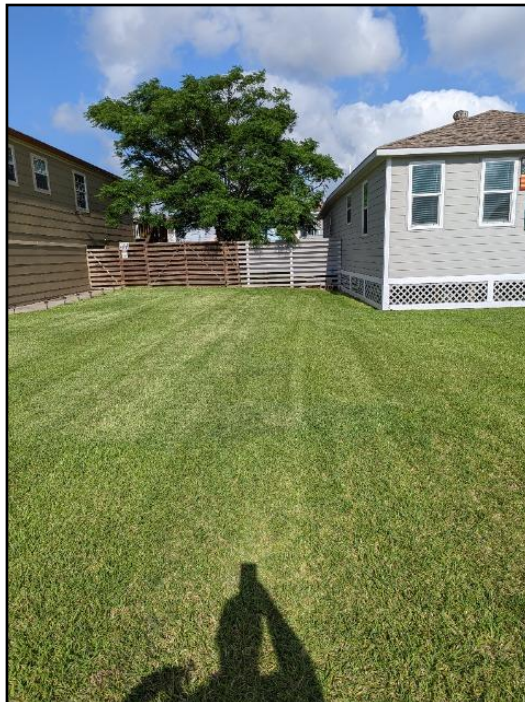
61. Tank not located

**Condition:** • Key Note: Unable to locate septic tanks at the time of the inspection. It appears to be beneath the new HVAC PAC system on the left side of the home. Recommend consultation for mapping and full excavation to tank lid cover prior to close.

50. Condition: • Tank not located

Implication(s): Reduced operability | Hygiene issue

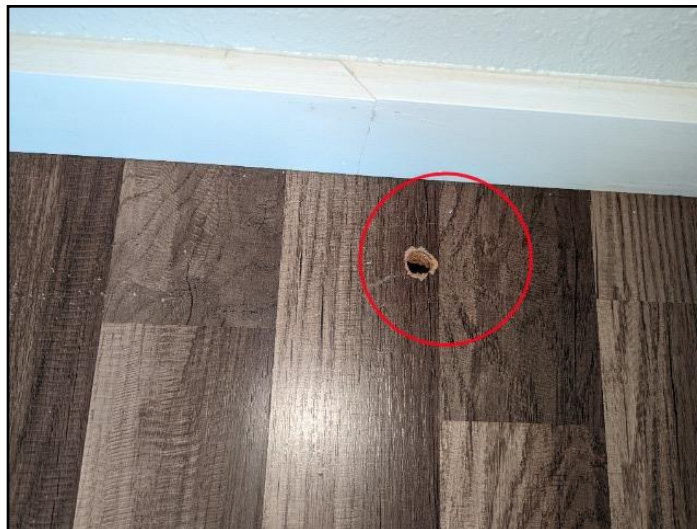
66. *Damage*

Implication(s): Trip hazard

Location: Rear Left Side Bedroom

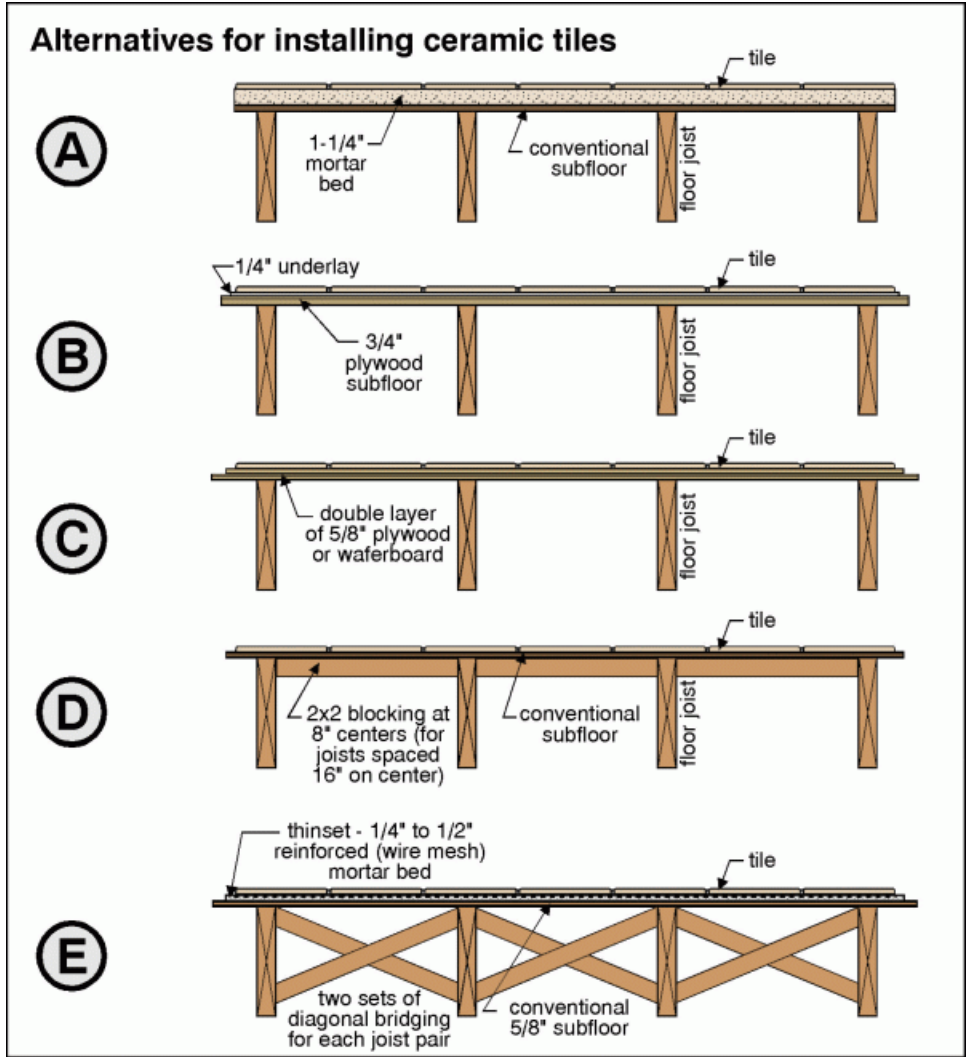
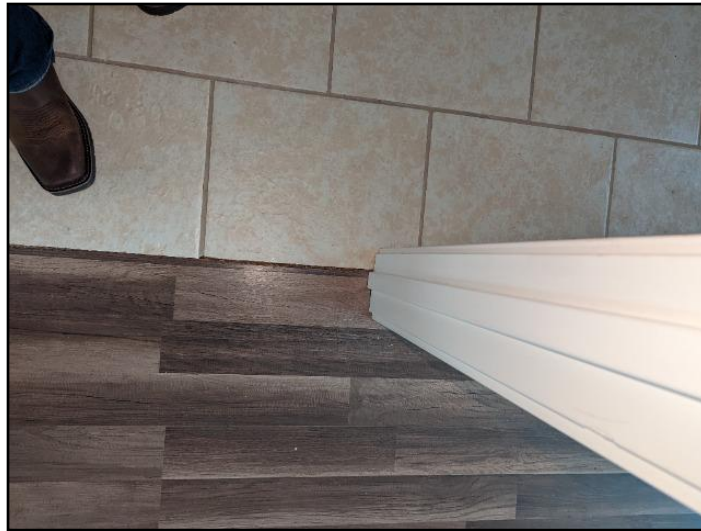
67. Grout missing

Implication(s): Trip or fall hazard

Location: Laundry Area

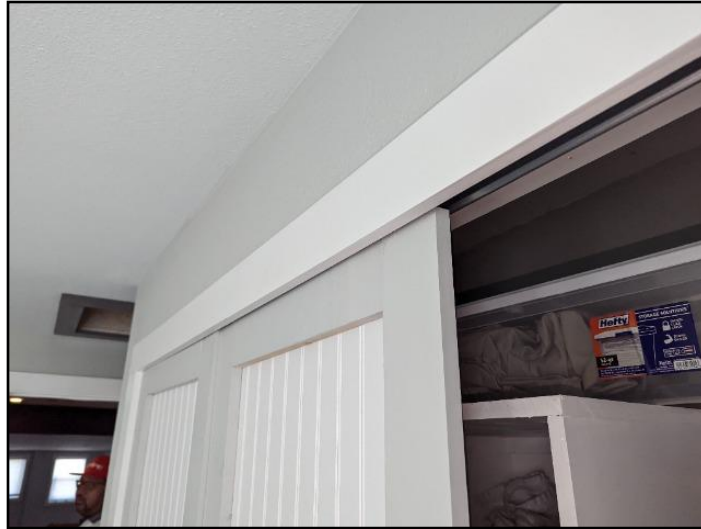
71. Inoperable

**Location:** Various Closets

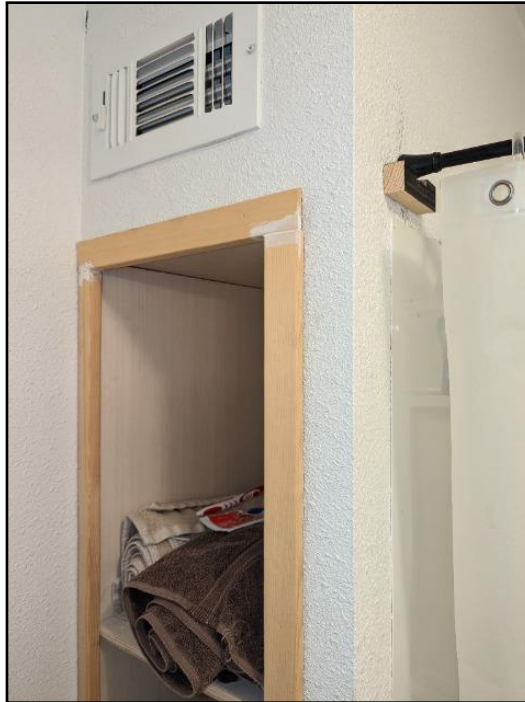
74. Loose

Location: Linen Closet Bathroom

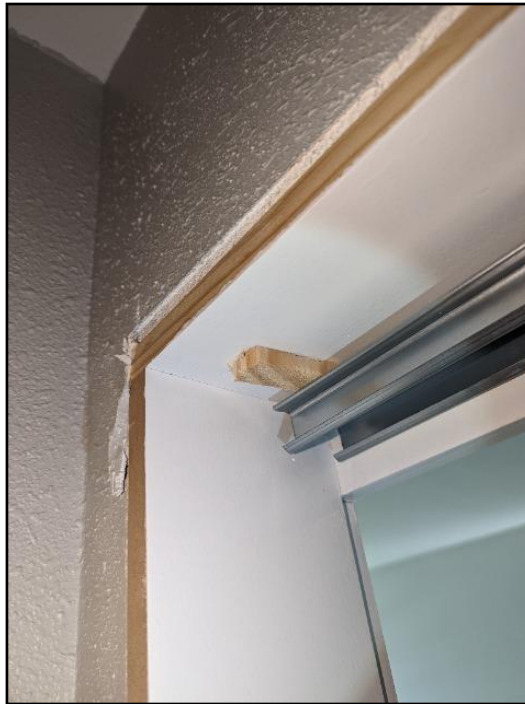
75. Missing

60. Condition: • [Missing](#)

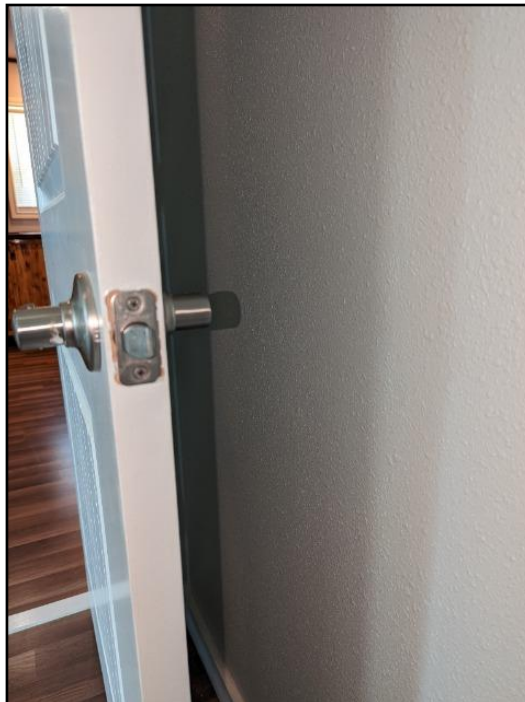
76. Doorstops missing or ineffective

61. Condition: • [Doorstops missing or ineffective](#)

Location: Various Throughout

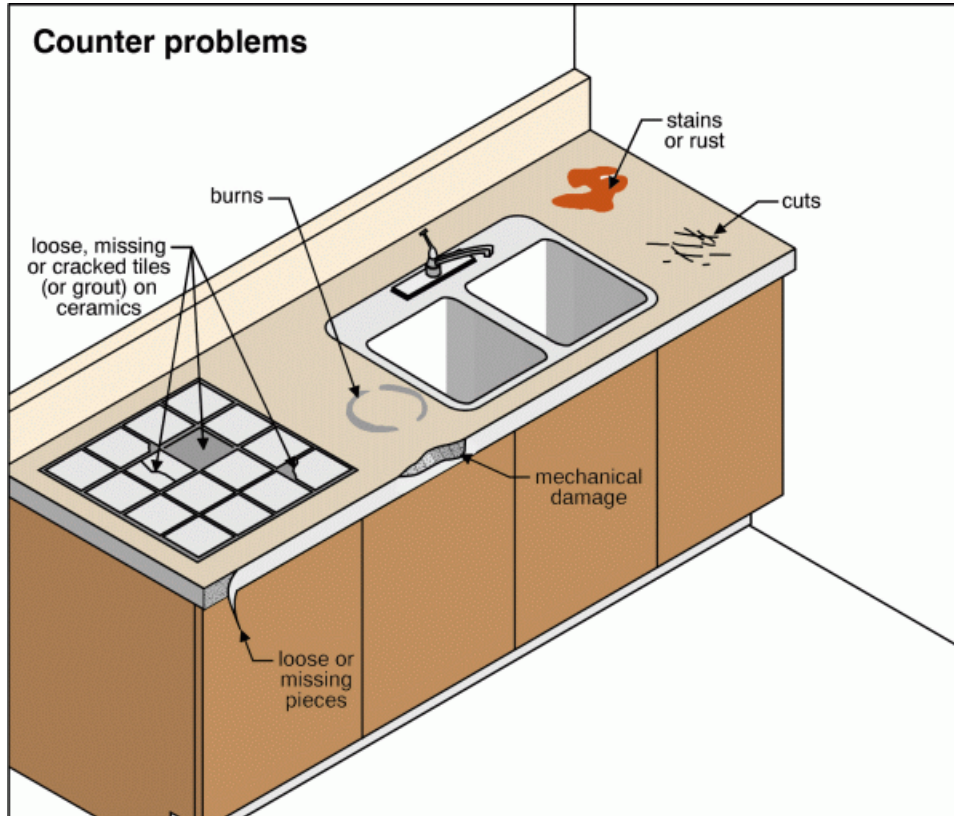
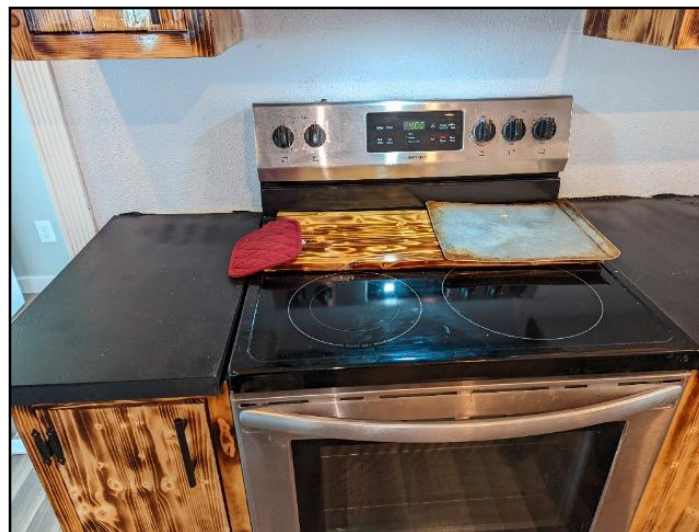
77. Damage, stained

Location: Various Kitchen

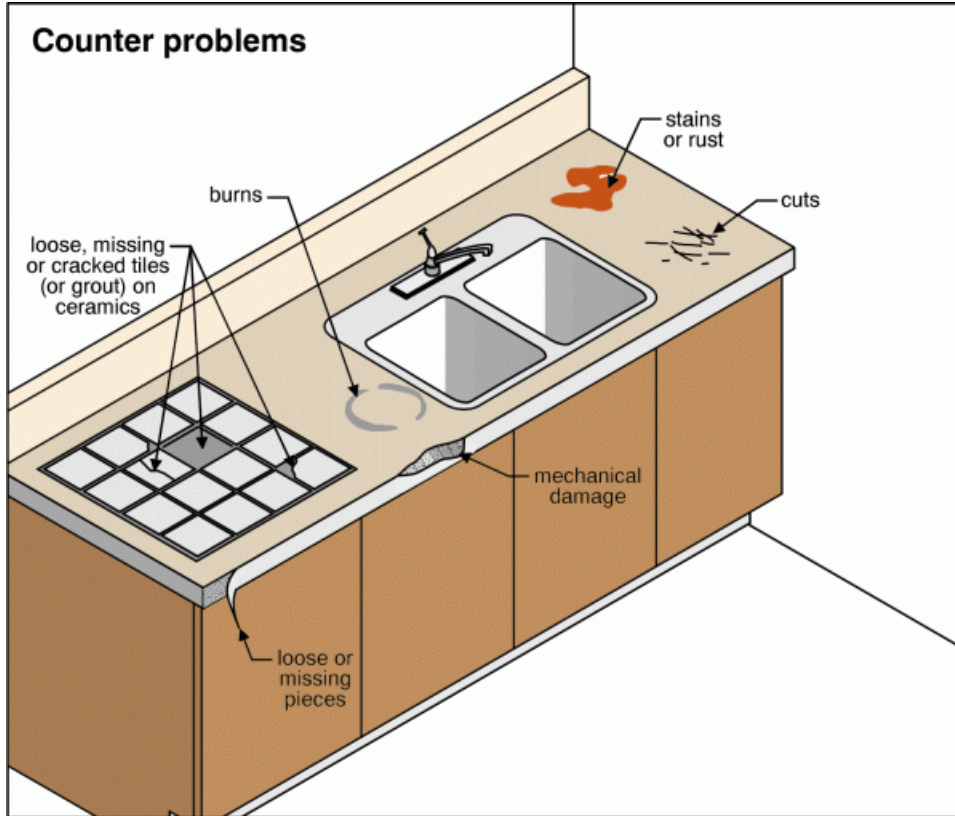
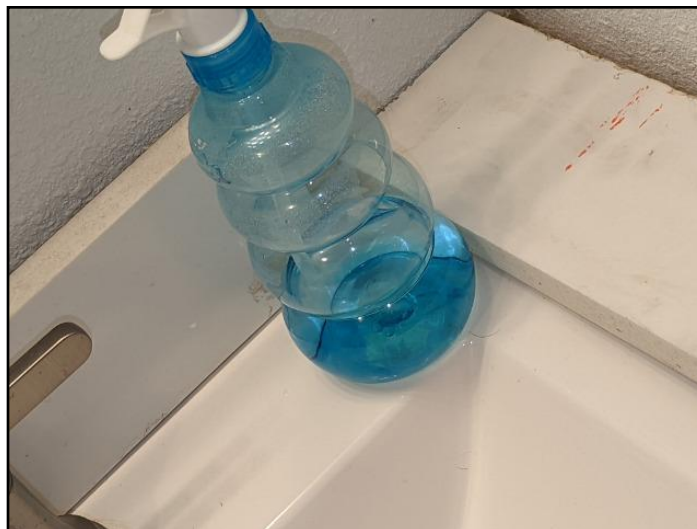
78. Tiles loose, missing, cracked, stained or...

63. Condition: • [Tiles loose, missing, cracked, stained or broken](#)

**Location:** Hallway Bathroom
