# Your Inspection Report

7109 Delesandri Dr  
Hitchcock, TX 77563

Wednesday, May 11, 2022

# PROPERTY INSPECTION REPORT FORM

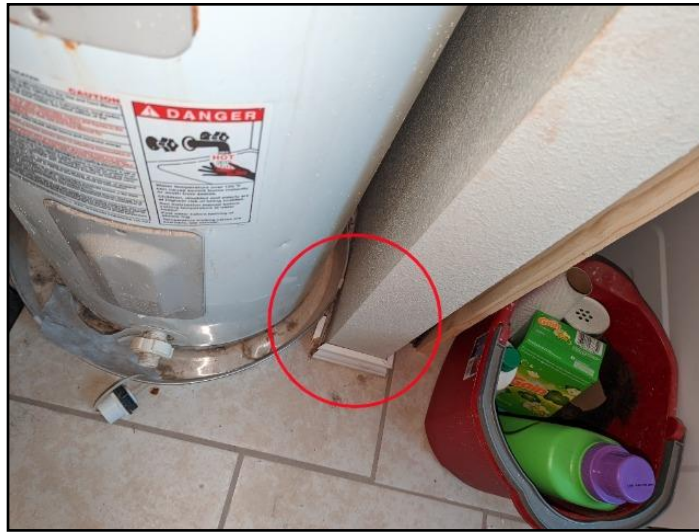
79. Loose

**Location:** Laundry Area

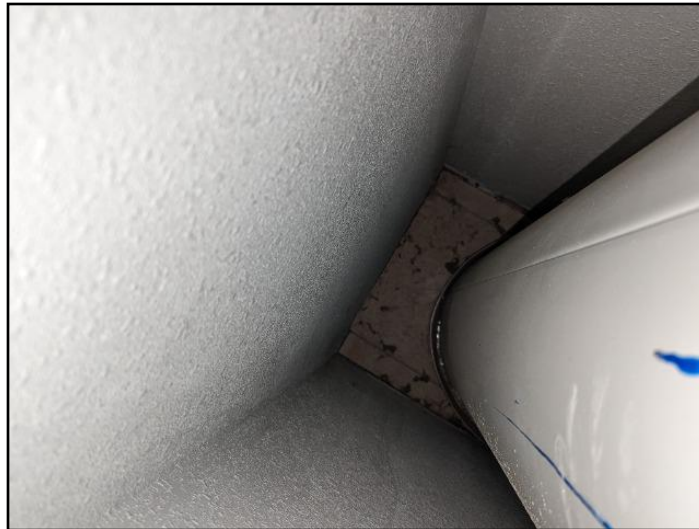
80. Missing

65. **Condition:** • [Missing](#)

**Location:** Left Side Laundry Area

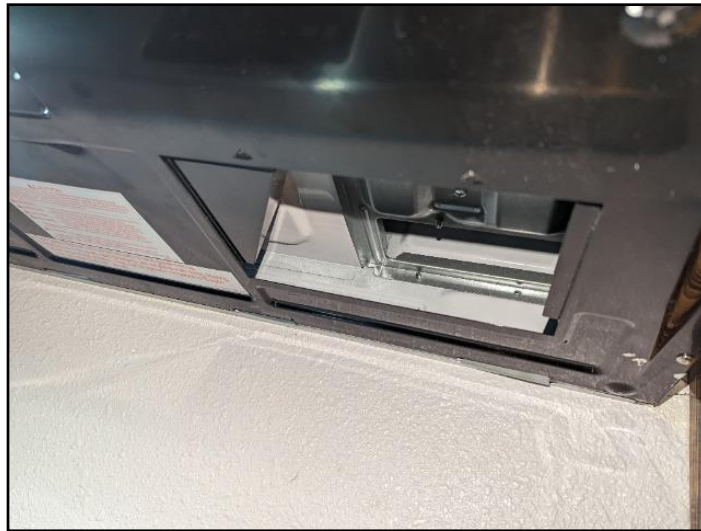
82. *Filter missing*

**67. Condition:** • Filter missing

**Location:** Kitchen

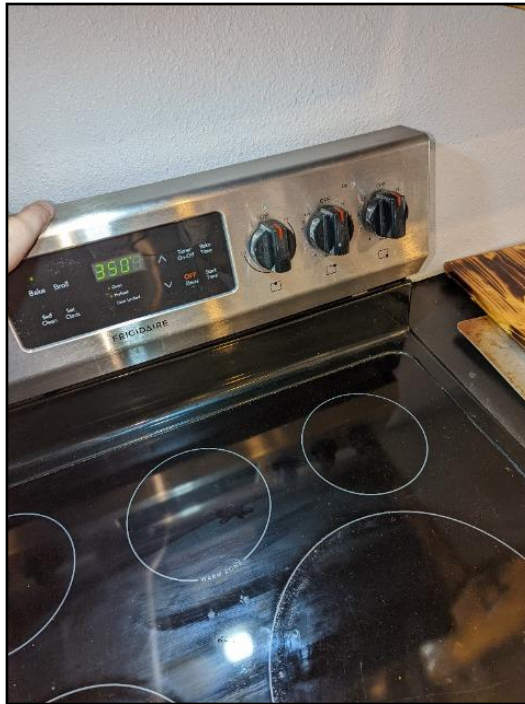
83. Anti-tipping device missing

- Appliances\Oven: **Anti-tipping device missing** Location(s): **Kitchen**

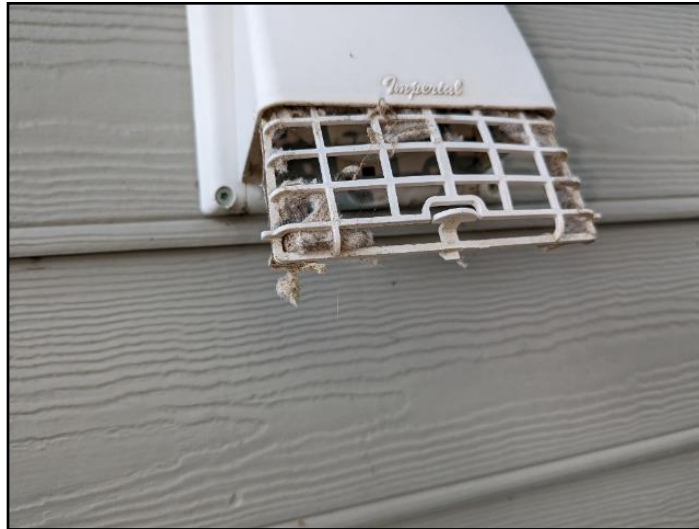
**85.** *Dryer vent obstructed*

**Location:** Rear Left Side Exterior Wall
