Wood Destroying Insect Report

10/14/2020

4131 Durness Way

TEXAS OFFICIAL WOOD DESTROYING INSECT REPORT

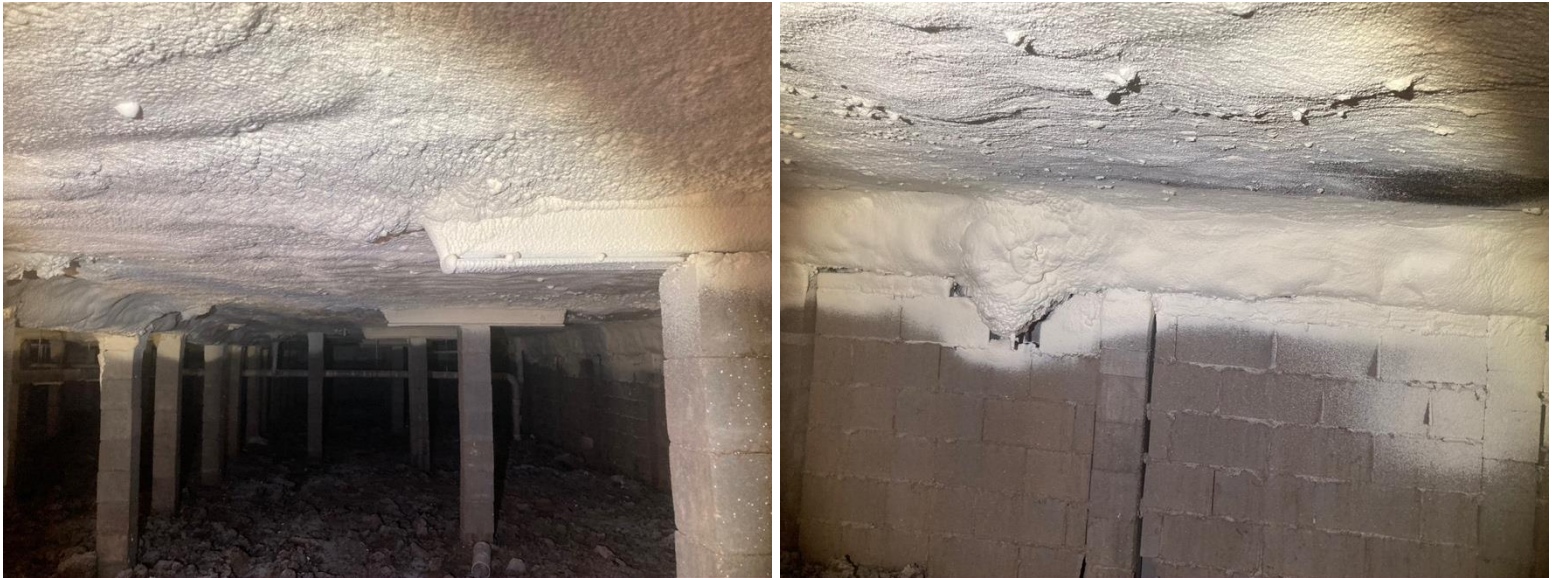
Obstructed view of the Sub floors

Conducive conditions obstruct visibility and limit the inspection for wood destroying insects. It is recommended that all conducive conditions be corrected and the obstructed areas be reinspected once the work is complete.

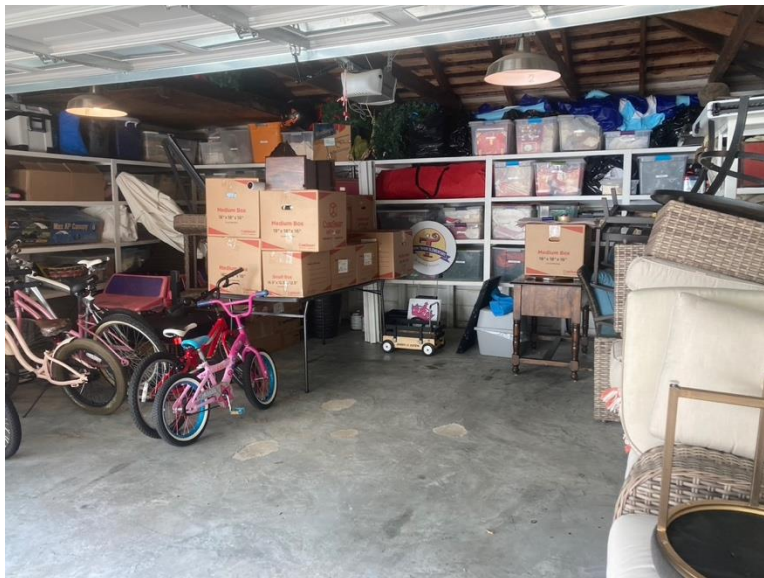
Obstructed view in the garage

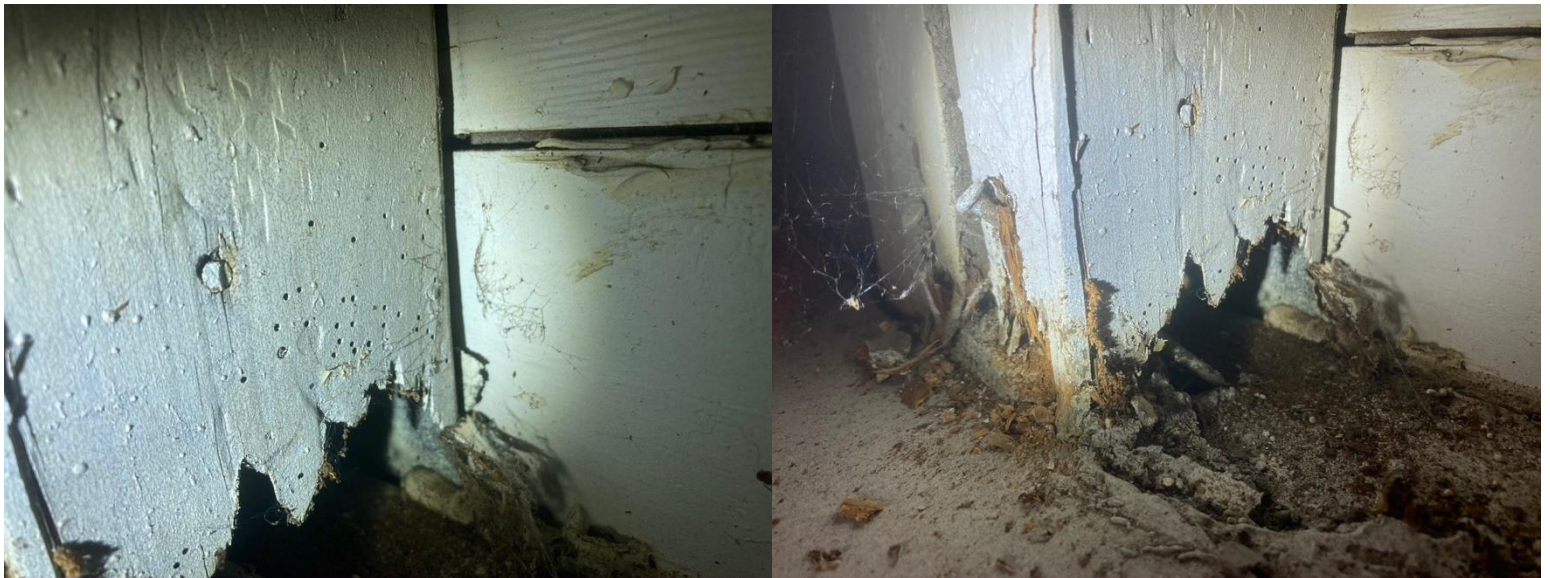
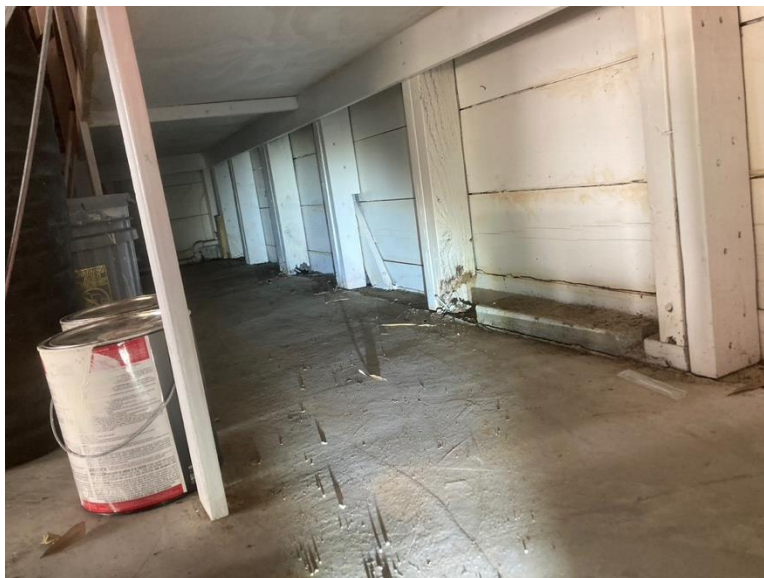
11G. Visible evidence of: **Wood Boring Beetles** has been observed in the following areas: **Garage**

(PB) Wood Boring Beetles - Evidence of previous infestation. Condition appears inactive - No treatment is recommended.

Evidence of Previous Beetle damage observed in the garage.

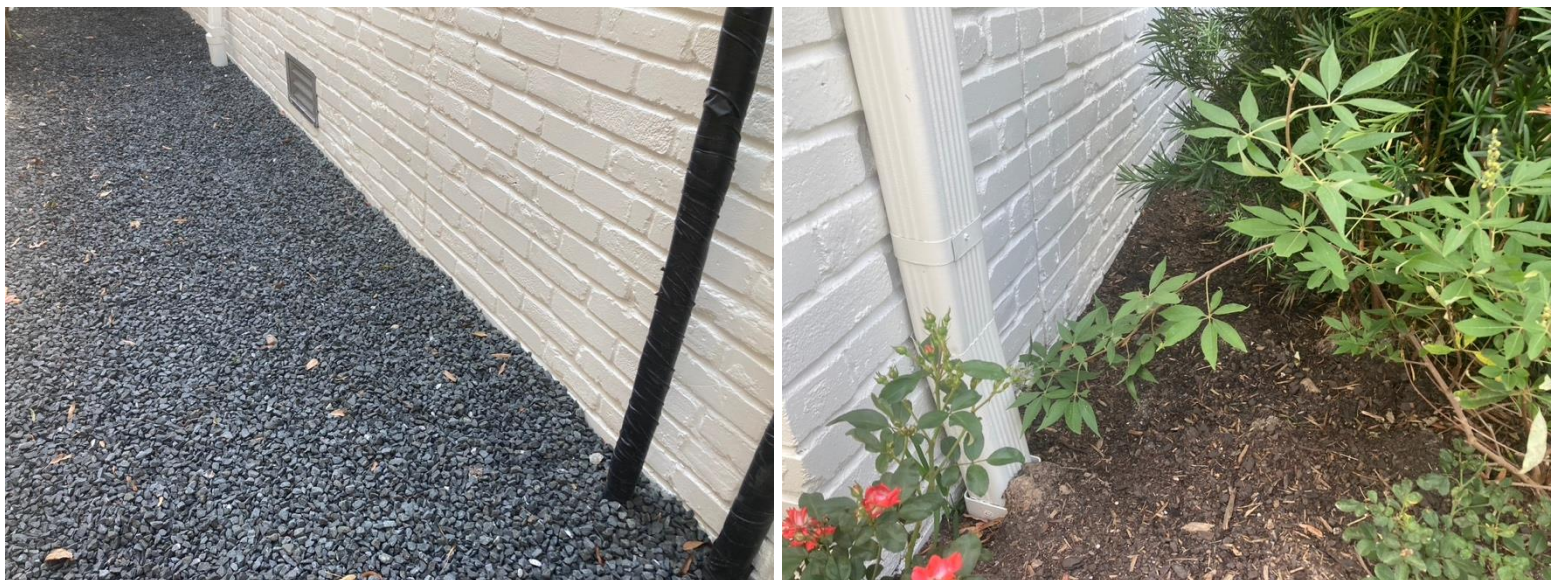
Additional Comments: **(L) High Soil - Soil should be lowered to below the top of the foundation.**

High Soil

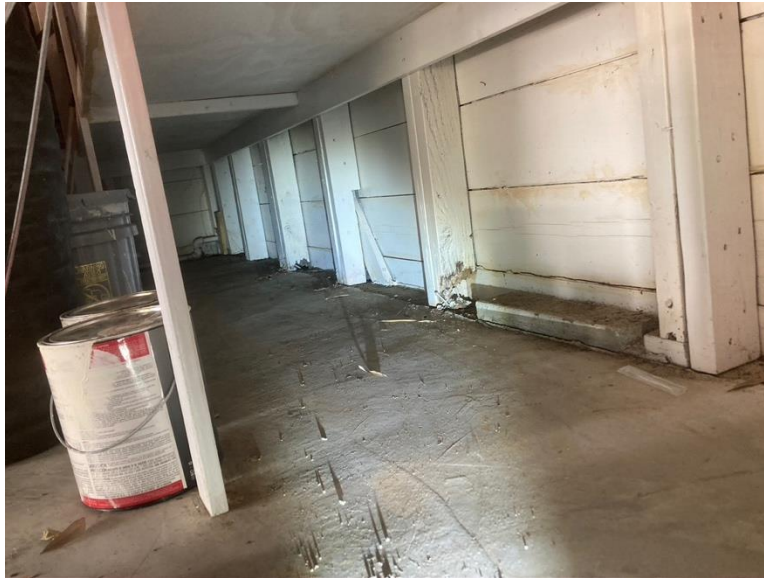
Wood Rot

(M) Wood Rot - All damaged or affected wood materials should be properly repaired or replaced.
