## MECHANICAL INSPECTION

4131 Durness Way  
Houston TX 77025

Monzer Hourani c/o Mandie Peel  
OCTOBER 14, 2020

# PROPERTY INSPECTION REPORT

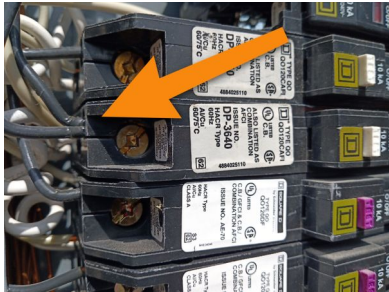
**1: Breaker - Double lugged**

A breaker was observed inside the panel with more than one wire attached. Each wire should be on its own breaker.

**Obtain Cost Estimate**

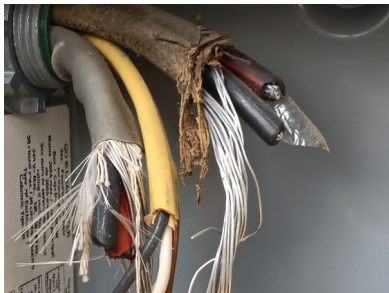
**2: Wires - Terminated improper**

Wires that were improperly terminated were observed in the breaker panel box. The purpose of the wires was not determined. Further investigation is reconected with an electrician.

**Obtain Cost Estimate**

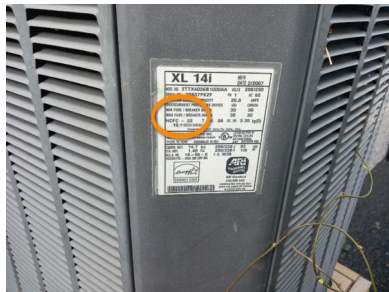
The condensing unit label indicate that the equipment operates with the old R-22 refrigerant, rather than the currently required R410A refrigerant. R-22 is no longer the current standard in the industry and will be more expensive to refill when servicing. It is recommended that a service company be contacted for further investigation.

**Further investigation is recommended**

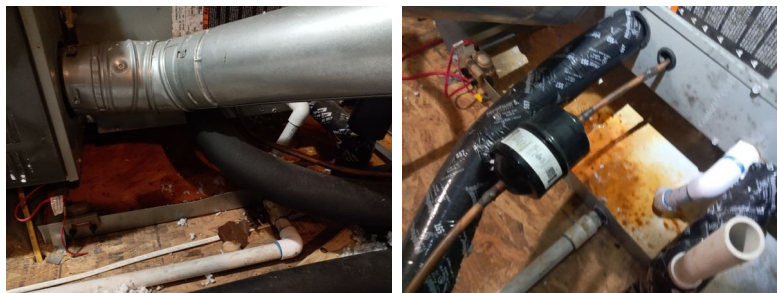
Both coils

**2: Overflow Pan - Rust**

Rust was observed in the overflow pan under the coil, apparently due to water backing up at the primary drain line and overflowing into the pan. No water was observed in the overflow pan at the time of the inspection, however since the equipment was only operated for a short time during the inspection, It is recommended that the primary drain line and the coil be checked by an air conditioning service company.

**Obtain Cost Estimate**

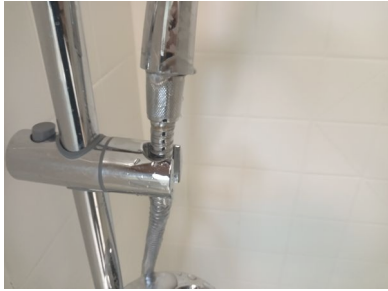
Front bathroom

**1: Shower/Tub - Shower head leak**

The shower head was leaking at the connection and needs to be repaired.

**Obtain Cost Estimate**

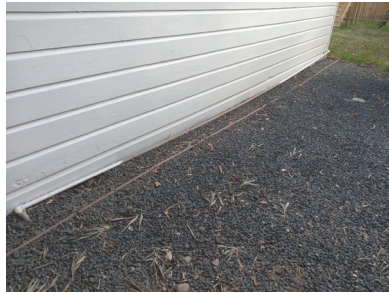
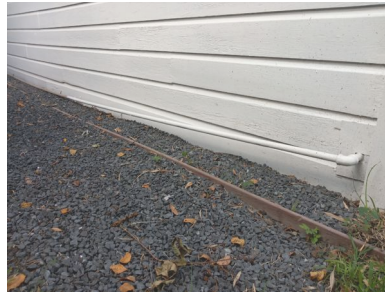
A gas supply line that was not properly supported/secured and needs to be repaired was observed.

**Obtain cost estimate**

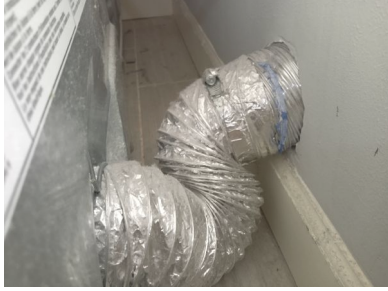
The dryer vent was observed to be a flexible vent material rather than a rigid sheet metal vent pipe. This is considered a fire hazard as lint can back up inside of the flexible vent material at the ribs. It is recommended that the flexible vent material be replaced within approved material.

**Obtain Cost Estimate**
