## STRUCTURAL INSPECTION

4131 Durness Way  
Houston TX 77025

OCTOBER 14, 2020

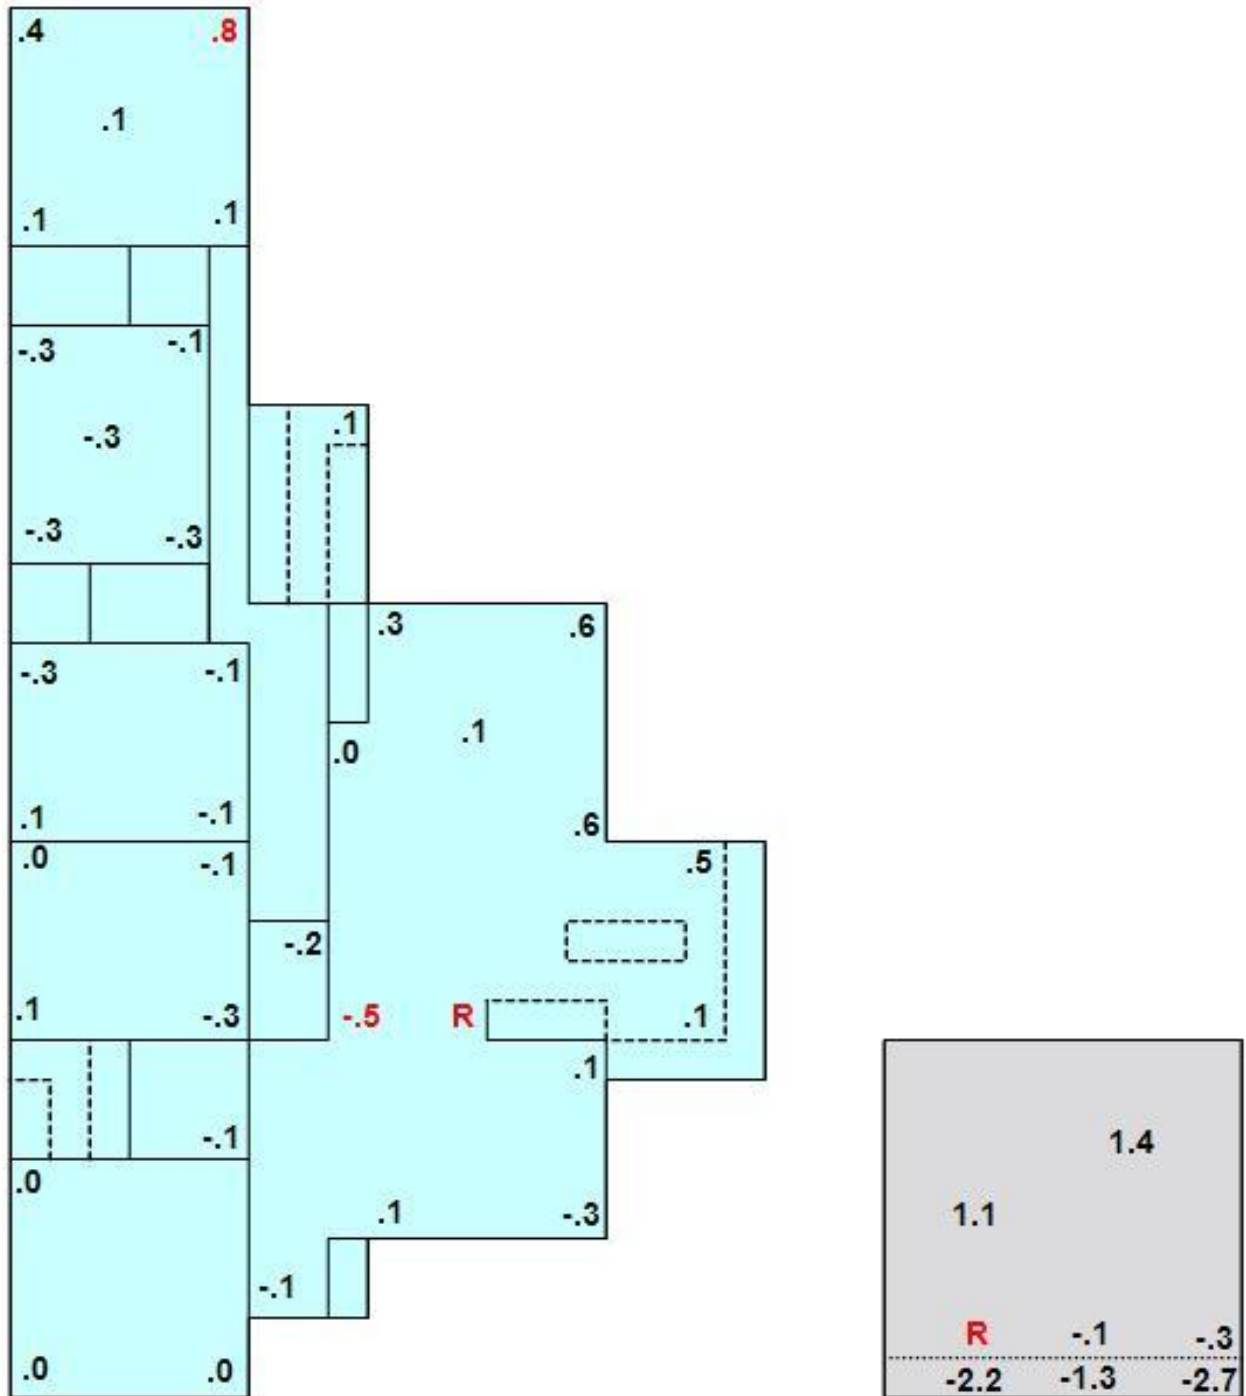
## Elevation Readings 4131 Durness Way

The floors were checked with an electronic level, and were observed to be sloping from the rear of the house towards the front. The difference in elevation between the high point and low point was 1.3 inches. The high point was located at the south bedroom, and the low point was located at the dining room. The unlevelness takes place over a horizontal distance of approximately 50 feet.

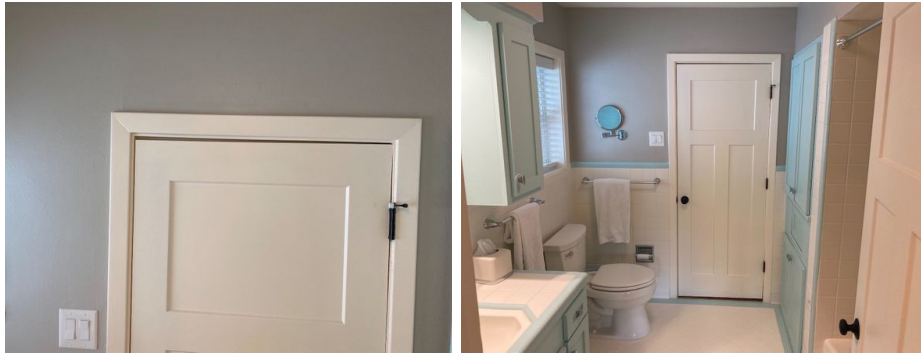
Master Bath

Door frames that were out of square, leaving a triangular separation between the door and the door frame at the top of the door were observed where a separation was visible at the top of the door.

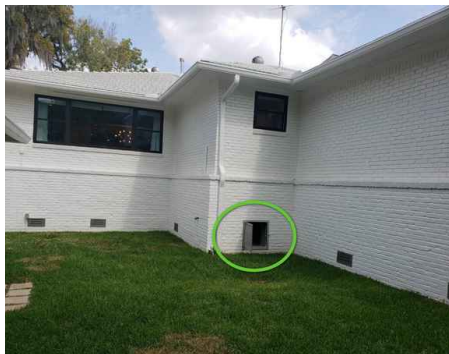
The access to the crawlspace under the house was located as described above, and we entered the crawlspace during the inspection. It is pointed out that the inspector only crawls to those areas under the house that can be safely accessed without having to crawl through water or other hazardous conditions.

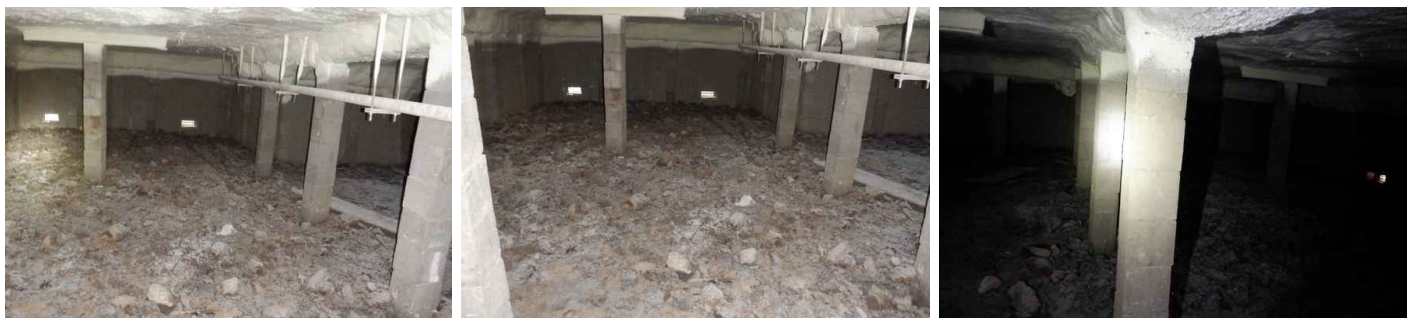
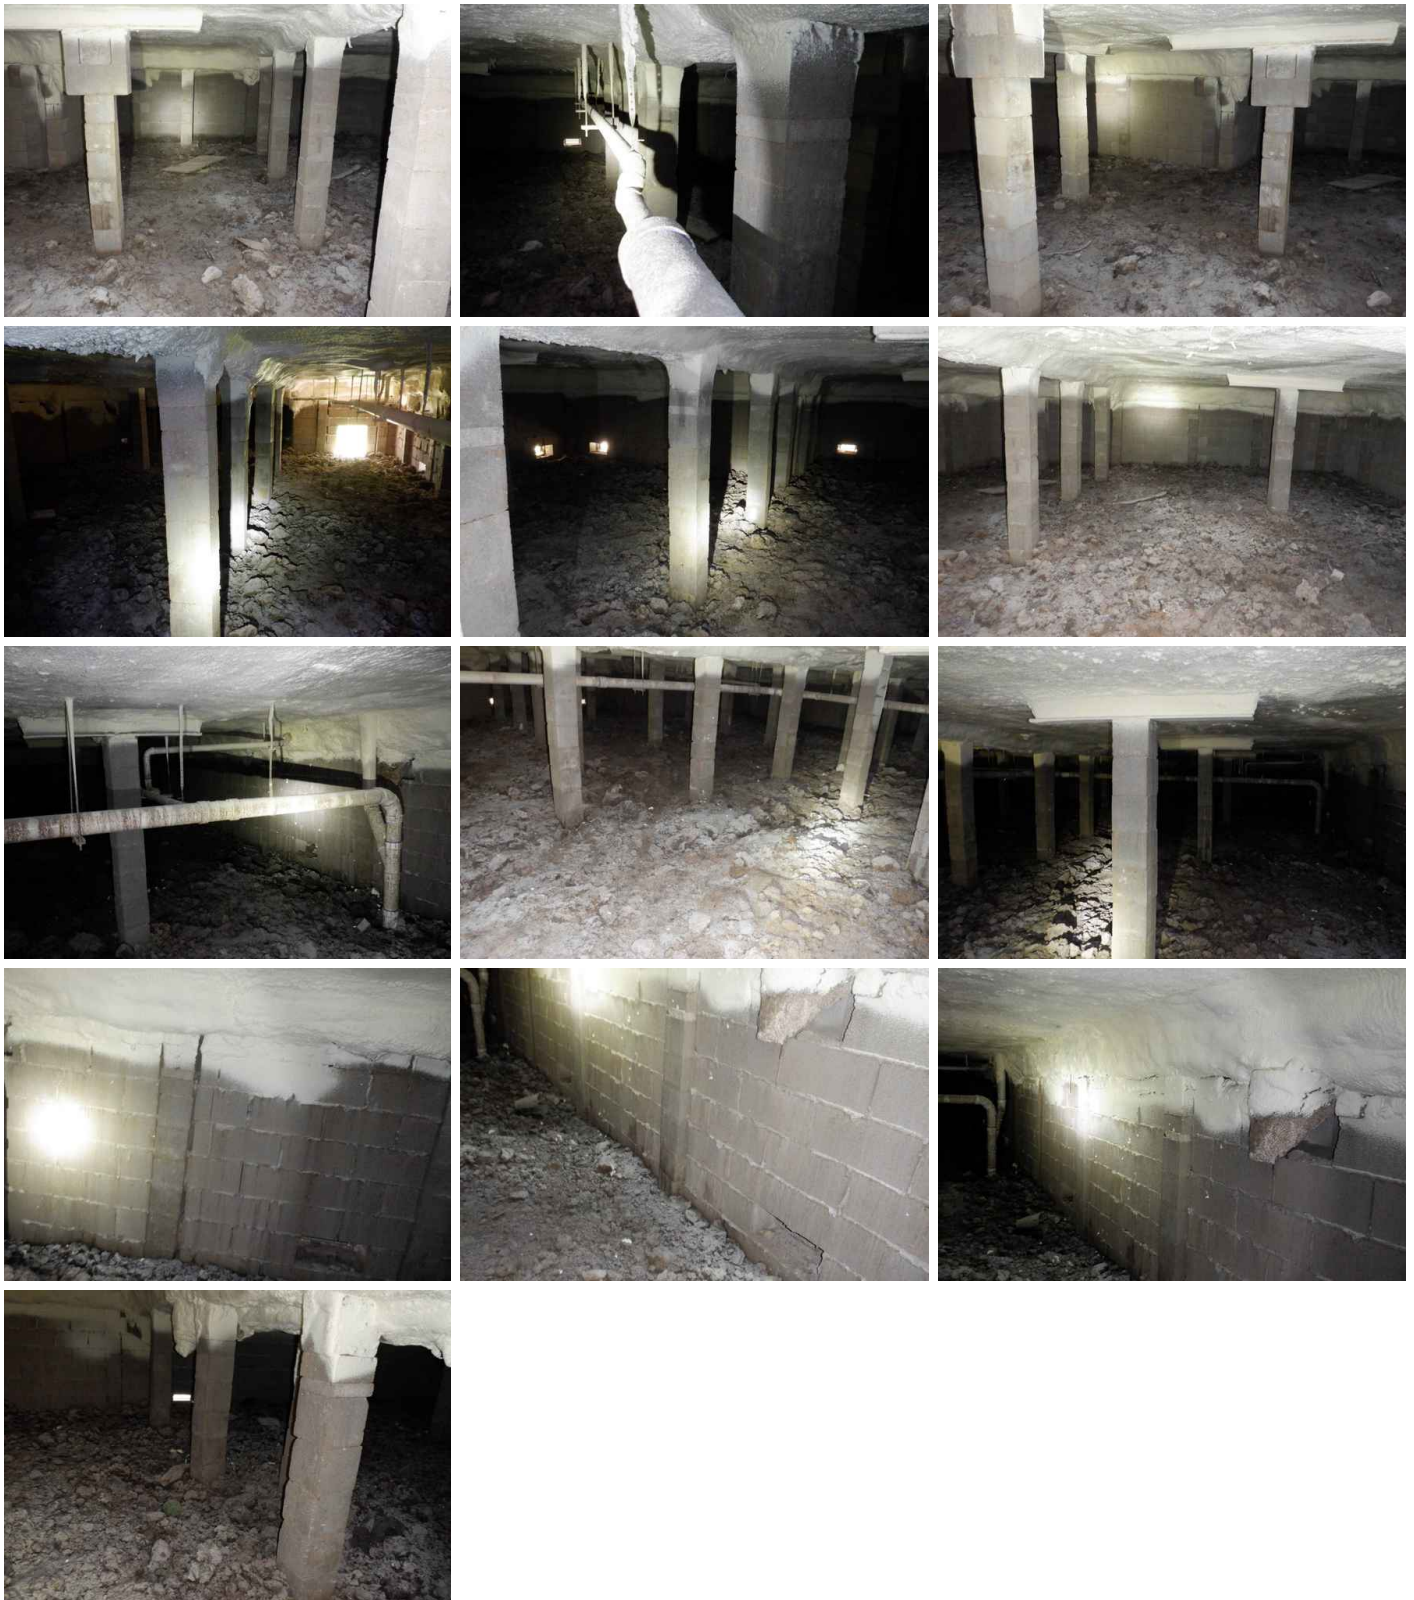
We observed concrete block piers under the house at the crawlspace were in generally good condition, with no repairs needed at the time of the inspection.

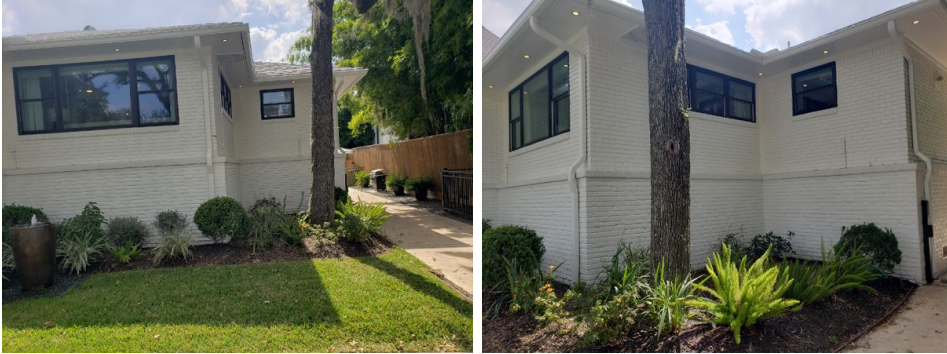
**TREES - RECOMMEND ROOT BARRIER**

Trees and/or foliage were observed in the vicinity of the house, which can contribute significantly to differential movement of the house foundation. Care should be taken to prevent the trees and foliage from removing an excessive amount of water from near the foundation of the house. Consideration should also be given to cutting the tree roots that extend under the foundation, and installing a root barrier to prevent any further moisture from being removed from under the interior of the house.

Contact a qualified professional.

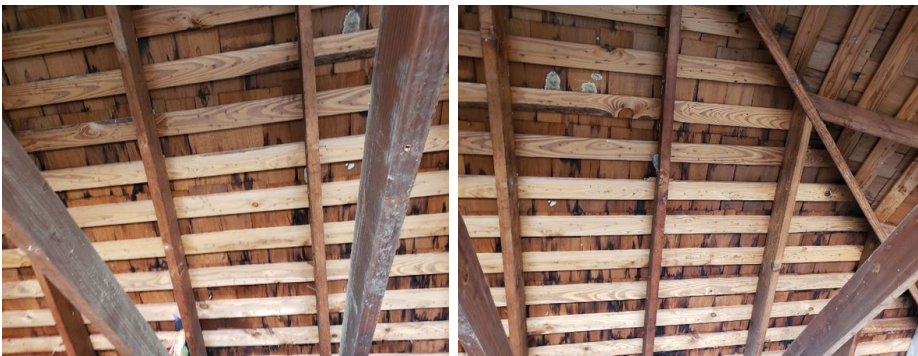
The composition shingles were observed to have been installed over a previous roof, and the old shingles have been used as the deck to secure the composition shingles. Although it is not a structural defect to have an overlay, it is pointed out for your information that having an overlay may affect your homeowners insurance and it is recommended that you check with your insurance company about this condition.

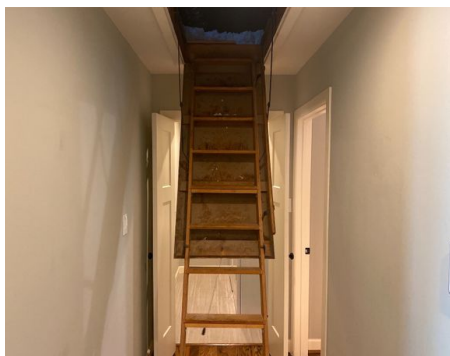
The access ladder into the attic appeared to be the original installation ladder, and the ladder was not labeled to indicate the rated capacity of the ladder. The ladder does not meet current code requirements for ladders into attics. Consideration should be given to replacing the ladder with a ladder that meets current code requirements.

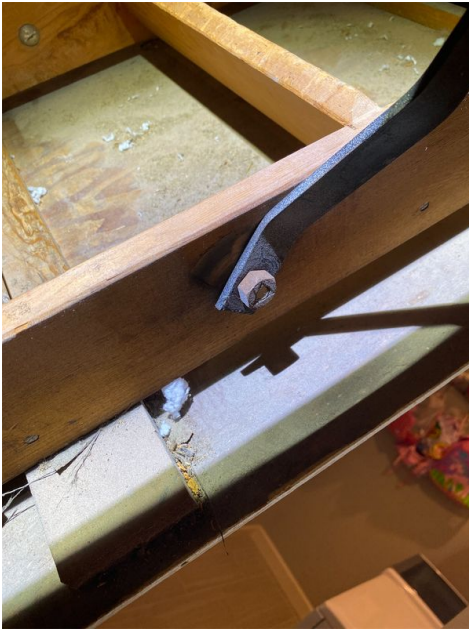
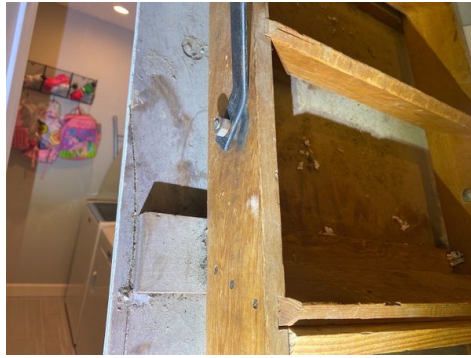
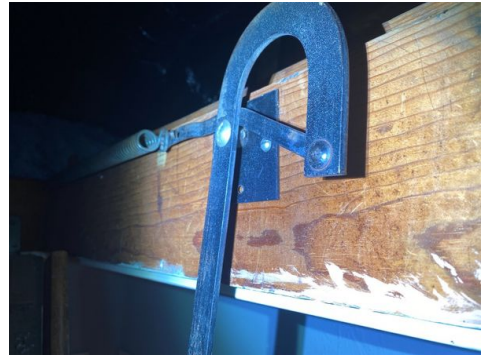
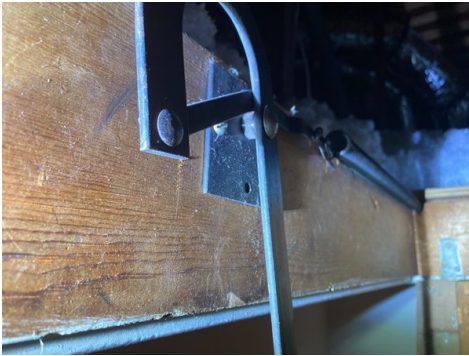
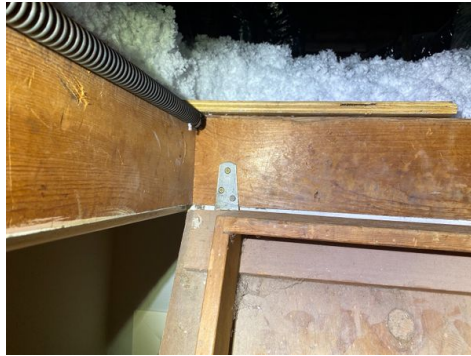
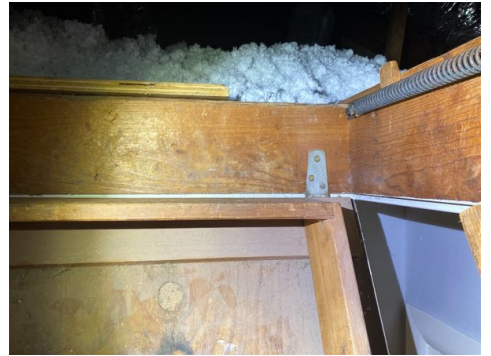
**LADDER ATTACHMENT IMPROPER**

Nails missing in spring arm pivot, Nails missing in corner brackets, Less than sixteen 16d nails or 1/4 X 3" lag screws, Assembly is secured with screws instead of sixteen 16d nails

The stair assembly was not properly installed or secured to the framing members, and repair is needed for safety purposes. The condition(s) can be a safety hazard, and repair is needed, as an improperly installed stair assembly can possibly collapse.

Contact a qualified professional.

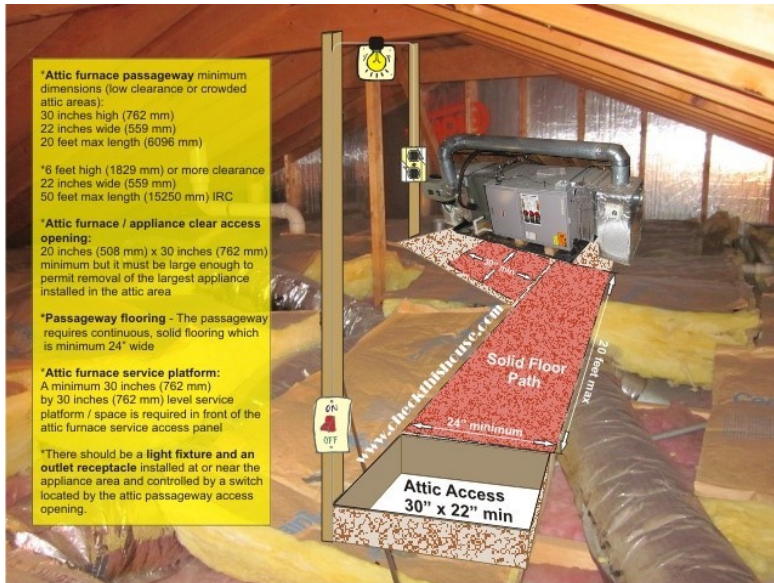
## 8.2.1 Service decking/platform decking

**INADEQUATE WALKWAY DECKING**

Contact a qualified professional.

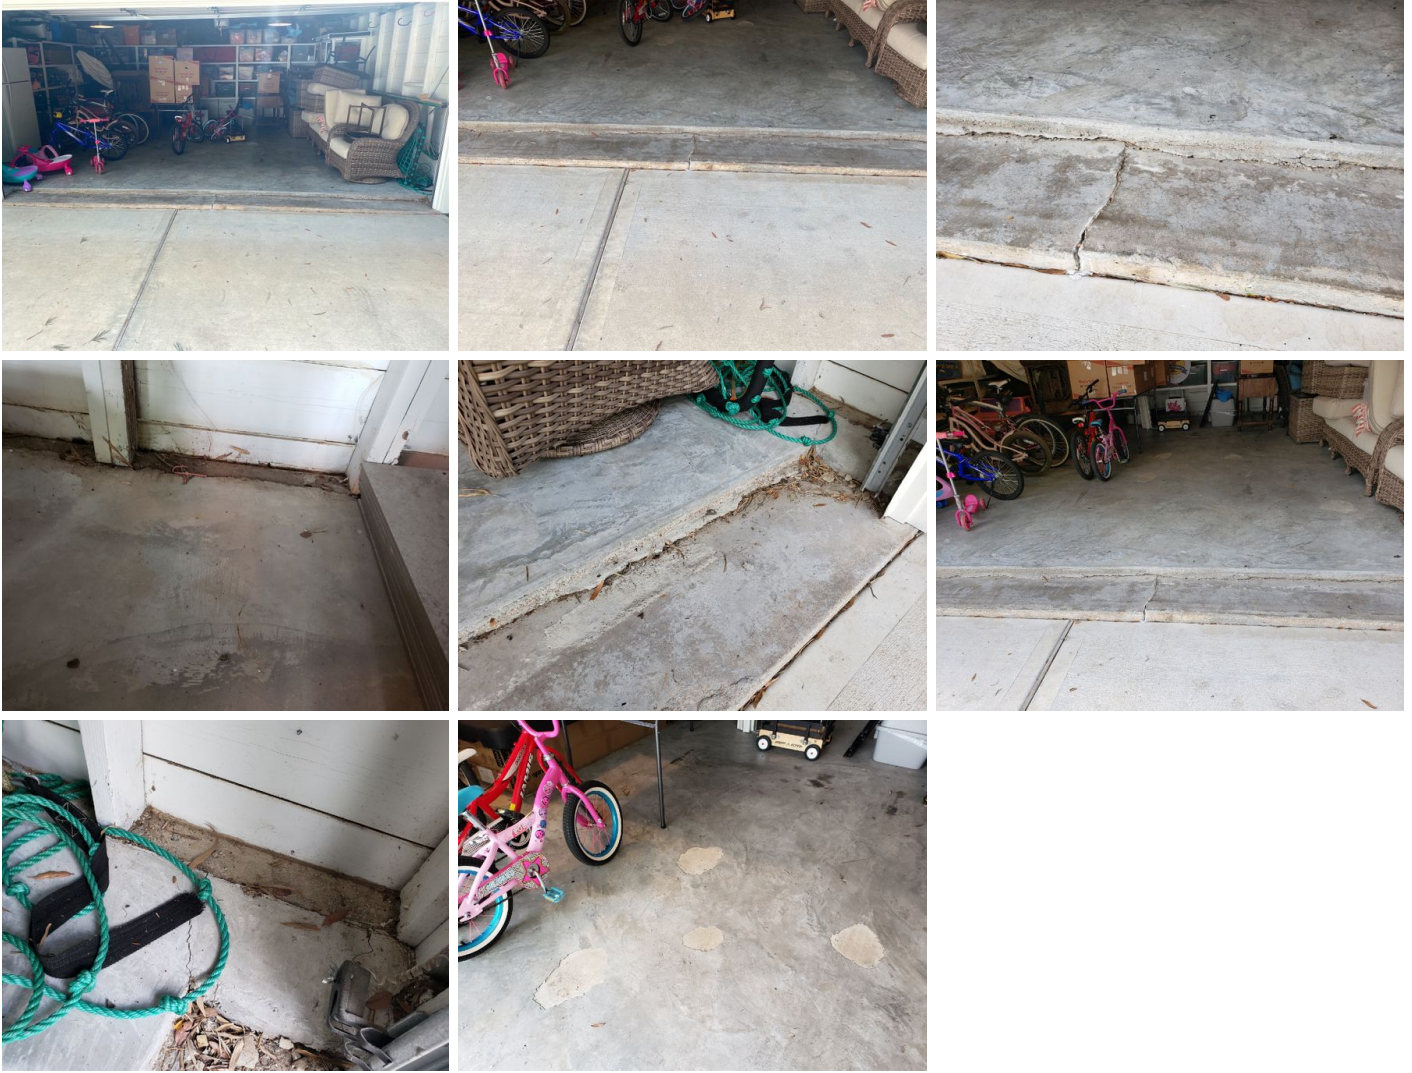
The concrete floor of the garage was observed to have several cracks, but was still functional at the time of the inspection. However, the portion of the cracks that were visible were observed to be approximately 1/16-1/8 inch wide. The exterior perimeter of the garage has experienced some settlement, but the degree is not such at this time to recommended foundation releveling. The garage foundation should be monitored in the future for additional

movement as it can be expected that additional movement can take place. Also, the original foundation has been capped with approximately 2 inches of concrete, and the new surface was in generally good condition.

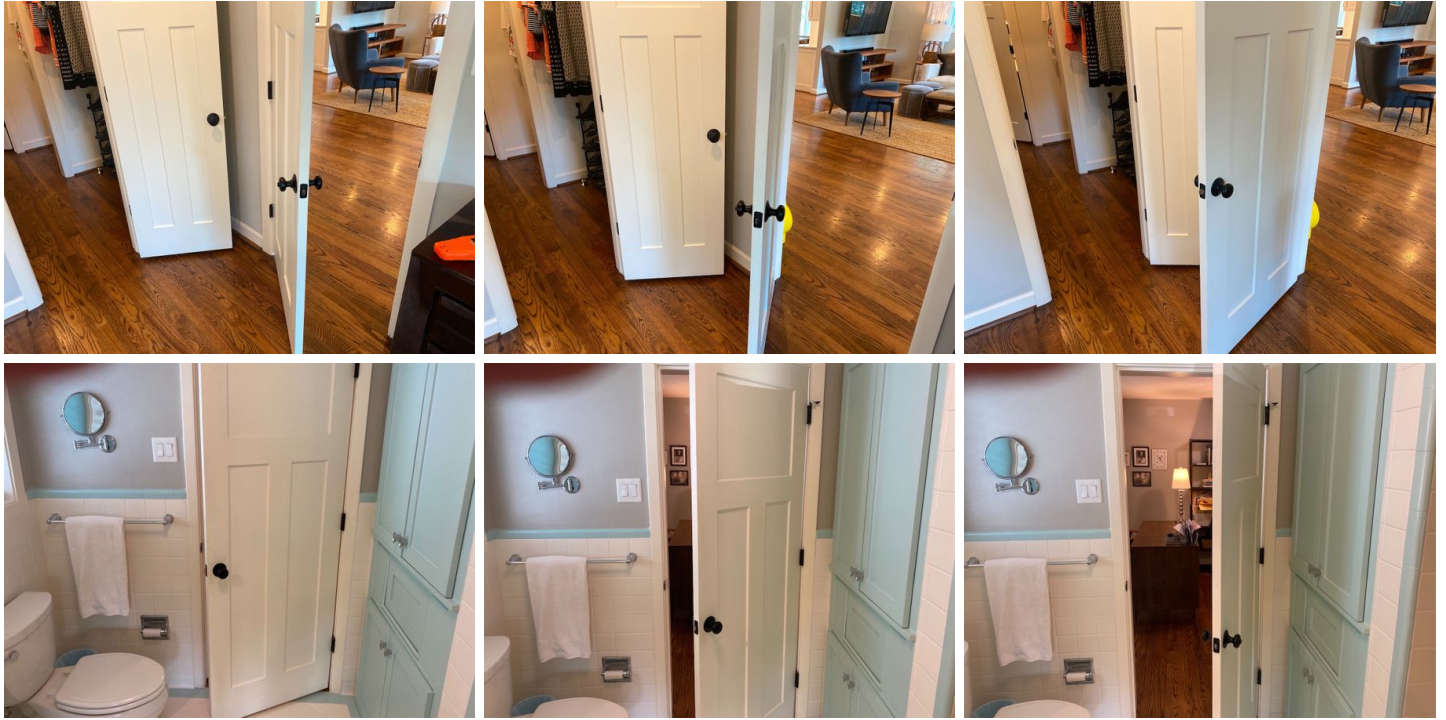
We observed a "ghost" door that opens/closes by itself, and the door needs to be adjusted. Contact a service company to make the needed repairs.

Contact a qualified professional.

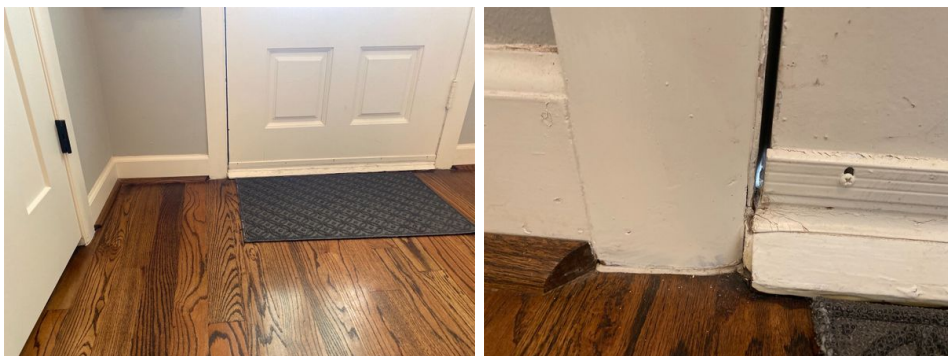
11.1.2 Doors

**DAYLIGHT VISIBLE AT EXTERIOR DOOR**

We observed daylight at the bottom of the exterior door when in the closed position, and the condition needs to be repaired.

Contact a qualified professional.

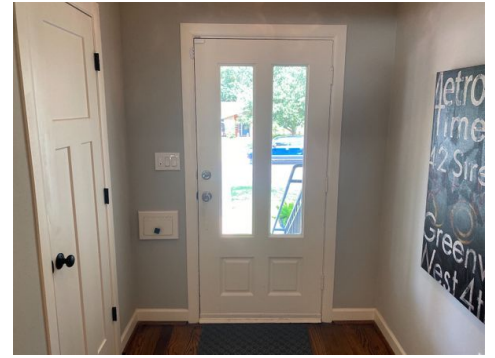
## 11.2.1 Windows

**WINDOW NEAR EXTERIOR DOOR NOT MARKED AS SAFETY GLASS**

The window(s) at the sides of the exterior door did not bear any markings to indicate that they were safety glass. Since the panels are within two feet of the door, they should be safety glass. It is recommended that you check with the owners to see if they can provide documentation or if the builder can provide documentation to show that the panes are safety glass.

Contact a qualified professional.
