**Foundation Inspection Report  
for  
718 Sue Barnett Drive  
Houston, Texas 77018**

**February 8, 2019**

**Charles J. Jenkins, P.E.**

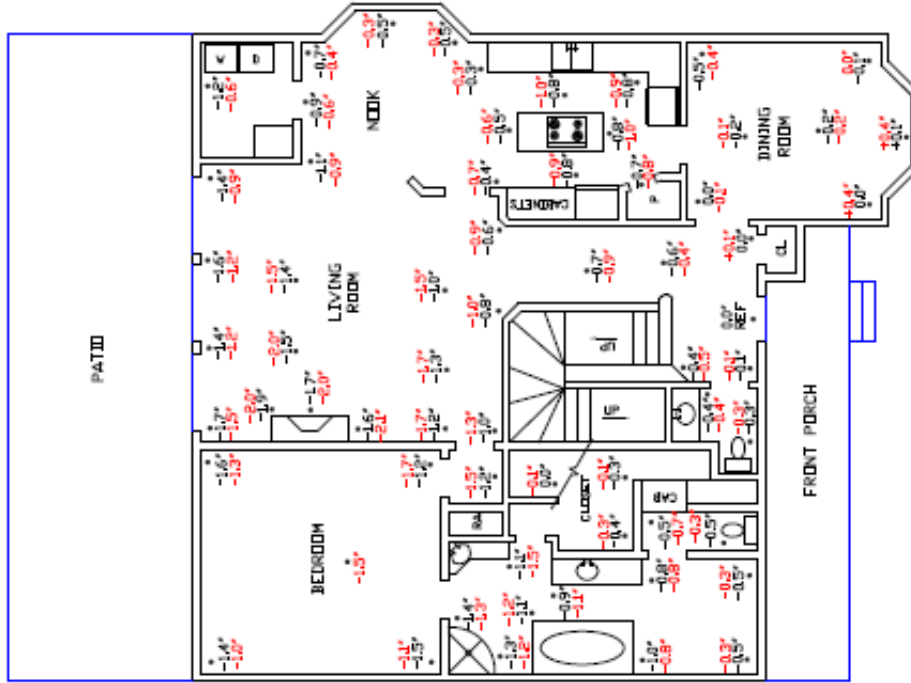
ELEVATION SURVEY  
 <COMPARISON 2016 V 2019>

A topographical (elevation) survey was performed on the ground floor level to determine the extent of floor deflection. In this survey, spot elevations were measured using an electronic manometer (“Compulevel” or “Zip Level”) that operates in the same manner as a “water level”. Elevations were measured in relation to a zero reference that was set at the middle of the front entry door. Elevations were then adjusted for changes in floor covering so that all elevations were relative to a common floor level. Measured elevations on the ground floor of this house were found to range from +0.4” to -2.1”. A drawing showing the results of this survey, as well as the survey taken in 2016, is provided as an attachment to this report.

A review of the topographical surveys taken in 2016 and 2019 found noticeable, but for the most part, relatively minor changes in floor deflection. The area shown in blue is that with the most negative change in elevation (settlement), which correlates well with evidence of such movement. That said, the areas shown in magenta shows apparent positive changes, uplift. Of course, if the reference point moved, it would affect the size and nature of all changes measured. How it moved, however, whether up or down, would be an educated “guess” based on the overall magnitude and orientation of damage found. That said, in this case, evidence supports the conclusion that the reference point has been reasonably stable, supporting the conclusion that changes are essentially as observed.

That said, the dining room shows very minor elevation changes that are contrary to the nature of the damage observed. This means that the nature and/or placement of damage observed in the dining room is opposite that which would be expected from the elevation changes measured. This suggests that the damage was caused by movement that occurred during the flood, but that this movement was ameliorated when the soil dried after the storm.

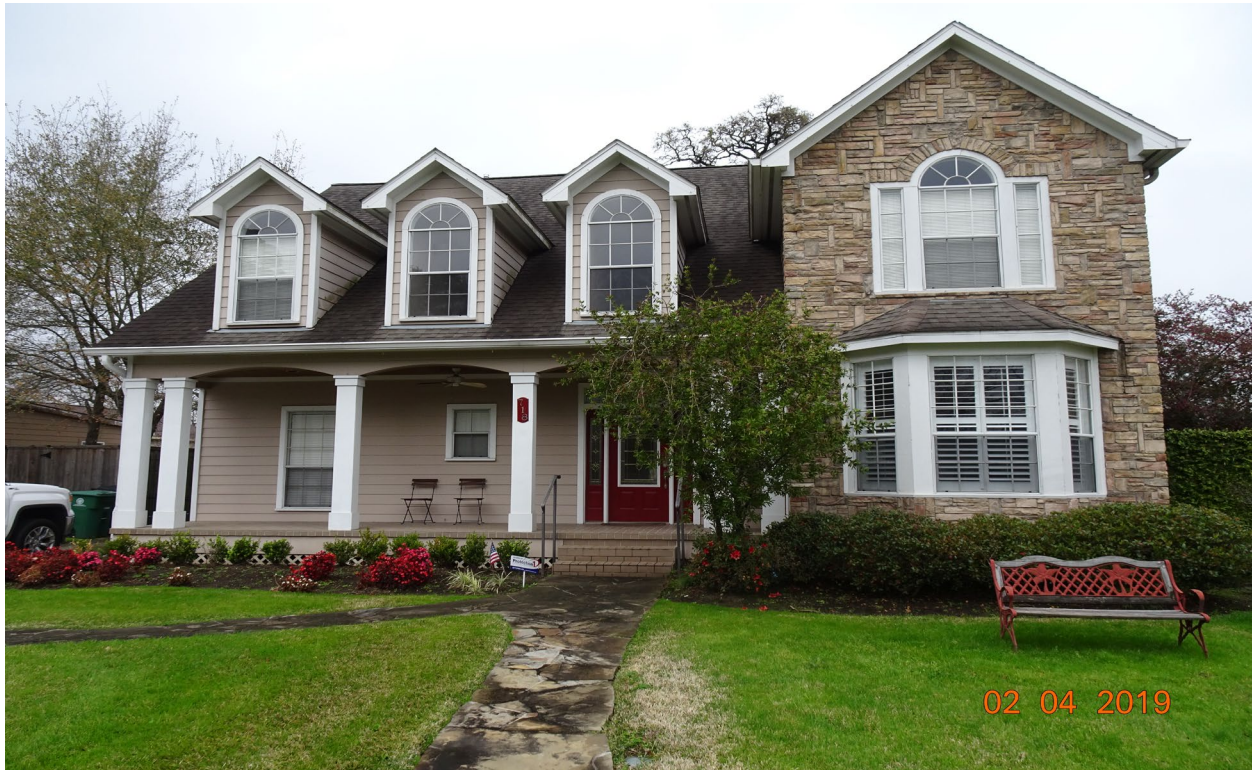
Photo # 1 Front of house

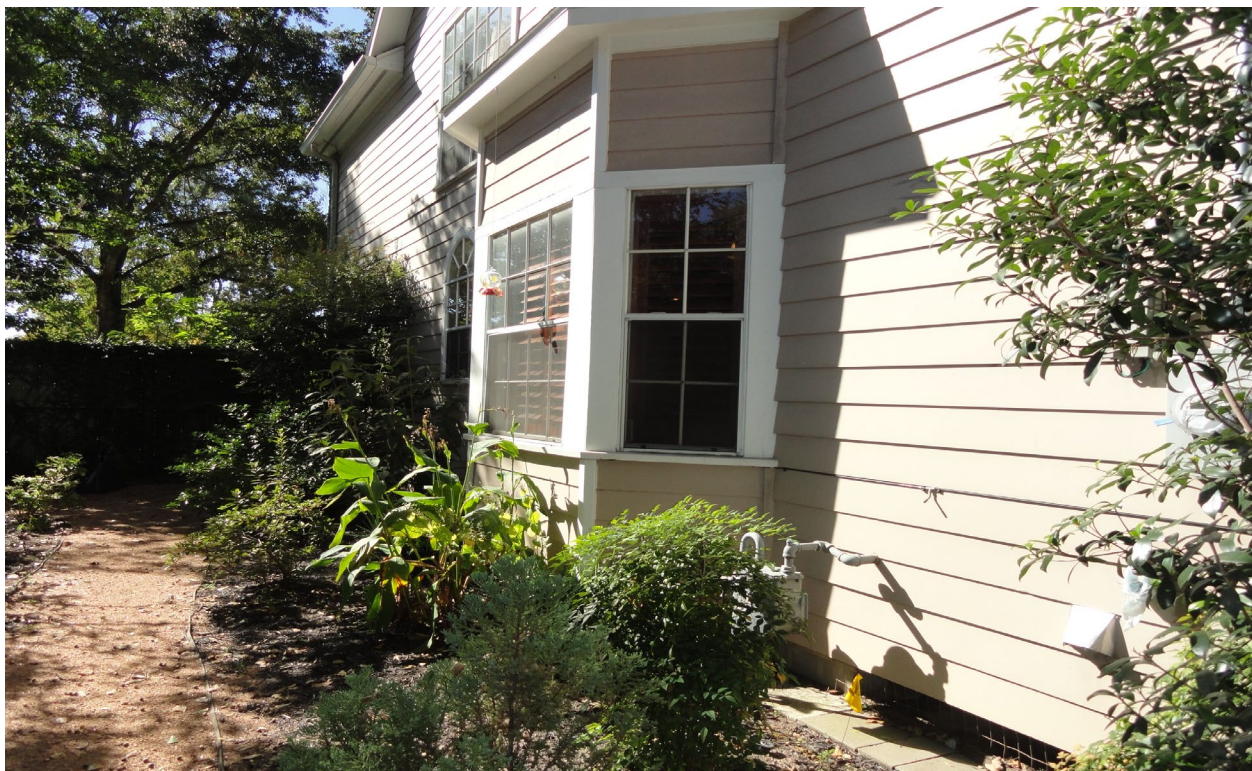
Photo # 2 Right side from rear

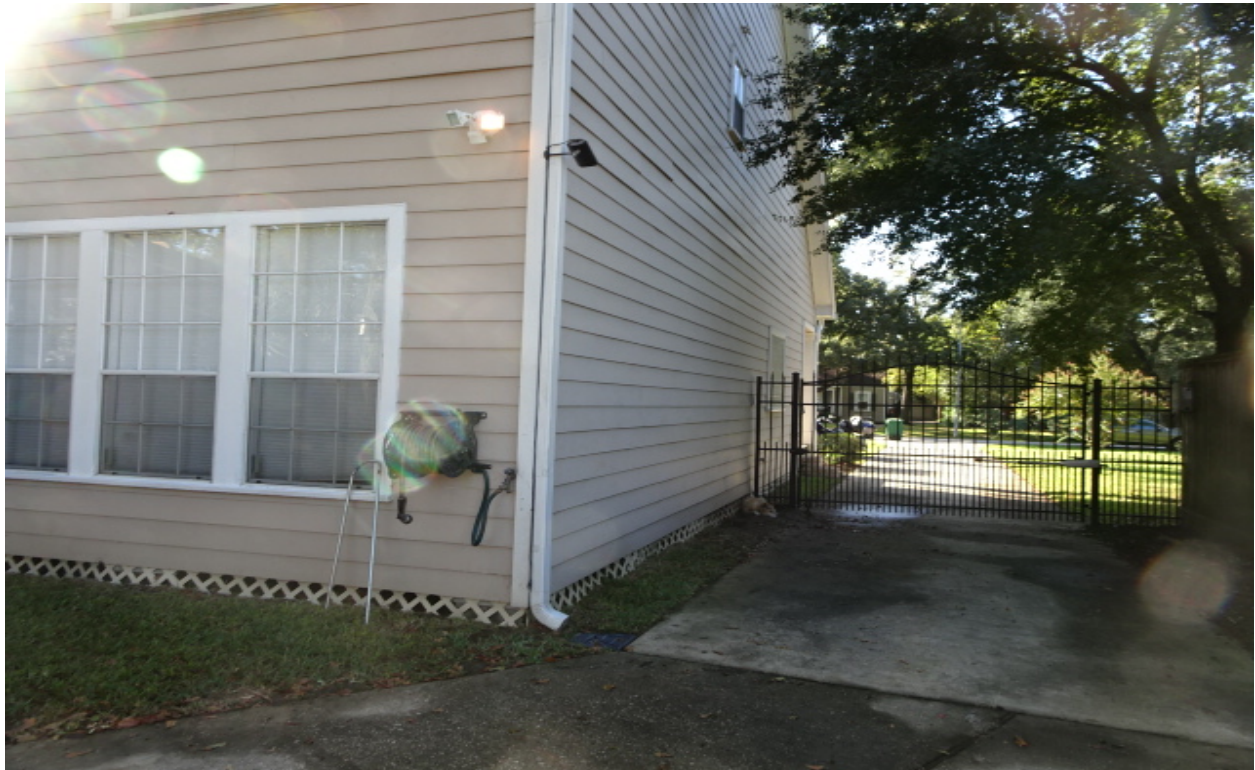
Photo # 3 Left side of house from rear

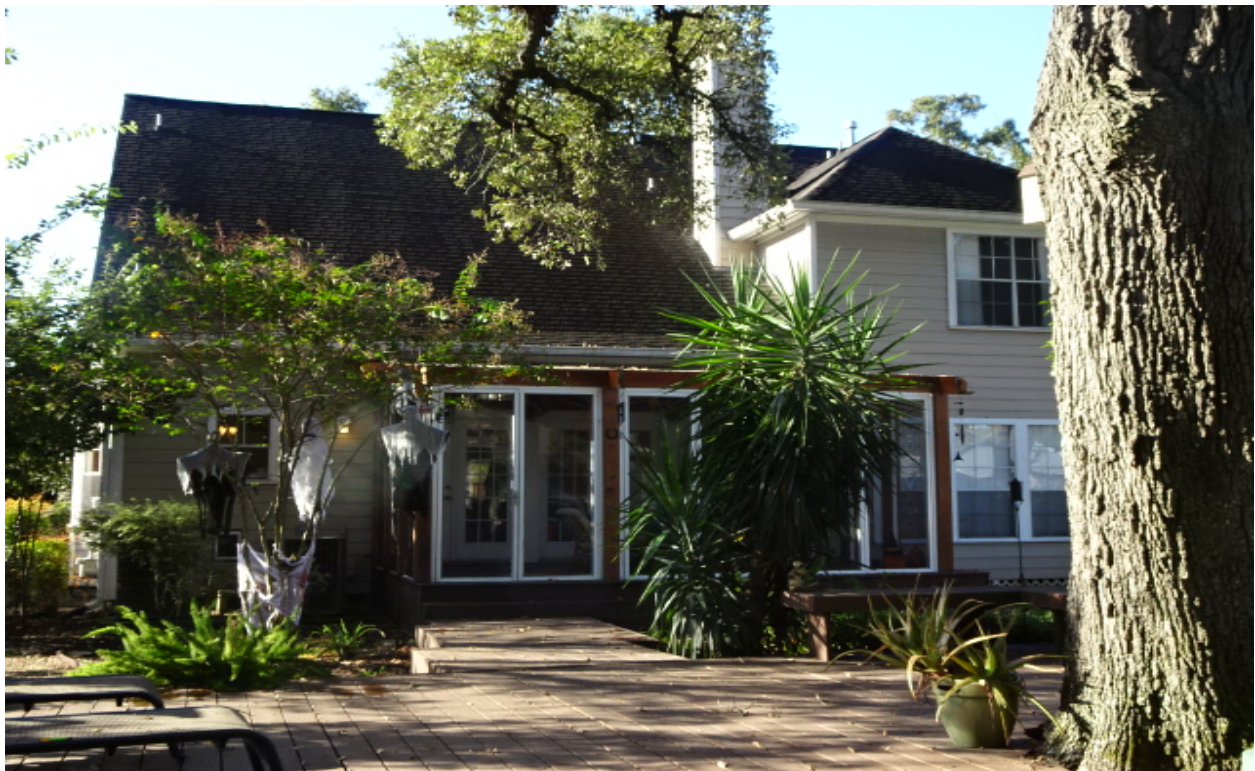
Photo # 4 Rear of house

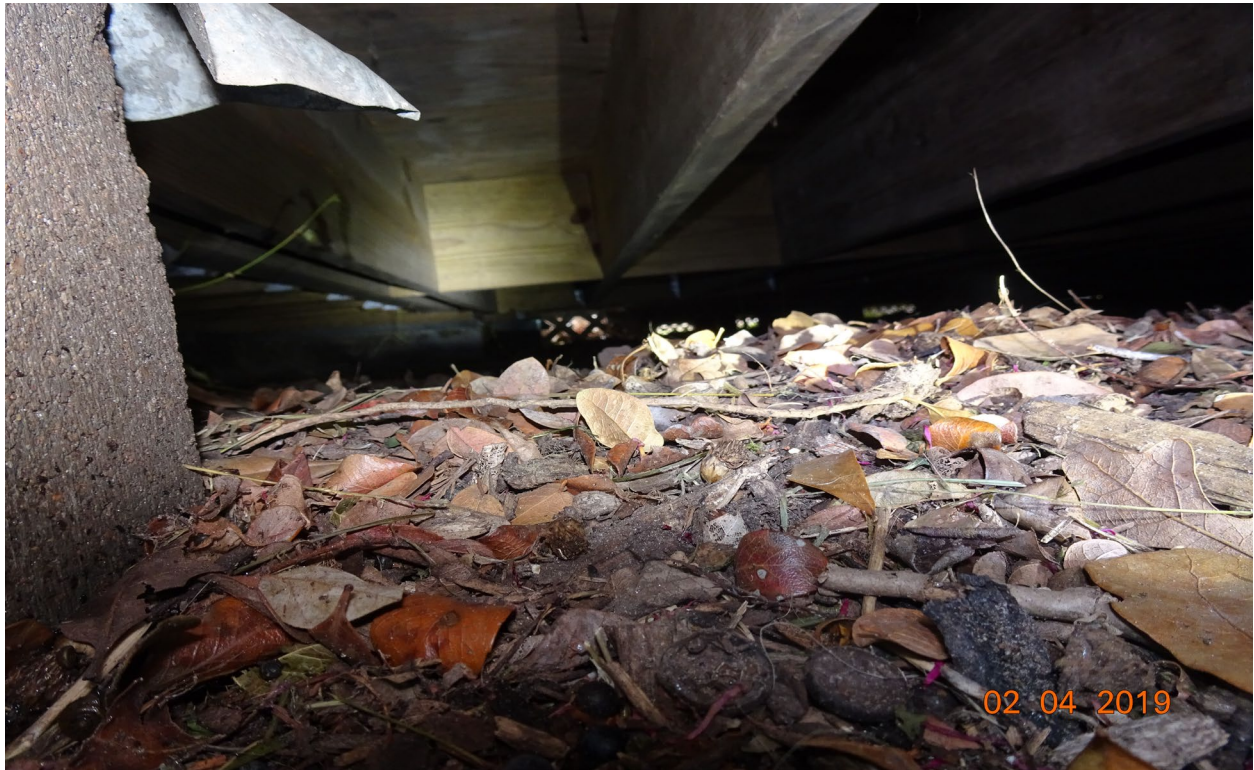
Photo # 5 Crawl space

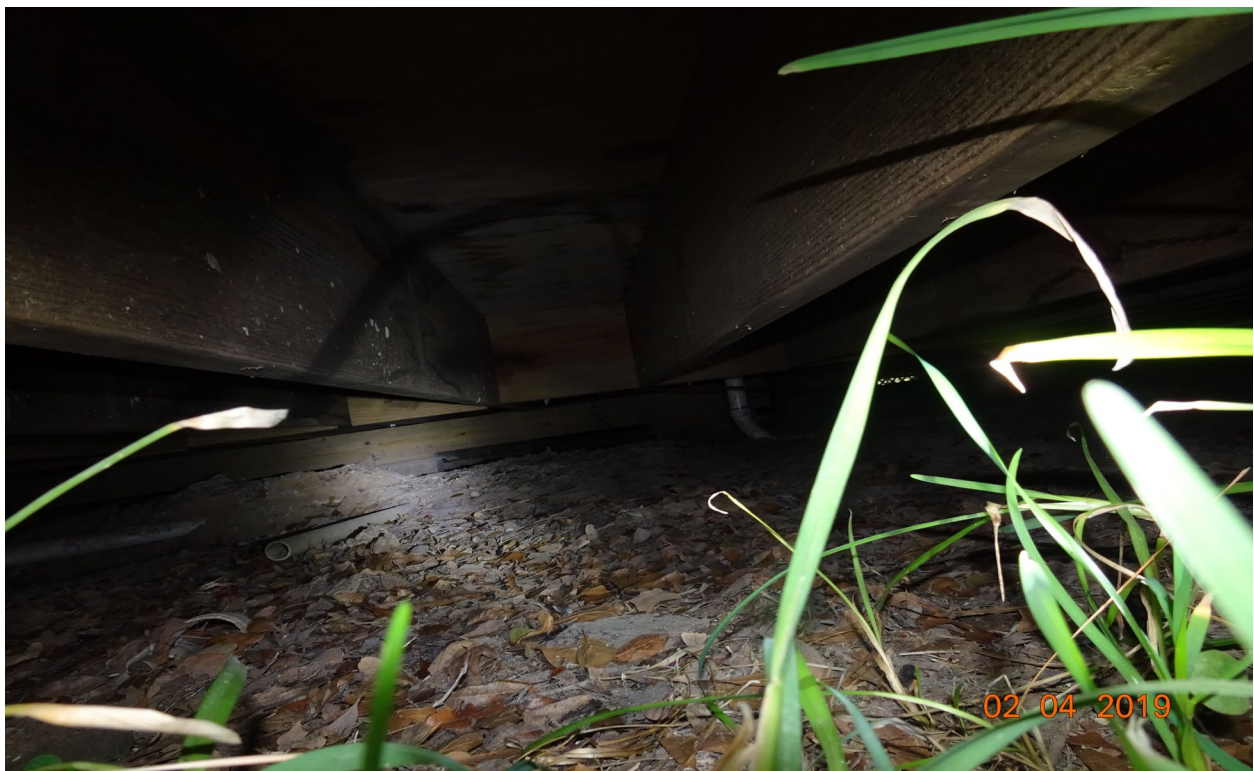
Photo # 6 Crawl space – minimal clearance under beam

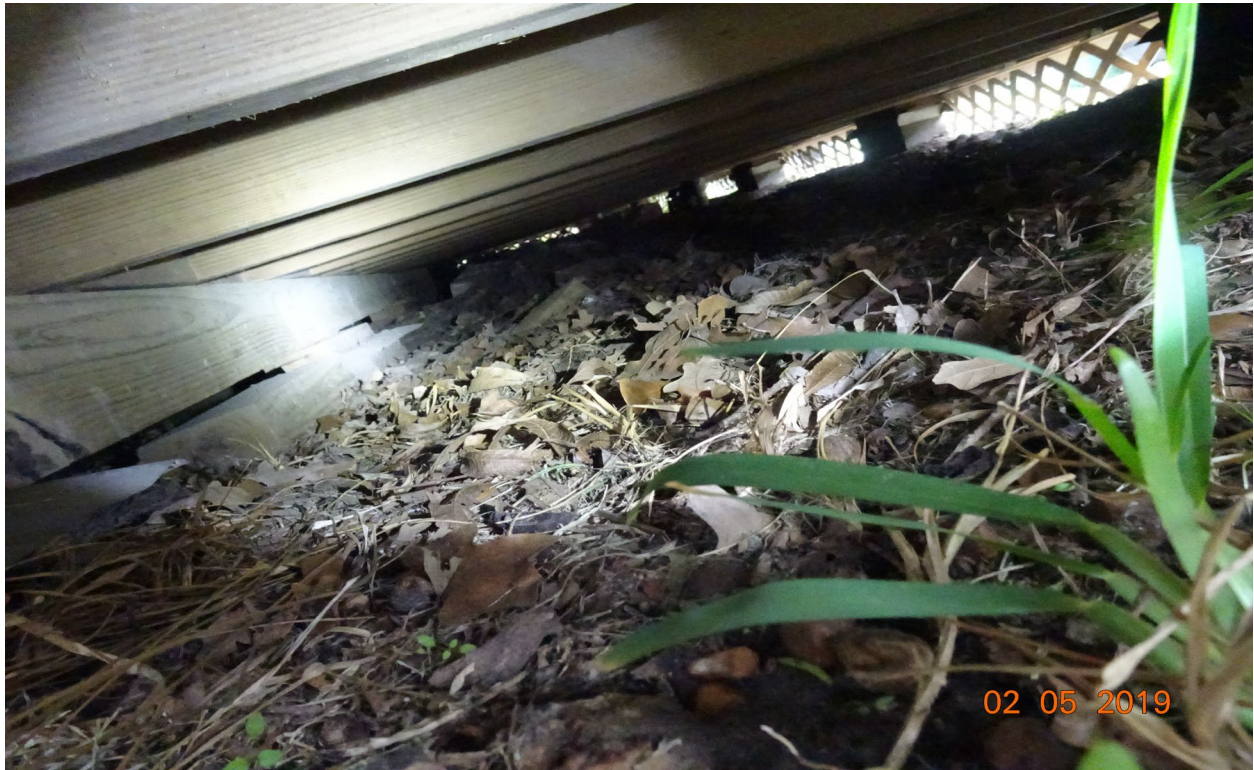
Photo # 7 Crawl space from left rear

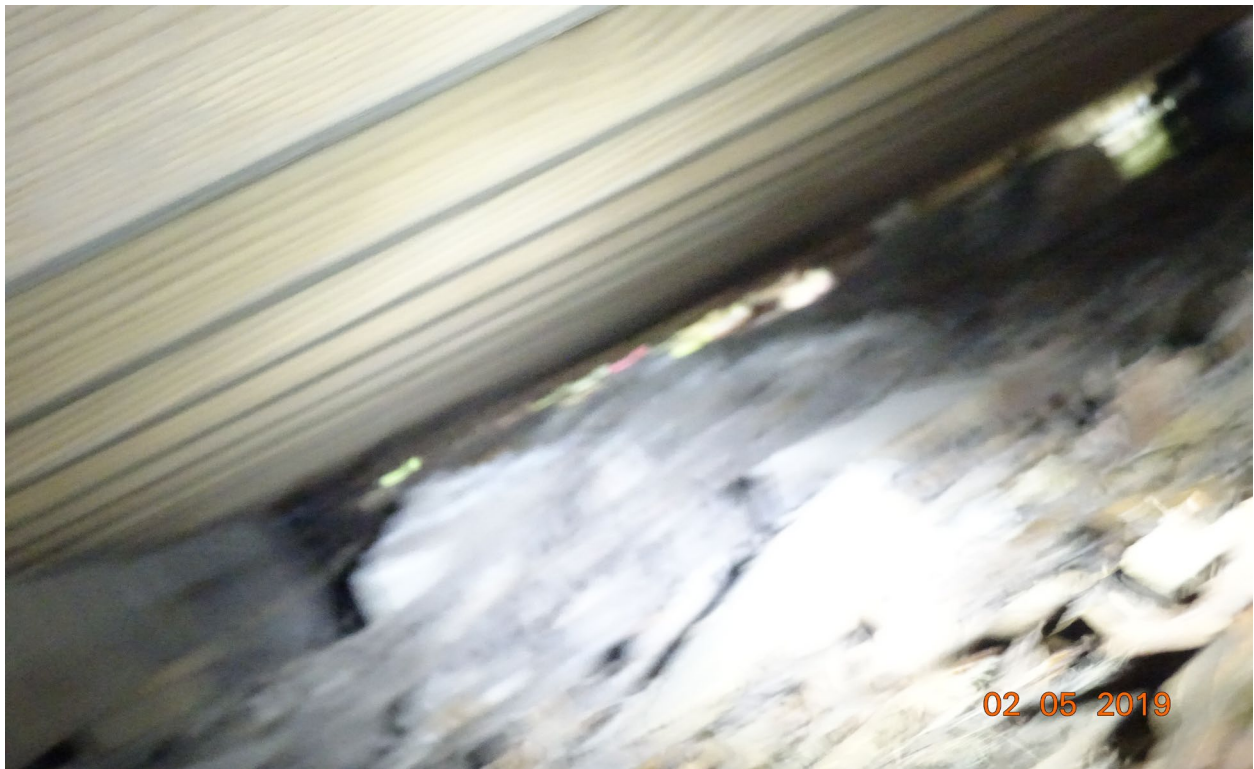
Photo # 8 Crawl space from rear

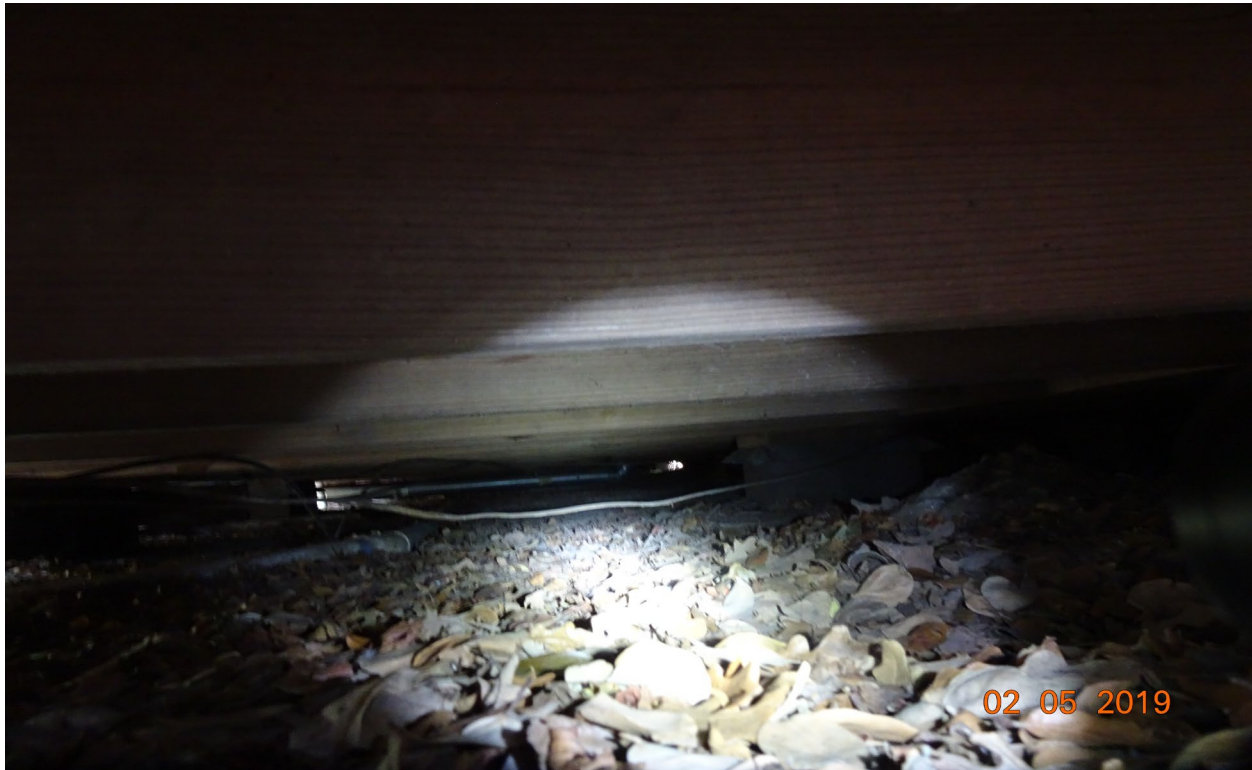
Photo # 9 Crawl space from right rear

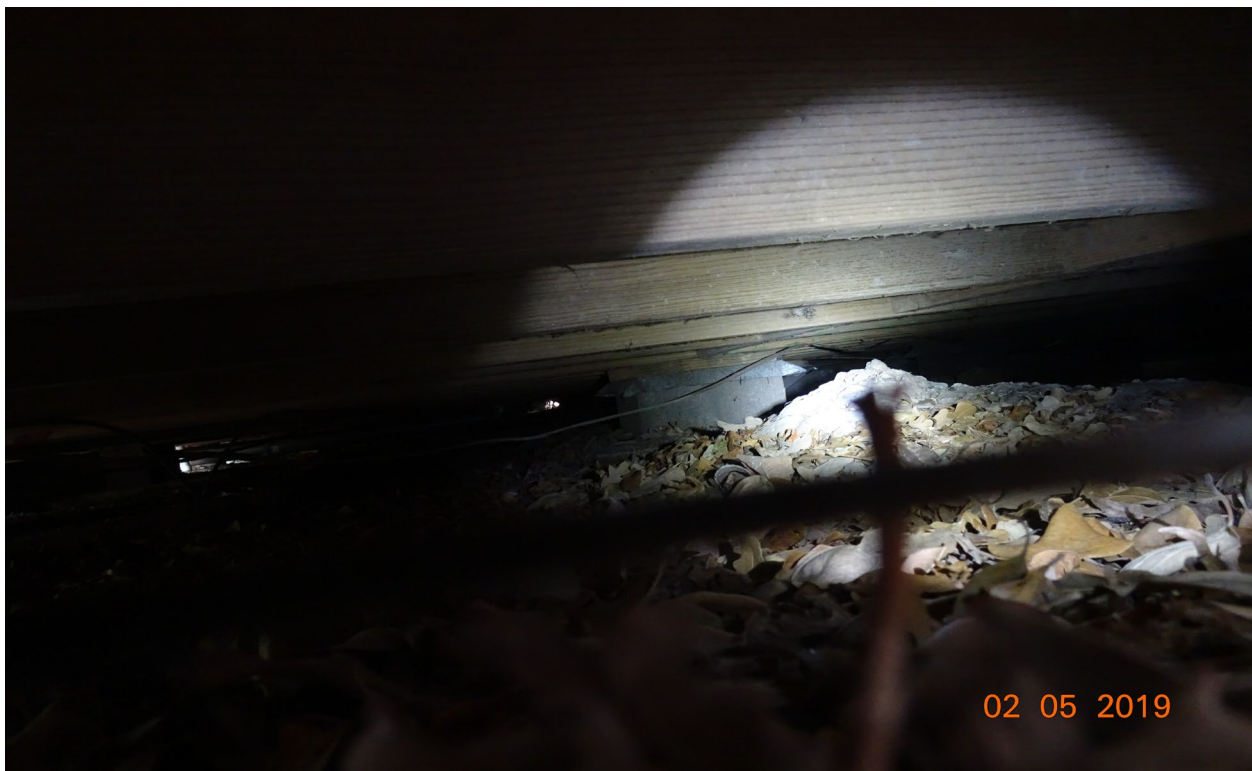
Photo # 10 Crawl space from right rear

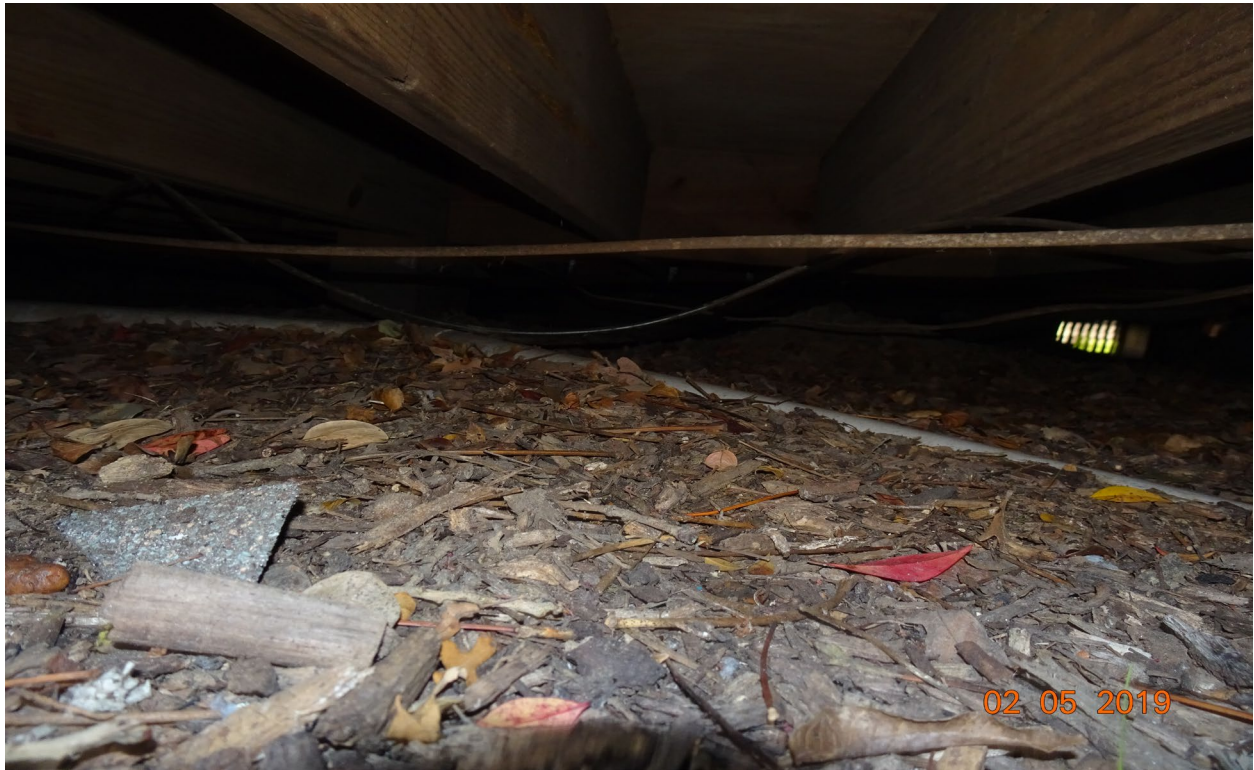
Photo # 11 Crawl space from right side

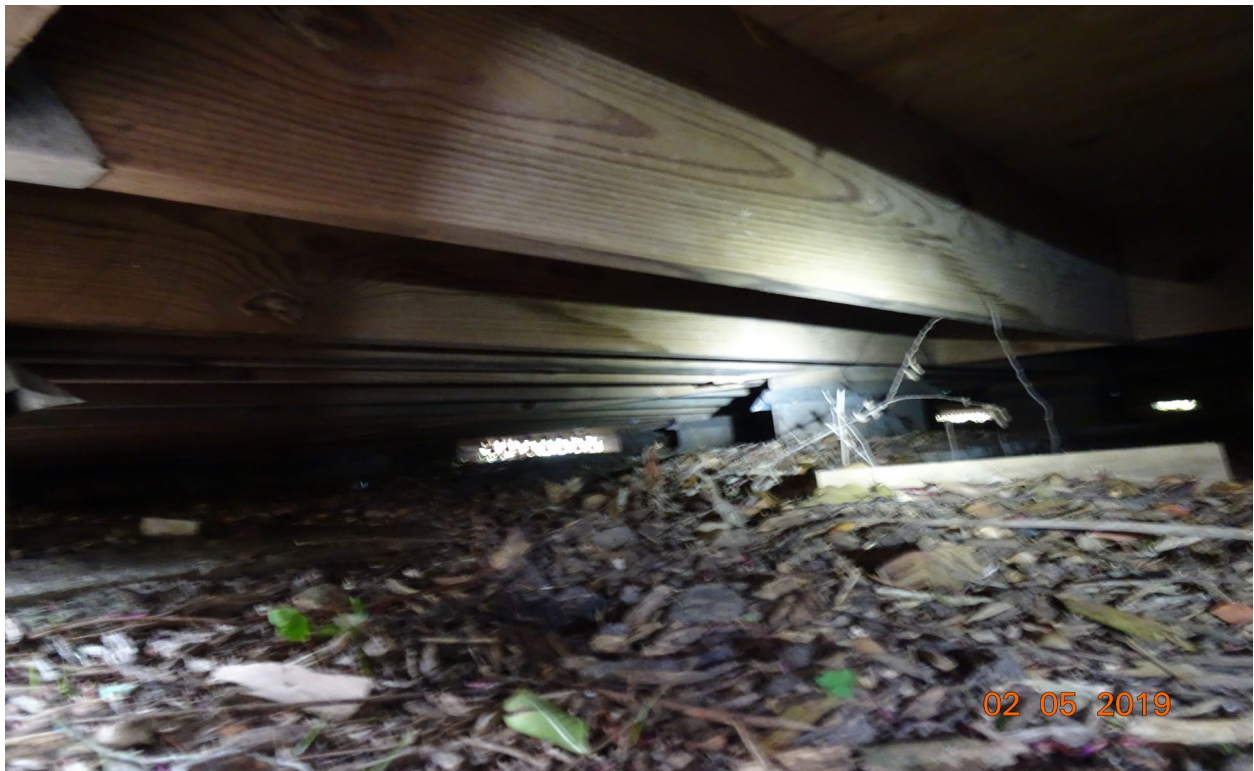
Photo # 12 Crawl space

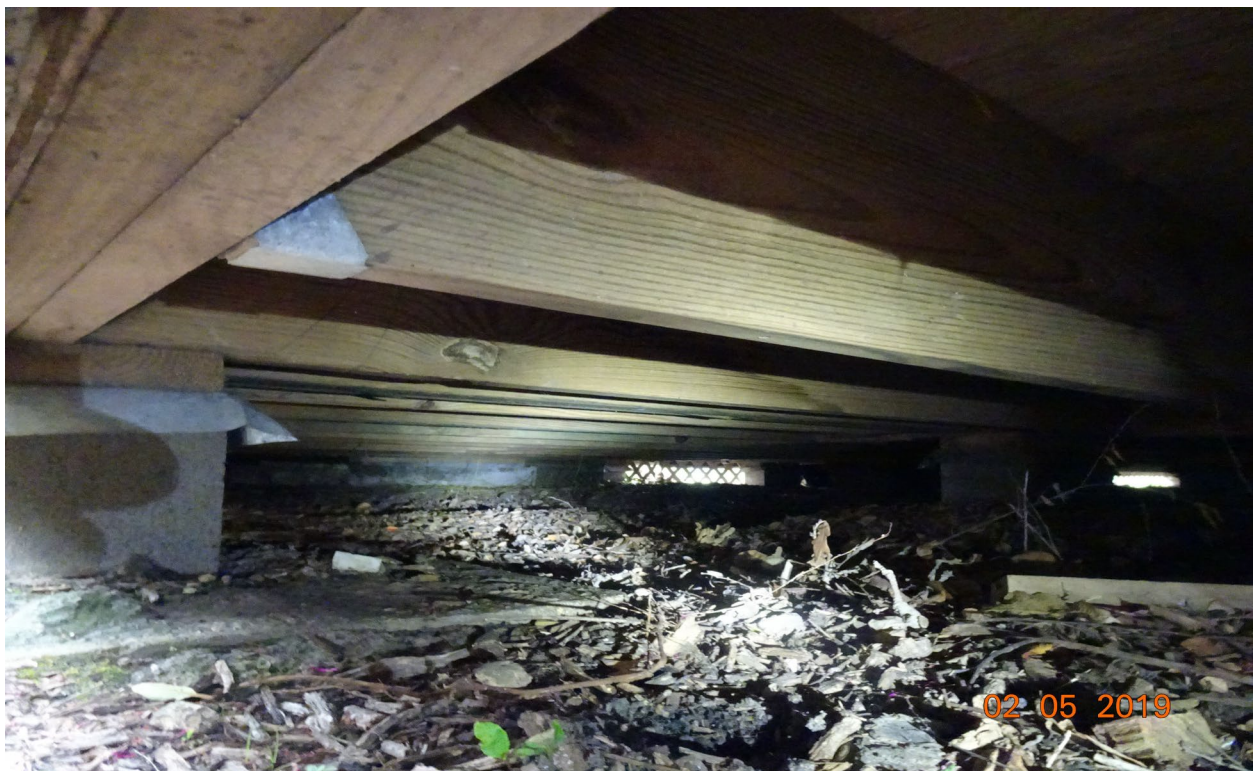
The perimeter of the crawl space under the house is enclosed by a plastic lattice, with little visibility of the crawl space through lattice openings. The stone veneer appears to be set on a concrete beam, preventing a close examination of the crawl space and supporting structure. Ventilation of the crawl space is excellent. Low clearance prevented entry into the crawl space, resulting in its being examined by looking through the latticework around the perimeter. The grade under the house appeared to be slightly above the surrounding grade. No deficiencies were observed in structural components within the crawl space, other than that wood had been used for shims between block supports and primary wood beams.

Photo # 14 Crawl space, note wood shims

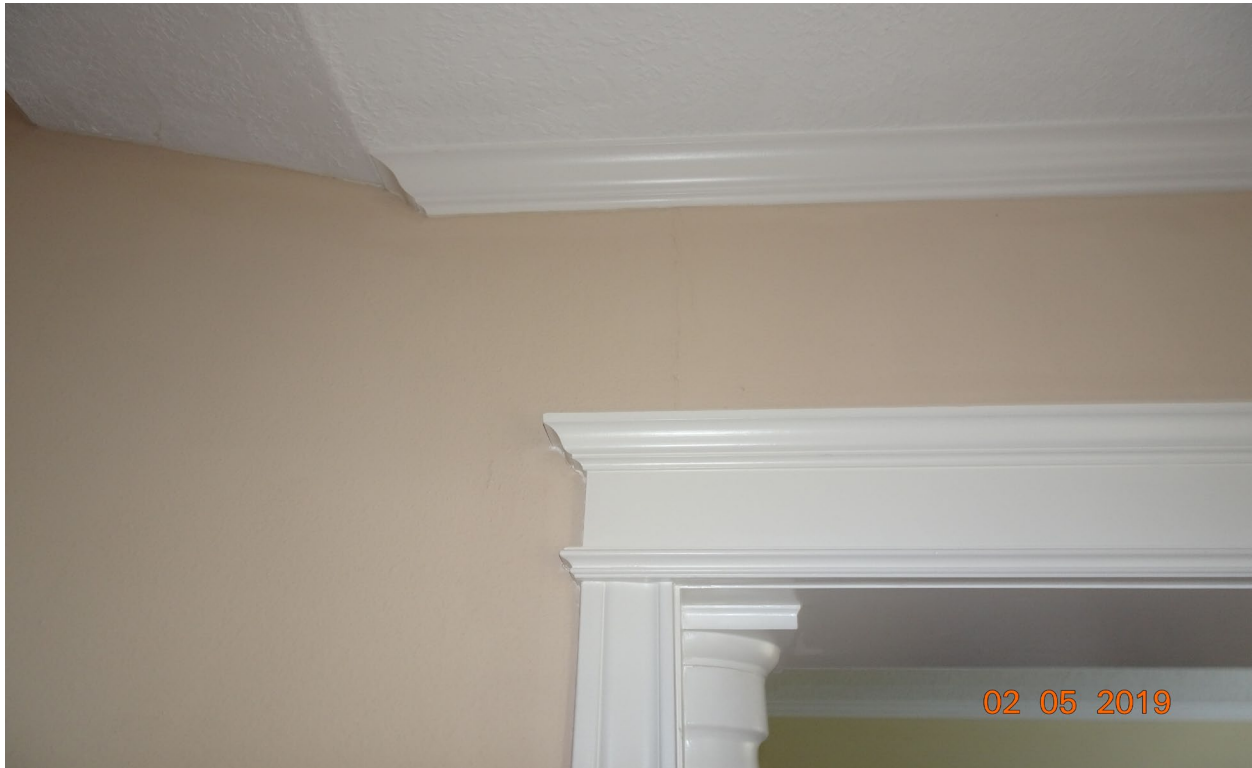
- In the foyer and entry hall,
  - A hairline horizontal sheetrock crush was found at the top front of the powder room door.
  - A hairline diagonal sheetrock crack was found at the top rear of the powder room door.
  - A hairline vertical sheetrock crush was found at the top rear of the doorway to the dining room.

Photo # 15 Crack in wall at top rear of dining room doorway

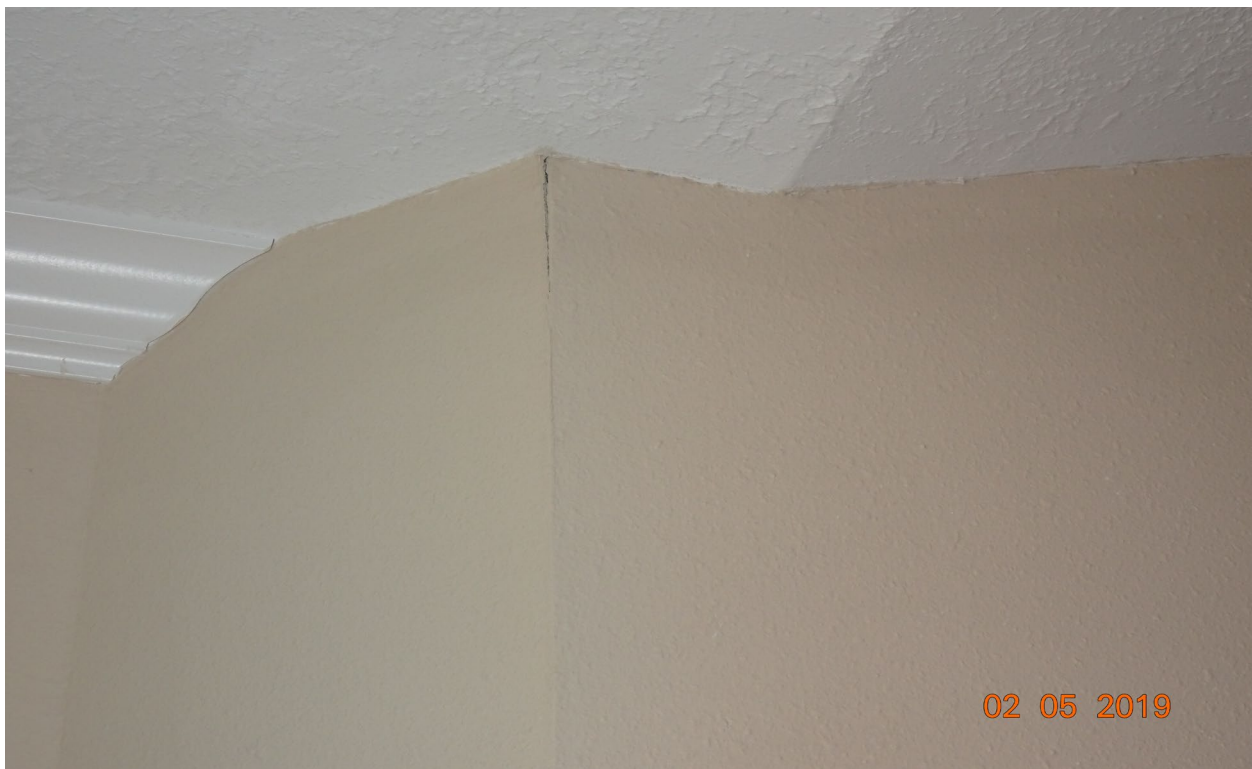
- A hairline vertical sheetrock crack was found at the top rear of the left side, 45-degree, wall at the stairs.
- In the powder room, hairline separations were found at corners of crown molding.

Photo # 16 Crack at ceiling, left side of entry hall diagonal offset corner

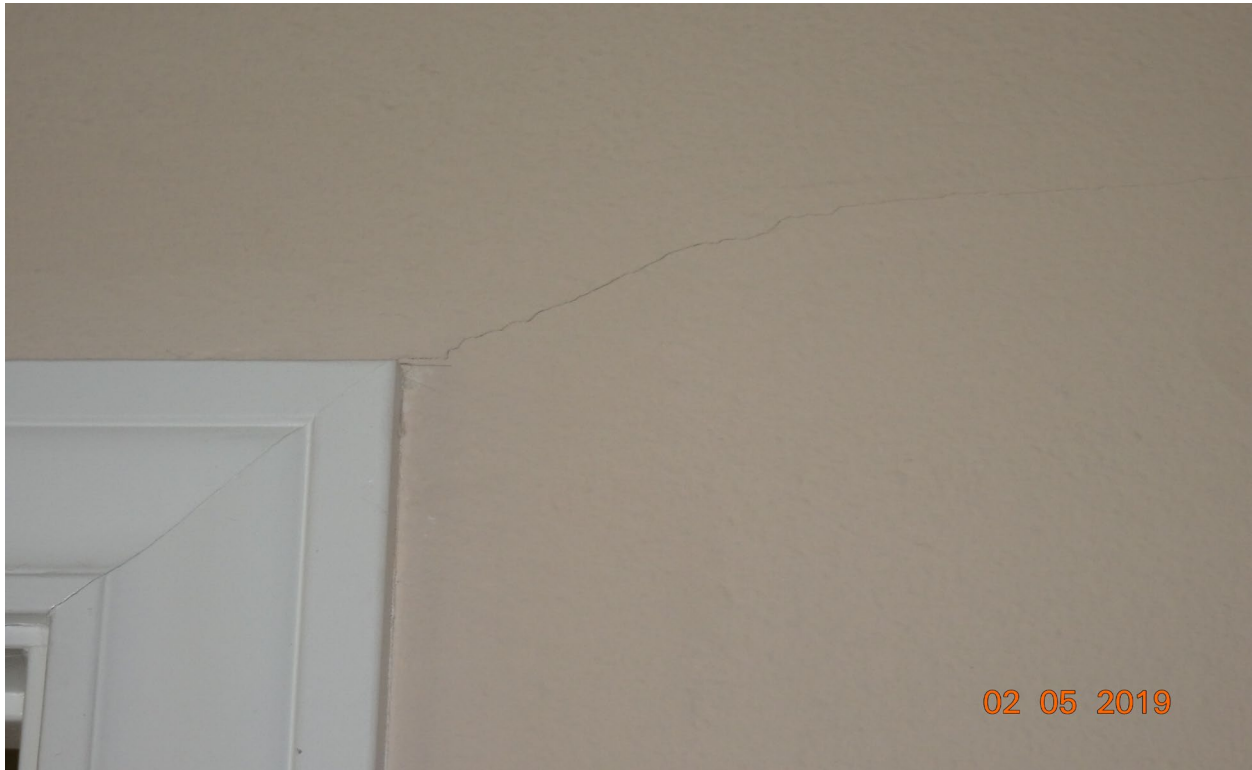
Photo # 17 Crack at top of powder room doorway

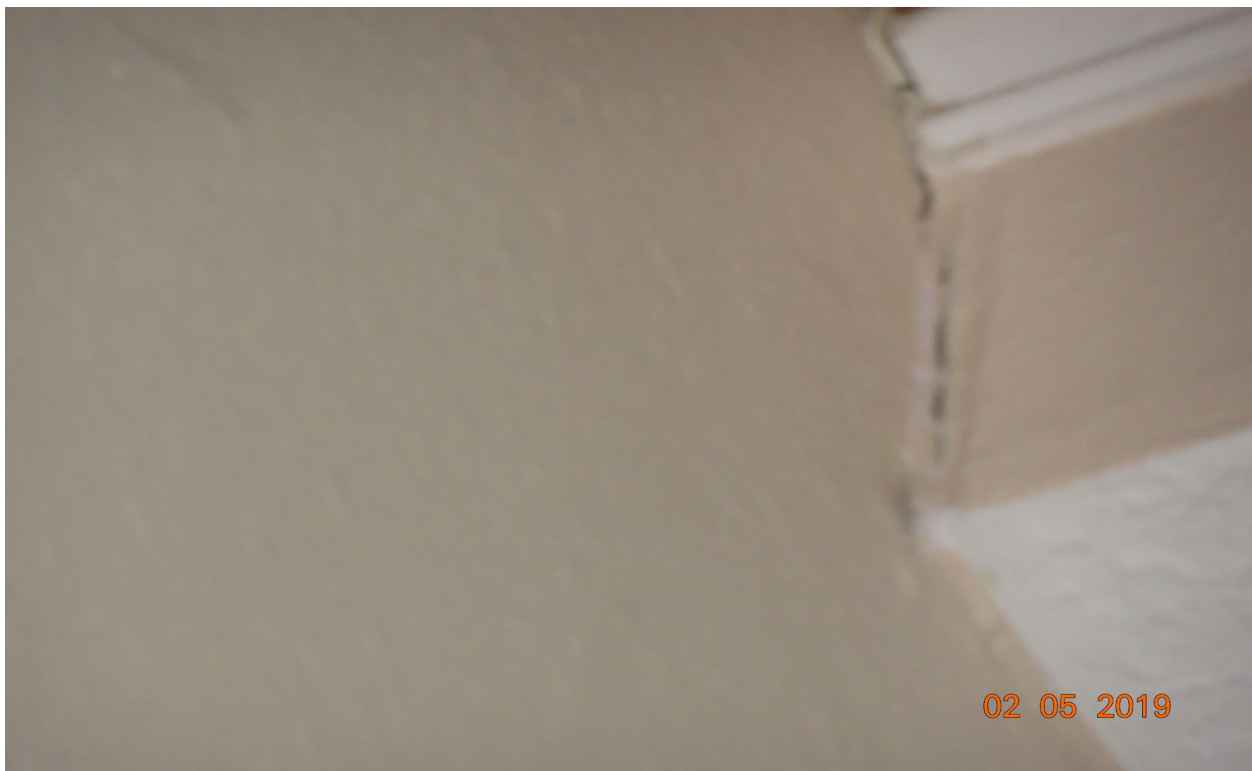
- In the front entry hall, a 1/16" vertical sheetrock crack was found at the left side of the second level bridge floor.
- In the dining room,
  - A 1/16" diagonal sheetrock crack was found at the top right of the kitchen door.

Photo # 18 Crack at left side of “bridge” over foyer

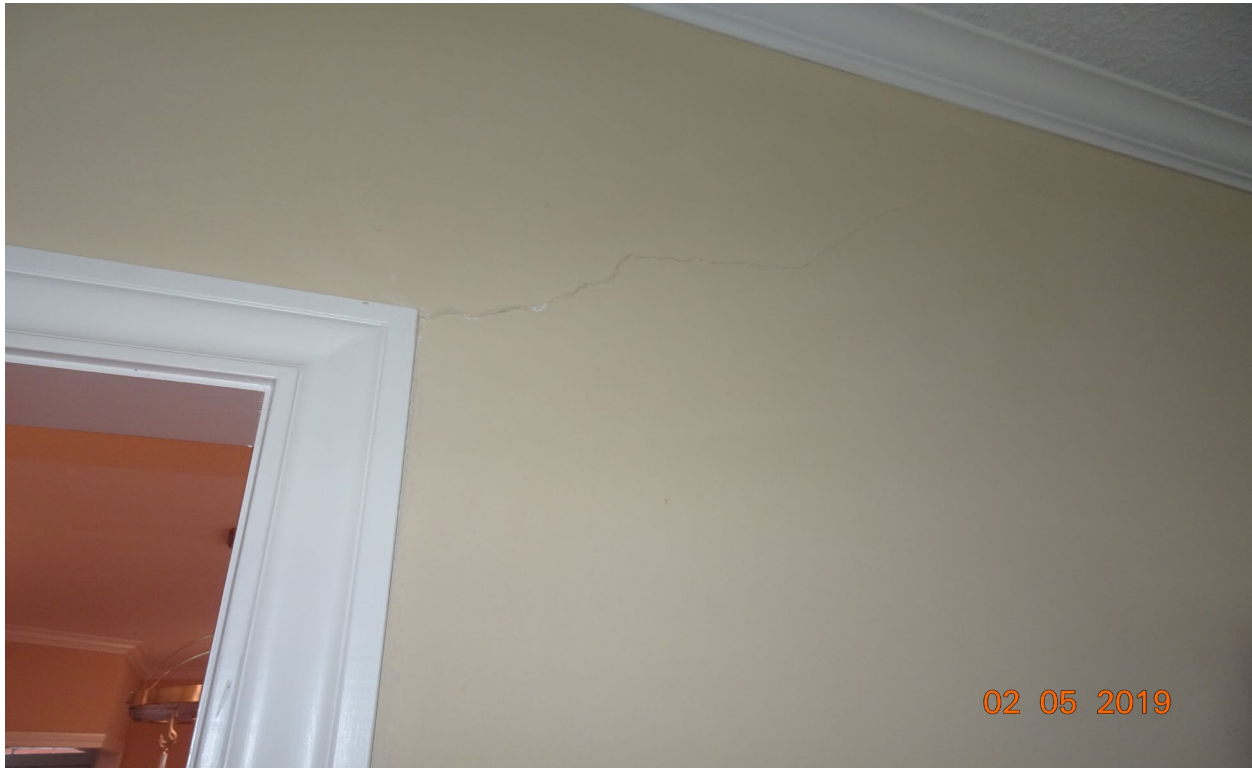
Photo # 19 Crack in sheetrock at top right of dining room door to kitchen

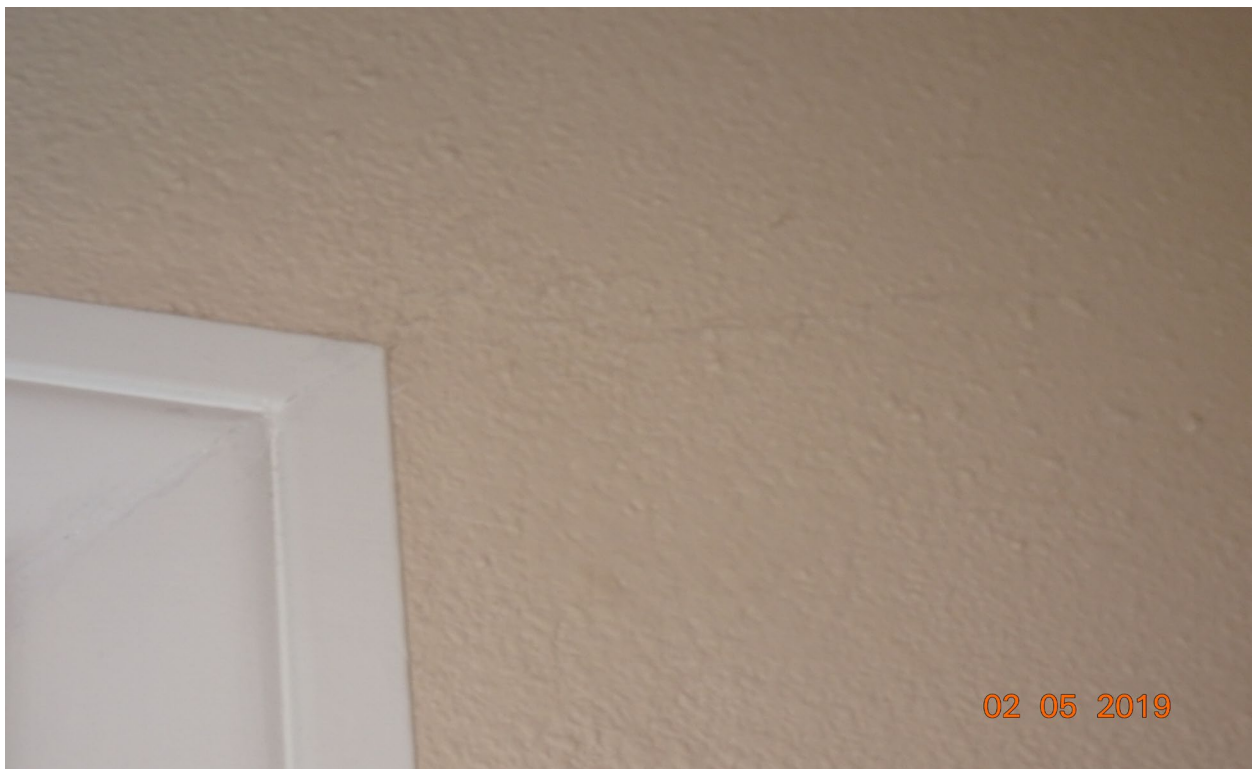
- A horizontal sheetrock buckle was found between the middle, front, and rear windows of the bay window.
  - A diagonal sheetrock crush was found at the top right of the utility room door.

Photo # 20 Crack at top right of door to utility room
