HOME INSPECTION REPORT

Prepared For:	Cassandra Saldivar	
	(Name of Client)	
Concerning:	8523 Asterglen Way, Rosharon, TX, 77583	
	(Address or Other Identification of Inspected Property)	
By:	Bob Wiesner 22223 Sean ODonnell 23124	3-26-2020
	(Name and License Number of Inspector)	(Date)
	,	
	(Name, License Number of Sponsoring Inspector)

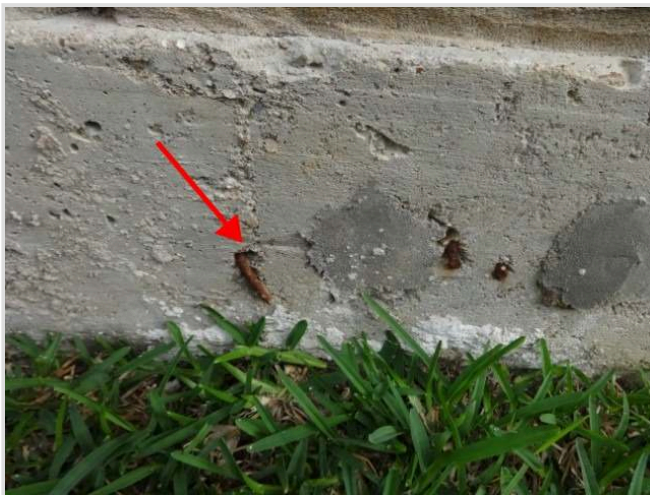
There exposed nails on the right side.

Exposed nails on right side exterior beam

- There exposed nails on the right side.
- There were what appeared to be shrinkage cracks on the garage floor.

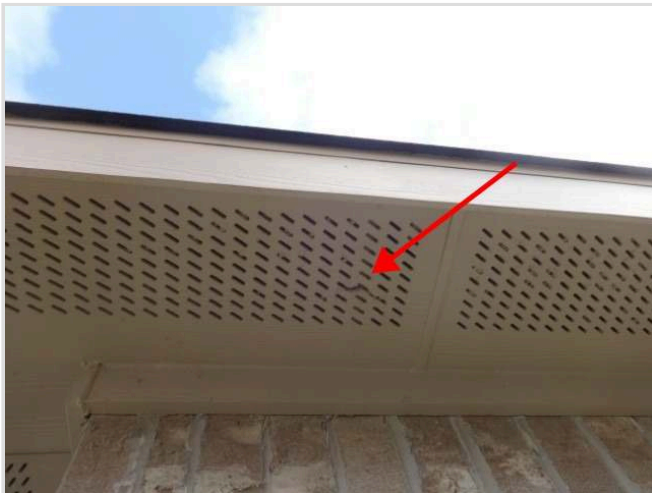
There was damage to two piece of soffit above the right wall.

Damage

- There was damage to two piece of soffit above the right wall.

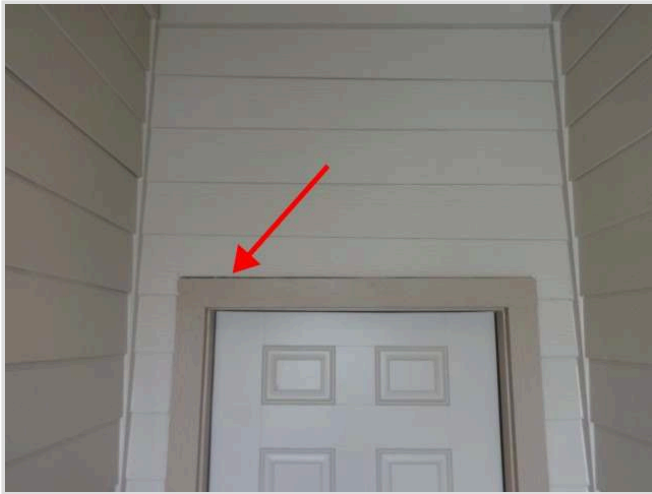
There was a gap above the front entry door on the exterior.

Gap above front door

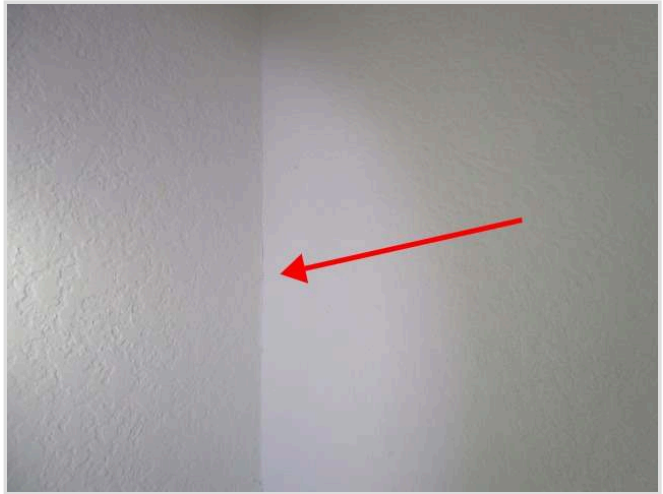
There were several sheet rock cracks in the closet corners. Among those were in the master bedroom closet, the hallway coat closet

Crack - front hallway closet

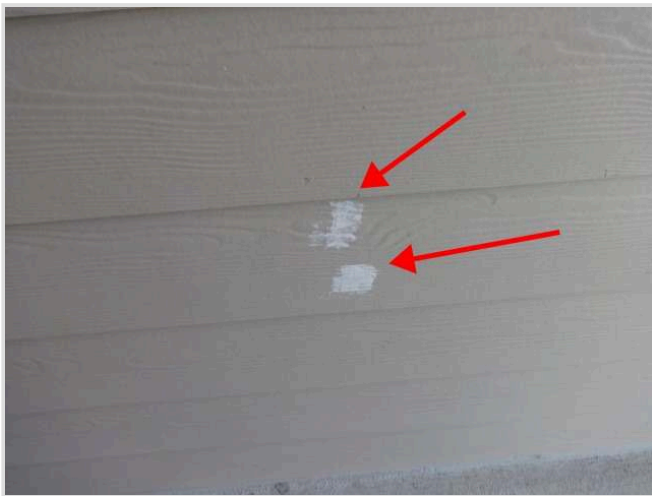
Paint mark - Front porch siding

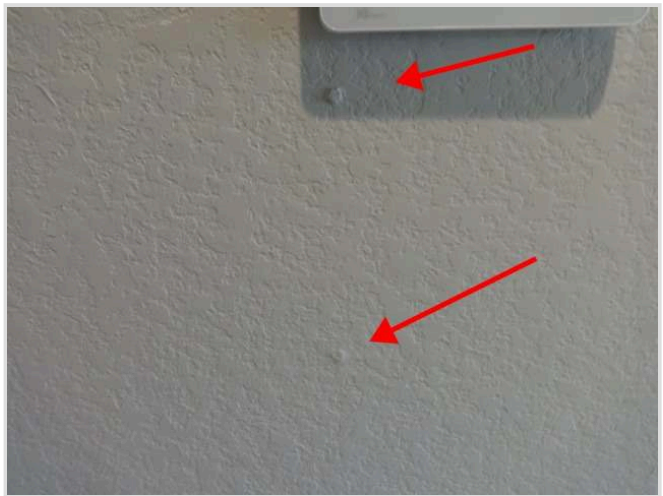
There were several touch-ups needed. Among those were 1) paint in the master bathroom, 2) exposed mounting holes in the front hallway, 3) rear living room corner by exterior door.

Hallway wall - mounting holes

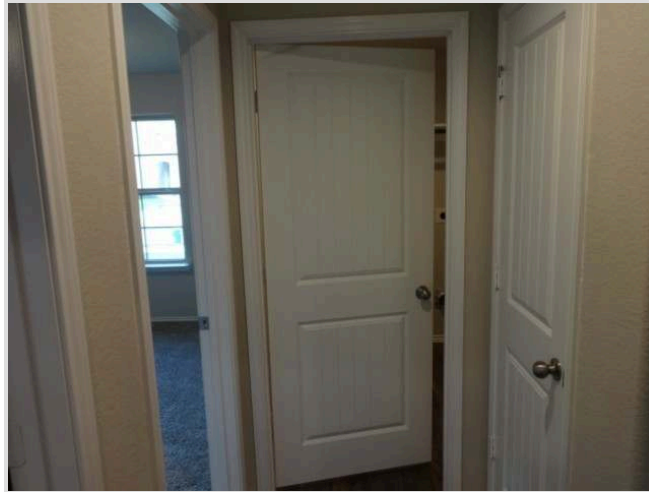
The laundry room door and the door to the master bathroom water closet would not latch.

Laundry room door would not latch

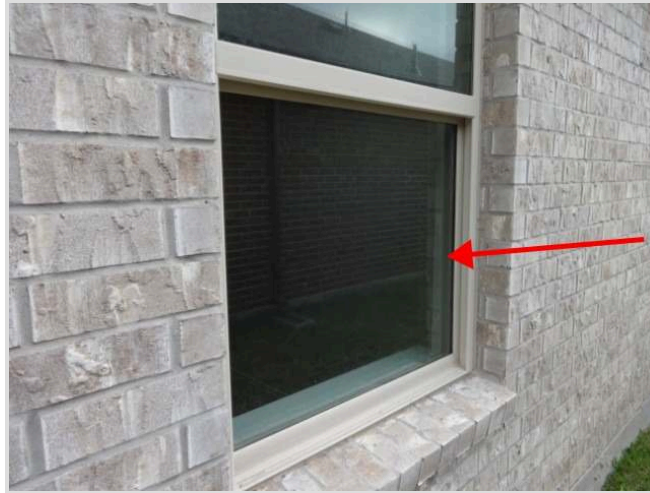
A window on the right wall was missing a screen.

No screen

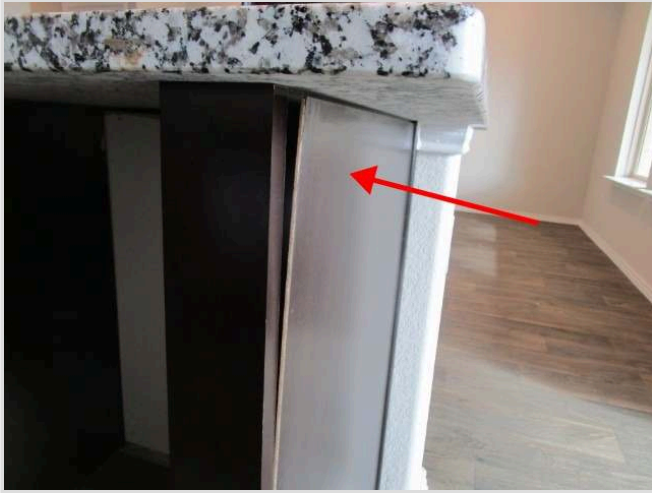
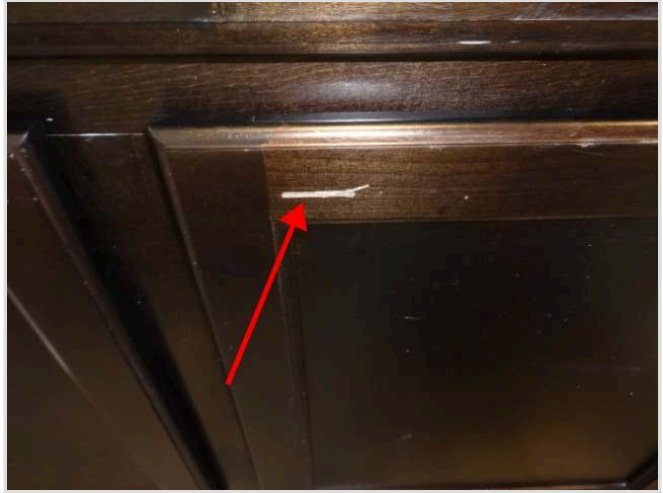
There were several small damaged areas on cabinets in both bathrooms and kitchen that needed touched up.

Damage to hallway bath cabinet door

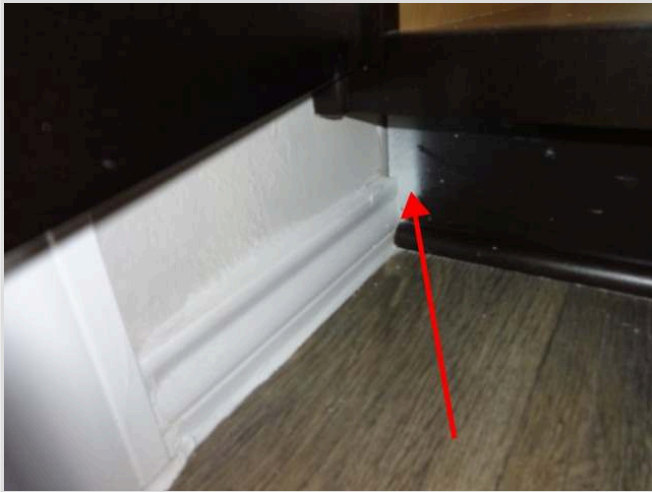
There was overspray on the kickboard at the bottom of the master bathroom sink cabinet.

Over spray on master bath cabinet kick plate

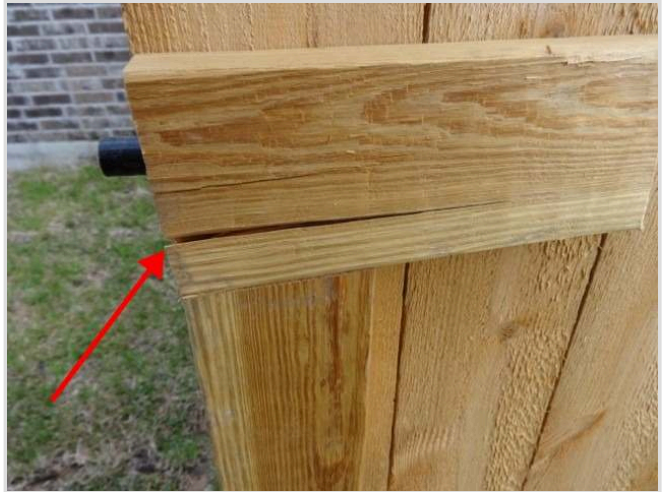
There was a piece of 2 x 4 on the fence entry gate that was cracked.

Cracked 2x4 - fence gate

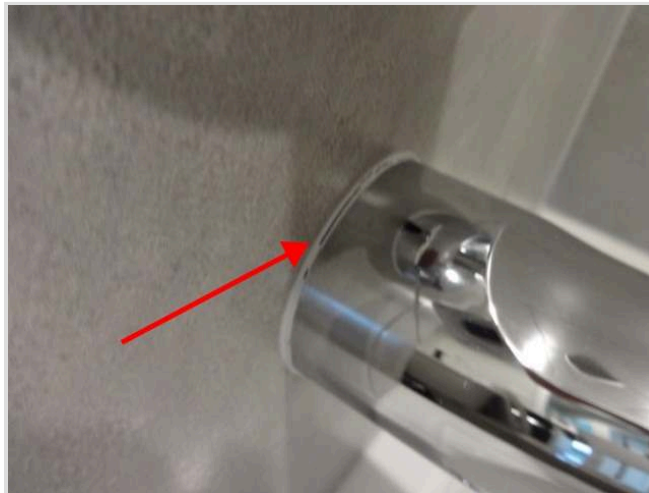
The spout for the tub in the hallway bathroom was not properly sealed.

Gap in tub spout sealant

- The spout for the tub in the hallway bathroom was not properly sealed.

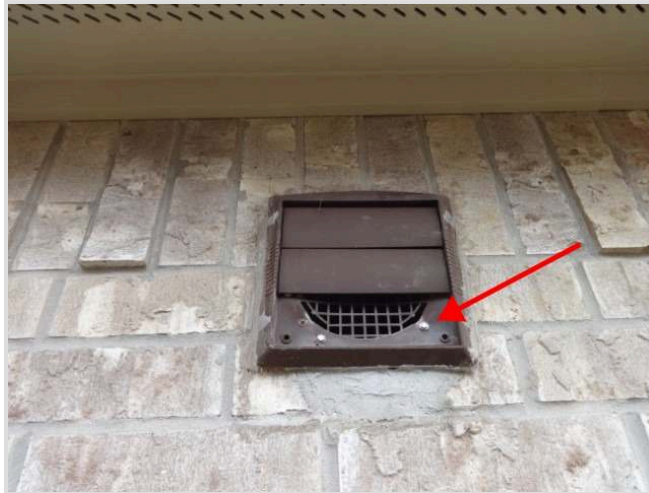
The vent cap on the right side of the exterior wall was missing a piece.

Missing louver

- The vent cap on the right side of the exterior wall was missing a piece.
