PROPERTY INSPECTION REPORT FORM

Mackinley Tatom <i>Name of Client</i>	04/29/2022 <i>Date of Inspection</i>
15340 Gorham Drive , Houston, TX 77084 <i>Address of Inspected Property</i>	
Tim Carpenter <i>Name of Inspector</i>	#23947 <i>TREC License #</i>
<i>Name of Sponsor (if applicable)</i>	<i>TREC License #</i>

Home Inspection Report

PROPERTY INSPECTED:
15340 Gorham Drive
Houston, TX 77084

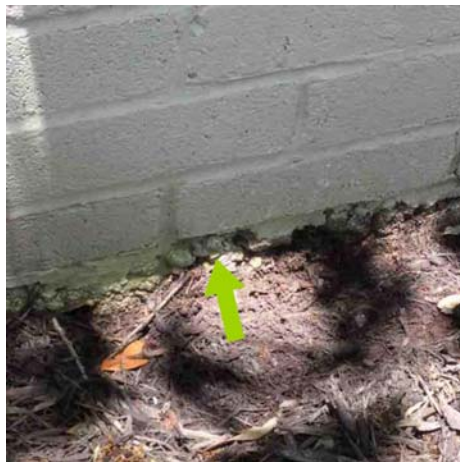
- **Spalling noted. Recommend repair and reparging to reduce further deterioration.**

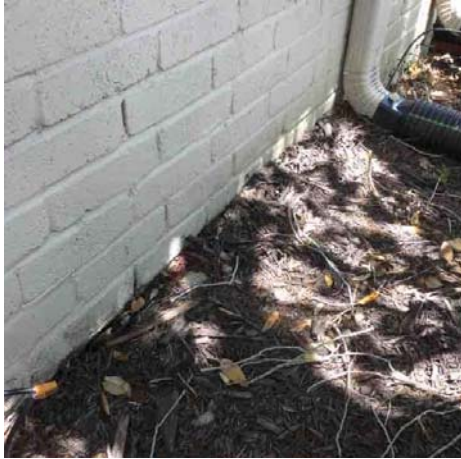
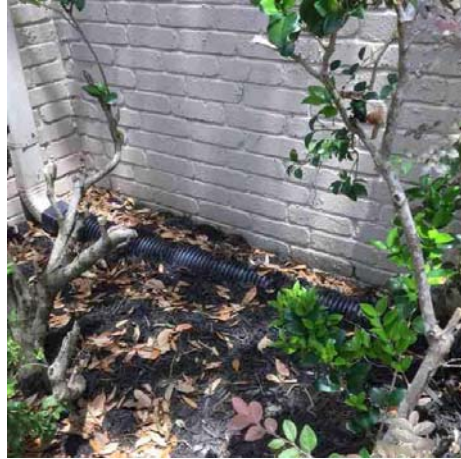
- Soil grade is level with or above brick; this is conducive to pest and moisture intrusions. Recommend lowering soil grade height to expose approximately 4 inches or more between the brick or siding veneer and final soil height, then regrade surrounding soil levels in a manner that will move moisture away from foundation areas in a positive manner.

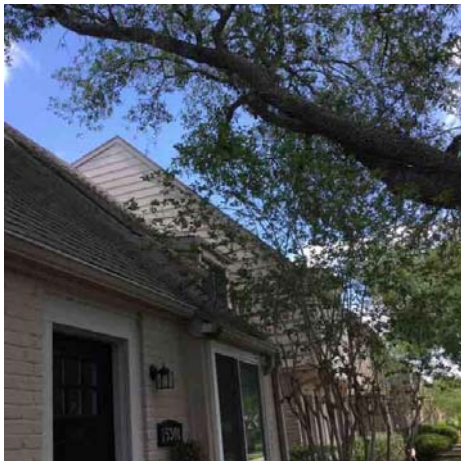
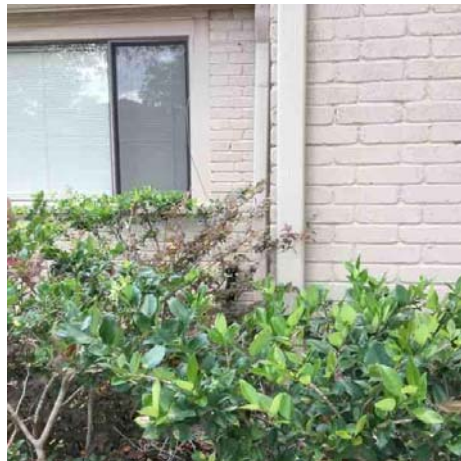
- Vegetation direct contact. Cut back away from siding, roof covering and slab to reduce the amount of moisture close to structure, and to reduce the amount of wear to building materials

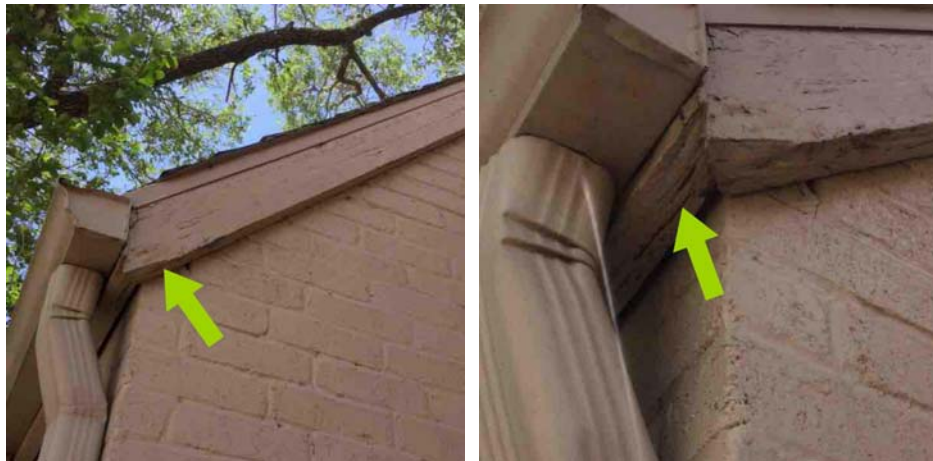
- **Wood decay observed at several locations of the fascia and/or soffit. Recommend licensed contractor replace.**

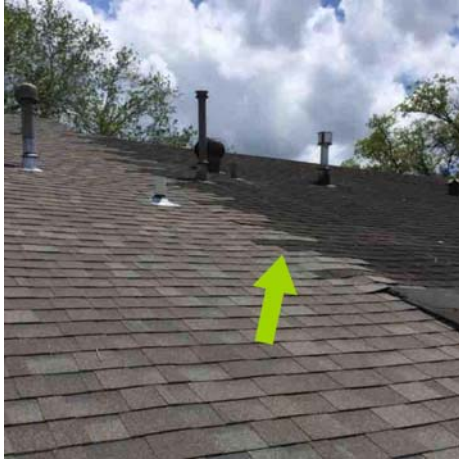
- Evidence of previous repairs to the roof surface were noted. Recommend consulting with homeowner as to the reason for repairs and if any warranty exists and is transferable. If none exists, recommend a qualified roofing contractor further evaluate the repairs.

Entire north facing slope was replaced in 2021

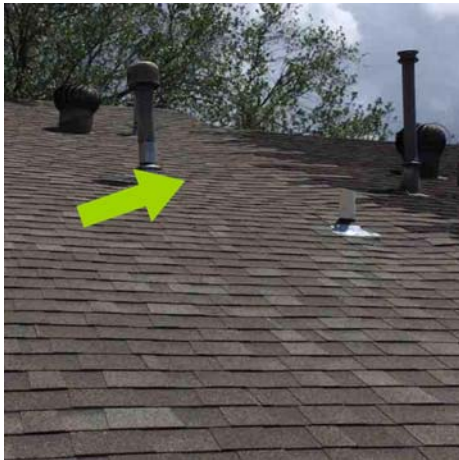
- Deflection was observed on the back right side of the roof. Recommend licensed roofing contractor evaluate and repair.

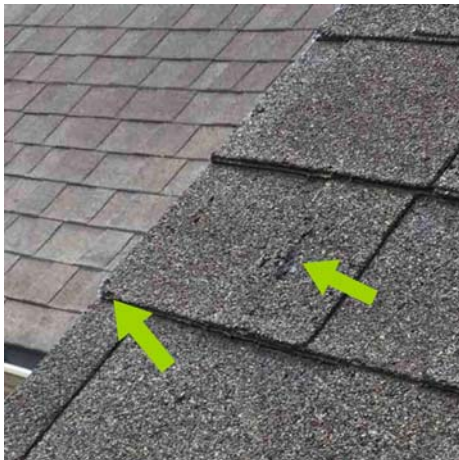
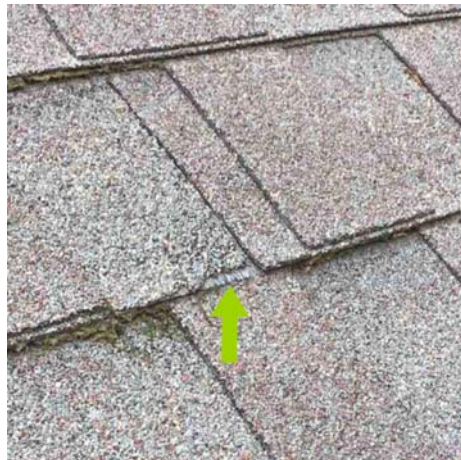
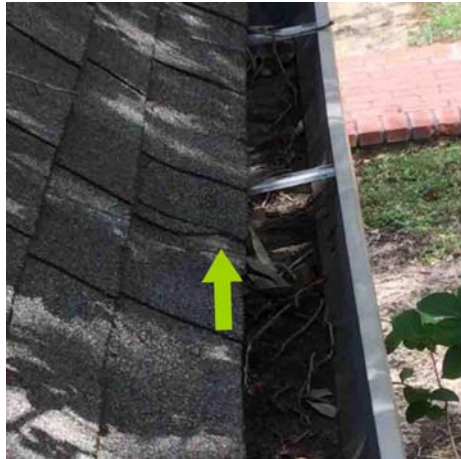
- Missing shingle and granule loss noted. Recommend licensed contractor evaluate and repair or replace.

HOA notified about south facing slope

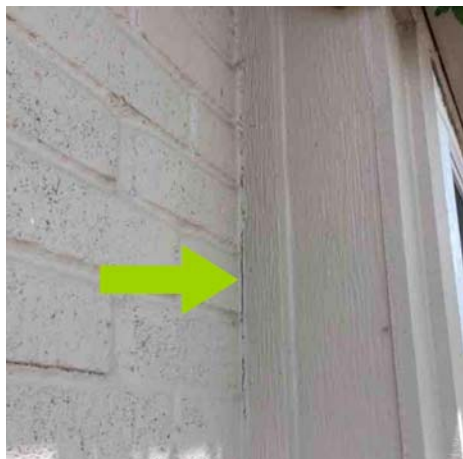
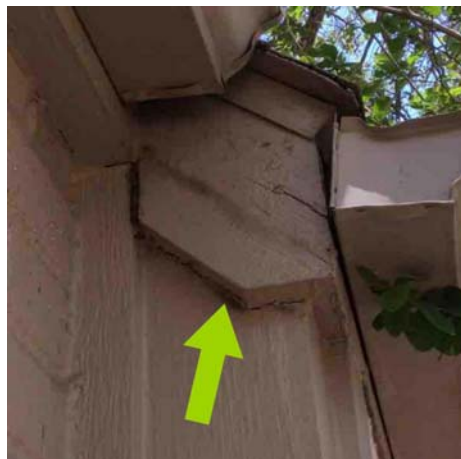
• Seal all open joints, gaps, and penetrations to prevent moisture or pest intrusions.

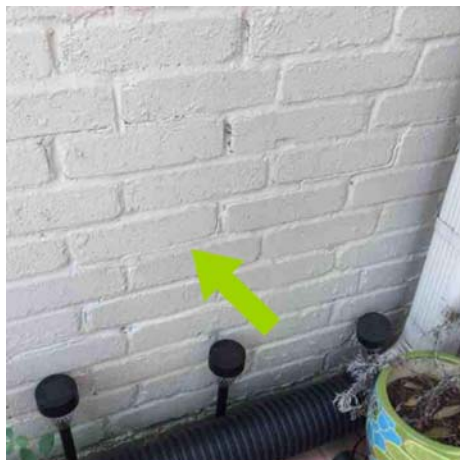
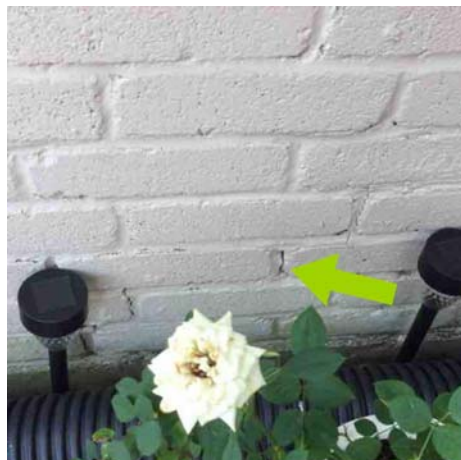
• Exterior walls show typical minor settling cracks, no other visual indications of structural movement were noted at the time of the inspection. Re-point mortar area(s) and seal as necessary to reduce unwanted moisture intrusions and promote good weather seal.

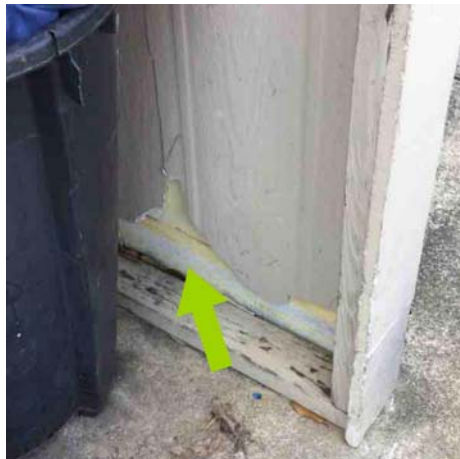
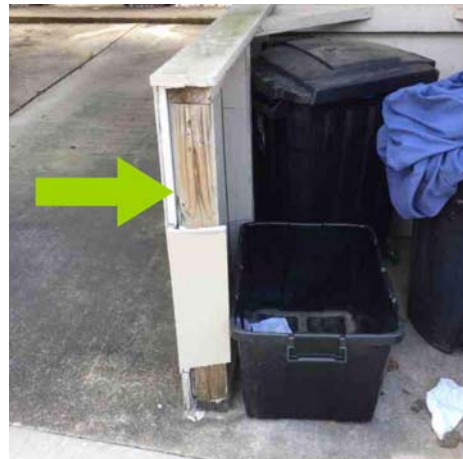
- Damaged siding noted. Where trash bins are stored.

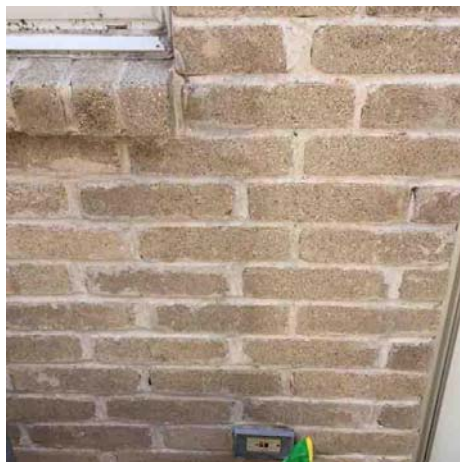
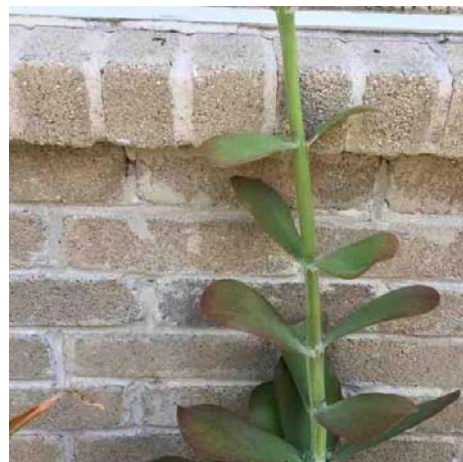
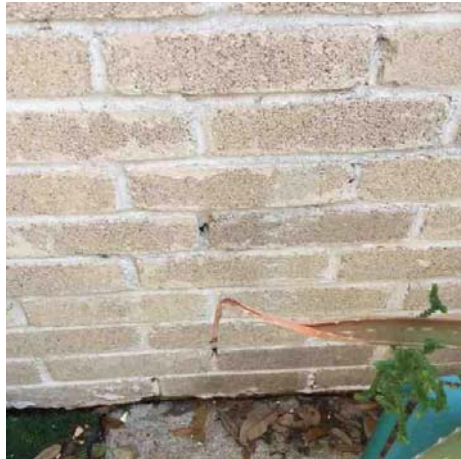
- Mortar between the bricks is showing signs of deterioration and repointing is advised.

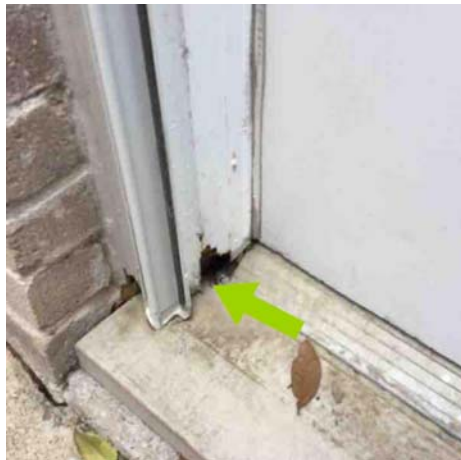
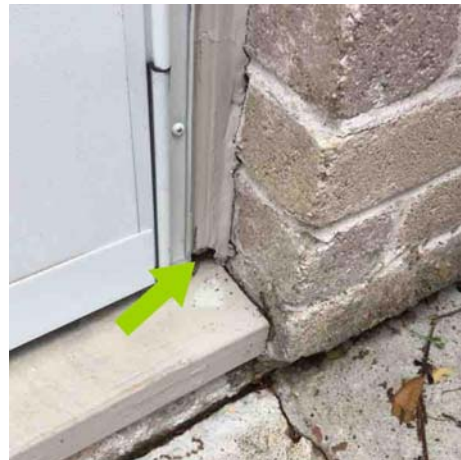
- Wood decay observed at door frame of exterior passage door. Recommend removal of damaged material and repair or replace materials, as needed. (Exterior Back)

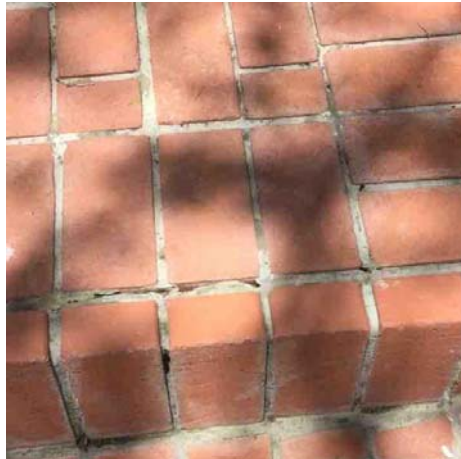
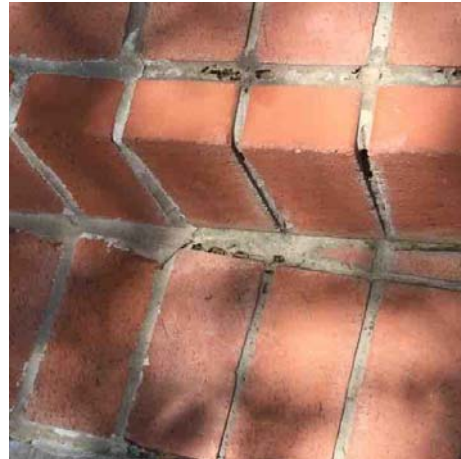
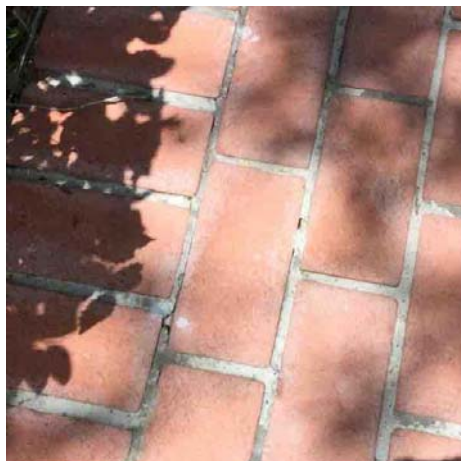
- Mortar between bricks on front porch is missing in several areas and repointing is advised.

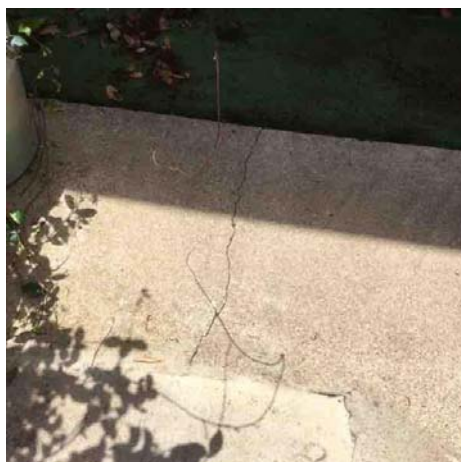
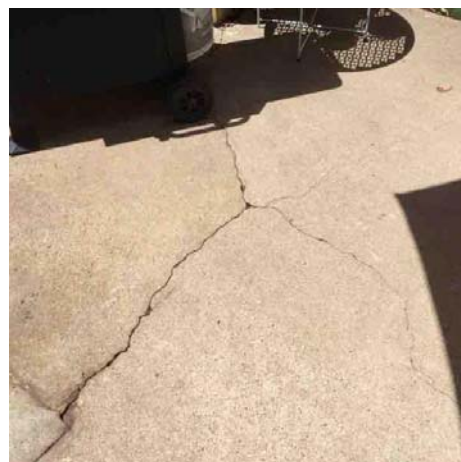
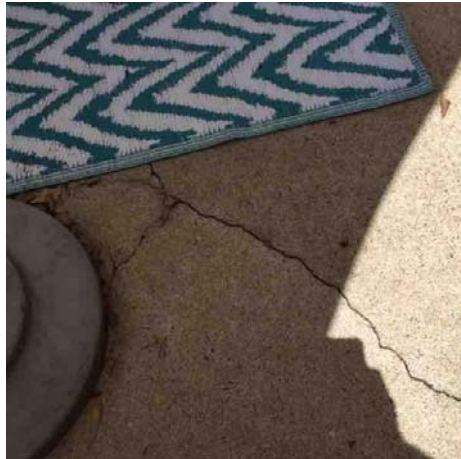
- Concrete patio presents cracking to the surface area. Recommend these cracks be sealed to prevent water penetration and potential erosion under the hard surface. Continued monitoring is advised.

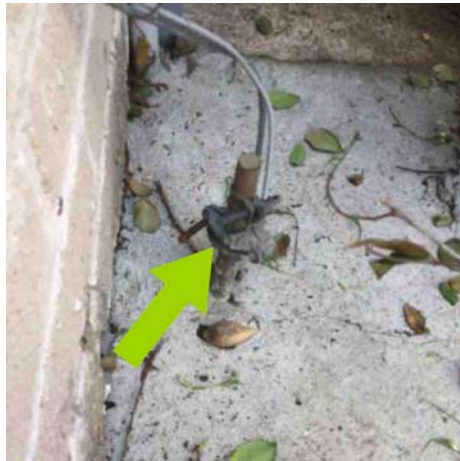
- Improper use of a pipe clamp was observed securing ground wire to ground rod (see photo). Recommend replacement of pipe clamp with a proper "Acorn" type clamp.

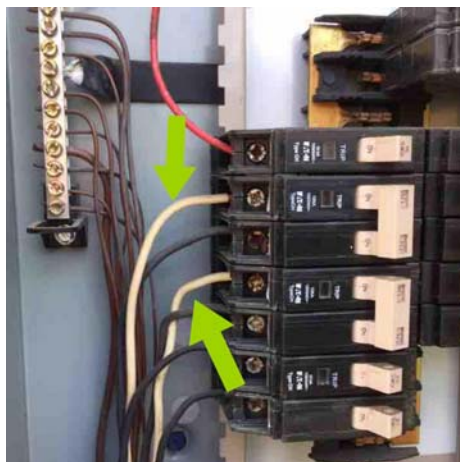
- White wires to 240 volt appliances were not marked as "hot" in the distribution panel. Wire should be marked with black electrical tape to indicate purpose.

Repaired

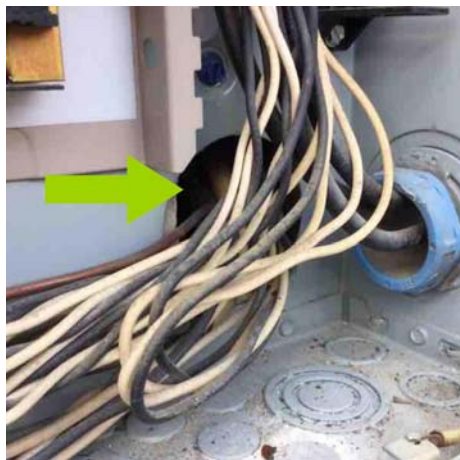
- Electrical panel is missing strain relief grommets. Install grommets to properly protect the wires for safety.

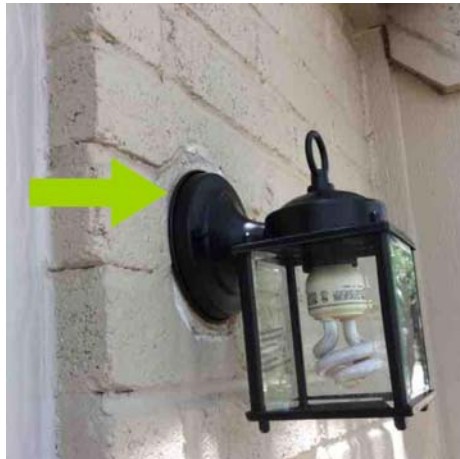
- Sealants observed missing at exterior wall mount light fixtures around perimeter of residence (see photo). Recommend applying good exterior-grade sealant to tops and sides of fixtures, leaving bottoms un-sealed.

Repaired

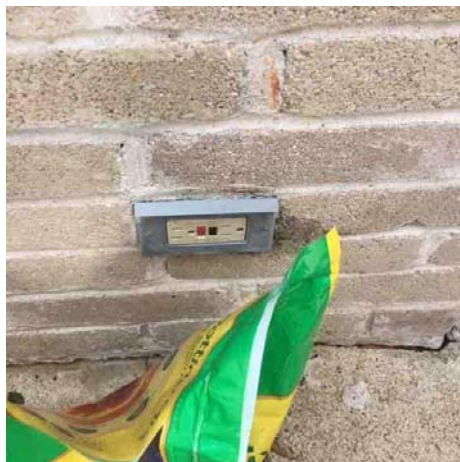
- Missing/broken cover plates and they should be installed for safety reasons.

Replaced outlet

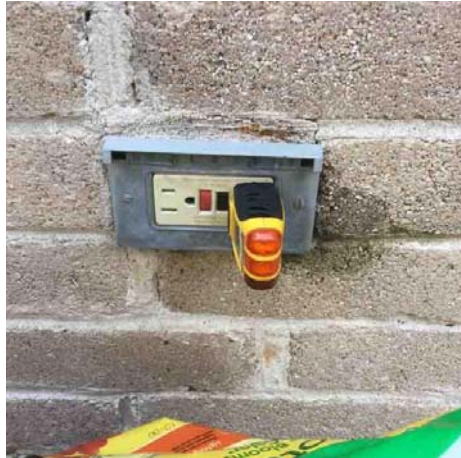
- **Ground Fault Circuit Interrupter (GFCI) electrical outlets in the home did not trip, re-set, were slow to re-set or made a buzzing sound when re-set. This indicates that the condition of GFCI electrical outlets in the home is deteriorating. This is a safety issue. The Inspector recommends replacement of all exterior GFCI outlets to ensure that they work correctly when required. (Exterior Back)**

Replaced outlet

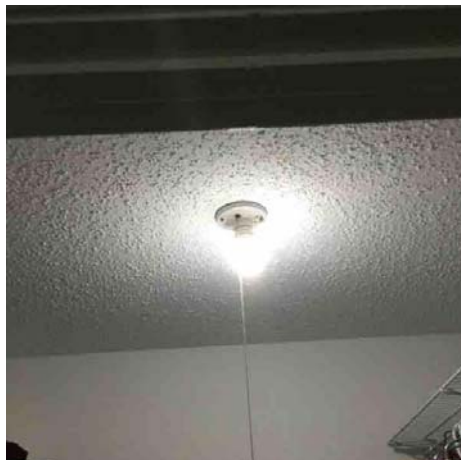
- **All closet light fixtures require covers to prevent injury and shock.**

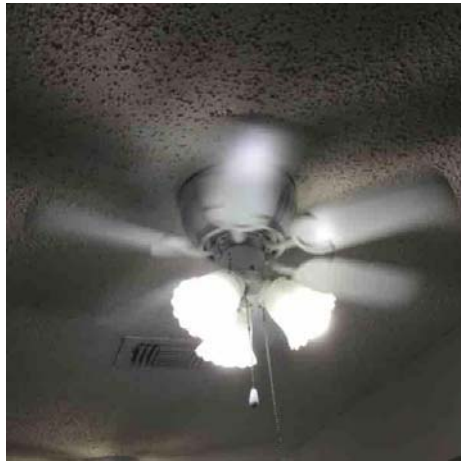
- **Ceiling fan is out of balance, recommend adjusting/balancing to restore intended function and reduce undue stress and wear. Kitchen.**

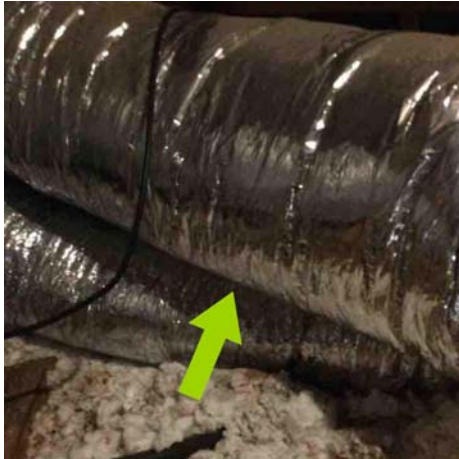
- Ducts that are stacked or touching can cause moisture build up. Recommend installing hangers or insulation to separate ducts.

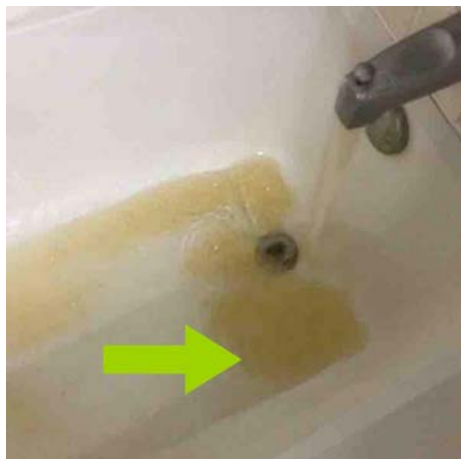
- Galvanized water lines noted in home for the main water supply. These lines can corrode and clog over time reducing or stopping water flow/pressure. While visual evidence at the time of the inspection notes the system is functioning within normal parameters, consider upgrading to PEX pipe to reduce possible failure in lines and related issues.

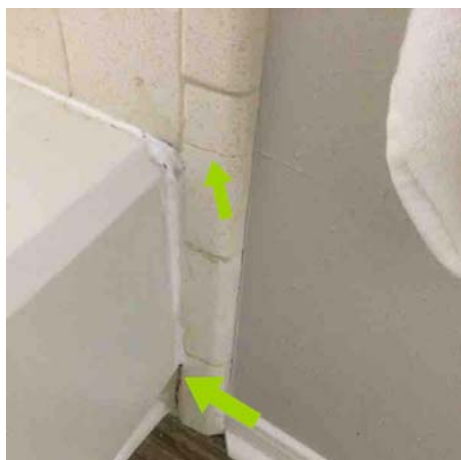
- Shower / bath area tile/grout is damaged/missing. Recommend having all affected areas repaired to reduce possible moisture intrusion and associated issues.

Repaired
