RESIDENTIAL INSPECTION REPORT

303 Mellon St
Richmond TX 77469

Paul Edwards
MARCH 27, 2021

Inspector
Neal Harris
TREC #23748
(281) 484-8318
office@inspectorteam.com

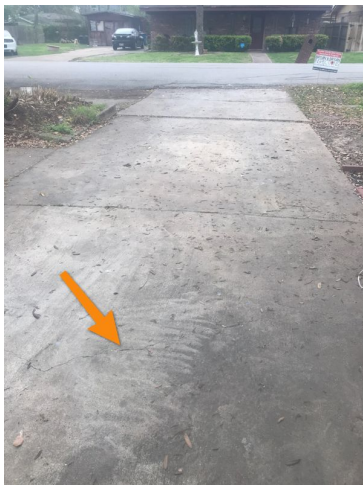
1: Grading & Drainage: Uneven/Cracked Driveway

Uneven or Cracked driveways can be a trip hazard.

Recommendation: Contact a qualified professional.

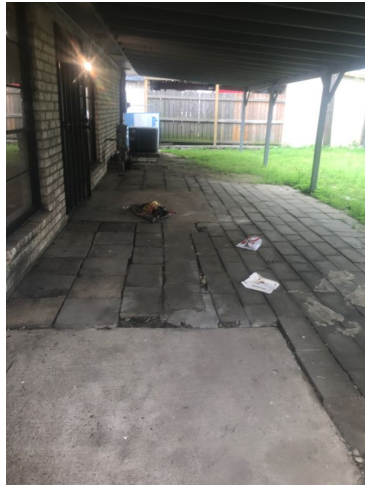
2: Grading & Drainage: Inadequate

Low spots, ruts, and/or damaged sod were present at the time of inspection. Regrading by a qualified landscaping contractor or foundation contractor so that water flows away from the home is recommended.

Recommendation: Contact a qualified landscaping contractor

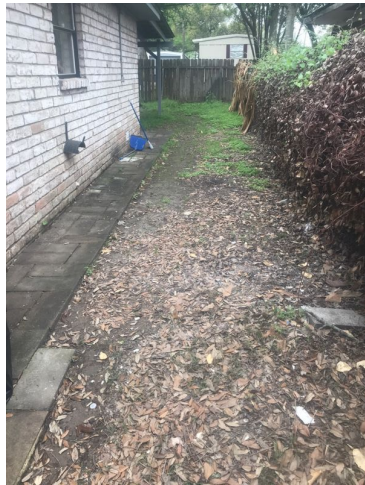
3: Grading & Drainage: Soil Erosion

Soil erosion was observed which can lead to grading issues. Evaluation and remedy by a landscaping contractor as needed to prevent further erosion is recommended.

Recommendation: Contact a qualified landscaping contractor

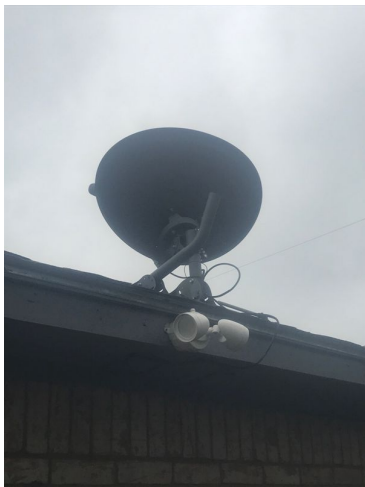
Satellite dish(es) mounted to the roof. The inspector was unable to determine the condition of the roofing materials underneath. Remedy as needed.

Recommendation: Contact a qualified roofing professional.

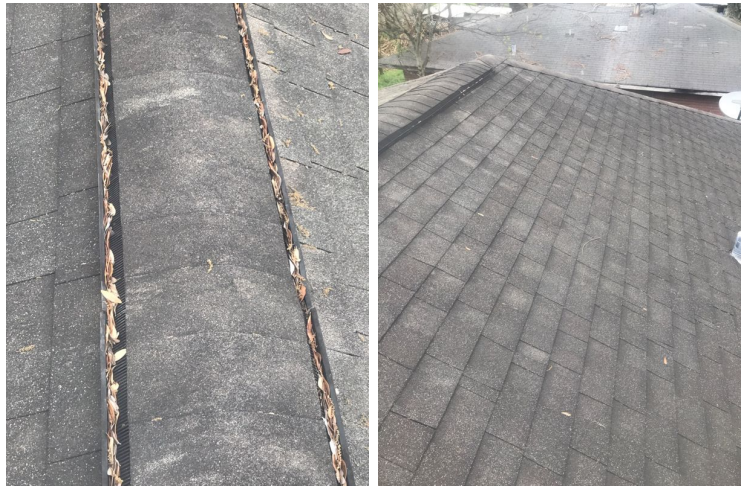
2: Excessive Granule Loss

Excessive granule loss of the roofing shingles was observed exposing base layers of shingles. Granule loss indicates aging and wear of the roof covering. A full evaluation by a qualified roofing professional is recommended.

Recommendation: Contact a qualified roofing professional.

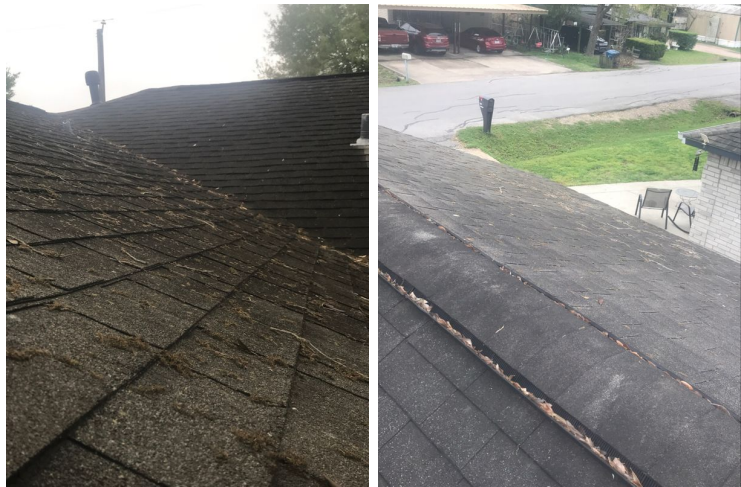
3: Debris on roof

Debris was present on roof surface. The condition of the roof covering underneath could not be determined. Removal of debris and evaluation of the roofing materials underneath is recommended.

Recommendation: Contact a qualified professional.

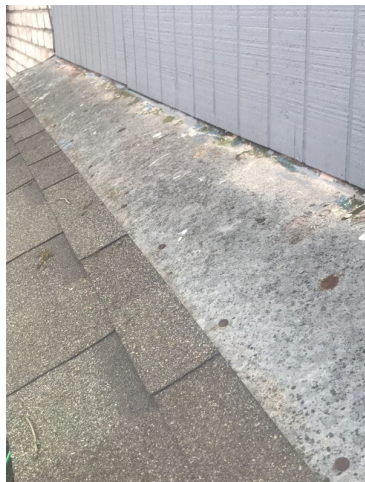
4: Exposed fasteners

Exposed fasteners were observed. Seal as needed to prevent moisture intrusion.

Recommendation: Contact a qualified roofing professional.

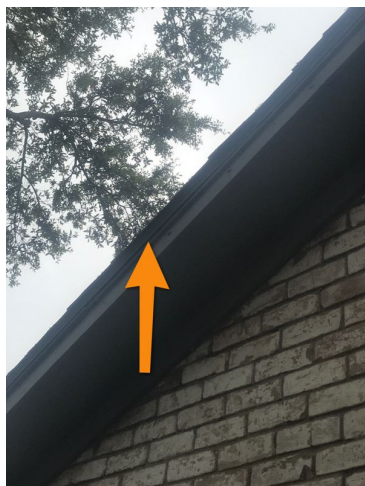
5: Drip Edge: Loose, Damaged, or Not Continuous

Sections of drip edge were loose, damaged, or not continuous.

Recommendation: Contact a qualified roofing professional.

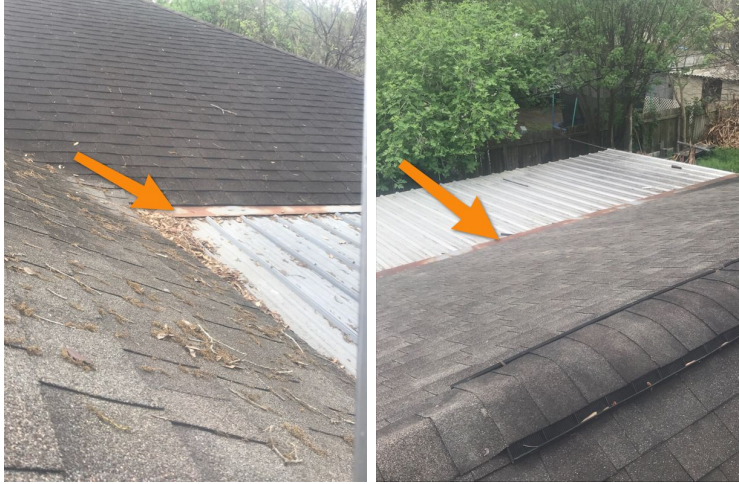
6: Flashing: Rusted flashings

Rusted flashings were present. Remedy as needed.

Recommendation: Contact a qualified roofing professional.

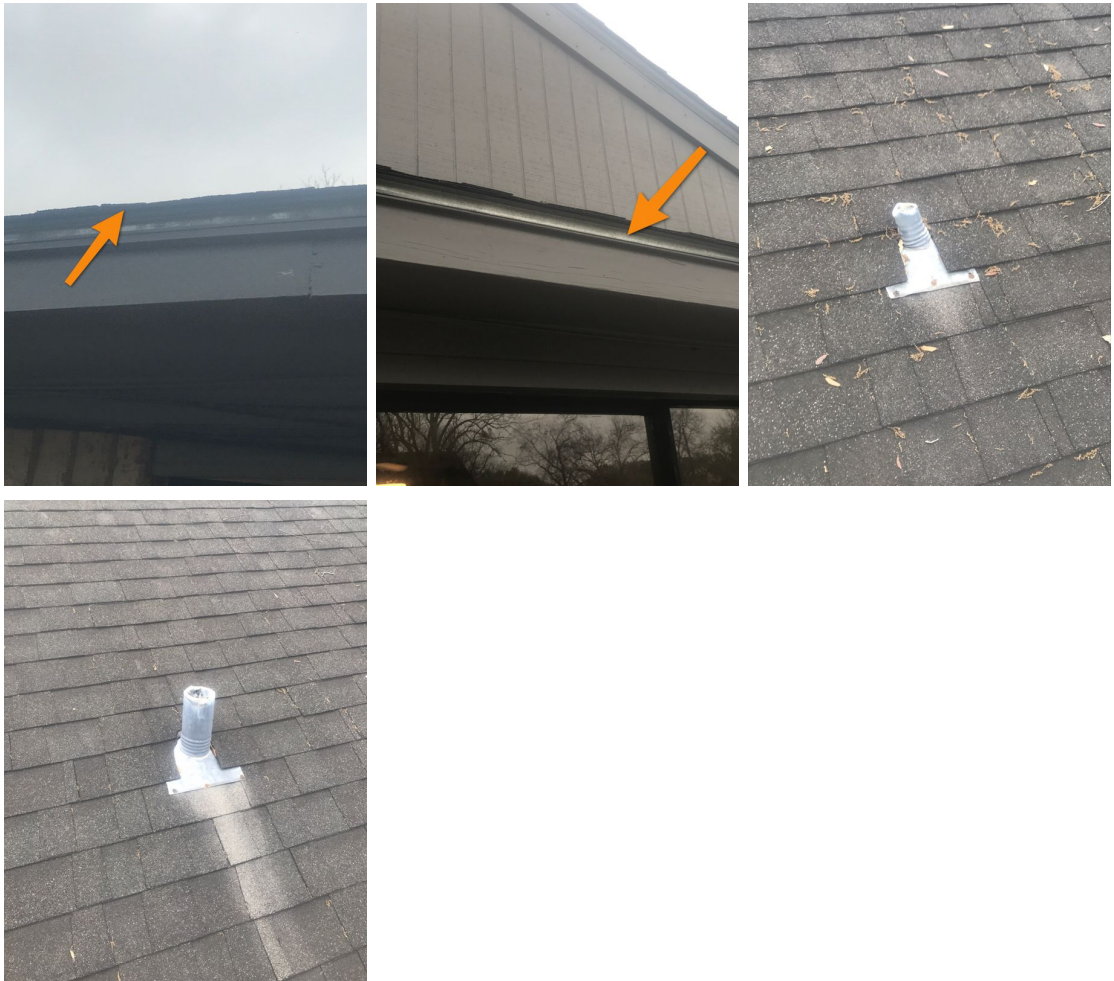
7: Flashing: Unpainted Materials

Roof materials were not painted (flashings, roof jacks). This can help extend the life of the flashing material, but also helps maintain a consistent look with other roofing materials. Remedy as needed.

Recommendation: Contact a qualified roofing professional.

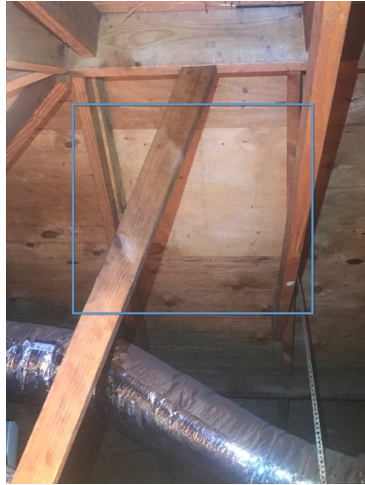
8: Patched roofing materials

Previous repairs or patched areas of the roofing were observed. Repair documentation from the seller/property owner is recommended in case warranty protections apply.

Recommendation: Contact the seller for more info

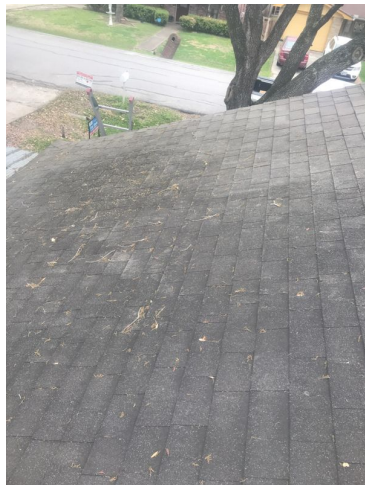
9: Discoloration

Roof shingles were discolored, which can be caused by moisture, rust or soot. Evaluation and/or repair by a qualified roofing professional.

Recommendation: Contact a qualified roofing professional.

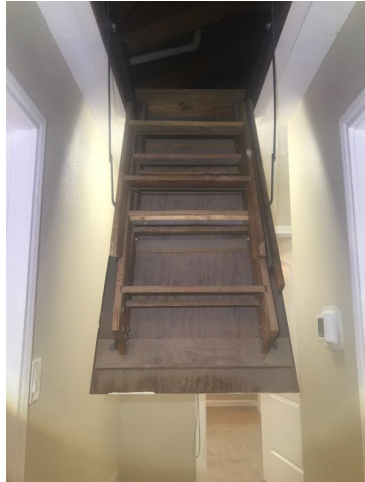
The ladder door was not insulated or weatherstripped. This can lead to increased energy loss. Remedy as needed.

Recommendation: Contact a qualified professional.

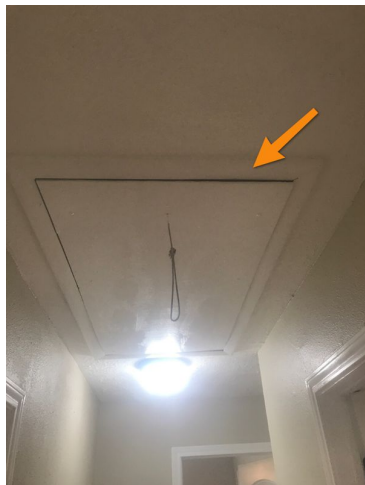
2: Pulldown stairs/ladder: Improper seal

The attic pull-down ladder door did not make a proper seal when closed. Adjust as needed

Recommendation: Contact a qualified professional.

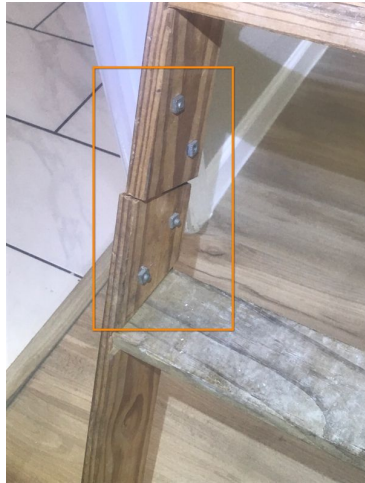
3: Pulldown Stairs/Ladder: Damaged Hardware

Attic access ladder hardware is damaged. Evaluate and remedy as needed.

Recommendation: Contact a qualified professional.

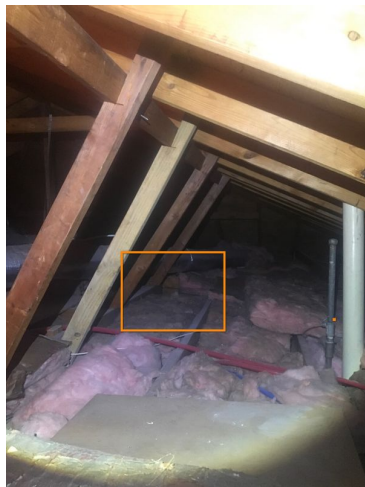
4: Insulation: Voids

Gaps or areas of poor insulation coverage were observed in one or more locations of the attic. This may reduce the R value of the insulation system.

Recommendation: Contact a qualified insulation contractor.

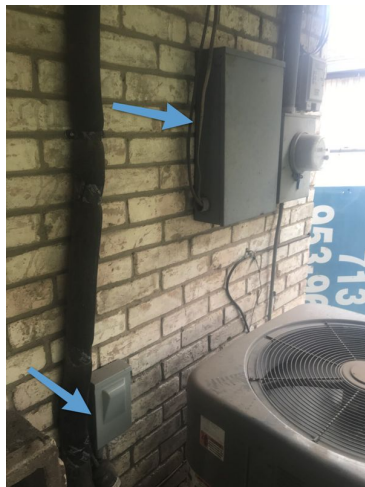
1: Exterior: Seal Wall Fixtures

Note: Modern building practices recommend sealing around components that are mounted on or pass through the exterior wall to limit moisture intrusion.

Recommendation: Recommended DIY Project

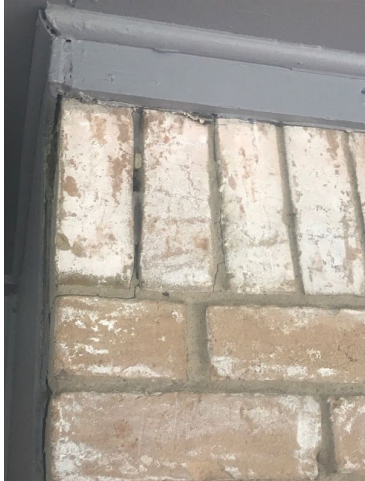
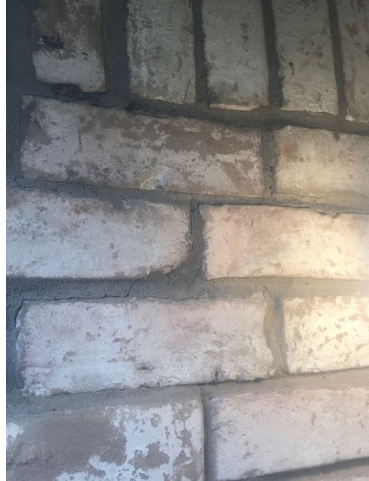
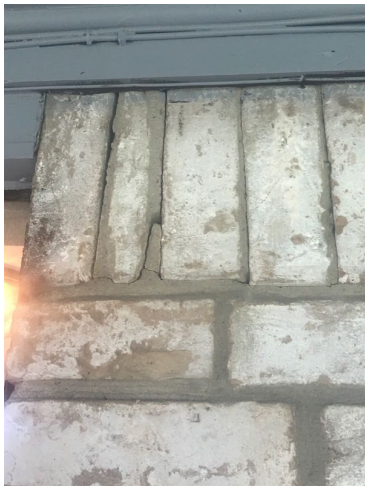
2: Exterior Masonry: Minor Brick Cracks

Cosmetic hairline cracks were observed in the masonry siding. Hairline cracks may be a result of thermal expansion of the veneer and/or normal structural movement. Monitoring is recommended.

Recommendation: Recommended DIY Project

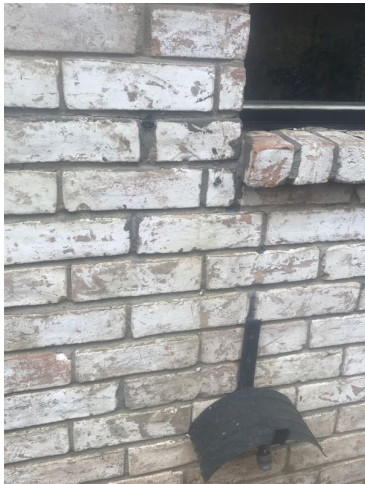
3: Exterior Masonry: Previous Repairs

Previous repairs to exterior masonry were observed. Obtaining documentation of all previous work is recommended.

Recommendation: Contact a qualified professional.

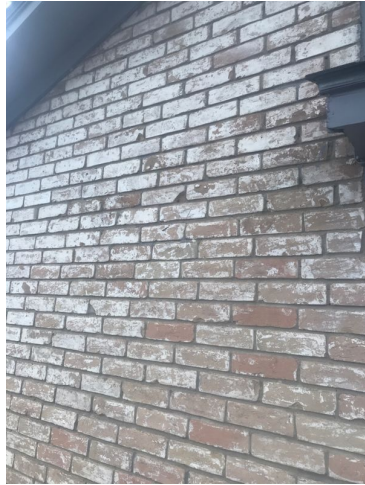
4: Exterior Masonry: Deterioration

There was deteriorated brick/masonry. Evaluate and remedy as needed.

Recommendation: Contact a qualified masonry professional.

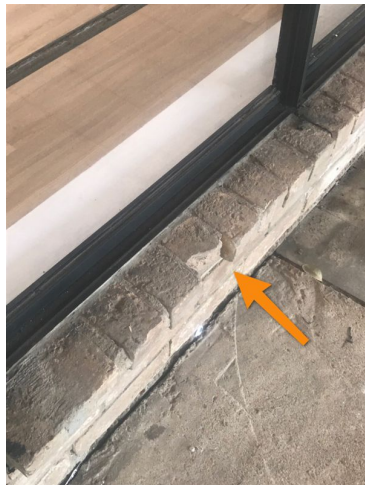
5: Exterior Masonry: Damage

There was damaged brick/masonry. Evaluate and remedy as needed.

Recommendation: Contact a qualified masonry professional.

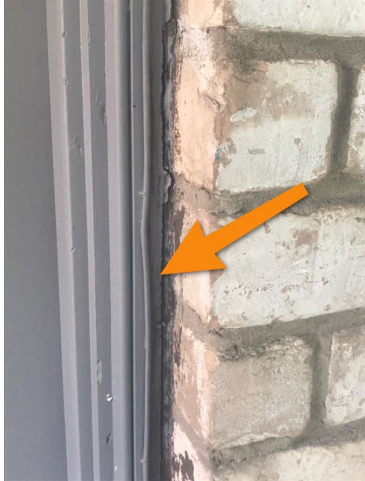
6: Exterior- Caulking: Deteriorated/Missing

Caulking around siding or trim was deteriorated or missing.

Recommendation: Contact a qualified professional.

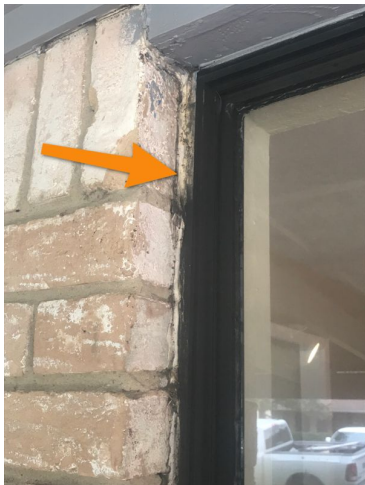
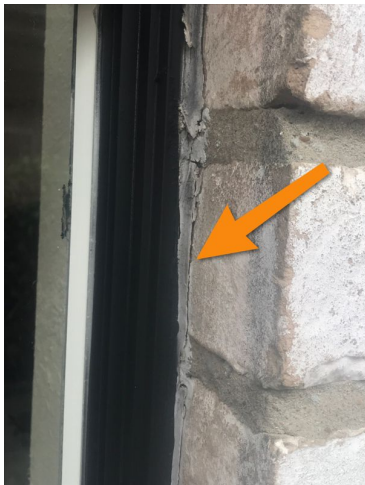
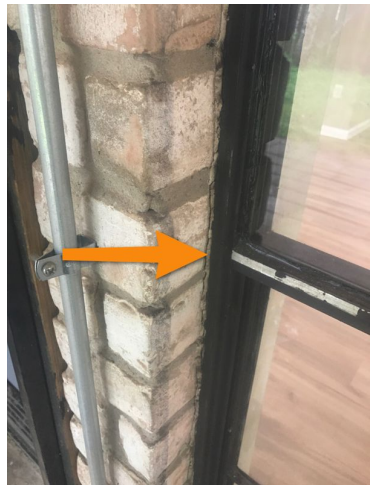
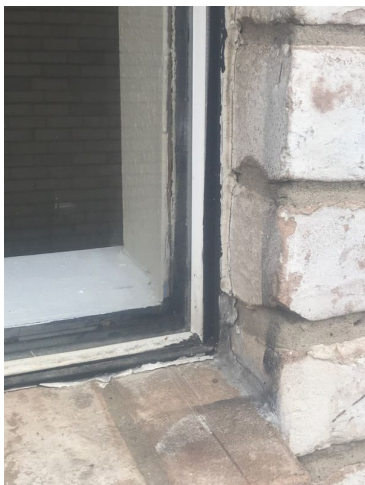
7: Exterior- Caulking: Deteriorated/Missing Around Window Frames

Caulking around window frames was missing or deteriorated. Caulking around window frames is an important barrier to moisture and air intrusion. Most exterior sealants have a lifespan of 5 to 8 years and should be regularly maintained with that lifespan in mind. Evaluate and remedy as needed.

Recommendation: Contact a qualified professional.

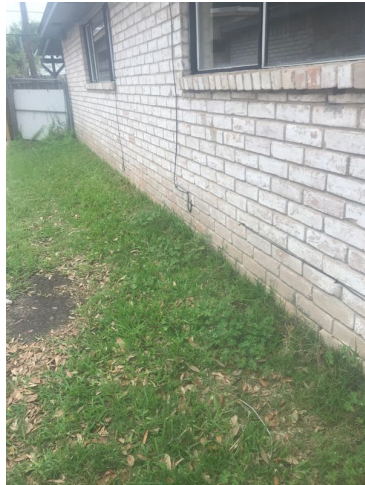
8: Exterior: High Soil

A high soil level was observed. The foundation should have at least 4 inches of exposure. Remedy as needed.

Recommendation: Contact a qualified landscaping contractor

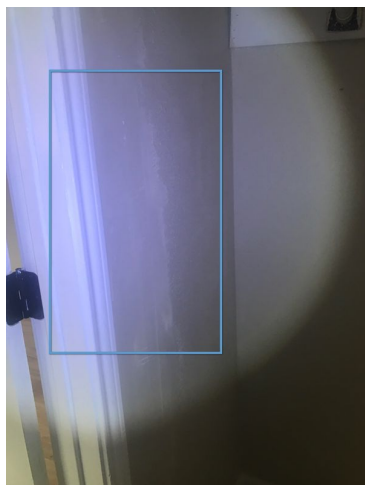
9: Note: Patched Walls

Patched wall areas were observed at the time of inspection. Obtaining all previous work documentation is recommended.

Recommendation: Contact a qualified professional.

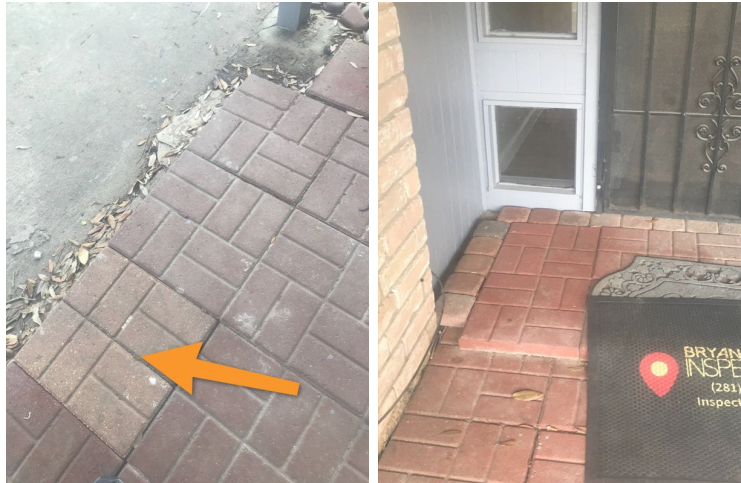
1: Flooring: Tiles Loose

Floor tiles were loose. Recommend re-attaching and sealing.

Recommendation: Contact a qualified professional.

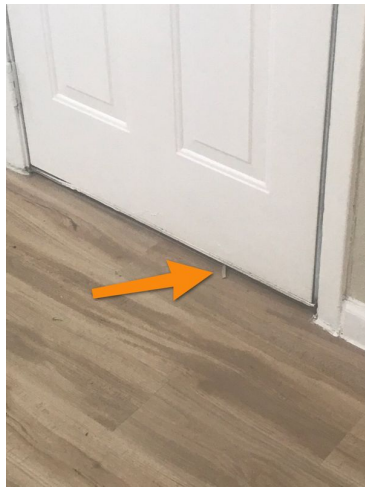
1: Door: Weatherstripping Missing or Damaged

Door is missing standard weatherstripping. This can result in significant energy loss and moisture intrusion. Recommend installation of standard weatherstripping.

Recommendation: Contact a qualified door repair/installation contractor.

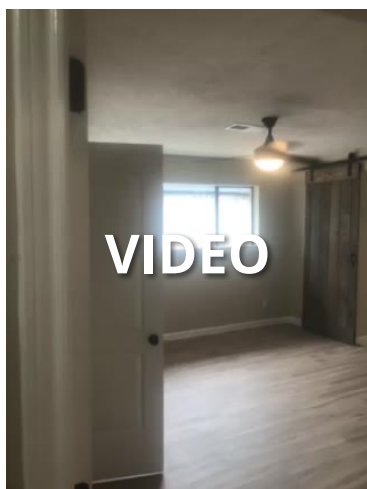
3: Door: Swings Open/Closes on its Own

For Example: Primary Bedroom
Evaluate and remedy as needed.

Recommendation: Contact a qualified professional.

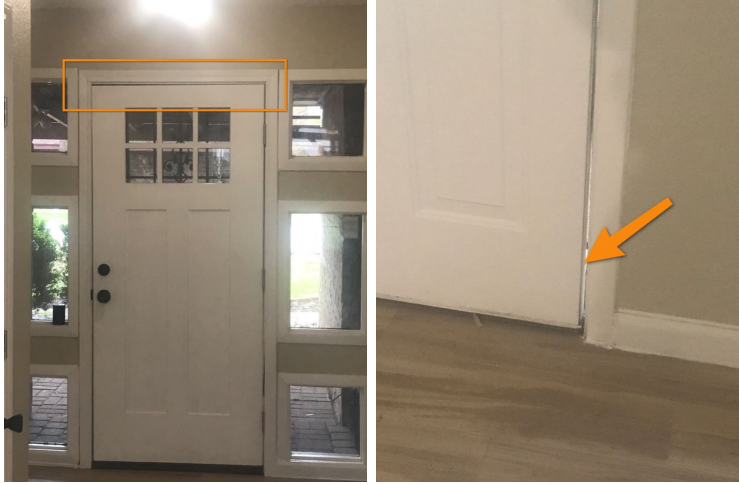
4: Door: Noticeable Gap at Frame

Gaps were observed between the door and frame, which could result in energy loss. Evaluate and remedy as needed.

Recommendation: Contact a qualified door repair/installation contractor.

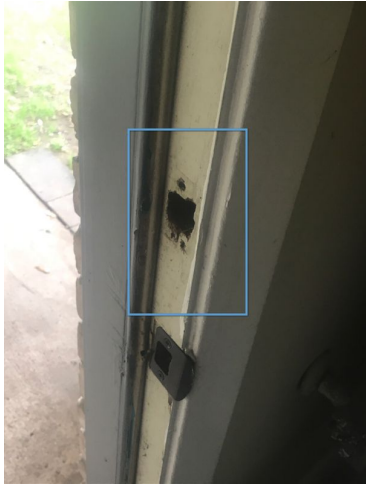
5: Door Hardware: Missing/Damaged Hardware

One or more door had missing or damaged hardware. Evaluation and remediation is recommended.

Recommendation: Recommended DIY Project

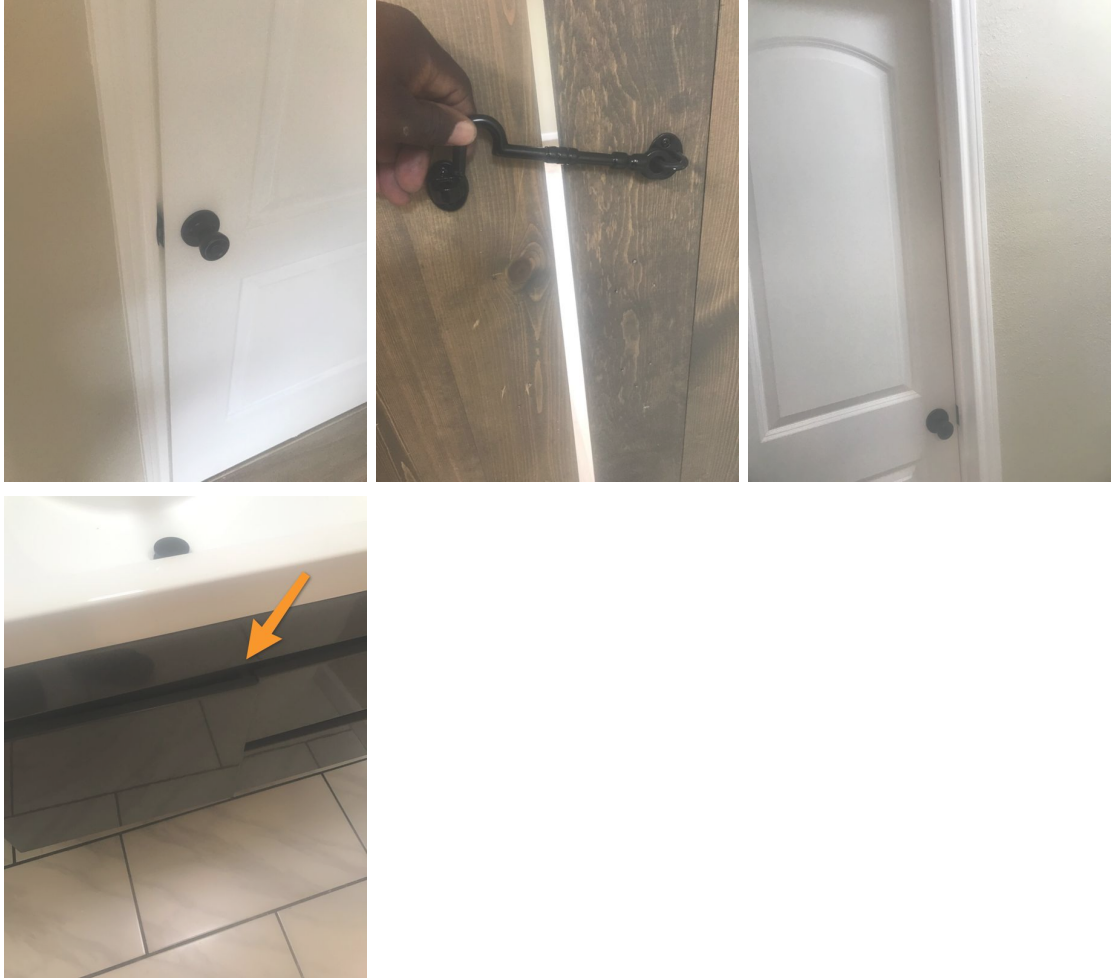
6: Door Hardware: Doesn't Latch

Door did not latch properly. Handyman repair of latch and/or strike plate is recommended.

Recommendation: Contact a qualified handyman.

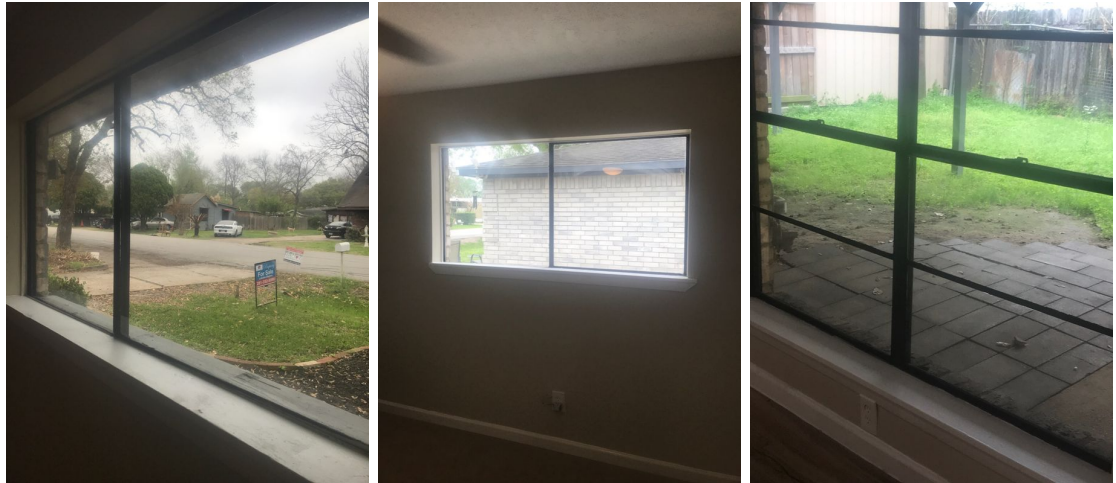
1: Missing/Damaged Screen(s)

One or more windows are missing a screen or had a damaged screen. Replacement of screens is recommended.

Recommendation: Contact a qualified window repair/installation contractor.

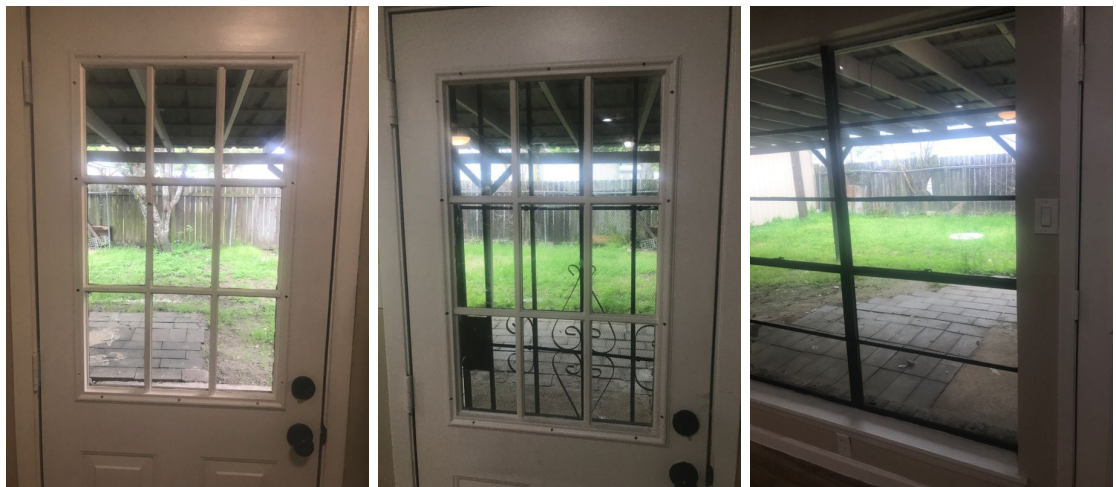
2: Safety Glass not Installed

Safety glass with a tempered stamp should be installed in all hazardous locations, such as:

Recommendation: Contact a qualified professional.

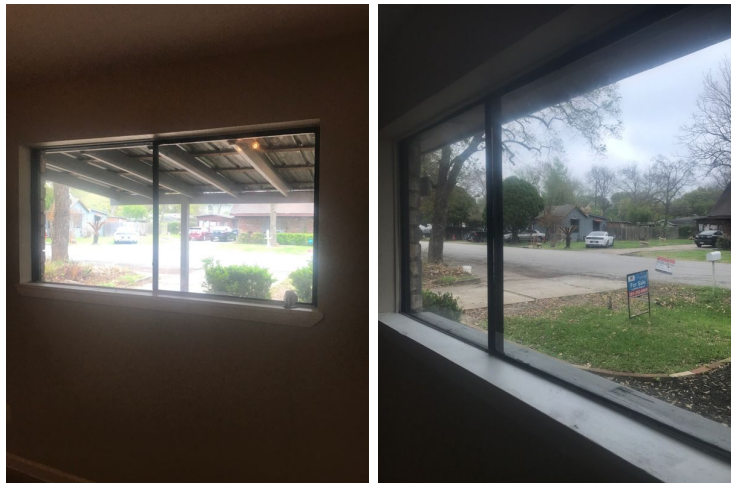
3: Difficult Operation

Windows were not operating properly. Evaluation and remediation by a window professional is recommended.

Recommendation: Contact a qualified window repair/installation contractor.

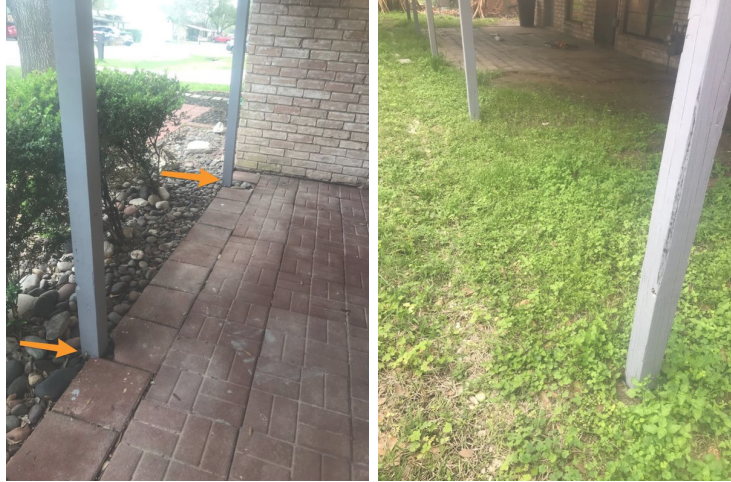
This condition is generally considered to be conducive to certain wood destroying insects and rot.

Recommendation: Contact a qualified professional.

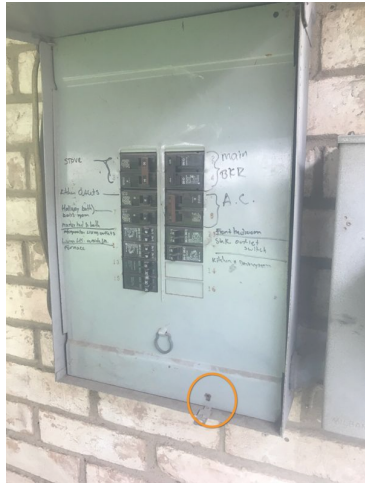
4: Missing Panel Screws

Screws that mount the cover to the electrical panel are missing. Remedy as needed.

Note: Blunt tipped screws designed for this application are recommended to prevent puncturing electrical wiring insulation.

Recommendation: Contact a qualified electrical contractor.

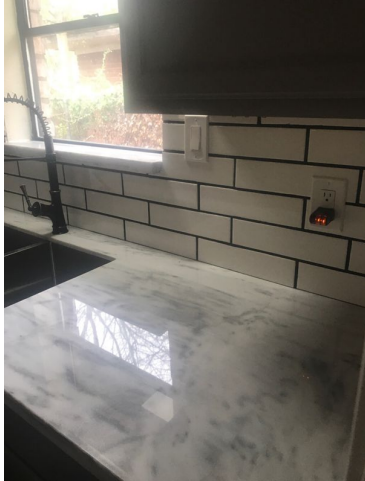
1: Receptacles: GFCI Protection Inadequate/Missing

GFCI protection was inadequate or missing. Current building standards recommend the installation of ground fault protection:

Recommendation: Contact a qualified electrical contractor.

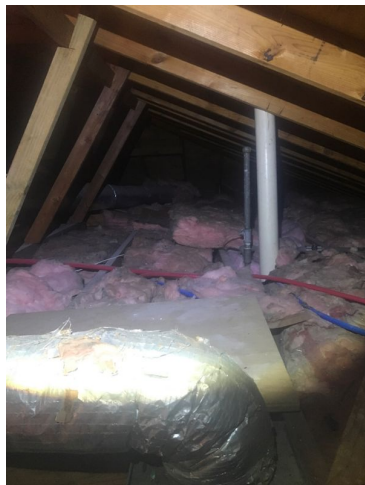
1: Note: Prior Repairs

Evidence of prior plumbing repairs was present in one or more areas of the home. It is recommended that you request repair documentation such as invoices, work orders, permits, or further explanation from the seller.

Recommendation: Contact the seller for more info

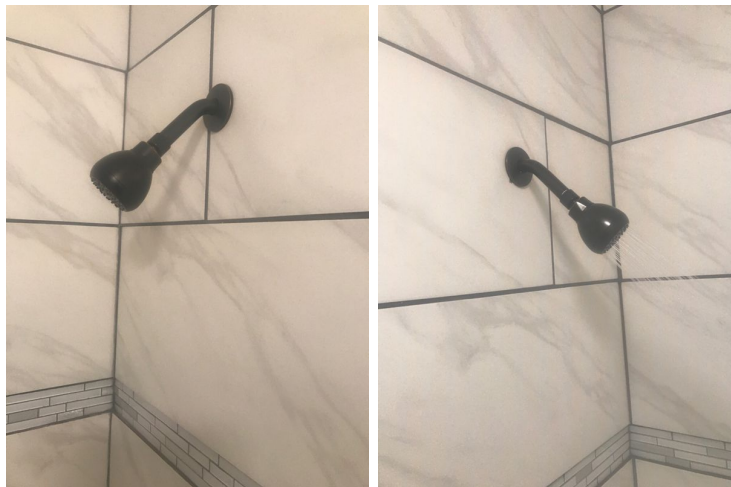
3: Shower: Loose pipe at showerhead

The pipe supplying water to the showerhead was loose at the wall . Remedy as needed.

Recommendation: Contact a qualified plumbing contractor.

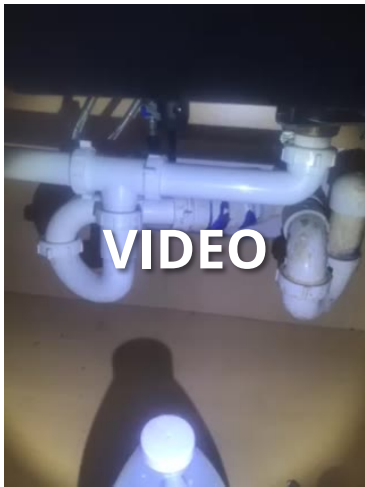
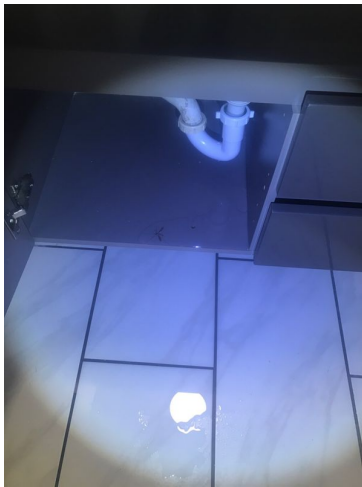
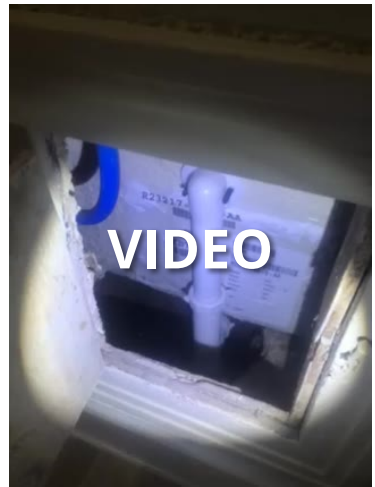
1: Drain piping: Leaks

Leaking was observed at time of inspection. Evaluation and/or remediation by a licensed plumber is recommended.

Recommendation: Contact a qualified plumbing contractor.

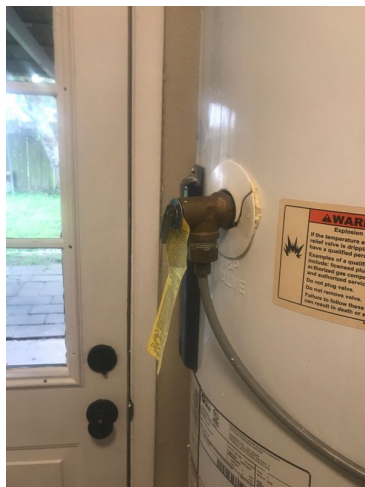
4: TPR Valve Note: Replacement may be needed

The manufacturer recommends replacement of the pressure relief valve every three years to ensure proper emergency function. The inspector does not test TPR valves due to safety hazard or possible damage to unit.

Recommendation: Contact a qualified professional.
