Property Inspection Report

308 11th Ave N, Texas City, TX 77590

Inspection prepared for: Tim Shea

Date of Inspection: 11/27/2019 Time: 8:00 AM

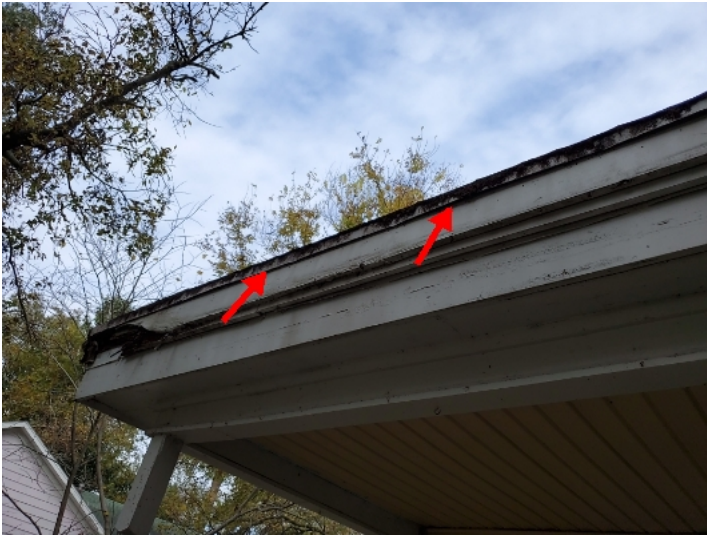
The roofing material on the front porch does not have the appropriate over hang on the left side causing water to drip down the fascia board on the front porch.

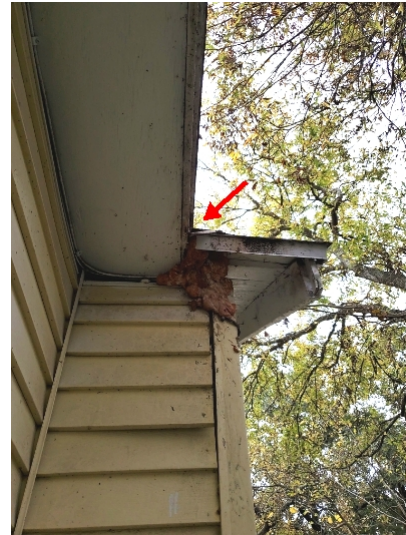
Improper/flashing that is not working properly on left middle of exterior.

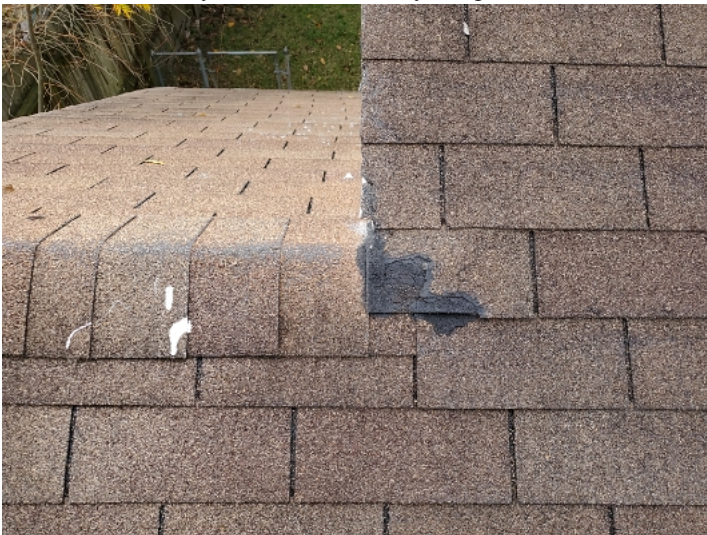
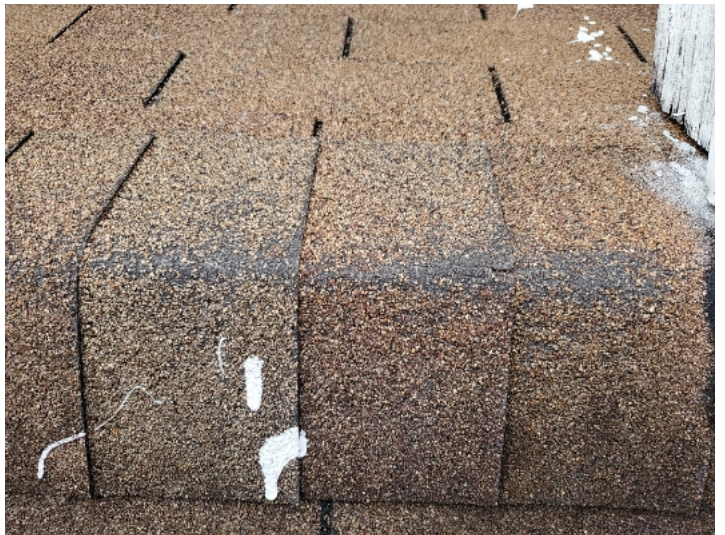
Wear on ridge cap shingles.

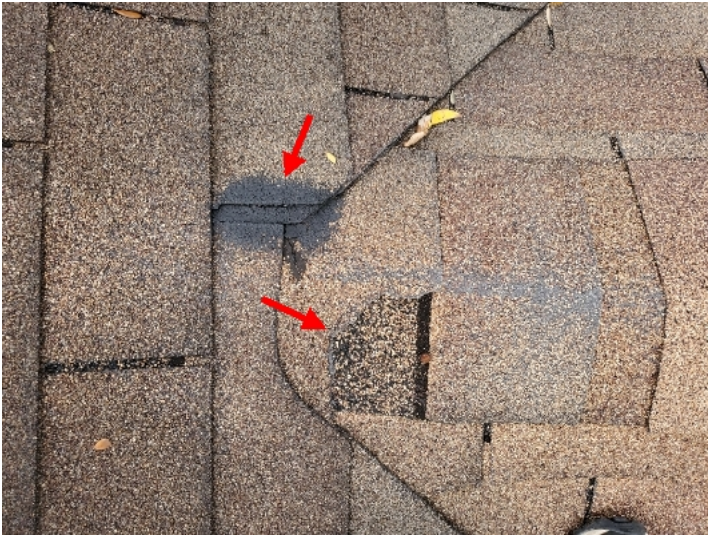
Damaged and torn ridge cap shingles.

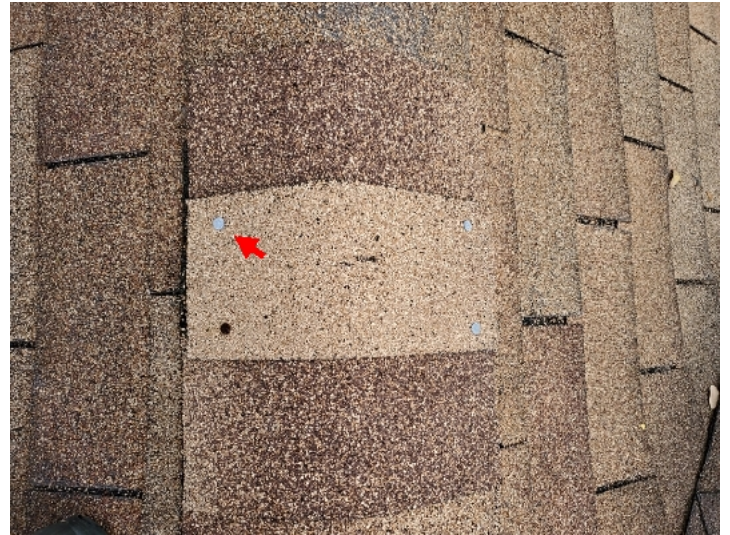
Multiple exposed nail heads.

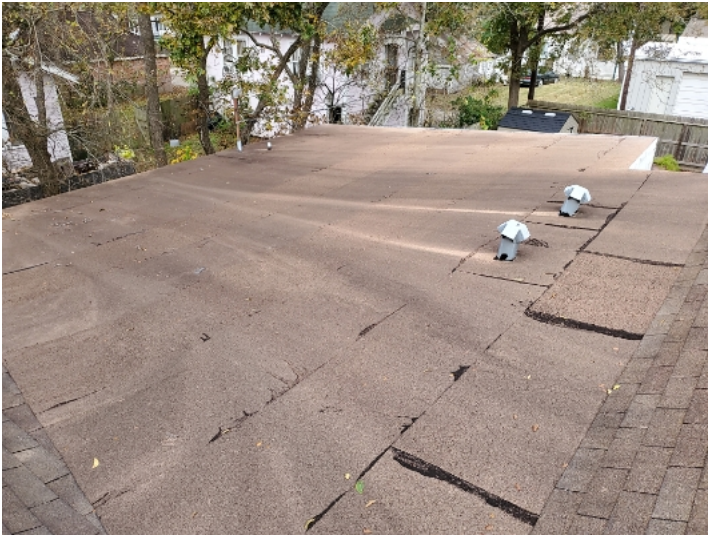
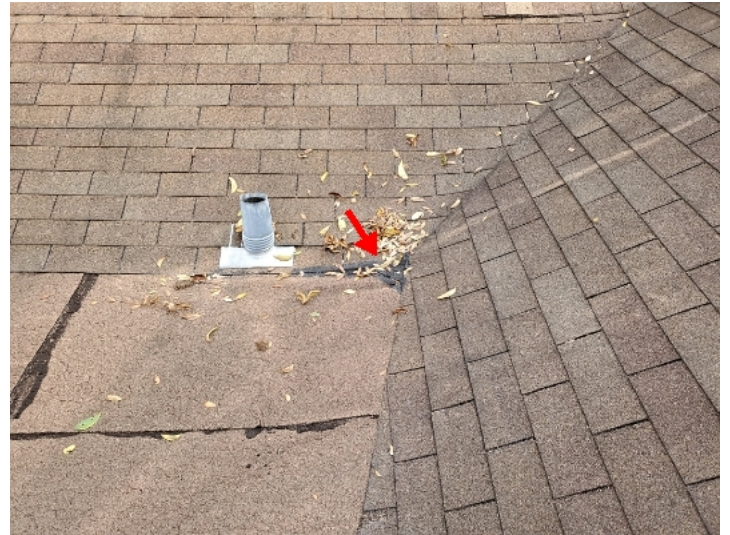
Evidence of sealing leaks.

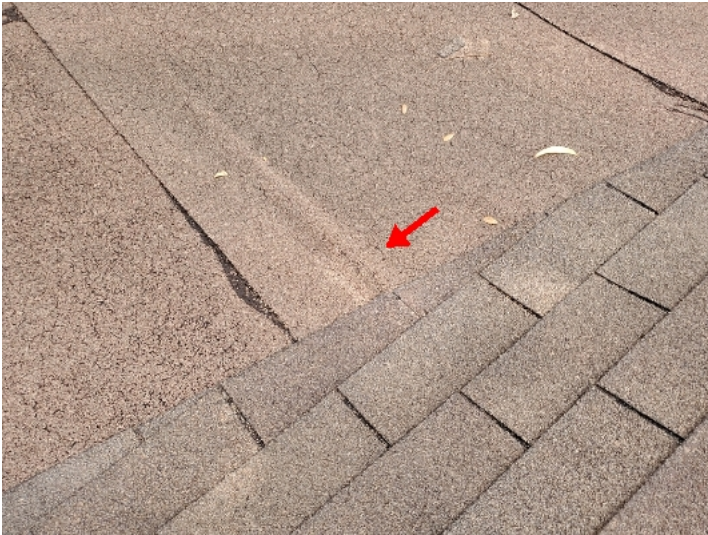
Wrinkled roll roofing material.

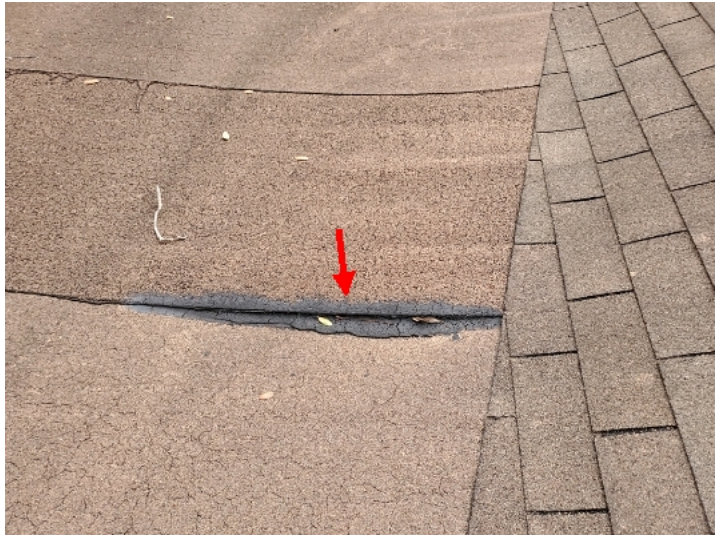
Evidence of sealing leaks.

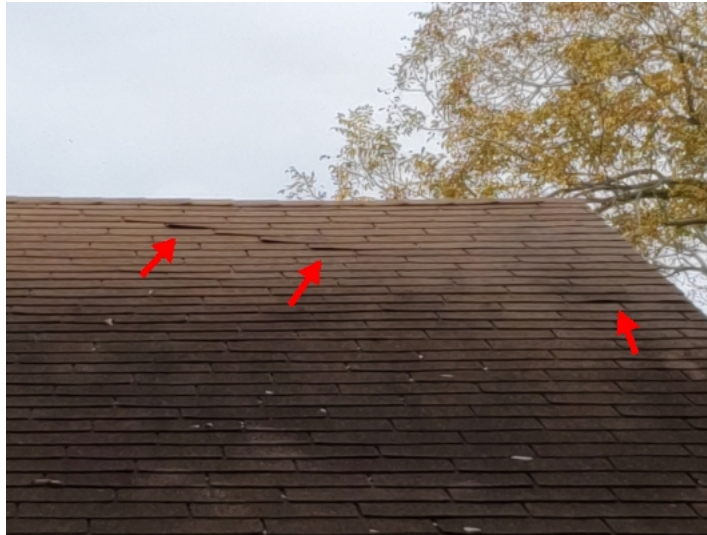
Various lifted shingles on roof.

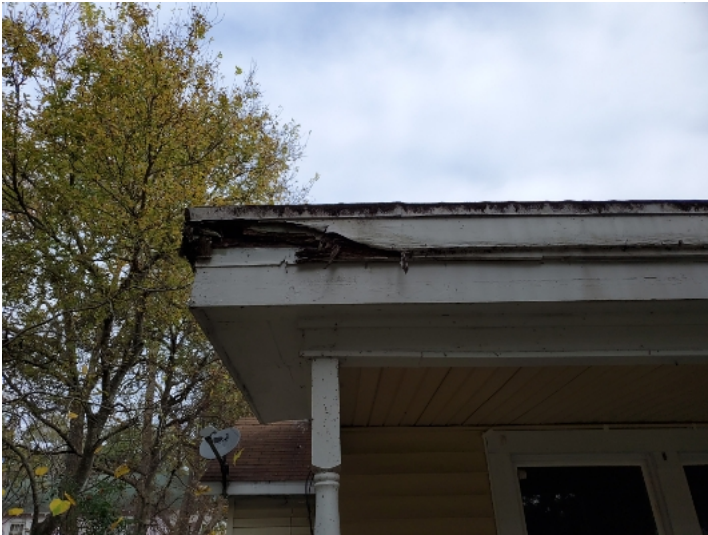
Damaged fascia board on left front of porch.

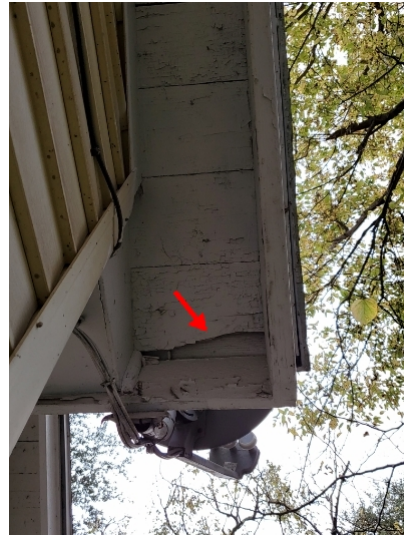
Decking and fascia damage on left middle of exterior.

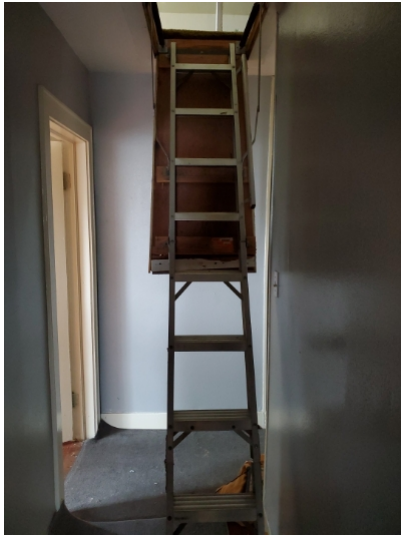
Damaged attic access ladder recommended repair/replace.

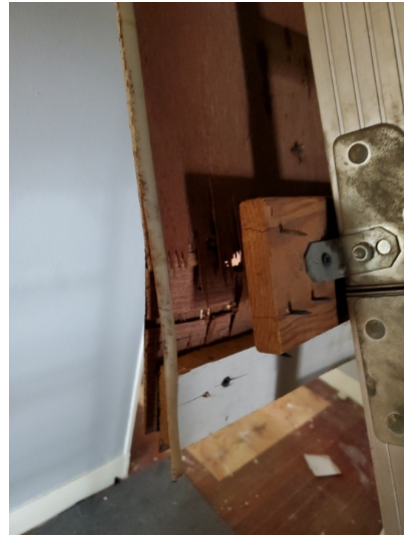
Damaged attic access ladder recommended repair/replace.

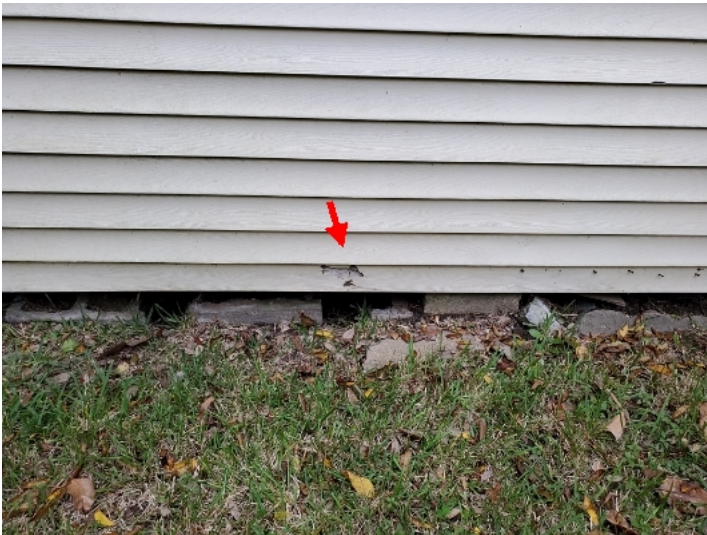
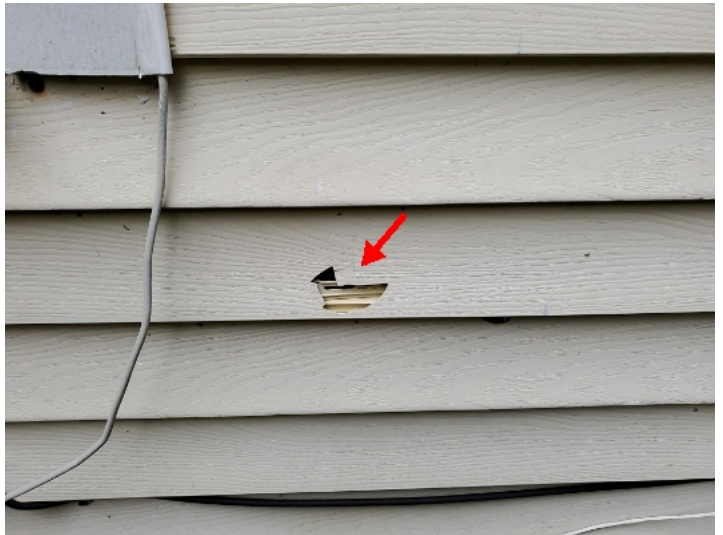
Damaged wood siding underneath vinyl siding on rear of house

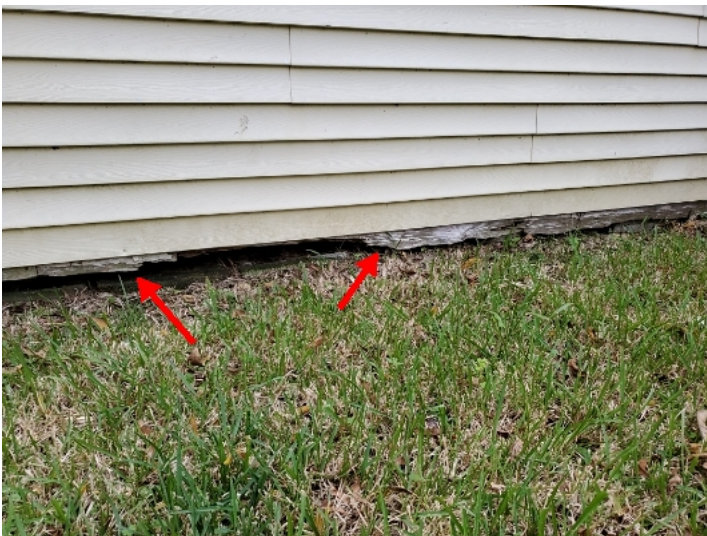
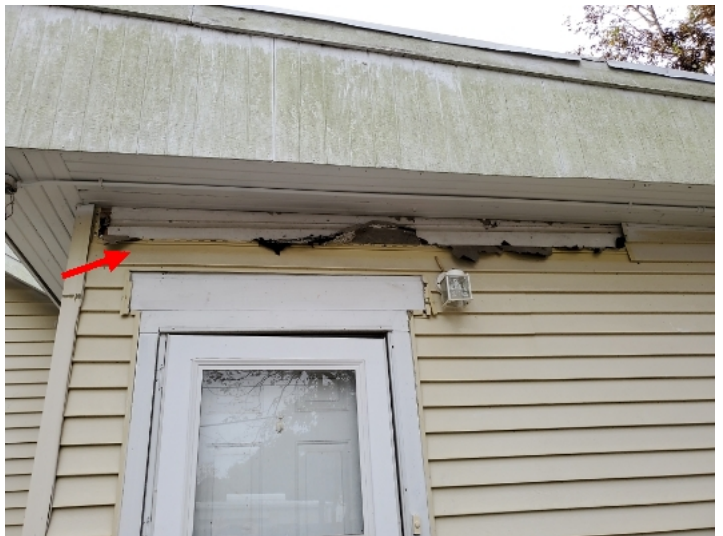
Section of missing vinyl siding of rear of house.

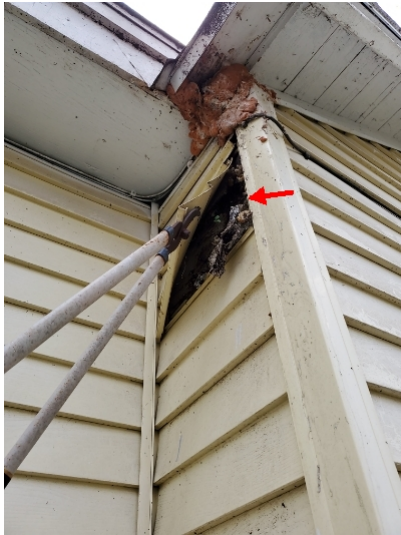
Water damaged siding in left middle of exterior.

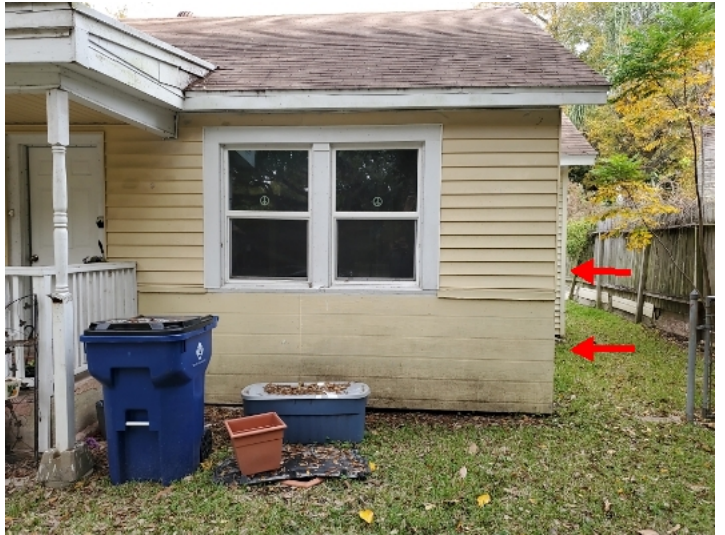
Mismatched of exterior siding on front of house.

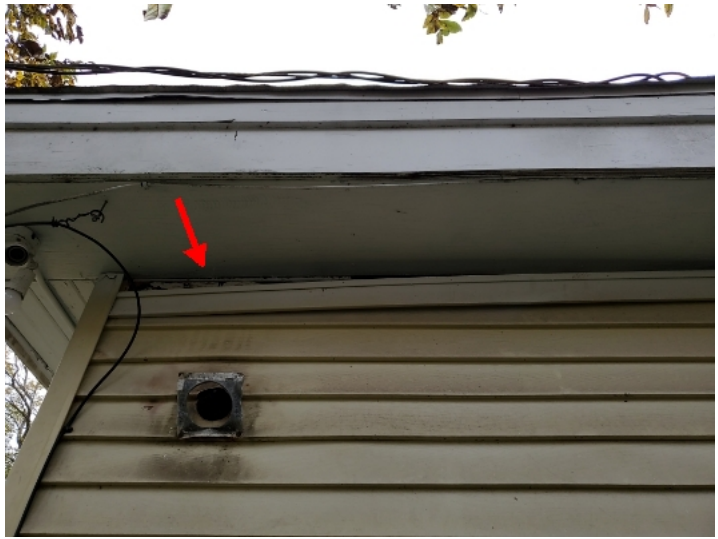
Loose vinyl siding on left rear of house.

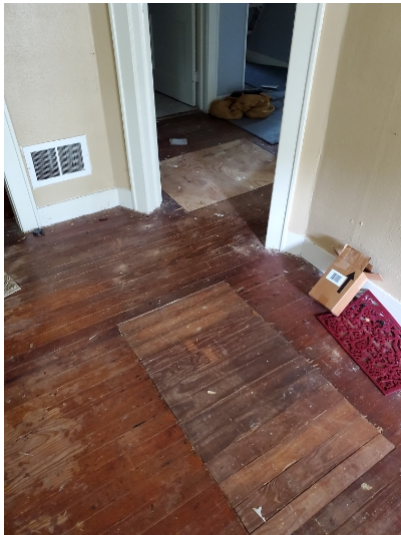
House will require new floors throughout.

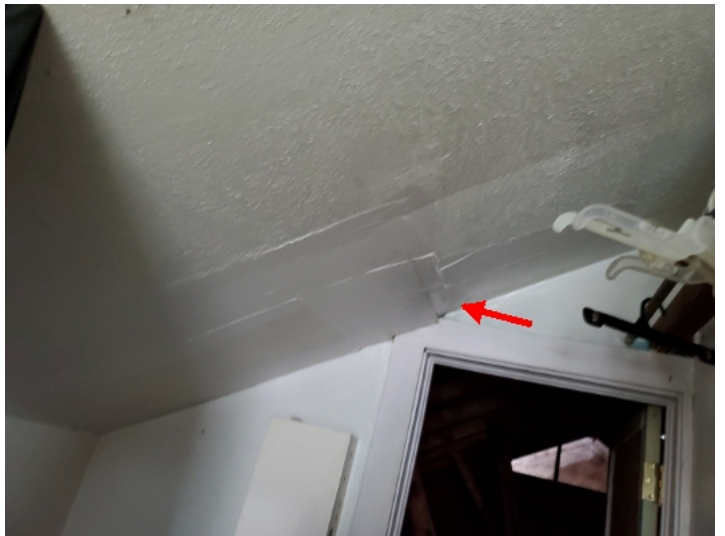
Various ceiling drywall damage in converted attic space.

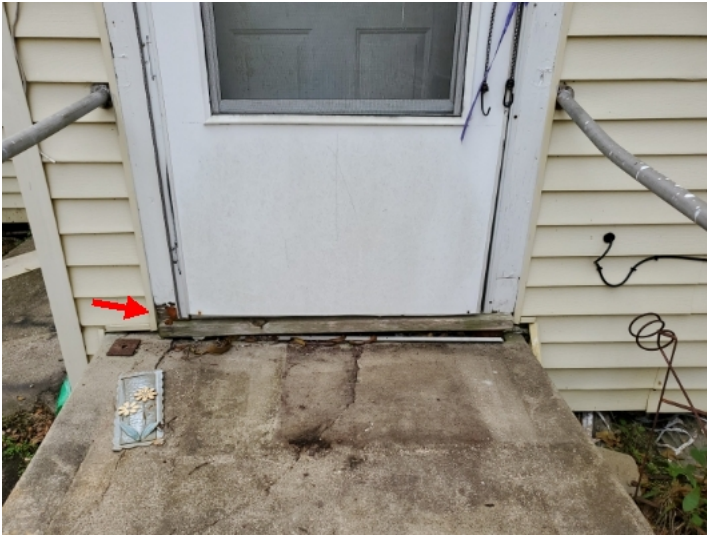
Damaged trim at the bottom of the back door.

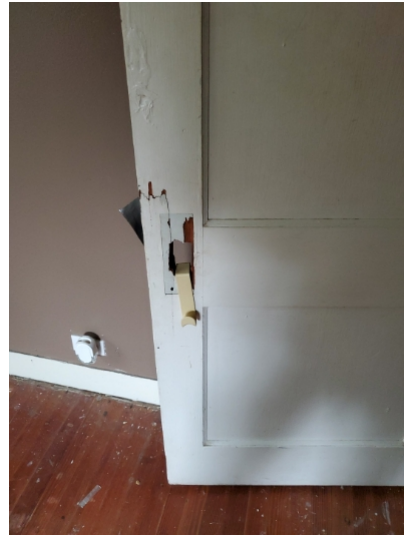
Various damage to interior doors and hardware.

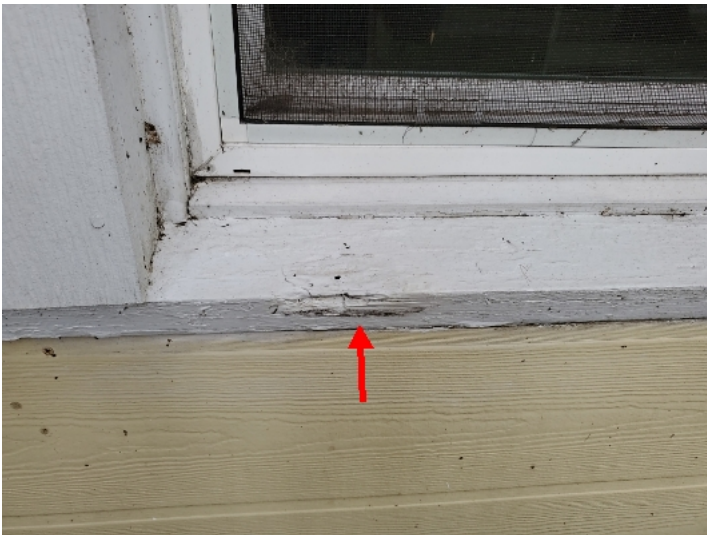
Various damaged window sill around exterior of the house.

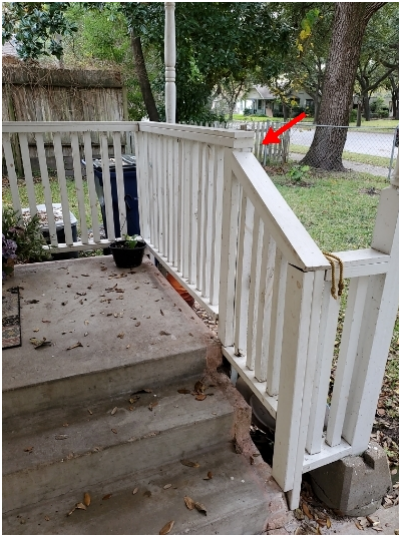
The hand rail on the front steps needs to be stabilized.

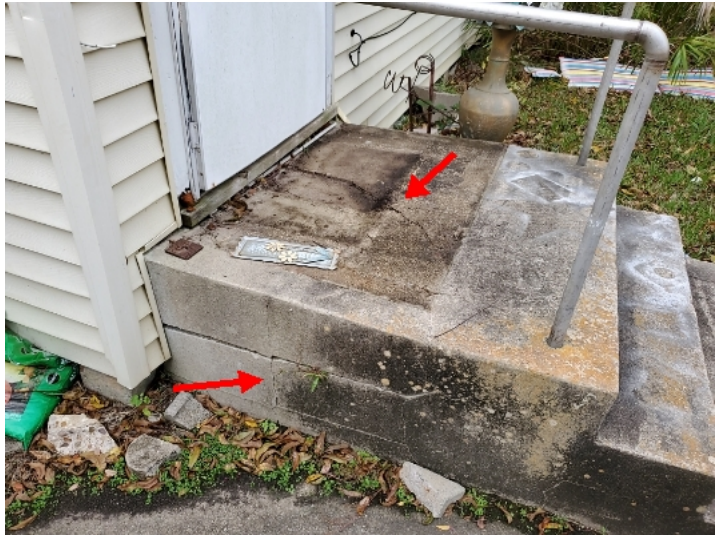
Large settlement cracks on back door steps.

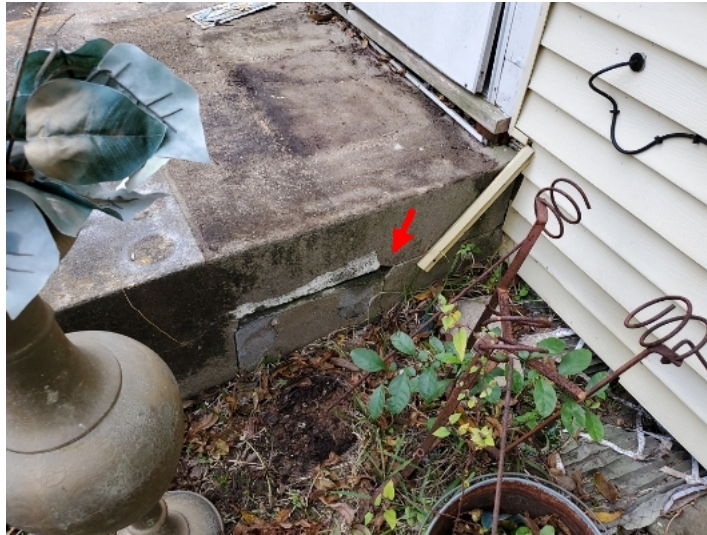
Large settlement cracks on back door steps.

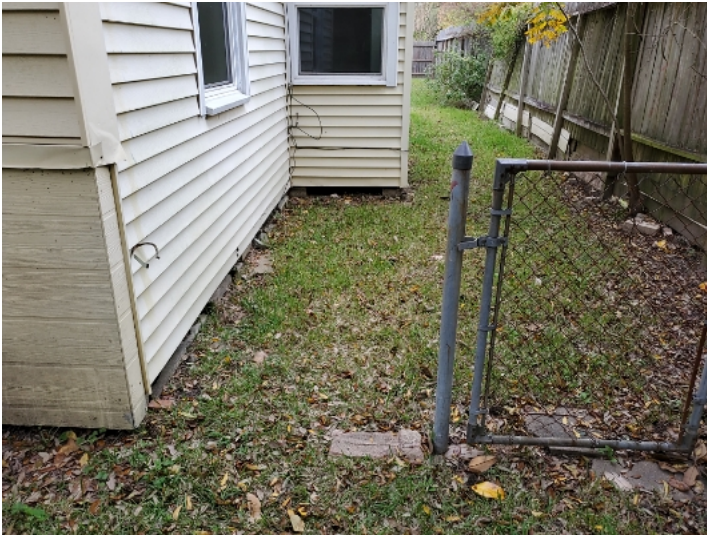
Missing section of fence on right front of house.

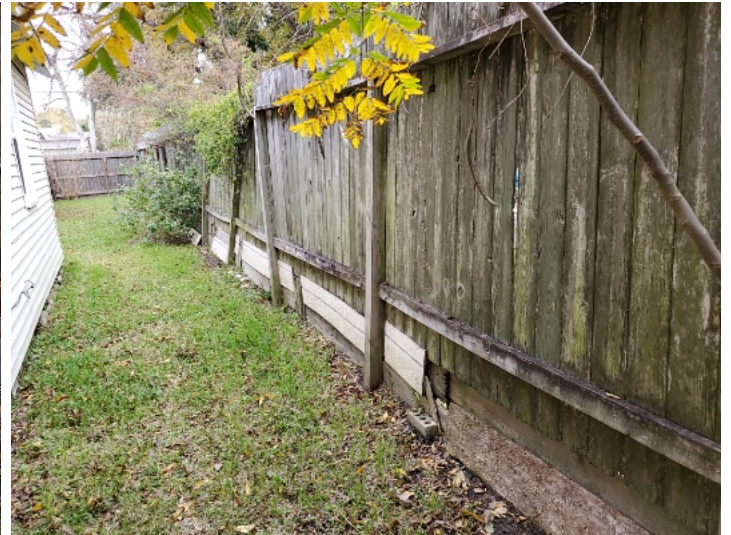
Various repairs to fence.

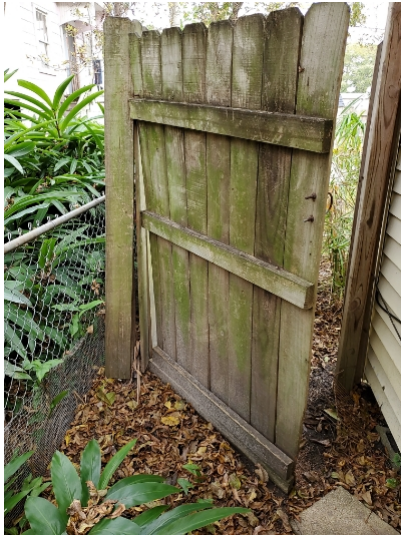
Left side gate is in need of adjustment and repairs.

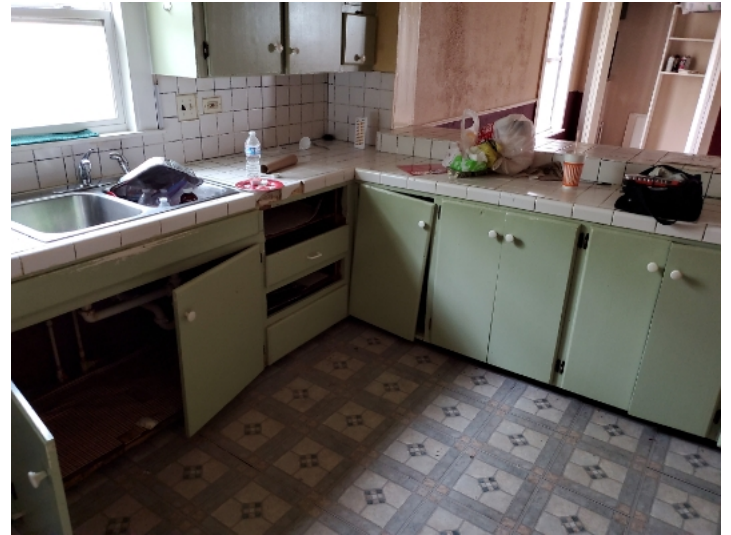
Kitchen cabinets are in poor condition and will need to be replaced.

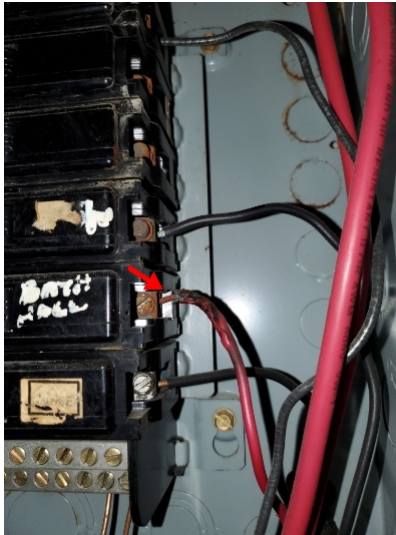
Charred wire in sub panel.

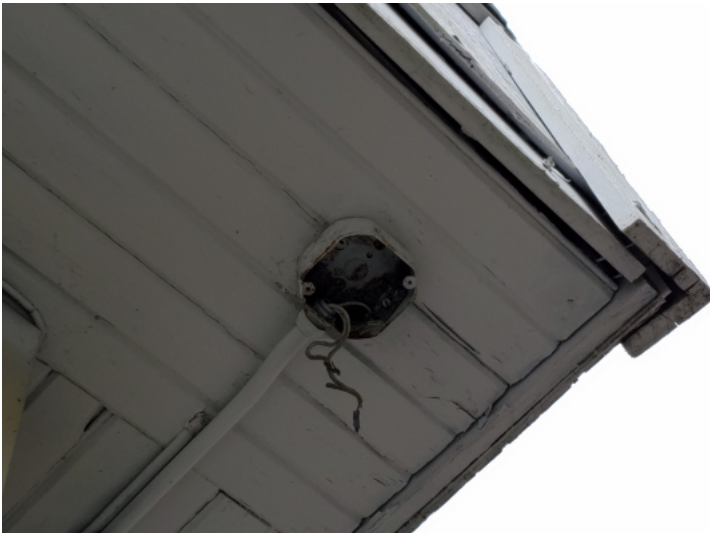
Exposed outlet box on rear of house above back door.

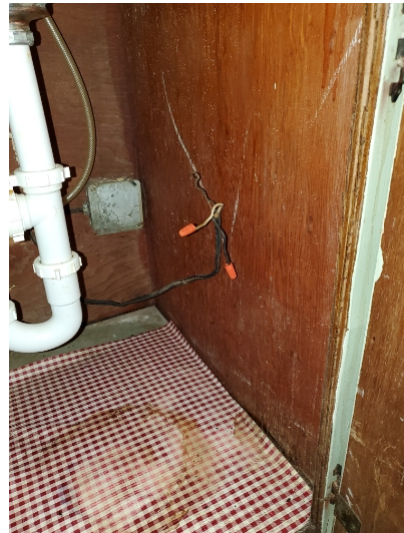
Exposed wires underneath kitchen sink.

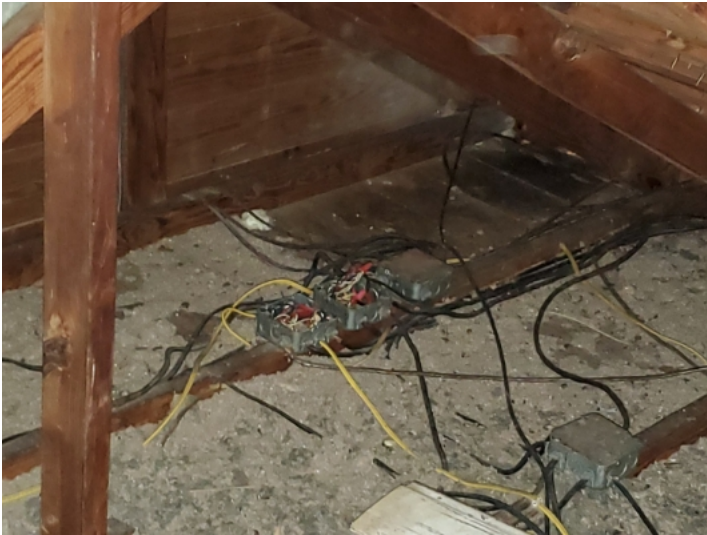
Open junction boxes and light fixtures that are not properly installed in attic.

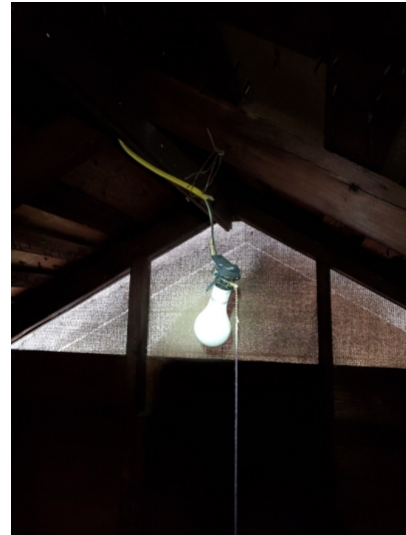
Open junction boxes and light fixtures that are not properly installed in attic.

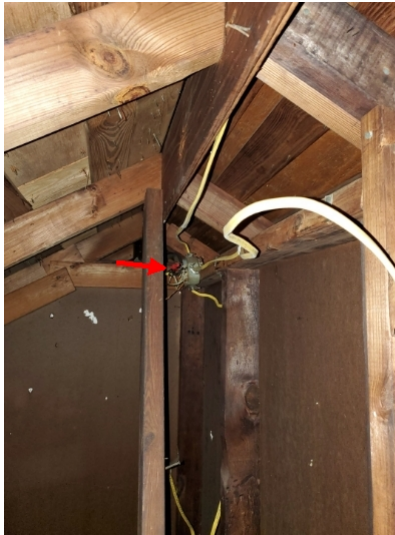
Open junction boxes and light fixtures that are not properly installed in attic.

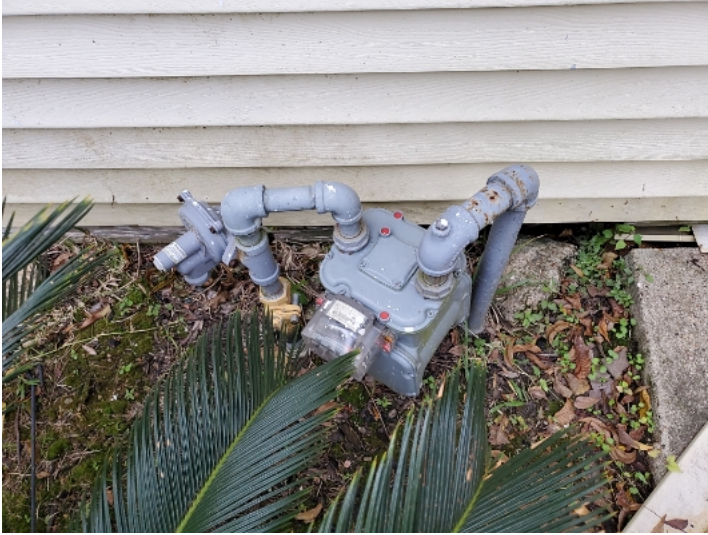
Gas meter is still present.

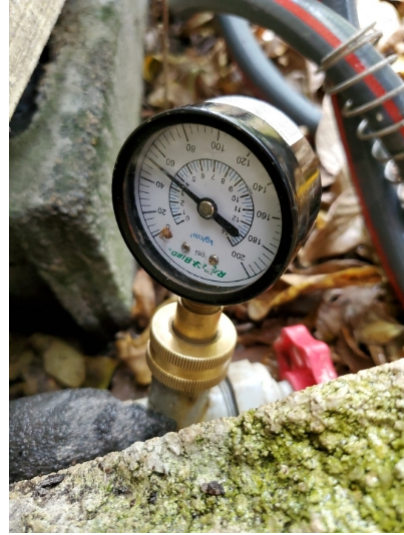
The anti static water pressure was observed between 45-55 PSI. Acceptable water pressure is between 40 and 80 psi.

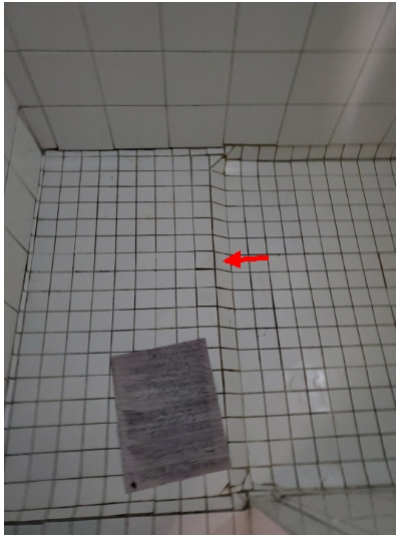
Loose tiles in Master bathroom shower.

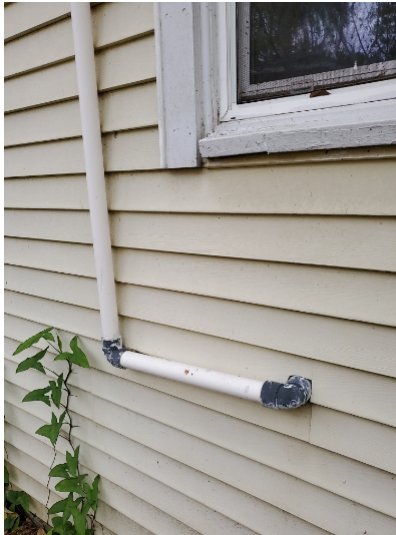
Kitchen sink vent stack in installed on the exterior of the house.

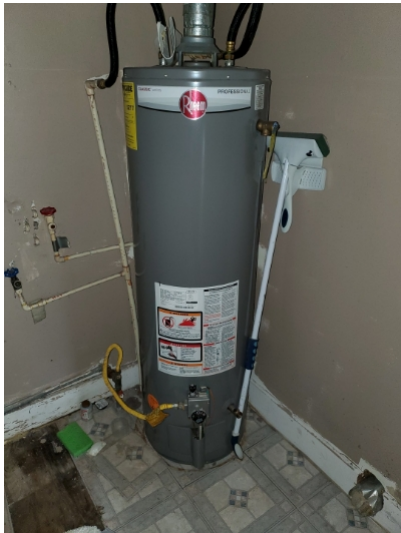
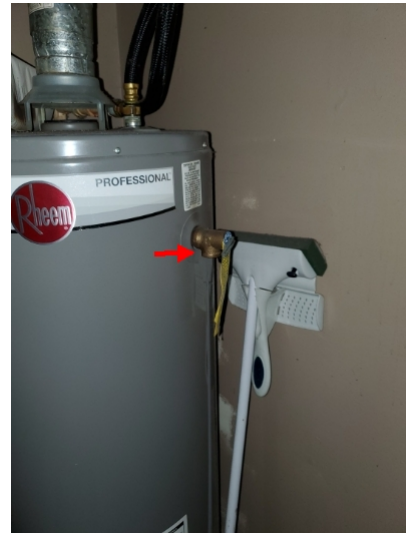
The TPR valve is not plumbing to a safe location.

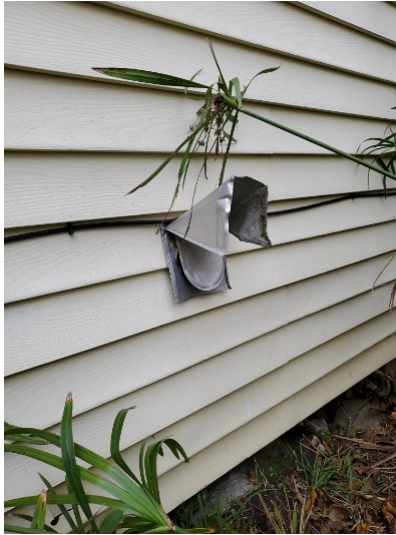
Damaged dryer vent damper is in need of replacement.
